# **HISTORIC STRUCTURES REPORT**

## **U.S. COMMISSIONER'S HOUSE**

**Mammoth, Yellowstone National Park**

**April 2011**

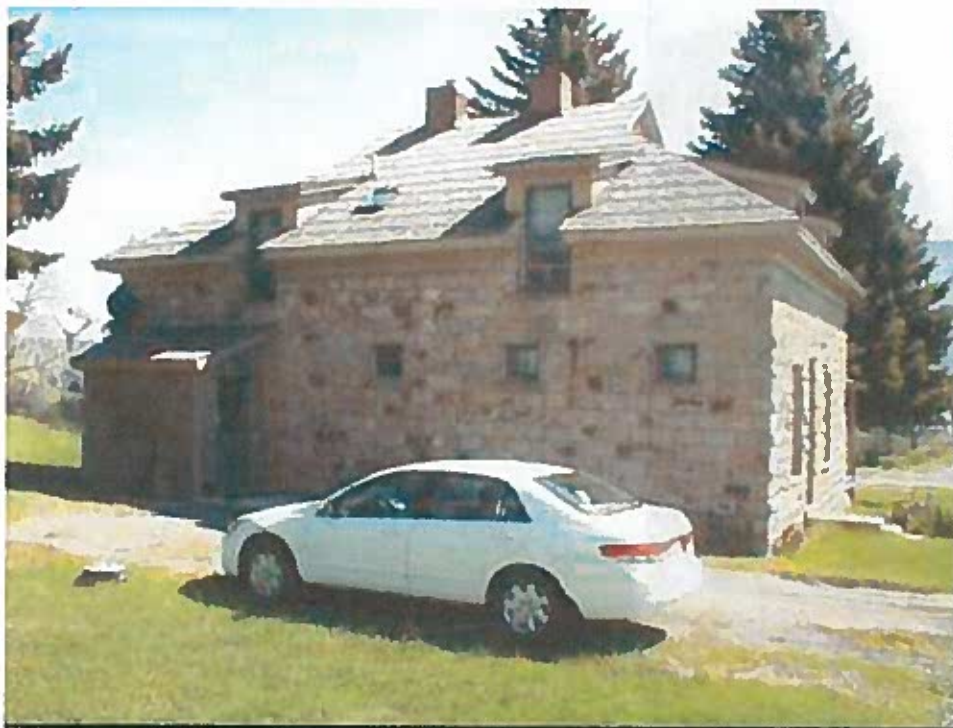
West Wall; the vestibule at the back door (shed roof) is not original. The three small square windows once served jail cells within the facility. Photo Credit: Ken Sievert.

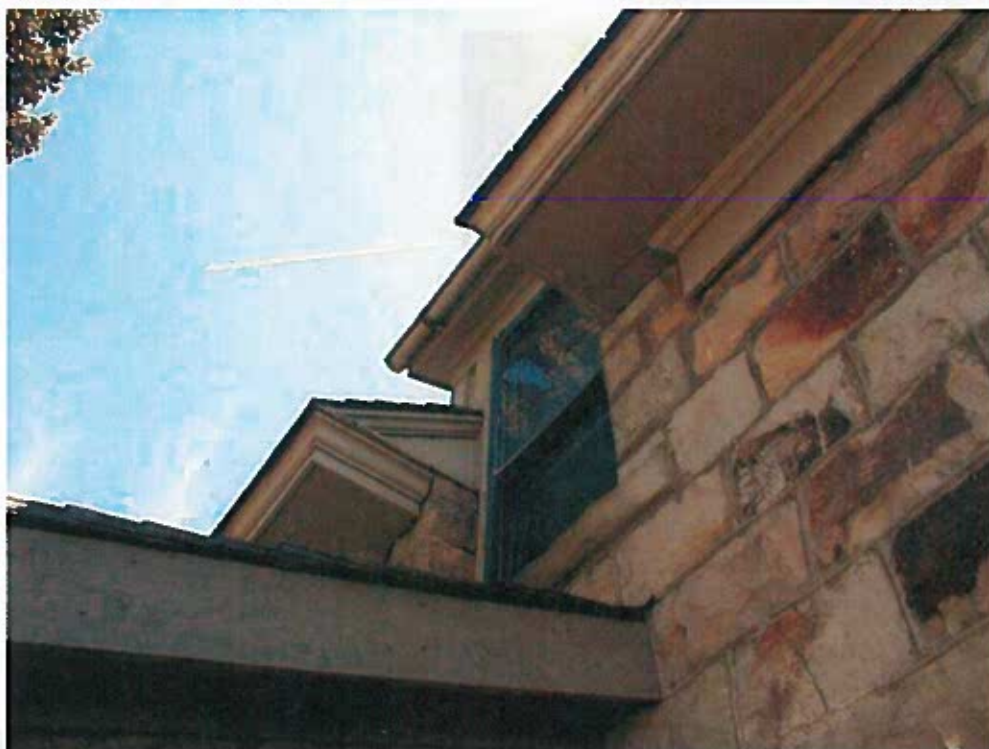
NE dormer above back door entrance vestibule. The relationship of the shaped ogee fascia, frieze board, and stonework can be seen in this photograph. Note that the newer fascia on the vestibule addition is a plain flat board. Photo Credit: Ken Sievert

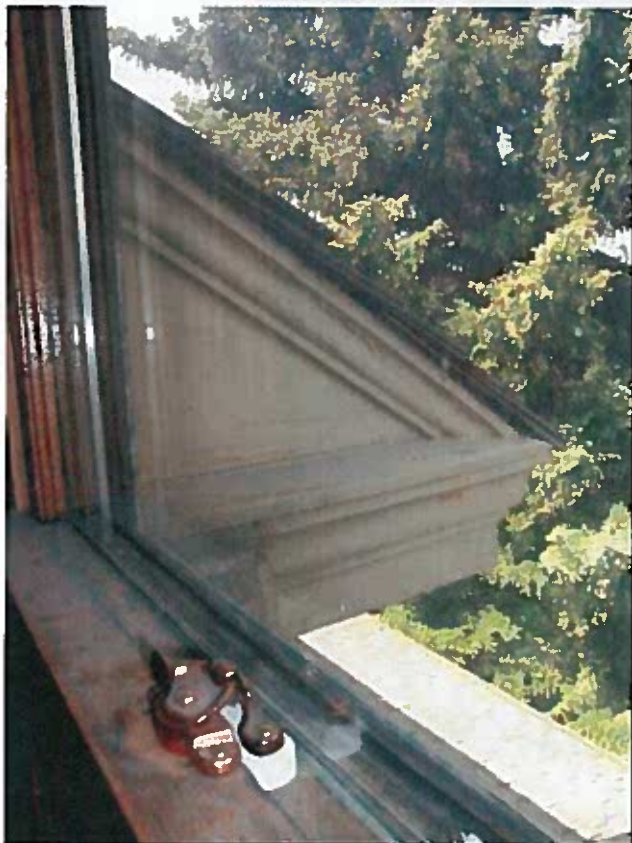
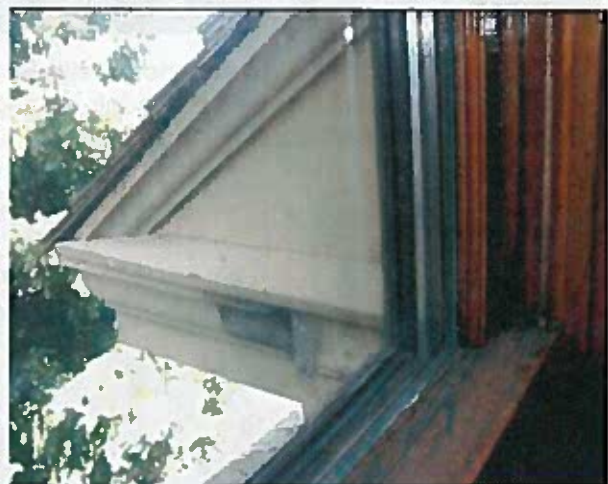
Wood detailing associated with the side pents of the dormer windows located in the east and west exposures of the house. Dormers in the north and south walls do not extend through the roof plane as previously noted. Photo Credits: Herb Dawson, NPS.

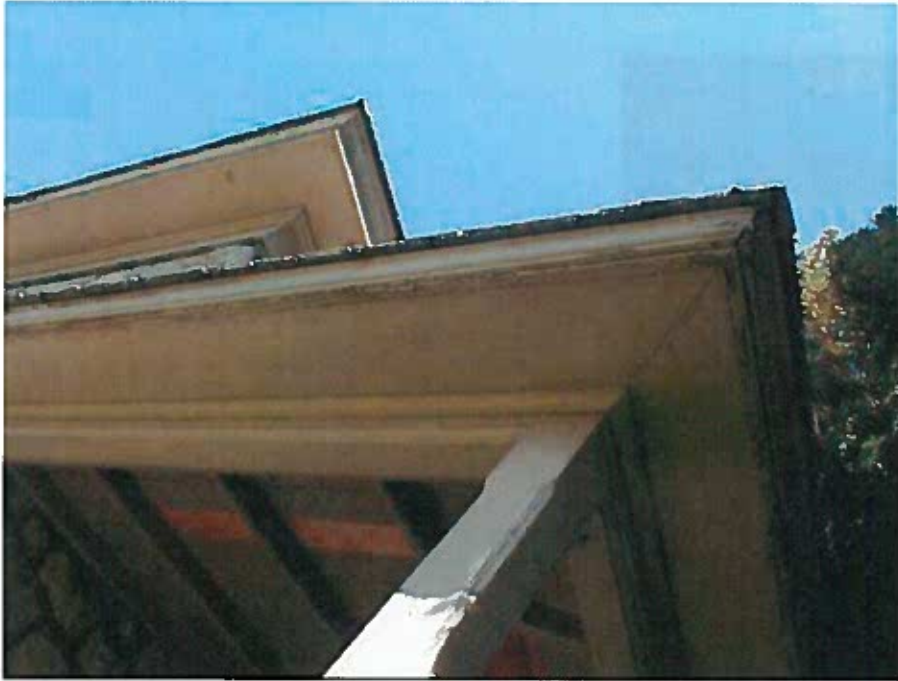
Soffit, fascia, and roof edge detailing at the porch; with the upper roof visible in the background above. Photo Credit: Ken Sievert .

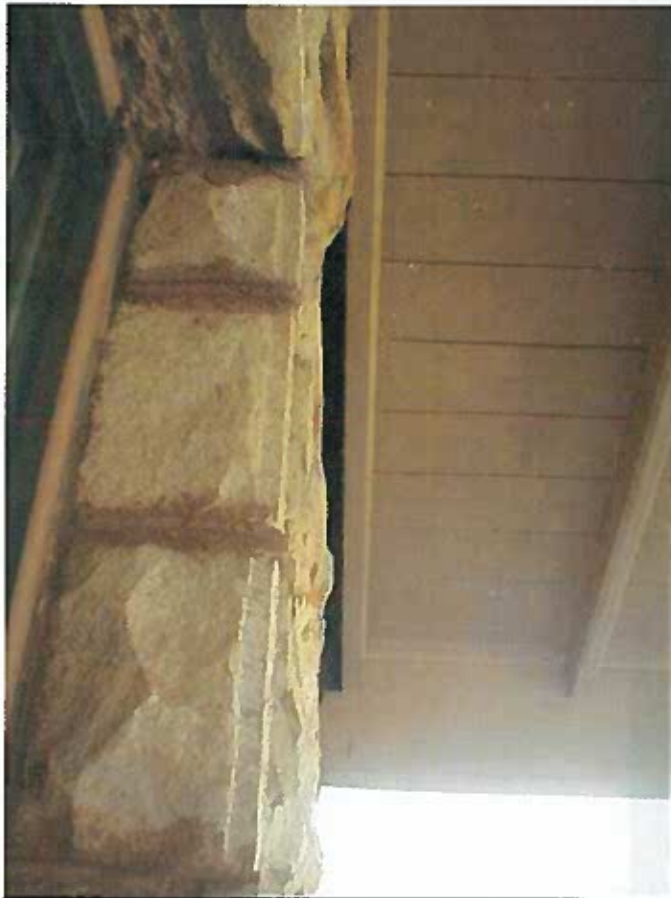
Intersection of the underside of the porch with the stone wall. Photo Credit: Ken Sievert .

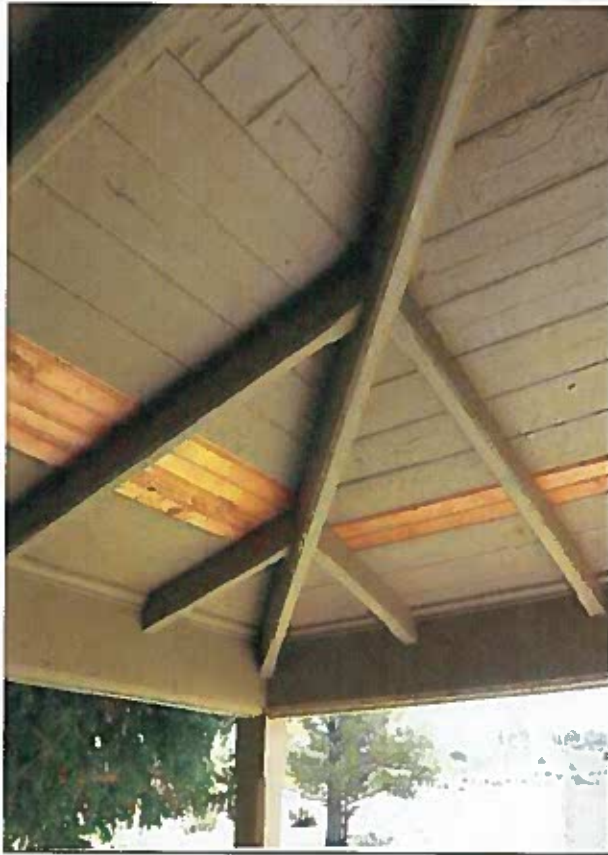
**Roof framing and underside of sheathing at entrance porch.**  
 Photo Credit: Herb Dawson, NPS.

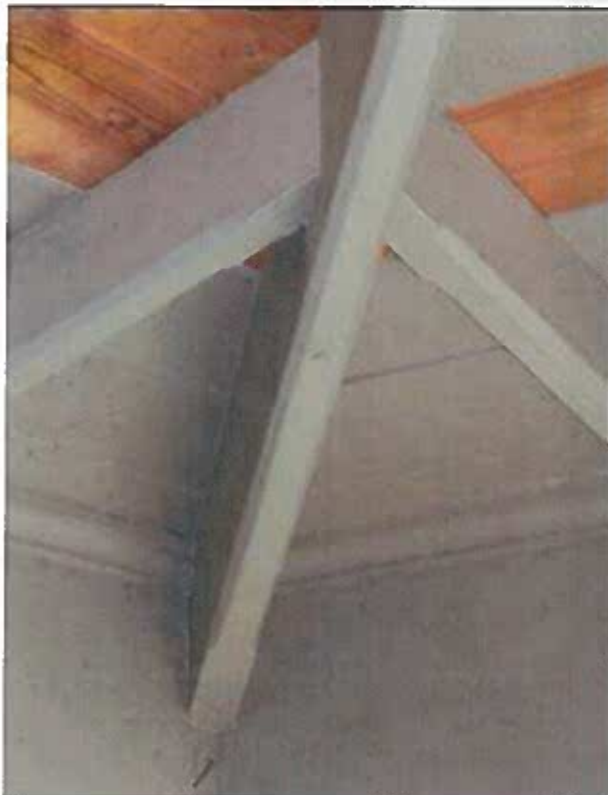
**Beveled chamfers on the exposed framing members. Recently replaced sheathing boards are unpainted.** Photo Credit: Herb Dawson, NPS

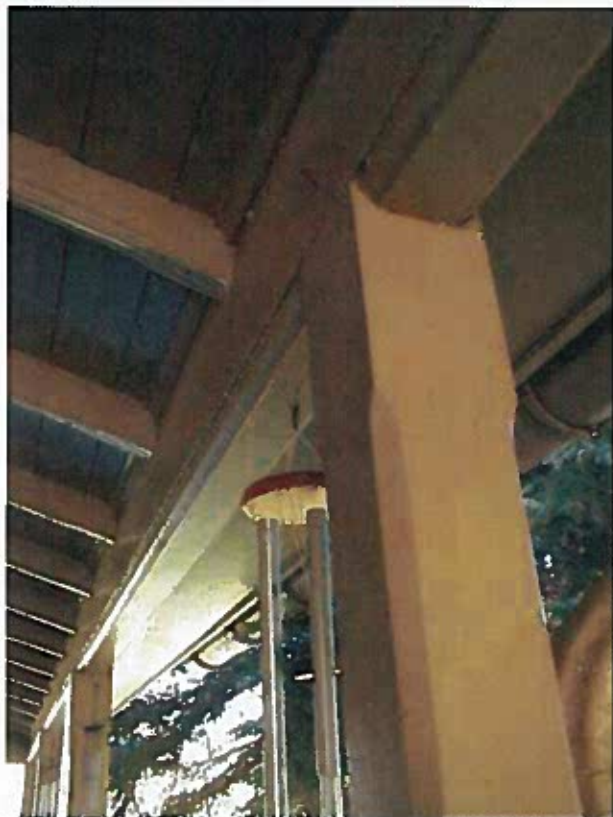
Front Porch column and beam supports.  
Photo Credit: Ken Sievert.

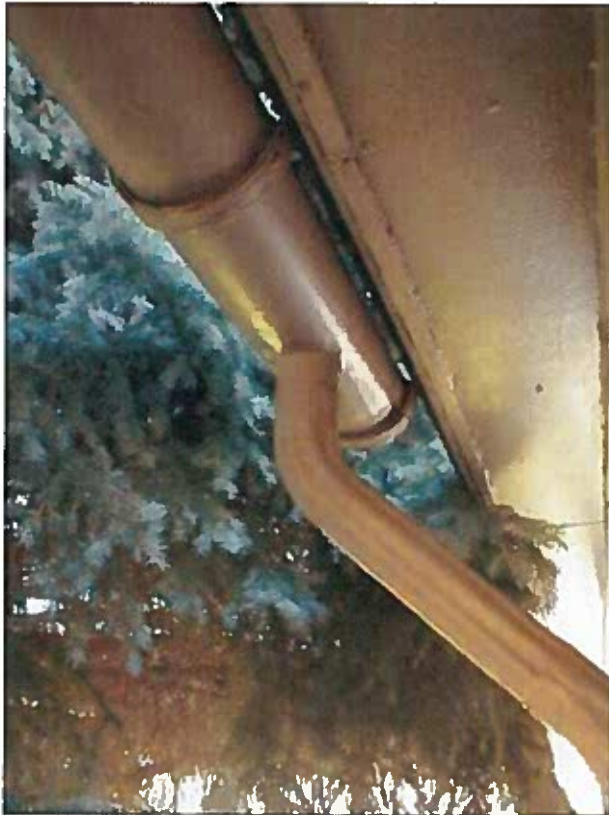
Calvary style half-round gutter at front porch. Similar gutters are used at the 2<sup>nd</sup> floor dormers. Photo Credit: Ken Sievert.

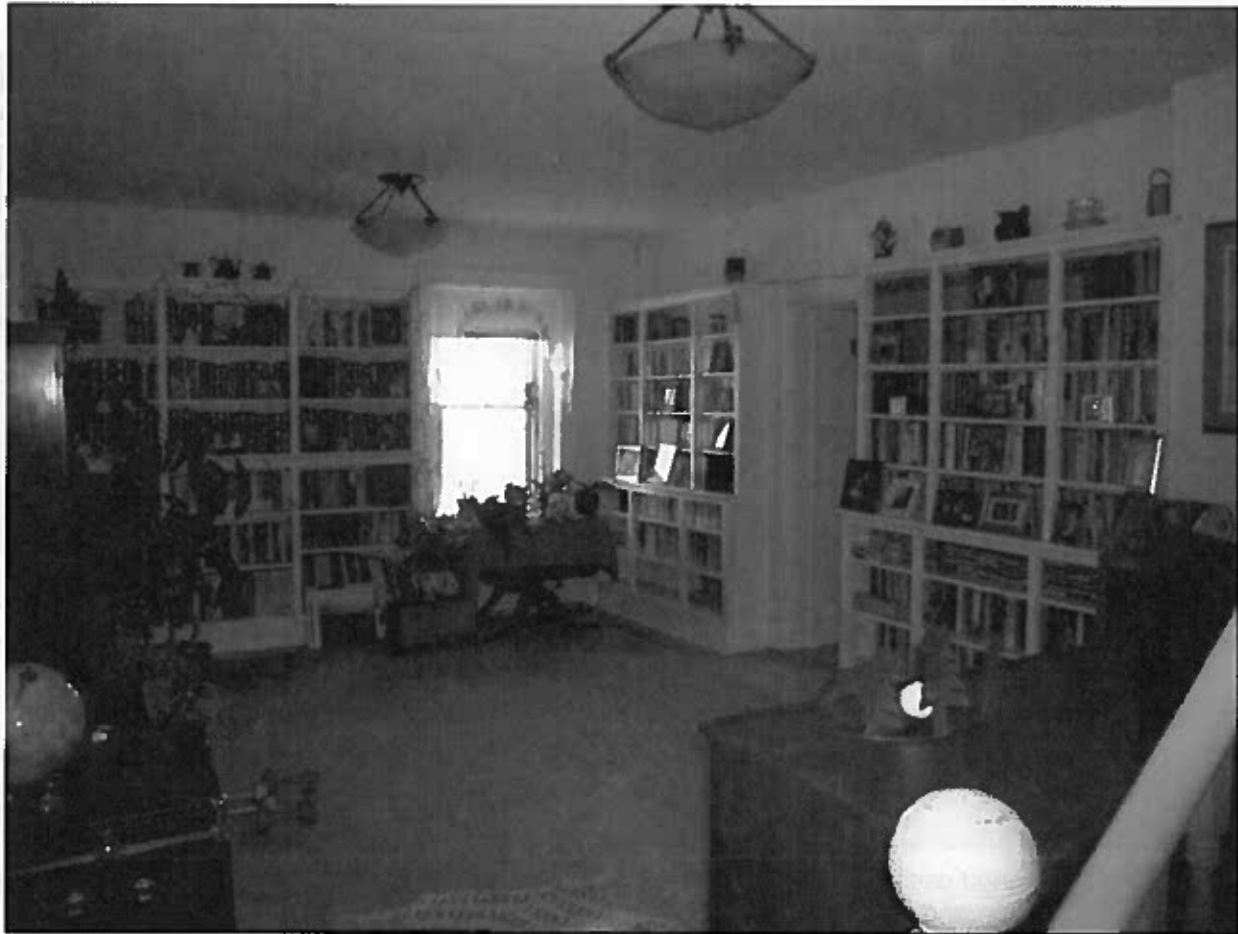
Interior of Living Room / Study. The door right-of-center accesses the original jail area – now used as a music room. Exterior walls on this floor of the U. S. Commissioner's house have been furred out and resurfaced with gypsum drywall. It is difficult to tell, but the period woodwork has either been re-installed or was replaced in-kind at the time of the wall modifications.

The ball finial atop the bottom balustrade post of the stairhouse serving upstairs areas is visible in the lower right of the photo.

Note the hardwood flooring within the area. It is not known if this material is original to the space; however, the material is period appropriate and is sensitive to the design of the house. Photo Credit: Herb Dawson, NPS.

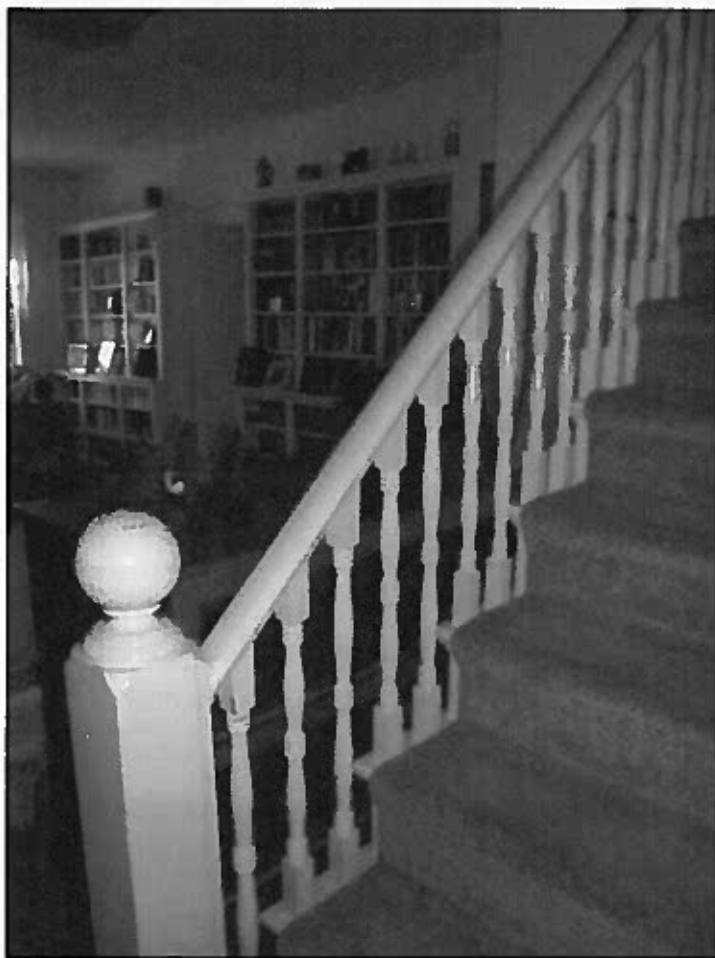
Detailing of stair between the Living Room and the sleeping areas located on the upper floor level. The woodwork in the railing, balustrade, and baluster posts may originally have been stained or natural. Photo Credit: Herb Dawson, NPS.

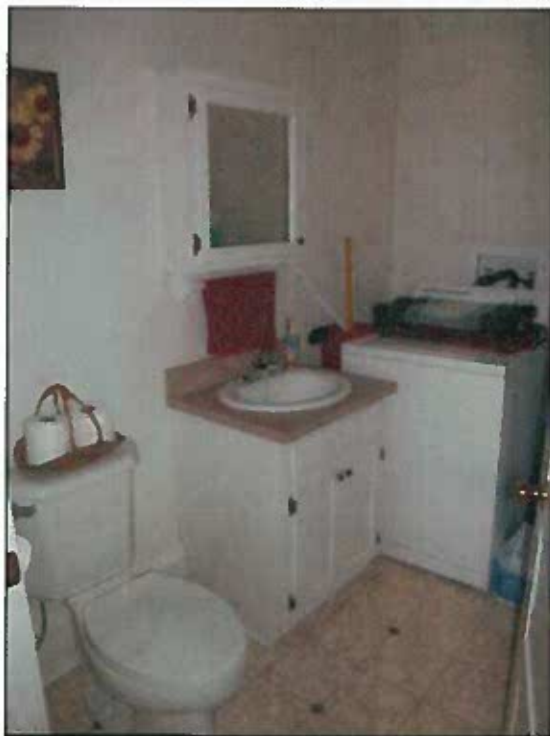
Bathroom / Utility room on the first floor. Materials and finishes within this space are contemporary. Photo Credit: Herb Dawson, NPS.

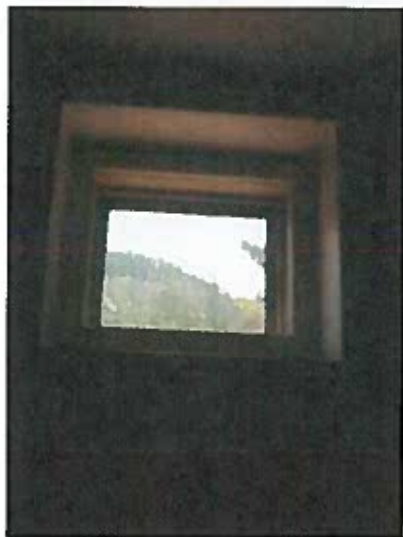
Replacement window in west wall of first floor bathroom. This window has been installed in an opening once used as a cell window.

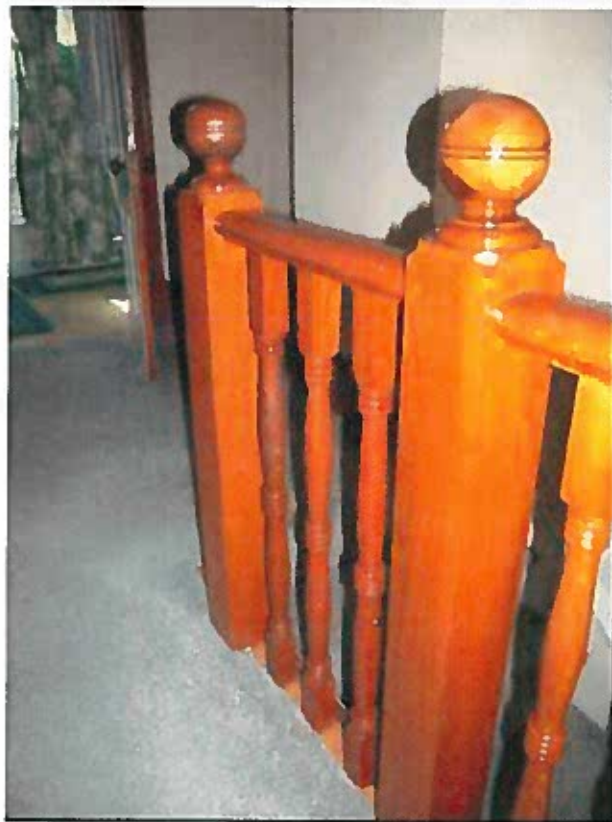
The upper landing has been re-configured at some time during the structure's history as evidenced by the duplication in Newel Posts at the top of the stair. Photo Credit: Herb Dawson, NPS.

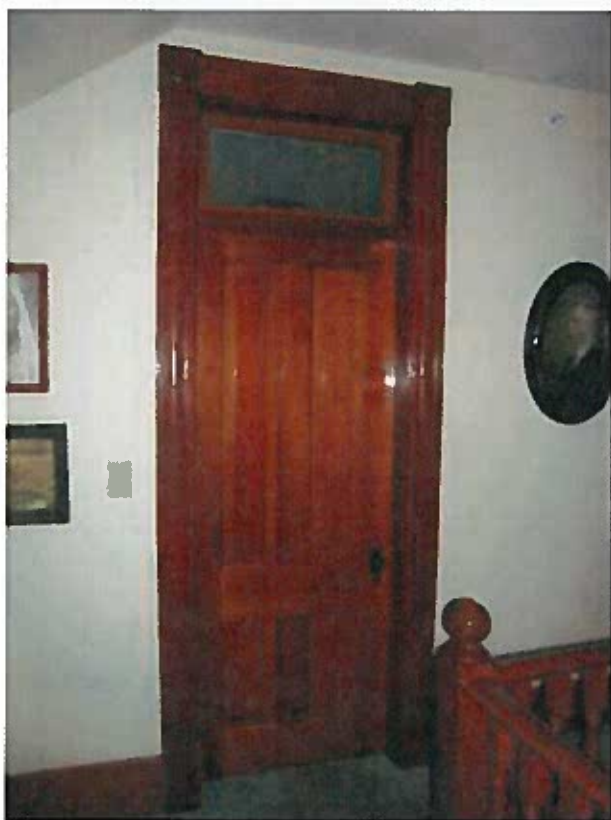
Entrance into Room 206 from the upper stairhall. The standing and running trim, transom, and door are typical throughout the floor and are all historic. Photo Credit: Herb Dawson, NPS.

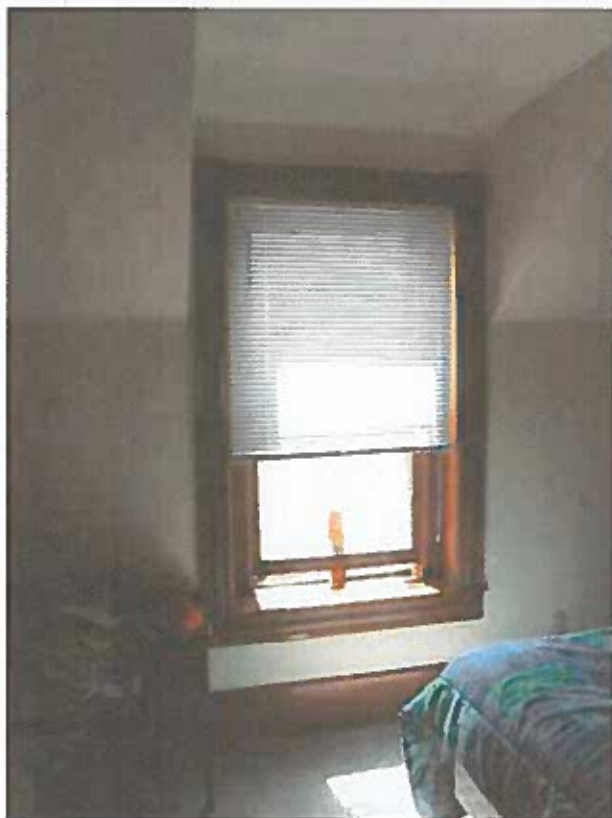
Bedroom 202 in the SW quadrant of the 2<sup>nd</sup> floor.  
Note the change in ceiling slope to accommodate the original dormer window. Wall finishes have been re-surfaced within the guidelines of DOI standards. Photo Credit: Herb Dawson, NPS.

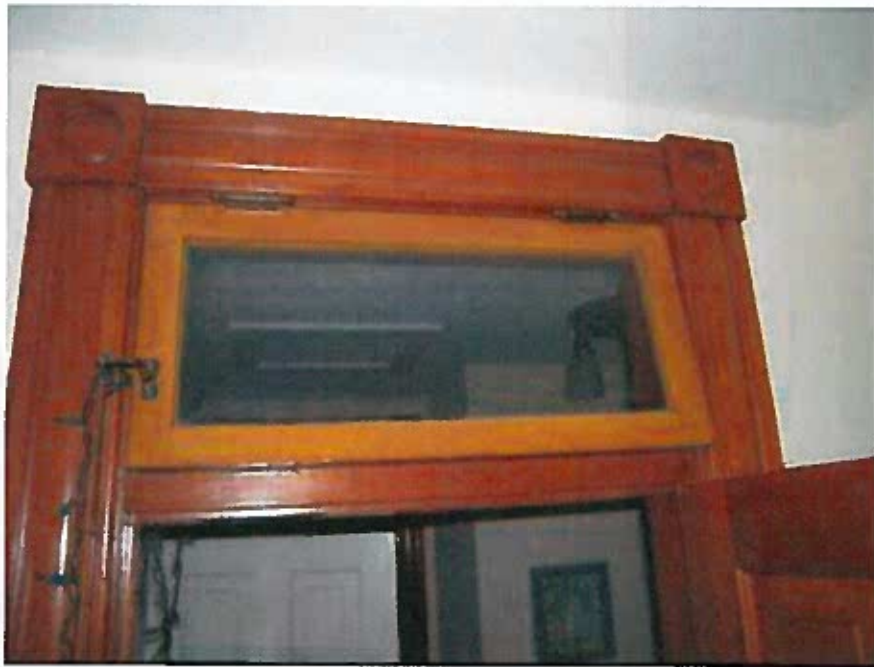
Original transom above entry door into Bedroom 202. All features associated with this assembly exhibit a high degree of integrity. Photo Credit: Herb Dawson, NPS.

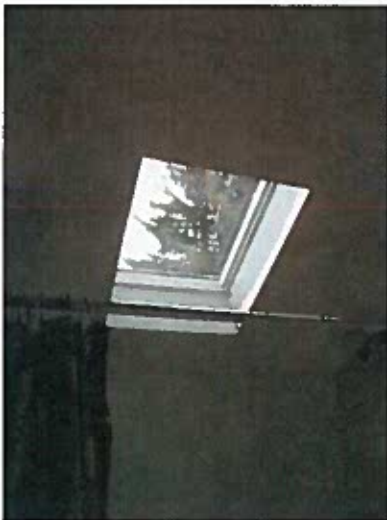
Introduced skylight above bathtub in Bathroom 203. Photo Credit: Herb Dawson, NPS.

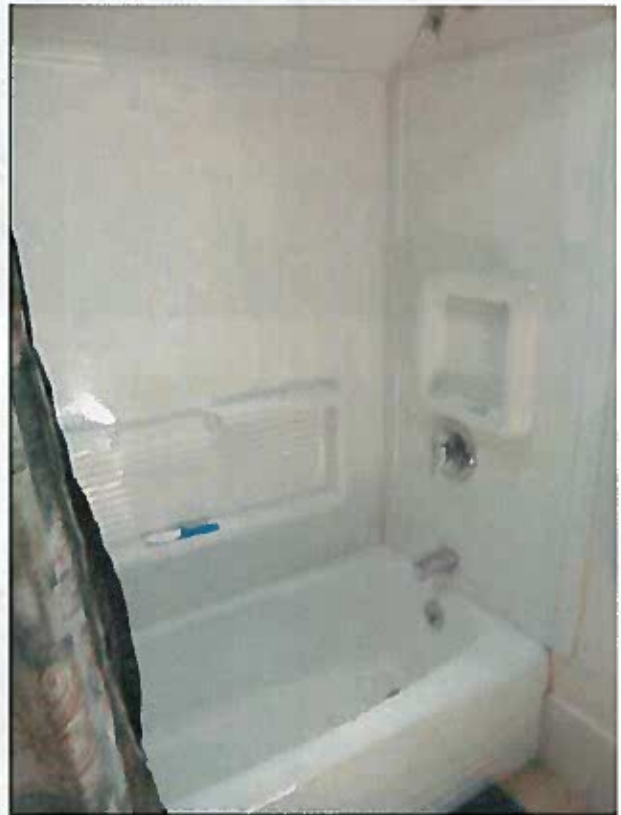
View within Bathroom 203 on the 2<sup>nd</sup> floor of the U. S. Commissioner's house. All plumbing fixtures are contemporary. Photo Credit: Herb Dawson, NPS.

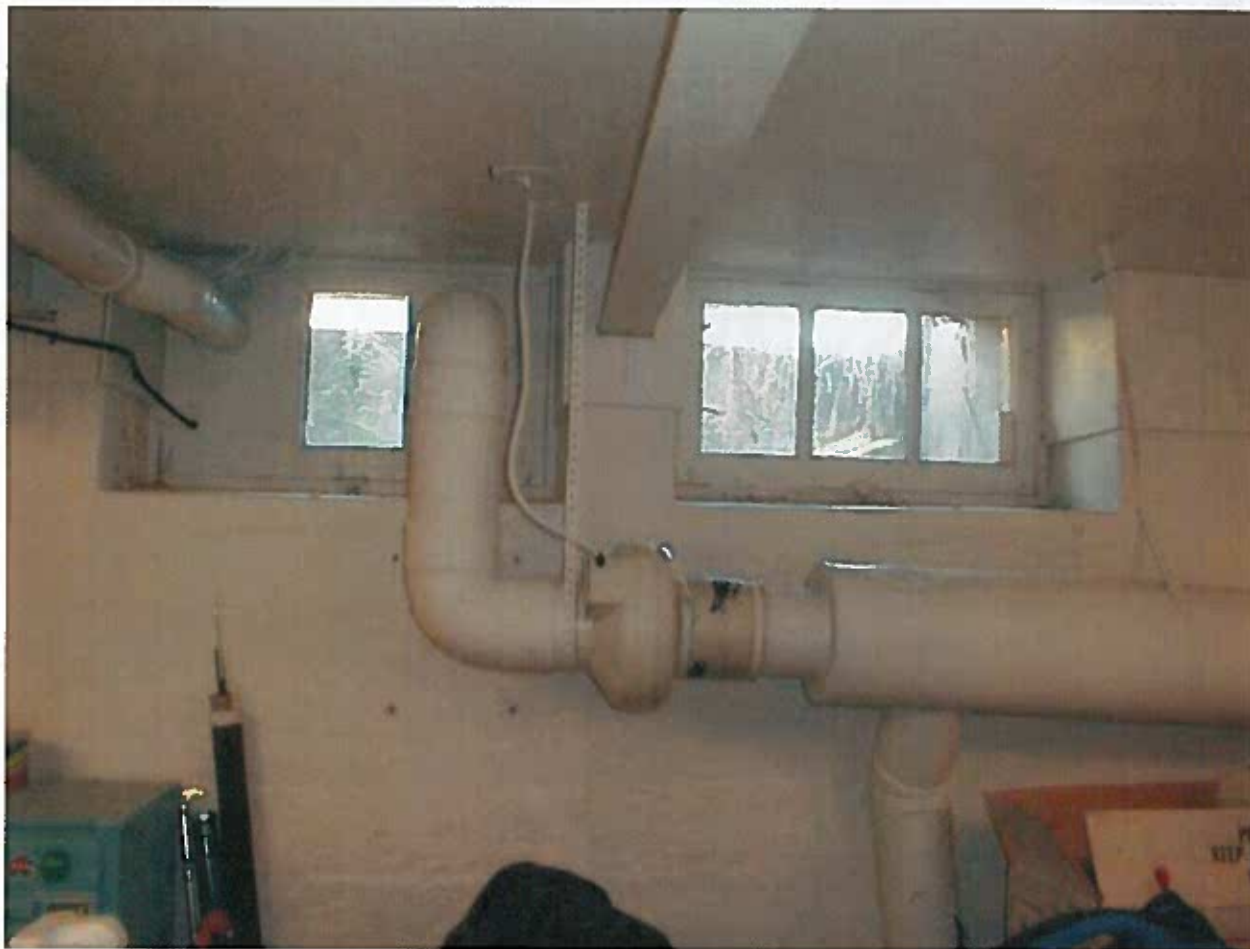
View of the north wall of the basement utility room. The pumped air system is for radon elimination from the sub-structure of the residence. Photo credit: Ken Sievert.

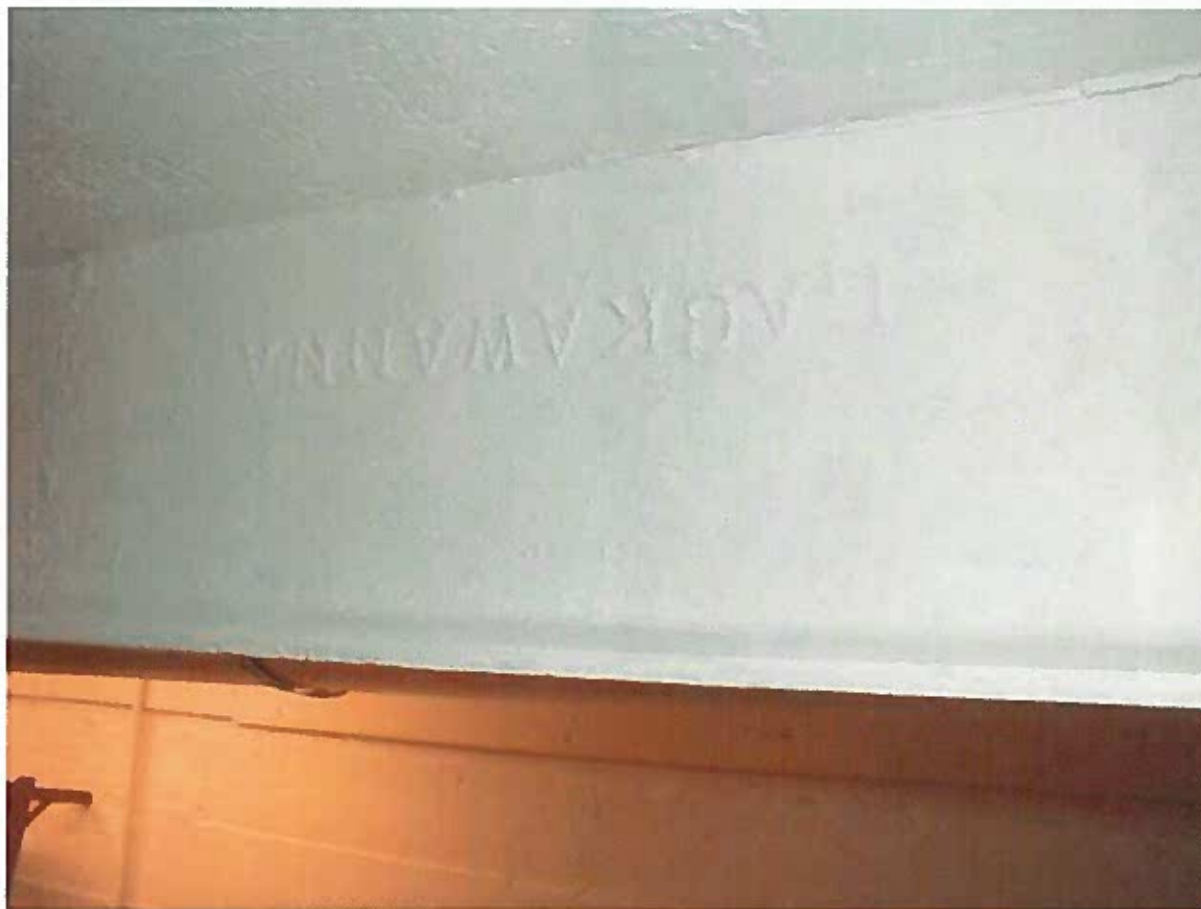
Steel support girder across the center of the north end of the house (see plan for location). The fabricator's foundry mark is visible on the side of the beam. Photo credit: Ken Sievert.

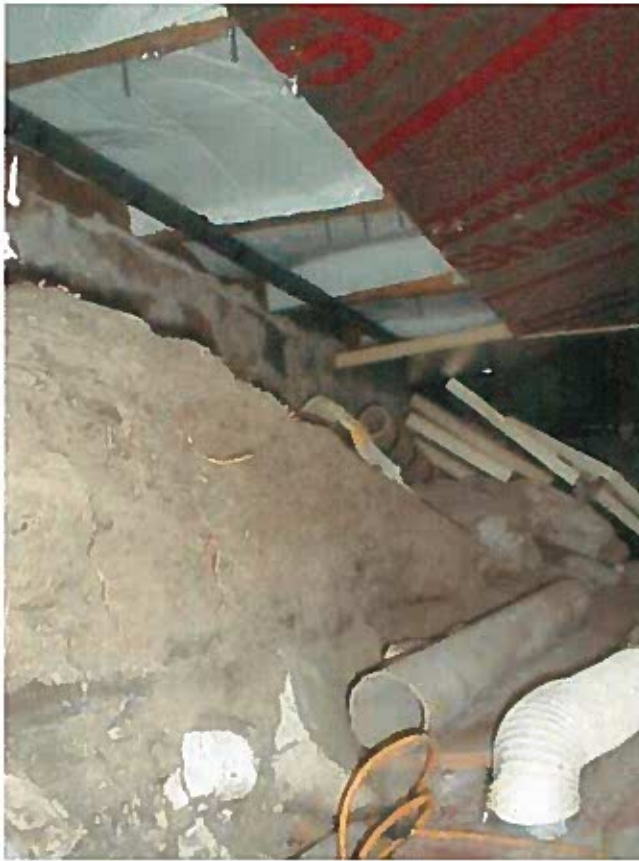
East access into the crawl space from the basement stair. The stone foundation can be seen as well as the earth berm against the footing. Note the contemporary weatherization materials applied to the floor structure. Photo credit: Ken Sievert

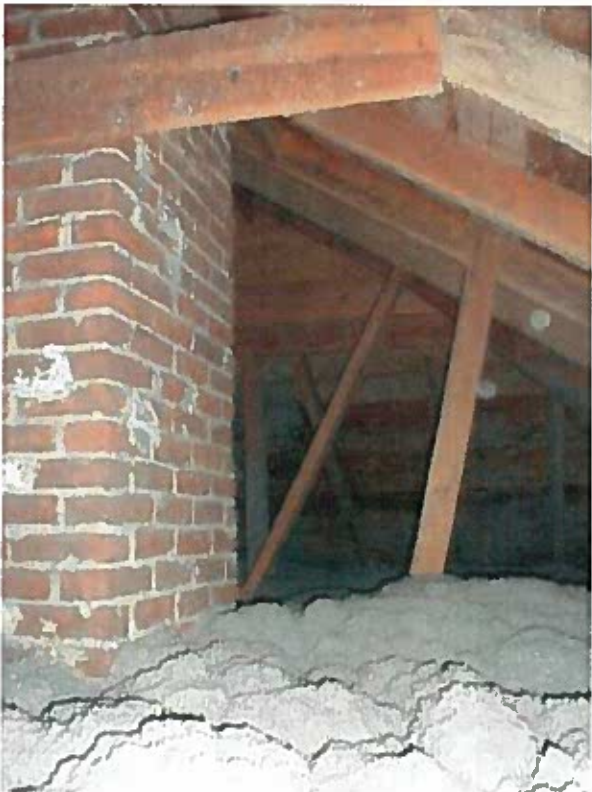
Attic – view to south showing south chimney. Note the replacement sheathing in the plane of the roof and the general good condition of the wood members throughout. Photo Credits: Ken Sievert

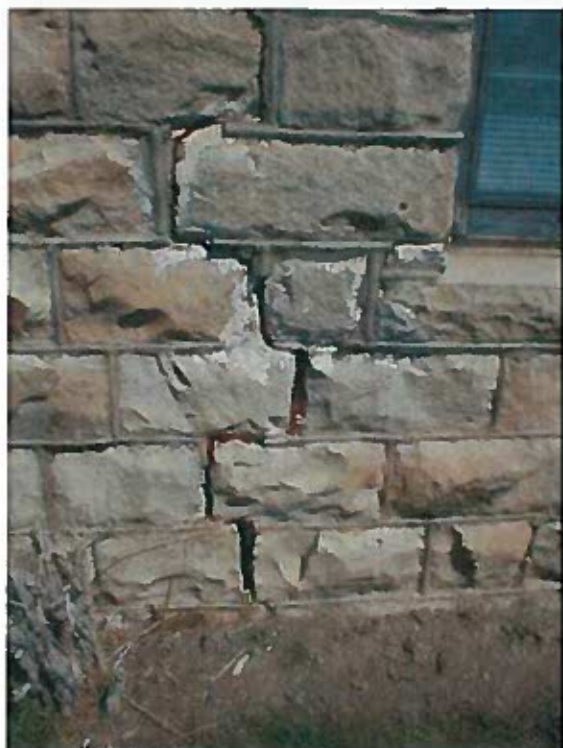
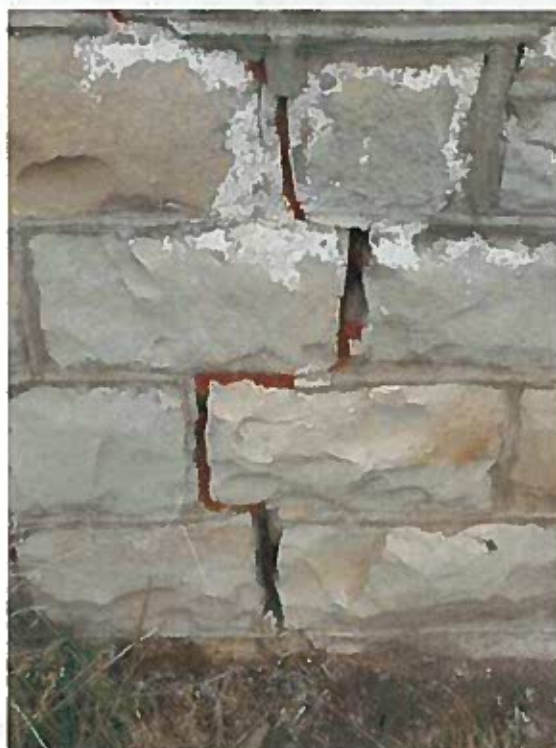
West end of south stone wall; this area of the structure exhibits the greatest amount of failed stone masonry in the building with significant cracks, spalls, and minor movement. Evidence of past repairs can be seen in some of the mortar joints in the detailed photos below, but deterioration has continued since the repairs. Photo Credits: Ken Sievert & Herb Dawson, NPS.

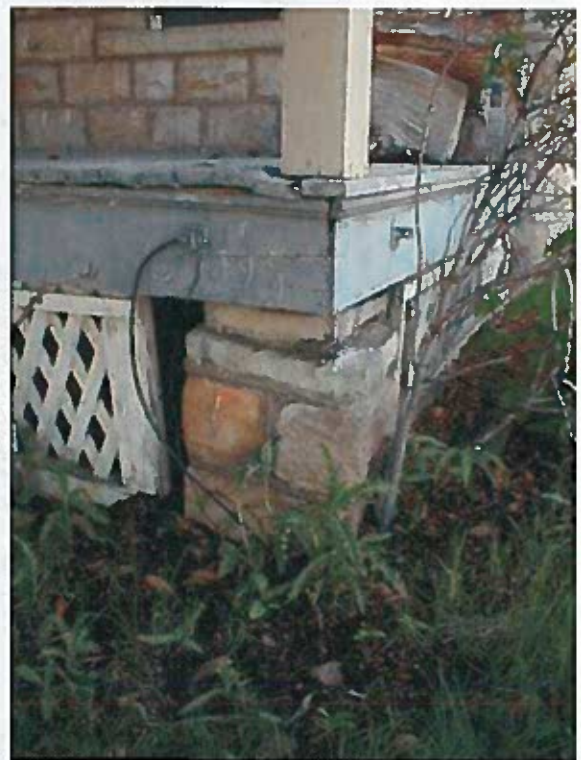
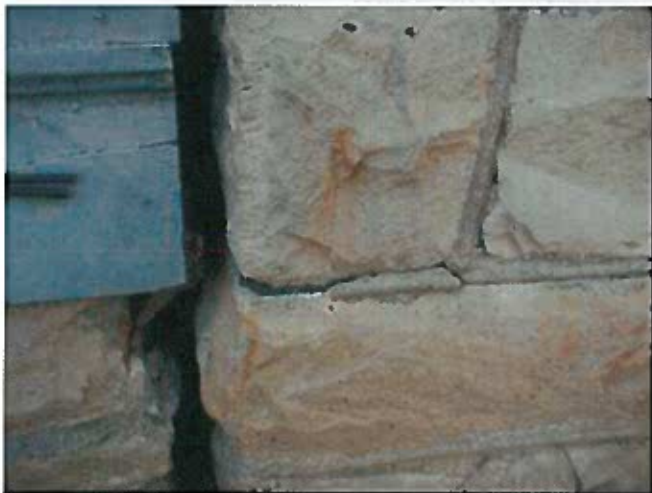
Stone porch piers along the north side of the entrance porch deck. Both piers are leaning and require stabilization. The latticework wood barrier adds architectural delicacy to the use of the structure as a place of residence, but is in need of repair. Photo Credits: Ken Sievert
