**Historic Structures Report**  
**Fort Yellowstone Power House**

**Historic Structures Report  
Fort Yellowstone Power House  
Final Document**

prepared by:  
**James R. McDonald Architects  
and  
Historical Research Associates, Inc.**

prepared for:  
**National Park Service  
Rocky Mountain System Support Office  
and  
Yellowstone National Park**

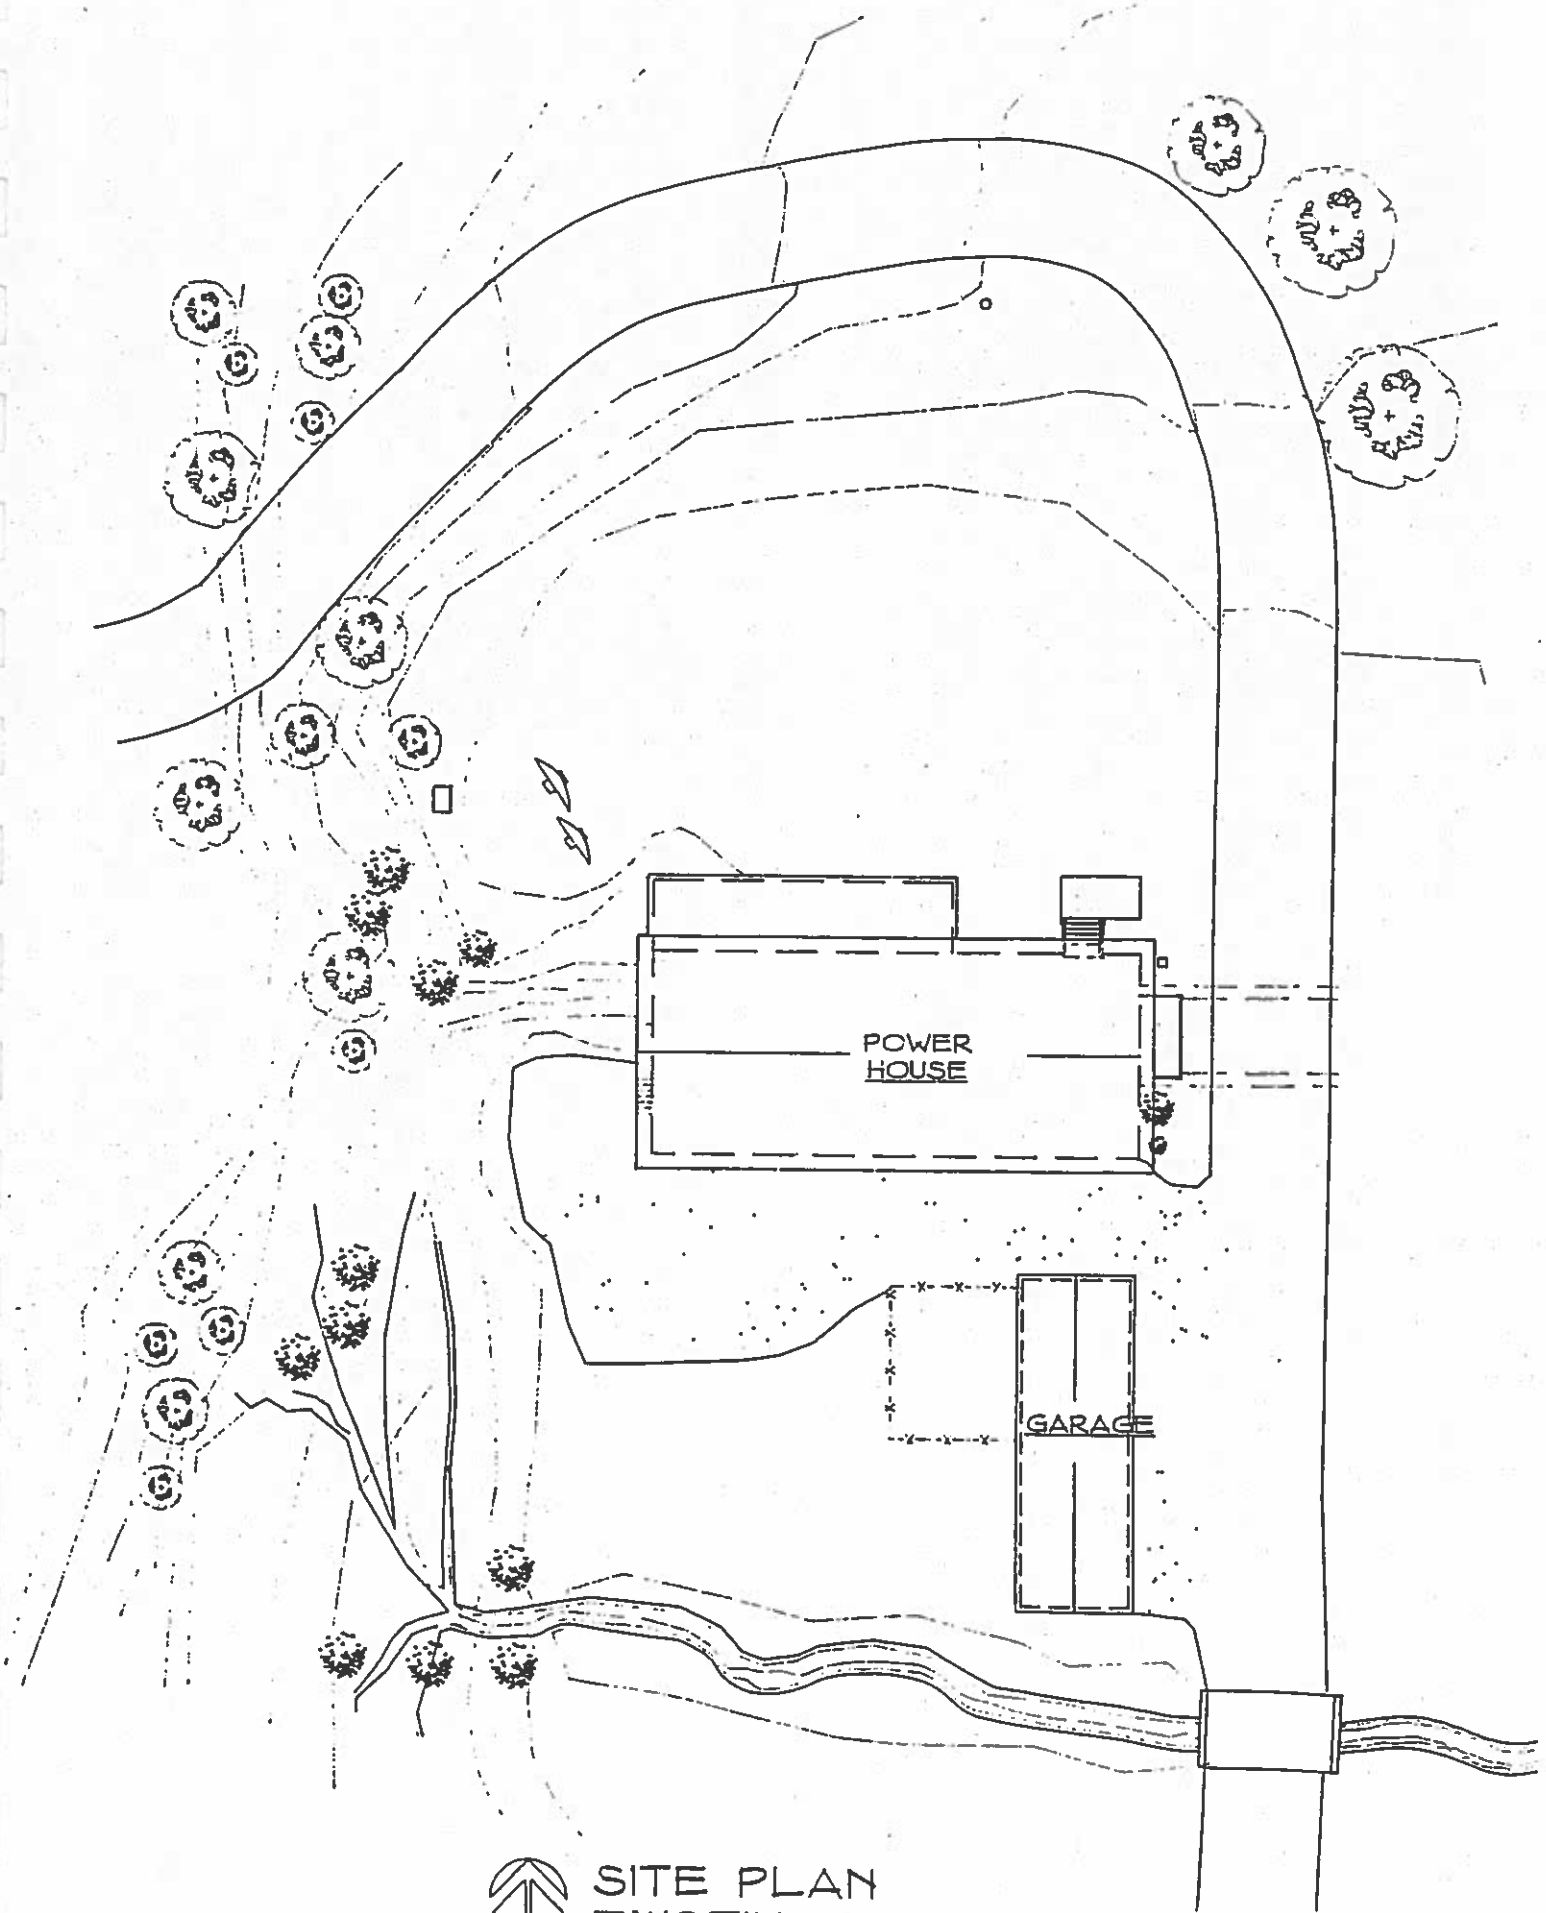
SITE PLAN  
EXISTING POWER HOUSE

The power house site is in good condition; the only major problem being the lack of drainage on the north side of the building. Inadequate drainage of water flowing on the slope to the west may also be a problem in high water years. The site is maintained and the area around the building is kept in good condition.

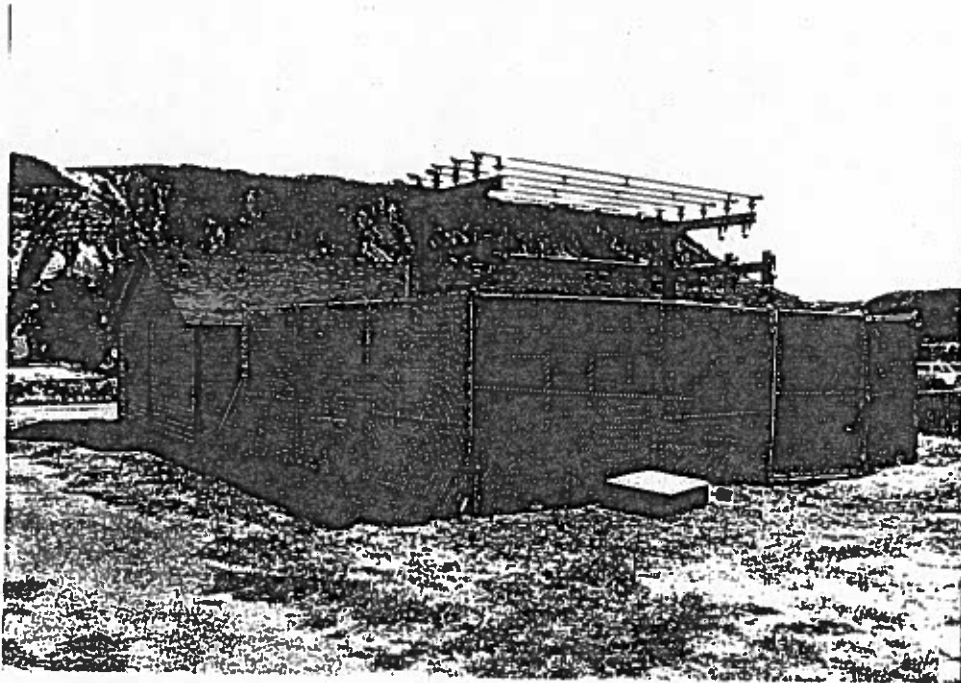
Figure 9. Looking southeast at the abandoned transformer grid on the south side of the power house and west side of the garage. This was abandoned at the same time as the power house.

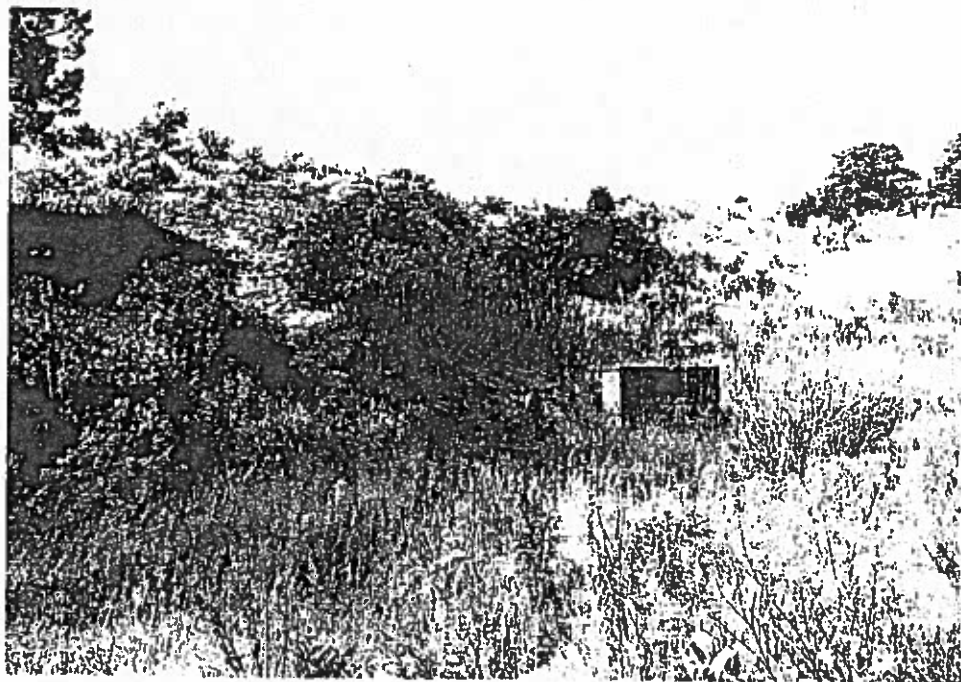
Figure 13. Looking west from the power house at the area where the original penstock is located. The concrete feature is part of the penstock.

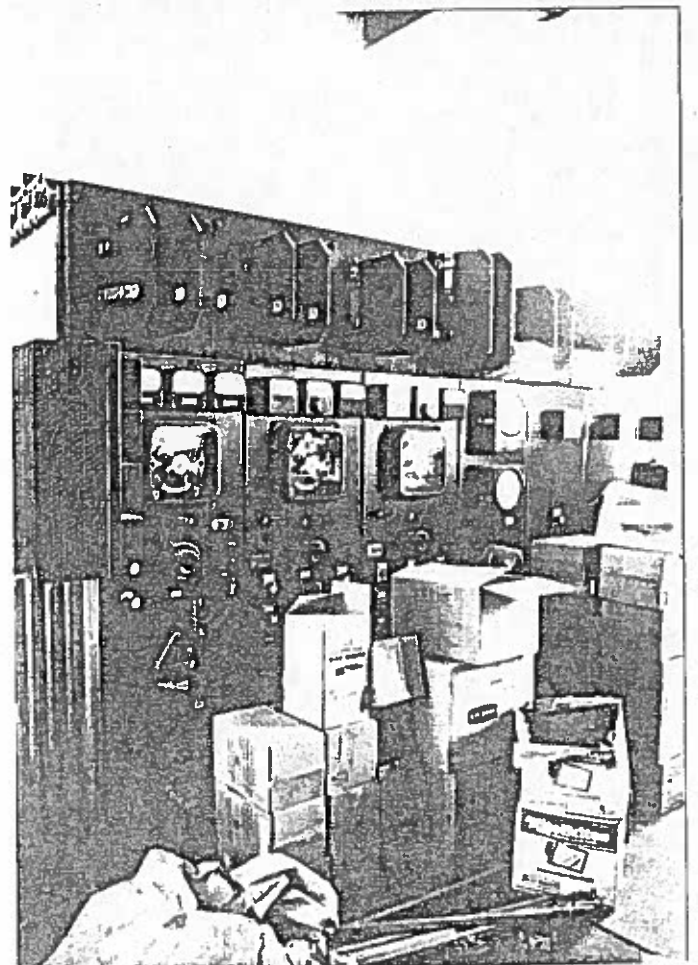
Figure 34.

Looking northeast at the main switches for the transformers on the east side of the generator room.

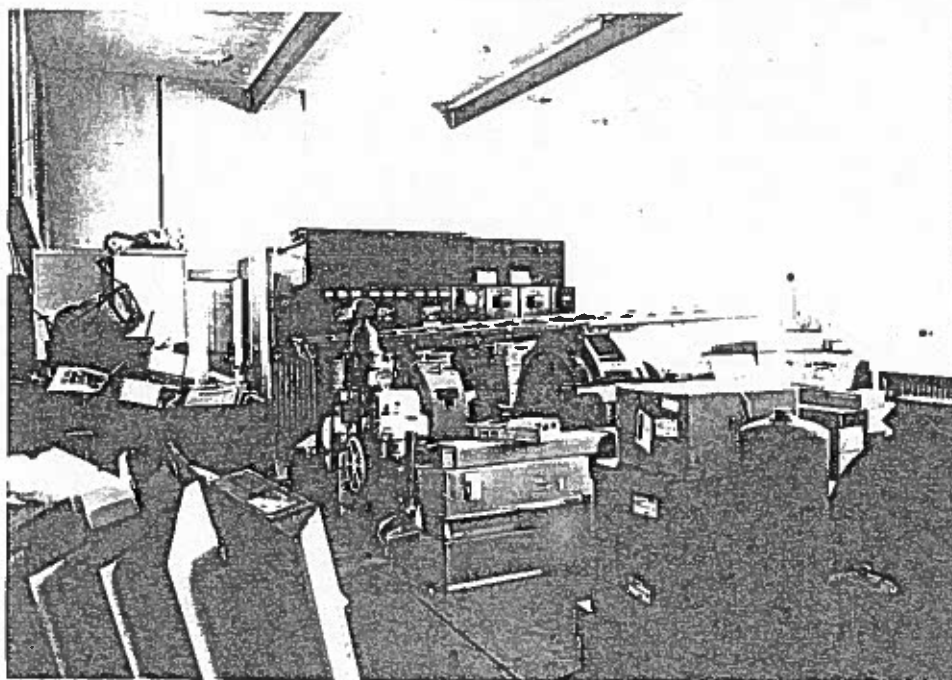
Figure 36. Looking southwest at the generator equipment in the center of the generator room. All of this equipment contributes to the significance of the building.

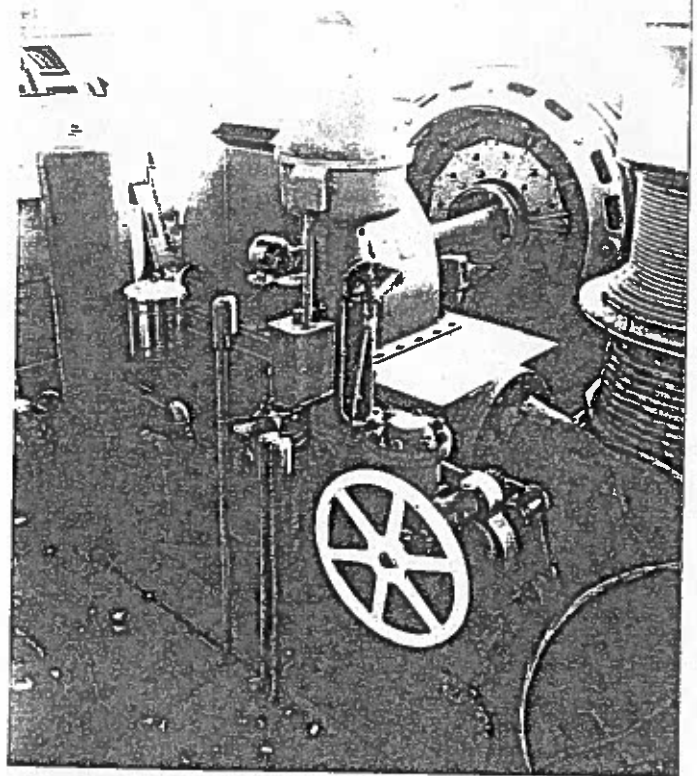
Figure 37. Looking east at the generator room, and original equipment. The room is currently used for storage.

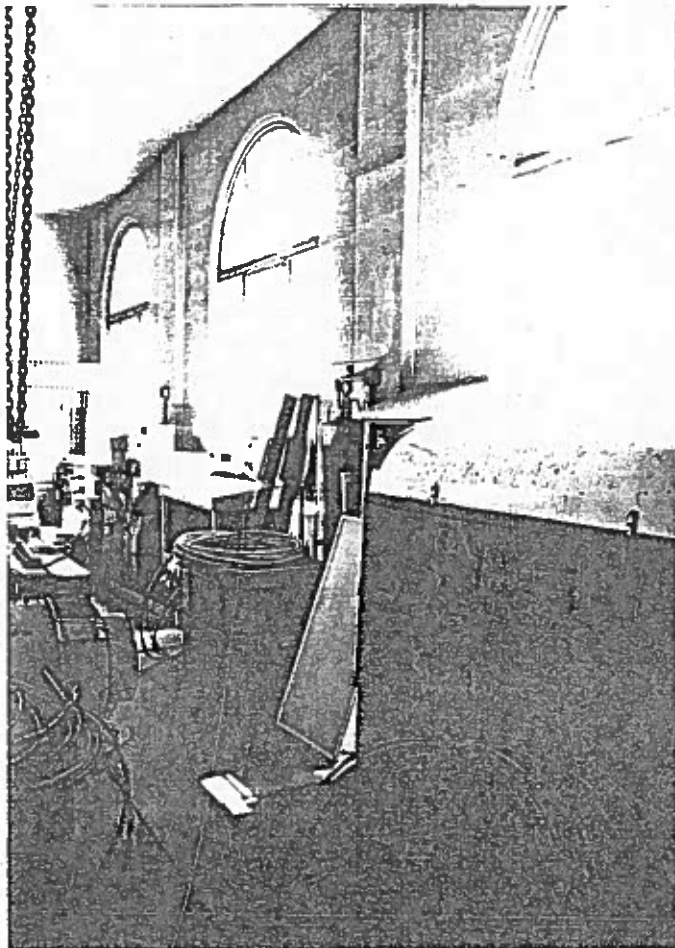
Figure 38. Looking southeast at the large windows on the south side of the building. The interior space and materials are in good condition.
