# Haynes Picture Shops Headquarters at Mammoth

## Historic Structure Report

Prepared by Sievert & Sievert Cultural Resource Consultants  
Great Falls and Bozeman, Montana  
August 20, 2008

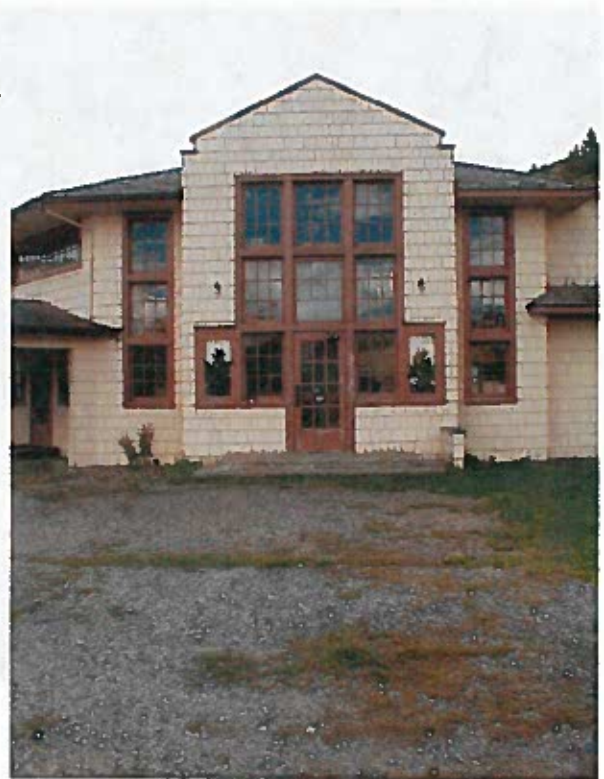
West elevation; the spacious lawn separates the Haynes headquarters from residences along the avenue. Note that some windows have been protected by temporary shutters.

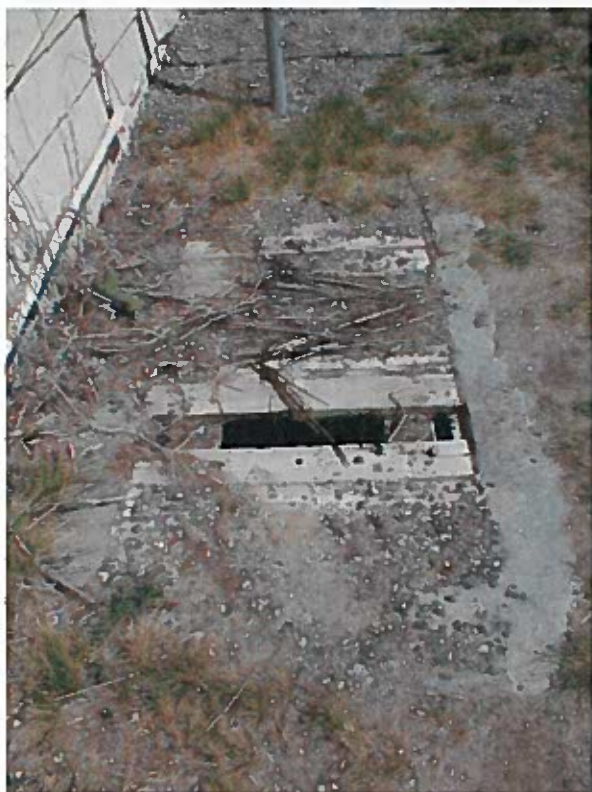
This areaway is a light-well for windows serving the small basement area below the south end of the dormitory wing; they have been covered in recent years.

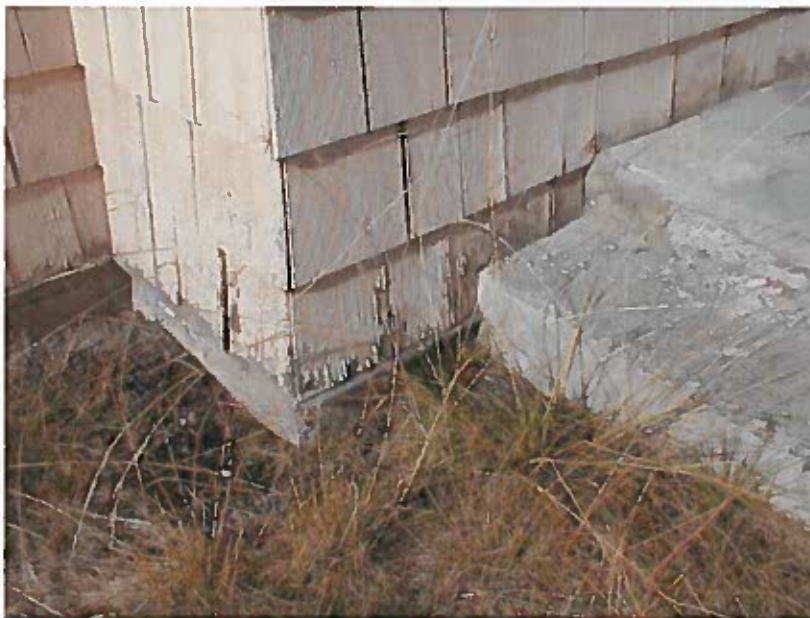
Condition of the wall shingles at the base of the exterior wall. This particular location has suffered from the long-term effects of snow drifts or piled snow.

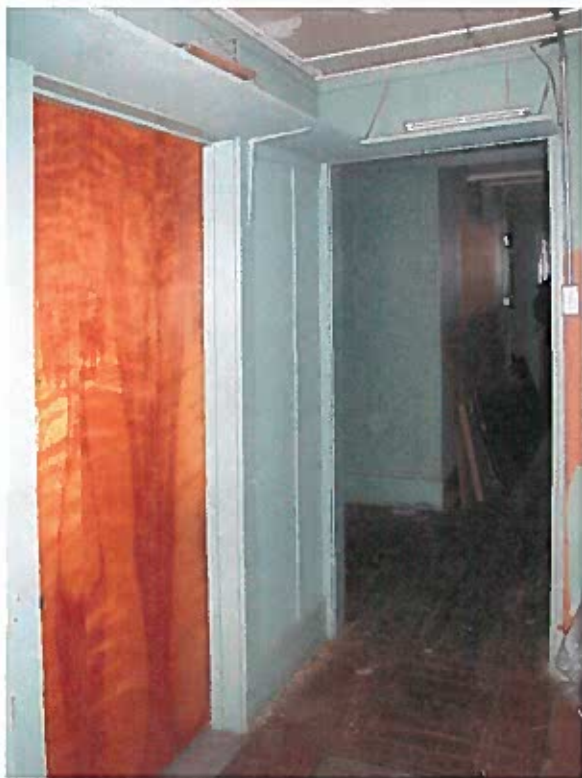
Northeast corner of room 105; note the introduction of the contemporary door.

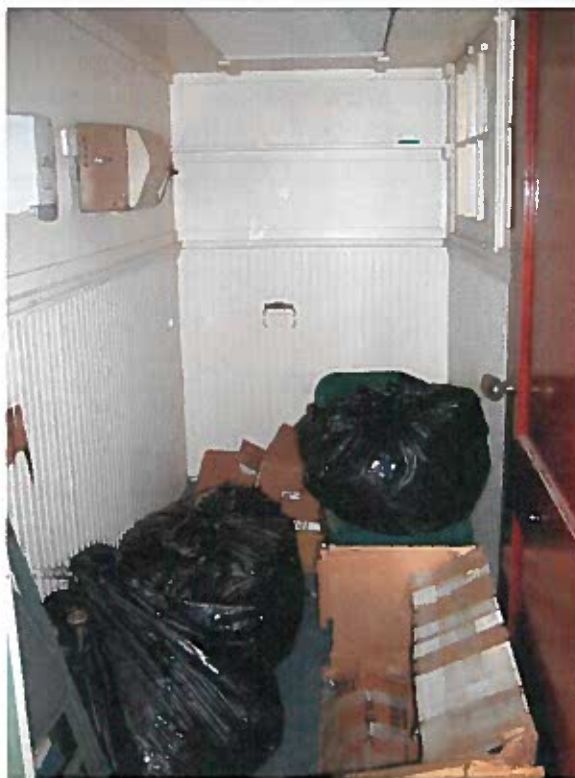
Utility bathroom 106. Beaded-wood wainscot is used throughout.

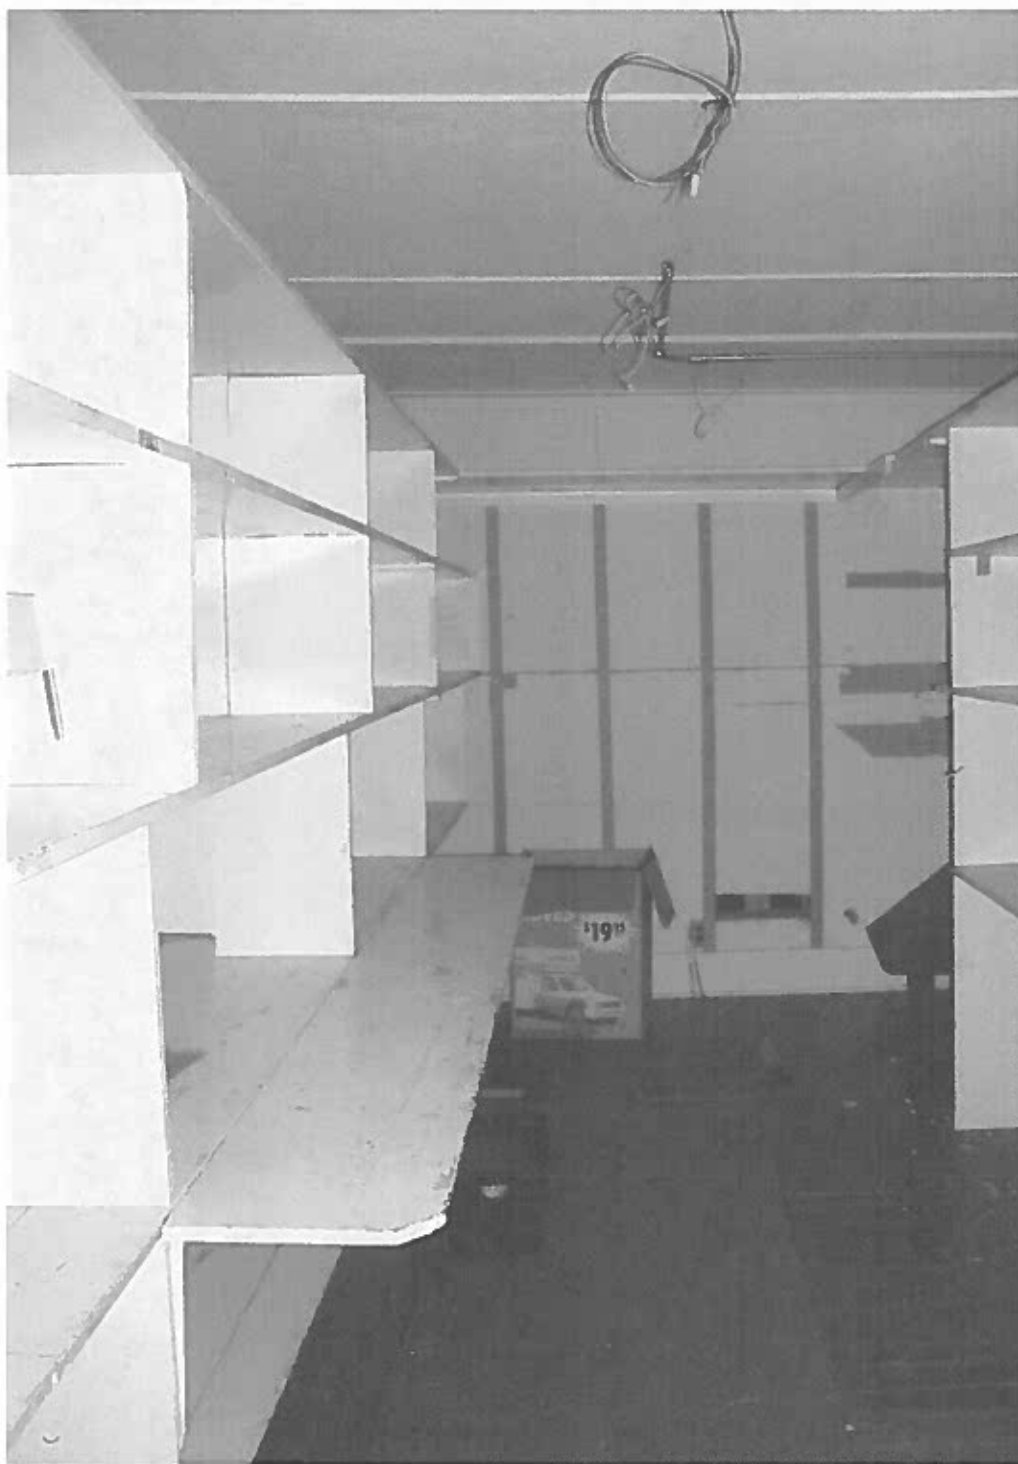
Storage room 109 immediately adjacent to the darkroom illustrated on the previous page.

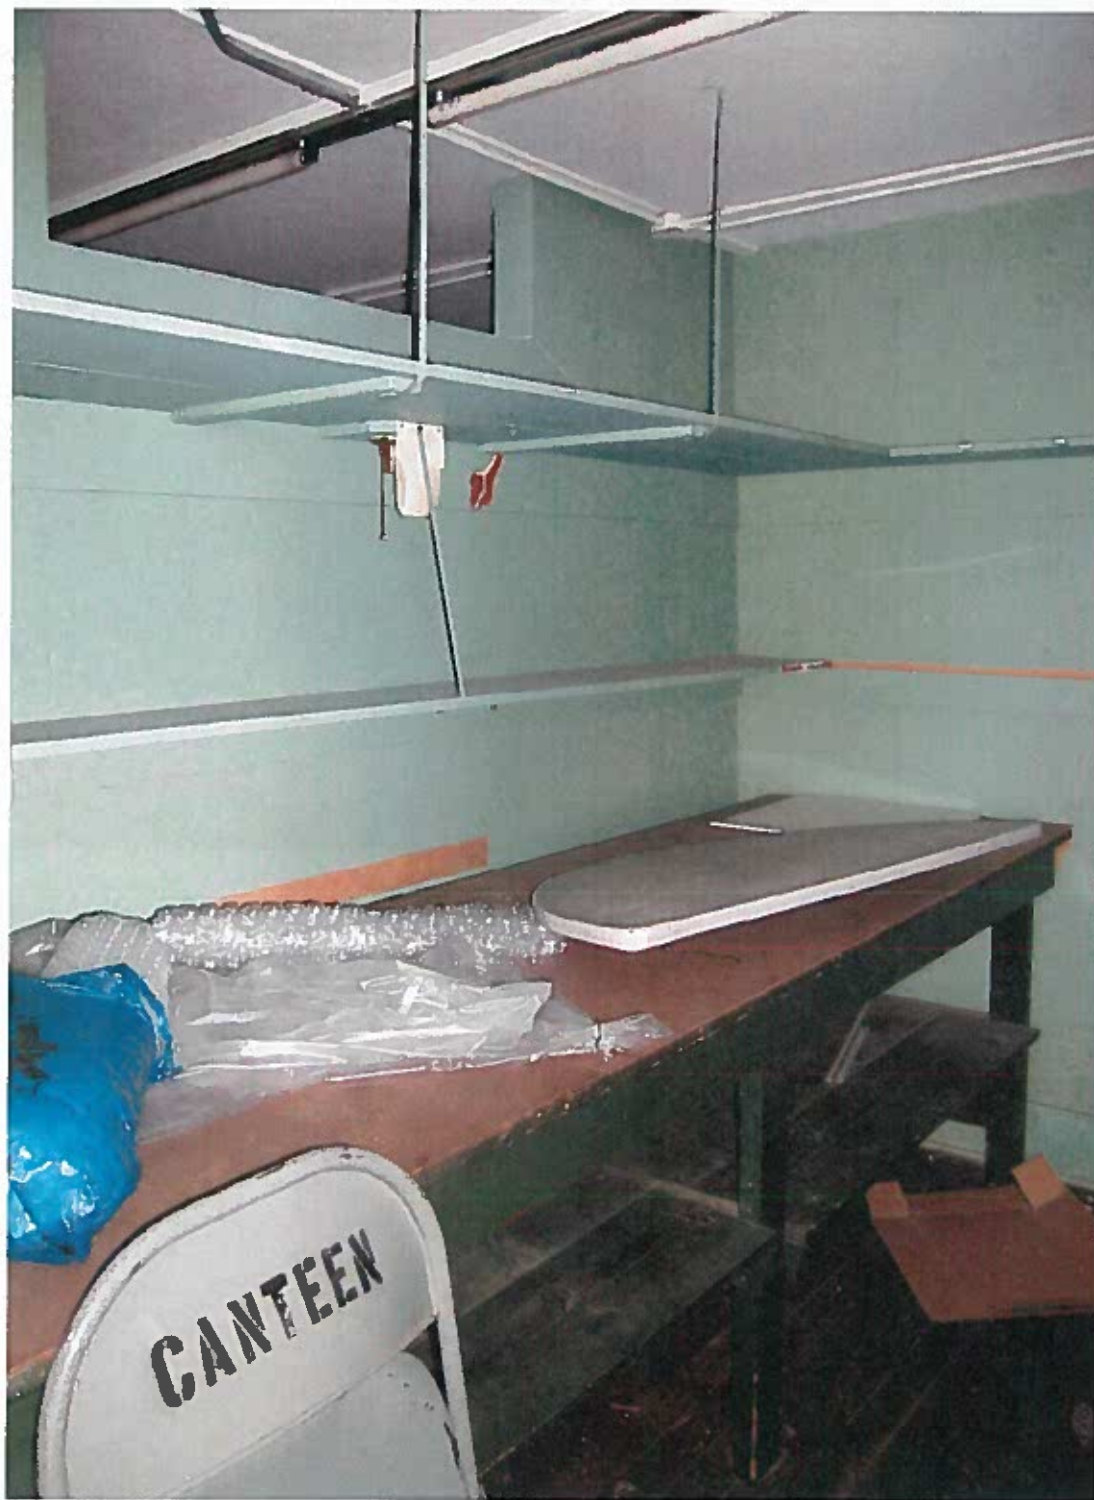
Work room 115; since this is an internal area without windows, the opening in the top of the wall is believed to be for ventilation. The use of every available space for storage continues into this space.

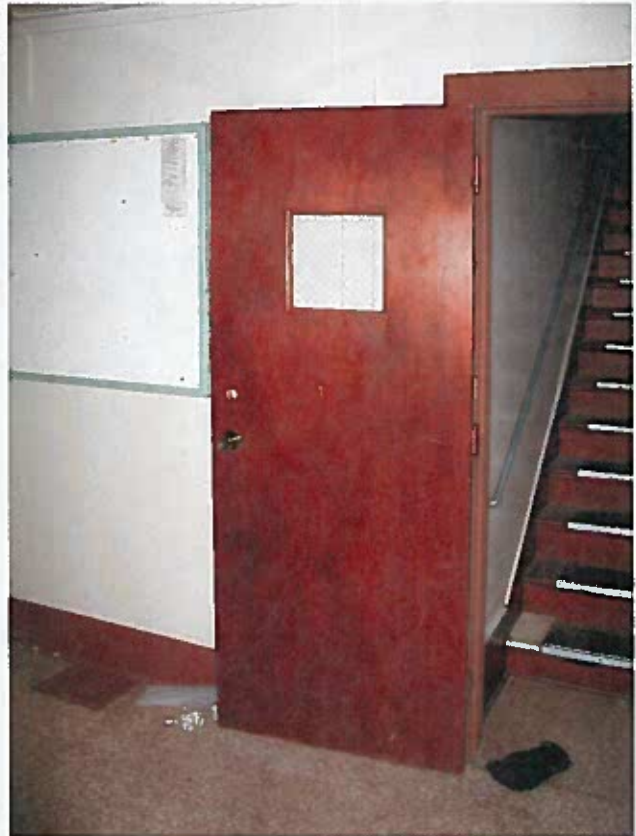
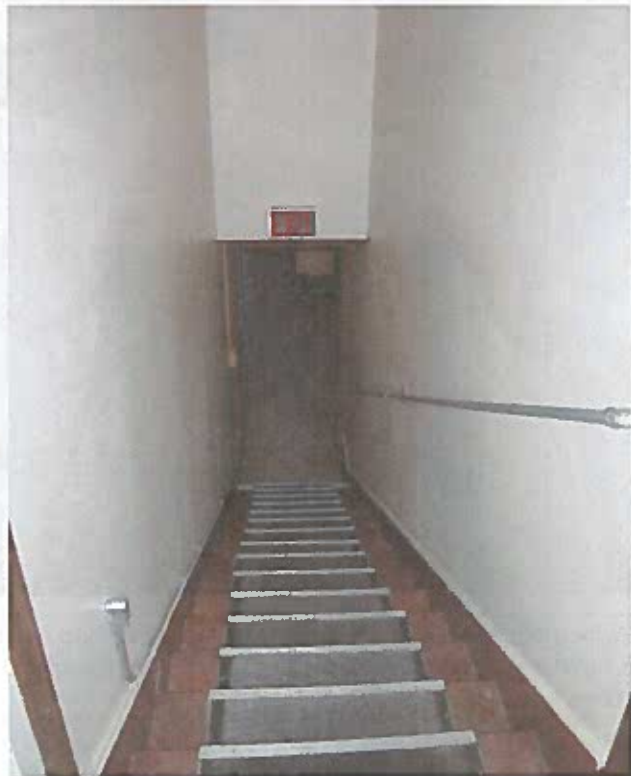
The stair exits at the first floor (as shown in the top photo) into the former dining room. The photo at the right is the stair as viewed from the top of the stair run. This assembly is constructed with gypsum drywall and would comply with fire resistant requirements of the building codes, although distance to the stair from some of the second floor dormitory rooms may not.

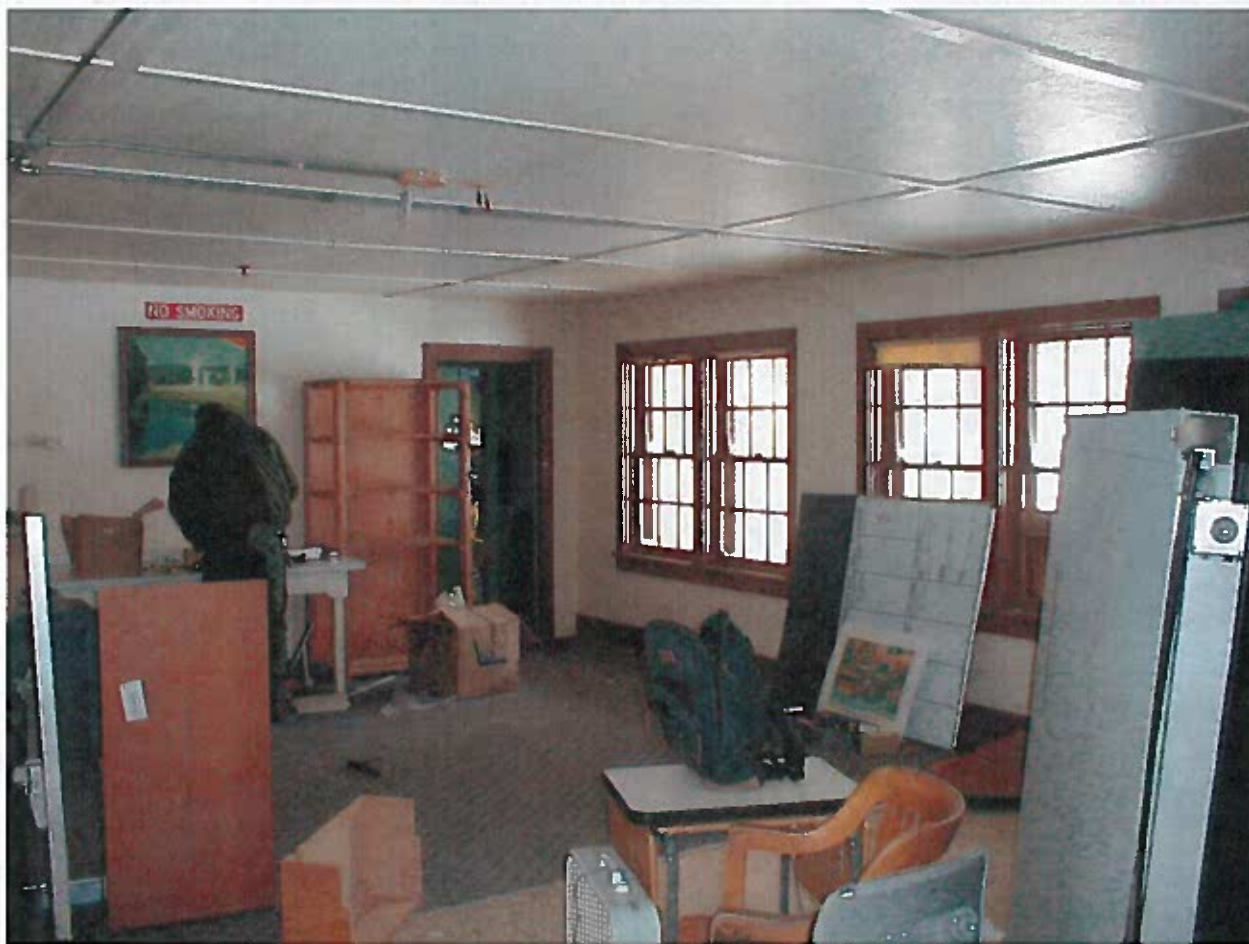
First floor dining room. This space looks out onto the lawn area to the west and is immediately adjacent to the west-facing porch.

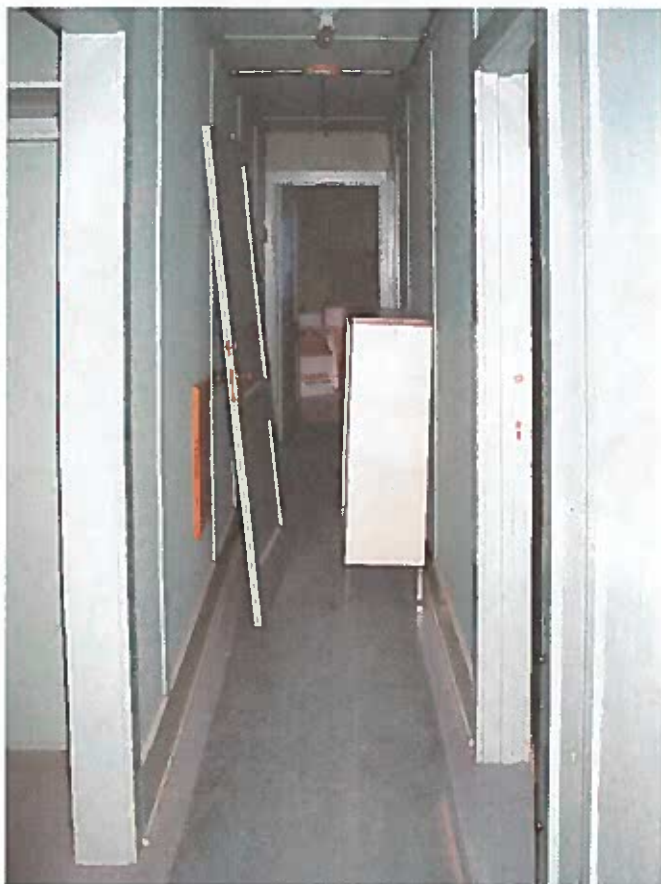
Corridor serving three dormitory rooms at the south end of the first floor. The tongue and groove fir flooring has been painted grey throughout this area.

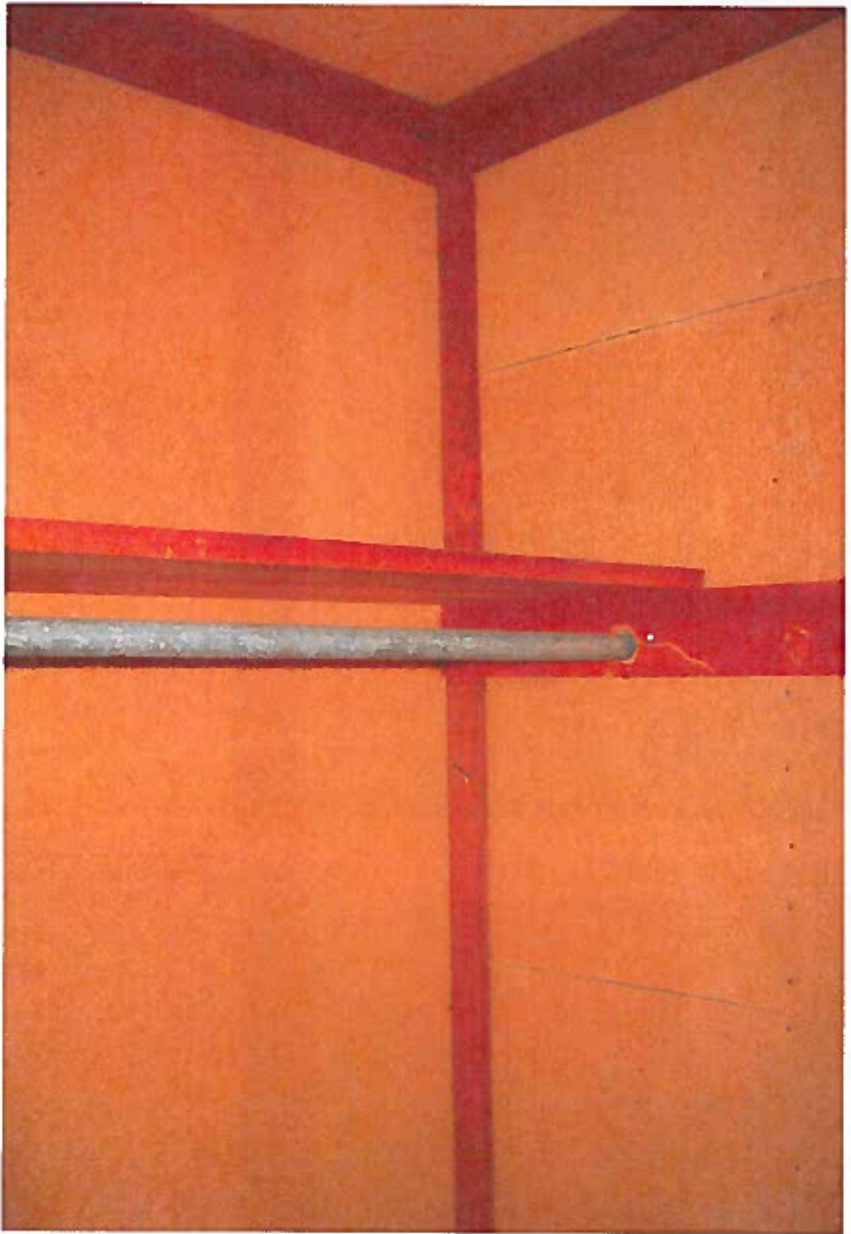
This is a good example of the Celotex material referred to throughout this report. This particular example, within the closet of room 208, is unfinished, and the texture and color of the cane material from which it is made can be seen in its natural state. It was widely used in this region in the 1920s and 1930s, particularly in association with log structures.

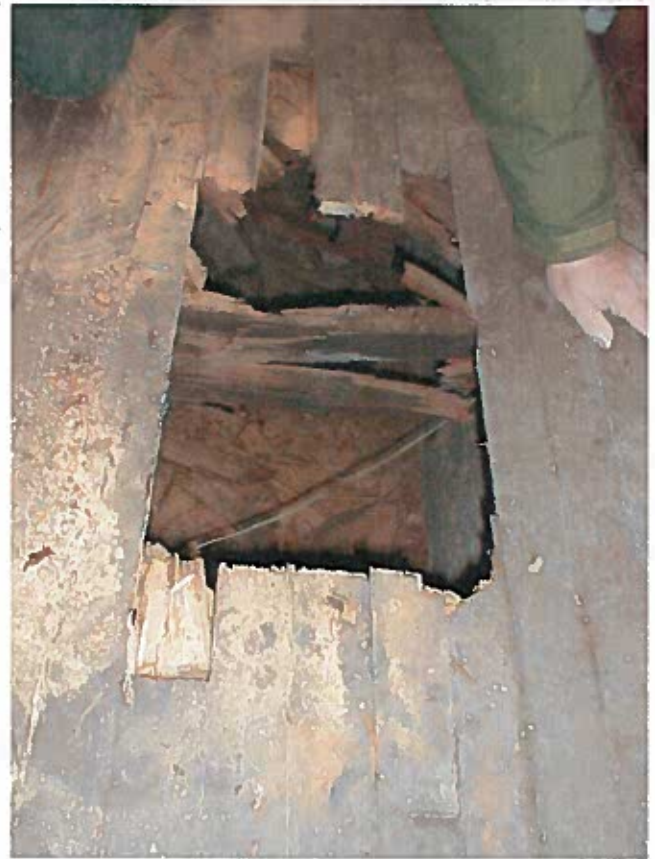
During preparation of this report, an area of deteriorated flooring was noted (and posted) immediately inside the north entrance into the retail sales area. On November 6, 2007, the floor was opened up for inspection by the consultant and NPS personnel. The photographs on the following pages document conditions found in this area of the first floor structure.

A number of rotted joists and supports were found in this immediate vicinity; deterioration was extensive at the affected members and was confined to this immediate locality. Due to the unusual and localized conditions, the NPS geologist was consulted. His office ruled out any ground-related phenomena (including geothermal) that may have contributed to this deterioration. These photos illustrate the completeness of the deterioration within the localized area.

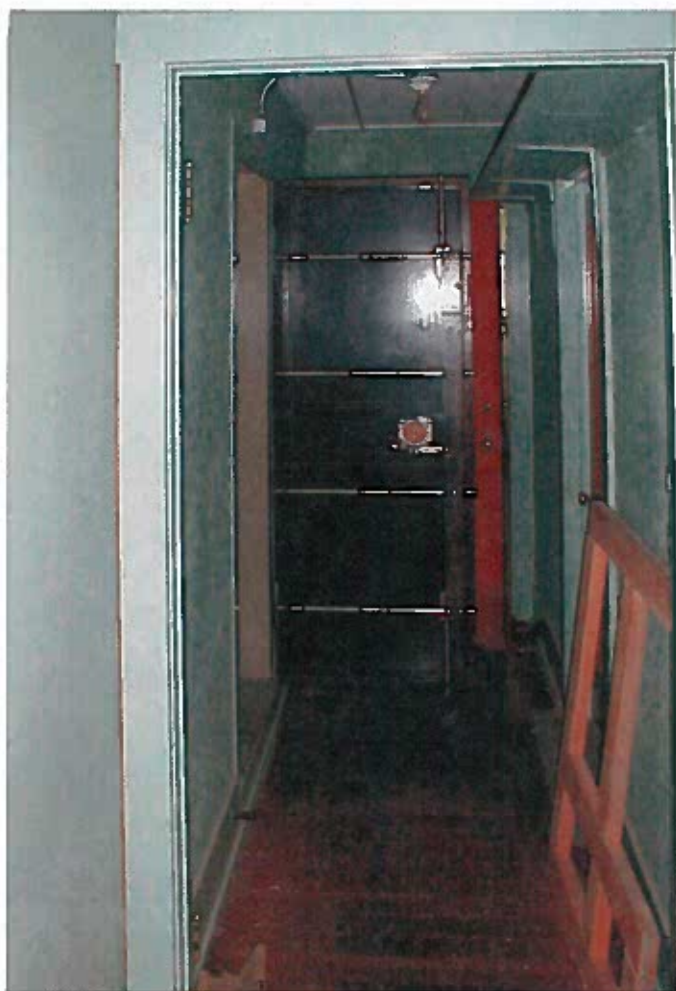
The first floor vault at the Haynes headquarters is substantially constructed with concrete and reinforcing; the interior is plastered. The steel door shown above befits the vault class used at the facility.

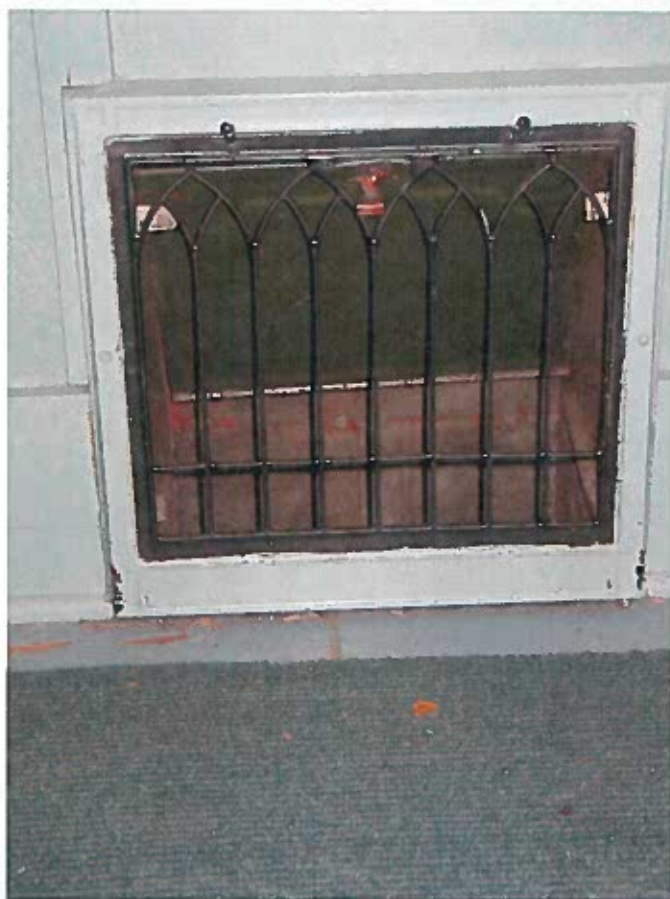
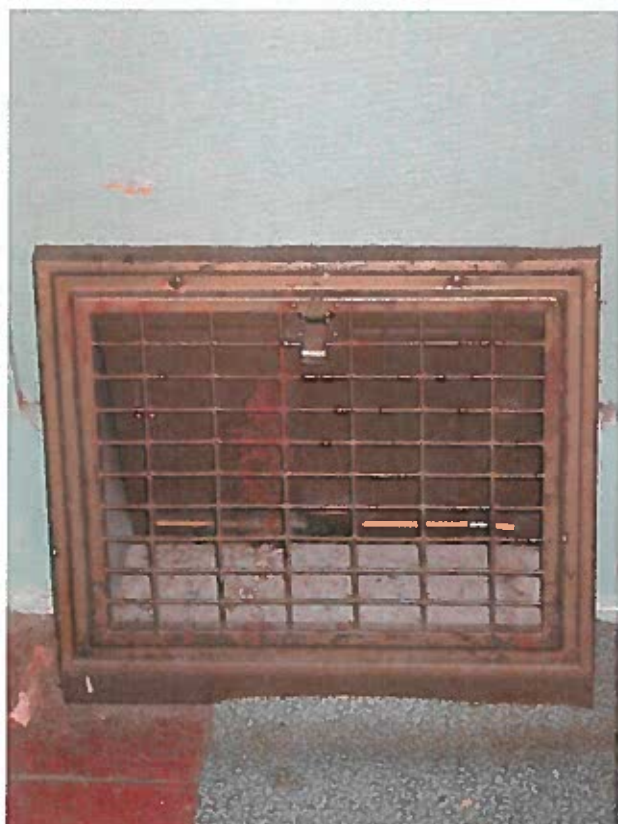
Two examples of mechanical grilles used in the Haynes headquarters; they are judged to be original features in the building.

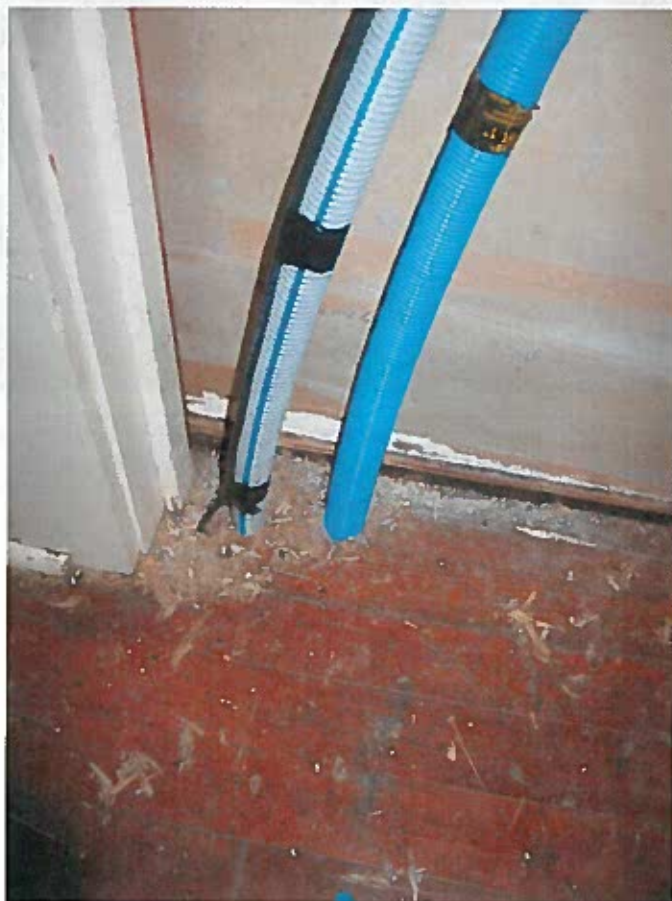
Contemporary wiring that has been intrusively installed in an abandoned doorway located in the southeast corner of room 109.

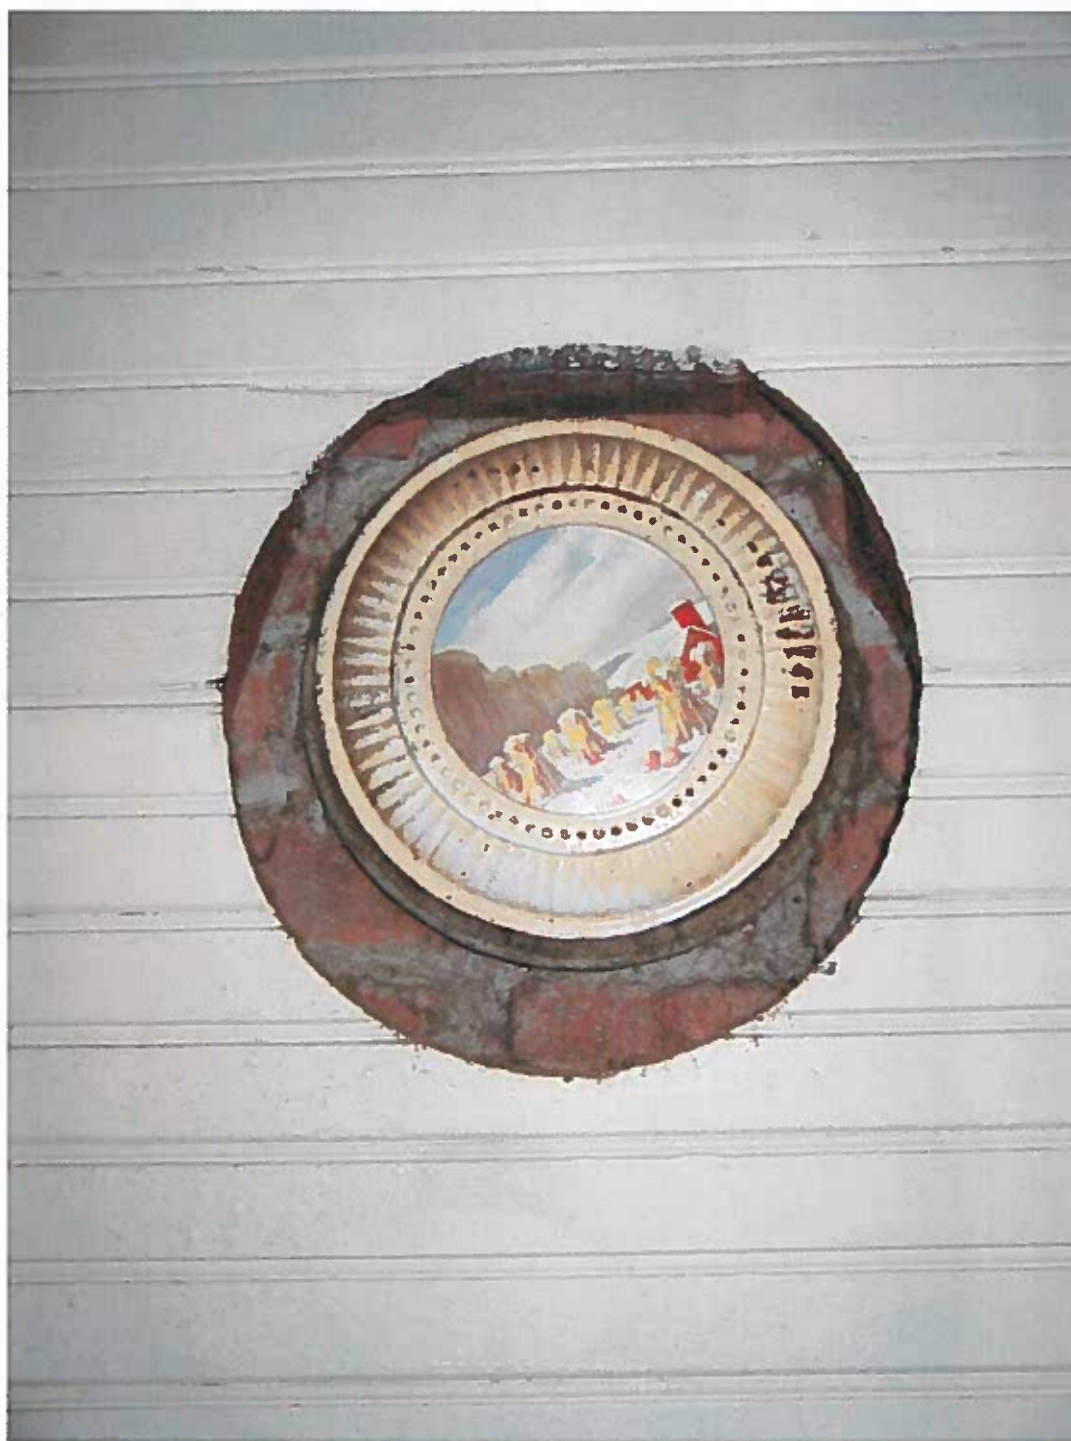
Decorative thimble in the brick chimney at the west wall of the kitchen.

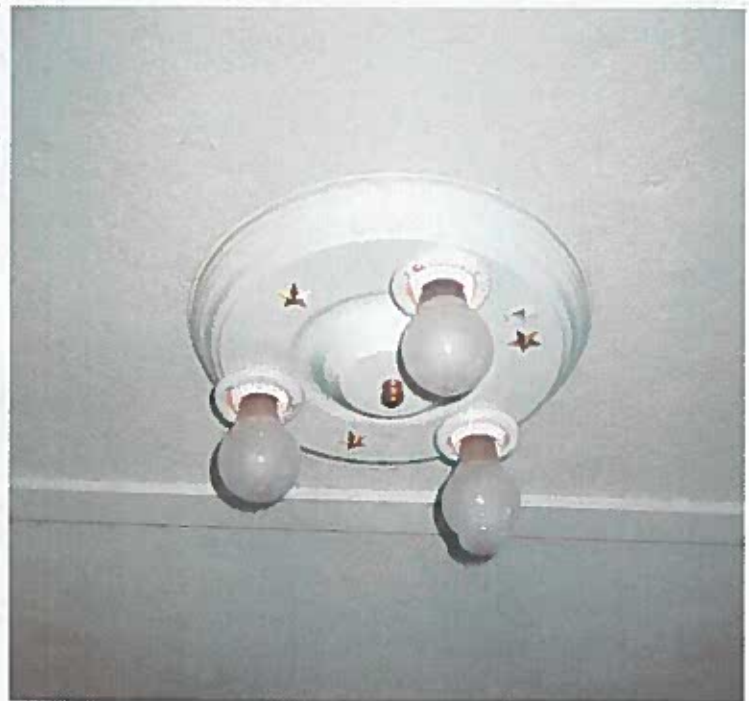
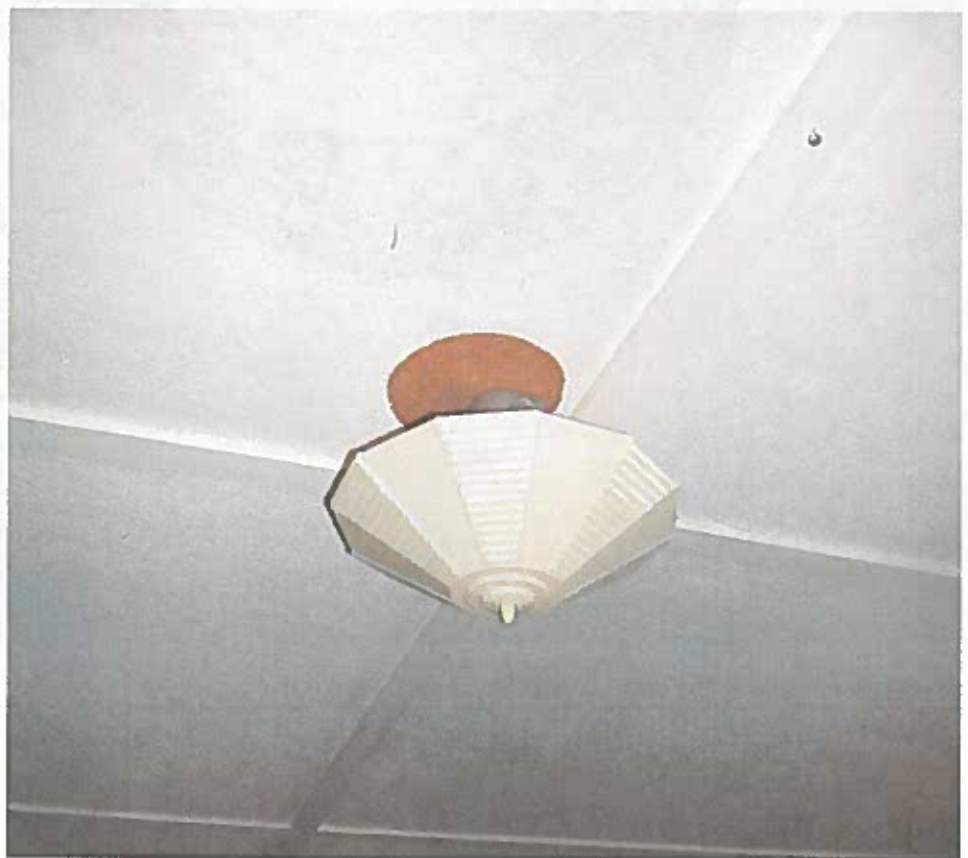
Examples of light fixtures in the dormitory rooms. The base of the upper fixture appears to be original; note the star pattern. The lower fixture could be a replacement.

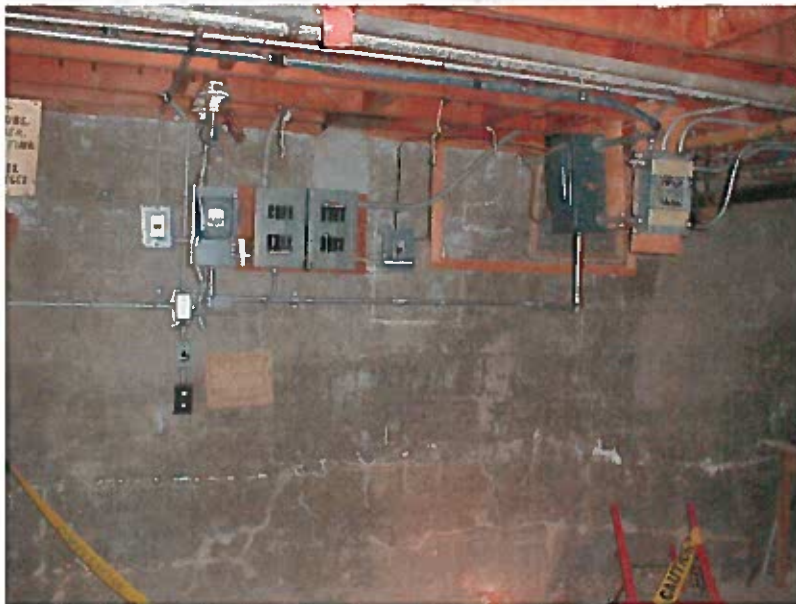
Electrical apparatus located at the south wall of the partial basement below the dormitory wing.

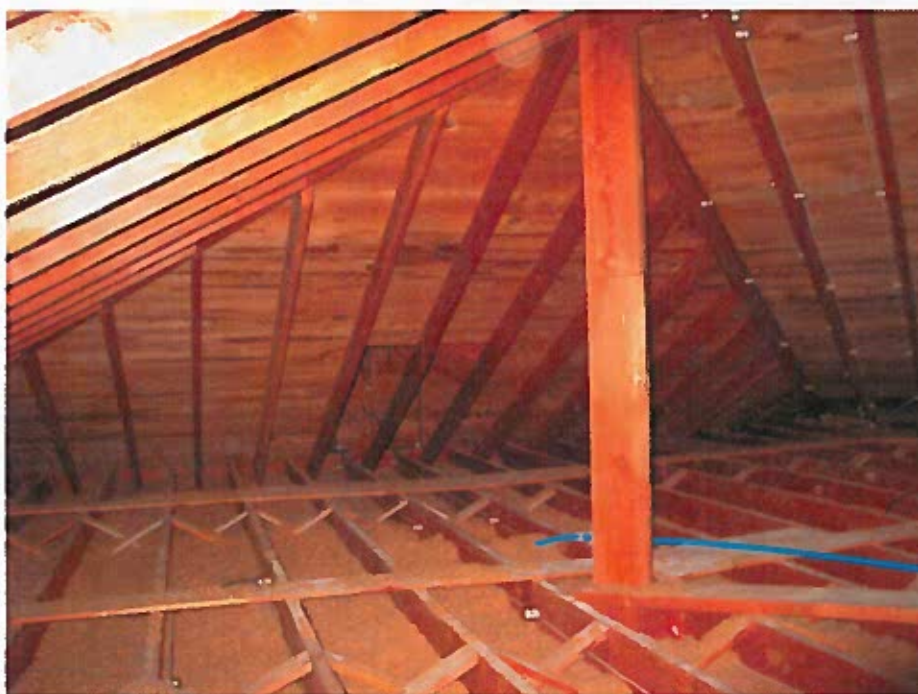
Ceiling and roof framing above the retail sales area. Note the extremely good condition of the wood framing materials. Vertical members supporting the center flat roof area need to be stiffened and steel (seismic resistant) connectors need to be incorporated in their attachment to beams and joists.

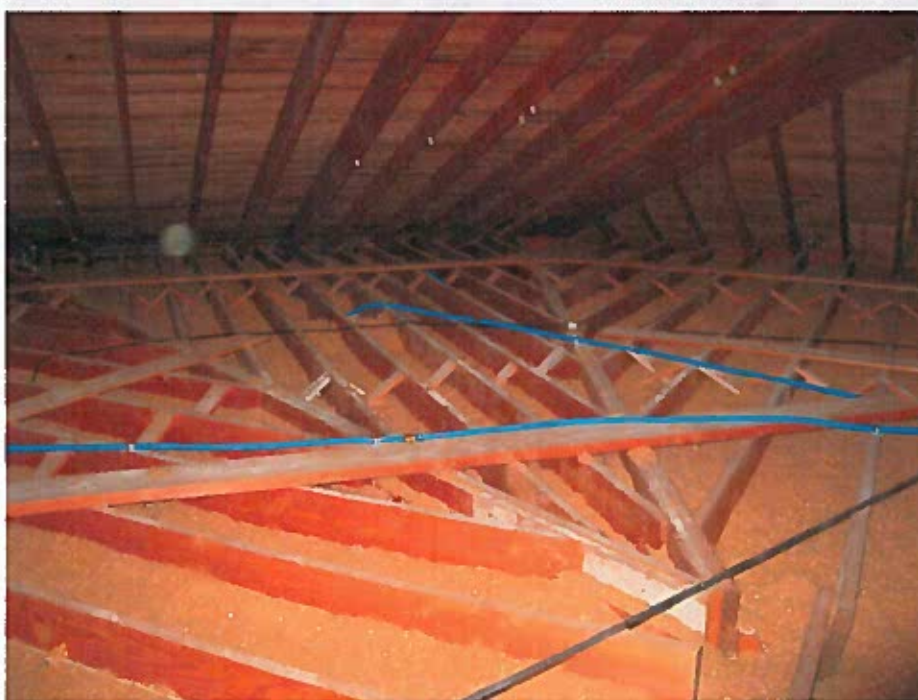
Another view of framing above the retail area; note the framing for the saddle that extends behind the north facing pediment and the extensive use of knob-and-tube wiring.

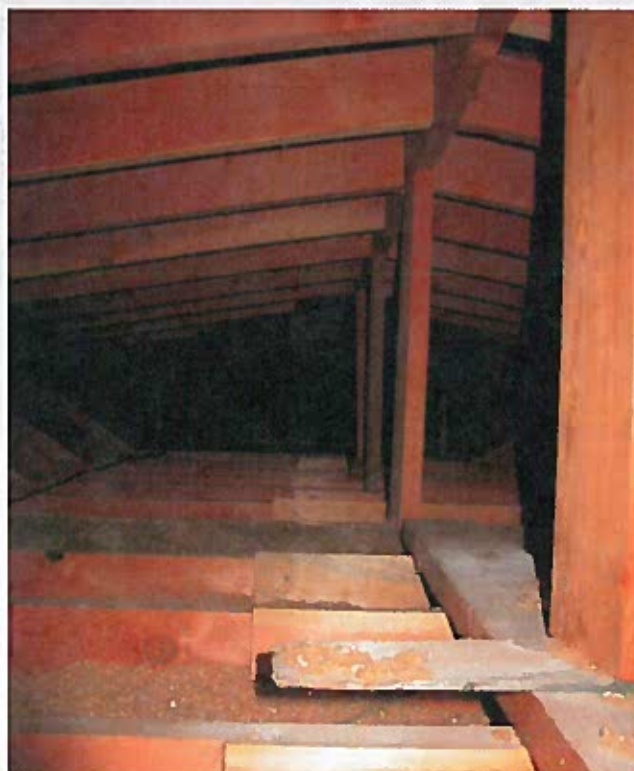
View in attic looking at the south end of the building. Cripple columns need to have metal framing anchors applied.

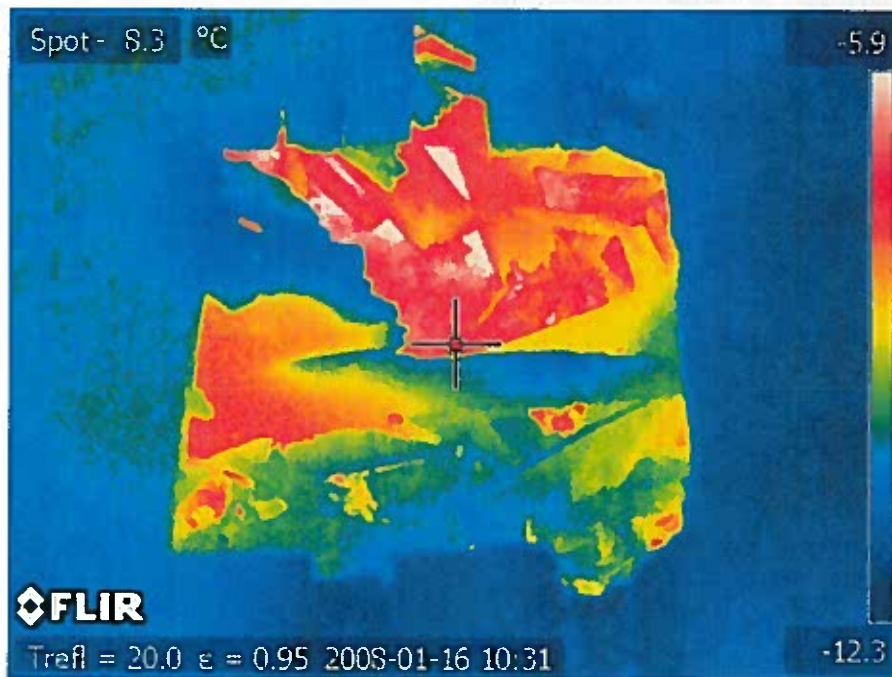
exposed to allow the direct measurement of ground temperatures. A hole was cut in the floor near the main northeast door of the Haynes headquarters. The visible image of the hole is shown in Figure 1 and the thermal infrared image of the hole in Figure 2. Note in Figure 2 the relatively warm area (red to white colors) is  $-6^{\circ}\text{C}$  ( $21^{\circ}\text{F}$ ).

Figure 1. A hole had been cut in the floor near the main northeast door of the Nature Store. Notice the door base on the right (north) of the photo. View to the west taken January 16, 2008, 10:31 am MDT.

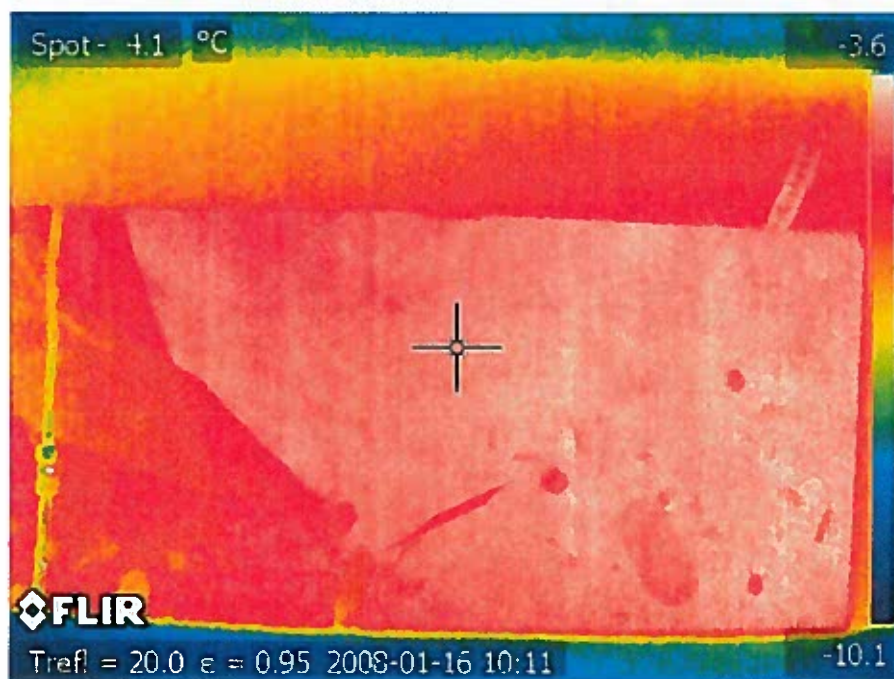
In the southwest corner of the main ground floor eastern room, an access panel was removed to expose the ground (Figure 3). Note that the temperatures of the ground exposed through the access hole are cold (Figure 4,  $-3.6^{\circ}\text{C}$  ( $26^{\circ}\text{F}$ )).

Figure 3. View of an access panel in the southwest corner of the main ground floor eastern room. The access area is about 0.5 meters (1.5 feet) in length by 0.3 meters (1 foot) in width. View to the west taken January 16, 2008, 10:11 am MDT.
