Building 36  
Mammoth Hot Springs, Wyoming

Historic  
Structures  
Report

AUGUST 2003

**ADMINISTRATION BUILDING**

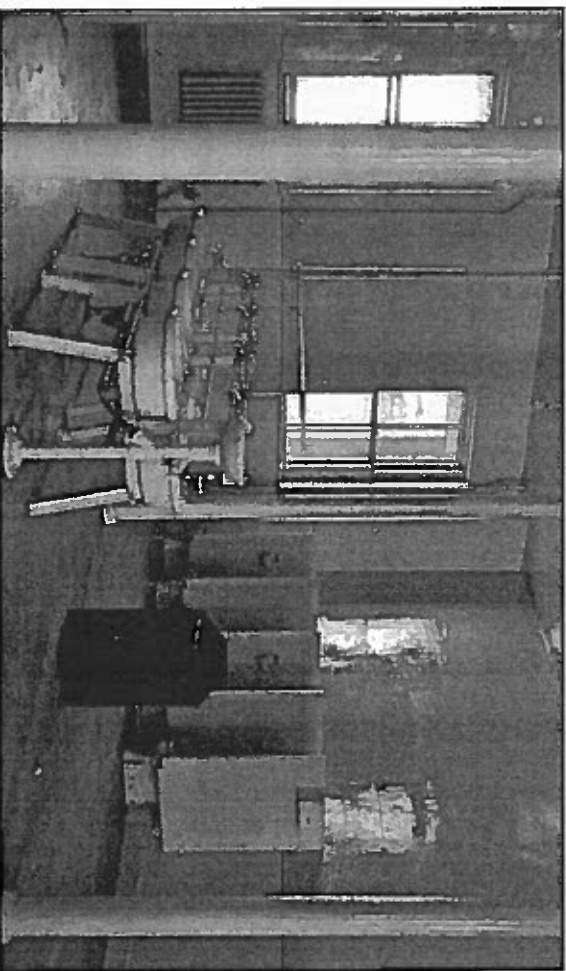
Figure 5. The interior of one of the original latrines prior to remodeling. Note the chair rail at the level of the base of the windows. (Photo No. 30598, Historic Photo Collection, RG 79, National Archives and Records Administration, Yellowstone National Park, Wyoming)

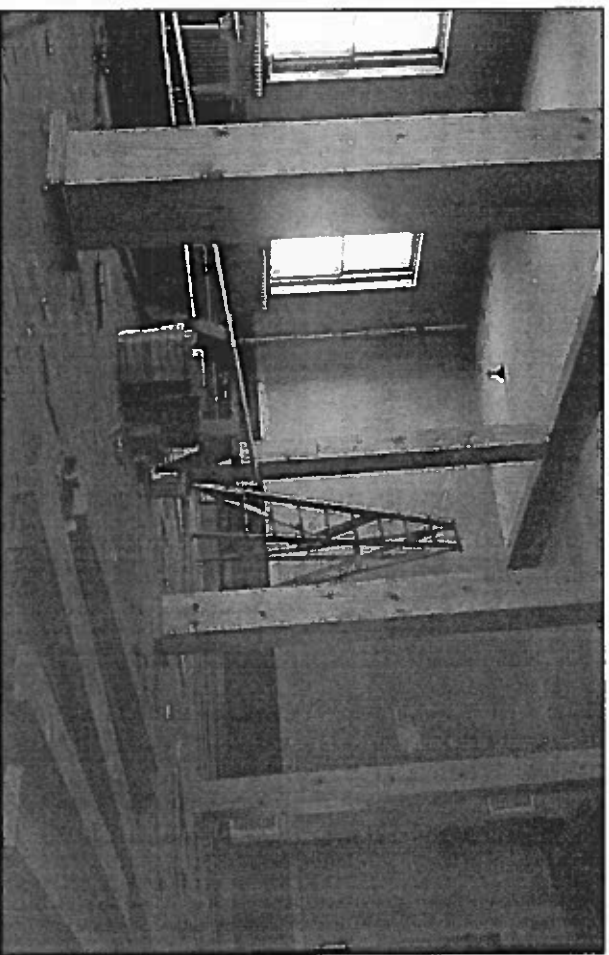
Figure 6. Circa 1935 photo of the remodeling of the dormitory, north wing.  
(Photo No. 20699, Historic Photo Collection, RG 79, YNP Archives.)

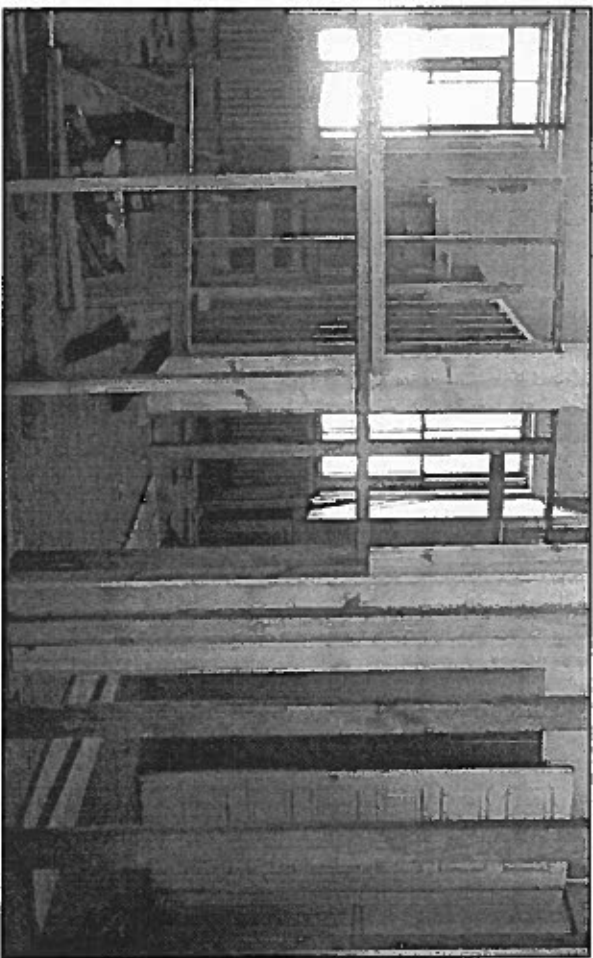
Figure 7. Circa 1935 photo of the remodeling of the north wing dormitory space in the north wing. (Photo No. 20753, Historic Photo Collection, RG 79, YNP Archives.)

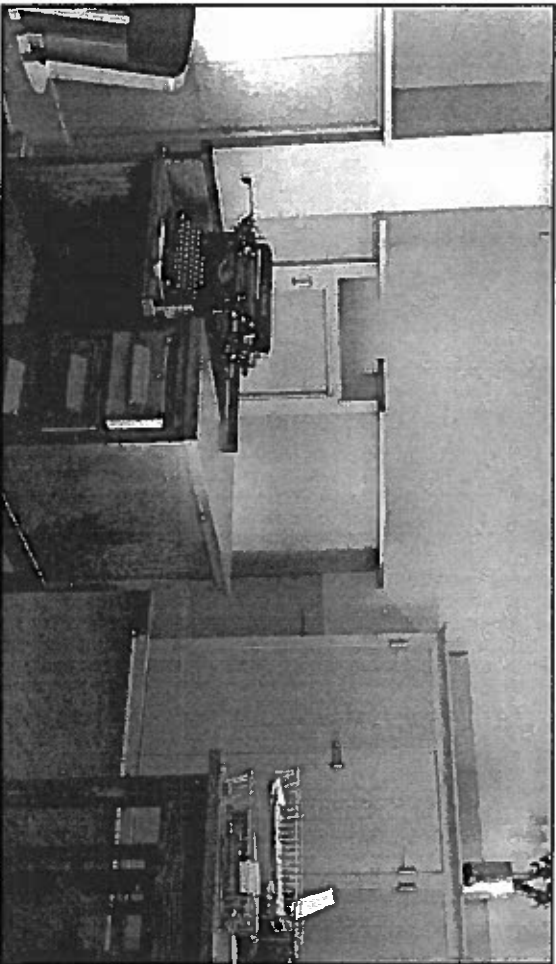
Figure 8. Interior finishes in remodeled office areas resulting from 1938/1939 remodeling. (Photo No. 30581, Historic Photo Collection, RG 79, YNP Archives.)

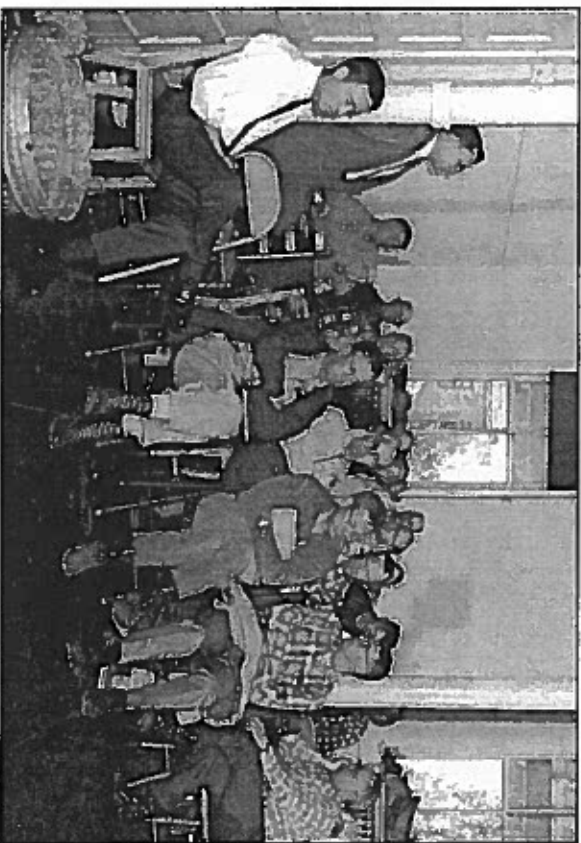
Figure 9. Circa 1960 photo of a meeting area in the first floor. Note the panel door and the 6' rail around the room. (Photo No. 20368, Historic Photo Collection, RG 79, YNP Archives)

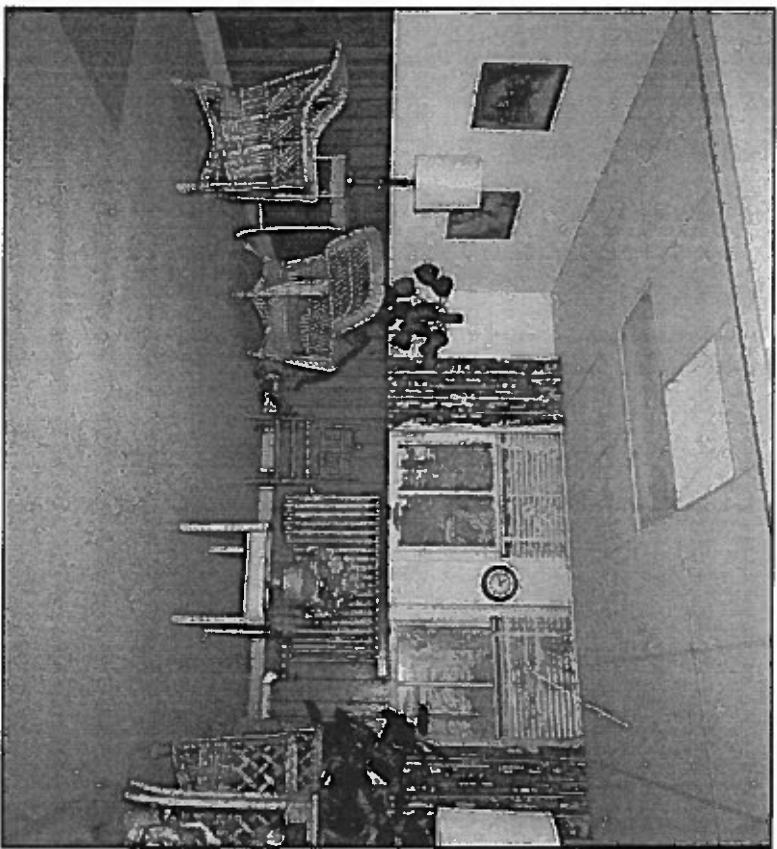
Figure 10. View of one of the reception areas in the Superintendent's Office circa 1975, prior to the most recent, 1982 remodel. Note the dropped ceiling that covers the top of the windows. (Photo No. 31031-9, Historic Photo Collection, RG-79, YNP Archives.)

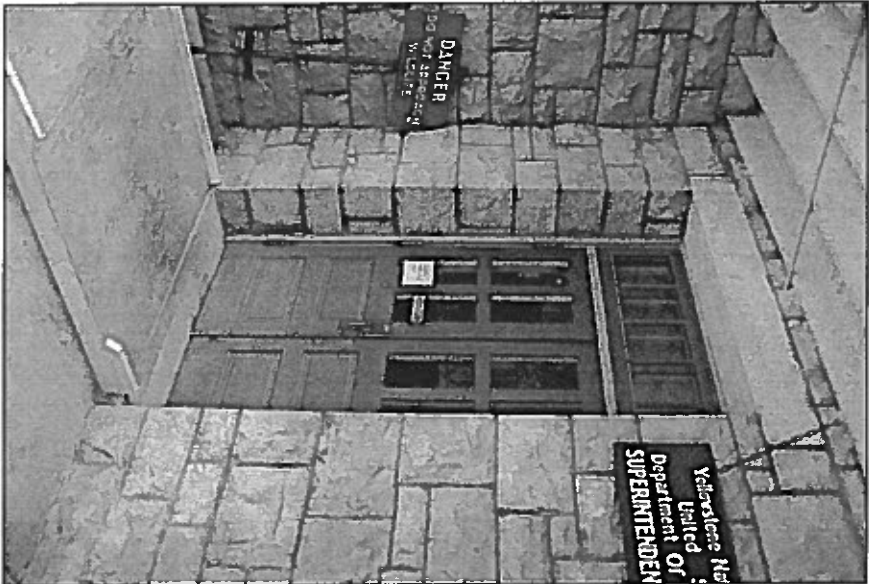
Figure 18: Looking southeast at the main facade of the Administration Building.

1. Preserve and maintain the stonework, including the rusticated walls, water table, window sills, and lintels. Restore the Columbus sandstone sills that are deteriorated. This can be accomplished with a sandstone patch or in-kind replacement.

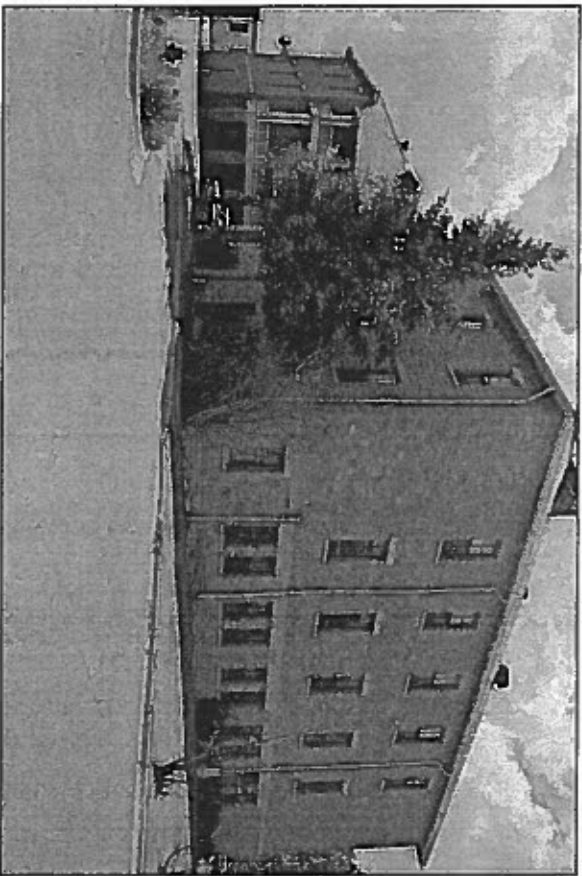
Figure 21: Looking southwest at the rear of the building.

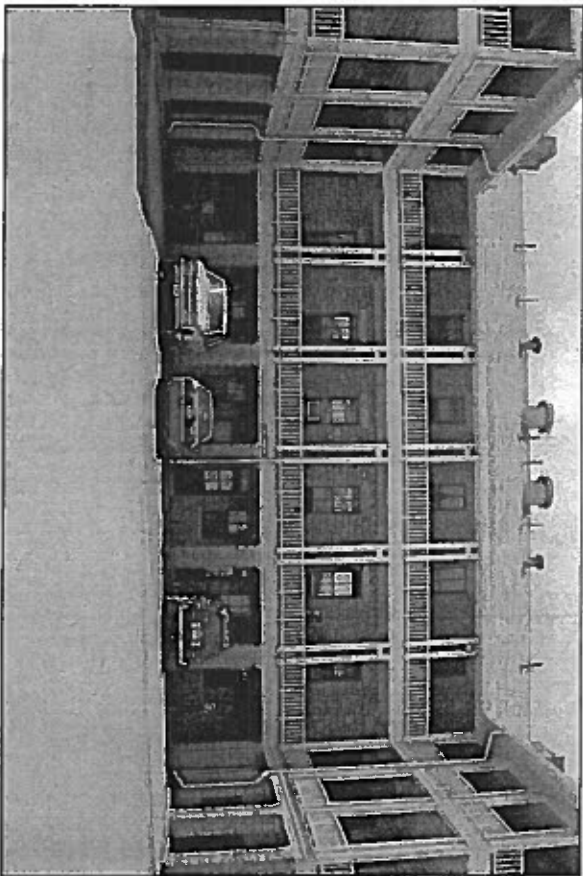
Figure 22: Looking west at the rear elevation and the connecting balconies on the building.

2. Preserve and maintain the balconies on the front and back of the building.
3. Preserve and maintain the clay tile roof of the building, along with the chimneys and metal ventilators. The present roof appears to be original and there was no documentation that it was ever replaced. Because of the years of wear, it will have to be replaced in the near future. Replace the tile roof in-kind to the original

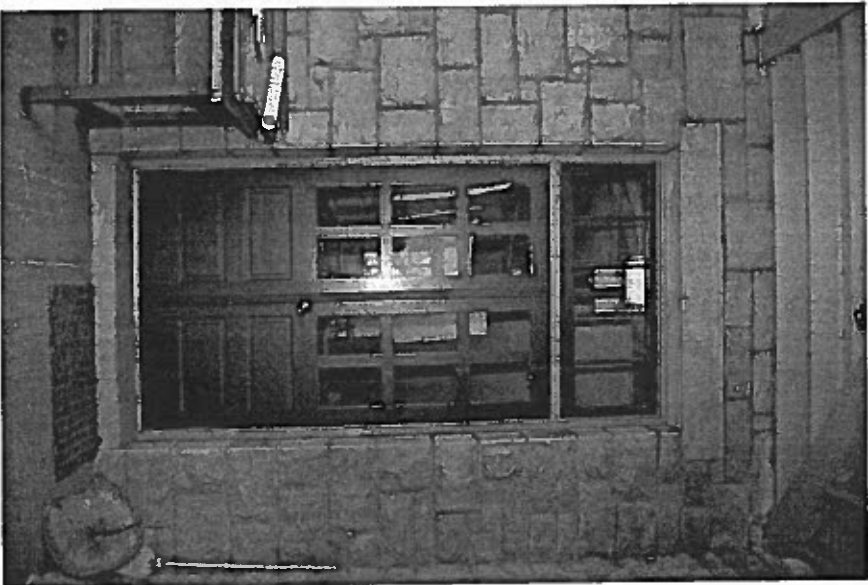
Figure 27: Looking southwest at the second floor balcony and structure. Additional connections were placed at the balcony and stone wall after the 1959 earthquake.

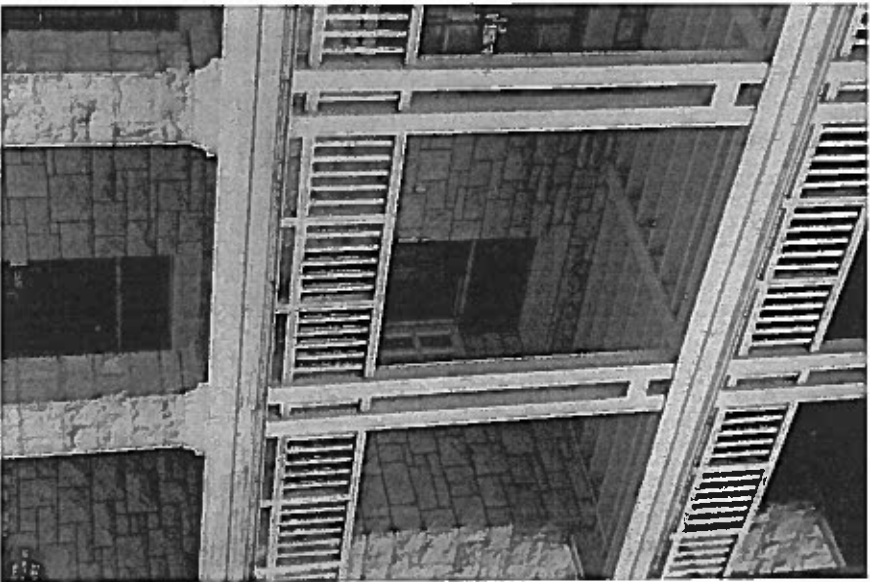
Figure 28: Looking southeast at the entrance doors from the second floor balcony on the front of the building.

4. Preserve and maintain the original window openings.
5. Restore the original 2 over 2 lite wood windows.
6. Preserve and maintain the door openings and restore the existing doors. Routine wear, as well as the attachment of various hardware, has caused deterioration of the wood elements. In some cases these doors will have to be replaced but they should be replaced in-kind. Hardware should be compatible with the historic doors.

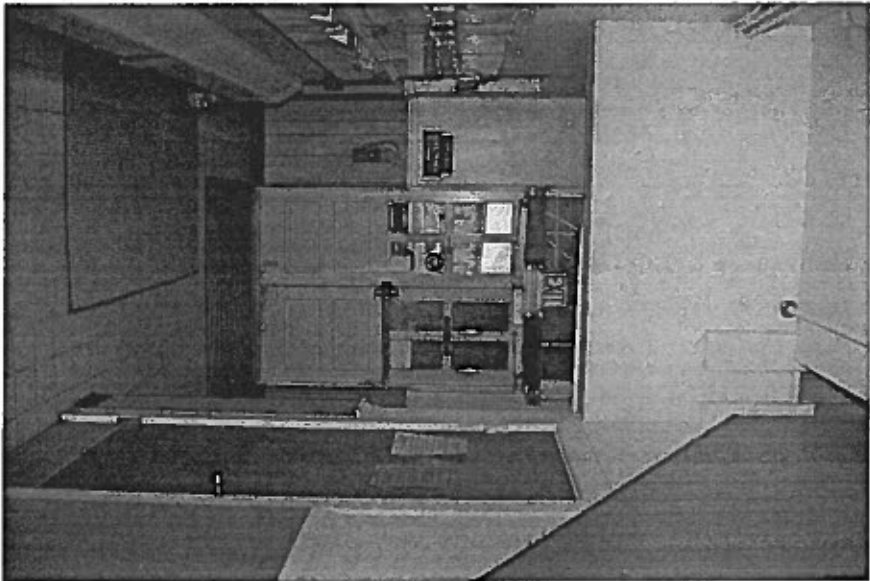
Figure 30: Looking east at the original doors and transom. The original corridor wainscot and base has been covered over with paneling, but the wood cap remains.

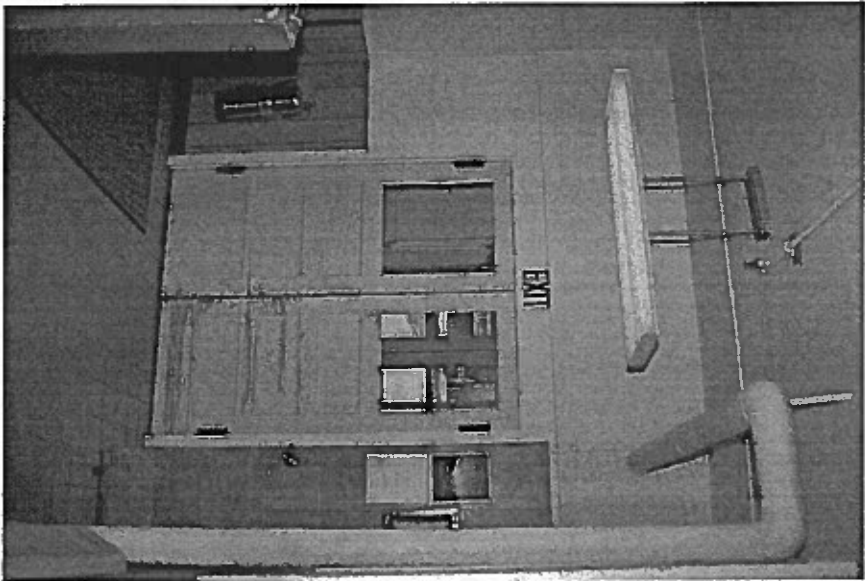
Figure 31: Looking southwest at the offices in the area of room 101. Note all of the later materials on the walls and ceilings that were not original to the building.

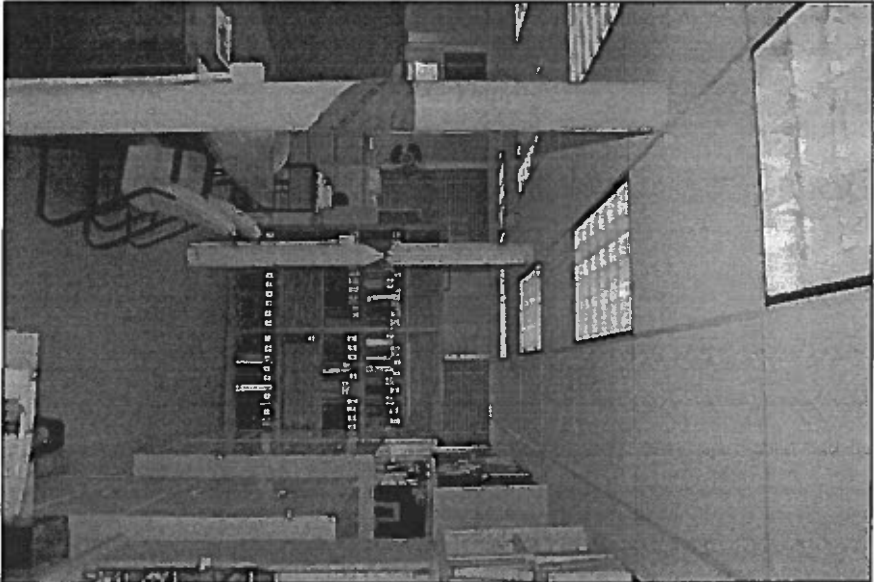
Figure 32: Looking south at room 109. Note the original iron columns. The ceilings have been covered over with new materials.

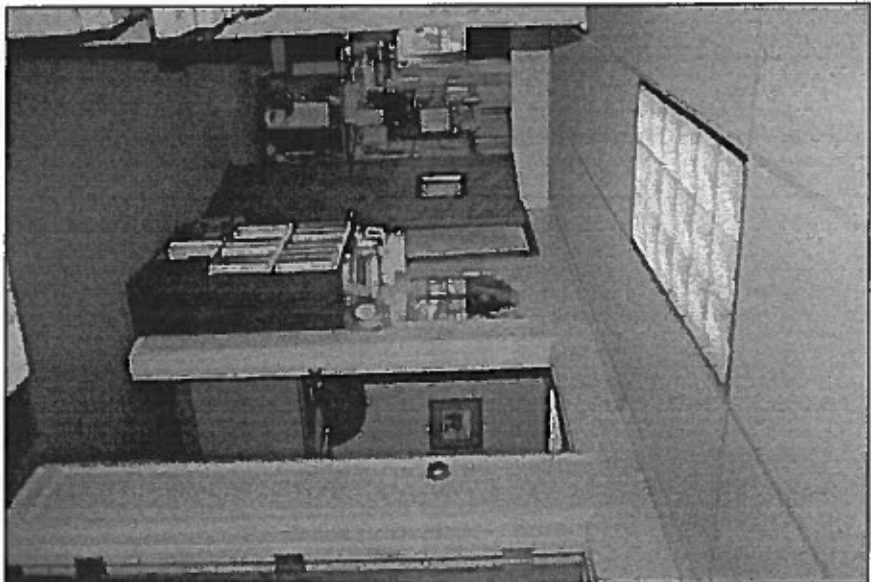
Figure 33: Looking northeast at a wood paneled door and transom in room 109. The base and door casings are all original to the 1909 building.

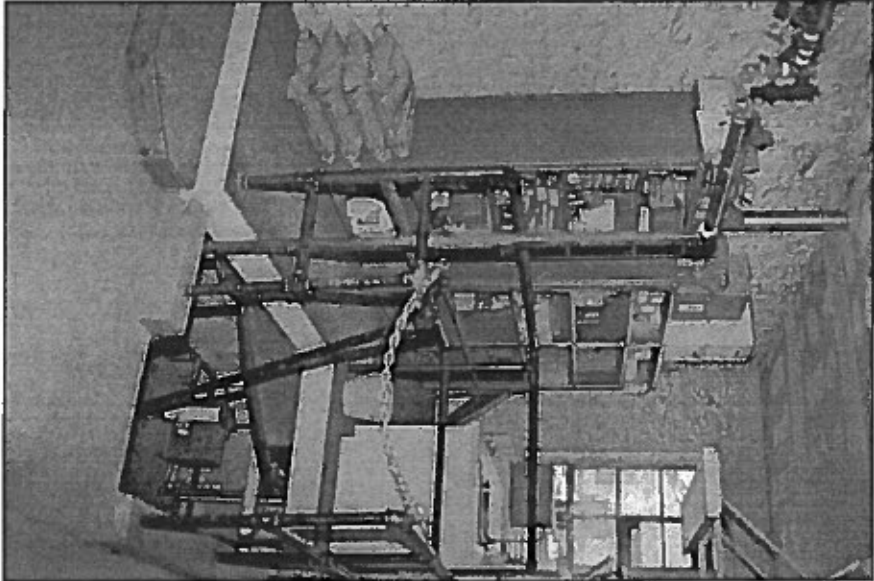
Figure 34: Looking south at the south boiler room in the original mechanical room 111. Note the original stone walls and concrete floor. The stairs lead to a lower mechanical room.

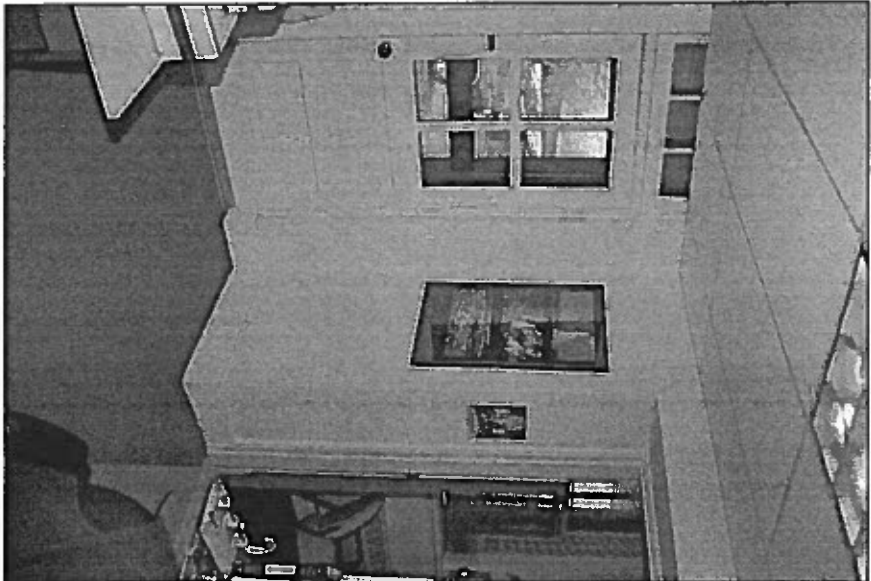
Figure 35: Looking northwest at the boiler room. Note the original brick and stone walls beyond. The ceiling has been covered with sheetrock.

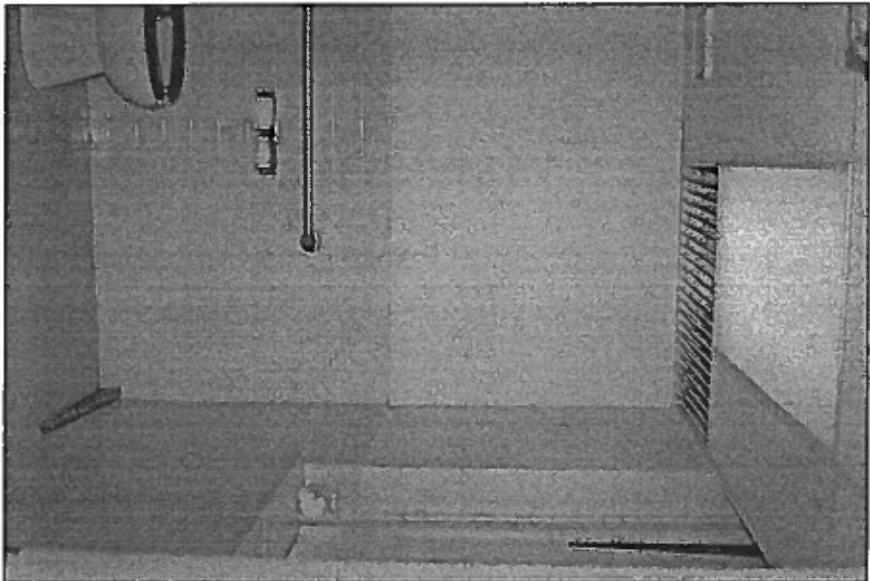
Figure 39: Looking east at an original door and window in room 119. Note the original plaster wall and wood casing around the door and window.

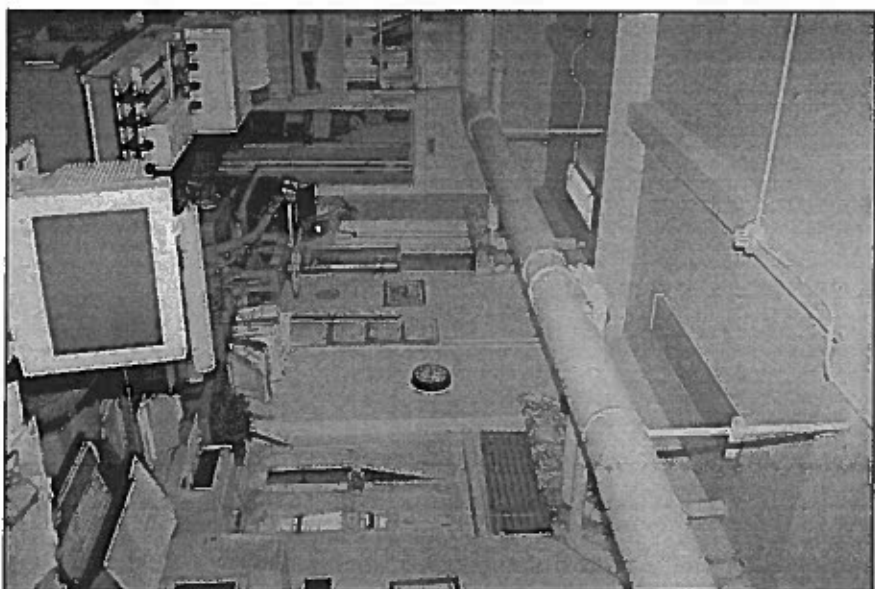
Figure 40: Looking southwest at room 122. This room has also been opened up from a series of small rooms. The exterior wall to the right has original materials and openings.

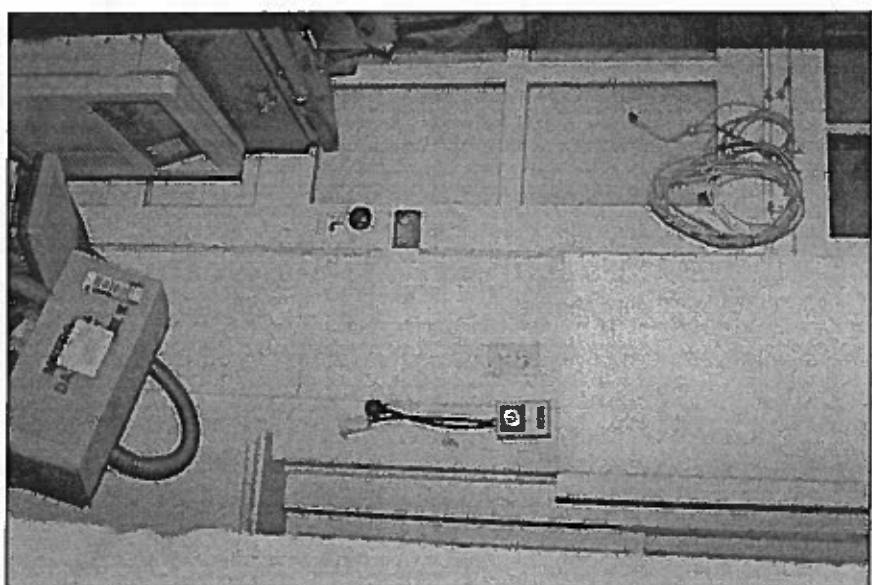
Figure 41: Looking east at the north stairway and hall. Note the original newel post and handrail. The original balusters on the right and the original wainscot on the left is under the paneling. The original wood stairs have been covered with carpet.

1. Protect the extant historic fabric in the stairways of the building in both the north and south halves. This includes the stairs, wood treads and risers, the railing and balusters (under the paneling), and the wood wainscot (under the paneling), along with the wood wainscot cap. A carpet runner could be used on the stairs if needed to protect them with the sides showing the original wood. The stair to the attic shows the original wood color on the treads. The wood floors should be restored or replaced where necessary.

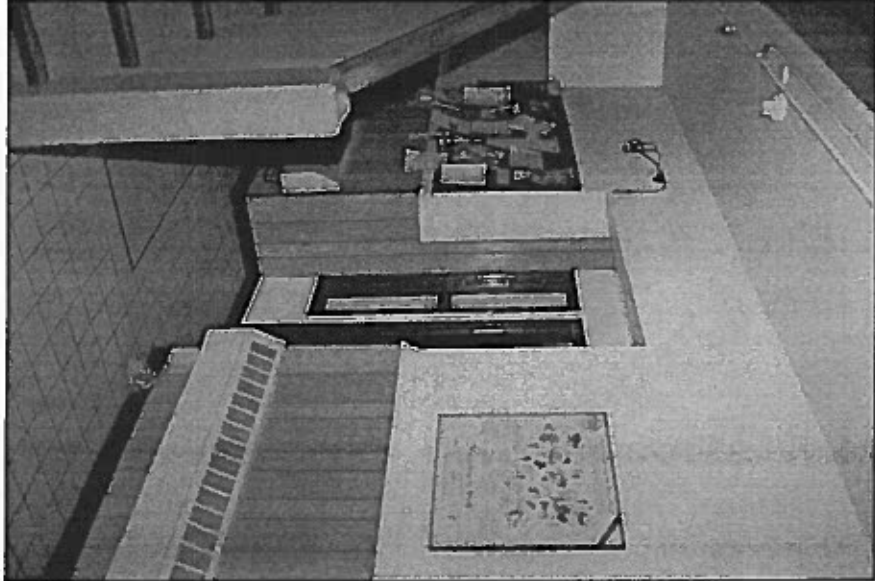
Figure 42: Looking southeast at the door into the central hallway from the stairway. The doors are new but the wall to the right is original. The original wood wainscot has been covered with paneling but the wood cap was not covered.

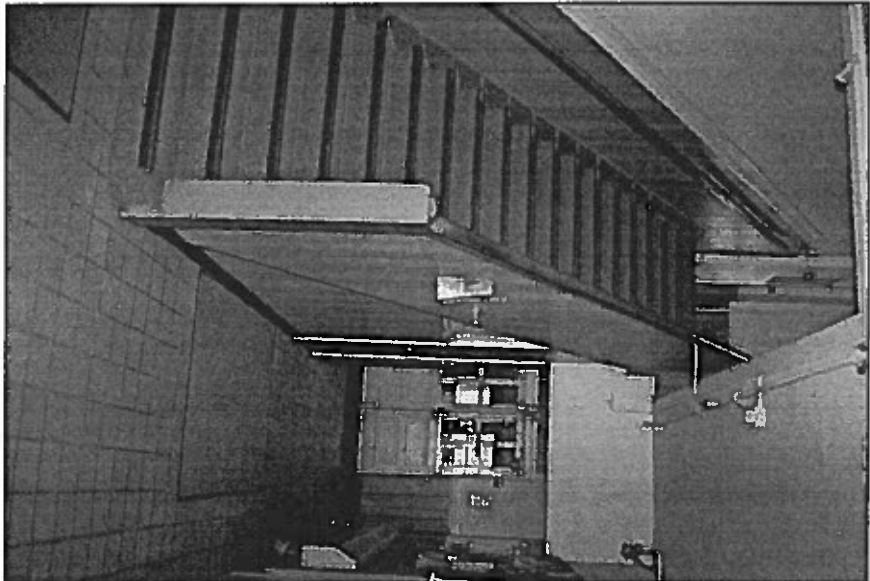
Figure 43: Looking east at the rear doors on the north end of the building. Note the original wood paneled doors and transom. The hardware has been modified over the years.

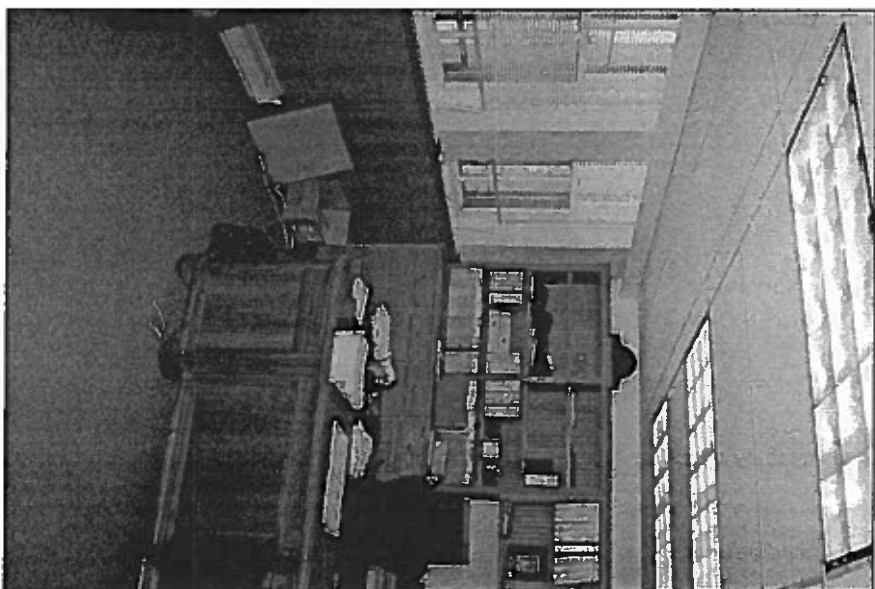
Figure 44: Looking northeast at the Superintendent's Office, room 127. With the exception of the windows and upper exterior walls, the room has new materials. The ceiling has also been lowered below the head of the window. The superintendent's office is typical of this wing of the building.

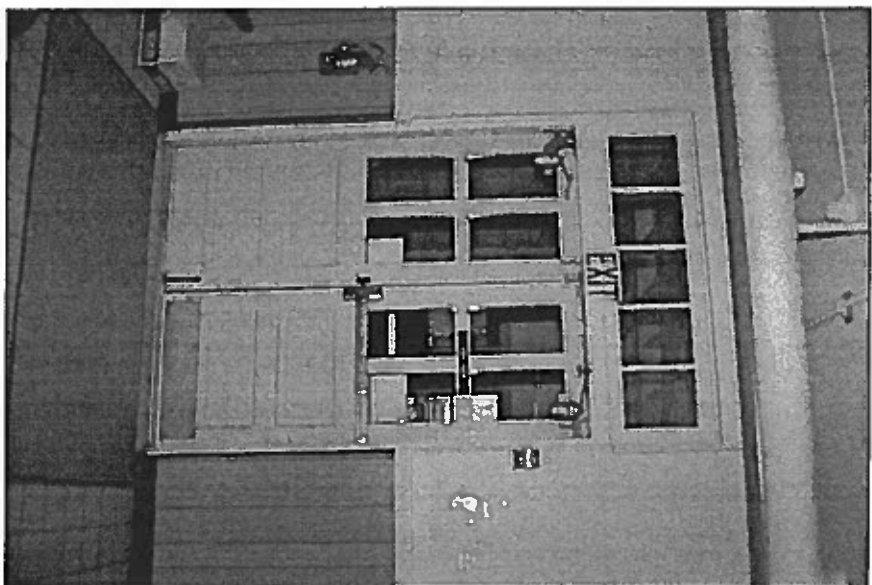
Figure 45: Looking northeast at the reception area, room 125, at the typical new materials.

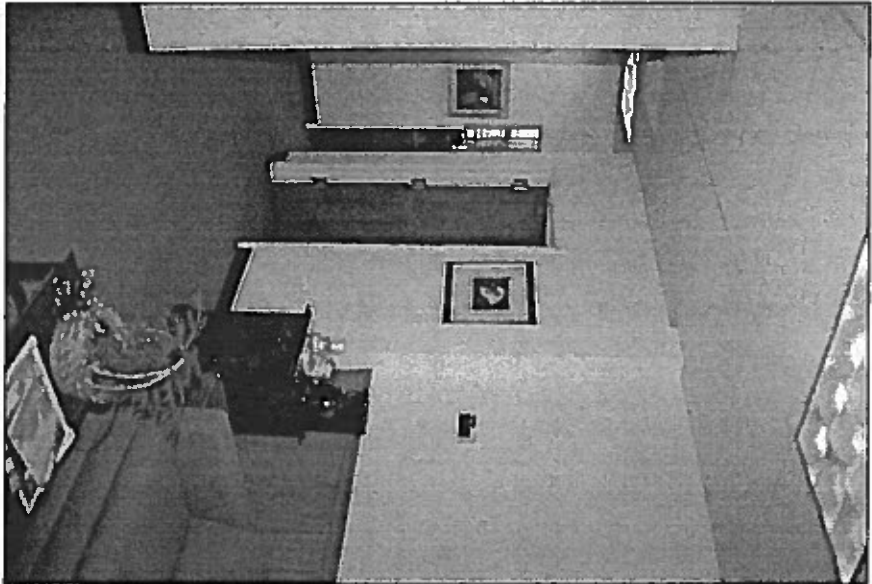
Figure 46: Looking southeast in conference room 128. All of the materials are new to the space.

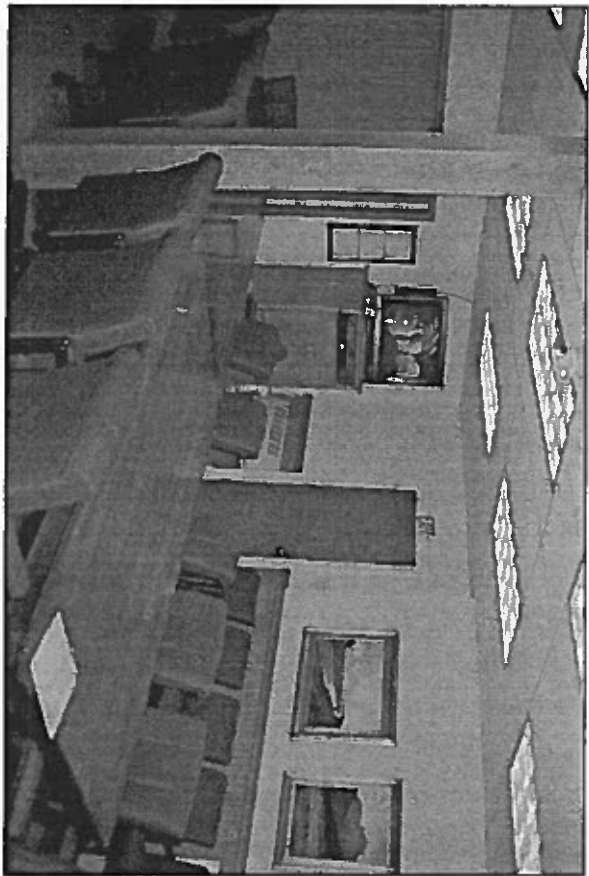
Figure 47: Looking southeast at room 133. The wall and windows are original to the building including the casing and sill of the window.

The chair rail has been covered. The ceiling has also been lowered below the head of the window.

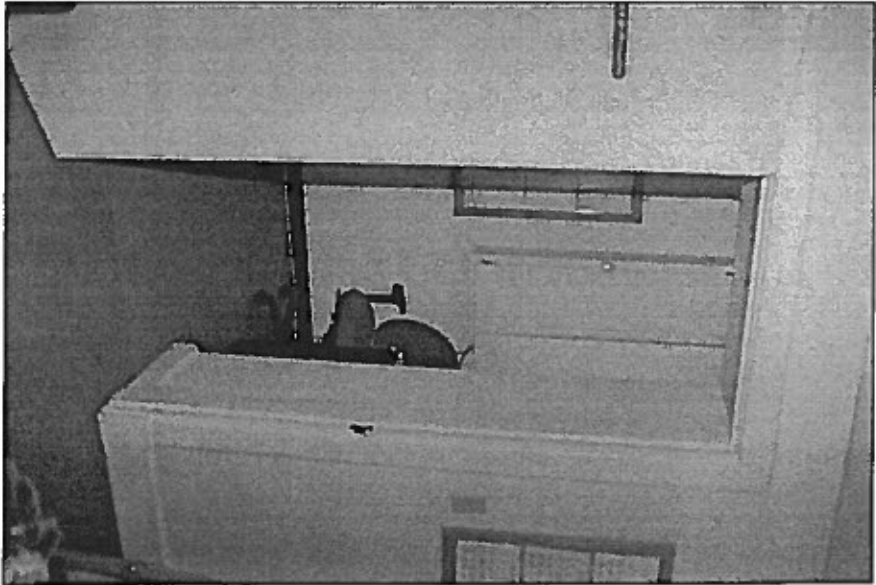
Figure 48: Looking west at the doorway from room 134. Even though the door is newer, the casing and base are original to the room.

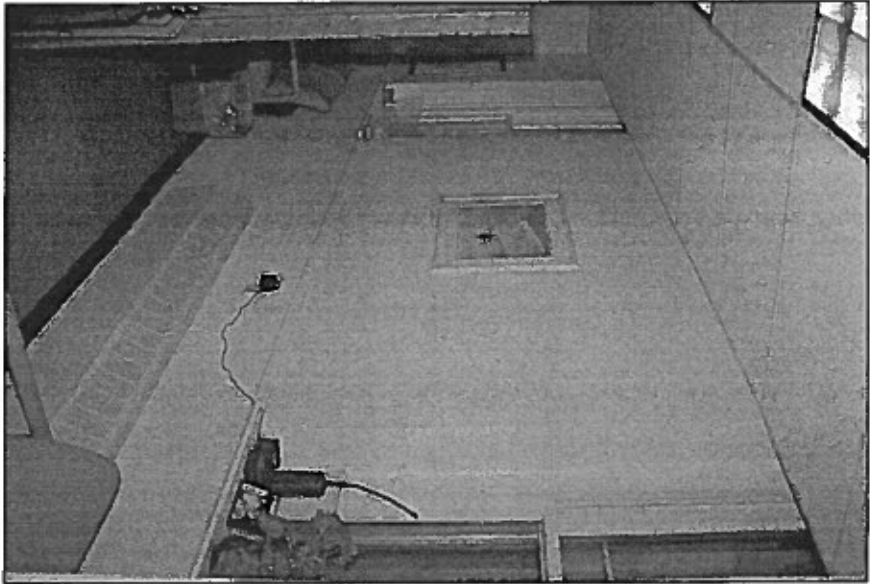
Figure 49: Looking northwest at the boiler room 135 in the north wing of the building. Note the original plaster walls and ceiling.

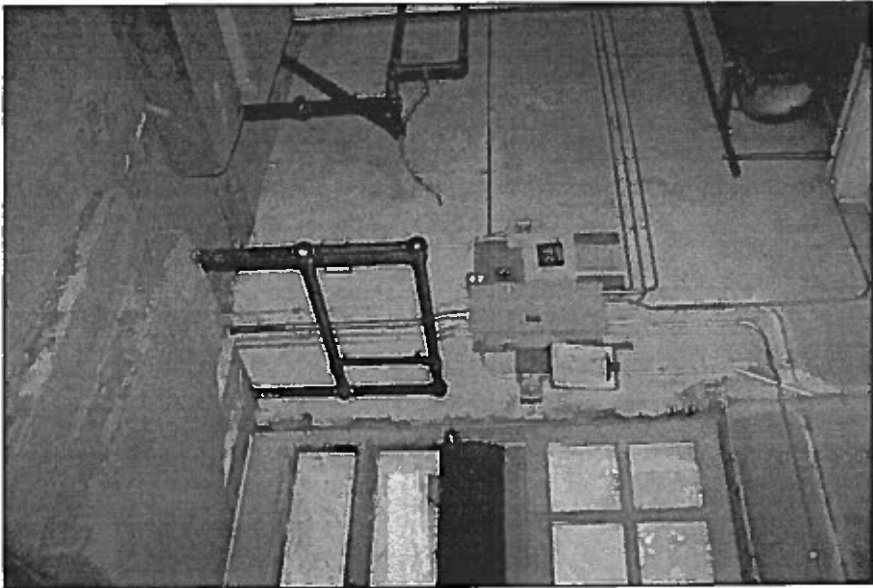
Figure 50: Looking northeast at the boiler room entrance and metal stair down to the lower area. Note the original plaster wall.

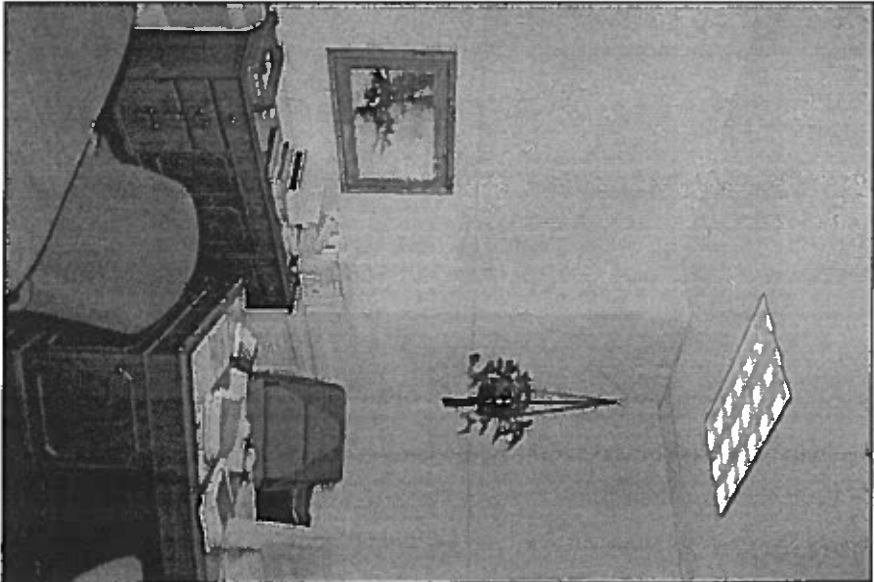
Figure 52: Looking southwest at the outside walls of room 204. Note the original passive ventilation shaft in the corner with the chair rail and high rail trim. This room also has the original base along with the plaster walls.

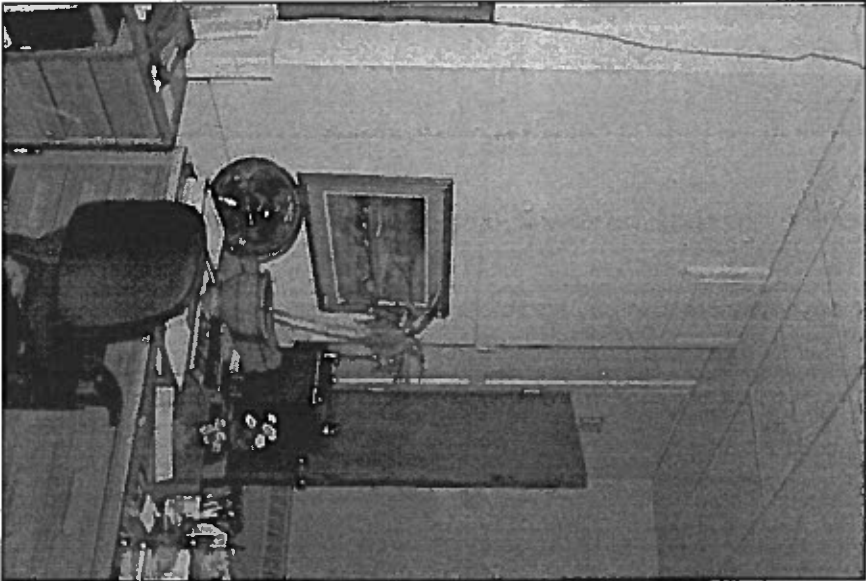
Figure 53: Looking southeast at room 207. Most of the materials are new to the space with the exception of the exterior wall to the right.

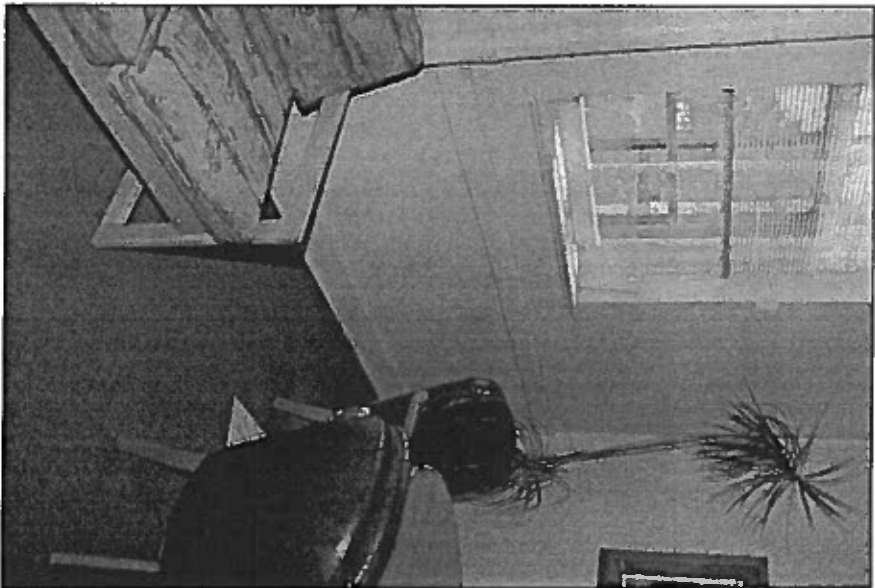
Figure 54: Looking southwest at room 207. Note the original plaster on the exterior wall along with the windows and upper rail, chair rail, and base. This is typical of rooms with exterior walls.

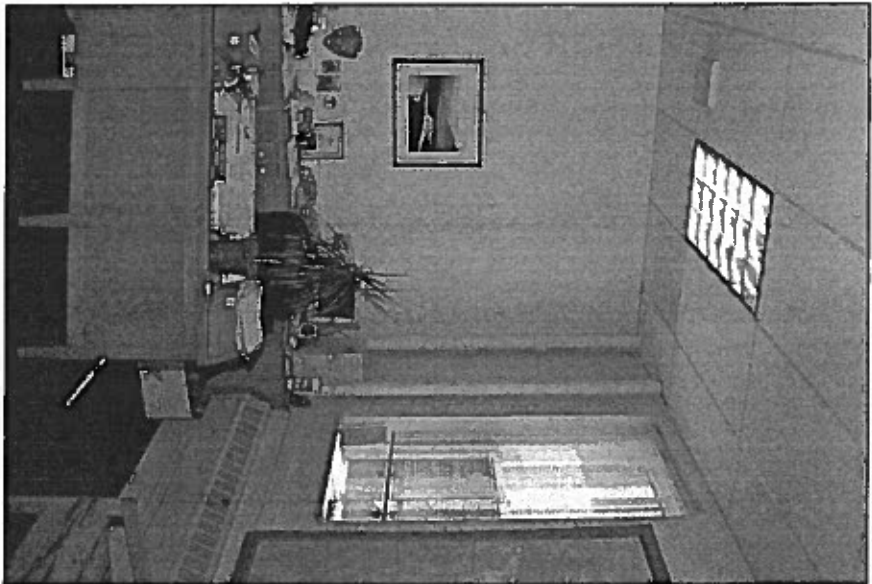
Figure 55: Looking east from room 201 into room 208 and beyond. Note the original door opening with transom to the NCO Quarters. All of the other materials to the right and left are new to the spaces.

14. In the openings to the NCO quarters, on the east end of the second and third floors, restore and reuse the high wood paneled doors with transoms.
15. Wood wainscot like that found in the NCO quarters hall could be used in public spaces to add texture to the walls.
16. The design of new bookshelves and cabinets should mimic the style of historic-era furnishings as represented in the third floor offices.
17. Period colors should be used to break up some of the spaces to avoid the sterile white look throughout.
18. To the maximum extent possible, bury all mechanical, electrical and fire suppression systems.
19. Minimize the impact of fire alarms, emergency lighting, and fire detection systems by painting the fixtures the color of the walls and minimizing their size.
20. Mechanical registers should be painted to blend in with walls and minimize impacts on the surfaces of the rooms.

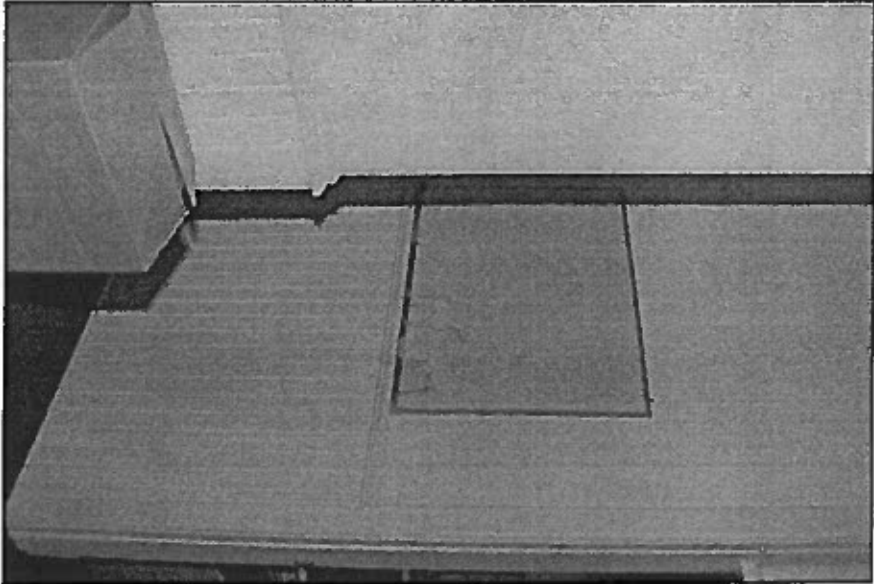
Figure 56: Looking southeast at corridor 211. Note the original wood wainscot and cap and casing around the door.

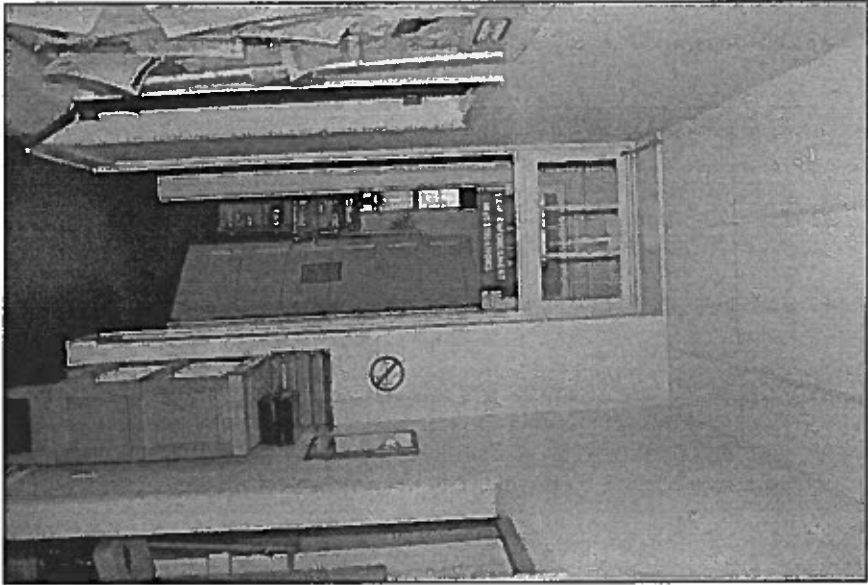
Figure 57: Looking west from room 214 to the corridor 211 at the original wood paneled doors and transoms. Also note the original casing around the doorway.

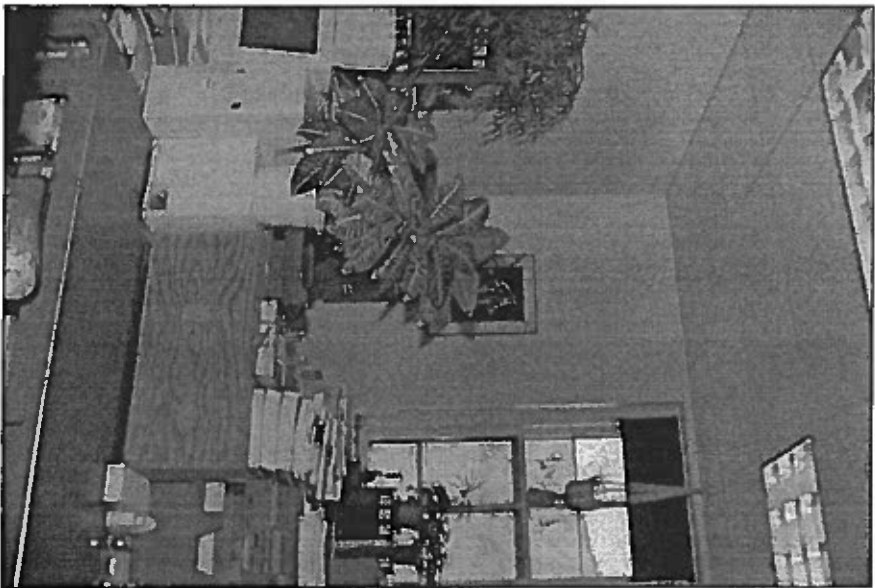
Figure 58: Looking east at room 215 where most of the room is original with exception of the lowered ceiling. The original ceiling is above the acoustical ceiling.

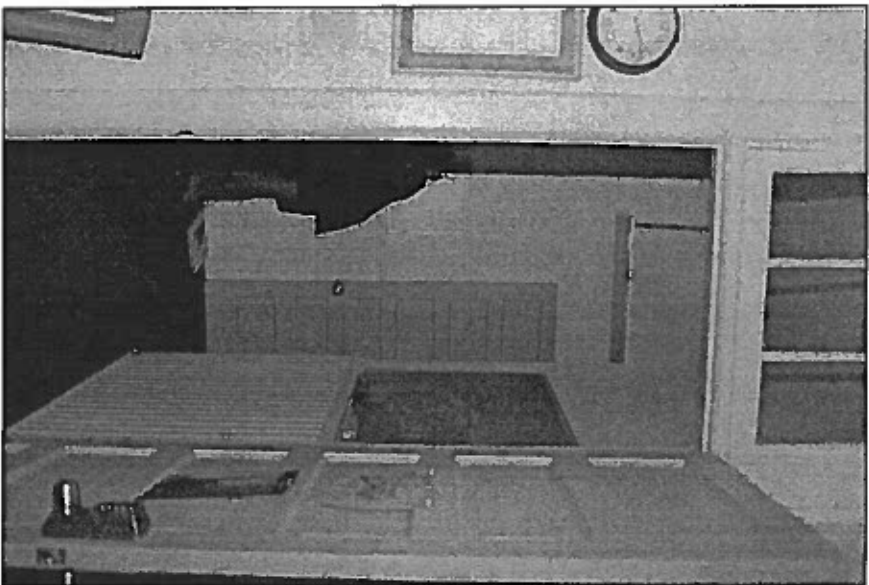
Figure 59: Looking northeast at room 220. Most of the materials are new to the space with the exception of the original materials on the exterior walls.

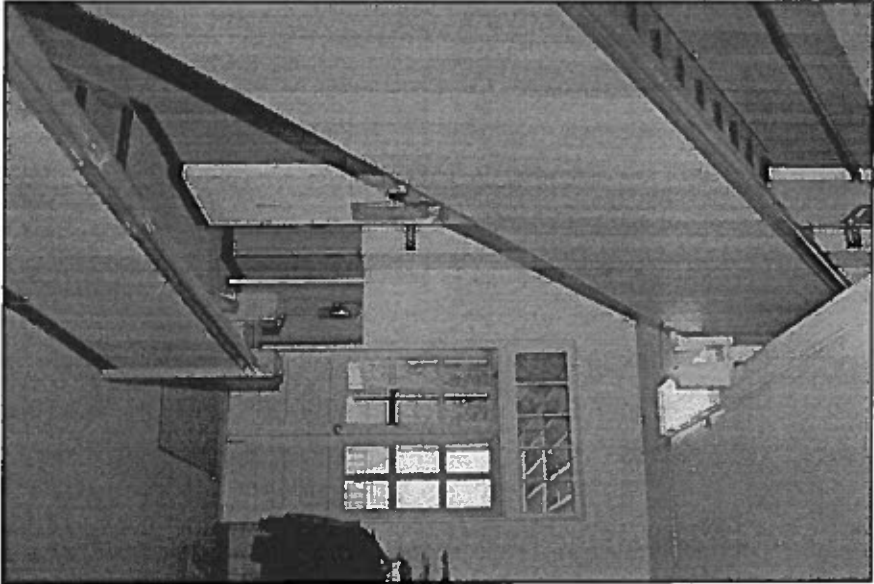
Figure 60: Looking east at the north stairway and corridor 231, towards the original doors to the balcony on the rear of the building. Note the panel-covered wainscot and stair balusters. The plaster walls are original to the space.

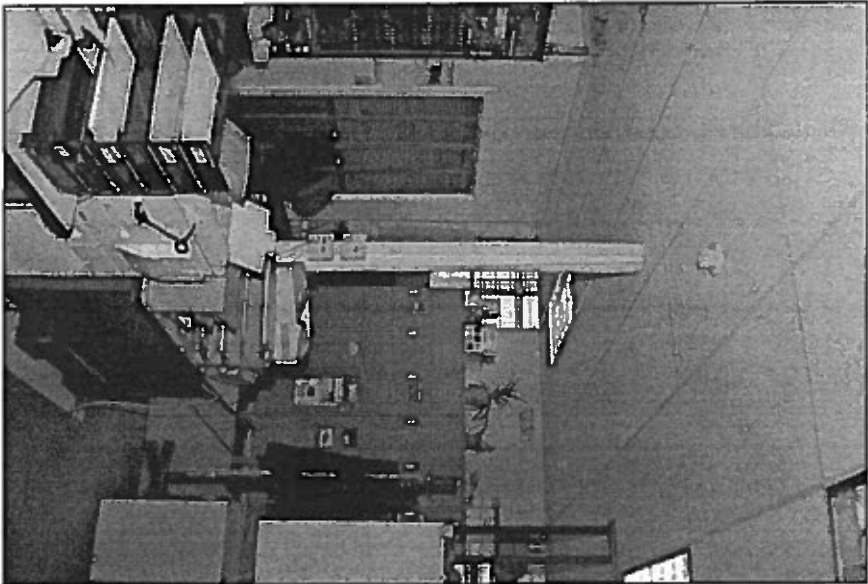
Figure 61 : Looking west at the north stairway and corridor 231 towards the original doors to the balcony on the front of the building.
