Building 36  
Mammoth Hot Springs, Wyoming

Historic  
Structures  
Report

AUGUST 2003

**ADMINISTRATION BUILDING**

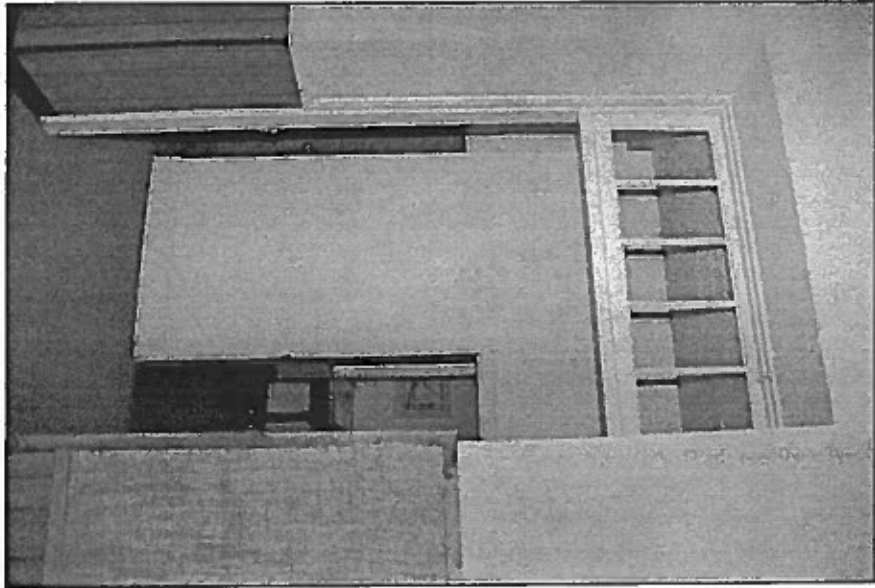
Figure 62: Looking south from stairway 231 to the doorway into room 230 and beyond. Note the original wood surround and transom.

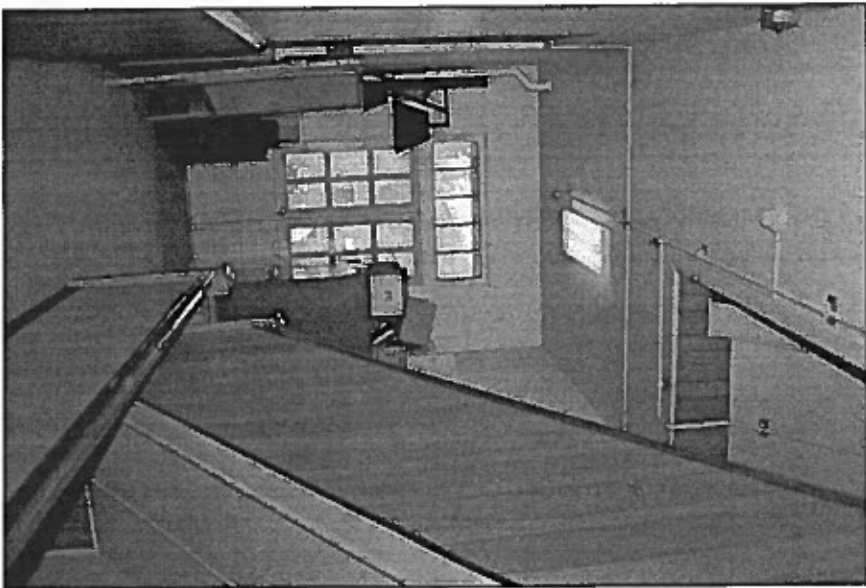
Figure 63: Looking south in room 227 at the new materials in these spaces.

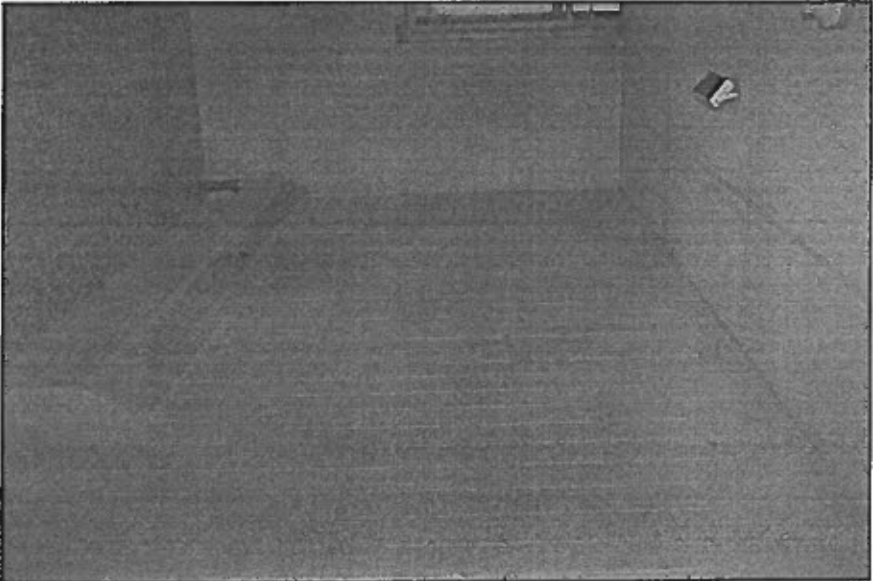
Figure 64: Looking east at the bathroom 228 and its new materials. The sill on the original window has also been replaced.

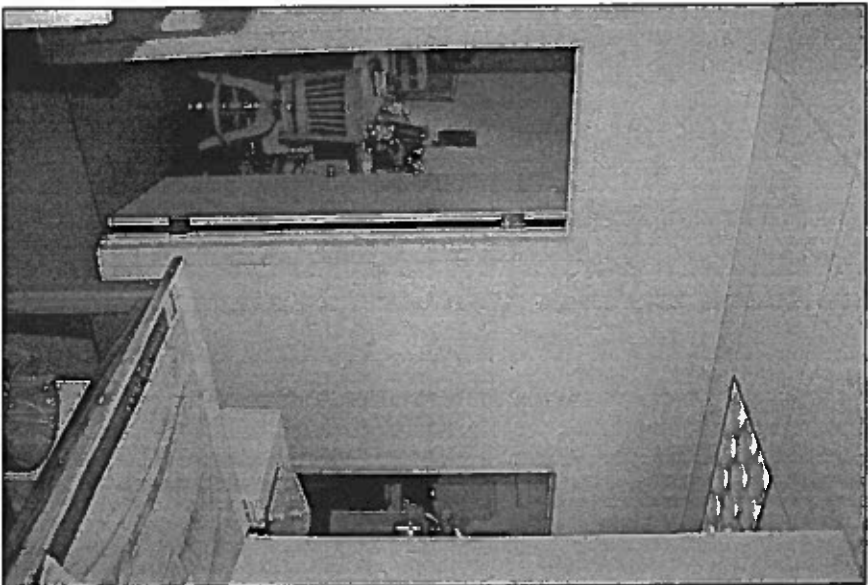
Figure 65: Looking west at room 239/236 where most of the materials are not original to the space.

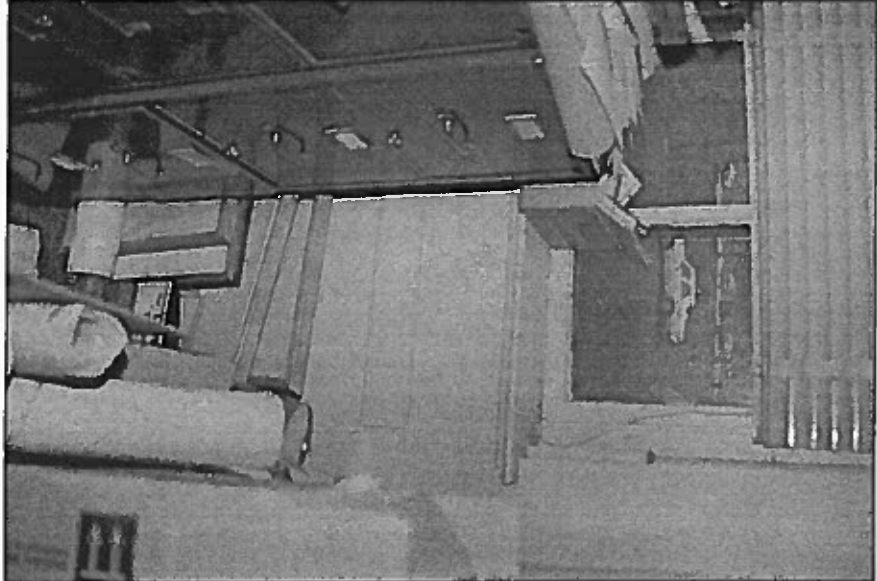
Figure 66: Looking west at a window detail in room 233. Note the original window casing, sill and the board backing for the original cast iron radiators.

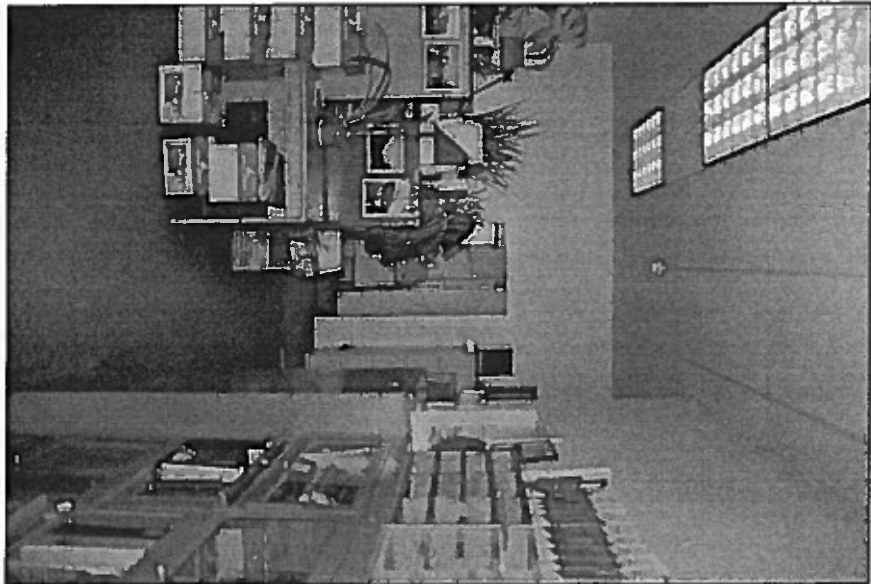
Figure 67: Looking south at a circa 1930's bathroom from room 233. Note the beaded board walls that are not original to the building.

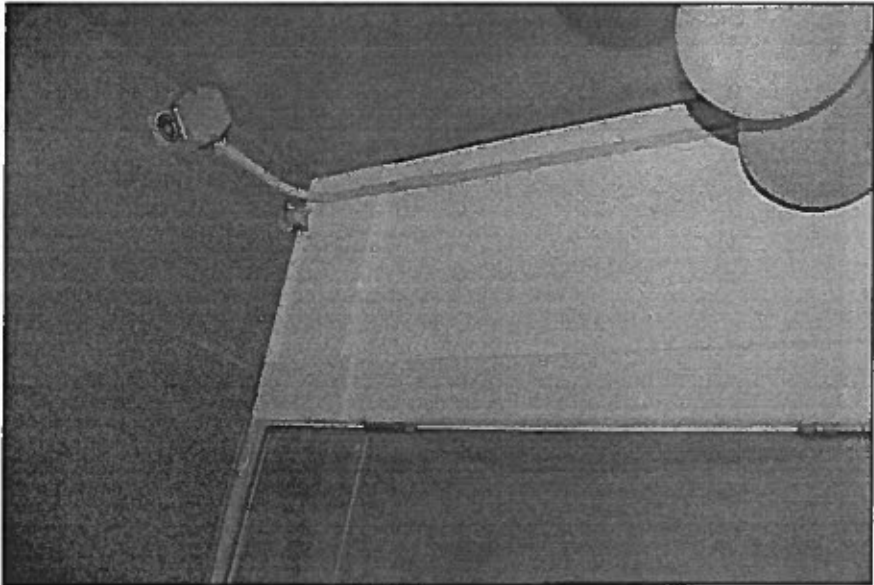
Figure 68: Looking south at the original wood base and casing at the door in room 232.

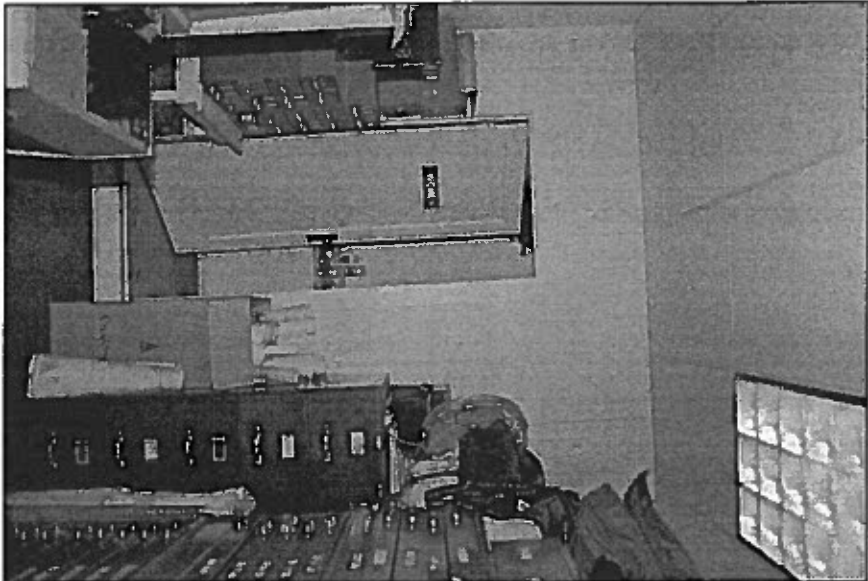
Figure 69: Looking south in room 232 at the transom above the ceiling in the door to the stairway. Note the original wood window and casing. The ceiling above the acoustical ceiling is original.

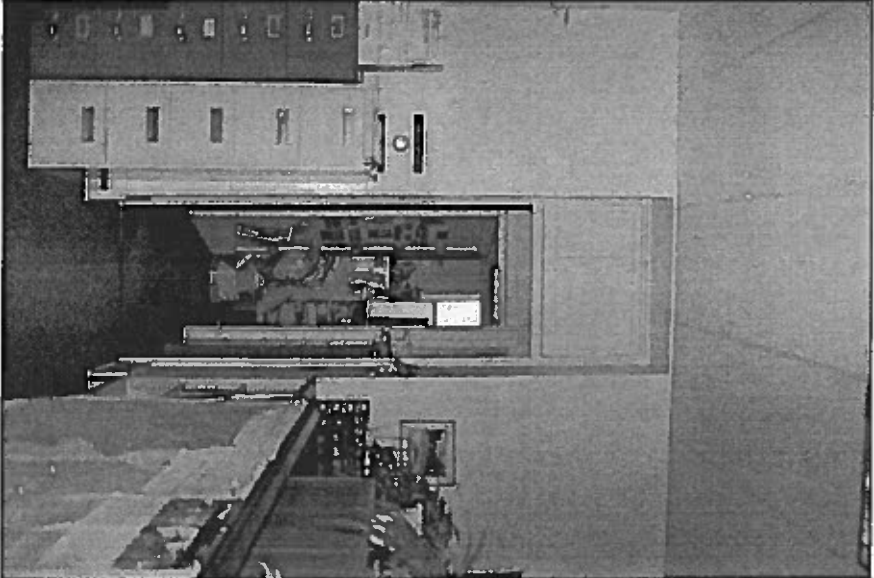
Figure 70: Looking east from room 239 to the original NCO Quarters. Note the original door and transom.

14. In the openings to the NCO quarters, on the east end of the second and third floors, restore and reuse the high wood paneled doors with transoms.
15. Wood wainscot like that found in the NCO quarters hall could be used in public spaces to add texture to the walls.
16. The design of new bookshelves and cabinets should mimic the style of historic-era furnishings as represented in the third floor offices.
17. Period colors should be used to break up some of the spaces to avoid the sterile white look throughout.
18. To the maximum extent possible, bury all mechanical, electrical and fire suppression systems.
19. Minimize the impact of fire alarms, emergency lighting, and fire detection systems by painting the fixtures the color of the walls and minimizing their size.
20. Mechanical registers should be painted to blend in with walls and minimize impacts on the surfaces of the rooms.

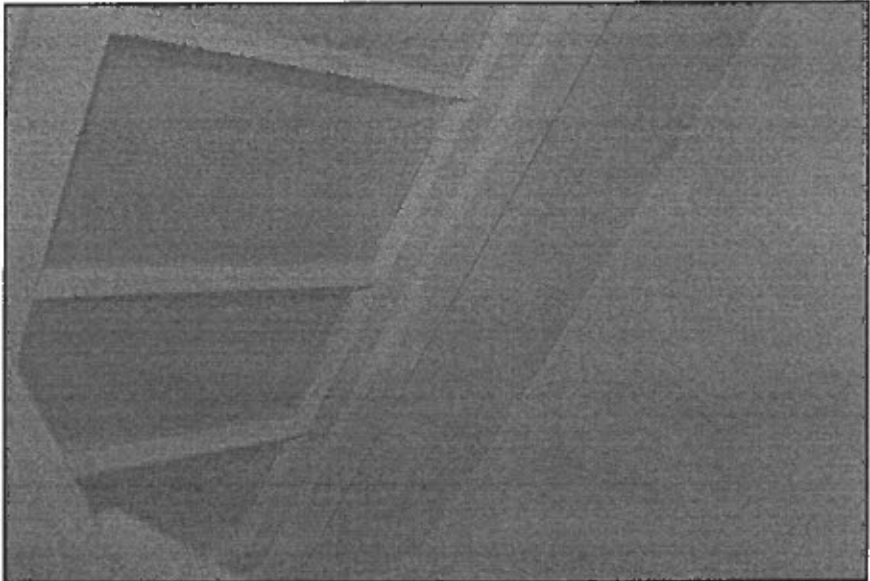
Figure 71: Looking at the original doorway and wall materials in the corridor to room 242. The rooms in this area are mostly original with the exception of the lowered ceilings.

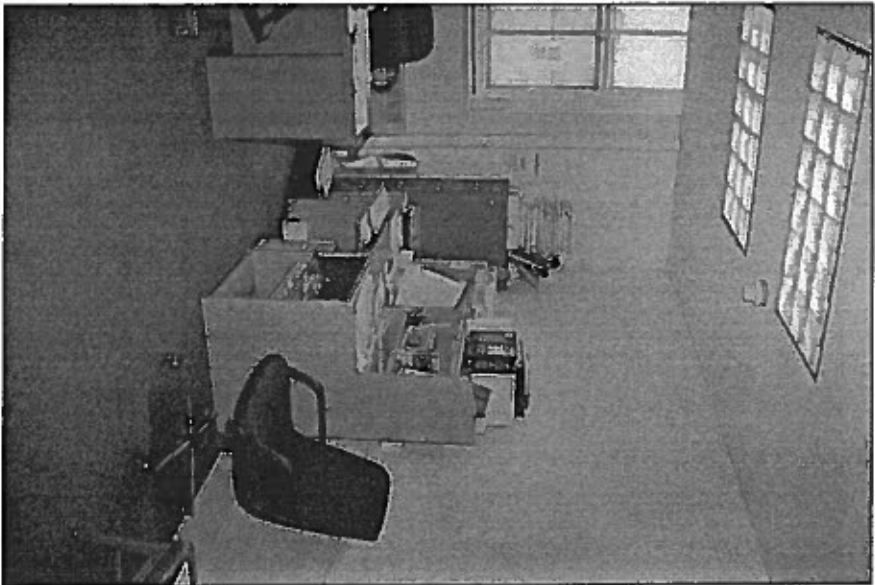
Figure 72: Looking northeast at room 242. The walls, including the chair rail, base and window, are original to the building. Note the lowered acoustical ceiling that drops below the window head.

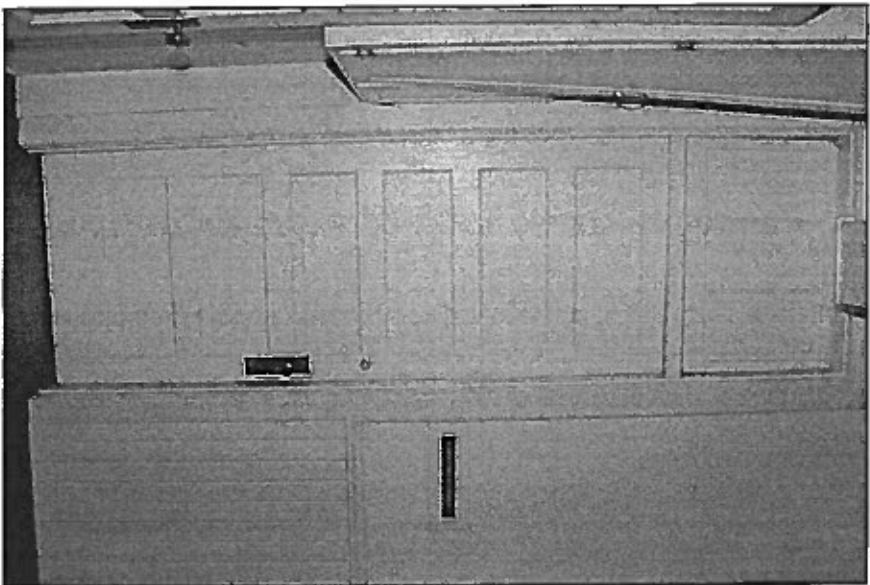
Figure 73: Looking east from stairway 300 at the original entrance doors to the balcony on the rear of the building. Most of the materials are original to the space with the exception of the paneling that covers the wainscot and balusters.

1. Protect the extant historic fabric in the stairways of the building in both the north and south halves. This includes the stairs, wood treads and risers, the railing and balusters (under the paneling), and the wood wainscot (under the paneling), along with the wood wainscot cap. A carpet runner could be used on the stairs if needed to protect them with the sides showing the original wood. The stair to the attic shows the original wood color on the treads. The wood floors should be restored or replaced where necessary.

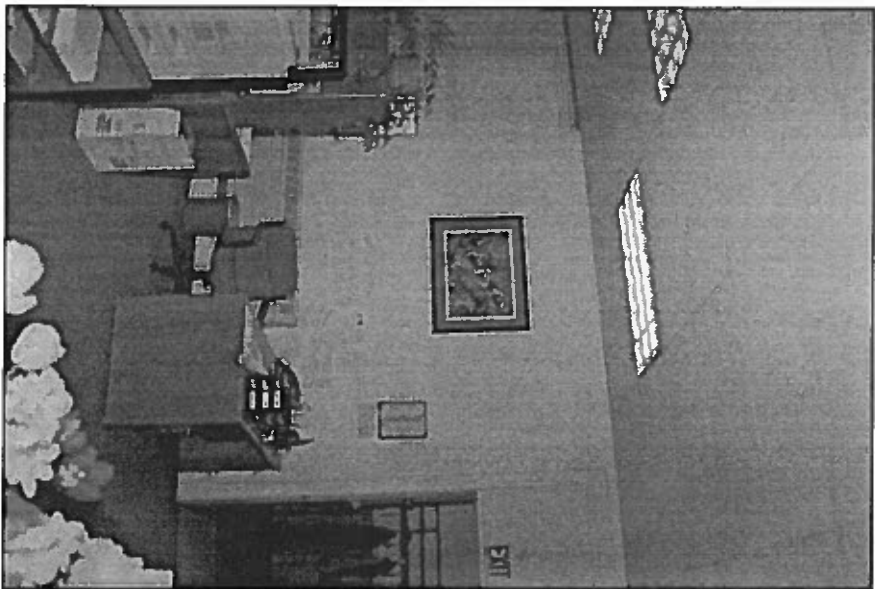
Figure 74: Looking west from stairway 300 at the original doors to the front balcony.

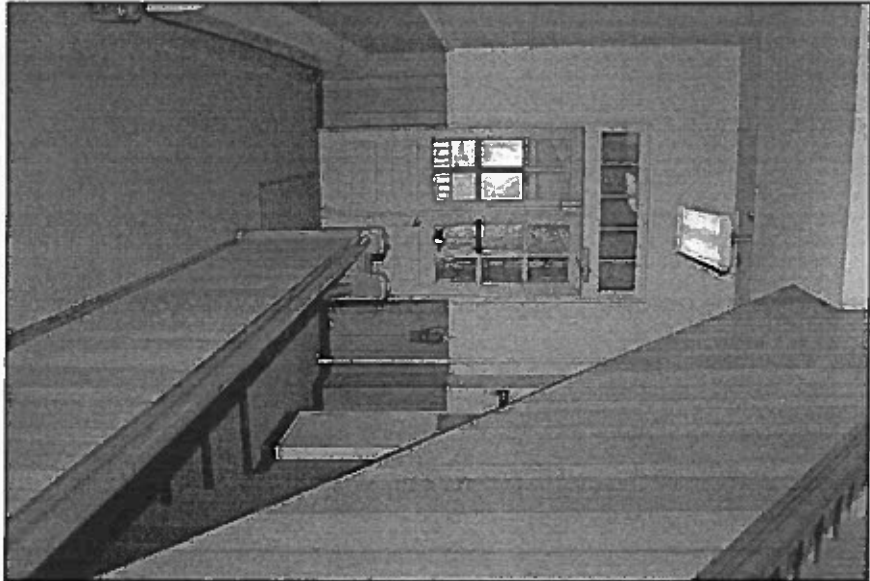
Figure 75: Looking southeast from stairway 300 at the stair to the attic. Note the original wainscot on the right wall.

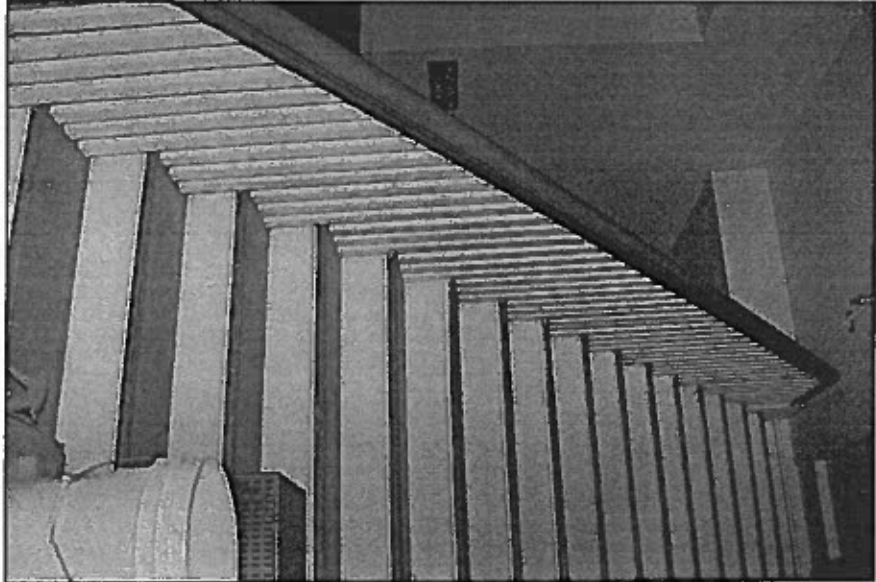
Figure 76: Looking northeast at the stair to the attic from stairway 300. Note the original balusters on the inside of the railing and wood treads.

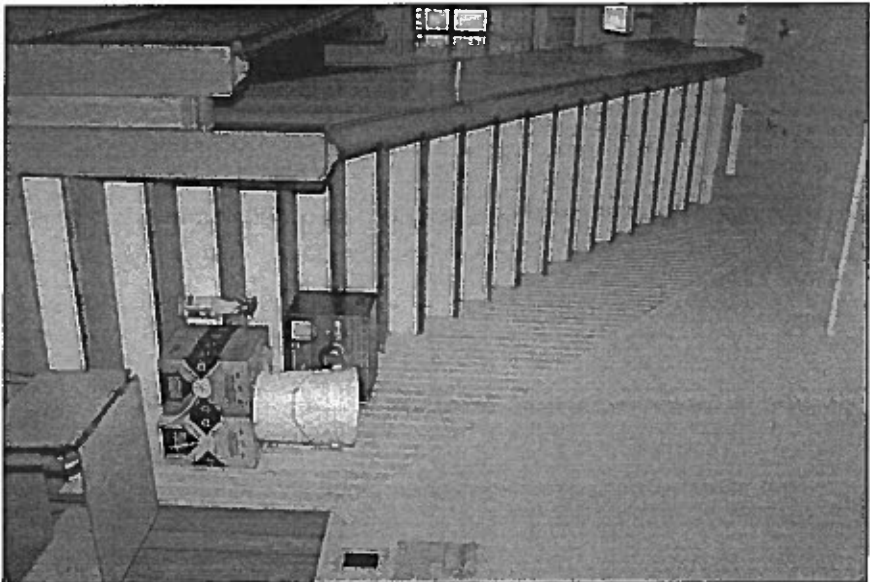
Figure 77: Looking south at the entrance to room 301 from the stairway. Note the newer in-filled doorway.

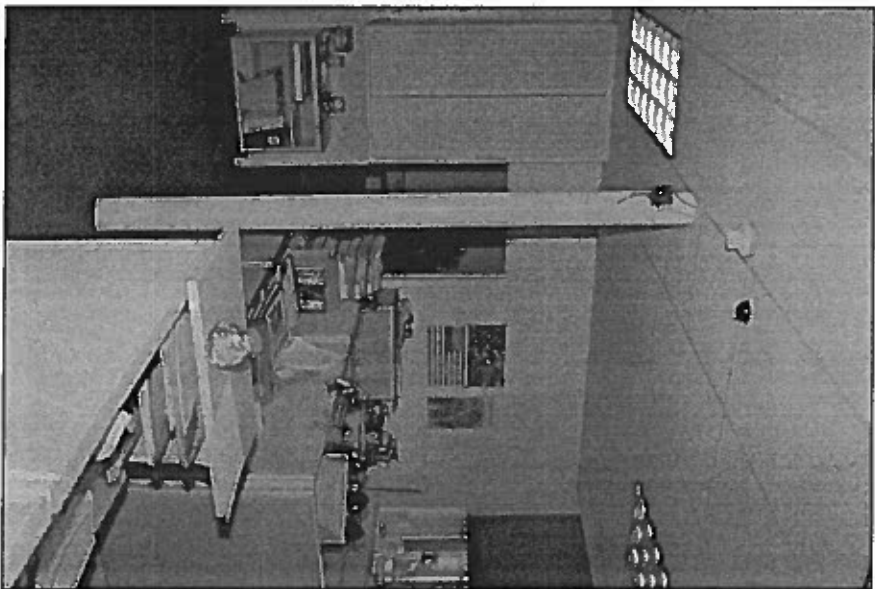
Figure 78: Looking south at room 301. Most of the materials are new with the exception of the exterior window walls. Note the original column.

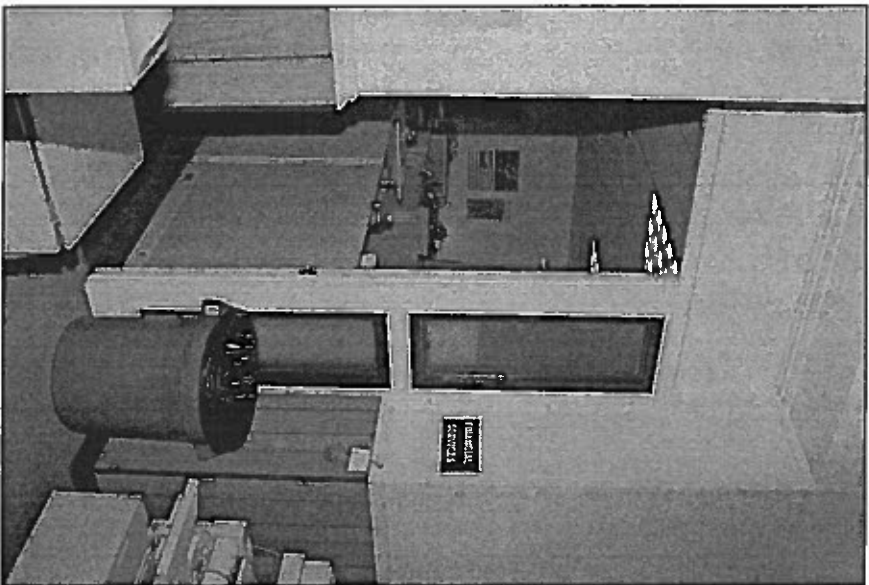
Figure 79: Looking south at room 302. Note the corner area that encloses the ductwork from the passive ventilation system. Note the original chair rail and windows.

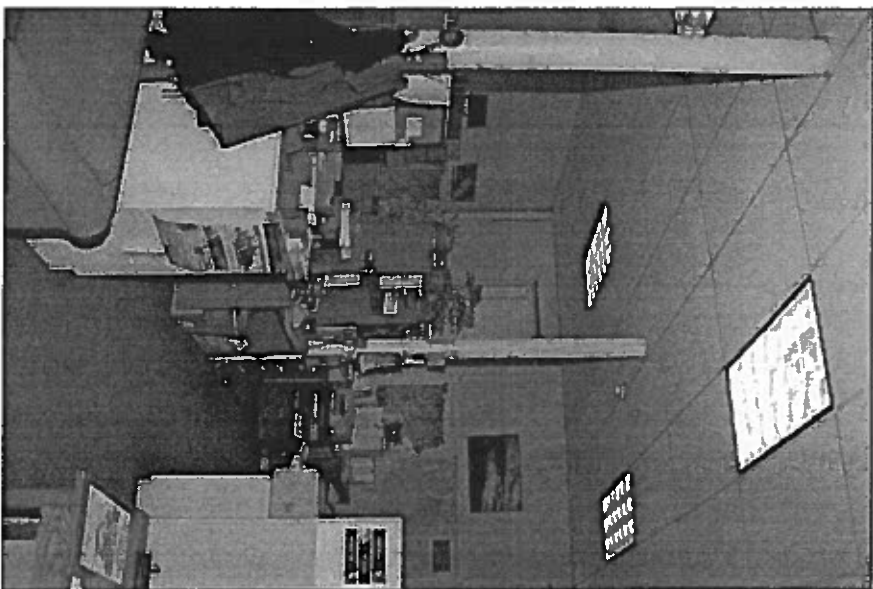
Figure 80: Looking south at room 305. Note the original columns and exterior walls.

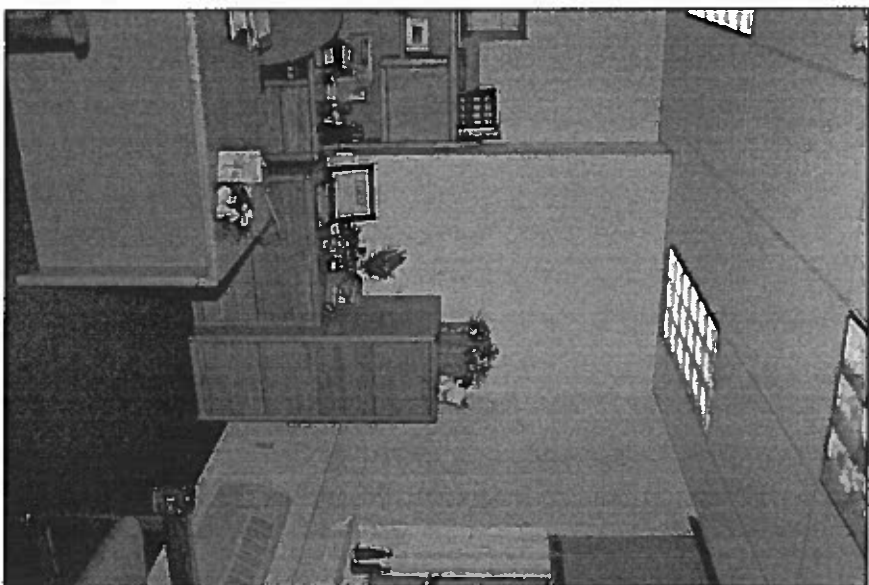
Figure 81: Looking southeast at the exterior wall of room 305. Note the cast-iron radiator from the 1908 period.

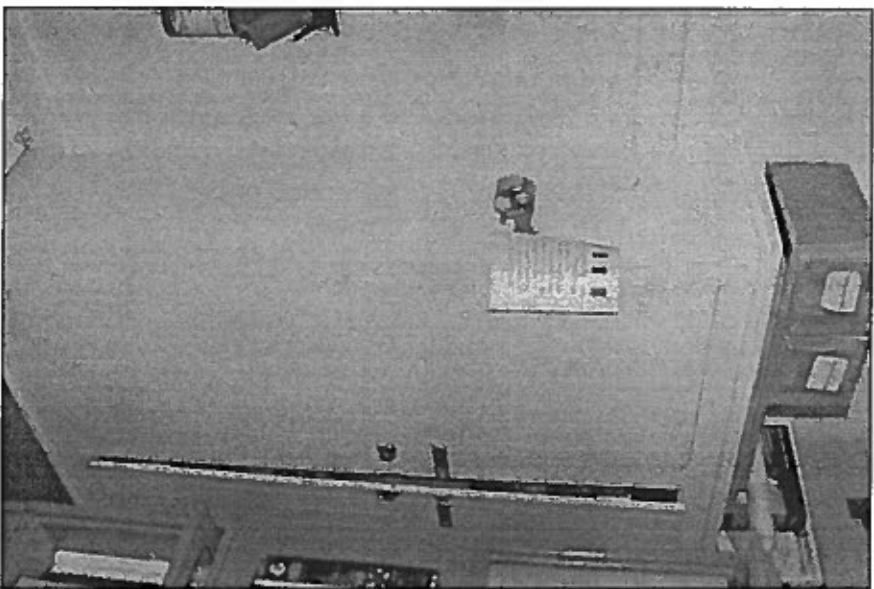
Figure 82: Looking east at an original built-in cabinet in room 307. Note the original wood vase and upper rail on the wall. The rooms in this part of the building are original.

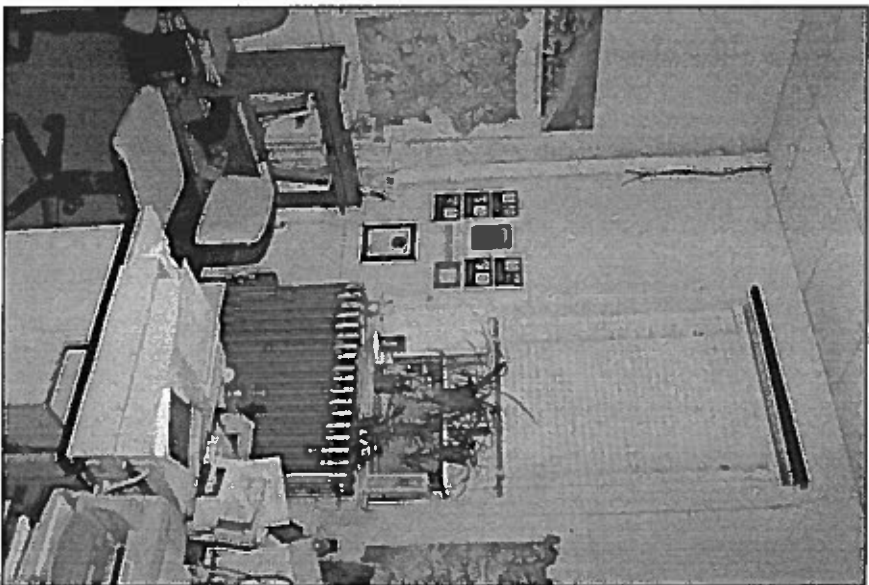
Figure 83: Looking south at the exterior wall in room 307. Note the radiator on the wall from the 1908 period.

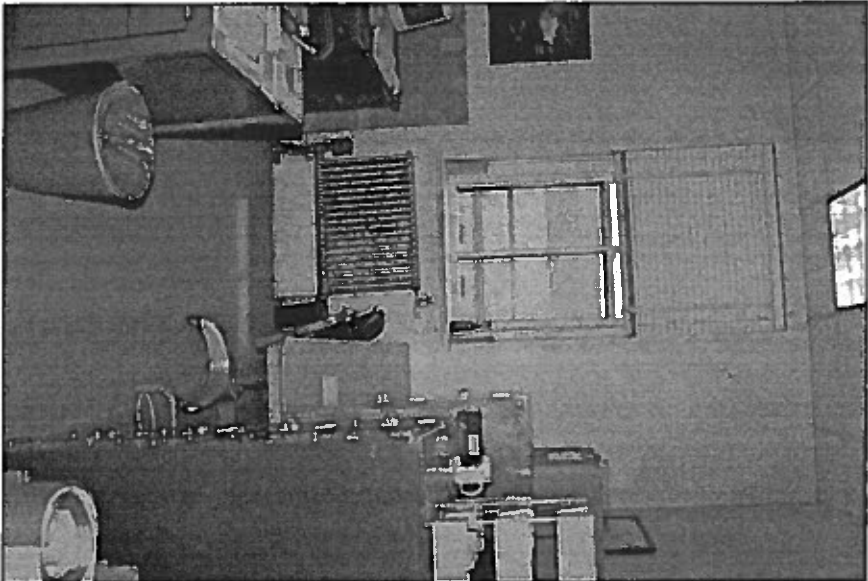
Figure 84: Looking north at room 310. Most of the walls and materials are new, however, the back wall is original.

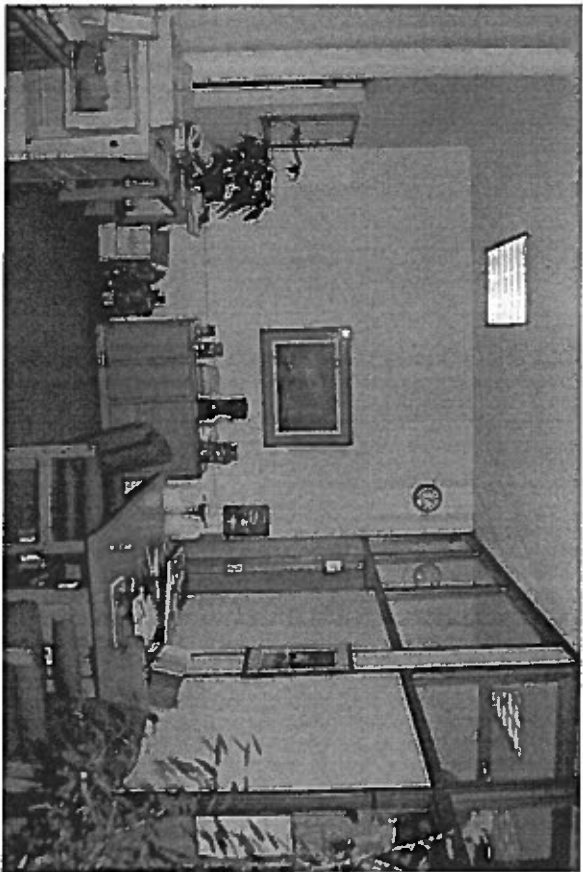
Figure 85: Looking southeast at room 310. Note the original walls and trim including the passive ventilation shaft and window.

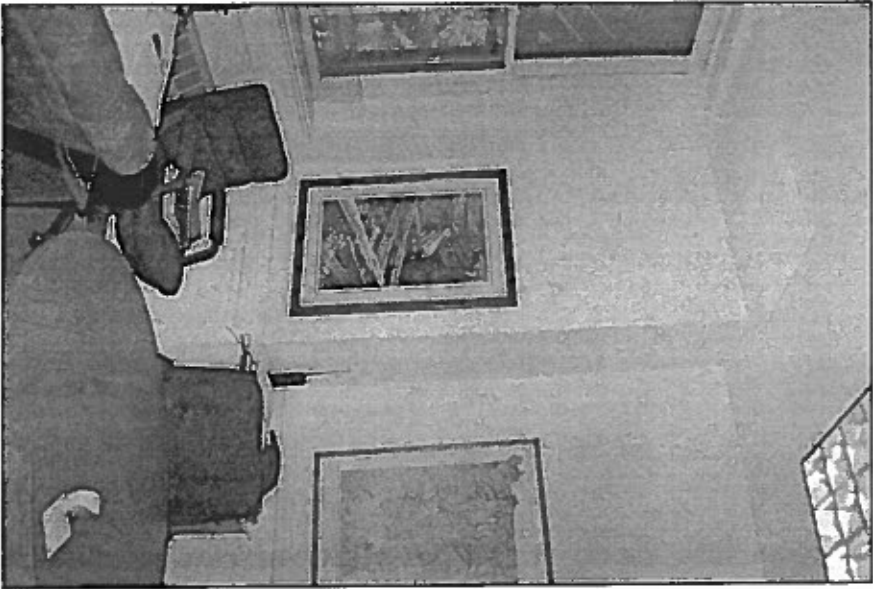
Figure 86: Looking southeast at room 312. Note the original walls and trim, including the passive ventilation shaft and window.

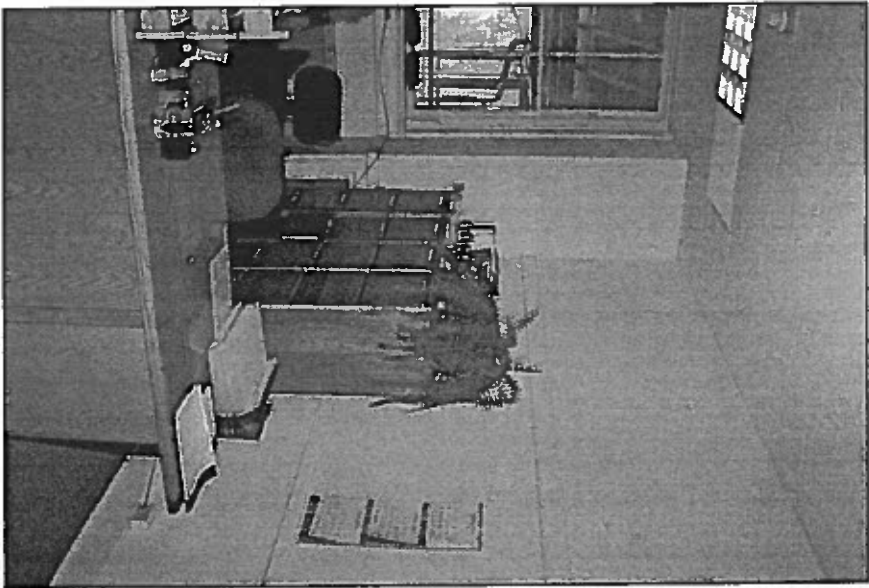
Figure 87: Looking east at the north stairway 324 and at the original doors to the rear balcony. Note the paneling covering the wainscot and balusters.

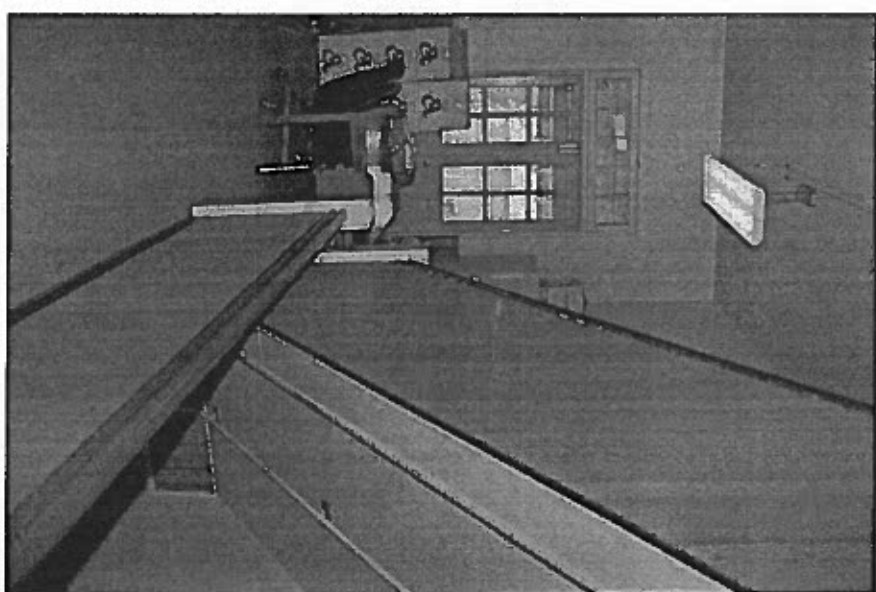
Figure 88: Looking west at the original front balcony doors from the stairway.

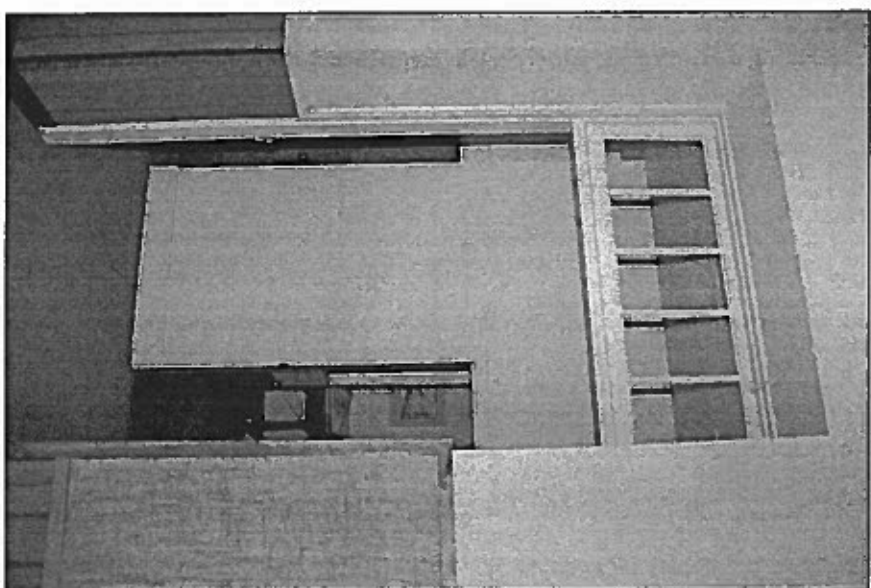
Figure 89: Looking northeast at the stair to the attic floor. Note the original wood wainscot and cap, wood treads, and newel posts.

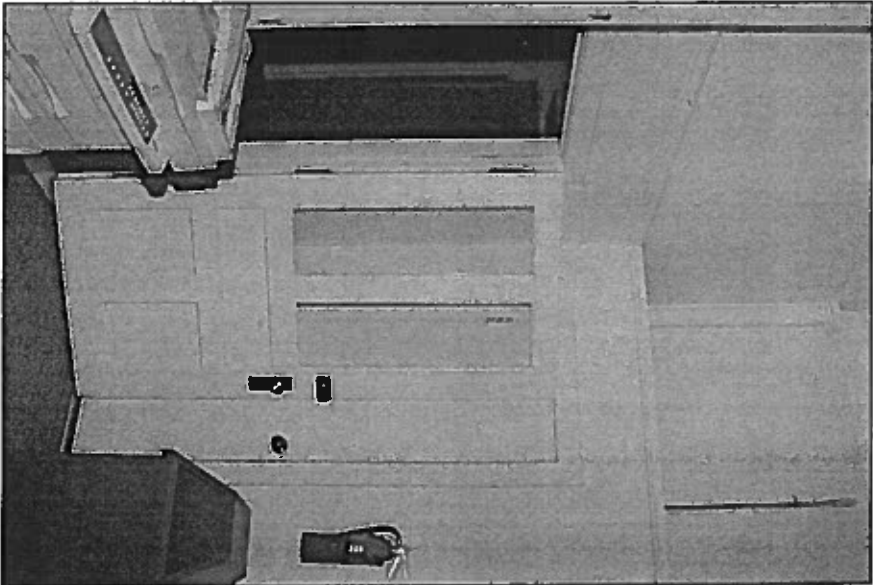
Figure 90: Looking southwest at a doorway in room 322. This wall and door has a combination of original materials as well as a 1930's renovation.

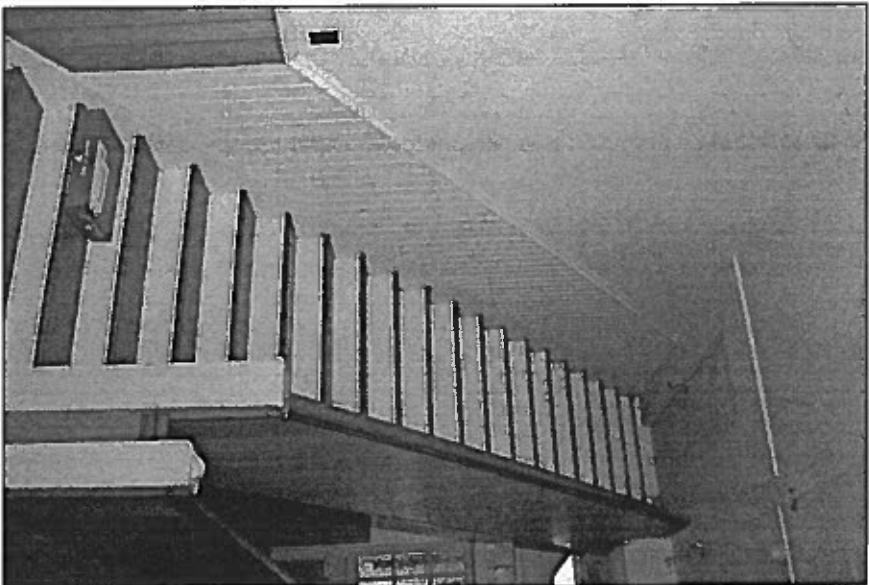
Figure 91: Looking southwest at room 315. Note the original built-in bookcase and ductwork for the passive ventilation system. Note the original wood base.

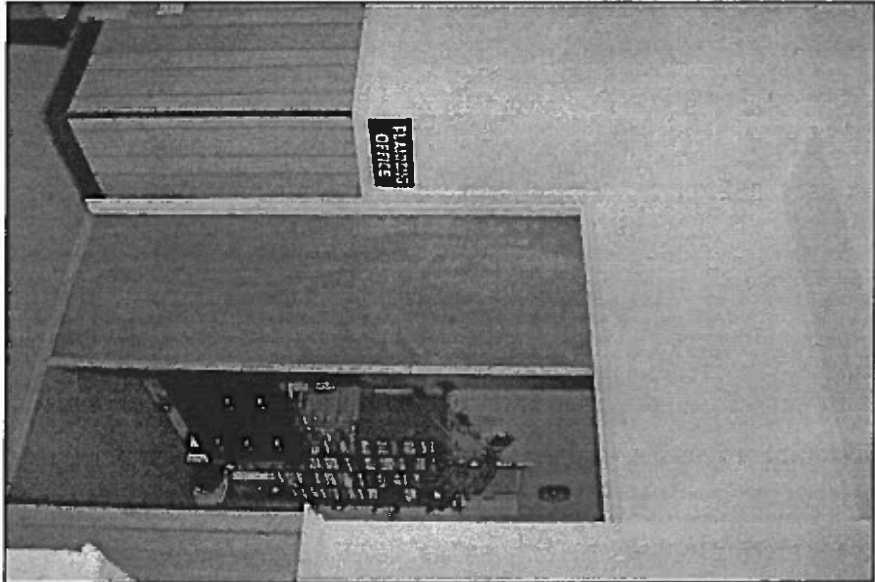
Figure 92: Looking northwest at the entrance to room 325 from stairway 324. The doors and transoms have been filled in and changed to new materials.

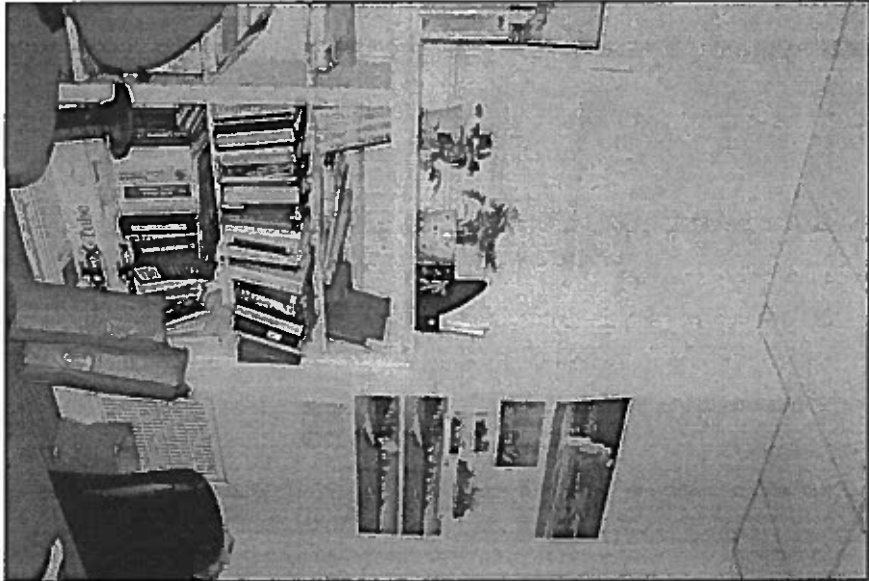
Figure 93: Looking northwest at room 328. Note the corner ventilation ductwork with the original base.

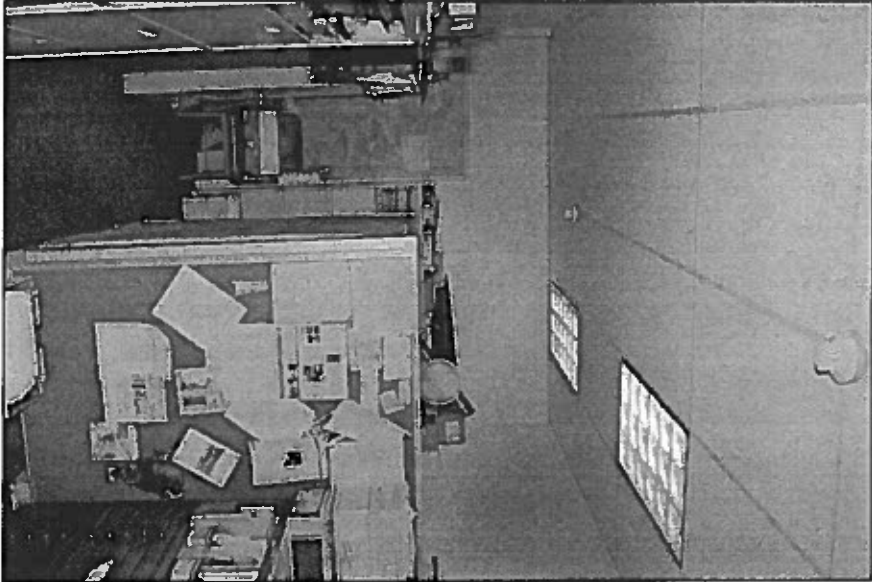
Figure 94: Looking east at room 329. Note the new ceiling and wall materials that are not original to the building.

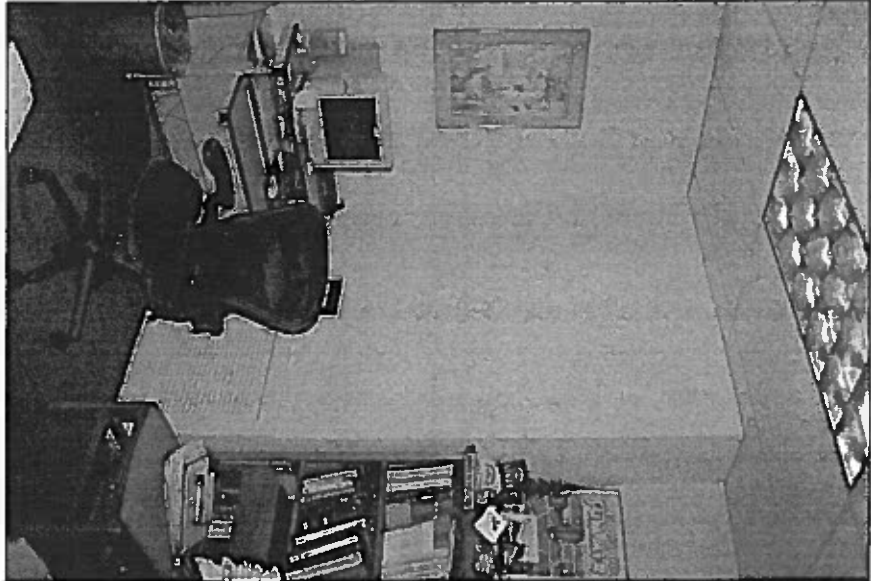
Figure 95: Looking north at room 333. Most of the materials in these rooms are new with the exception of the outer wall and north wall to corridor 336.

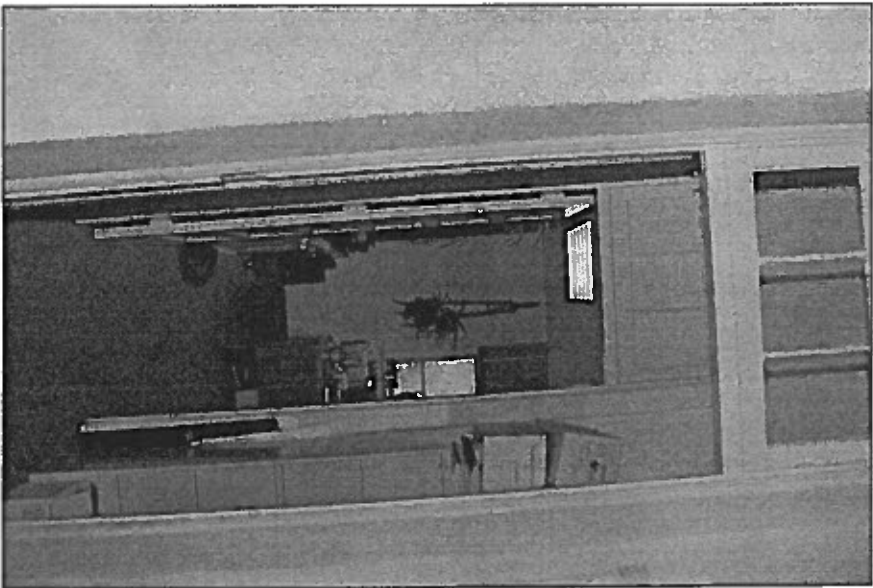
Figure 96: Looking east at the original wood doorway and transom to corridor 336 and room 337 beyond.

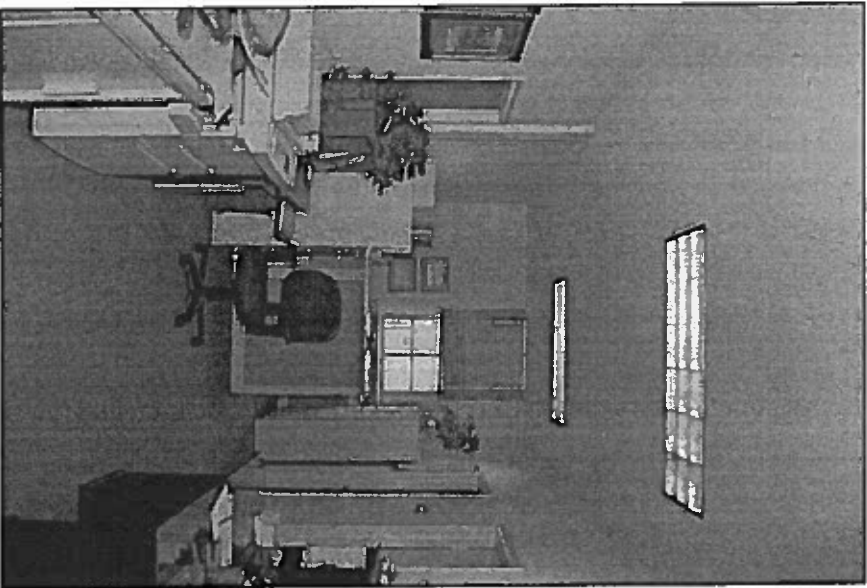
Figure 97: Looking northeast at corridor 336 and the original plaster walls and wood trim materials. All of the rooms in this area of the building are original.

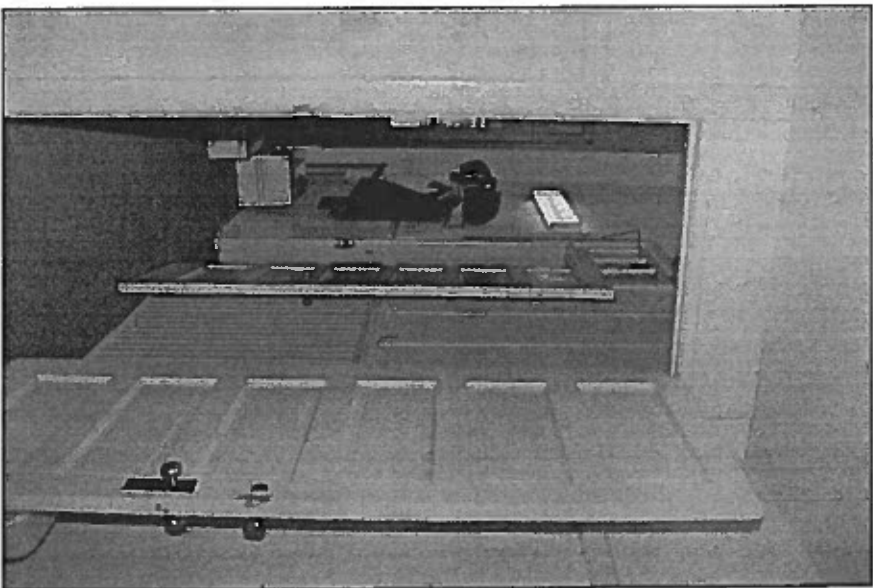
Figure 98: Looking south at the corridor from room 338. Note the original door with enclosed transom and original wood casing.

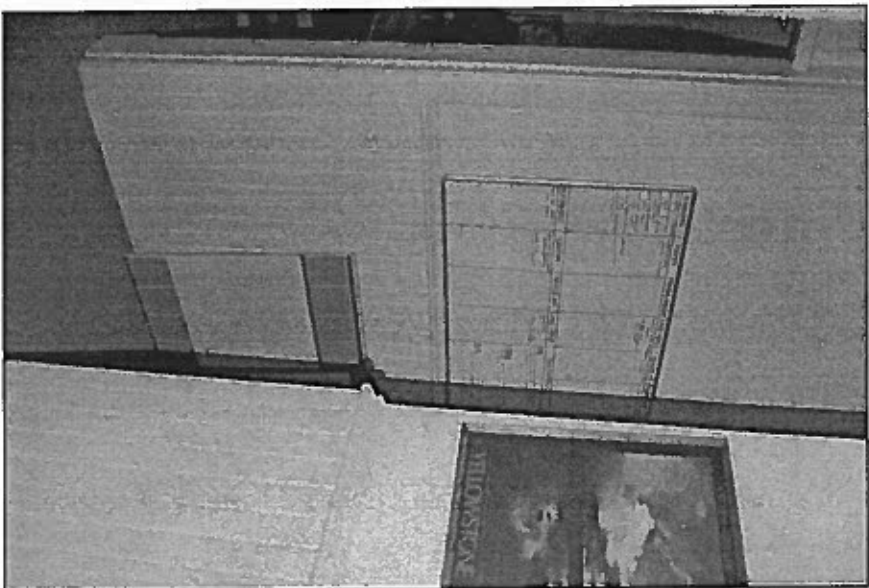
Figure 99: Looking northeast at room 338.  
Note the original wood base and high wood  
rail on the plaster walls.

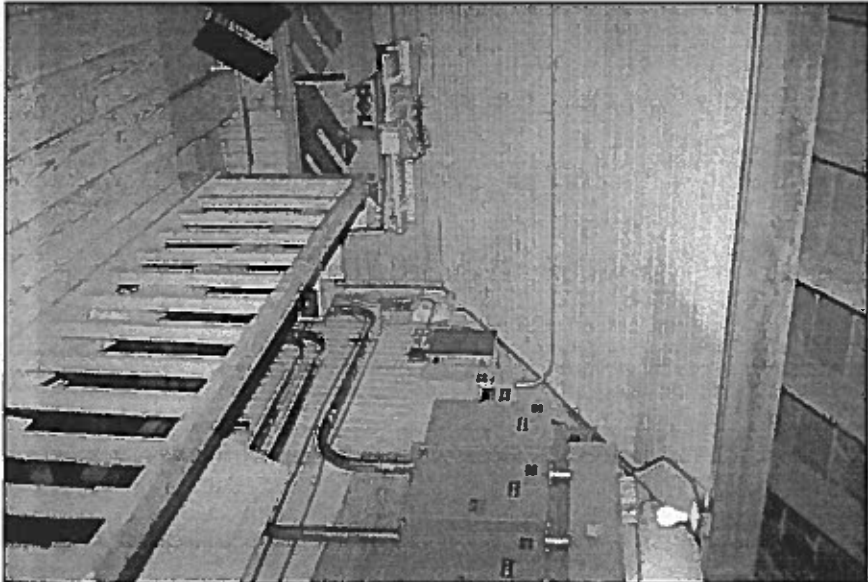
Figure 101: Looking southwest at the stone wall and roof along the stairway in room 400.

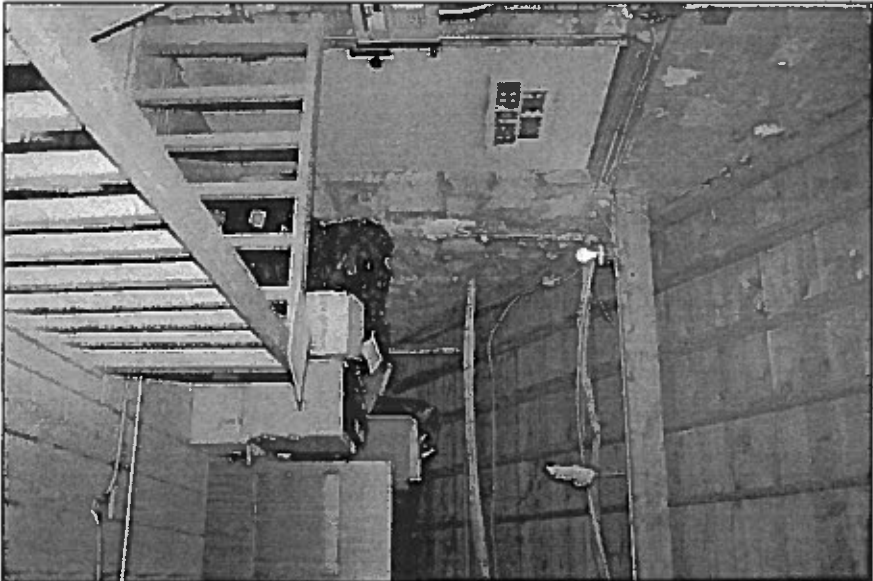
Figure 100: Looking southeast at the south stair area of room 400. Note the original wainscot and ceiling that extend up from the third floor.

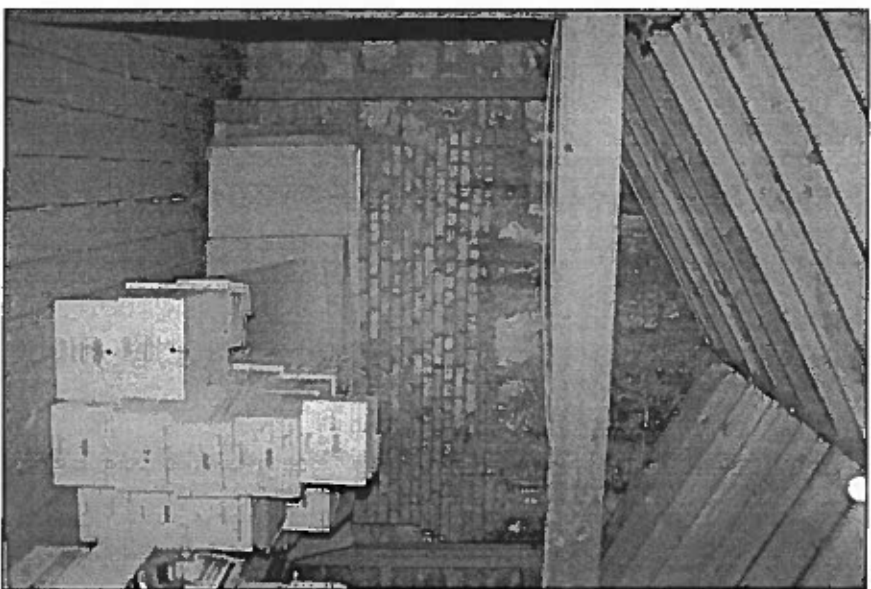
Figure 102: Looking east at room 401. Note the original brick area.
