Building 36  
Mammoth Hot Springs, Wyoming

Historic  
Structures  
Report

AUGUST 2003

**ADMINISTRATION BUILDING**

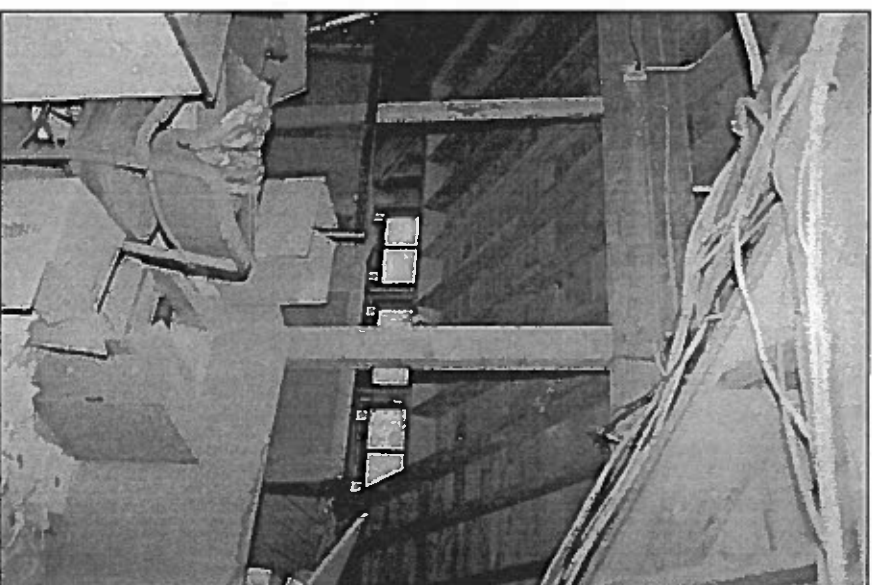
Figure 103: Looking west at room 401. Note the original dormer and windows from the attic.

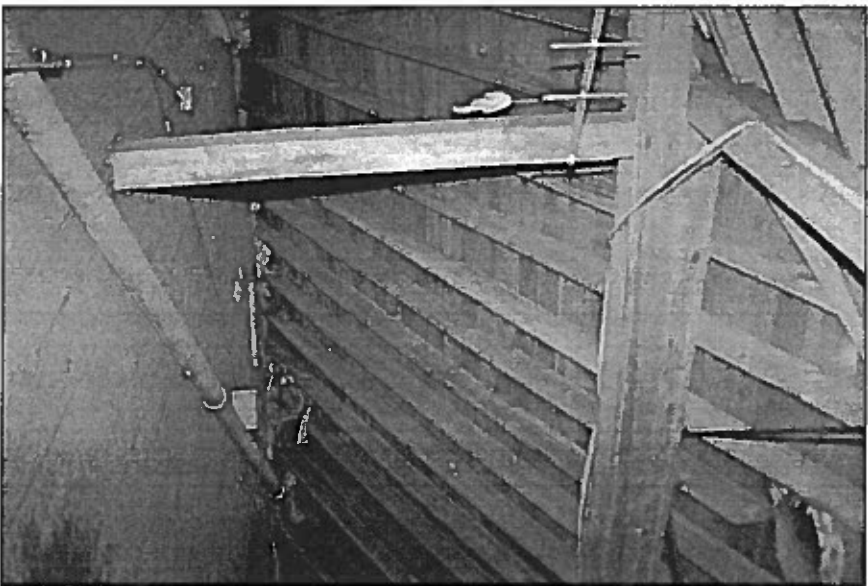
Figure 104: Looking southeast at room 402.  
Note the original structure and remaining  
upper part of the ventilation ductwork.

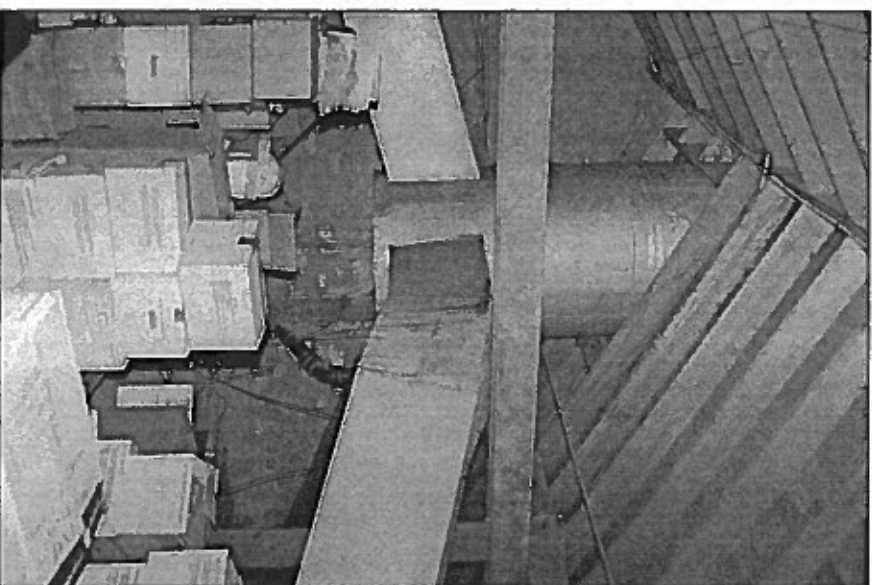
Figure 105: Looking north at room 403 and  
the passive ventilation system ductwork.  
Also, note the stone center wall of the  
building.

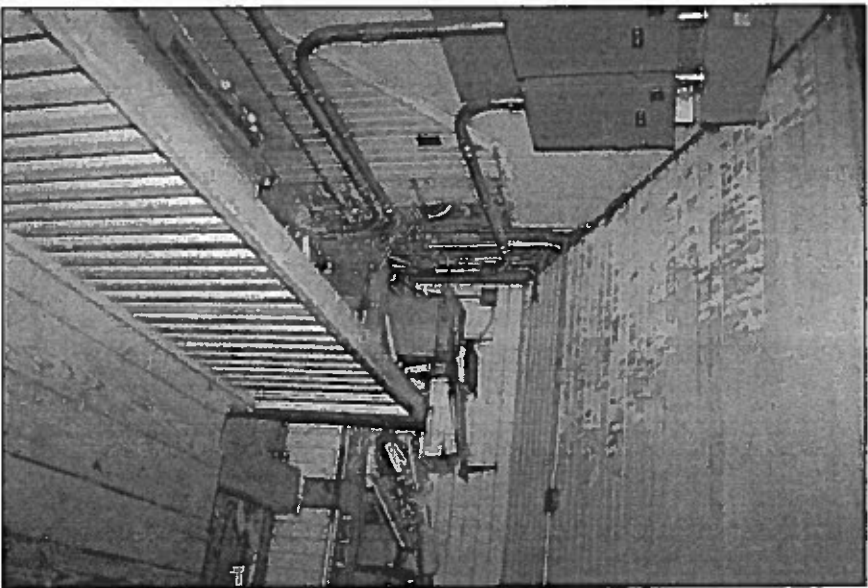
Figure 107: Looking south at room 404. Note the original roof rafters and the passive ventilation ductwork.

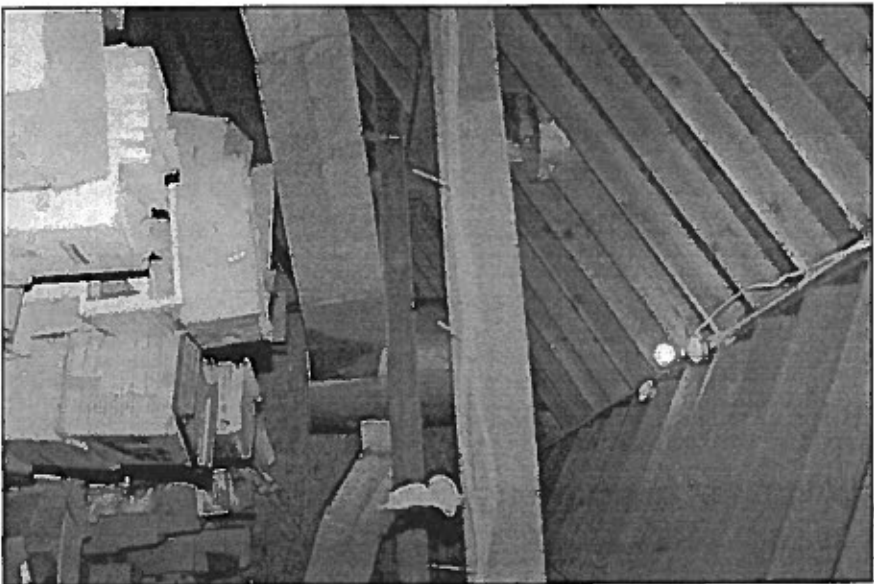
Figure 106: Looking east at the north stairway in room 405. Note the original wood wainscot and wood ceiling material.

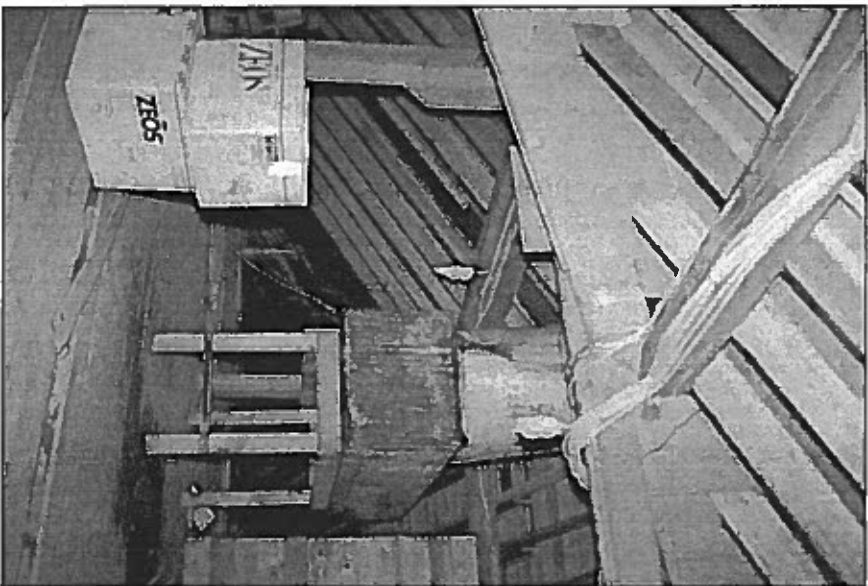
Figure 108: Looking north at room 406 and the passive ventilation system ductwork.
