HISTORIC STRUCTURES REPORT

**LOWER & UPPER SERVICE STATIONS  
AT OLD FAITHFUL**

**YELLOWSTONE NATIONAL PARK, WYOMING**

**August 1998**

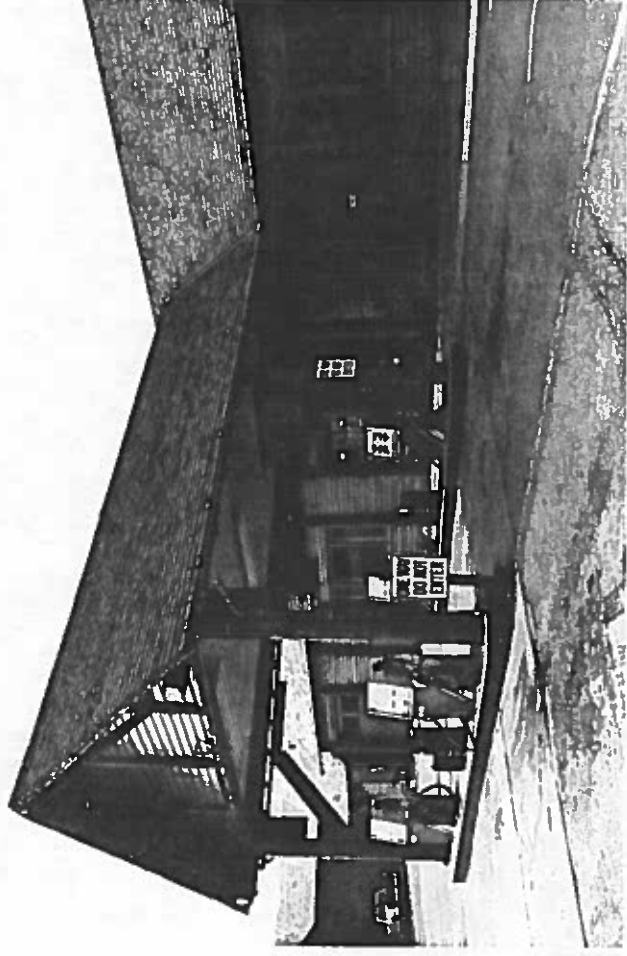
Figure 7: Looking southeast at the covered pump area. The log columns and concrete islands are in good condition.

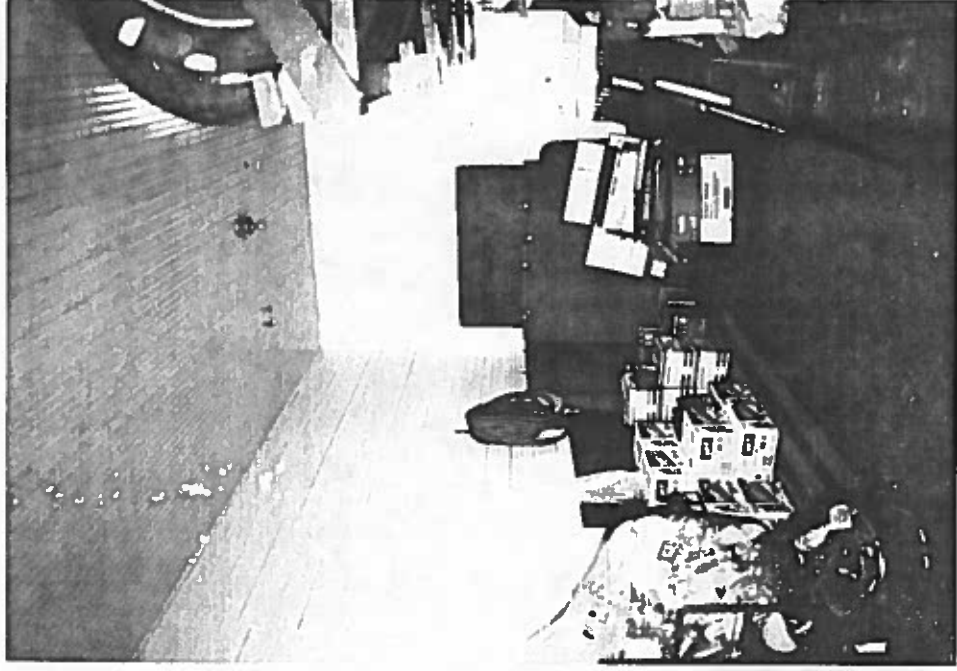
Figure 24: Looking west at the interior of the storage space in the station. The narrow, wood tongue-and-groove walls and ceiling are in good condition. Note the concrete floor and incandescent lighting.

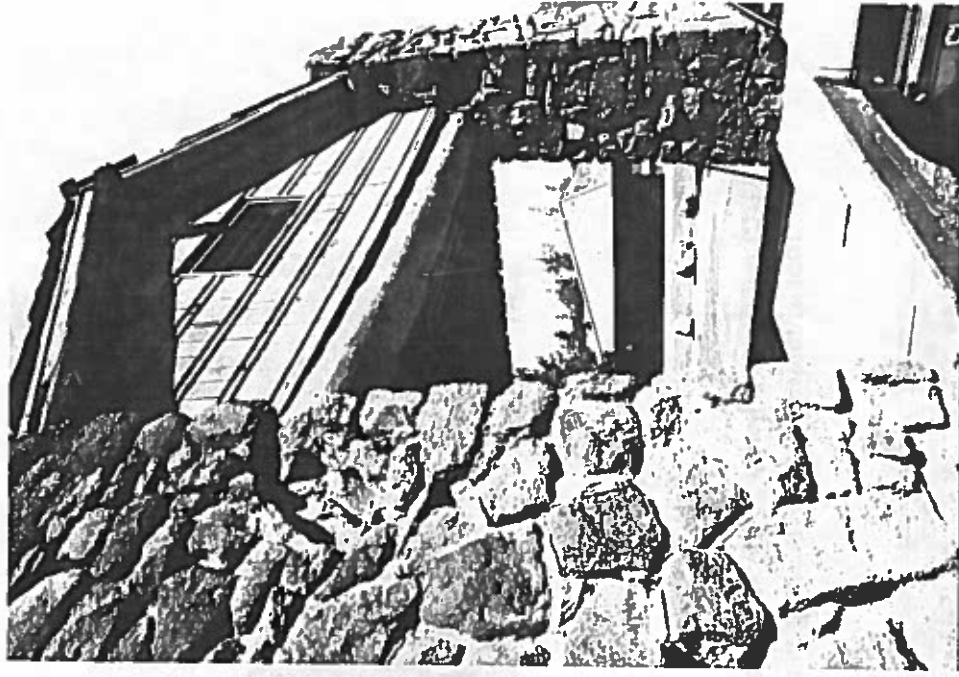
Figure 40: Looking west at the original wood doors on the east bay of the station. There is new hardware on the doors.

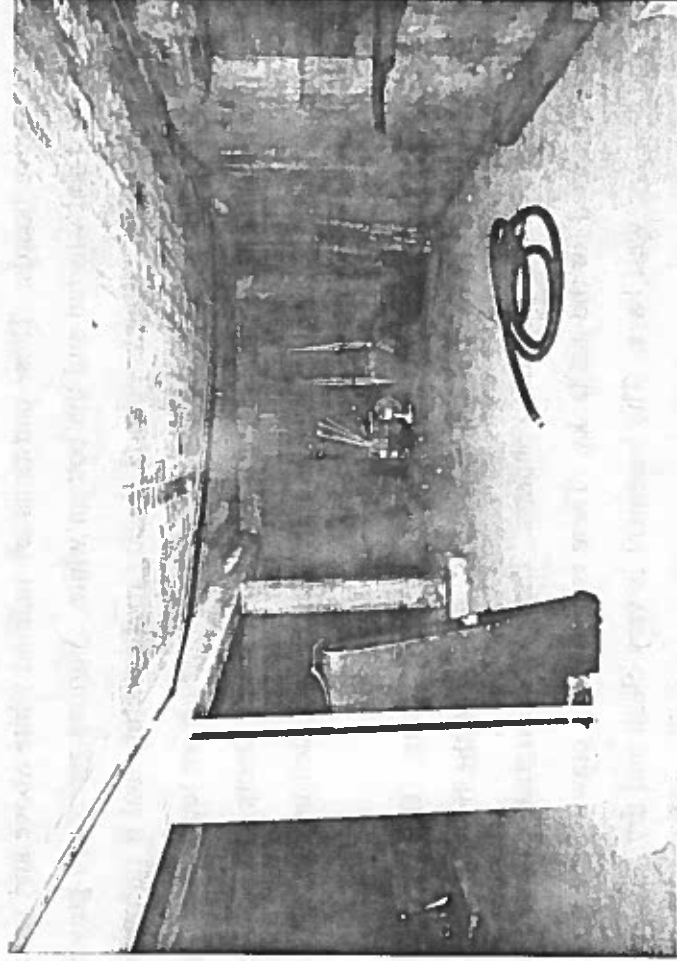
Figure 55: Looking north at the concrete basement of the station. Originally the gas tanks were located in this area.
