**HISTORIC STRUCTURE REPORT**

**Architectural Data Section**

**THE ATWOOD-HIGGINS HOUSE**

**Cape Cod National Seashore**

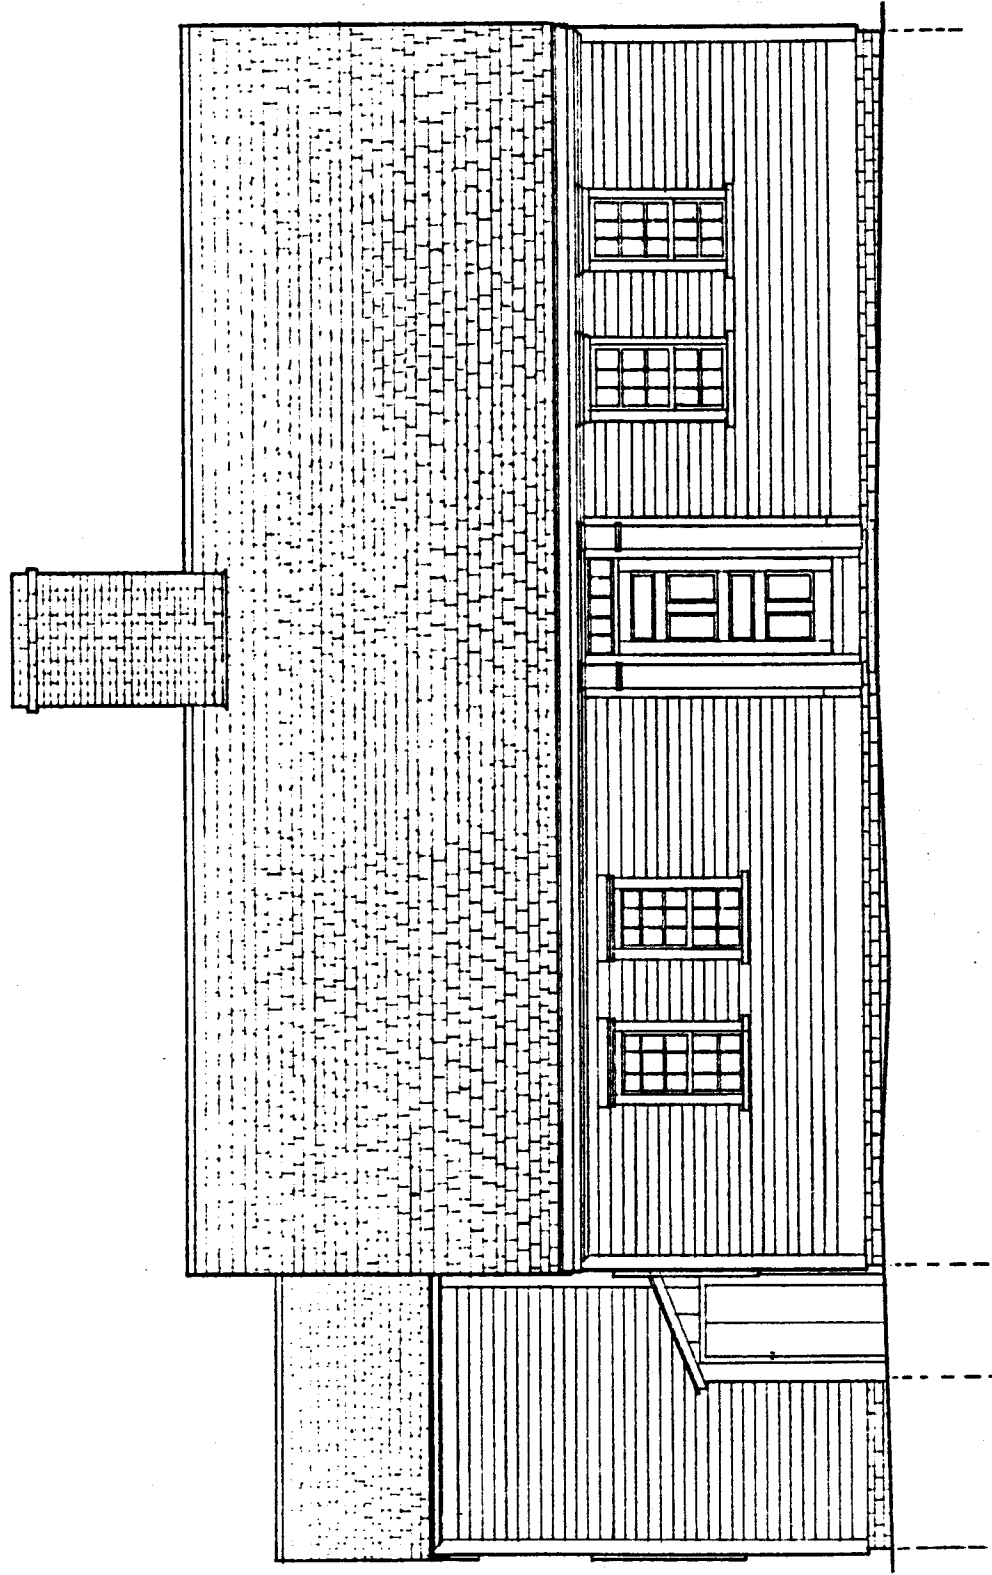
Illustration 12. Atwood-Higgins House: South (Front) Elevation.

The south facade of the main house and of the northwest ell (Ils. 12, 13) are the only walls finished with wooden clapboards. The clapboards on the upper two-thirds of the main house are beaded on the lower edge of their exposure, which varies from 4 to 4-1/2 inches in width. They have feathered joints, and are painted light tan. The clapboards on the lower third of the main house appear to date from 20th-century sill repairs. This can be inferred from the fact that:

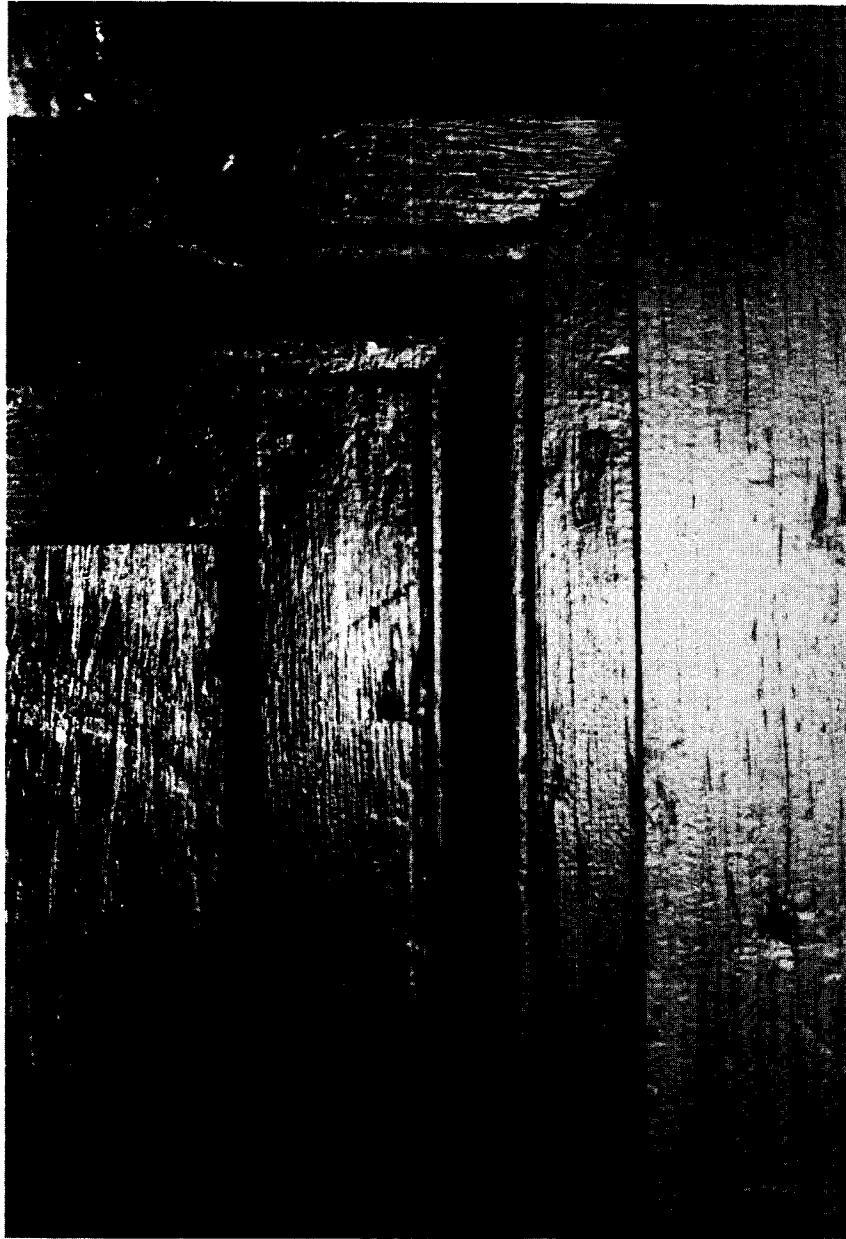
**Illustration 49.** Atwood-Higgins House: East Kitchen, Doorway Casing  
104/103 and Door.

The next alteration to occur in this room saw the introduction of the northeast window's sash, c. 1840. Elements from the mid-19th century include the door 101/104, installed during the refurbishing of the East Front Room 101, and several baseboards. These baseboards are found on the north wall, west of the north chimney post; and on the east wall, north of doorway 104/103 (Ill. 49). These are the only wooden baseboards in the room.

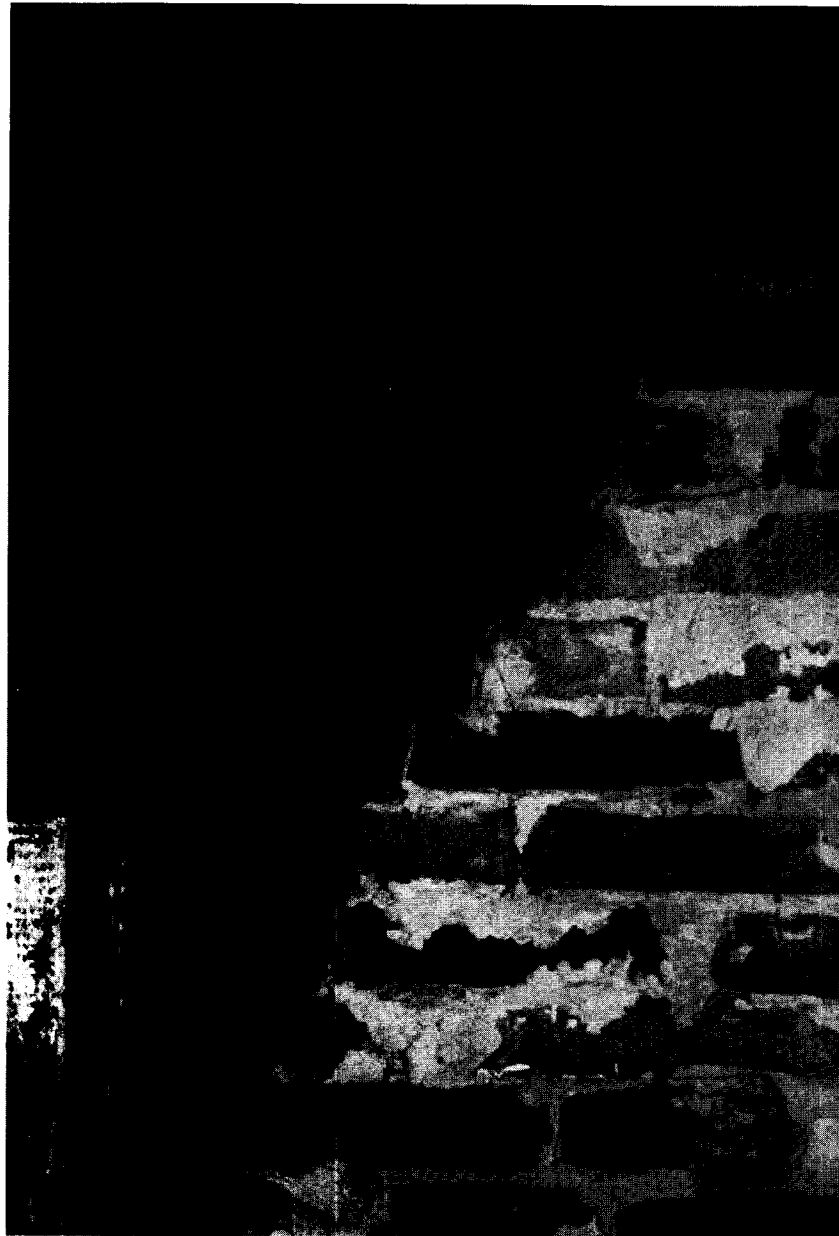
- stair ghosts on a vertical-board partition to the west of the East Kitchen 104 (Ils. 56-57), viewed from behind the chimney mass. The stair ghosts appear to be from a straight run of stairs ascending in an easterly direction; it may have included winders and a lower straight run ascending in a southerly direction.

**Illustration 57.** Atwood-Higgins House: Central Chimney  
Void, Stair Ghost on Rear Surface of  
East Kitchen's Fireplace.

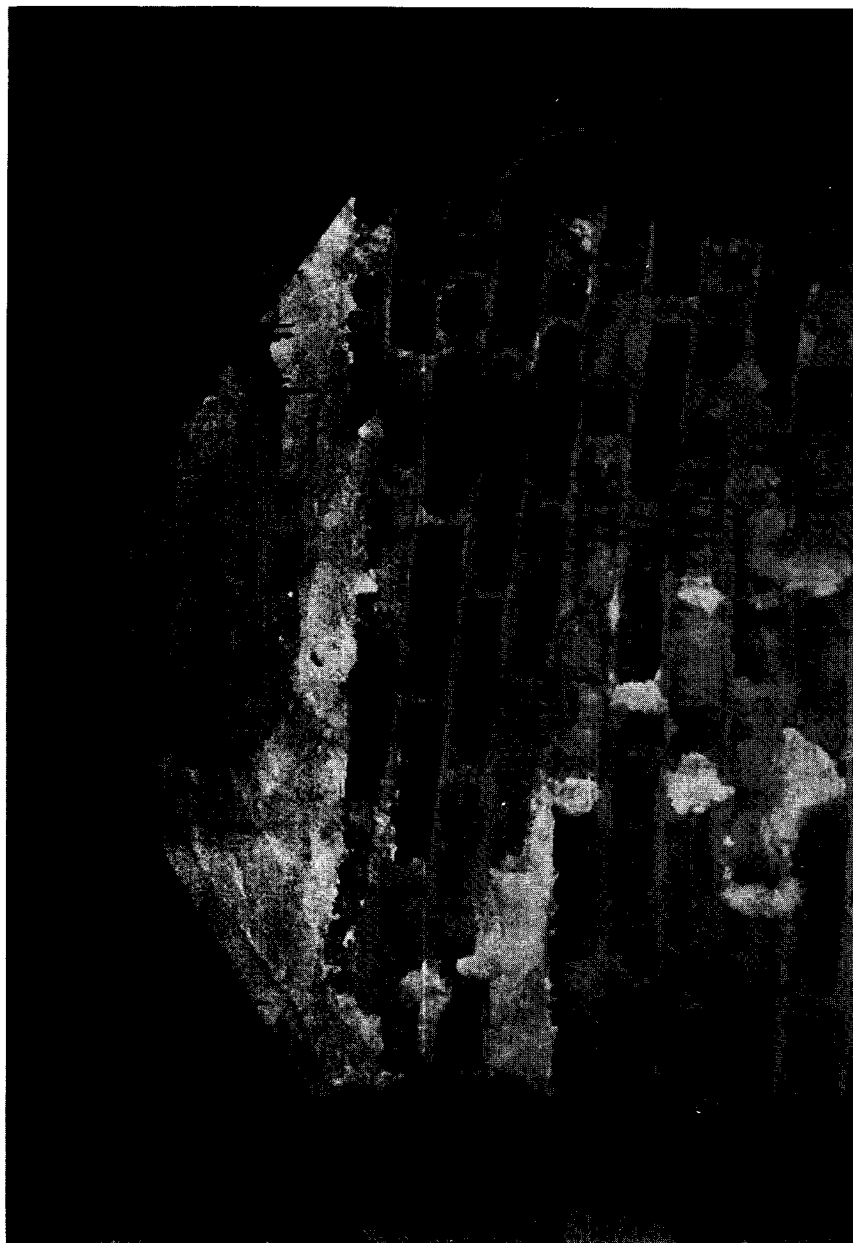
**Illustration 96.** Atwood-Higgins House: Attic, West Side of Chimney.

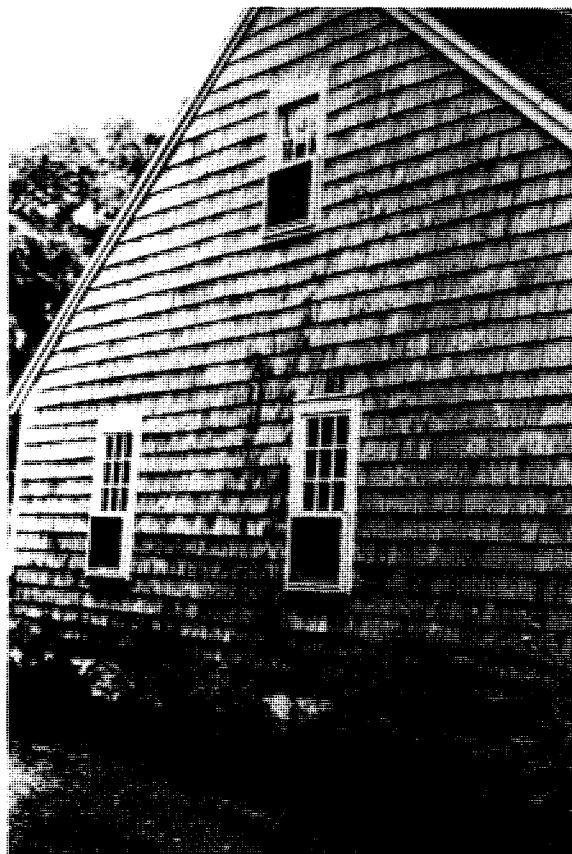
**Illustration 101.** Atwood-Higgins House:  
East-Elevation Shingles.

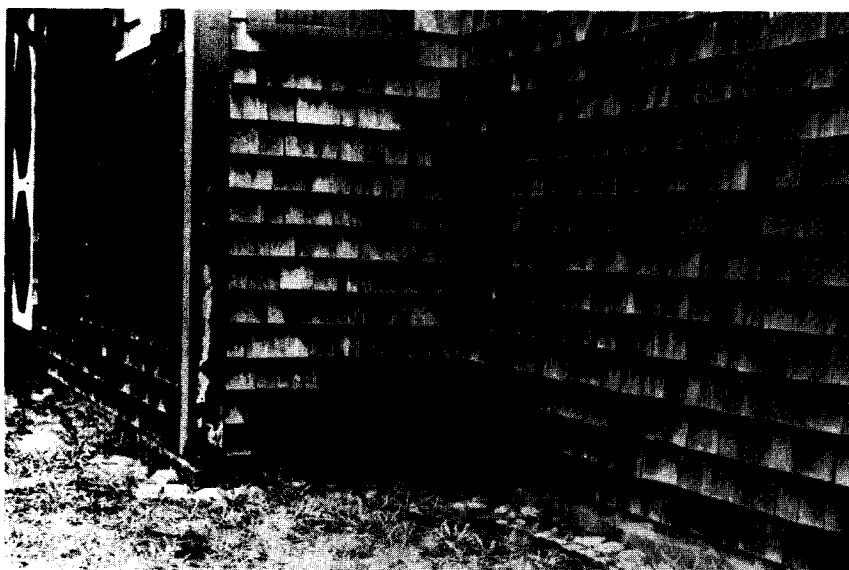
**Illustration 107.** Atwood-Higgins Country Store: Flaking Paint.
