HISTORIC STRUCTURES REPORT 001438

COUNTY JAIL

Appomattox Court House National Historical Park

Prepared by  
Orville W. Carroll  
Architect  
July 1965

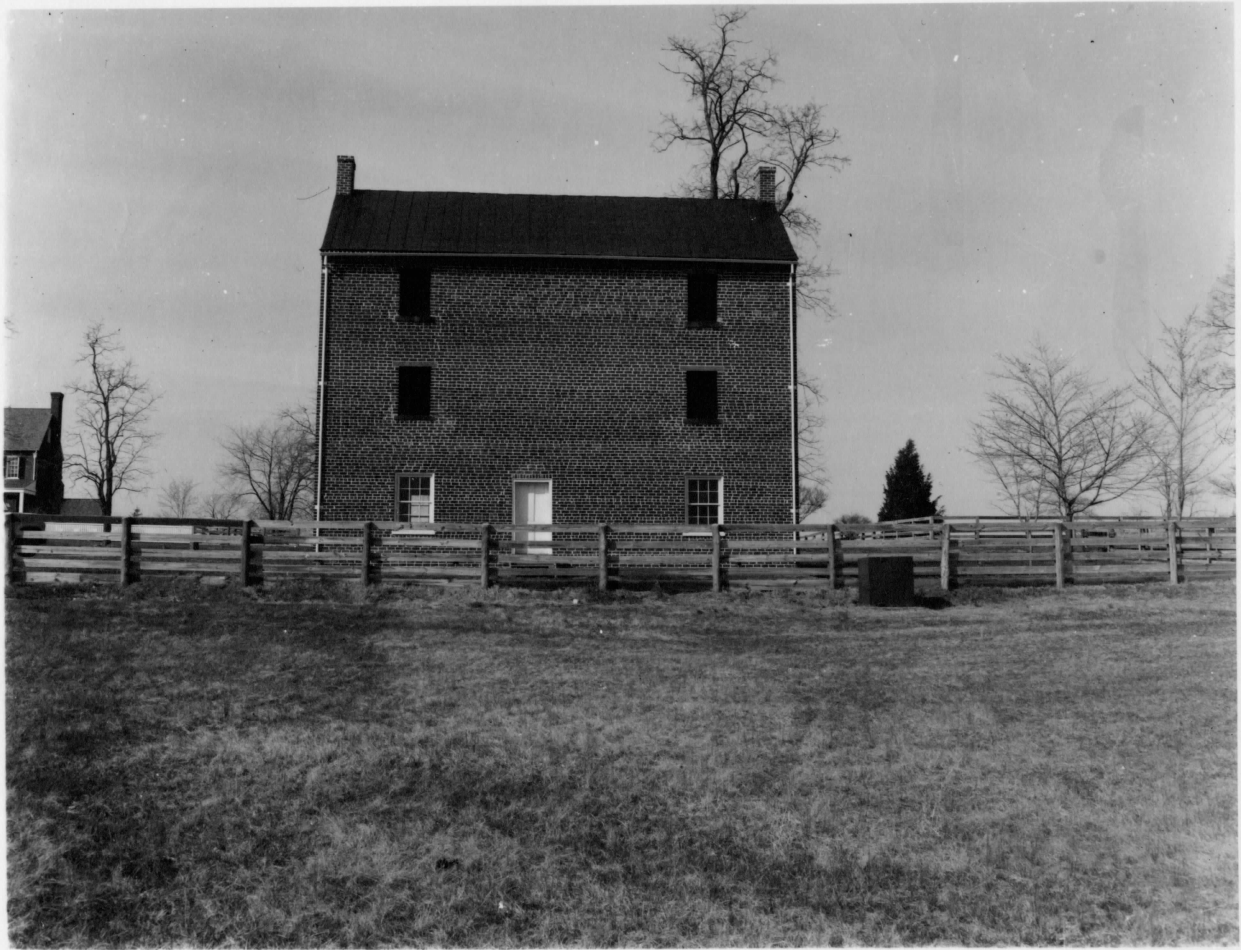
ILLUSTRATION NO. 11

View from northwest showing the completed building after the stage road was lowered to its original grade.

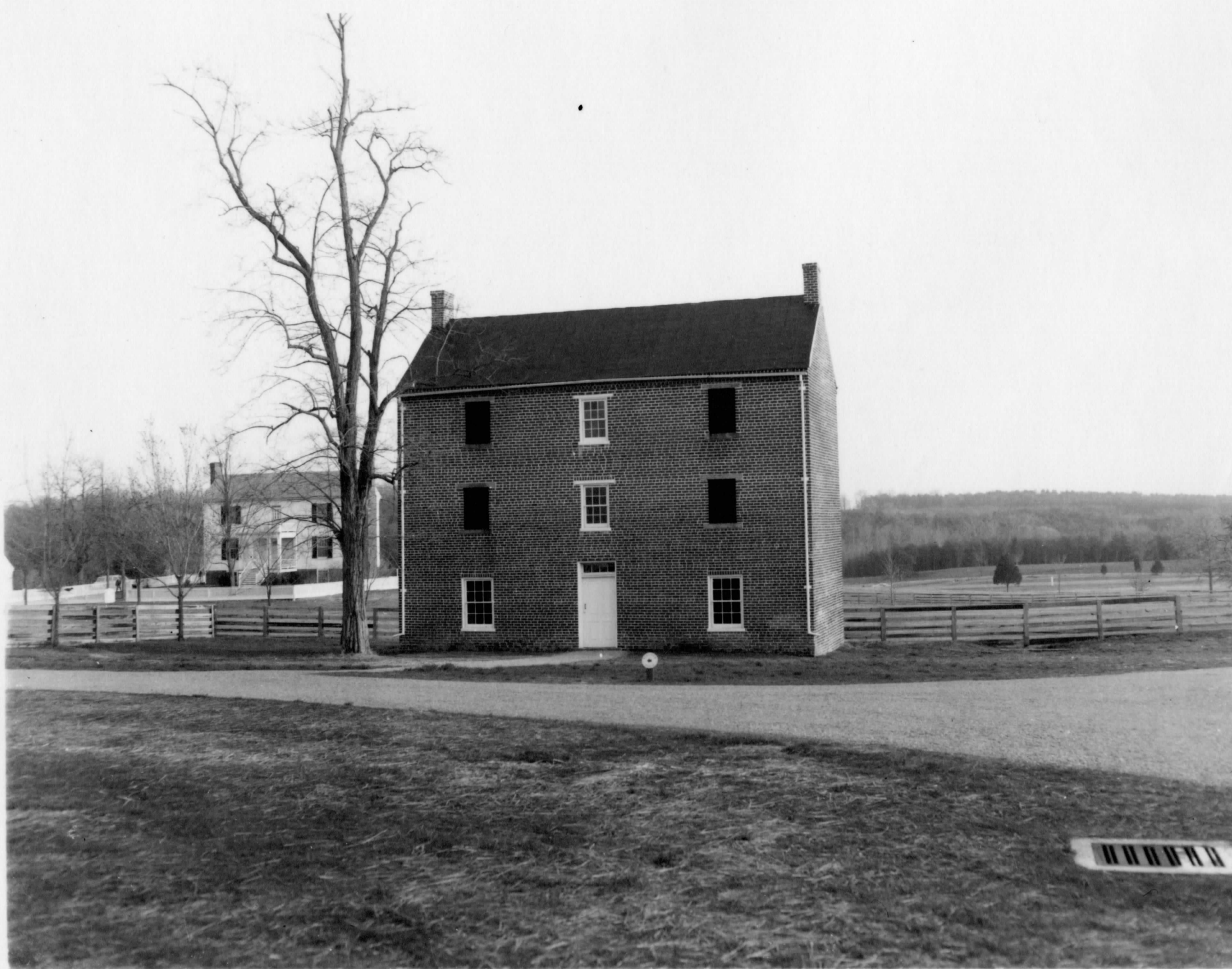
ILLUSTRATION NO. 12

View of Jail from the northwest corner  
of the "Village Green" with the reconstructed  
Court House (1963-64) to the right and the  
Bocock-Isbell House in the background.
