HISTORIC STRUCTURES REPORT:  
PHYSICAL FABRIC SECTION

THE CHARLES SWEENEY CABIN  
APPOMATTOX COURT HOUSE  
NATIONAL HISTORICAL PARK  
APPOMATTOX, VIRGINIA

by  
REED L. ENGLE  
January, 1988

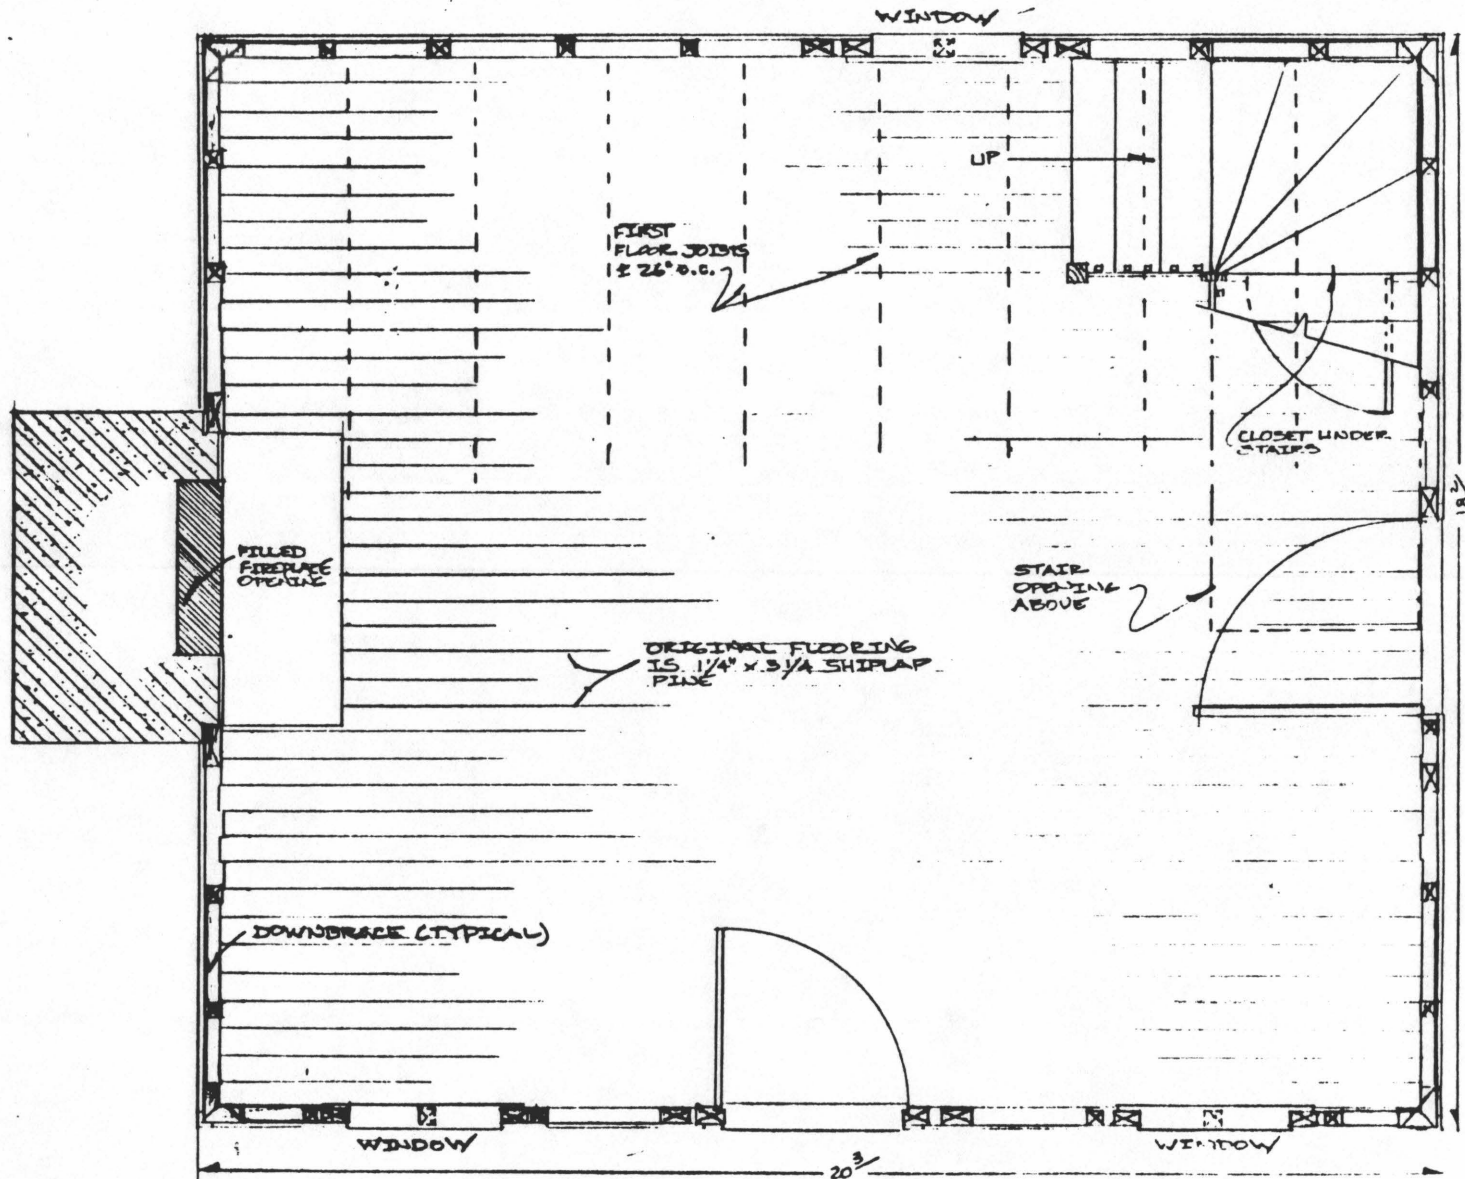
ILLUSTRATION #5: PLAN OF ORIGINAL CABIN FIRST FLOOR

The corner post at the southeast corner of the cabin is split from top to bottom on a diagonal from the interior to exterior corners. Although the tenons at girt and rafter plate have held the upper end in correct alignment, the lack of a sill plate joint has allowed the south elevation sill to move outward almost 6". The other corner posts are heavily damaged by powder post beetles and termites; the damage is so extensive that full replacement is required.

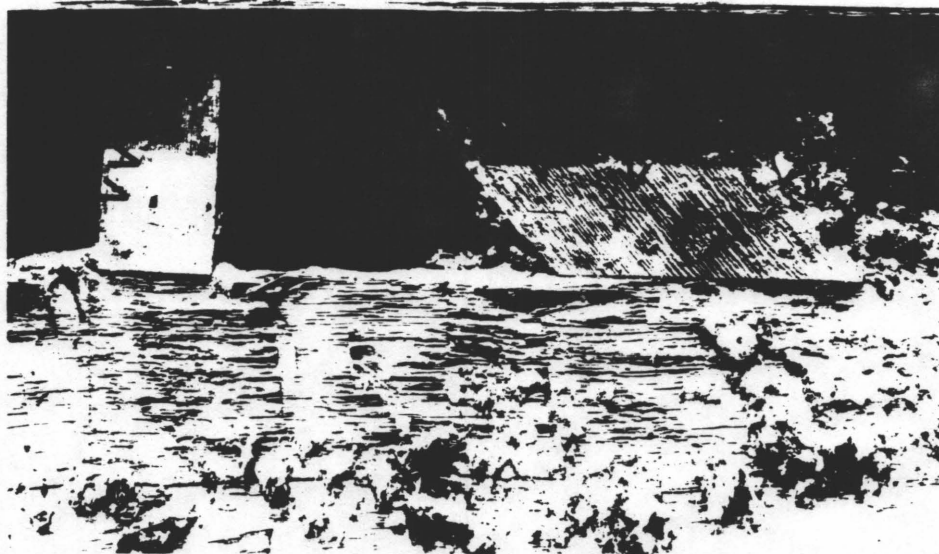
PHOTOGRAPH 13  
DETAIL OF DOWNBRACE AND SECONDARY  
STUD SEEN IN PHOTOGRAPH 17 ABOVE.

Note the use of multiple X's (shown  
with arrows) to mark the mortise  
and tenon connections in lieu of  
the traditional Roman Numerals.

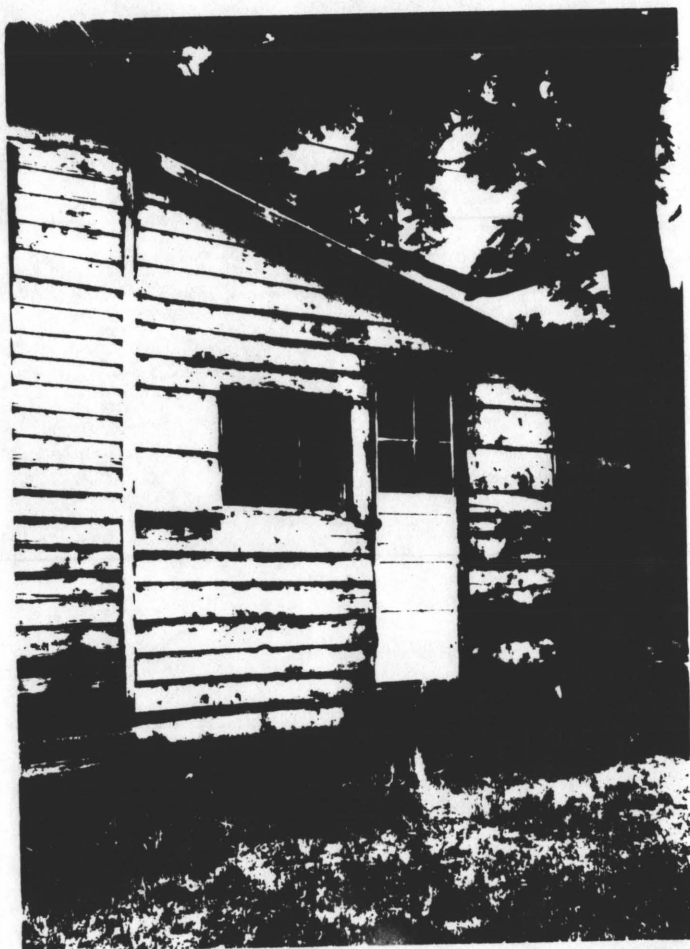
The addition is clad in several types of siding: the south elevation with pine weather boards having random exposures of between 5 1/2" and 13 1/2"; the east elevation with vertical boards of widths from 4 3/4" to 14 1/4"; and, the north elevation with clapboards with an average exposure of 5 1/2"-6". The south and east elevation boards are reused: some are tongue-and-grooved, some rough sawn with a wide-radius circular saw, and many show kerfs with broken nails indicative of the fact that they were first used as flooring.

PHOTOGRAPH 25  
THE EAST ADDITION,  
SOUTH ELEVATION.

The east addition presents a more difficult question. The reused materials in the shed are of architectural interest, but none are in situ. Although lean-to kitchens were common on the cabins around Appomattox Court House, this one is not original and appears to have replaced the out kitchen seen in the Frankenstein watercolor. It offers a usable interpretive space, but its retention would prevent restoration and accurate interpretation of the original cabin. It is therefore recommended that the kitchen addition be removed, but that selected portions of the historic, but reused, joists, flooring, and rafters be salvaged and entered into the park museum collections.

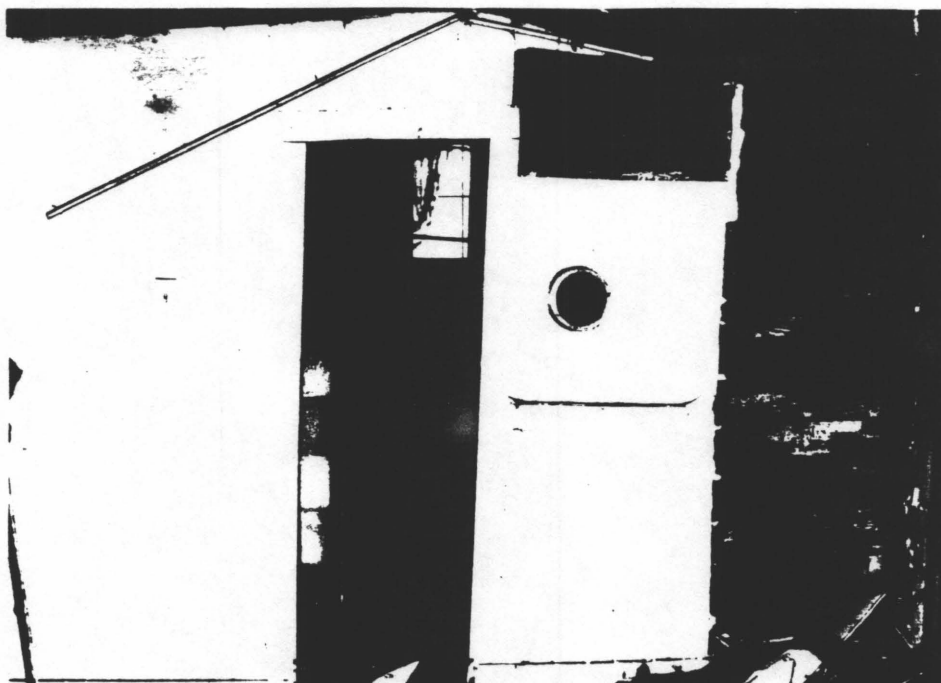
PHOTOGRAPH 30  
NORTH ELEVATION OF  
THE EAST ADDITION  
LOOKING INTO THE  
CMU NORTH ADDITION.

The north addition is structurally sound but visually inappropriate. It is not "historic" by definition and will have to be removed to allow for the replacement of the north and east sills and the adjacent studs.
