# **PRESERVATION OF THE HISTORIC LOCKWOOD HOUSE**

**Phase I, FY2009-2010**

**HARPERS FERRY  
NATIONAL HISTORICAL PARK**

**HISTORIC STRUCTURES TREATMENT RECORD**

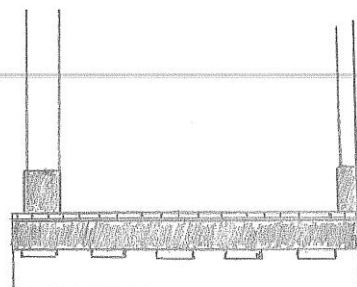
South Elevation of west porch

Note - All framing inside architrave replaced  
 Note - All second floor ceiling boards replaced  
 All second floor flooring replaced
