PART II, PORTION, ROOF

FIRST BANK OF THE UNITED STATES

INDEPENDENCE NATIONAL HISTORICAL PARK

HISTORIC STRUCTURES REPORT  
PART II (PORTION)  
ARCHITECTURAL DATA SECTION  
ON  
THE FIRST BANK OF THE UNITED STATES  
RESTORATION OF ROOF  
Independence National Historical Park

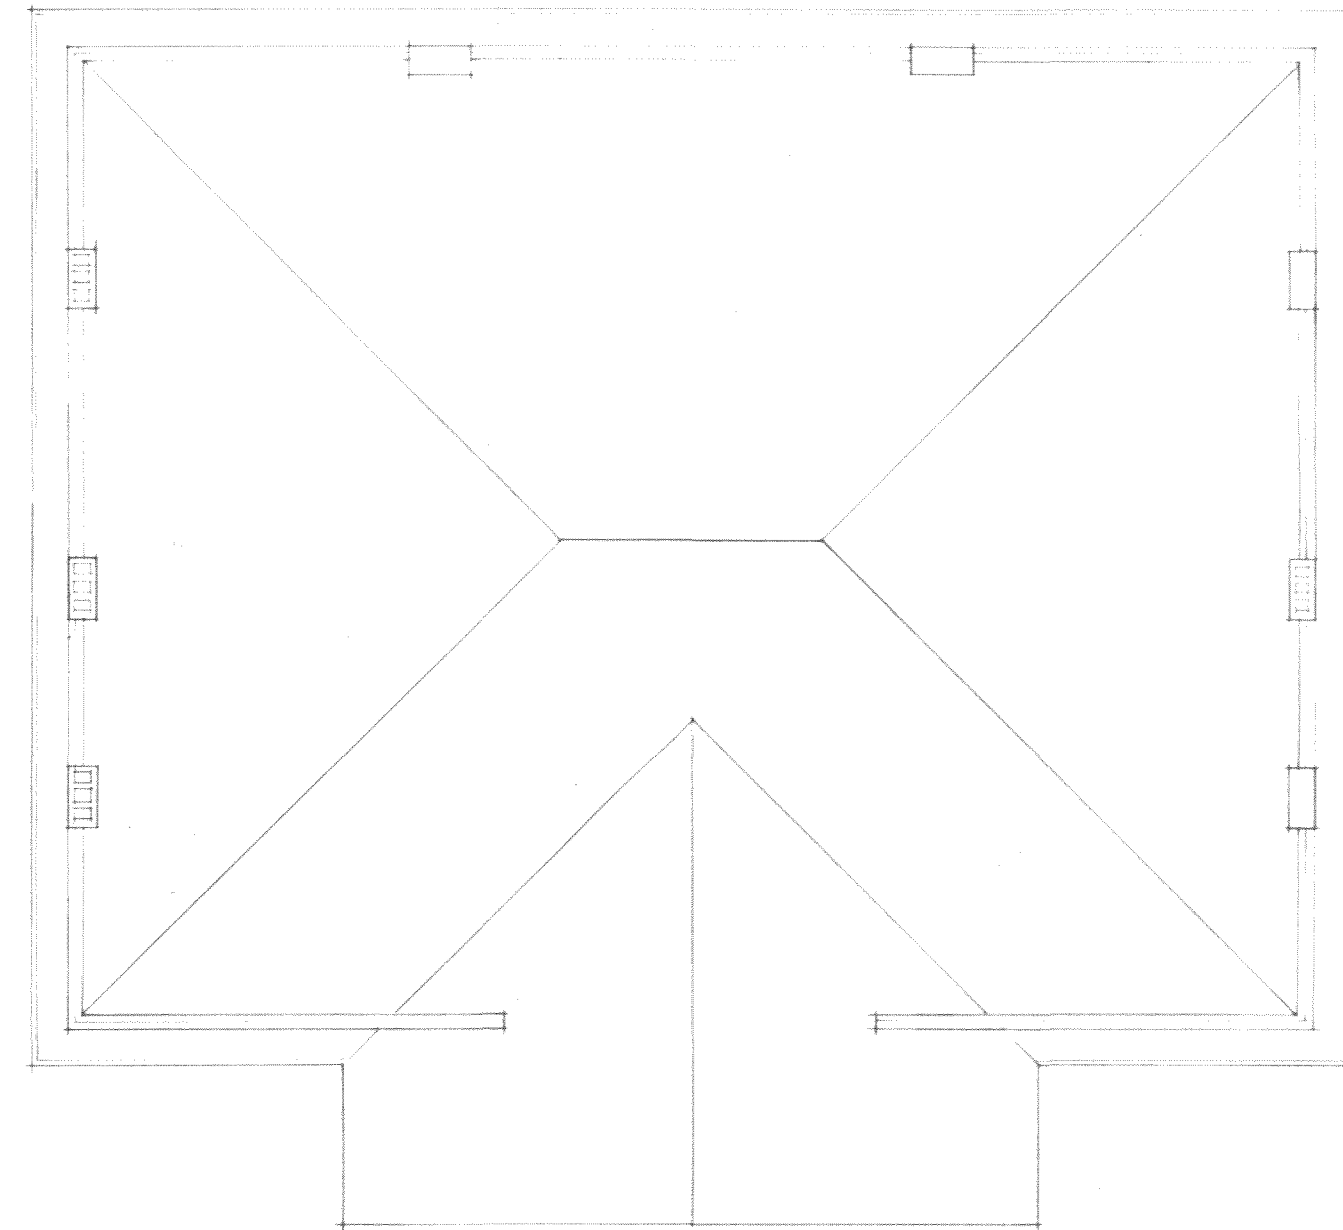
ROOF PLAN

The present condition of the skylight is poor. Much of the metal work is rusted on the exterior and water is admitted around the glass panels.

1. The repair of the existing glass skylight to make it watertight until the roof restoration could be done.
2. The removal of the glass skylight and the extension of the present steel framing to cover the skylight area (see sketch No. 1).

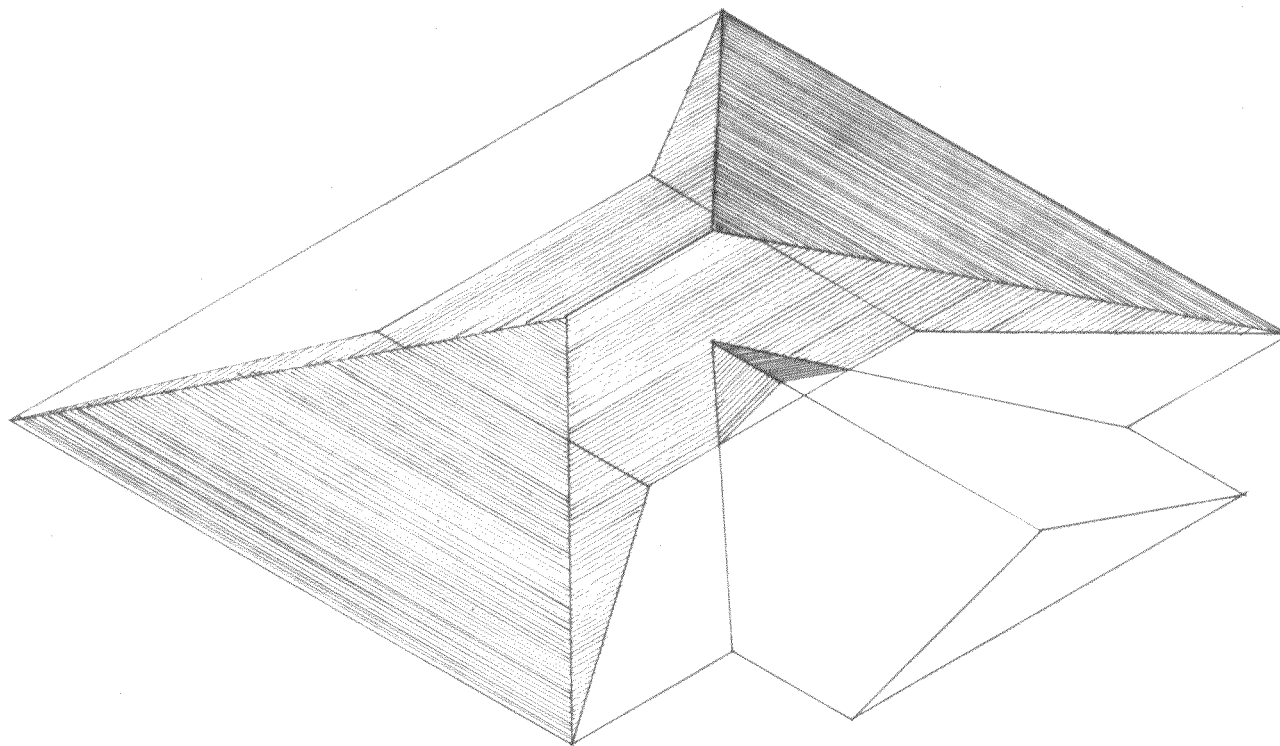
SK-1

ISOMETRIC SKETCH SHOWING AREAS  
OF FALSE ROOF OVER EXISTING ROOF
