HISTORIC STRUCTURES REPORT

OLD CITY HALL

Independence National Historical Park

Structural Rehabilitation

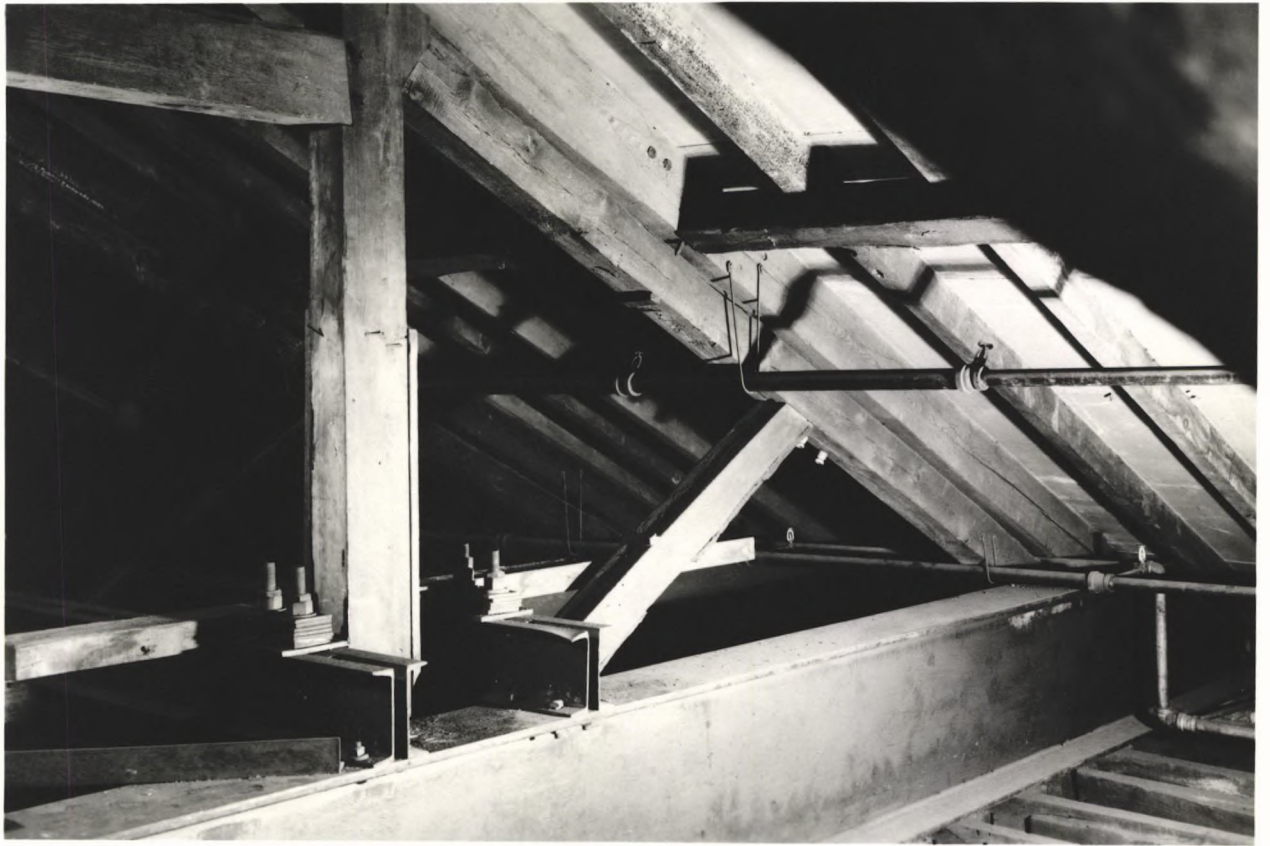
Photo: Theodore F. Dillon, 19 August 1960  
Neg. No. EODC 1196

Visible in the foreground is one of the 24 and 26 inch steel girders (at truss No. 4) that was installed in the restoration carried out under the direction of the Philadelphia Chapter of the American Institute of Architects in the early 1920's. These two steel girders were designed to provide structural support for the original wooden wall truss at the second floor level. This wooden wall truss in turn carried major second floor beams. The entire second floor structural system was strengthened at this time and carried from above. Note the double pairs of channels which span between the steel girders. From these channels the second floor wall truss is supported with hanger rods. It is intended to strengthen the 24" wide flange beam so as to carry the additional roof loads. Basically the limited structural work carried out in the 1920's was of sound design and the proposed structural rehabilitation is merely an extension of that work.
