HISTORIC STRUCTURES REPORT  
PART II (PORTION)  
ON  
SECOND BANK OF THE UNITED STATES  
Restoration of Roof and Iron Work  
Independence National Historical Park

Prepared by  
Joseph Petrak  
Architect  
May 1964

Restoration of Roof and Iron Work

Independence National Historical Park

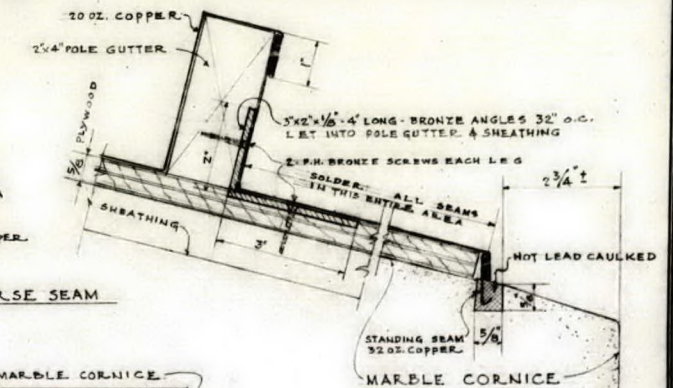
ORIGINAL MARBLE CHIMNEY ELEVATIONS<sup>1</sup> THRU<sup>6</sup>  
SCALE:  $\frac{1}{2}" = 1'-0"$

The six chimneys are original. Except for the hood over the chimneys, they appear to be in sound structural condition. The large cap stones below the hoods are held together at the joints with surface iron cramp anchors. Three chimney hoods and two hood supports have been replaced with pre-cast concrete slabs. The flue openings have been capped with cement. A detail of an original reglet and joint flashing (see Illustration No. 17), shows the method that was employed to flash the chimneys. This was uncovered behind the present tin flashing.

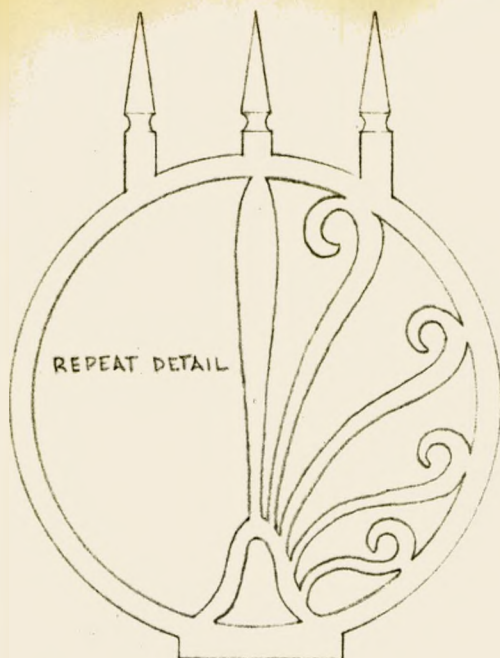
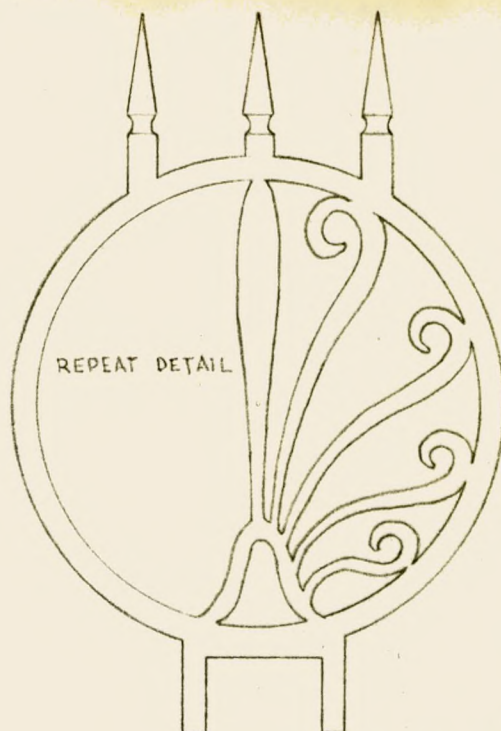
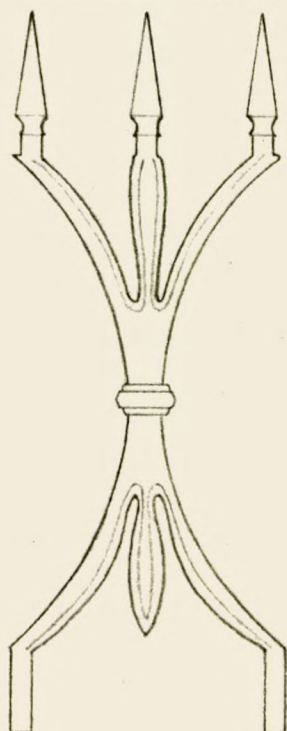
The railing and gates that flanked the north terrace (Chestnut Street) on the side of the west passage was removed when the passage was widened in 1881. The railing and gates on the side of the east passage was removed sometime after 1910.

It is recommended that new castings be made to match the originals for a railing and gate assembly for the east and west passages that flank the north terrace and for the missing portions flanking the south terrace. See Sketch No. 1, illustrating the four types of castings that would be required.
