Historic Structures Report Part I  
on  
Congress Hall  
Independence National Historical Park

Prepared by  
Staff  
Independence National Historical Park  
Philadelphia, Pennsylvania

May, 1959

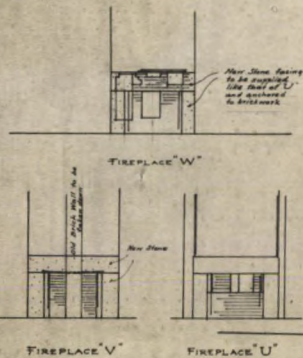
ELEVATIONS OF FIRST STOREY  
FIREPLACES

Light lines show how at present filled up.  
New openings to be formed and flues built  
clear and continuous

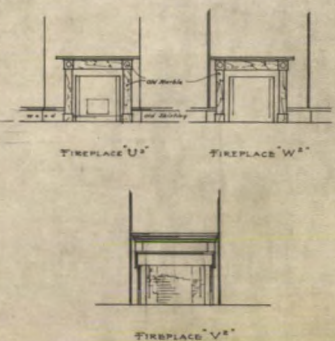
ELEVATIONS OF SECOND STOREY  
FIREPLACES

Light lines show how at present filled up.  
New openings to be formed and flues built clear and continuous

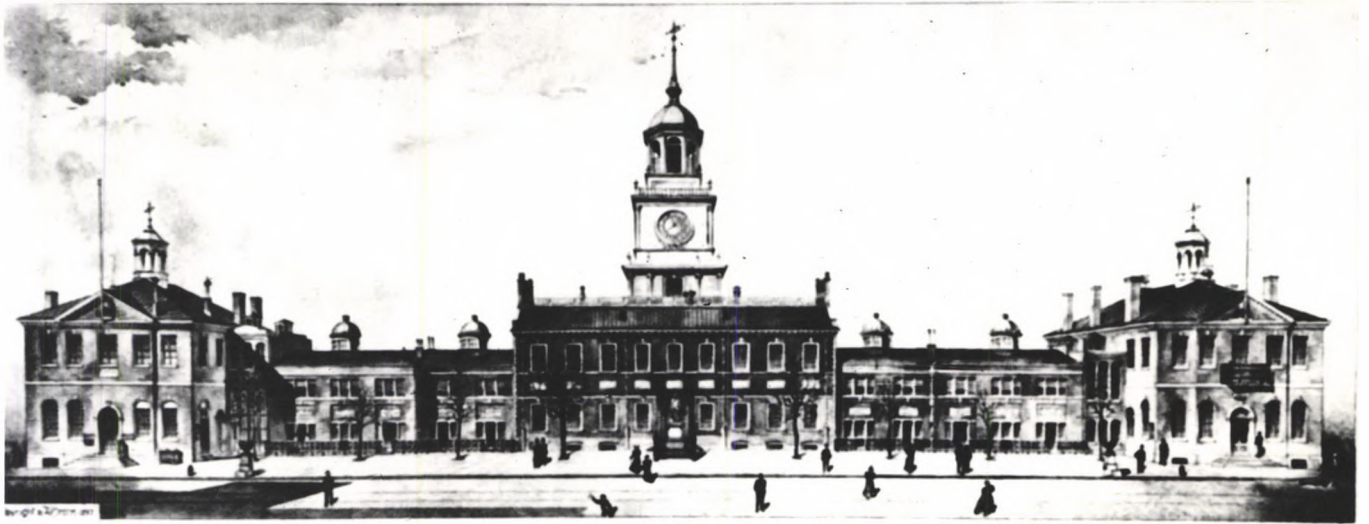
Independence Hall, Congress Hall, and Old City Hall in 1895. Note structure abutting Congress Hall. Also note appearance of front doors and of former door opening in east wall. Courtesy of American Philosophical Society.

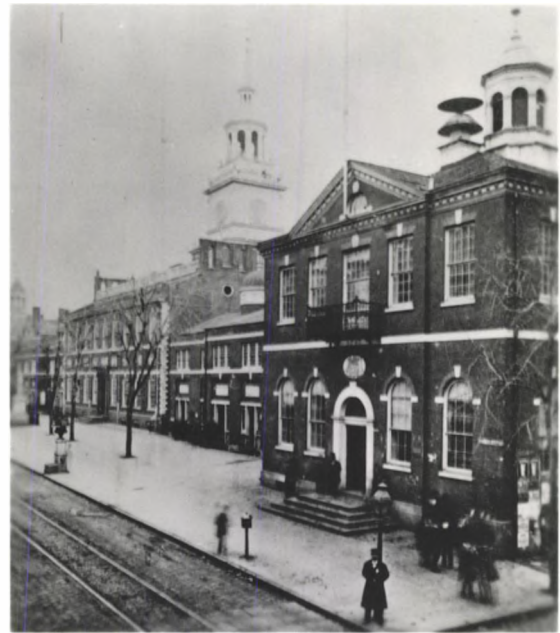
Independence Hall, Congress Hall, and Old City Hall  
around 1896. Note details of balcony and stonework  
of facade. Ventilator forward of cupola was a late  
19th century "improvement." Courtesy of Picture  
Post Library, London.

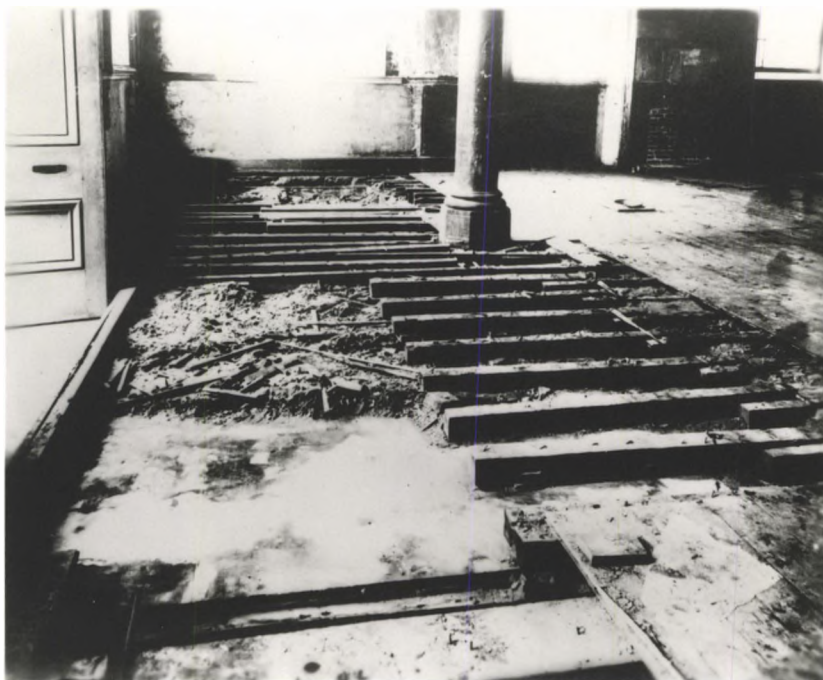
View of the north room, first floor of Congress Hall, taken October 5, 1900, during removal of modern flooring. Note "the original marble pavement" of the vestibule. Later investigation showed that this marble floor was not original.

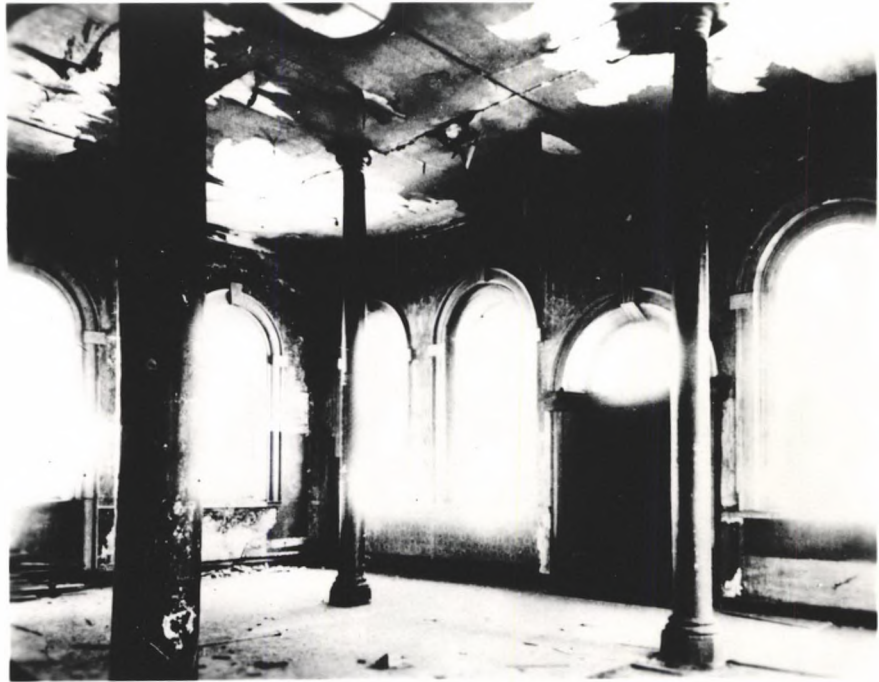
Photo taken in 1900, showing north and west walls of north room, first floor. Note plaster patch half way up west wall in corner which indicates landing of original west staircase. Note also that the frame of the original Chestnut Street door is still in place, although the doorway has been blocked up.

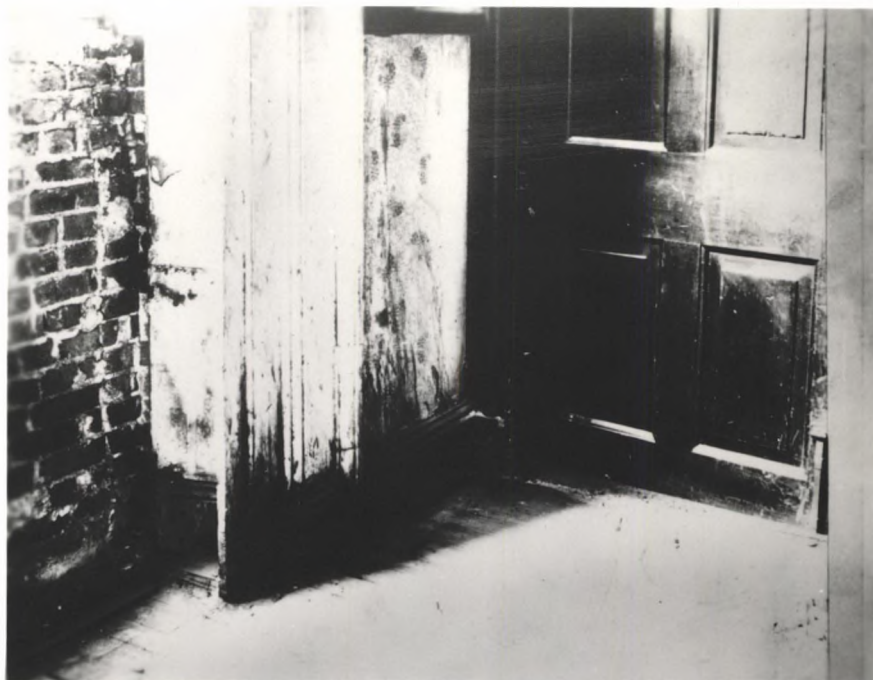
Photo taken October 19, 1900, showing original surbase  
in north room, first floor.

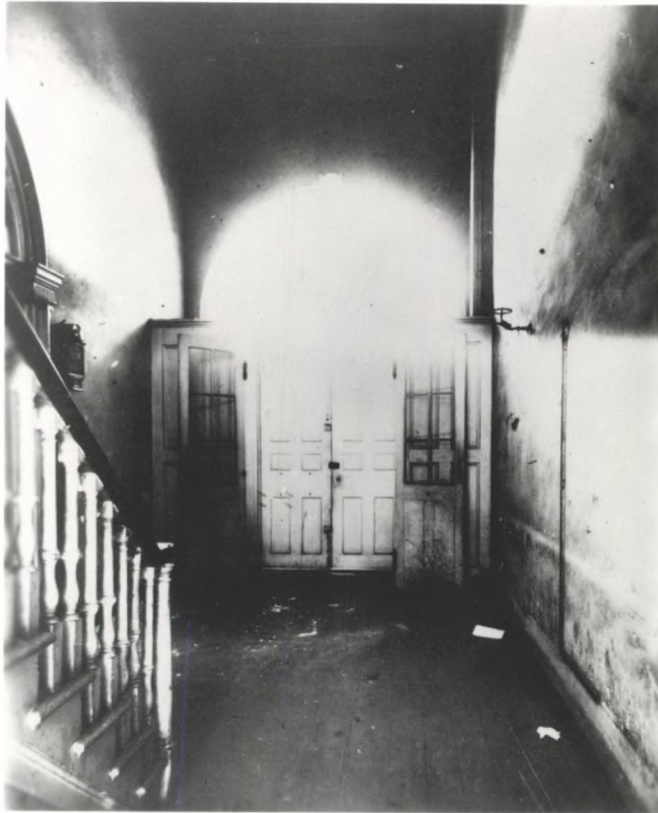
The 1818-1820 cross hall, photo taken August 6, 1900. The stairway shown at left was removed from its original location at the west of the vestibule, altered, and re-installed in the cross hall.

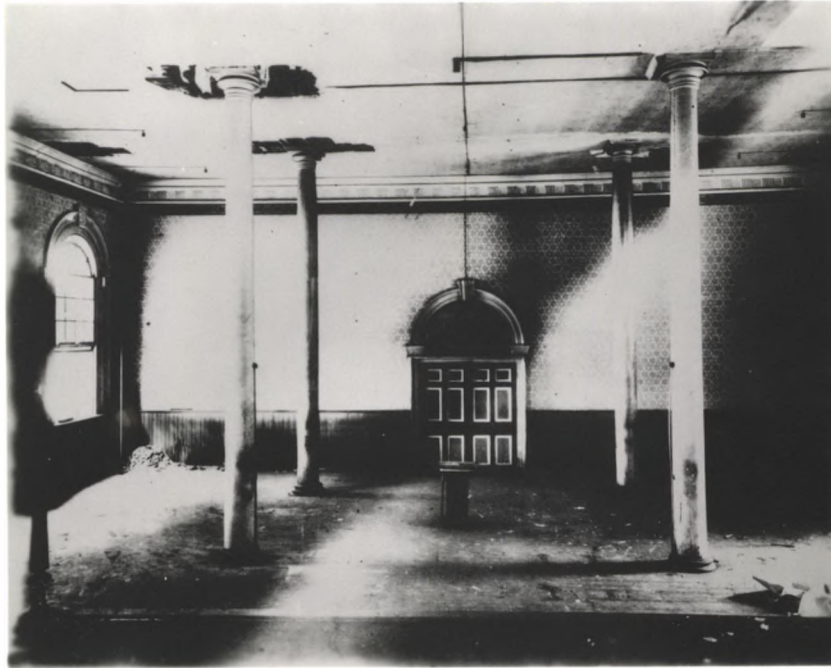
South room, first floor, looking north in August 1900. Note the door centered in the south (brick) partition of the cross hall. The frame of the door was thought by the A.I.A. to have been the frame of the vestibule door leading to the House Chamber.

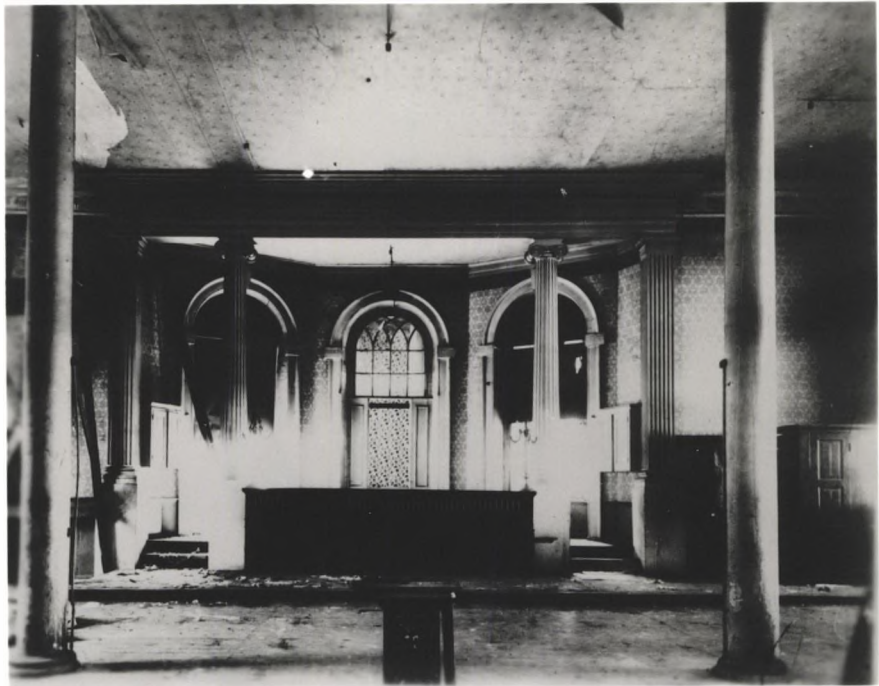
Photo taken in August, 1900, showing the southern end of the south room, first floor. The judges' tribunal in the bay was added after 1800; beneath its floor and above its dropped ceiling the A.I.A. found portions of original finish.

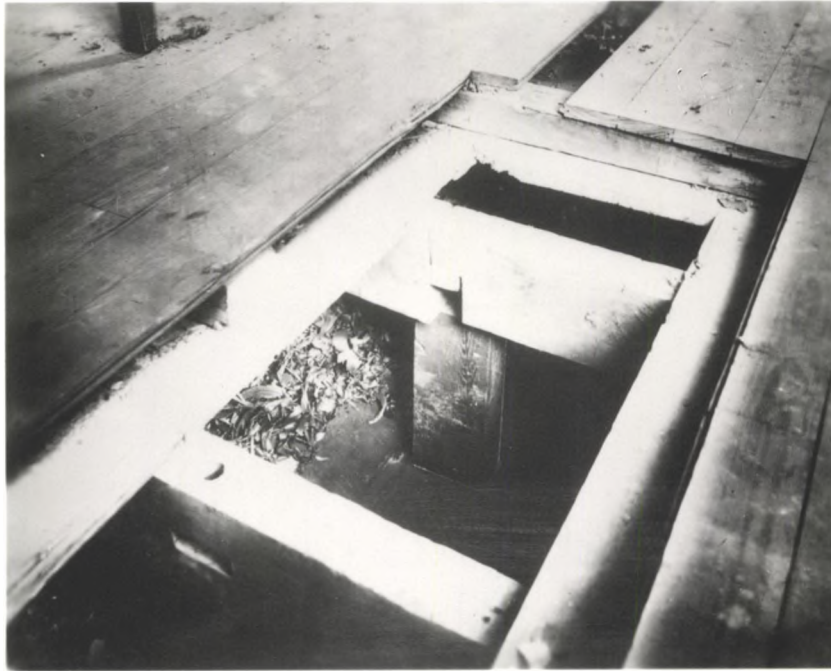
South room, first floor, showing judges' platform cut away to expose original floor beneath it. Photo taken October 19, 1900.

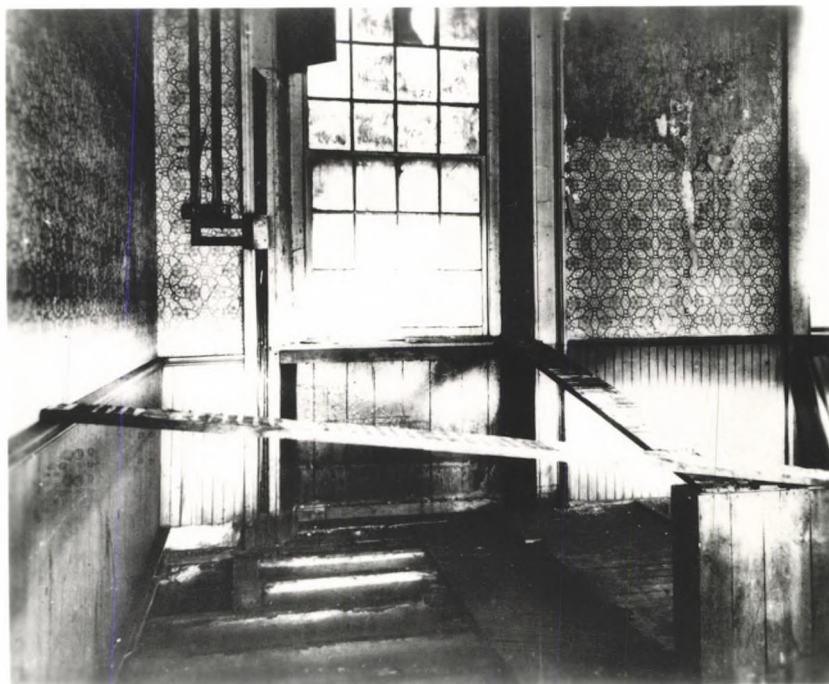
View of the northwest corner of south room  
showing the three floors found during the  
A. I. A. investigation, taken in August 1900.

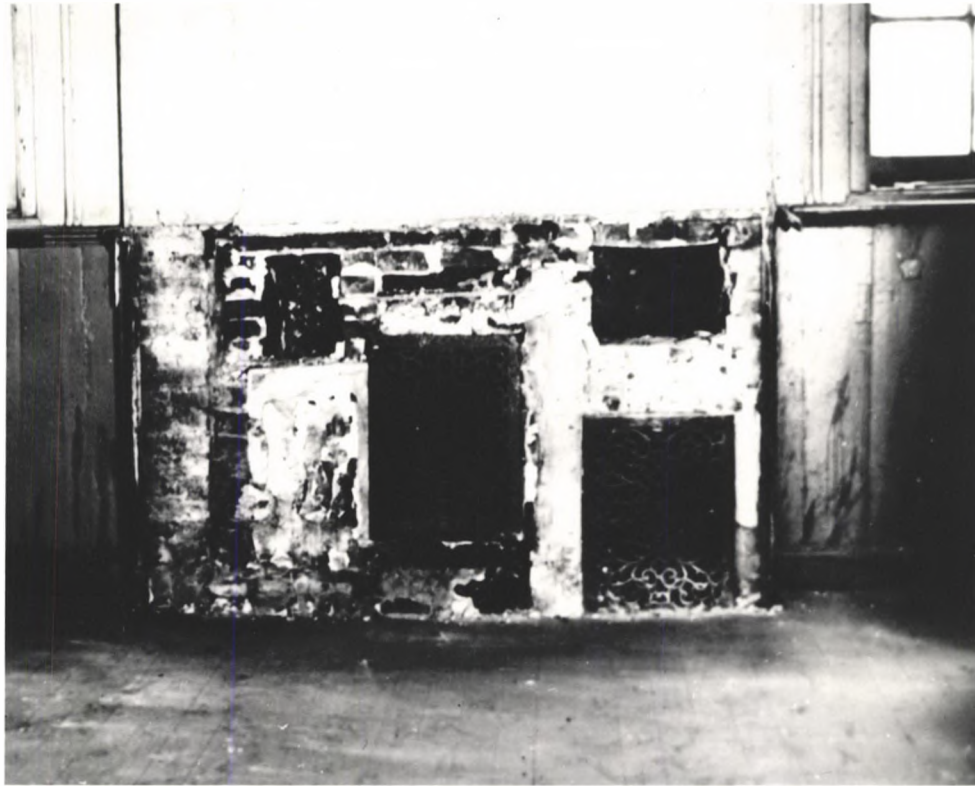
A view of fireplace and wainscot, south room, first floor, taken October 19, 1900. Later investigation of this fireplace revealed that it had originally been a high, arched niche.

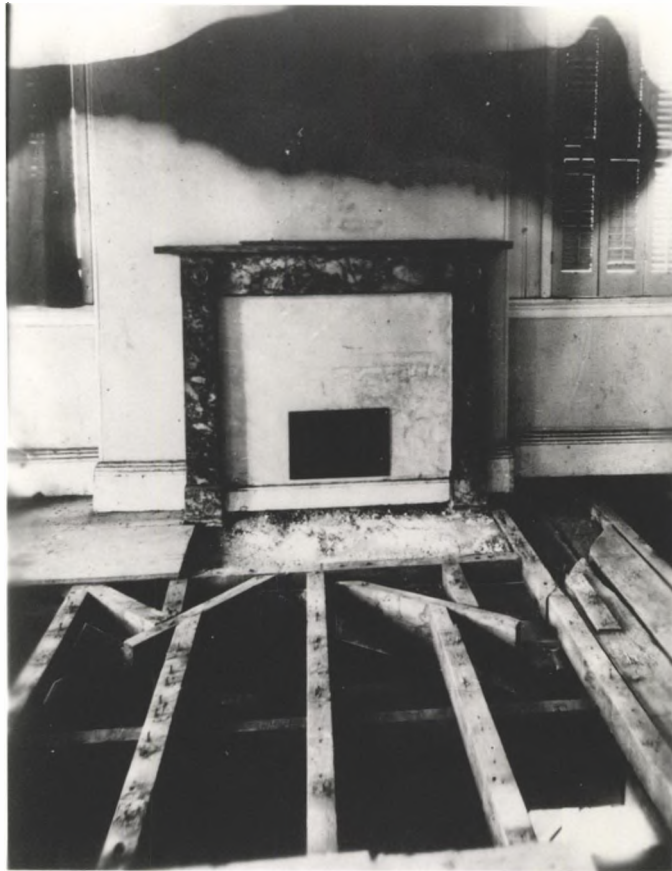
Floor construction, east side of north room,  
second floor, in photo taken November 6, 1900.  
Note also window sill and chair rail on window  
to right.

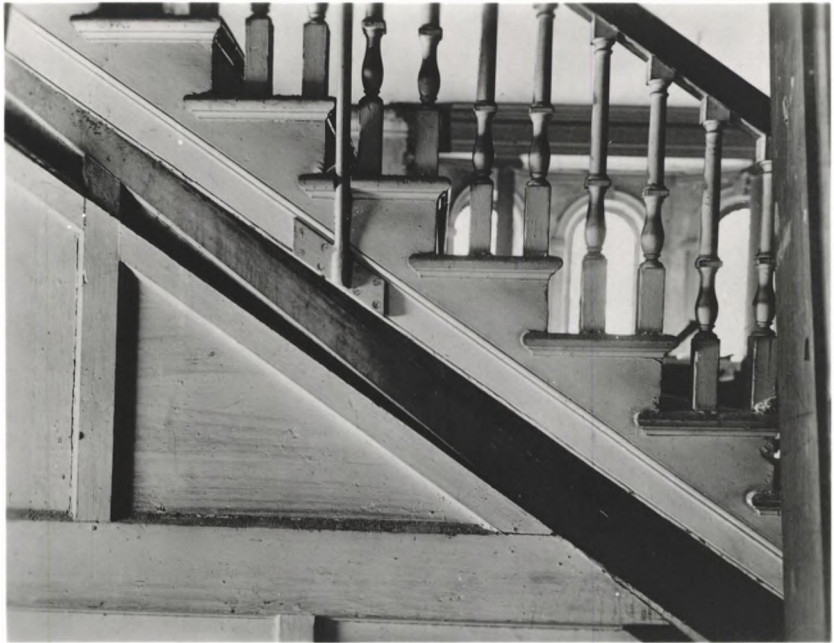
View of cross hallstairs taken in the spring of 1912. Note the lines of old rails and line of inserted rails applied on the face of older panels.

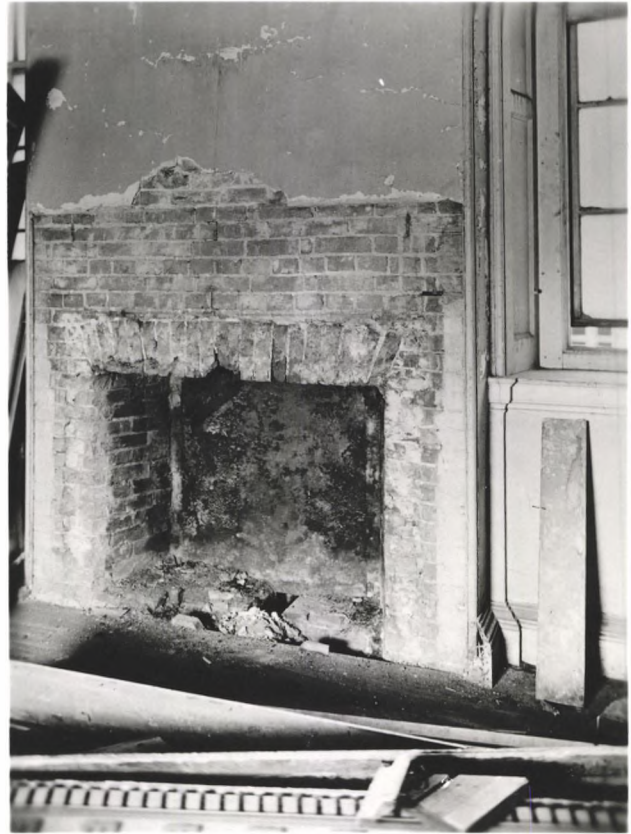
View of fireplace in west middle Committee Room taken March 5, 1912. Note outline of facing and mantel, as well as section of original cornice in foreground.

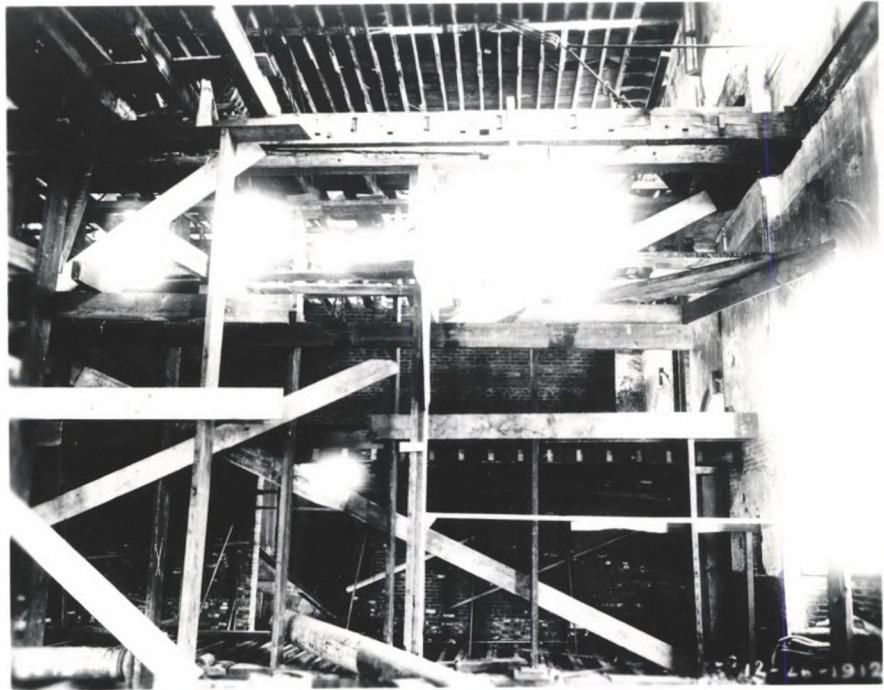
View of House Chamber taken Dec. 26, 1912, showing re-stored south (brick) partition of vestibule. Other structural elements include Girder "D" which has been separated preparatory to insertion of steel beam, Girder "E" in position at gallery level, and wood columns. Note pedestal for easternmost column in foreground.

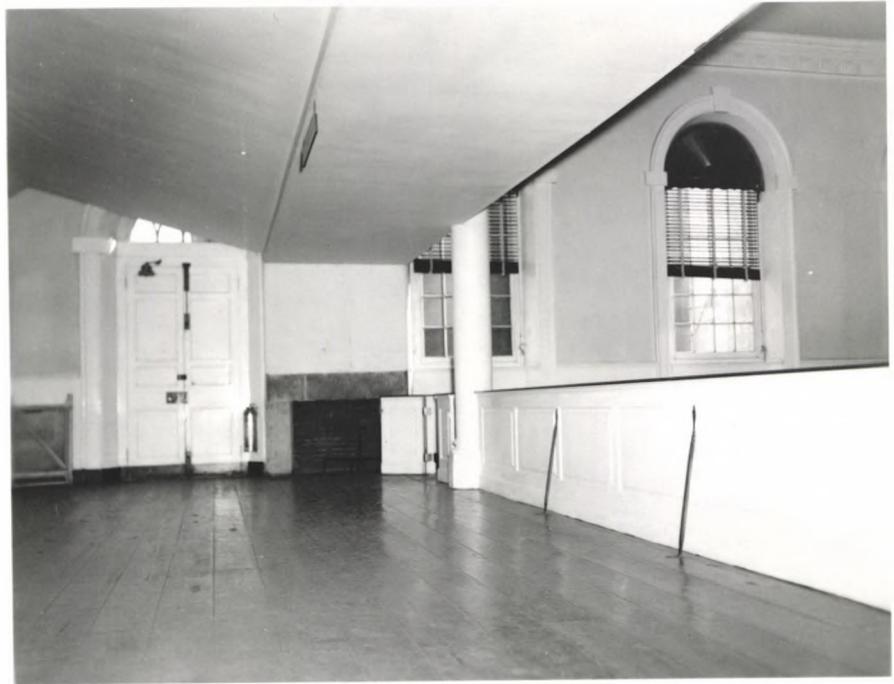
View looking east under the restored gallery in the House of Representatives Chamber, 1913. Note that the facing of the fireplace is original; the original back is in place behind the new back shown. Note also the path followed by the bottom of the gallery, which cuts across the transom of the east door.
