# Quarters 1 Superintendent's Residence, Garage, and Permanent Masonry Landscape Features Historic Structure Report

## Quarters 1

# Historic Structure Report

June 2013

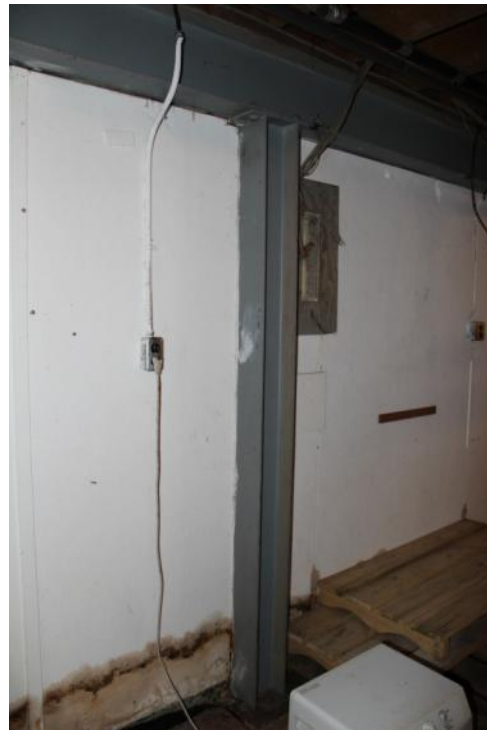
*Figure 85, right.* A steel column and beam system supports the floor frame at the center of the basement. Photo: HPTC (06/20/12).

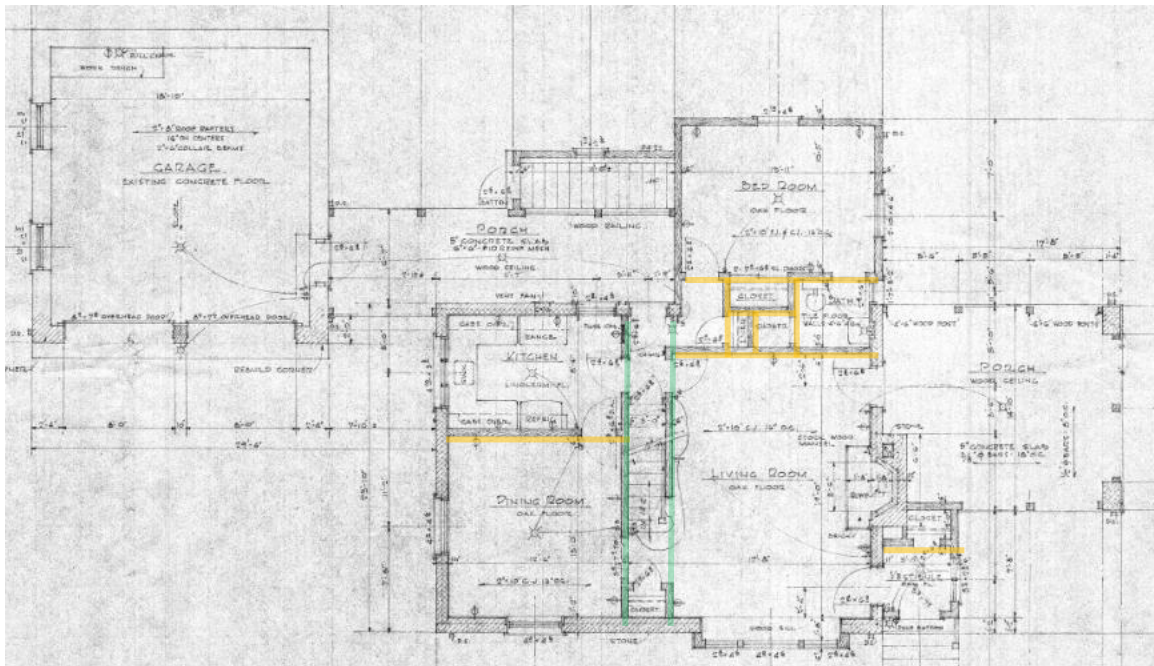
The main block second-floor structural floor frame is inaccessible. The drawings specify 2"x10" wood joists, running north-south, at 16"OC. It is assumed there is also diagonal bracing and 1"x6" and 1"x8" subfloor, laid diagonally, above. The joists are supported by the exterior masonry foundation walls and the interior load-bearing frame walls (fig. 86).

Figure 86. First-floor plan. Green lines: load-bearing walls. Orange lines: partition walls. Drawing: Custodians Residence (Sheet 2 of 9), NCR lands database.

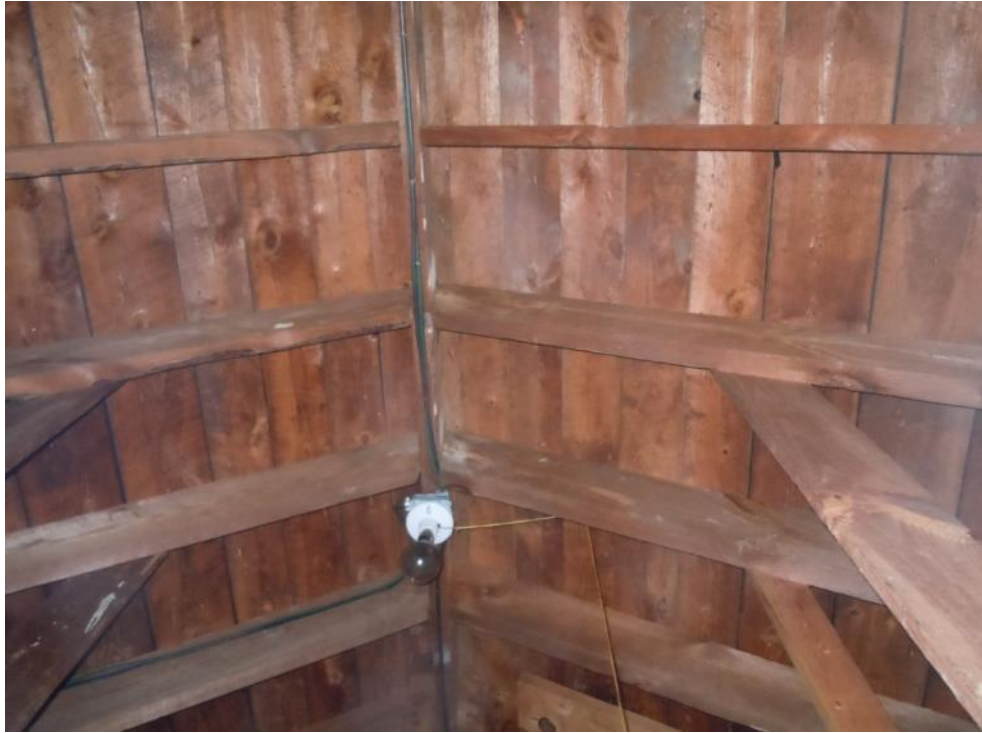
The garage gable roof structural frame is inaccessible to measure, but is visible through a scuttle in the second-floor framing (fig. 87). The drawings specify 2"x8" wood rafters, running north-south, at 16" OC. The ridge board, queen posts, and perpendicular can also be seen.

Figure 87. The garage roof structural frame can be seen through a scuttle from the first floor. Photo: HPTC (07/17/12).

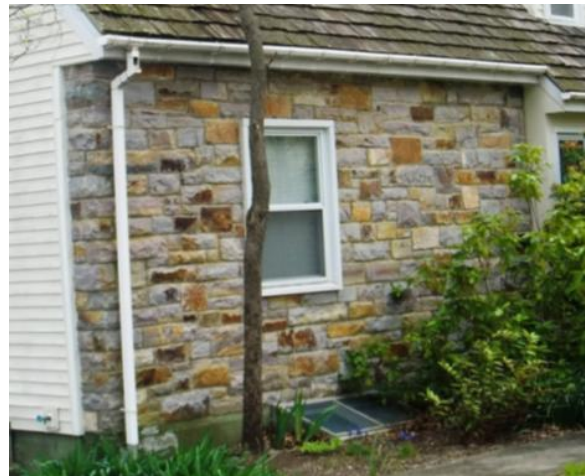
*Figure 91.* The stone masonry west façade as seen in 2012. Photo: HPTC (04/21/12).

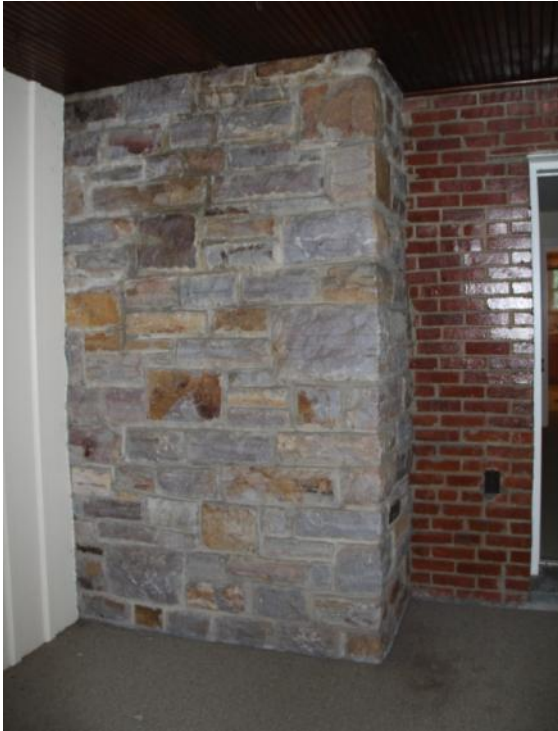
The main block chimney is also composed of stone in a broken ashlar pattern (fig. 92). According to the drawings, there is no brick backing. The flues are lined with terra cotta.

*Figure 92.* The main block broken-ashlar stone chimney walls can be seen in the sun porch. Note the exposed brick wall. Photo: HPTC (06/12/12).

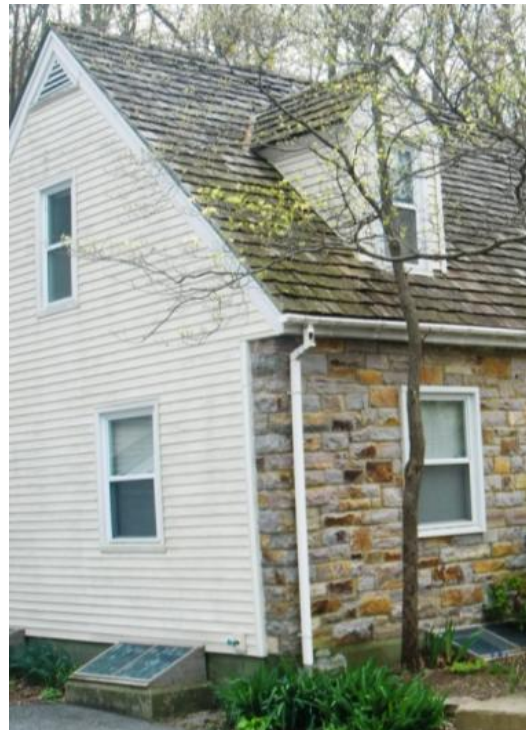
*Figure 95.* The brick on the north wall has been covered with vinyl siding. Photo: HPTC (04/21/12).

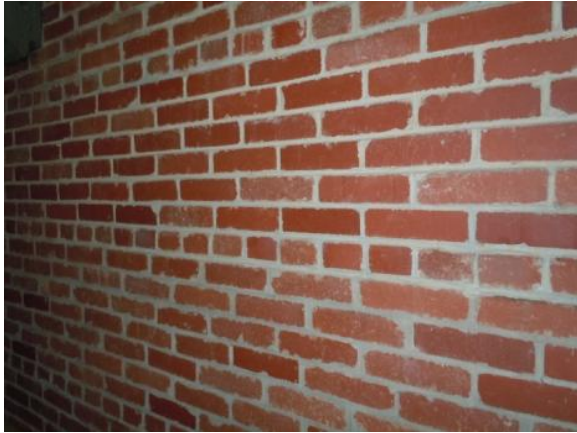
*Figure 96.* The brick is still exposed on the east façade (6:1 common bond with partial-Portland cement mortar. Photo: HPTC (08/29/12).

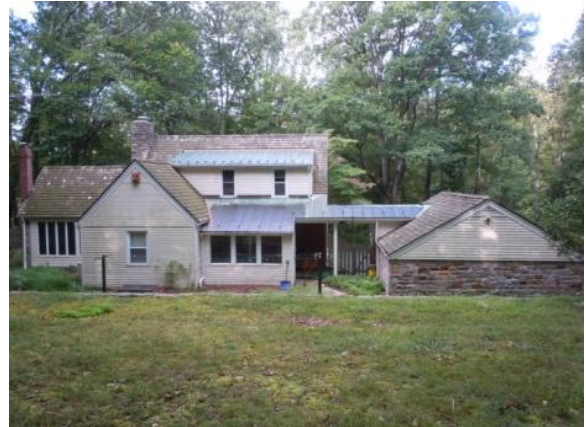
*Figure 101.* All of the wood-frame exterior walls have been clad with modern vinyl siding. Photo: HPTC (08/29/12).

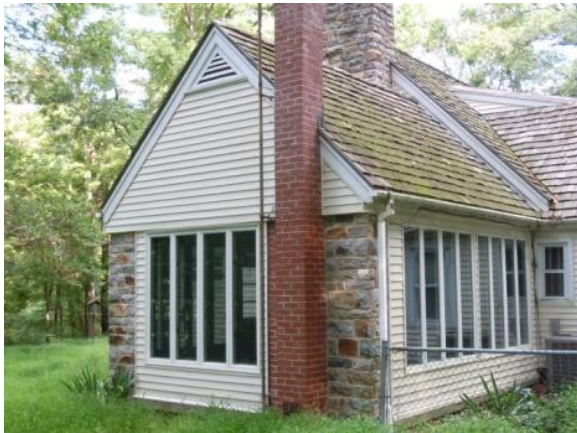
*Figure 104.* The wood-frame exterior walls of the sun porch, including the lower portion of the infill window walls, are clad with modern vinyl siding. Photo: HPTC (08/29/12).

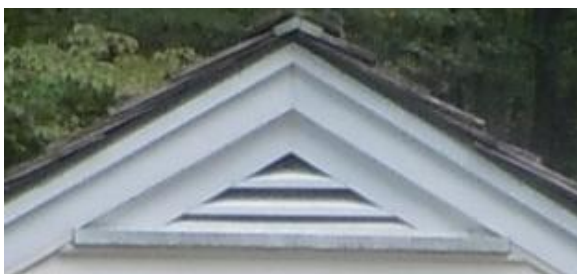
*Figure 106.* The gable-end louvers have been replaced with metal-clad louvers. Photo: HPTC (08/29/12).

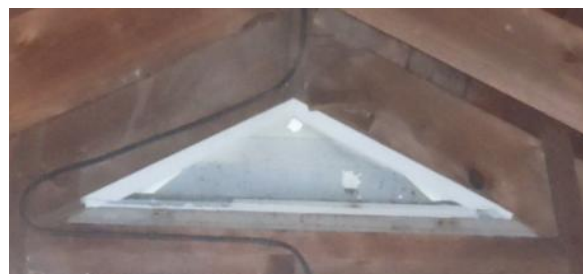
*Figure 107.* The interior of the north garage louver has a screen. Photo: HPTC (07/17/12).

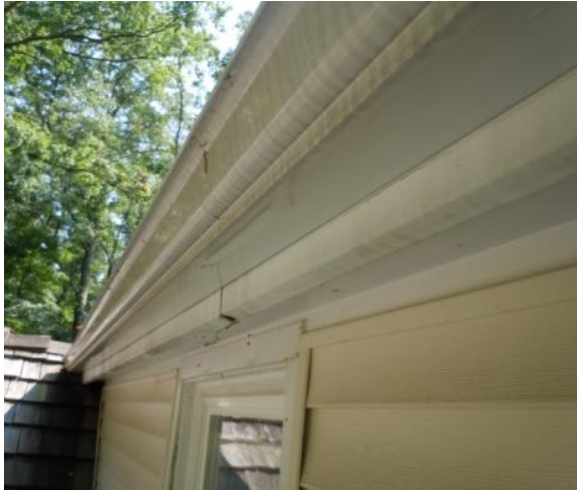
*Figure 108.* The metal-clad soffit of the rear dormer shed roof. Photo: HPTC (07/17/12).

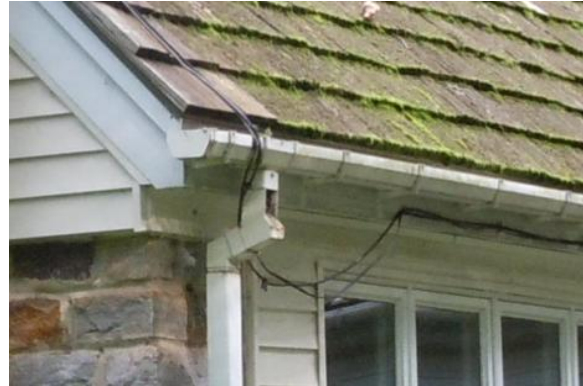
*Figure 109.* The metal-clad soffit of the sun porch gable roof. Photo: HPTC (08/29/12).

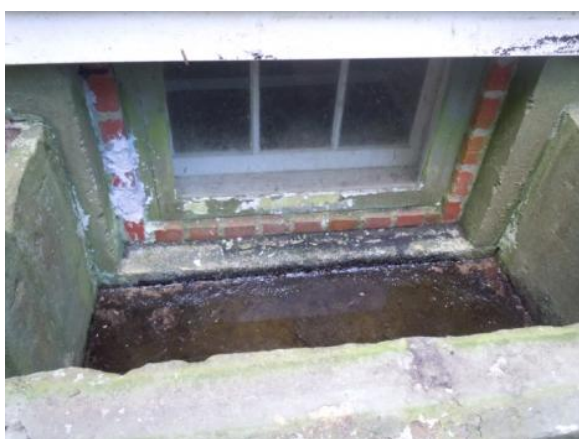
The original three-lite wood main block basement hopper windows are extant (W001-005; fig. 110). The units include exterior wood-frame screens and interior wood-frame storms. Additionally, a modern screen and wood-resin frame covers each window well to deter accumulation of debris in the area (fig. 111).

*Figure 110.* All of the basement windows are original. Photo: HPTC (08/29/12).

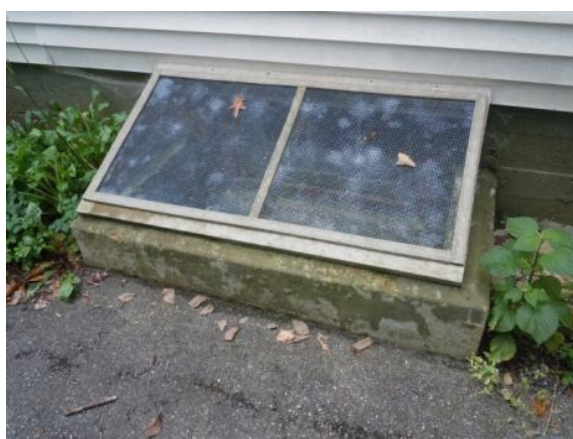
*Figure 111.* The basement window openings include screened frames above the window well. Photo: HPTC (08/29/12).

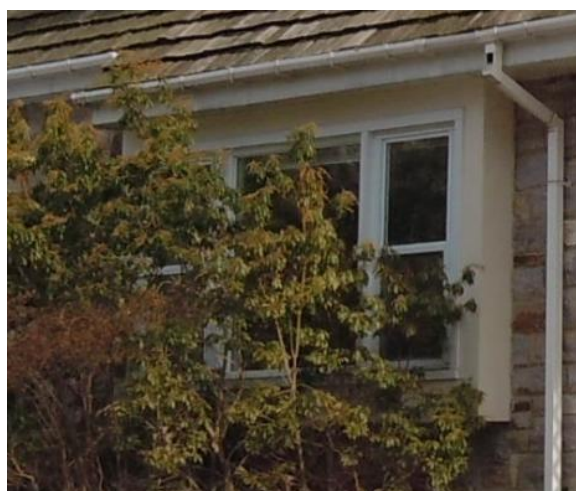
All of the replacement windows are out of character with building design. When replacement occurred, no attempt was made to replicate the historic window light patterns in the synthetic replacement windows. The new windows exhibit a loss of lite patterns from the original windows and an increase of sash frames (i.e. W106-107, et al). These changes are not compatible with the historic building.

*Figure 115.* The living room bay window units have been replaced with modern vinyl units. No attempt was made to replicate historic window lite patterns in synthetic modern replacement windows. Photo: HPTC (02/14/12).

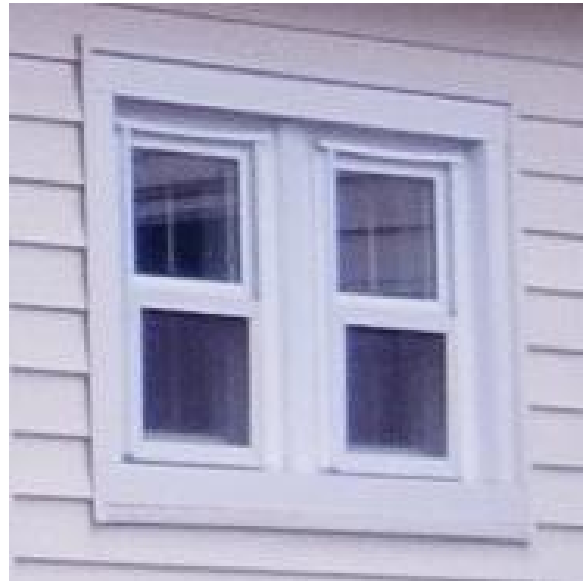
*Figure 117.* The vestibule windows have been replaced with vinyl-clad, double-hung units. Photo: HPTC (04/21/12).

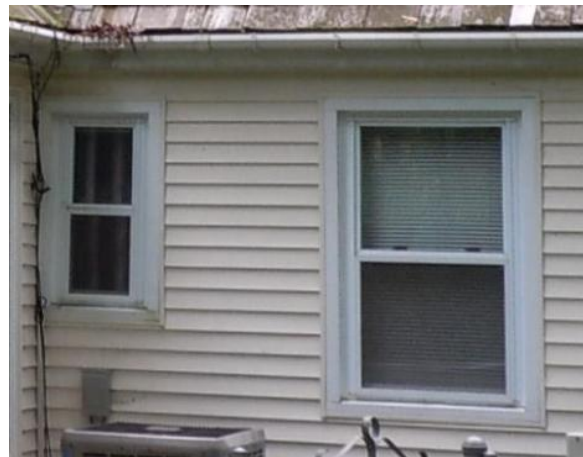
*Figure 119.* The bathroom and bedrooms windows have been replaced with vinyl-clad, double-hung units. Note the absence of divided lites. Photo: HPTC (08/29/12).

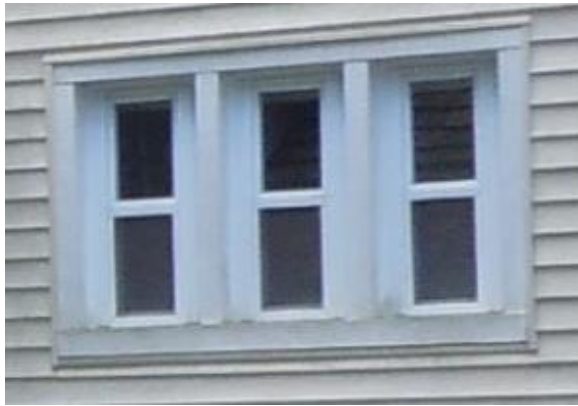
*Figure 120.* The north elevation kitchen windows have been replaced with vinyl-clad, double-hung units. Photo: HPTC (08/29/12).

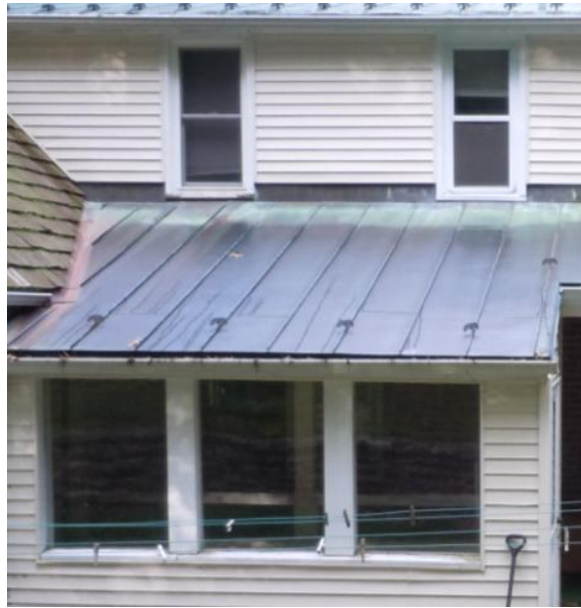
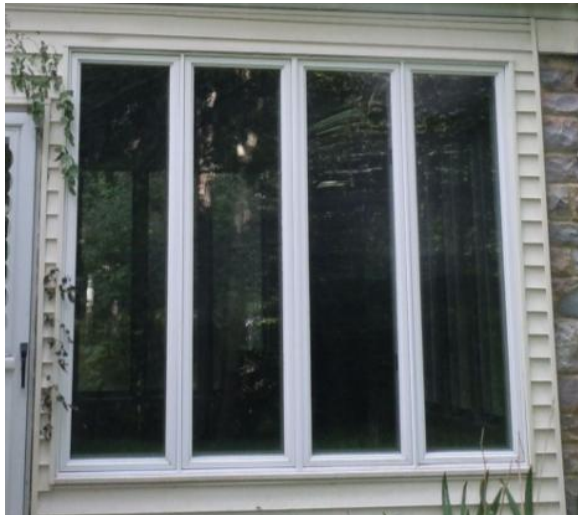
The sun porch originally was screened in and did not include windows (see fig. 99). In 1994 Anderson® casement windows were installed in order to enclose the porch. The windows were replaced with Pella® casement windows (four units with four windows each: W108-111, W112-115, W116-119, W120-123); the date of these replacements is unknown (fig. 122).

*Figure 122.* The sun porch was infilled with windows in 1994; these windows have since been replaced. Photo: HPTC (08/29/12).

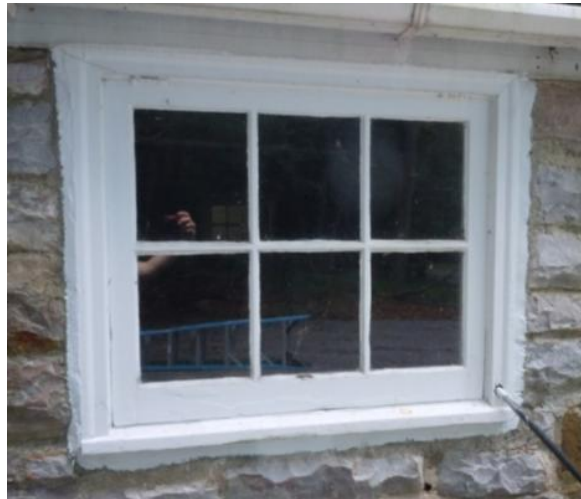
The original (to 1948) wood garage windows are extant (WG101-G102). They are six-light hopper windows (fig. 123).

*Figure 123.* The 6-lite garage hopper windows are originally to the 1948 rebuild of Quarters 1. Photo: HPTC (08/29/12).

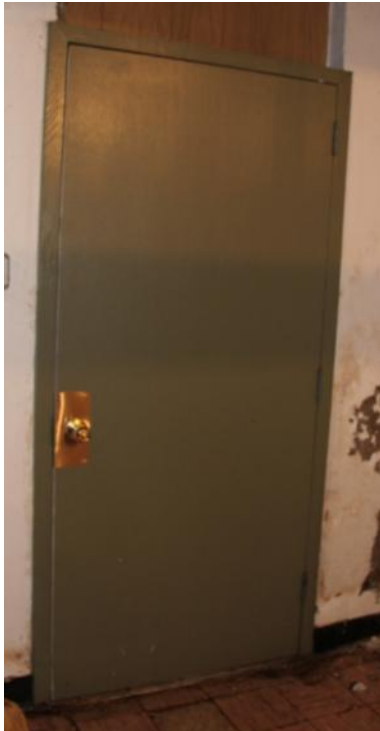
The single basement exterior door (D004E) was replaced in 1997 with a solid-core wood door (fig. 124). The original style is unknown.

*Figure 124.* D004E is a replacement solid-core wood door. Photo: HPTC (06/20/12).

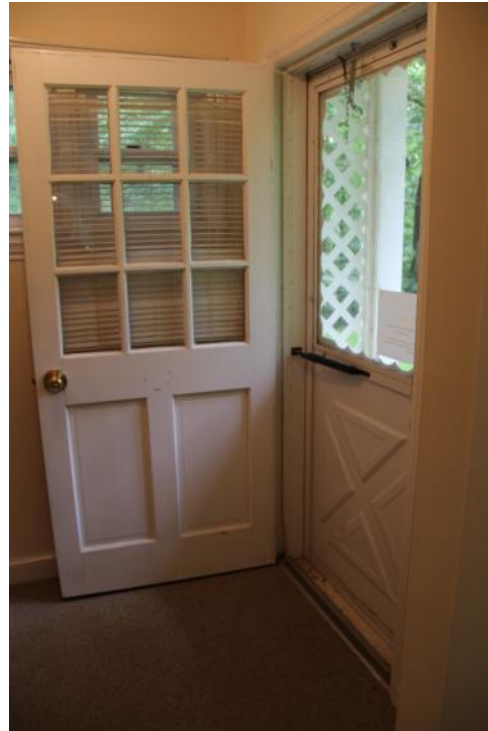
The main block originally had three exterior doors. With the enclosure of the sun porch, D106 is now considered an interior door. The other two main block exterior doors, D104E and D110E were replaced in 1995 due to the presence of lead paint. D104E was originally a wood door with nine lites above and a cross-buck below; D110E was originally a wood door with six lites above and two panels below. Both replacement wood doors have nine lites above and two vertical panels below (figs. 125-126). Additionally, both openings have an exterior aluminum storm door; the installation dates of these storms are unknown.

*Figure 125.* D104E was replaced in 1995. Photo: HPTC (06/12/12).

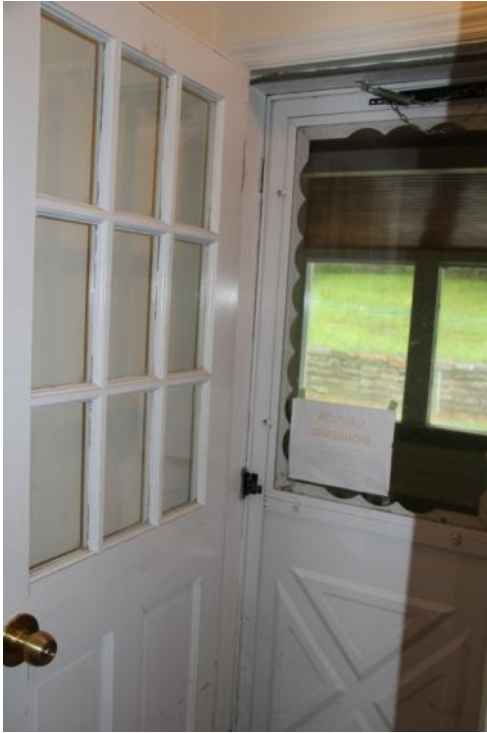
Figure 126. D110E was replaced in 1995. Photo: HPTC (06/12/12).

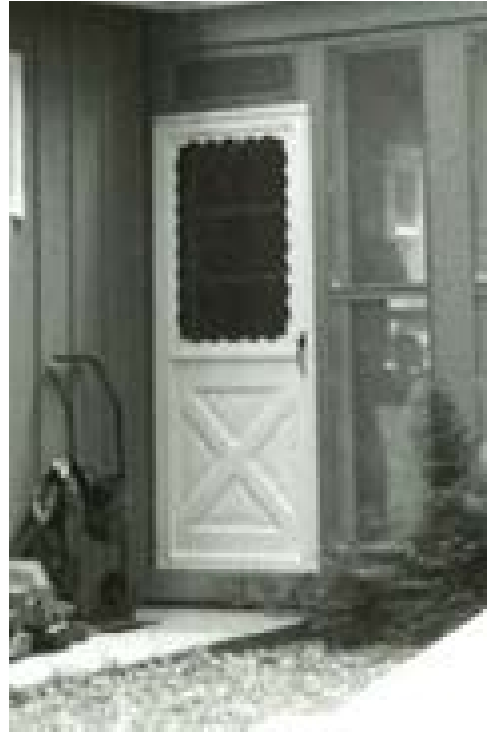
Figure 127. A sun porch exterior door (D106E) was installed prior to the 1994 enclosure, as seen in this ca. 1992 photograph. Photo: CATO Bldg. 128 building file.

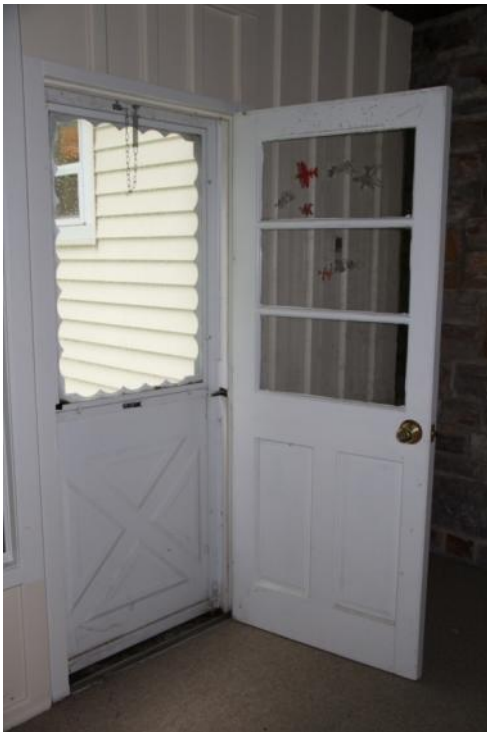
Figure 128. The extant D106E with exterior aluminum storm door. Photo: HPTC (06/12/12).

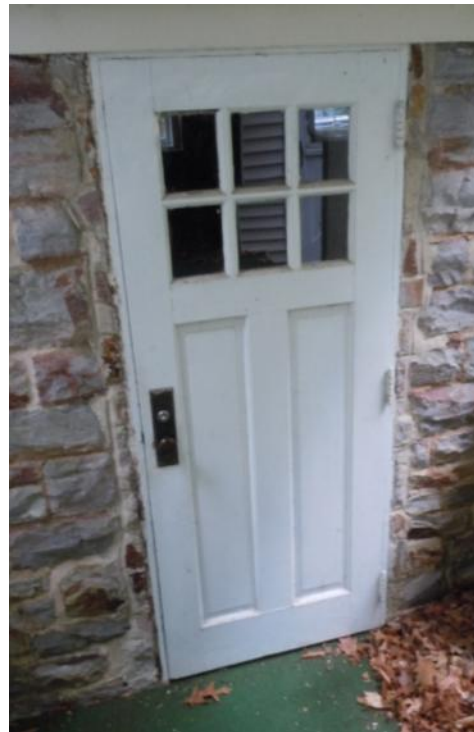
The garage exterior entry door (DG103) is original to 1948; the wood door has six lites above and two vertical panels below (fig. 129). The garage overhead doors (DG101 and 102) have been replaced. Originally the wood doors each included six lites across the top and eighteen panels below (fig. 130). The extant steel doors, installed in 1994, include sixteen panels each (fig. 131).

Figure 129. Exterior door DG103 is original to 1948. Photo: HPTC (08/29/12).

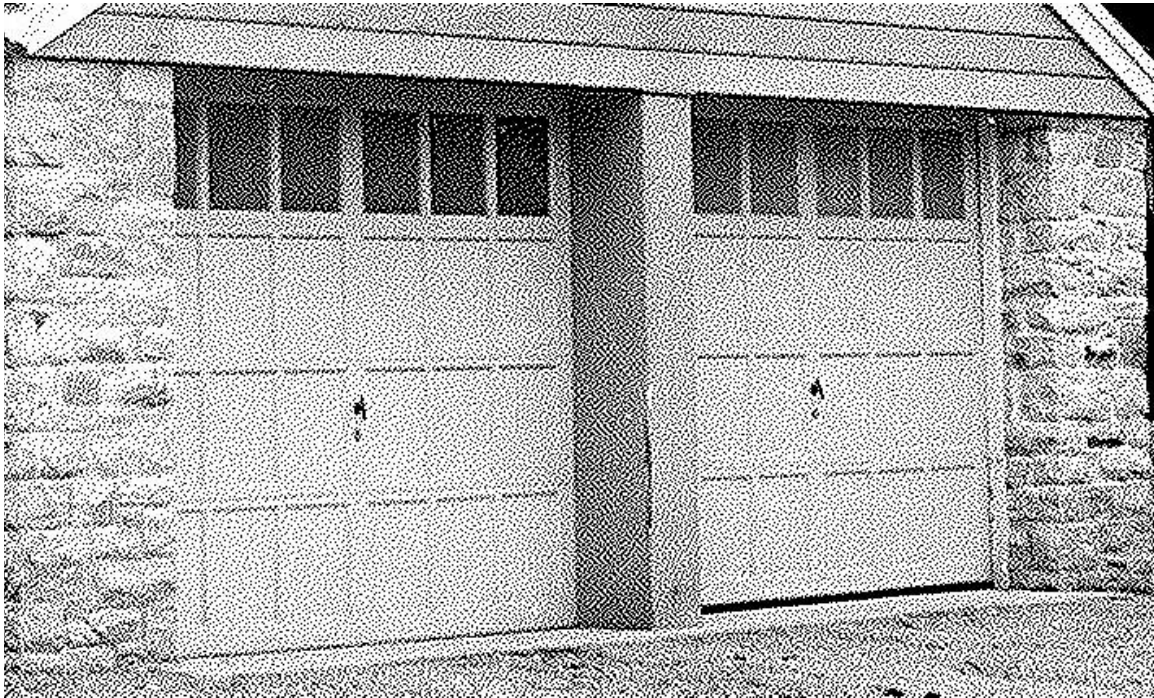
*Figure 130.* As seen in this ca. 1950 photograph, the original garage overhead wood doors each included six lites and eighteen panels (DG101 and DG102). Photo: CATO Bldg. 129 building file.

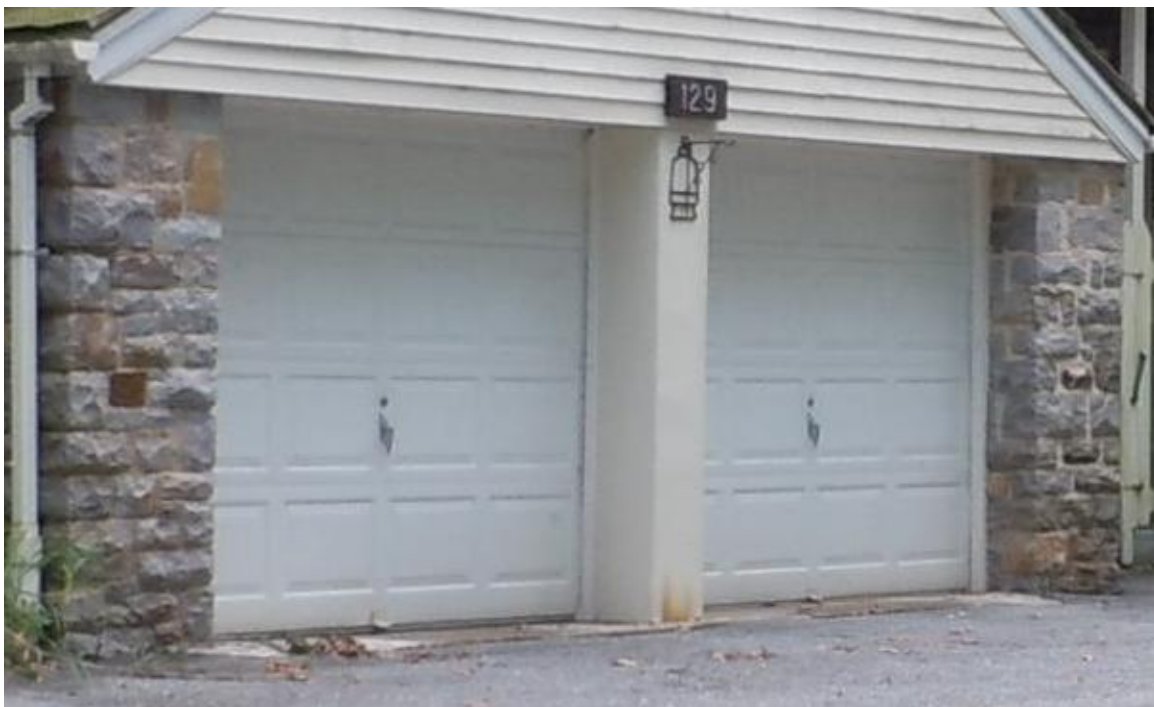
*Figure 131.* The overhead garage doors were replaced with sixteen-panel steel doors which are not character-defining features (DG101 and DG102). Photo: HPTC (08/29/12).

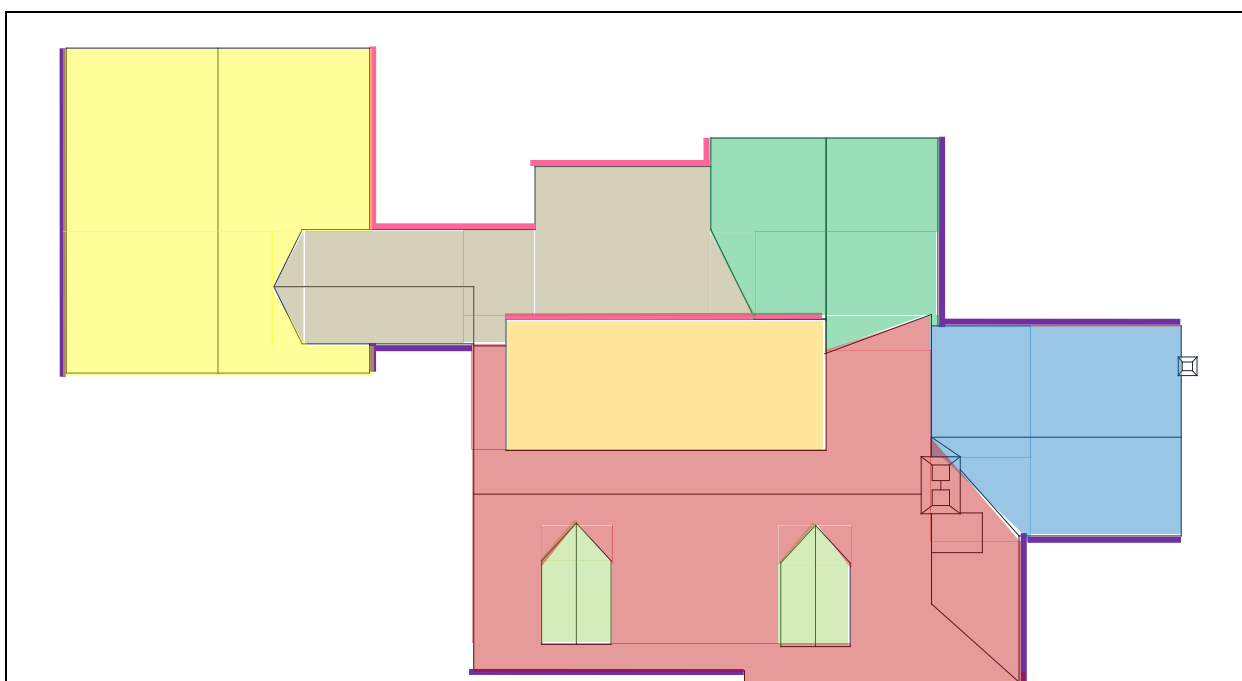
The roof can be divided into the following areas (fig. 132): the main block gable and hipped roof; the front dormer gable roofs; the rear dormer shed roof; the eastern ell gable roof; the sun porch gable roof; the breezeway shed and gable roof; and the garage gable roof.

There are two types of extant roof drainage systems located at Quarters 1 (see fig. 132). The first system utilizes U-shaped vinyl gutters and square vinyl downspouts with cleanouts at the upper elbow. This system can be seen along the west and south eaves of the main block gable and hipped roofs (fig. 145), the west and east eaves of the sun porch, the south eave of the eastern ell (fig. 146), the north and south (western portion) eave of the garage, and the west eave of the breezeway.

*Figure 132.* The Quarters 1 roofscape can be divided into distinct areas. Red overlay: main block gable and hipped roof. Light green overlay: front dormer gable roofs. Orange overlay: rear dormer shed roof. Dark green overlay: eastern ell gable roof. Blue overlay: sun porch gable roof. Brown overlay: breezeway shed and gable roof. Yellow overlay: garage gable roof. Purple lines: vinyl drainage system; pink lines: aluminum drainage system. Drawing: HPTC (2012).

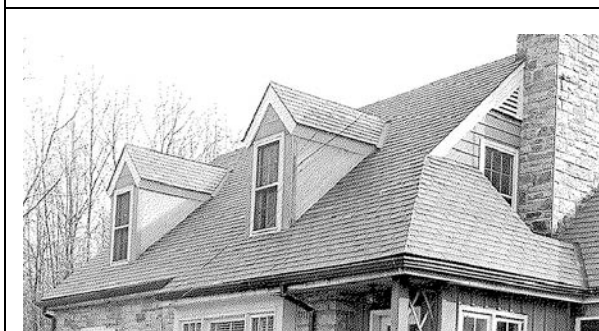
The main block gable and hipped roof was originally specified as a slate roof on the design drawings. This condition can be seen in historic photographs (fig. 133). Cedar shakes currently cover this roof (fig. 134).

*Figure 133.* As seen in this ca. 1950 photograph, the main block gable/hipped roof and the front dormer gable roofs were originally slate. Photo: CATO Bldg. 128 building file.

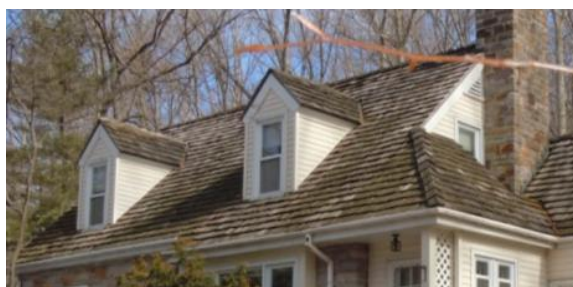
*Figure 134.* The main block gable and hipped roof and the front dormer gable roofs are now clad in cedar shakes. Photo: HPTC (02/14/12).

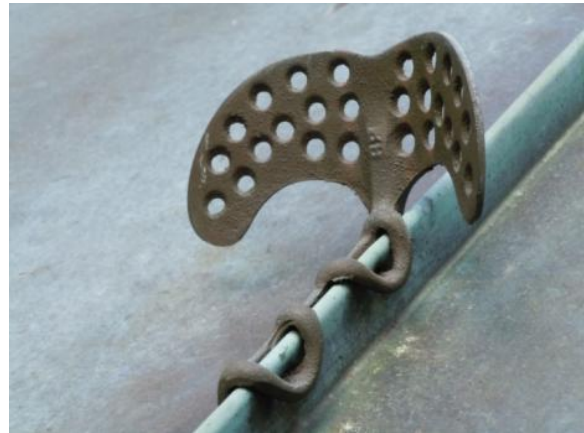
The rear dormer shed roof was originally specified as a metal roof on the design drawings. No historic photographs have been found showing this condition. The roof is currently clad in standing-seam copper (fig. 135). Metal snow guards are located at the lower end of every seam (fig. 136).

*Figure 136, right.* Metal snow guards are located at every seam on the metal roofs. Photo: HPTC (08/29/12).

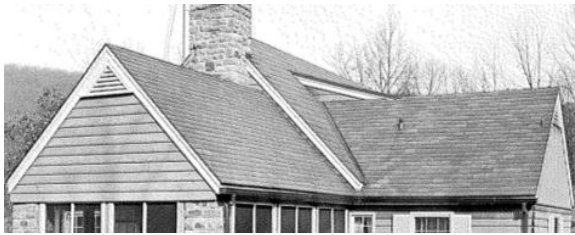
The eastern ell, sun porch, and garage gable roofs were originally specified as slate roofs on the design drawings. These conditions can be seen in historic photographs (figs. 137-138). Cedar shakes currently cover these roofs (figs. 139-140).

*Figure 137.* As seen in this ca. 1950 photograph, the eastern ell and sun porch gable roofs were originally clad in slate. Photo: CATO Bldg. 128 building file.

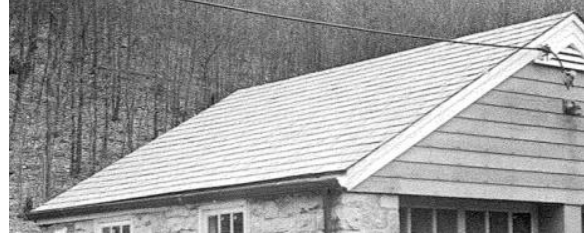
*Figure 138.* As seen in this ca. 1950 photograph, the garage gable roof was originally clad in slate. Photo: CATO Bldg. 129 building file.

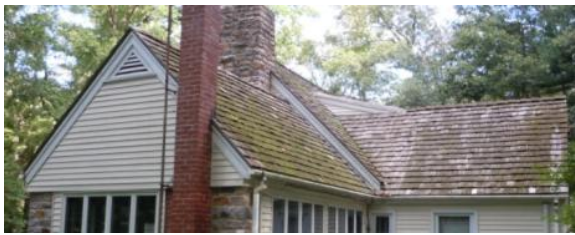
*Figure 139.* The eastern ell and sun porch gable roofs are now clad in cedar shakes. Photo: HPTC (08/29/12).

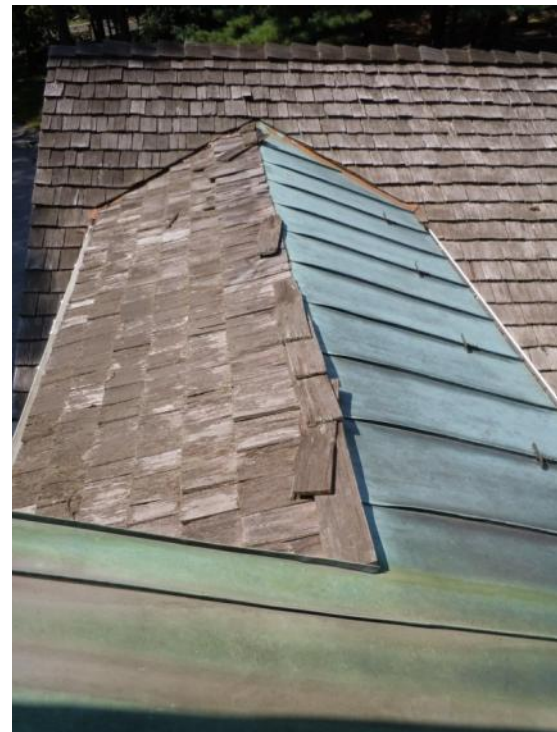
The breezeway shed and gable roof was originally specified as a slate roof on the design drawings. No historic photographs have been found showing this condition. Currently, each slope is clad in a different material (see fig. 140). The eastern slope of the gable roof and shed portions are clad in standing-seam copper; metal snow guards are located at the lower end of every other seam. The western slope of the gable roof portion is clad in cedar shakes.

*Figure 140, right.* The garage gable roof (background) is now clad in cedar shakes. The breezeway gable and shed roof is clad in cedar shakes and standing-seam copper. Photo: HPTC (07/17/12).

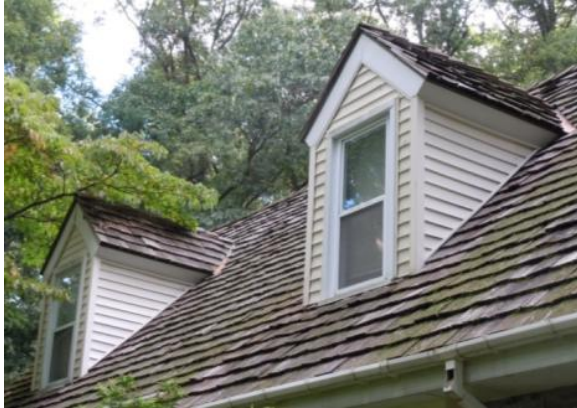
The front dormer walls are assumed to be flashed, though no flashing can be seen at these locations (fig. 141). The rear dormer walls are flashed on all sides with copper (fig. 142). The areaway on the exterior of W204 is heavily flashed with copper (fig. 143). The chimneys are flashed with copper. All roof valleys are also flashed with copper.

Figure 141. No flashing can be seen at the front dormers. Photo: HPTC (08/29/12).

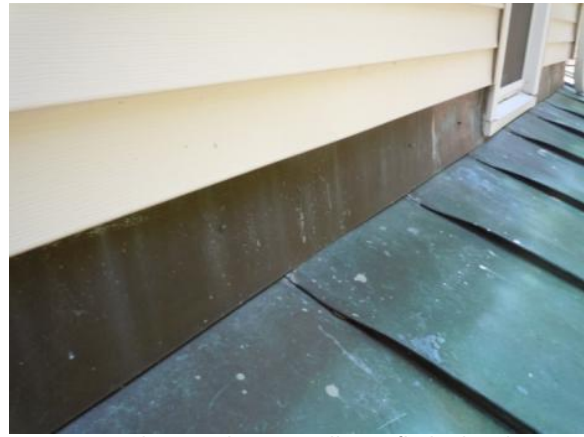
Figure 142. The rear dormer walls are flashed with copper. Photo: HPTC (07/17/12).

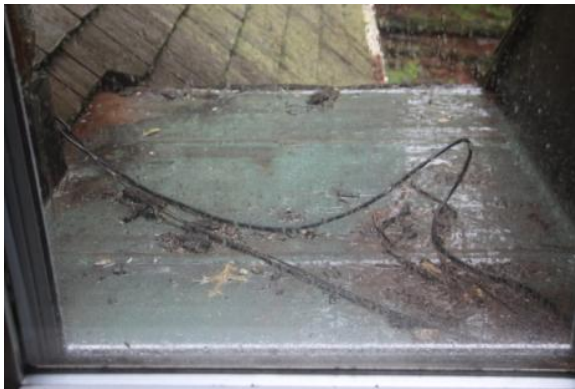
Figure 143. The areaway outside of W204 is flashed with copper. Photo: HPTC (06/12/12).

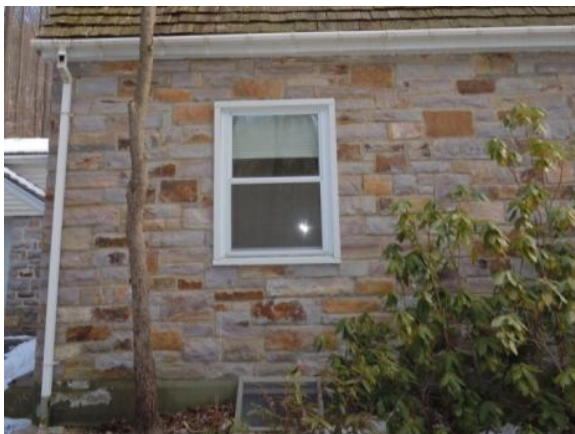
Figure 145. The vinyl drainage system on the west elevation of the main block. Photo: HPTC (04/21/12).

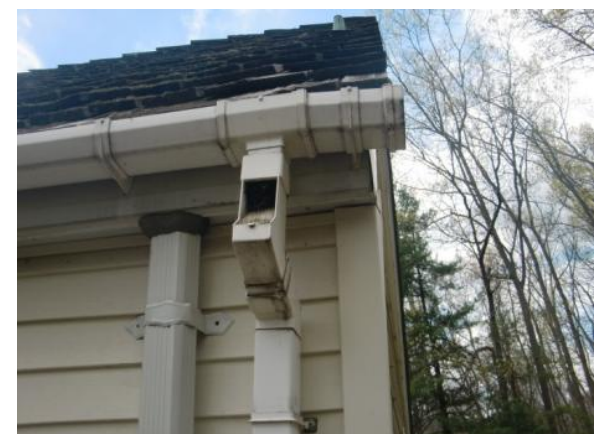
Figure 146. The vinyl drainage system on the south elevation of the eastern ell. The downspouts exhibit ice-dam prevention spouts. Photo: HPTC (04/21/12).

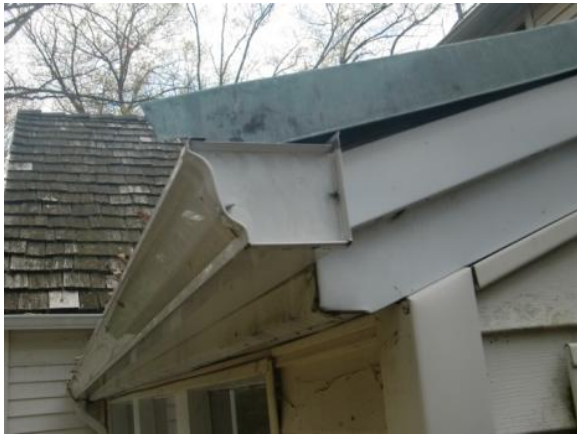
The second system utilizes aluminum K-style gutters and rectangular, corrugated downspouts. This system can be seen along the north eave of the eastern ell, the east eave of the main block rear dormer, the east eaves of the breezeway (fig. 147), and the south (eastern portion) eave of the garage (fig. 148).

*Figure 147.* The aluminum drainage system on the east elevation of the breezeway. Photo: HPTC (04/21/12).

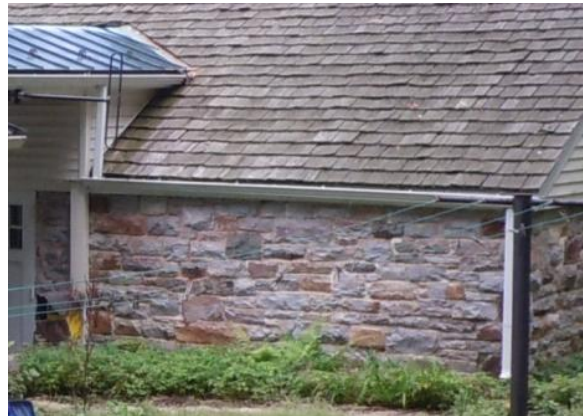
*Figure 148.* The aluminum drainage system on the south elevation (eastern portion) of the garage. Photo: HPTC (08/29/12).

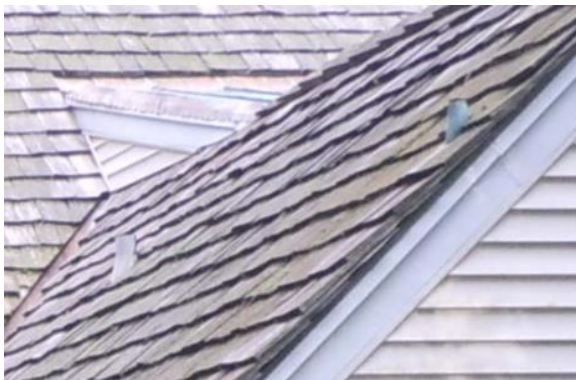
The only through-the-roof penetrations are two copper pipes located on the southern slope of the eastern ell gable roof (fig. 149). They are likely associated with the first-floor bathroom ventilation.

*Figure 149.* Two copper pipe vents penetrate the southern slope of the main block's eastern ell. Photo: HPTC (08/29/12).

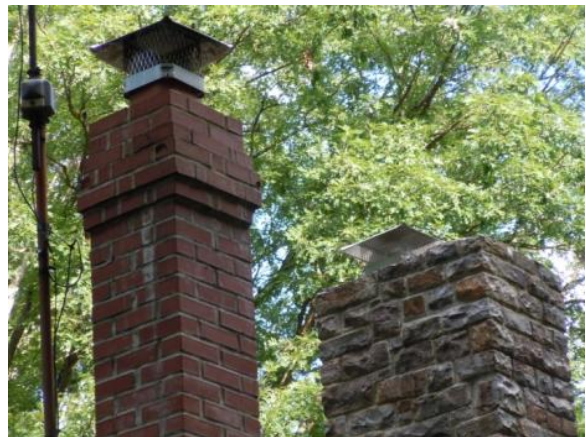
There are two chimneys located at Quarters. The main block stone chimney dates to the 1948 rebuild. Only one of the terra cotta flues has a screened metal cap (fig. 150). The sun porch brick chimney was constructed in 1992. Its single flue has a screened metal cap (see fig. 150).

*Figure 150.* The main block stone chimney is original; the sun porch brick chimney was built in 1992. Photo: HPTC (08/29/12).

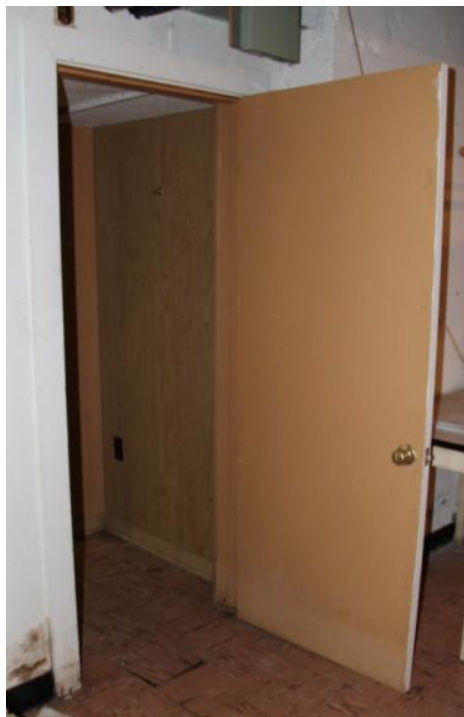
The design drawings specify the interior basement doors (D001-004) to be “batten” doors. An extant painted batten door is located at D004 (fig. 152). The other three doors have been replaced with unpainted hollow-core wood doors (fig. 153). With the enclosure of the space under the stairs, an additional door (D005) accesses this closet.

Figure 153. A replacement hollow-core basement door (D004). Photo: HPTC (07/17/12).

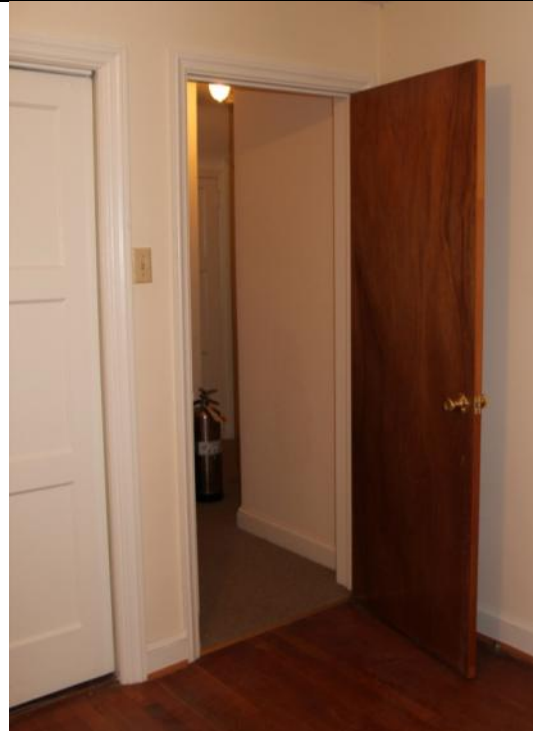
Originally, all of the first-floor interior doors were three-panel doors. Examples can be seen at D101, D108, and D110b (fig. 154). In 1995, many of these doors were removed, due to the presence of lead-based paint, and replaced with unpainted hollow-core wood doors (fig. 155); those removed included D102, D105, D107, D109, and D111.<sup>1</sup> Interior doors were originally found at openings D103, D110, and D112; however they were removed (dated unknown). D106 was originally an exterior door, but when the sun porch was enclosed became an interior door. It is painted and has 15 lites (fig. 156).

<sup>1</sup> Removal of interior doors due to the presence of lead-based paint was done as a reactionary management decision common at the time and was not based on a true understanding of the requirements of the then-recently-enacted legislation. Because of this action however, these character-defining features were irretrievably lost. See Preservation Brief #37: “Reducing Lead-Pain Hazards” for more information.

*Figure 155.* D109 is a replacement hollow-core wood door; conversely the adjacent D108 is an original sliding closet door. Photo: HPTC (06/12/12).

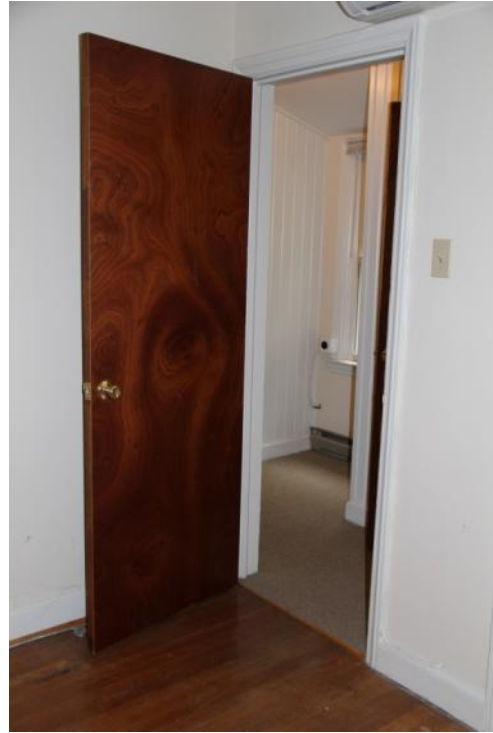
There were two types of second-floor interior doors originally: “batten” style and 3-panel. An original batten-style door can be seen at D205 (fig. 157); an original 3-panel door can be seen at D204 (fig. 158). D202, D206, and D207 were originally batten-style doors, but were replaced with unpainted hollow-core doors in 1995. D201, D103, and D209 were originally 3-panel doors, but were also replaced with unpainted hollow-core doors in 1995 (fig. 159).

Figure 159. D203 is a replacement hollow-core door on the second floor. Photo: HPTC (06/12/12).

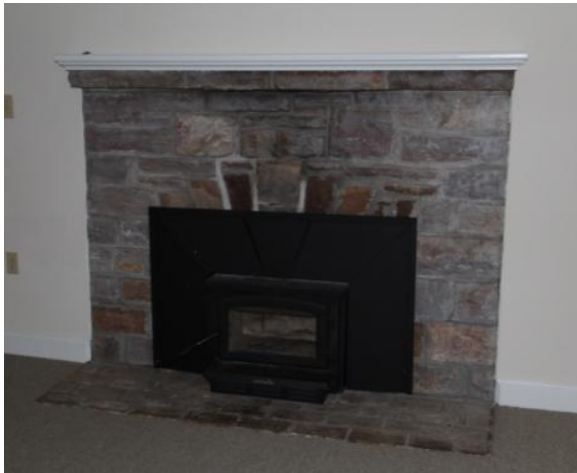
The fireplace located in Room 103 is original (fig. 166). It consists of a stone face with jack arch over the firebox opening and a brick hearth. A simple wood mantel with molding along the edge sits at the top of the stone face. A modern metal insert is located in the firebox.

*Figure 166.* The living room fireplace is original; the metal insert is modern. Photo: HPTC (06/12/12).

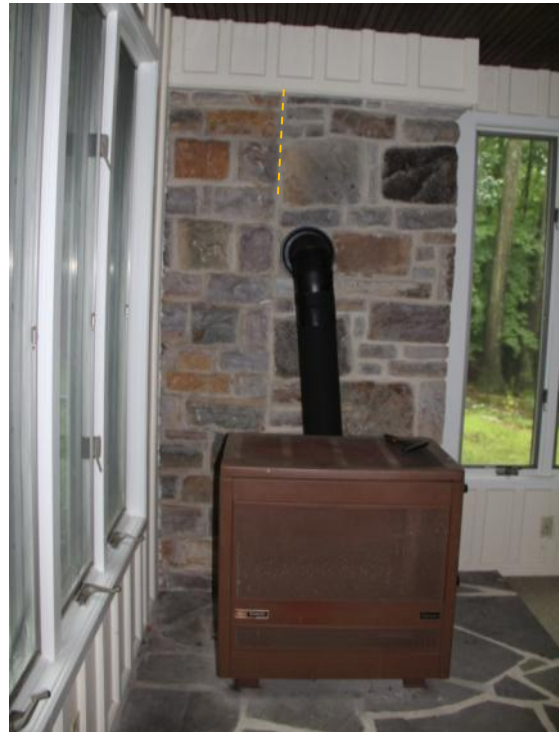
*Figure 167, right.* The fireplace on the sun porch was added in 1992. The seam between the original stone pier and modern stone chimney is obvious. Photo: HPTC (06/12/12).

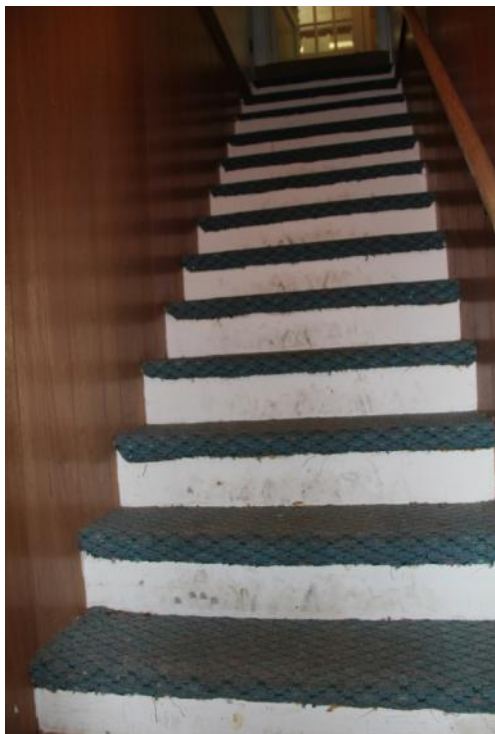
*Figure 168.* The basement stairs have painted risers, carpeted treads, and an unpainted banister. Photo: HPTC (06/20/12).

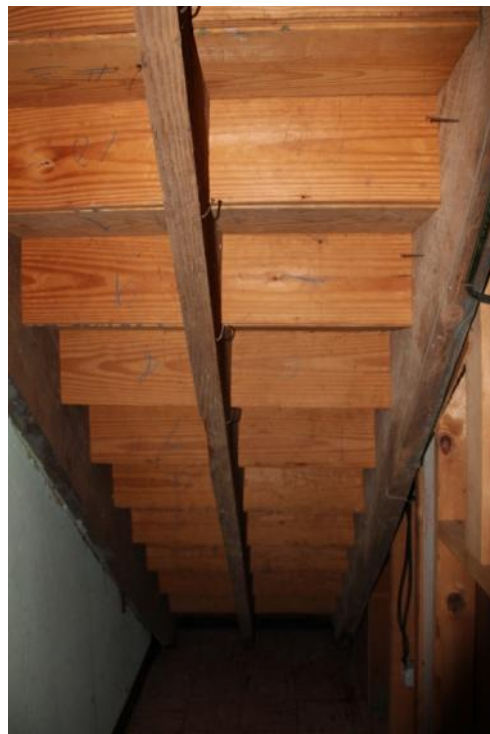
*Figure 169.* The basement stairs are composed of wood frame. Photo: HPTC (06/20/12).

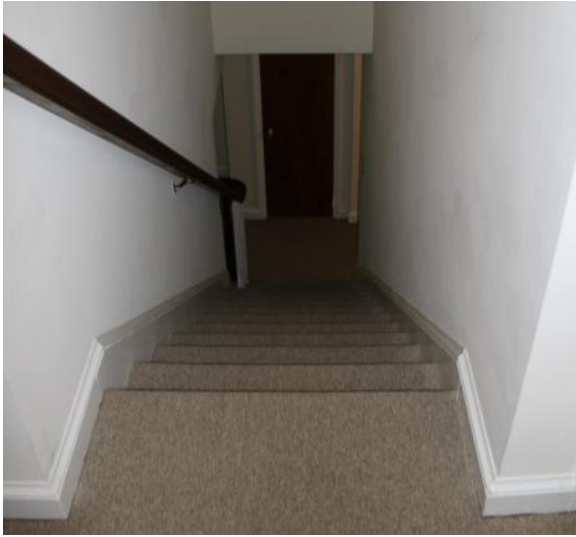
*Figure 170.* The main staircase is carpeted. Photo: HPTC (06/12/12).

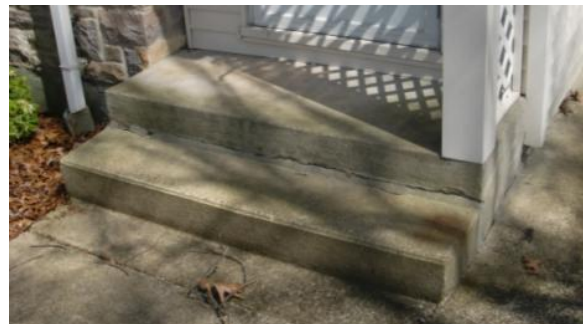
*Figure 173.* The lowest tread of the exterior stair is now level with the grade. Photo: HPTC (04/21/12).
