# Quarters 1 Superintendent's Residence, Garage, and Permanent Masonry Landscape Features Historic Structure Report

## Quarters 1

# Historic Structure Report

June 2013

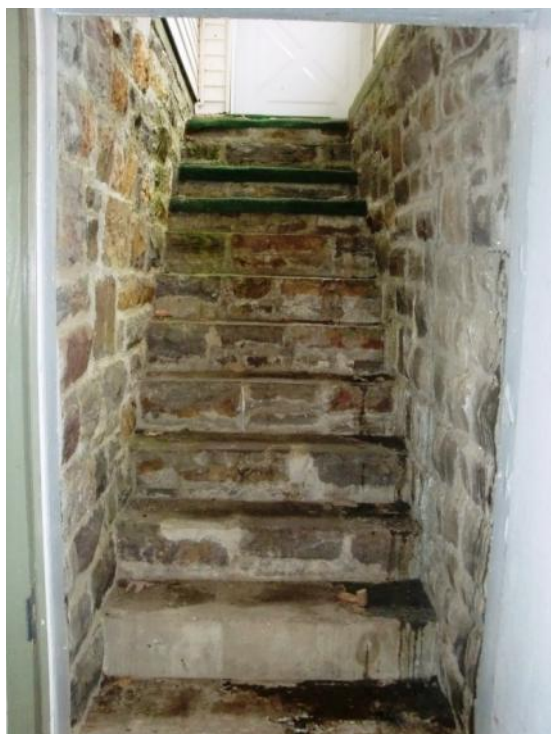
The exterior staircase between the basement and grade is composed of a straight run of twelve risers (fig. 174). The stone structure has Astroturf on the top four treads. There is no railing located at this stair.

Figure 174. The stone exterior basement staircase; the four upper treads are covered with AstroTurf. Photo: HPTC (04/21/12).

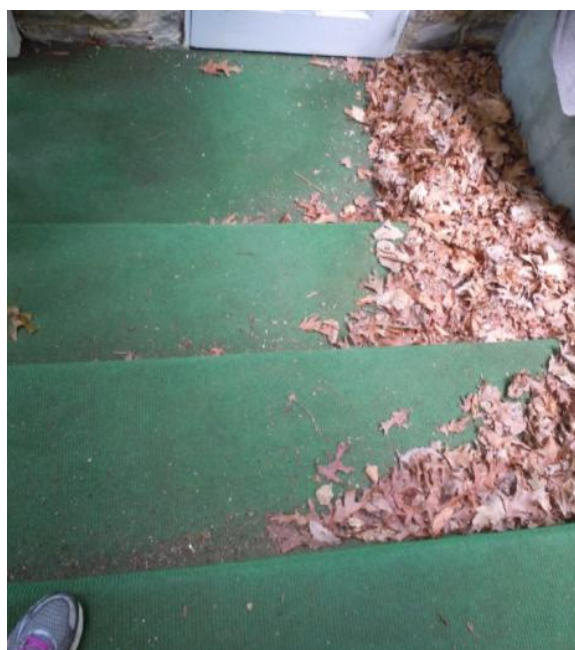
The exterior staircase located on the breezeway is composed of a straight run of three risers (fig. 175). The concrete structure is covered with Astroturf. There is no railing located at this stair.

Figure 175. The breezeway stair is composed of concrete covered with AstroTurf. Photo: HPTC (08/20/12).

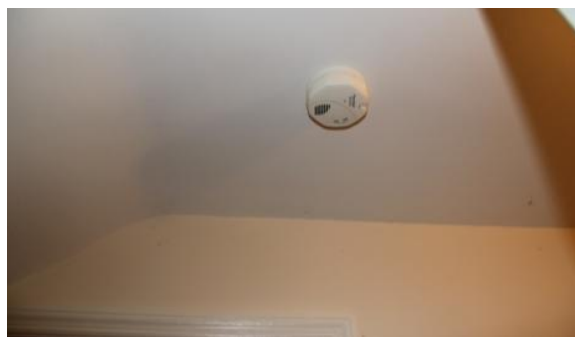
A battery-operated smoke and carbon monoxide detector is located on the ceiling of Room 110; it is inoperable (fig. 183). A battery-operated smoke detector is located on the ceiling of Room 208; it is operable, but its batteries need to be replaced (fig. 184). There are no smoke detectors in the basement or in the garage.

Figure 183. The battery-operated smoke and carbon monoxide detector in Room 110. Photo: HPTC (06/12/12).

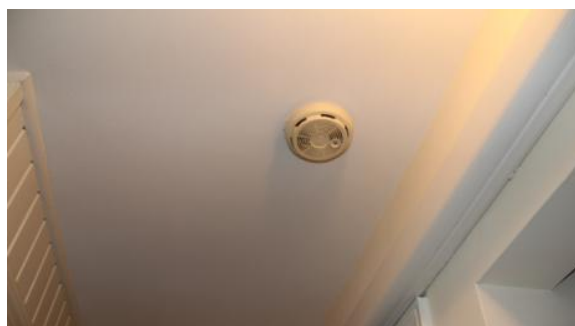
Figure 184. The battery-operated smoke detector in Room 208. Photo: HPTC (06/12/12).

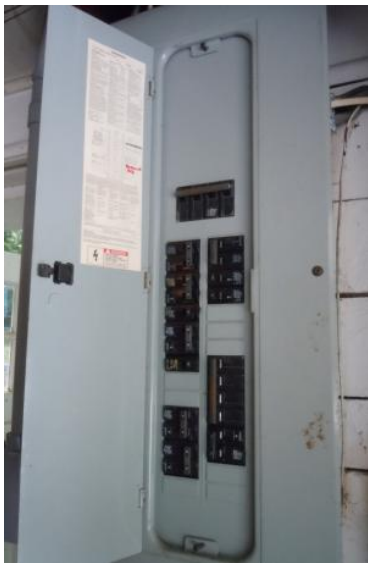
The main electrical panel for Quarters 1 is located in the garage (fig. 185); it is modern (date of installation unknown). There are two subpanels. One is located on the south wall of the kitchen (Room 112); it dates to 1948 (fig. 186). The other is located on the south wall of Room 004 (fig. 187); it is modern.

*Figure 185.* The main electrical panel is located in the garage. Photo: HPTC (07/17/12).

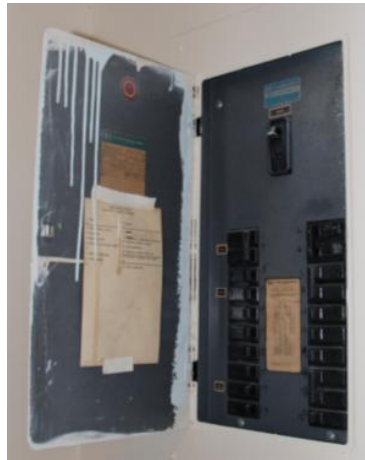
*Figure 186.* An original subpanel is located in the kitchen. Photo: HPTC (06/12/12).

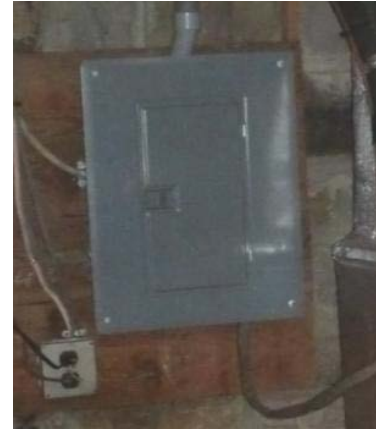
*Figure 187.* A modern subpanel is located in the basement. Photo: HPTC (03/21/12).

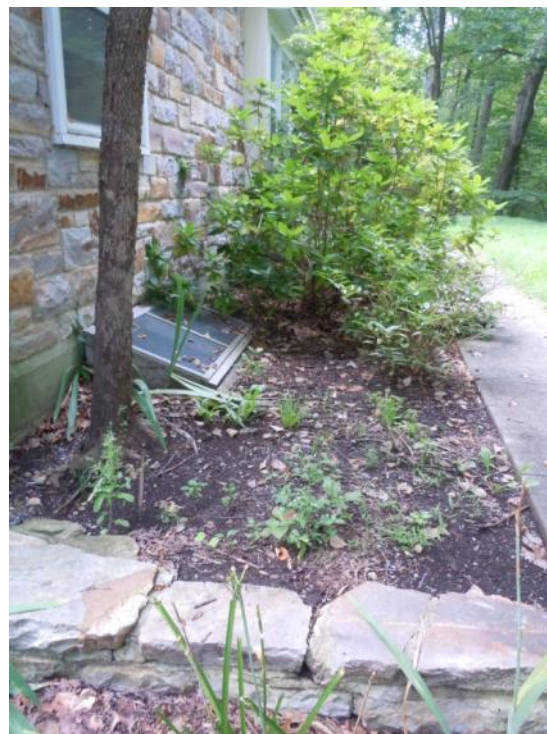
*Figure 201, right.* The front planting bed includes plantings which are very close to the foundation. Photo: HPTC (08/29/12).

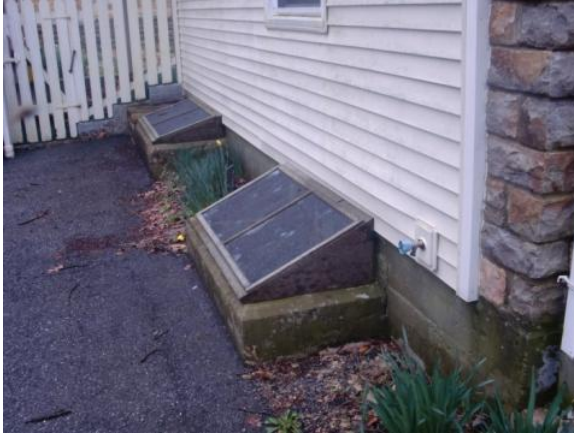
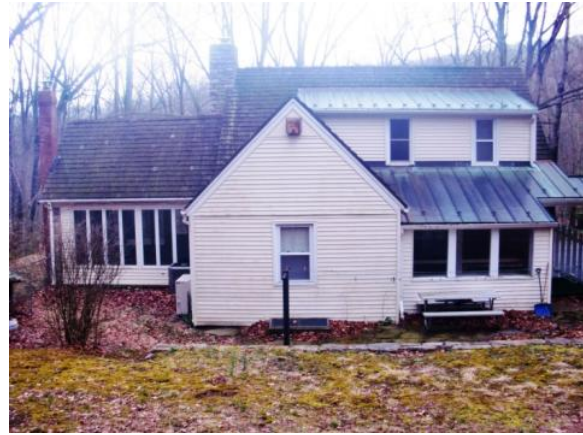
Generally, site drainage around the building is fair to poor. The house is located on a level terrace that tends to trap water from the surrounding hillside. Rainwater drains from east to west following the natural grade of the mountainside. Moisture problems in the basement indicate that the site drainage should be improved especially in the east and north sides of the buildings (figs. 204-206).

Figure 204, left, and Figure 205, right. Two areas most affected by poor site drainage are the north (left) and east (right) elevations mainly due to their orientation to the grade of the site causing the entrapment of moisture. Photos: HPTC: (03/21/12).

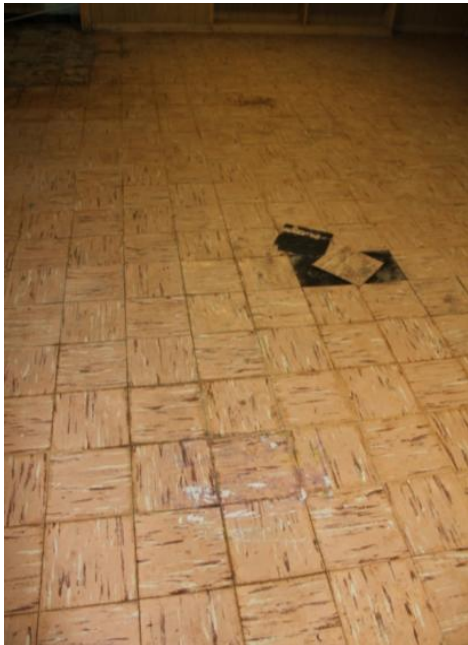
The concrete slab floor is covered with rigid asbestos-containing tile (installation date unknown; fig. 209).<sup>5</sup> Some of the tiles have been replaced through the years.

<sup>5</sup> According to the 2010 "Asbestos-Containing Materials Survey," some of the vinyl-floor tiles in the basement contains asbestos (chrysotile). The percentage of asbestos content is not known, nor is it known whether the tile is friable or non-friable. The floor tiles are not dangerous unless found to be friable. [Boggs Environmental Consultants, Inc. "Asbestos-Containing Materials Survey (US EPA AHERA Level)." *Quarters #1 (HS128), Catoctin Mountain National Park, Thurmont, Maryland 21788*. Prepared for Prizim, Inc. June 16, 2010, p. 5.]

Figure 209. The concrete floor slab is covered with rigid tile. Photo: HPTC (06/20/12).

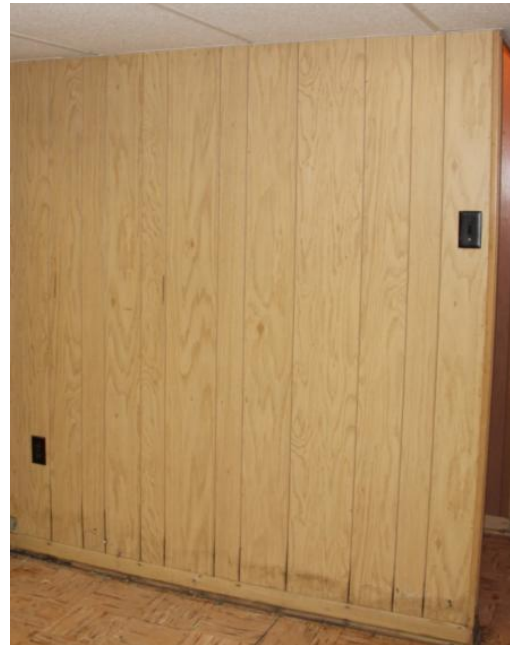
The concrete foundation walls and the interior partition frame walls are covered with faux-wood paneling which is firred out from the foundation walls with 2x4 framing (date unknown; fig. 210). The paneling has been removed in the northeast corner of the room (fig. 211); the exposed concrete is painted.

Figure 210. The walls are covered with faux-wood paneling. Photo: HPTC (06/20/12).

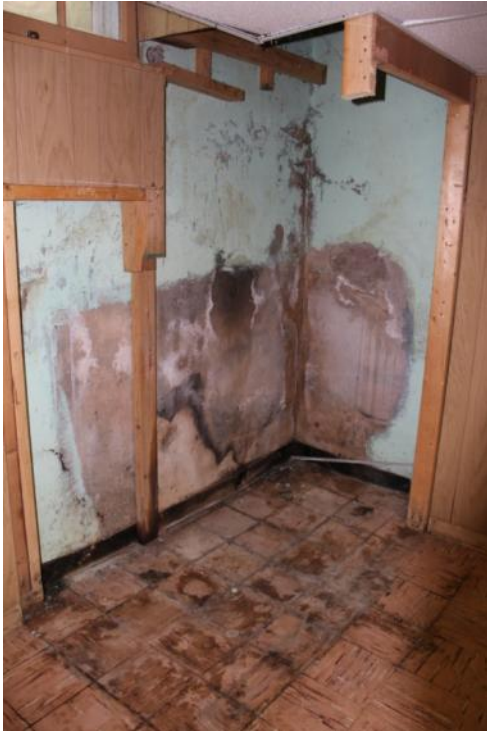
*Figure 211, left.* The exposed concrete foundation walls are painted. Note the vinyl baseboard. Photo: HPTC (06/20/12).

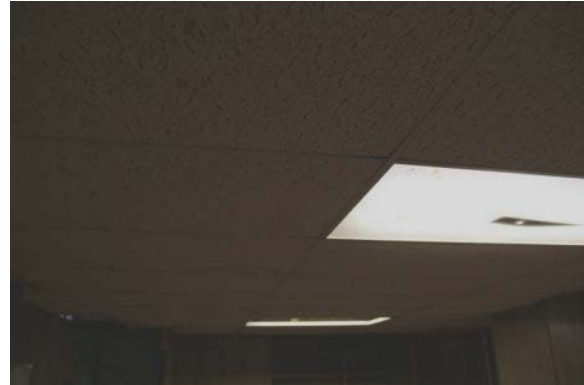
A suspended acoustical ceiling is hung from a 2x4 frame approximately 1'-2" below the joists above (fig. 212). The suspension system was added in 1991; the panels were replaced in 1997.

*Figure 212.* The ceilings are covered with a suspended acoustical tile system. Photo: HPTC (06/20/12).

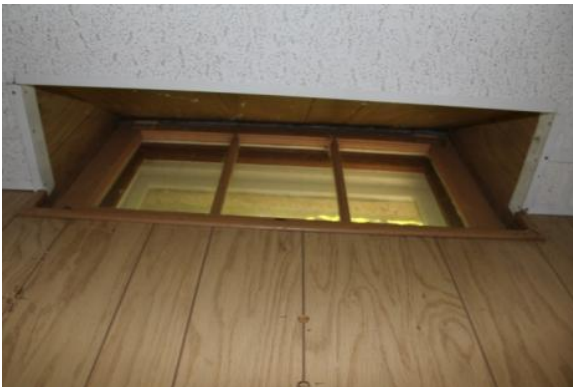
W001, W002, and W003 are identical. They are original painted wood hopper units with exterior wood storms and original metal hinges and locking hardware; W003 also includes a screen between the window and the storm (fig. 213).

*Figure 213.* W003 is located on the west wall of Room 001; it is original. Photo: HPTC (06/20/12).

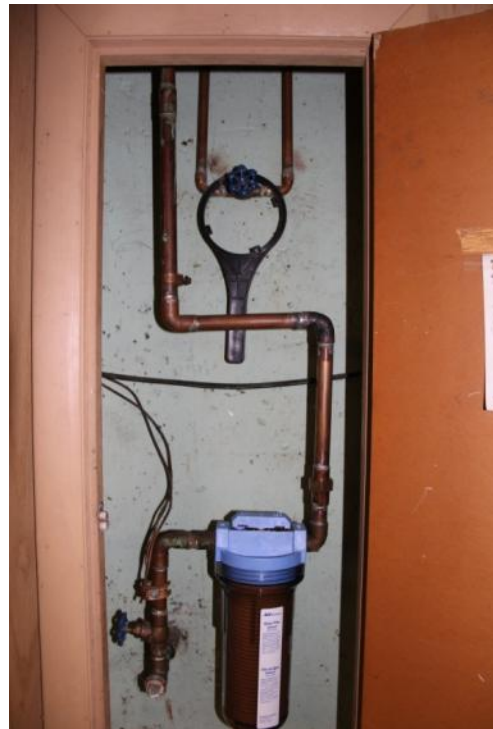
A modern water filter/softener is located on the north wall of room (installation date unknown; fig. 214).

*Figure 214.* A water filter/softener is located on the north wall of Room 001. Photo: HPTC (06/20/12).

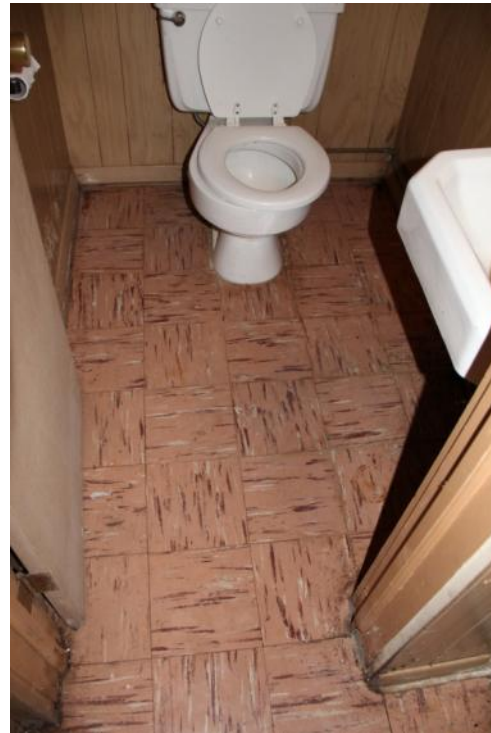
The concrete slab floor is covered with rigid asbestos-containing tile (installation date unknown; fig. 216).<sup>6</sup>

<sup>6</sup> According to the 2010 "Asbestos-Containing Materials Survey," some of the vinyl-floor tiles in the basement contains asbestos (chrysotile). The percentage of asbestos content is not known, nor is it known whether the tile is friable or non-friable. The floor tiles are not dangerous unless found to be friable. [Boggs Environmental Consultants, Inc. "Asbestos-Containing Materials Survey (US EPA AHERA Level)." *Quarters #1 (HS128), Catoctin Mountain National Park, Thurmont, Maryland 21788*. Prepared for Prizim, Inc. June 16, 2010, p. 5.]

*Figure 216.* The concrete floor slab is covered with rigid tiles. Photo: HPTC (06/20/12).

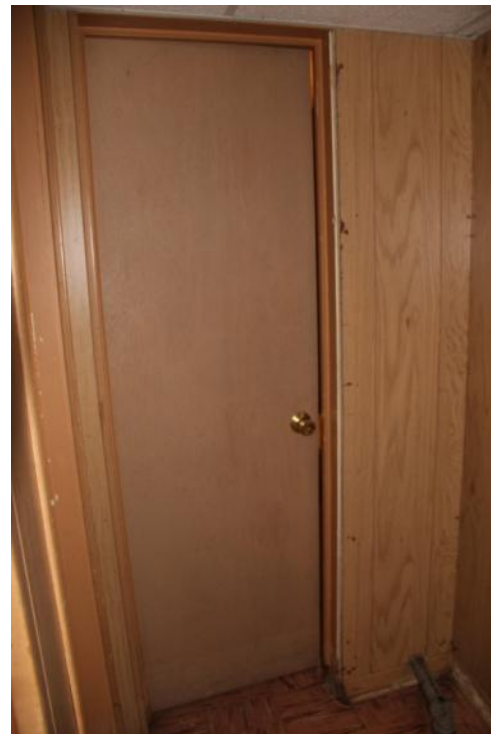
D001 is modern hollow-core wood door installed in 1995 (fig. 218). It has modern metal hinges and knob.

*Figure 218, right.* D002 was replaced with a hollow-core wood door. Photo: HPTC (06/20/12).

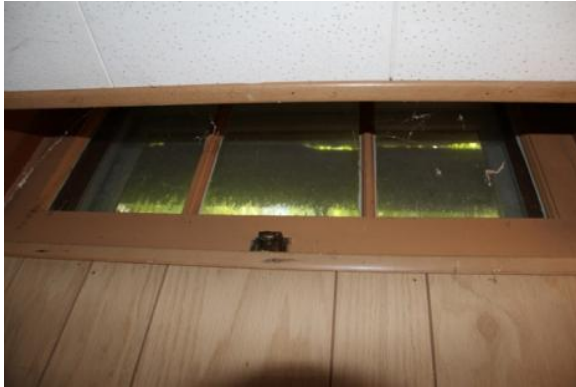
W004 is an original painted wood hopper unit with exterior wood storm and original metal hinges and locking hardware (fig. 219).

Figure 219. W004 is an original wood hopper window. Note the original locking hardware on the bottom rail. Photo: HPTC (06/20/12).

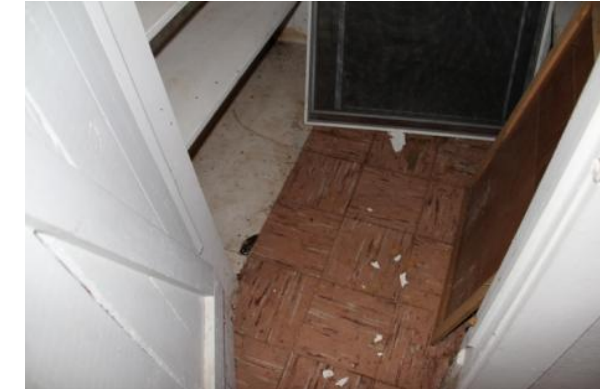
The concrete slab floor is covered with rigid asbestos-containing tile (installation date is unknown (fig. 222)).<sup>7</sup>

<sup>7</sup> According to the 2010 "Asbestos-Containing Materials Survey," some of the vinyl-floor tiles in the basement contains asbestos (chrysotile). The percentage of asbestos content is not known, nor is it known whether the tile is friable or non-friable. The floor tiles are not dangerous unless found to be friable. [Boggs Environmental Consultants, Inc. "Asbestos-Containing Materials Survey (US EPA AHERA Level)." *Quarters #1 (HS128), Catoctin Mountain National Park, Thurmont, Maryland 21788*. Prepared for Prizim, Inc. June 16, 2010, p. 5.]

*Figure 222.* The concrete floor slab is covered with rigid tile. Photo: HPTC (06/20/12).

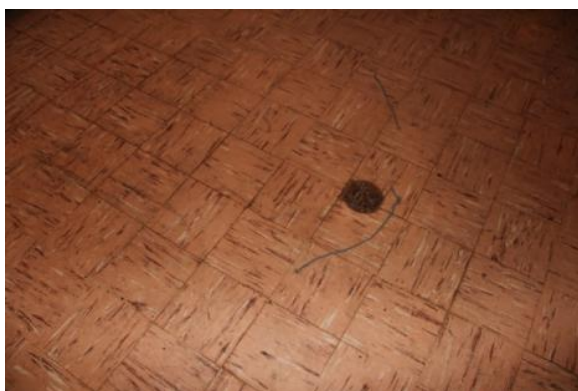
The concrete slab floor is covered with rigid asbestos-containing tile (installation date unknown).<sup>8</sup> Some of the tiles have been replaced through the years. Two floor drains can be seen at the third points of the room (fig. 227).

<sup>8</sup> According to the 2010 "Asbestos-Containing Materials Survey," some of the vinyl-floor tiles in the basement contains asbestos (chrysotile). The percentage of asbestos content is not known, nor is it known whether the tile is friable or non-friable. The floor tiles are not dangerous unless found to be friable. [Boggs Environmental Consultants, Inc. "Asbestos-Containing Materials Survey (US EPA AHERA Level)." *Quarters #1 (HS128), Catoctin Mountain National Park, Thurmont, Maryland 21788*. Prepared for Prizim, Inc. June 16, 2010, p. 5.]

Figure 227. The concrete floor slab is covered with rigid tiles. Photo: HPTC (06/20/12).

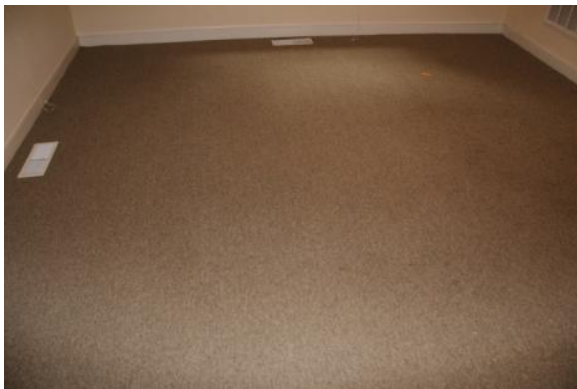
The floor of Room 101 is covered with modern carpet (installation date unknown; fig. 236). The carpet is assumed to cover the original oak strip flooring.

*Figure 236.* Carpet covers the floor of Room 101. Photo: HPTC (06/12/12).

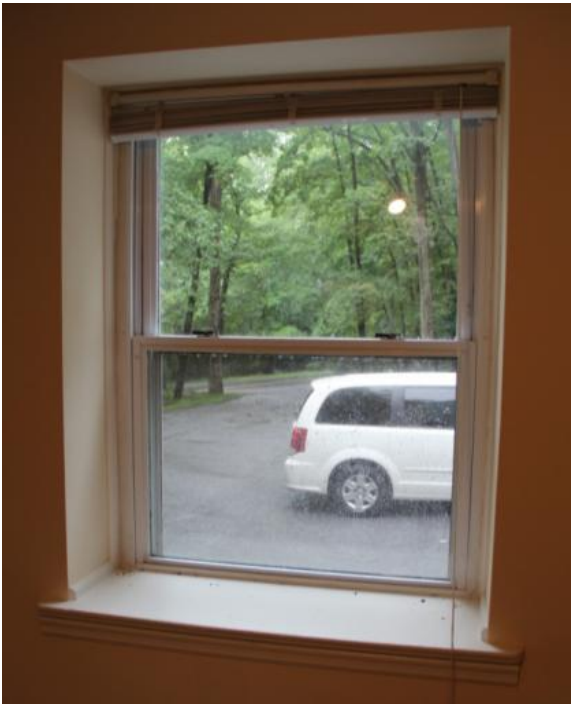
W101 and W102 have been replaced with modern 1/1 vinyl double-hung units (installation date unknown; figs. 238-239).

Figure 238. W101 is a vinyl replacement window. Photo: HPTC (06/12/12).

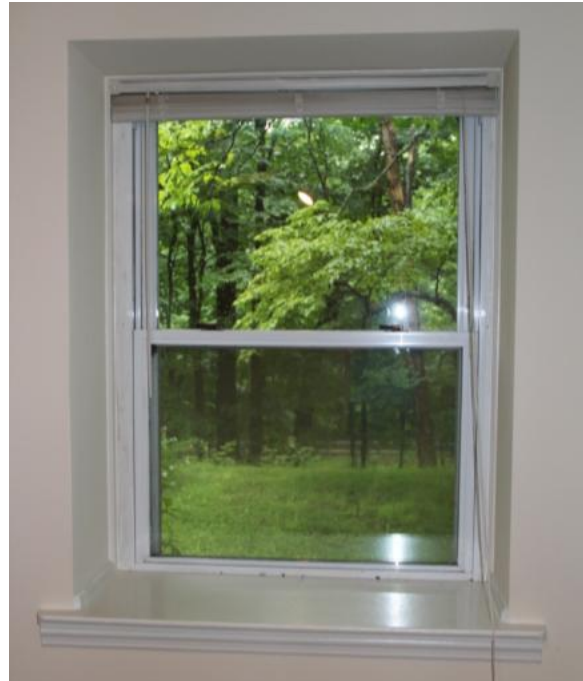
Figure 239. W102 is a vinyl replacement window. Photo; HPTC (06/12/12).

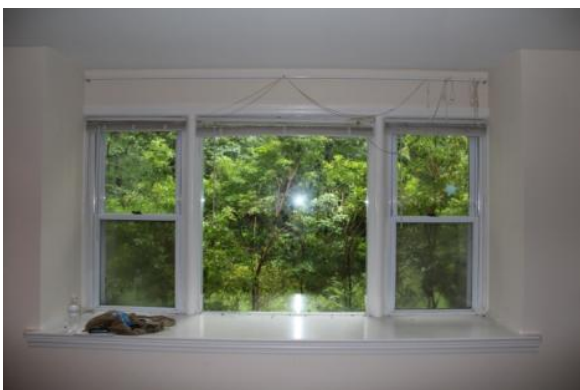
W103, W104, and W105 encompass the front bay windows. All three are vinyl replacement units (installation date unknown). W103 and W106, double-hung units, flank the central fixed-glass W104 (fig. 226).

*Figure 244.* W103-W105 are located in the front elevation bay window. Photo: HPTC (06/12/12).

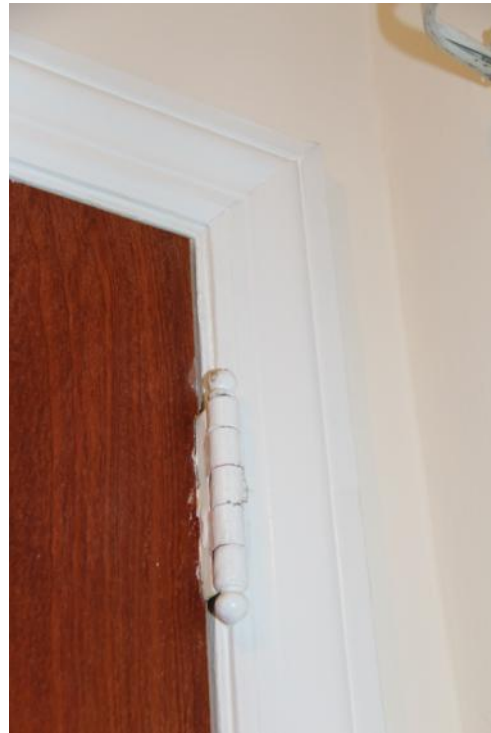
*Figure 247, right.* The door casing of D105 is original; the hinges for the door are also original. The door is a modern replacement. Photo: HPTC (06/12/12).

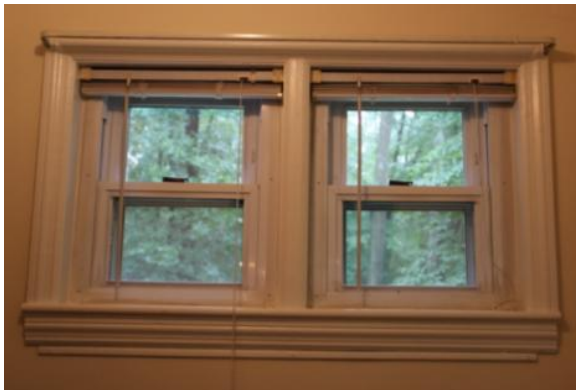
W106 and W107 are located side-by-side in the south wall. They have been replaced with modern 1/1 vinyl double-hung units (installation date unknown; fig. 248).

*Figure 248.* W106 and W107 are vinyl replacement units. Photo: HPTC (06/12/12).

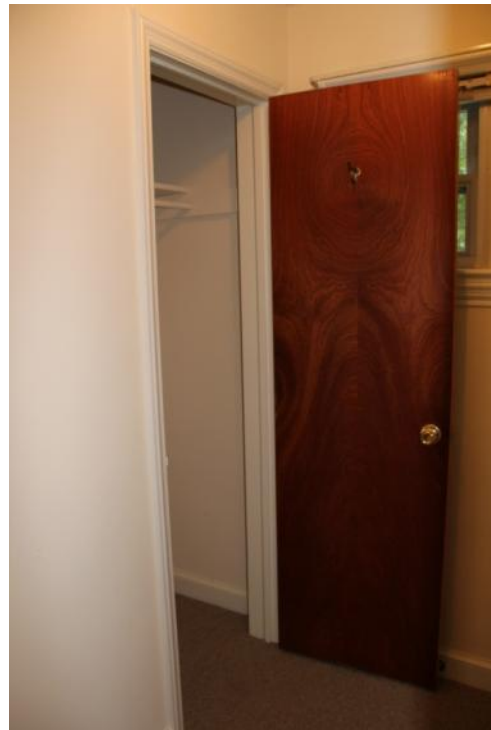
A closet, or Room 105, occupies the southeast corner of the vestibule. The floor is covered with carpet and the walls and ceiling are painted plaster. D105 is a modern hollow-core wood door with historic hinges and modern knobs (see fig. 247). A simple shelf and clothes rod occupy the interior (fig. 249).

*Figure 249, right.* Closet Room 105 opens into Room 104. Photo: HPTC (06/12/12).

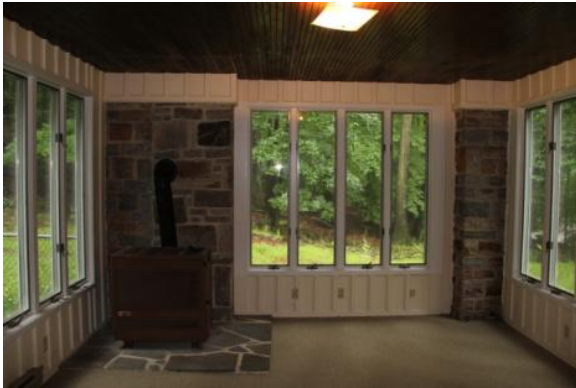
The sun porch is located at the south end of the main block. Rectangular in plan, the room measures 17'-1" x 13'-10" with an 8'-5" ceiling height (fig. 250).

A woodstove, which exhausts through the modern flue, sits on the hearth in the southeast corner of the room (see fig. 250). A mini-split unit is located on the north wall of the room (see fig. 179).

Figure 250. Room 106 looking south. Photo: HPTC (06/12/12).

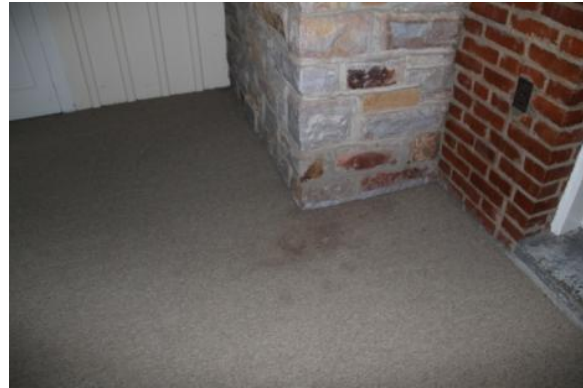
The north wall is composed of exposed stone (living room chimney) and brick (exterior walls). Stone piers anchor the southwest and southeast corners of the room. The infill walls are composed of wood framing and clad with painted board and batten on the interior (fig. 251).

Figure 251. The floor in Room 106 is covered with carpet. Note the brick, stone, and wood board and batten walls. Photo: HPTC (06/12/12).

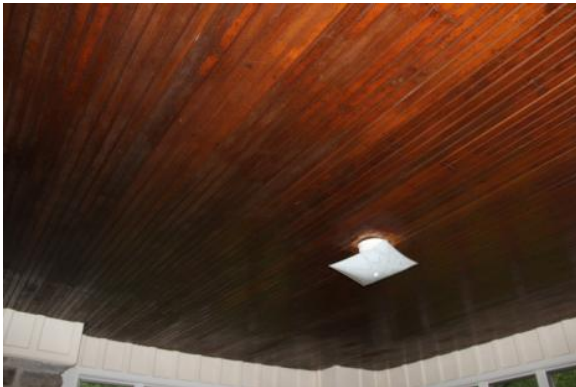
The ceiling is composed of stained wood beadboard (fig. 252).

Figure 252. The stained wood beadboard ceiling in Room 106. Photo: HPTC (06/12/12).

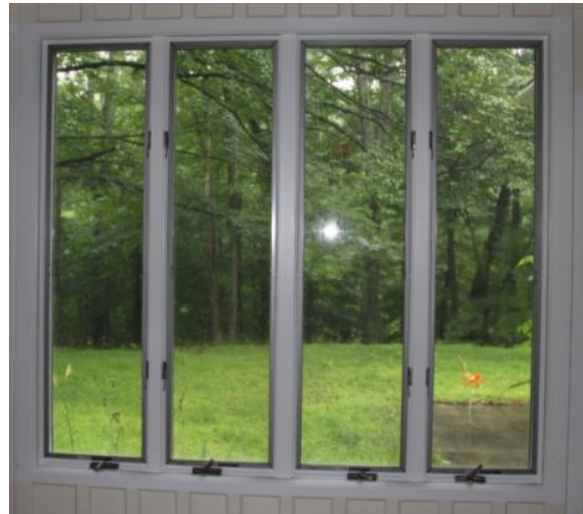
W108-123 are divided into four sections of four windows each. W108-111 are located in the west wall (fig. 253), W112-115 are located in the south wall (fig. 254), and W116-119 and W120-123 are located in the east wall (fig. 255). All of the windows are modern vinyl replacement casement units.

Figure 253, right. W108-W111 on the west wall. Photo: HPTC (06/12/12).

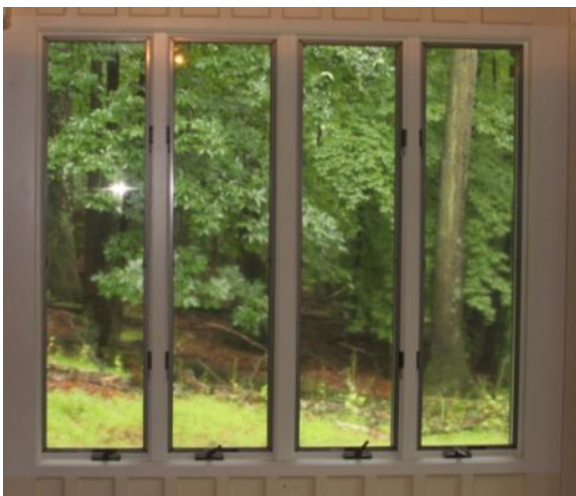
Figure 254, left. W112-W115 on the south wall. Photo: HPTC (06/12/12).

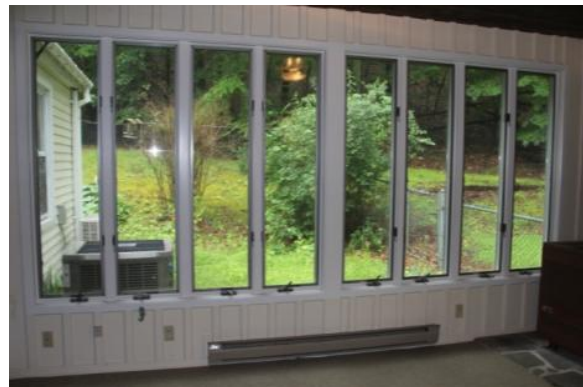
All of the electrical components are modern with flush-mounted switches, outlets, and light fixtures. An electric baseboard heater is located on the east wall (see fig. 255).

Figure 255. W116-W123 on the north wall. Note the electric baseboard heater. Photo: HPTC (06/12/12).

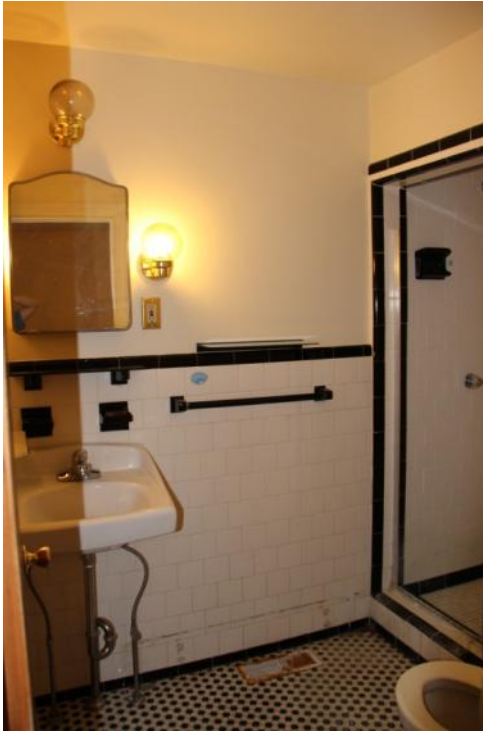
The southwest corner room of the eastern ell of the first floor is a bathroom. Fairly square in plan, the room measures 5'-9" x 5'-1" with a ceiling height of 7'-11" (fig. 256).

A floor forced-air supply vent is located in the floor at the west wall (see fig. 256).

*Figure 256.* Room 107 looking northwest. Photo: HPTC (06/12/12).

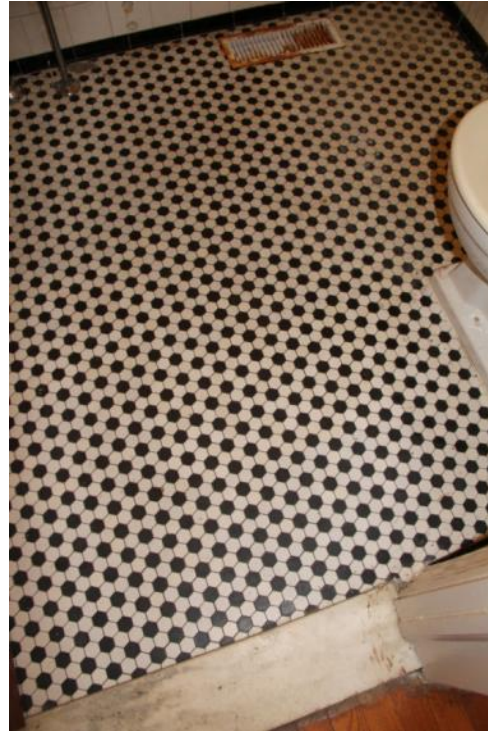
The floor of Room 101 is covered with ceramic black-and-white hex-tile; it may be original (fig. 257).

*Figure 257.* The floor of Room 107 includes historic ceramic hex-tile. Note the original marble door threshold. Photo: HPTC (06/12/12).

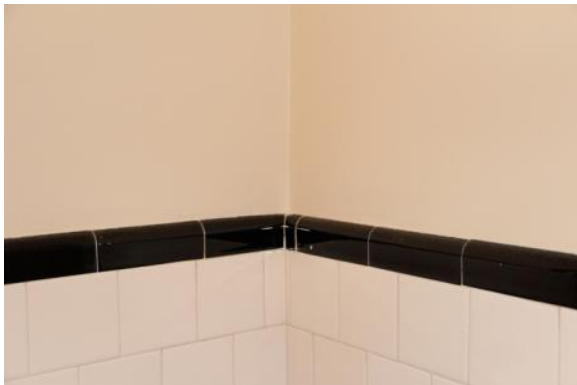
The lower half of the walls are covered with ceramic tile (date unknown). The upper half of the walls are composed of painted plaster (fig. 258).

*Figure 258.* The upper half of the walls in Room 107 are painted plaster; the lower half of the walls are covered with ceramic tile. Photo: HPTC (06/12/12).

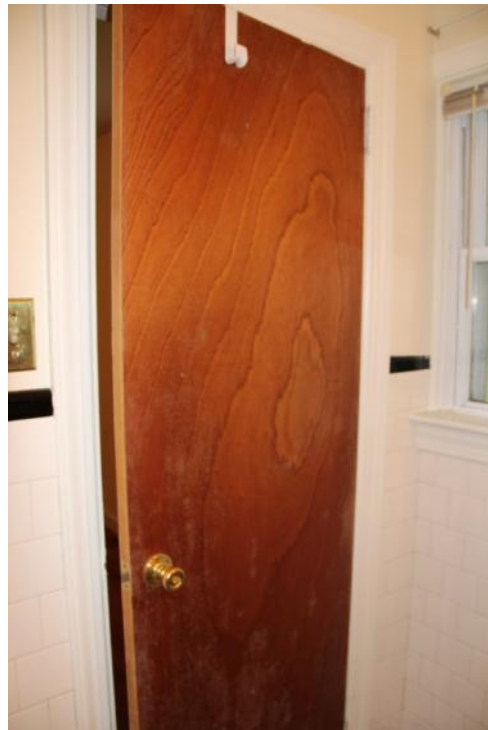
D107 is a replacement hollow-core wood door with modern knobs and historic hinges (fig. 259). The original marble threshold is extant (see fig. 257).

*Figure 259.* D107 is a replacement hollow-core wood door. Note the modern doorknob and historic hinges. Photo: HPTC (06/12/12).

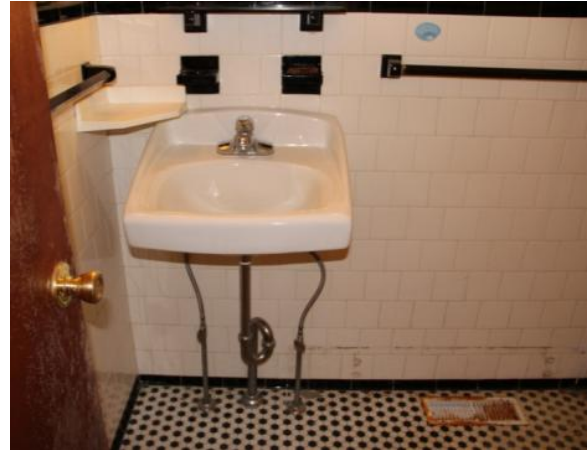
*Figure 261.* The modern sink in Room 107. Photo: HPTC (06/12/12).

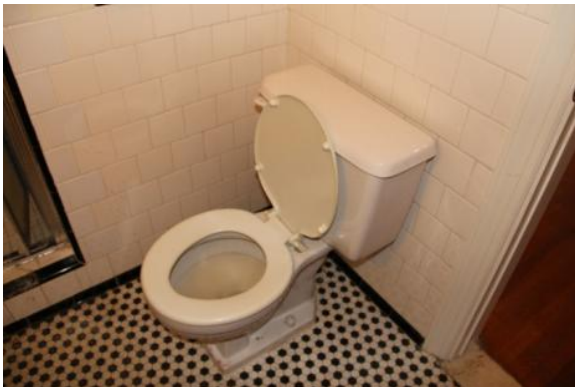
*Figure 262.* The modern toilet in Room 107. Photo: HPTC (06/12/12).

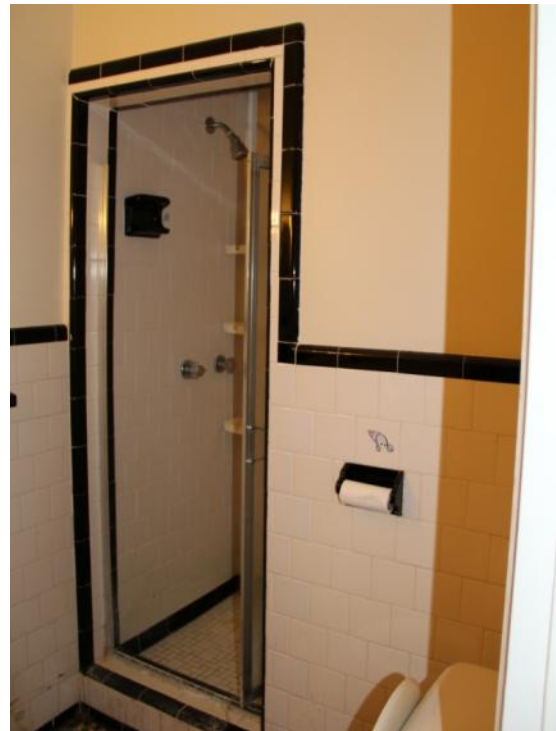
*Figure 263, right.* The original shower stall in Room 107. Photo: HPTC (06/12/12).

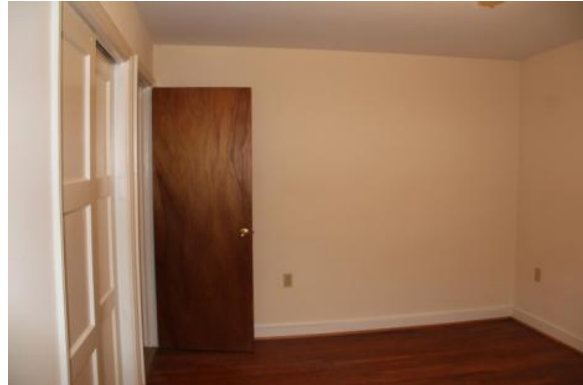
D109 is a replacement hollow-core wood door with a modern knob and historic hinges (see fig. 265).

*Figure 265.* Room 109 looking north. Photo: HPTC (06/12/12).

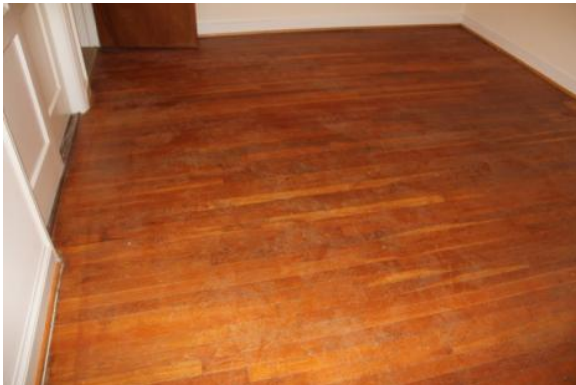
The floor of Room 101 is consists of the original oak strip flooring (fig. 266).

*Figure 266.* The original oak-strip flooring is exposed in Room 109. Photo: HPTC (06/12/12).

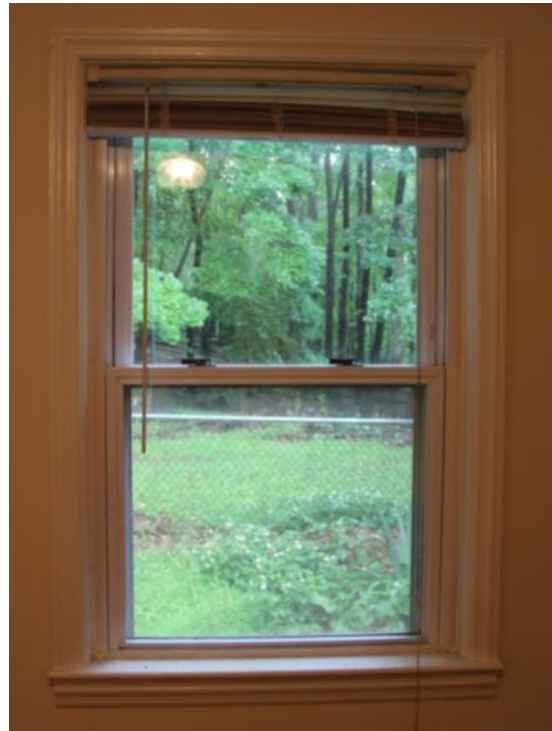
W125 and W126 have been replaced with modern 1/1 vinyl double-hung units (installation date unknown; figs. 267-268).

*Figure 267, right.* W125 is a vinyl replacement window. Photo: HPTC (06/12/12).

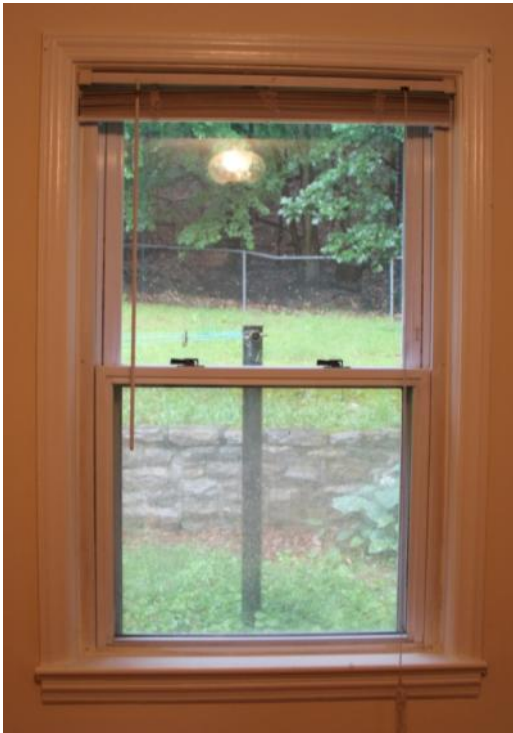
*Figure 268.* W126 is a vinyl replacement window. Photo: HPTC (06/12/12).

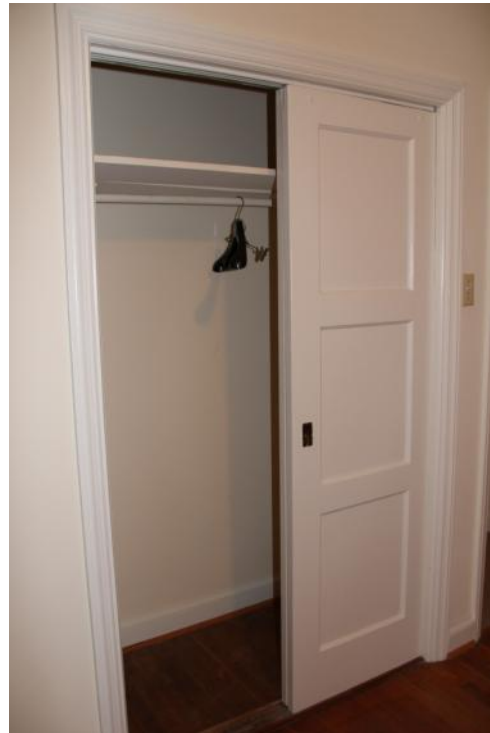
A closet, or Room 108, is located on the west wall of Room 109 (fig. 269). The floor consists of original oak strip flooring and the walls and ceiling are painted plaster. D108 is a pair of original three-panel painted sliding wood doors. The doors run in their original floor and casing tracks and have historic recessed door pulls. A simple shelf and clothes rod occupy the interior.

*Figure 269.* The interior of the closet (Room 108). The two original closet doors each have three panels with original recessed door pulls. Photo: HPTC (06/12/12).

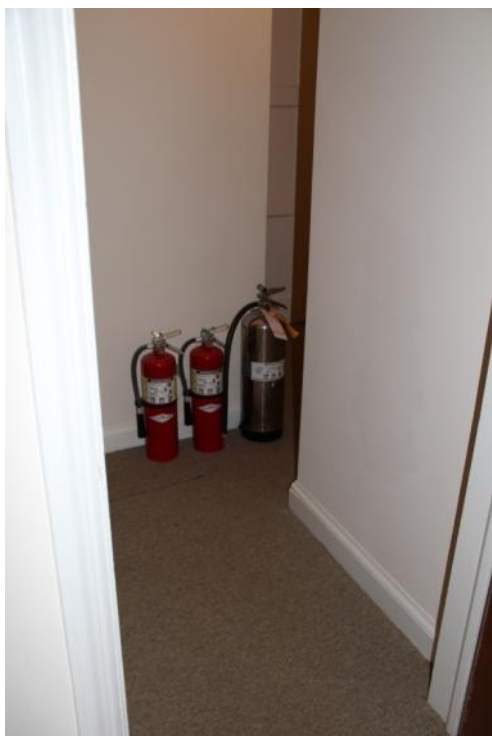
The floor of Room 110 is covered with modern carpet (installation date is unknown). The carpet is assumed to cover the original oak strip flooring (fig. 270).

Three recently-serviced fire extinguishers are located on the floor of this room (see fig. 270).

*Figure 270, left.* Room 110 has carpeted floors and painted plaster walls. The fire extinguishers on the floor belong distributed throughout Quarters 1. Photo: HPTC (06/12/12).

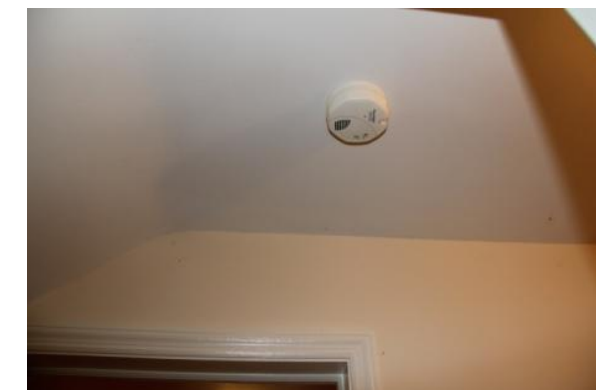
An inoperable battery-operated smoke and carbon monoxide detector is located at the ceiling in this room (see fig. 271).

*Figure 271.* The ceiling is painted plaster. The battery-operated smoke and carbon monoxide detector is inoperable. Photo: HPTC (06/12/12).

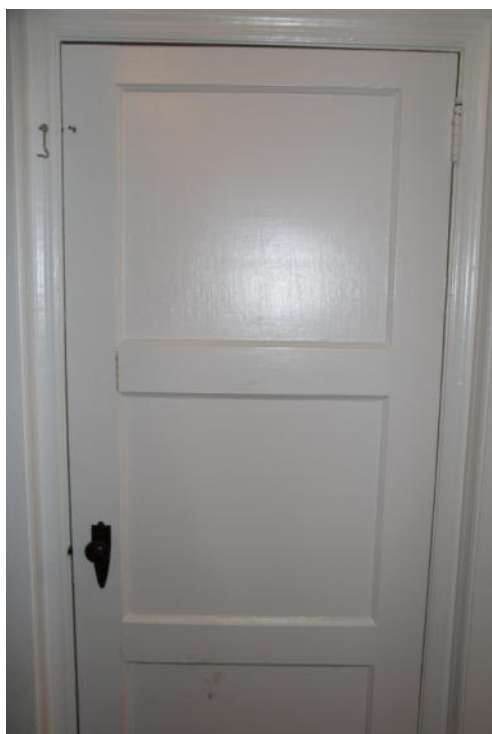
D110 is no longer extant. It is assumed that originally a painted wood three-panel door occupied this opening. Only the keeper is retained in the casing. D110B is an original 3-panel painted wood swinging door with original mortise knob set and hinges (fig. 272).

*Figure 272.* D110B is an original wood door which leads to the basement stair. Note the original mortise knob set and the original hinges. Photo: HPTC (06/12/12).

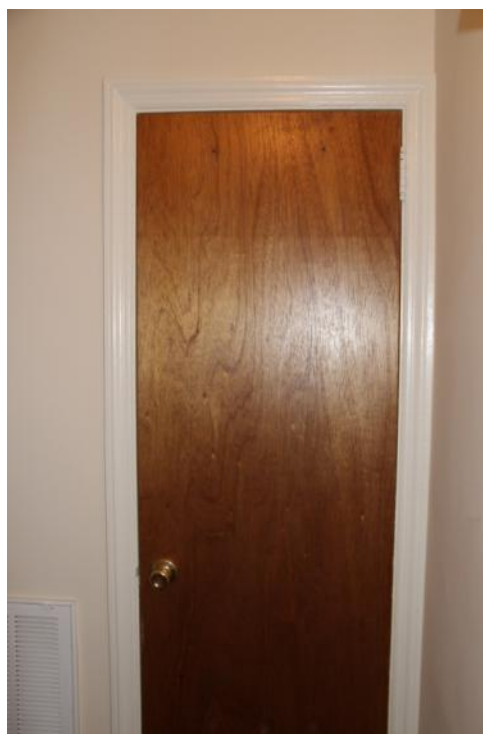
A closet, or Room 111, is located on the south wall of Room 110. The floor consists of carpet over the original oak-strip floor; the walls and ceiling are painted plaster. D111 is a modern hollow-core wood door with a modern knob and historic hinges (fig. 273). Simple shelves occupy the interior.

*Figure 273.* D111 is a replacement hollow-core closet door. It has a modern knob set and historic hinges. Photo: HPTC (06/12/12).

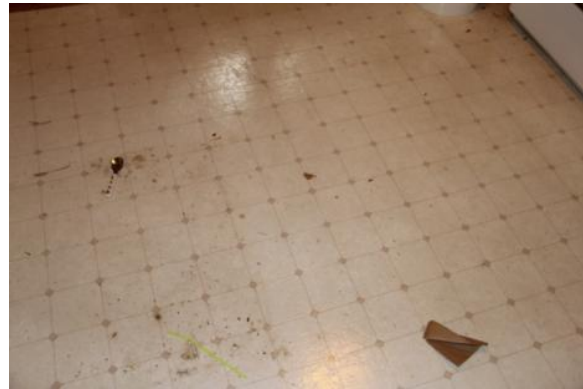
The floor of Room 101 is covered with modern sheet linoleum (installation date unknown; fig. 275).

Figure 275. The modern vinyl floor covering in Room 112. Photo: HPTC (06/12/12).

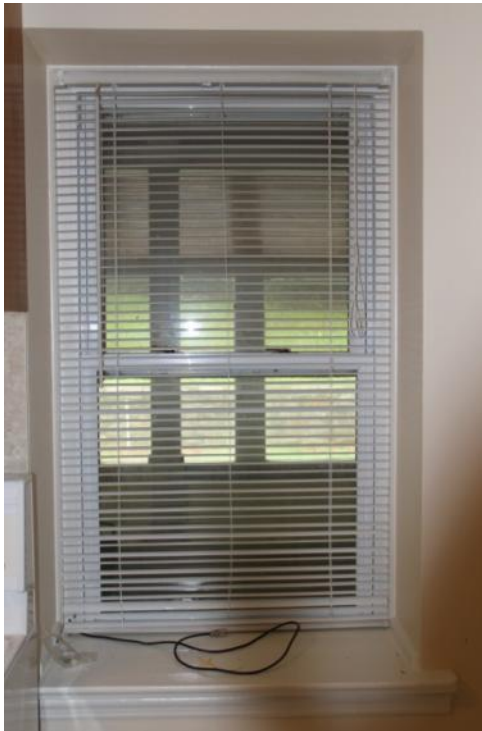
W127 and W128-W130 have been replaced with modern 1/1 vinyl double-hung units (installation date unknown; figs. 276-277).

Figure 276, left. W127 is a modern vinyl replacement unit. Photo: HPTC (06/12/12).

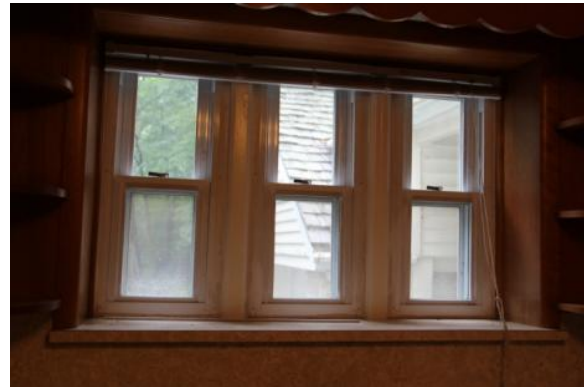
Figure 277. W128-W130 are modern vinyl replacement units. Photo: HPTC (06/12/12).

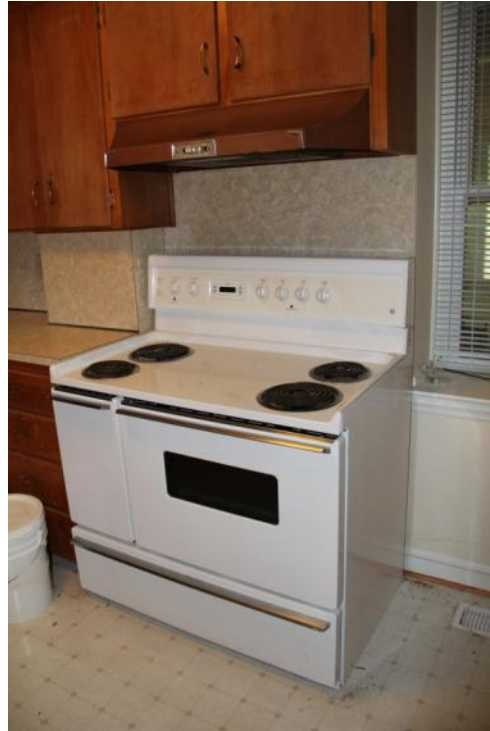
All of the electrical components are modern with flush-mounted switches, outlets, and light fixtures. A contemporary, but dated electric range and exhaust fan is located on the east wall (fig. 279). A sub-panel is located on the south wall.

*Figure 279, right.* The contemporary electric range and exhaust fan hood in Room 112.

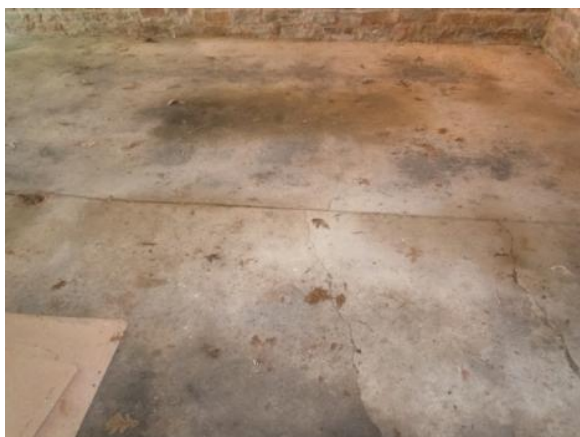
The floor of the garage is the unpainted floor slab (fig. 282).

Figure 282. The exposed concrete slab floor of Room G101. Photo: HPTC (07/17/12).

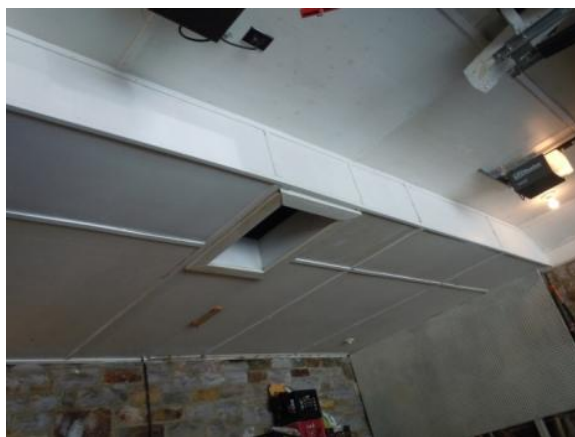
The ceiling is composed of painted wood board and batten (fig. 283).

Figure 283. The painted board and batten wood ceiling of Room G101. Photo: HPTC (07/17/12).

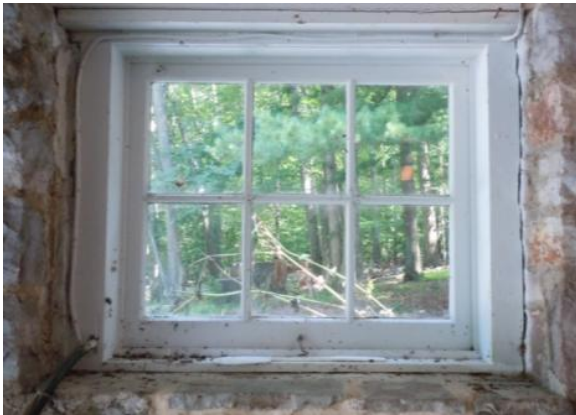
Figure 284. WG101 is an original wood hopper window. Photo: HPTC (07/17/12).

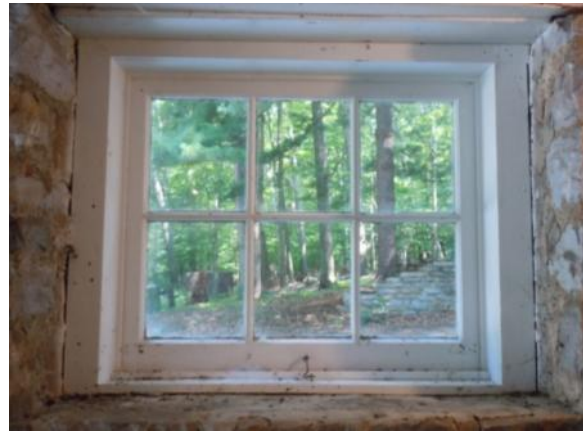
Figure 285. WG102 is an original wood hopper window. Photo: HPTC (07/17/12).

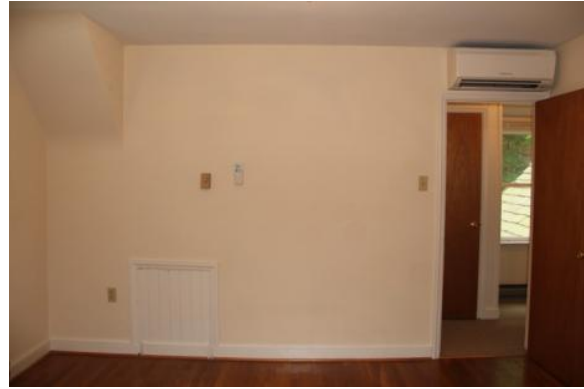
A modern mini-split unit is located above D201 (see fig. 288). Electric baseboard radiators are located on the north and west walls.

Figure 288. Room 201 looking east. Photo: HPTC (06/12/12).

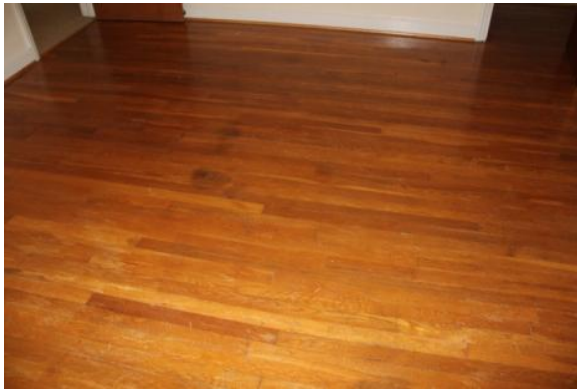
The floor in Room 201 is composed of oak-strip flooring (fig. 289).

Figure 289. Oak-strip flooring in Room 201. Photo: HPTC (06/12/12).

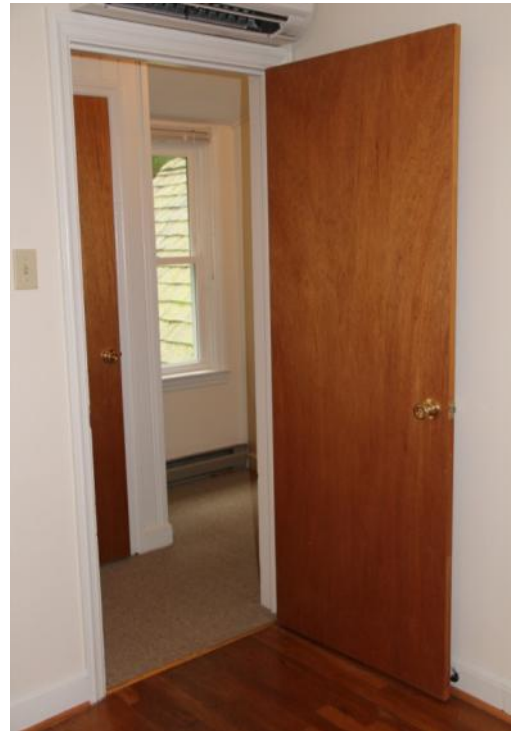
D201 is a replacement hollow-core wood door with modern knobs and historic hinges (fig. 290).

Figure 290, right. D201 is a replacement hollow-core door. Photo: HPTC (06/12/12).

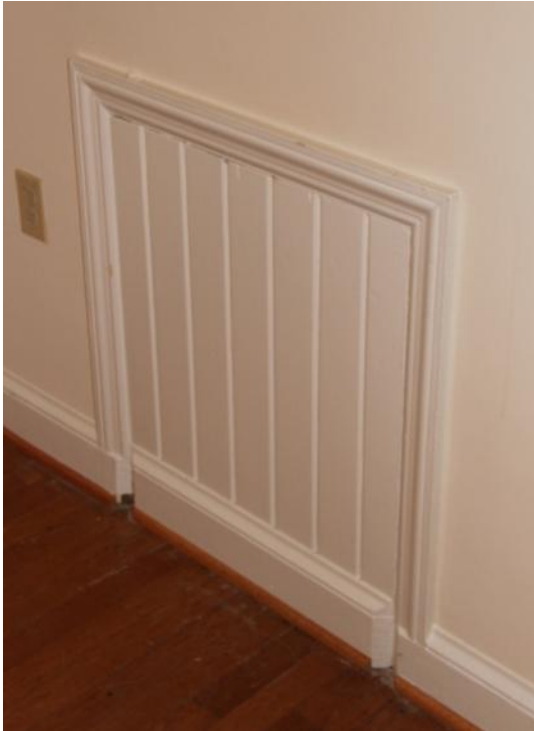
D201a is a painted wood batten access door for access to the bathtub plumbing in the adjacent room (fig. 291). There is no hardware present at this door.

*Figure 291.* D201A accesses the bathtub plumbing. Photo: HPTC (06/12/12).
