# Quarters 1 Superintendent's Residence, Garage, and Permanent Masonry Landscape Features Historic Structure Report

## Quarters 1

# Historic Structure Report

June 2013

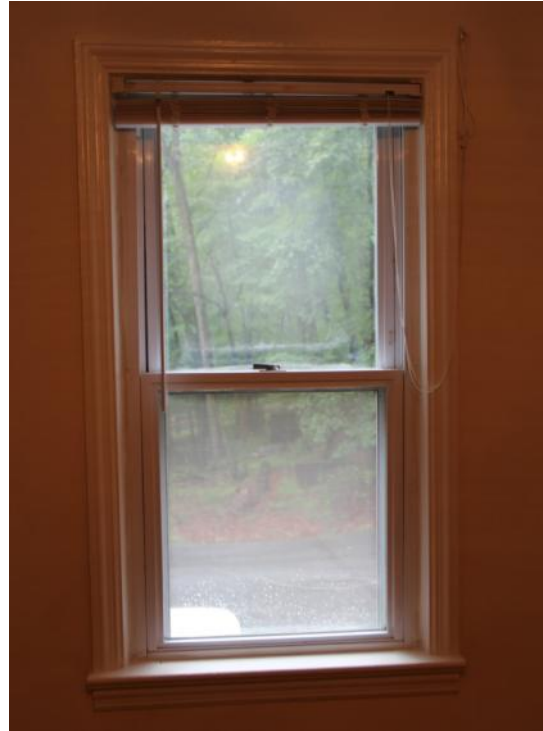
W201 and W202 are modern vinyl replacement windows (figs. 292-293).

*Figure 292.* W201 is a vinyl replacement window. Photo: HPTC (06/12/12).

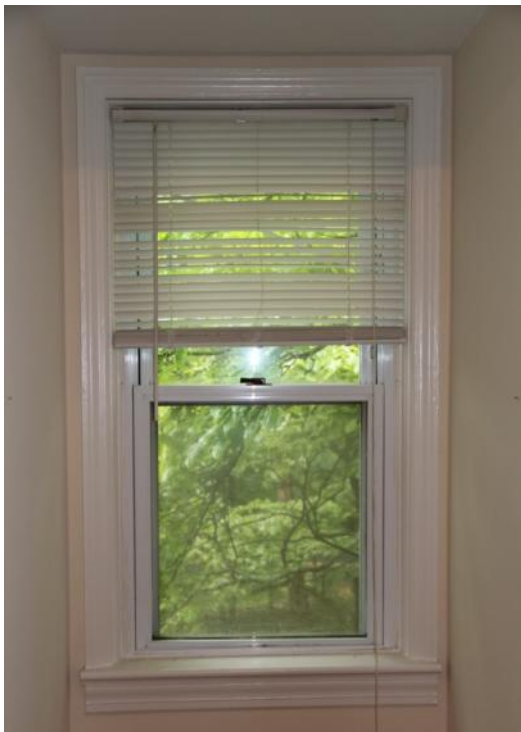
*Figure 293.* W202 is a vinyl replacement window. Photo: HPTC (06/12/12).

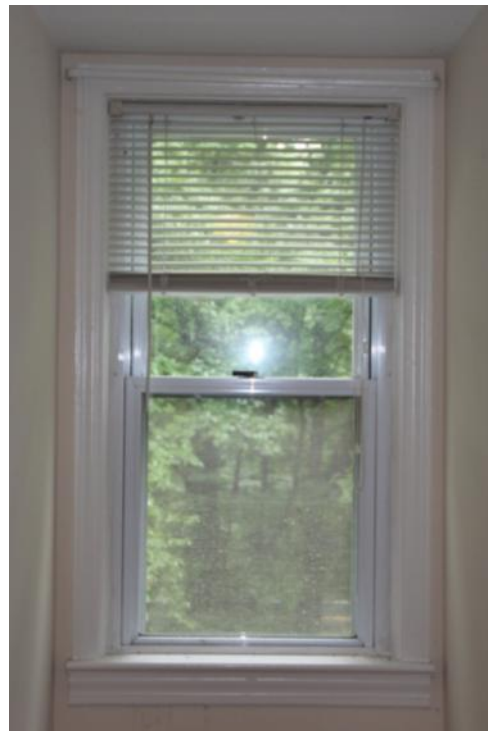
W203 and W204 are modern vinyl replacement windows (figs. 298-299).

Figure 298. W203 is a vinyl replacement window. Photo: HPTC (06/12/12).

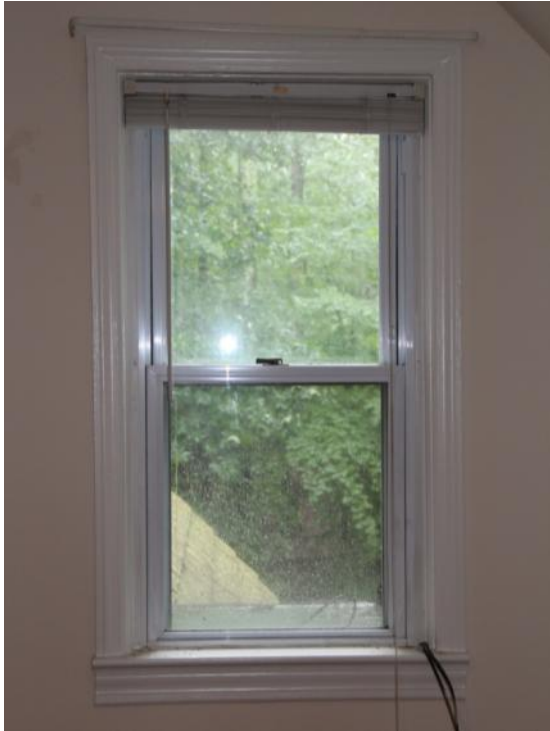
*Figure 299.* W204 is a vinyl replacement window. Photo: HPTC (06/12/12).

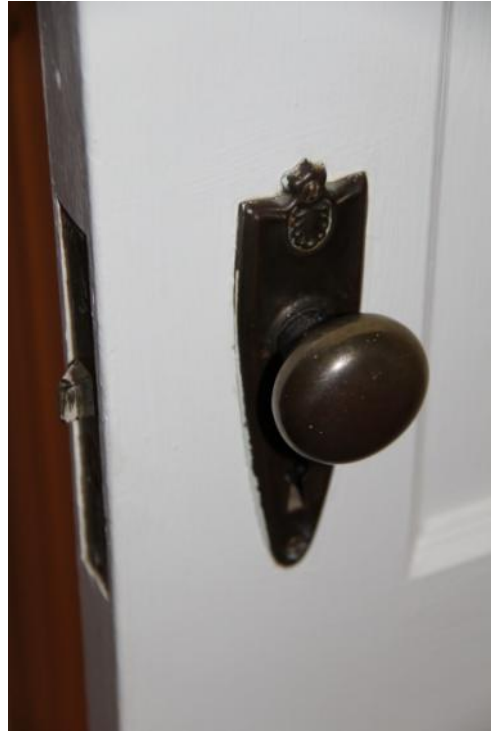
*Figure 300.* Historic mortise lock set and knob at D204. Photo: HPTC (06/12/12).

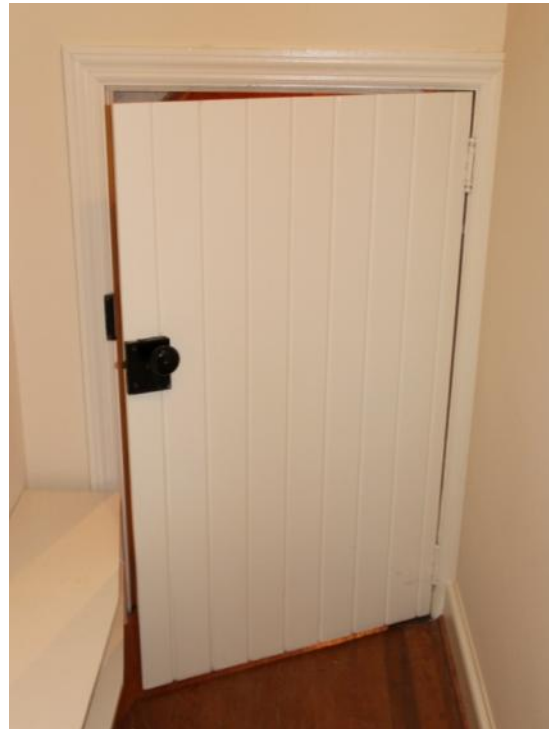
D205 is an original painted wood batten door with original rim lock set and hinges (fig. 304).

Figure 304, right. The original batten D205 with rim lock. Photo: HPTC (06/12/12).

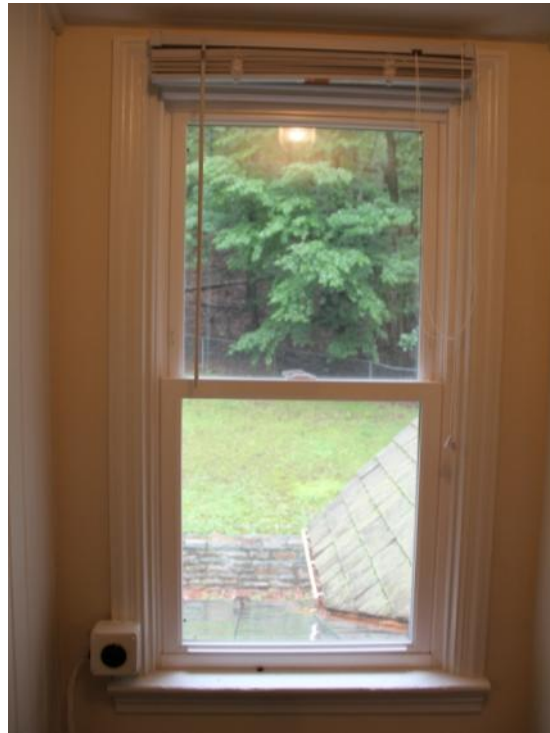
W205 is a modern vinyl replacement window (fig. 306).

Figure 306. W205 is a modern replacement unit. Photo: HPTC (06/12/12).

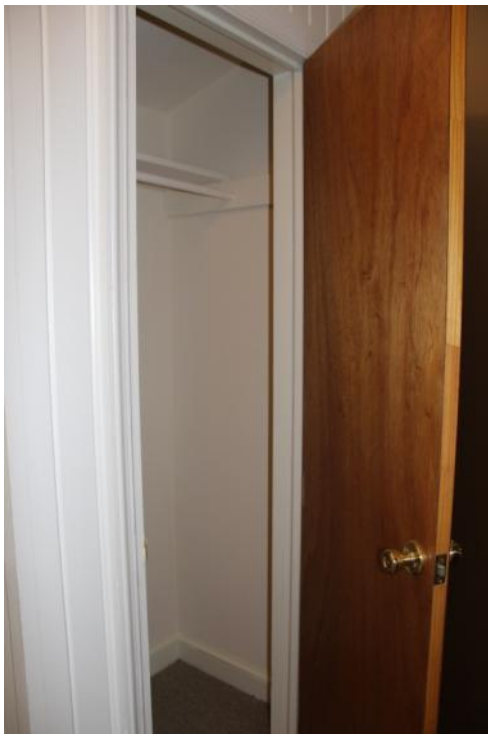
A closet, or Room 206, is located at the southeast corner of Room 208. The floor consists of carpet over original oak-strip flooring; the walls and ceiling are painted plaster. D206 is a modern hollow-core wood door with a modern knob and historic hinges (fig. 307). A simple shelf and clothes bar occupy the interior.

Figure 307. Room 206 with D206; note modern door knob. Photo: HPTC (06/12/12).

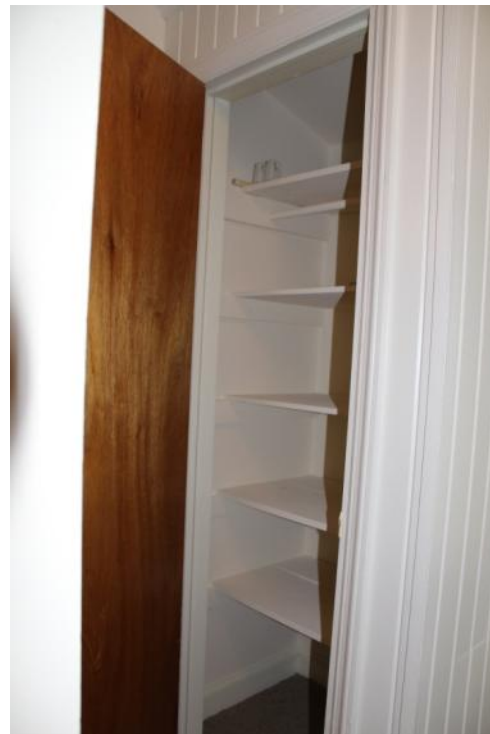
A closet, or Room 207, is located at the northeast corner of Room 208. The floor consists of carpet over original oak-strip flooring; the walls and ceiling are painted plaster. D207 is a modern hollow-core wood door with a modern knob and historic hinges (fig. 308). Simple shelves occupy the interior.

Figure 308. Room 207 with D207. Photo: HPTC (06/12/12).

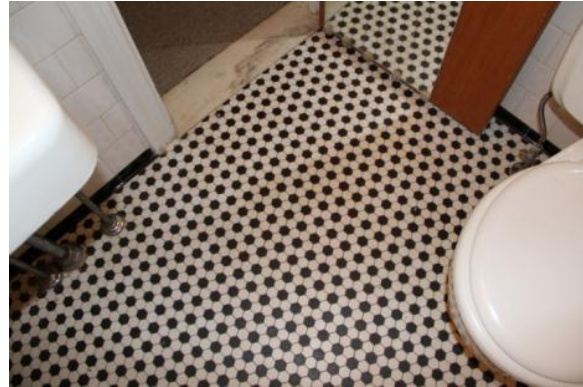
The floor in Room 201 is composed of original black-and-white ceramic hex-tile (fig. 310).

*Figure 310.* The original ceramic hex-tile on the floor. Photo: HPTC (06/12/12).

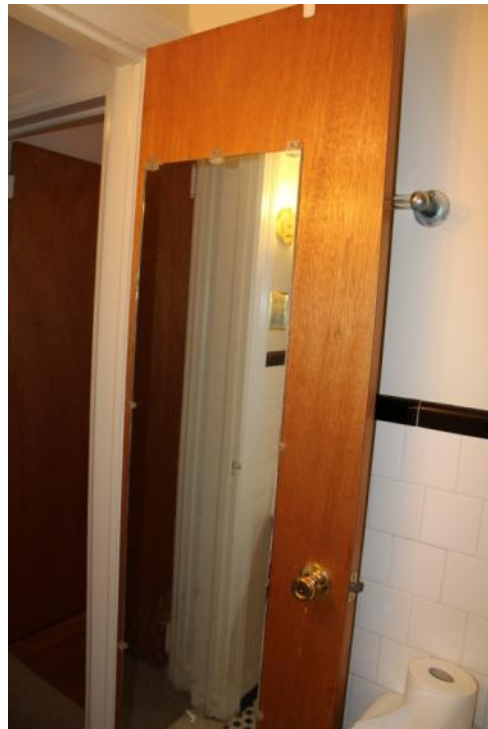
D201 is a replacement hollow-core wood door with modern knobs and historic hinges (fig. 312). The door opening retains the original marble threshold (see fig. 310).

*Figure 312, right.* D209 is a replacement hollow-core door. Note the modern door knob. Photo: HPTC (06/12/12).

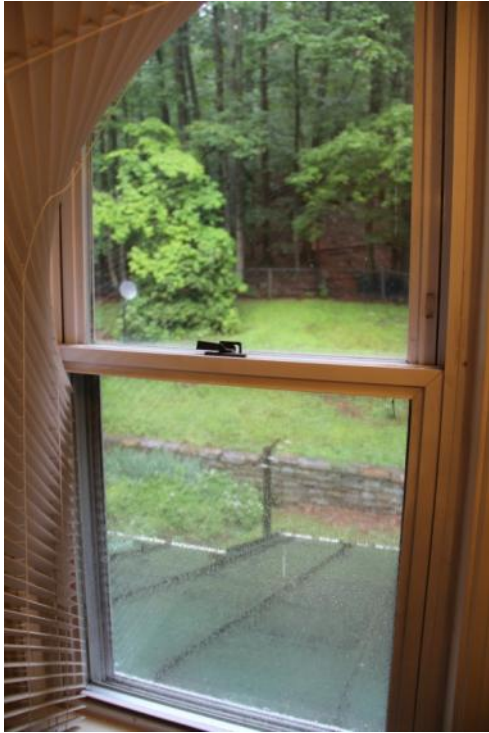
W206 is a modern vinyl replacement window (fig. 311).

*Figure 313.* W206 is a modern vinyl replacement unit. Photo: HPTC (06/12/12).

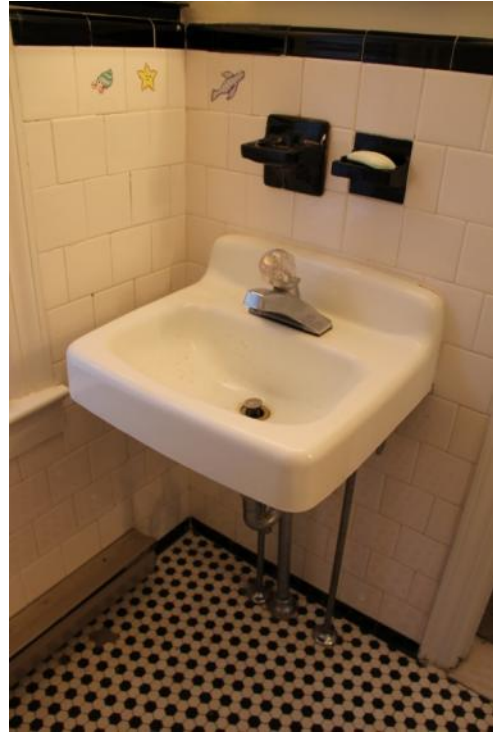
A modern fiberglass bathtub/shower is located along the north wall, a modern toilet is located on the west wall (see fig. 309), and a historic sink is located on the south wall (fig. 312).

*Figure 314.* The bathroom sink in Room 209 is likely original. Photo: HPTC (06/12/12).

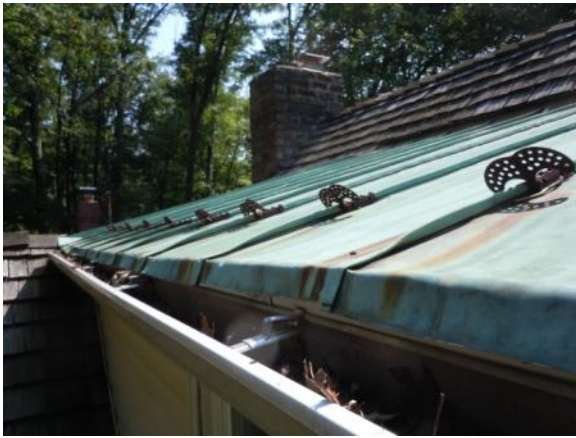
*Figure 317.* The standing-seam metal covering of the rear dormer shed roof is not original, but is a character-defining feature. Photo: HPTC (07/17/12).

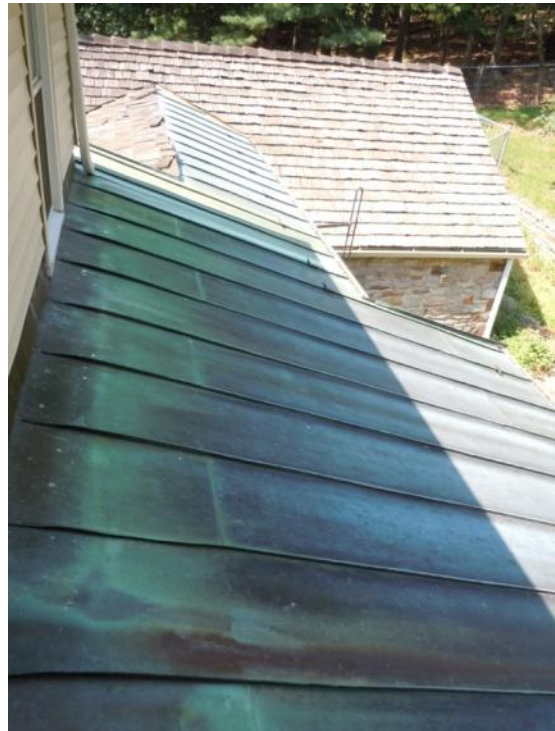
*Figure 318, right.* The standing-seam metal and cedar shake roof coverings of the breezeway and the cedar shake roof covering of the garage are not character-defining. Photo: HPTC (07/17/12).

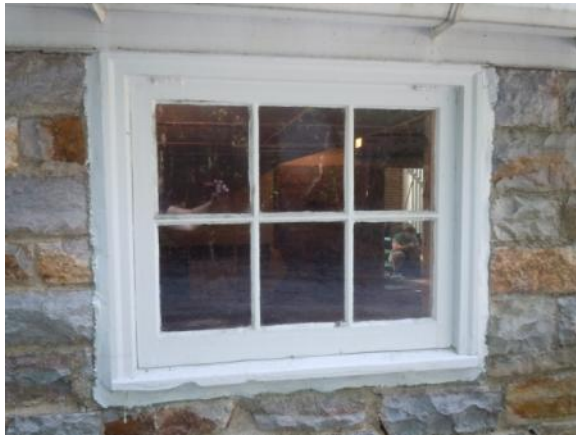
Figure 319, above. The wood six-lite hopper garage windows are original and character-defining features. Photo: HPTC (07/17/12).

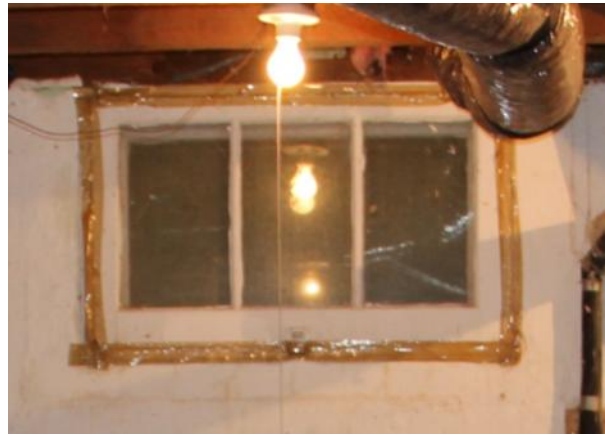
Figure 320, above right. The wood three-lite hopper basement windows are original and character-defining features. Photo: HPTC (06/20/12).

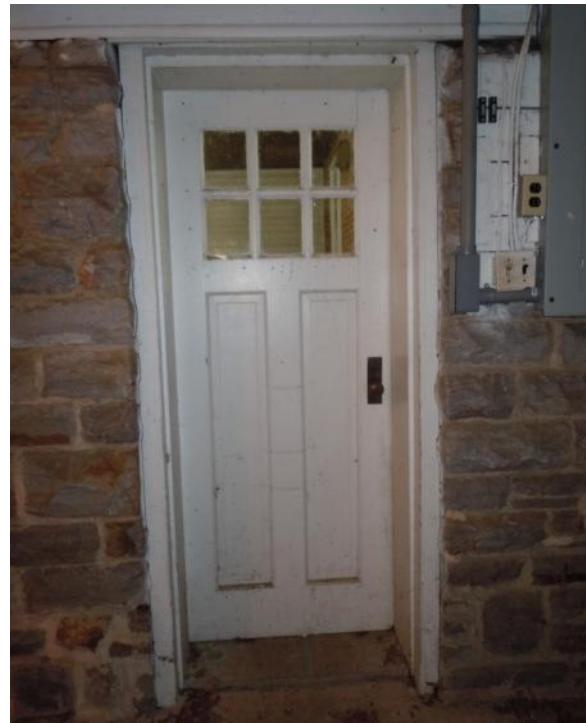
Figure 321, right. The wood six-lite, three-panel wood garage entry door is original and a character-defining feature. Photo: HPTC (07/17/12).

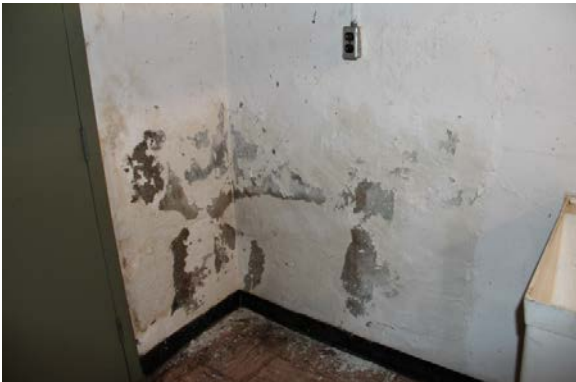
| <p>All exterior surfaces of the main block’s cast-in-place concrete foundation walls are in good condition. Below-grade surfaces of the foundation walls could not be accessed and therefore cannot be assessed.</p> <p>The interior surfaces of the foundation walls are in poor condition. The walls are painted, which is peeling and flaking due to mold and rising damp (fig. 344). Some cracks can be seen as well with indication of seeping water. Areas of particular concern are in the northeast corner of Room 001 and the east wall of Room 004 (figs. 345-346). Water is getting trapped within the basement window wells (particularly W001) and also under the stone structure at the northeast corner of the main block (fig. 347-348). There is no evidence of a foundation drainage system besides floor drains in the slab in Room 004. See <i>A103001-1 Main Block Basement Slab on Grade</i> for more information.</p> <p>Additionally, many of the interior surfaces of the concrete walls are covered with wood paneling; these walls could not be assessed without being removed (fig. 349).</p> <p>Condition Rating:        Poor<br/>Deficiencies Rating:    Serious</p> | | | |
| <div><div><p><i>Figure 344.</i> Evidence of rising damp, through flaking paint, and mold can be seen at the northeast corner of Room 004. Photo: HPTC (06/20/12).</p></div><div><p><i>Figure 345, right.</i> The area of immediate concern at the northeast corner of Room 001. Note the adjacent window opening (W001). Photo: HPTC (06/20/12).</p></div></div> | | | |

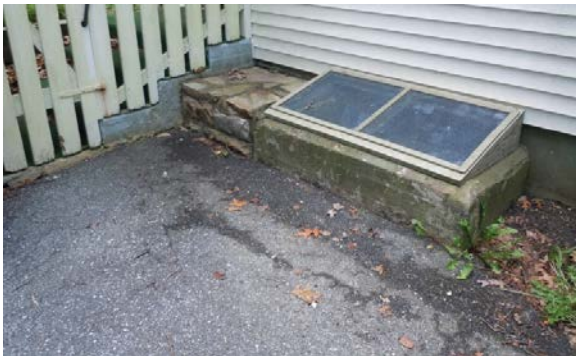
Figure 348. The mostly-paved area around the well of W001 and the stone structure in the corner is causing the retention of water at the northeast corner of Room 001. Photo: HPTC (08/29/12).

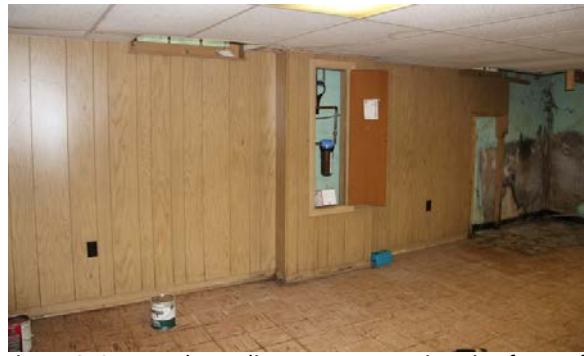
Figure 349. Wood paneling covers many interior faces of the foundation walls hiding the condition of the concrete behind. Photo: HPTC (06/12/12).

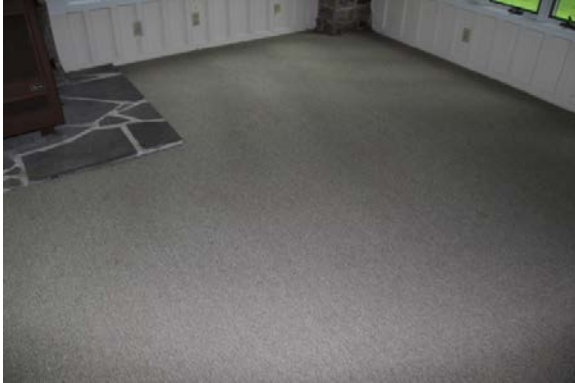
| <b>A103001-2</b> | <b>Sun Porch Slab On Grade</b> |
|---|---|
| <p>The concrete sun porch floor slab is completely covered with carpet on the interior of the room (fig. 350). See <i>C302005 Carpeting</i> for more information. Due to the inaccessibility of the concrete surfaces in these areas, the condition of the slab is unknown.</p> <p>The concrete floor slab is partially seen on the exterior; however is mostly hidden by vegetative growth. Despite limited biological growth across the slab, the concrete appears to be in fair condition (fig. 351).</p> | |

Figure 350. The sun porch concrete floor slab is covered with carpet on the interior. Photo: HPTC (06.12/12).

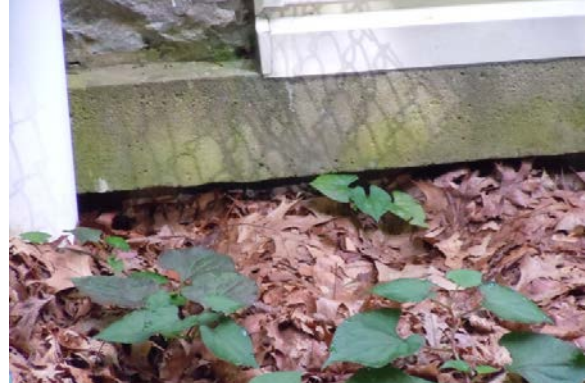
Figure 351. The sun porch concrete slab is mostly hidden by vegetative growth on the exterior. Photo: HPTC (03/21/12).

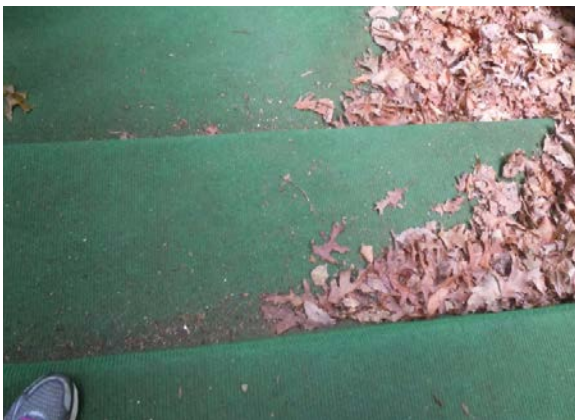
The concrete breezeway floor slab is completely covered with Astroturf-style carpet (fig. 352). See *C302005 Carpeting* for more information. Furthermore, the Astroturf is largely covered by the accumulation of fallen leaves (fig. 353). Due to the inaccessibility of the concrete surfaces, the condition of the slab is unknown.

Figure 352. Astroturf-style carpet covers the breezeway concrete slab. Photo: HPTC (08/29/12).

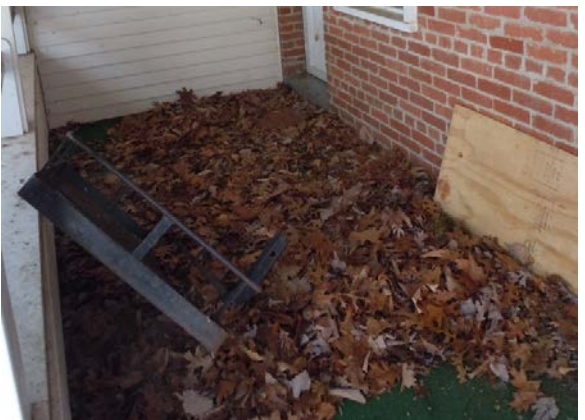
Figure 353. Leaves cover most of the Astroturf. Photo: HPTC (02/14/12).

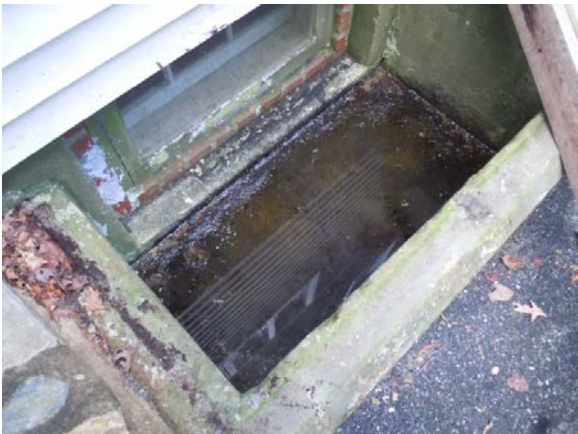
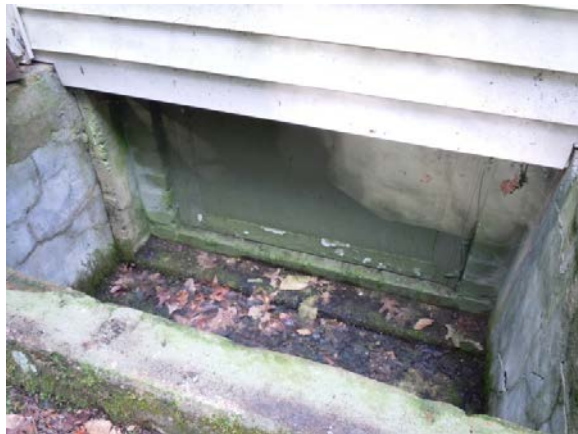
| B2020 | Exterior Windows |
|---|---|
| <p>The original, character-defining basement windows are in fair condition. Many are painted shut making them inoperable. The exteriors of all of the windows are covered with biological growth due to the damp conditions in the window wells (figs. 356-357).</p> <p>Condition Rating: Fair<br/>Deficiency Rating: Serious</p> | |
| <p><i>Figure 356.</i> The window wells retain water making damp conditions. Photo: HPTC (08/29/12).</p> | <p><i>Figure 357.</i> The character-defining basement windows are covered with biological growth on their exteriors. Photo: HPTC (08/29/12).</p> |

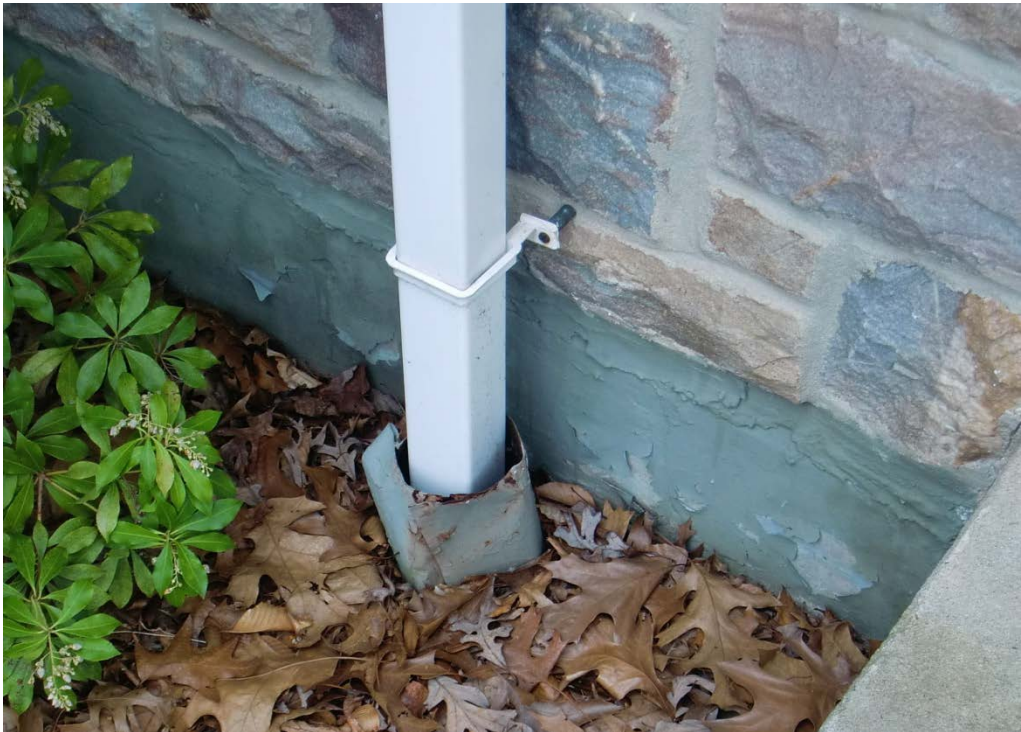
| <p>A significant amount of vegetative debris has accumulated in the gutters of the main block gable and hipped roofs. This accumulation has clogged the gutter and drainage into the downspouts causing the backup and retention of water in both the gutters and the downspouts.</p> <p>The modern, vinyl U-shaped gutters and square downspouts are not considered character-defining features as they do not match what would have been at Quarters 1 originally (metal K-style gutters with metal square downspouts). They appear to be smaller than the original gutters and downspouts which were sized for the slope and area of the roofs. This smaller-dimension gutters likely overflow every time there is a heavy rain and contribute to the degradation of the building's exterior surfaces, roof soffits and framing (ice dams), and the building foundation system.</p> <p>The extent of the underground drainage system is unknown (fig. 363). Any degradation of this system could be exacerbating the water damage/infiltration of the concrete foundation walls.</p> <p>Condition Rating:        Poor<br/>Deficiency Rating:      Critical</p> | |

Figure 363. The extent of the underground drainage system at Quarters 1 is unknown. Photo: HPTC (03/21/12).

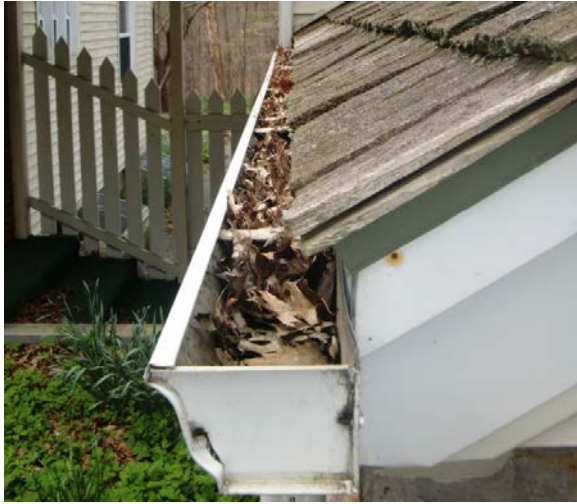
A significant amount of vegetative debris has accumulated in the gutters of the garage roof (fig. 367). This accumulation has clogged the gutters and drainage into the downspouts causing the backup and retention of water in both the gutters and the downspouts.

Figure 367. Collected vegetative debris can be seen in the garage roof gutters. Photo: HPTC (08/29/12).

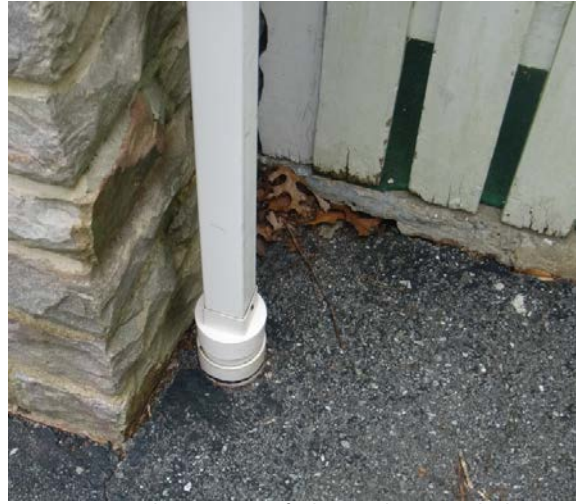
The extent of the underground drainage system is unknown (fig. 368). Any degradation of this system could be exacerbating the water damage/infiltration of the concrete foundation walls.

Figure 368. The extent of the underground drainage system at Quarters 1 is unknown. Photo: HPTC (08/29/12).

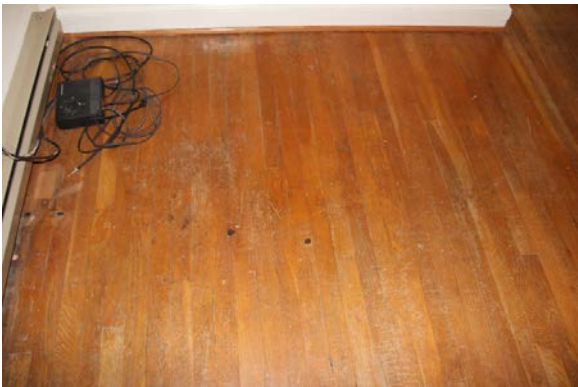
| C302003 Wood Flooring | |
|---|---|
| <p>The oak-strip floor finishes which are exposed are character-defining features (seen in Rooms 108, 109, and 201-204). Widespread scratches dull the surface finishes resulting in a fair condition rating (figs. 377-378). Floors have not been maintained as indicated by buildup of floor wax in corners and unfinished wood and scratched wood in high-traffic areas.</p> <p>Oak-strip flooring is assumed to be covered with carpet in Rooms 101-105, 110, 111, and 206-208. The condition of these wood floors is unknown.</p> <p>Wood pressboard flooring is seen in Room 205. It is in fair condition, but is of little concern due to the utilitarian space.</p> <p>Condition Rating: Fair<br/>Deficiency Rating: Minor</p> | |
| <p><i>Figure 377 and Figure 378, right.</i> The exposed oak-strip floors on the first and second floors are in a dull, but fair condition. Scratches indicate a lack of maintenance. Photo: 06/12/12.</p> | |

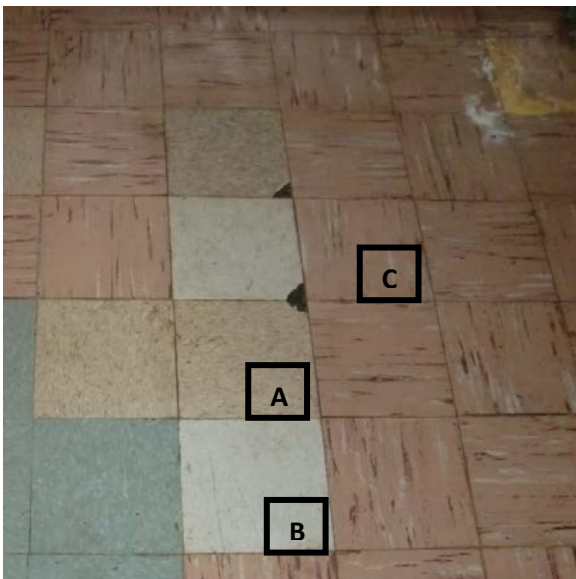
According to the 2010 “Asbestos-Containing Materials Survey,” some of the vinyl-floor tiles (VFT) in the basement contains asbestos (fig. 379-380).<sup>2</sup> These include:

Figure 379. Vinyl basement tiles which contain asbestos include the brown with white streaks (A), the white with grey streaks (B), and the orange with brown streaks (C). Photo: HPTC (03/21/12).

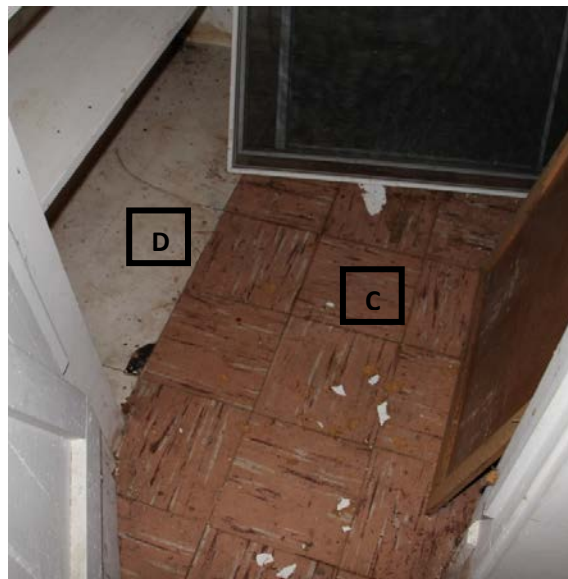
Figure 380. The white vinyl floor tiles (D) also contain asbestos. Photo: HPTC (06/20/12).

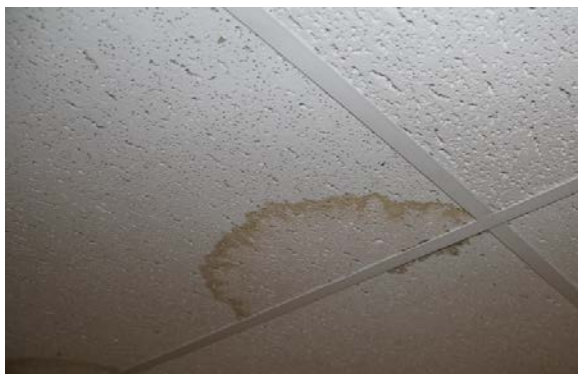
| <b>C303004 Acoustical Ceiling Tiles &amp; Panels</b> | |
|---|---|
| <p>Acoustical ceiling tiles can be seen in basement rooms 001 and 002. The 2'x2' tiles in Room 001 are suspended; various water stains can be seen across the ceiling (fig.381). The 1'x1' tiles in Room 002 are adhered directly to the ceiling; problems include pulling away from the substrate and dents (fig. 382).</p> | |

Figure 381. A water stain on an acoustical ceiling tile in Room 001. Photo: HPTC (06/20/12).

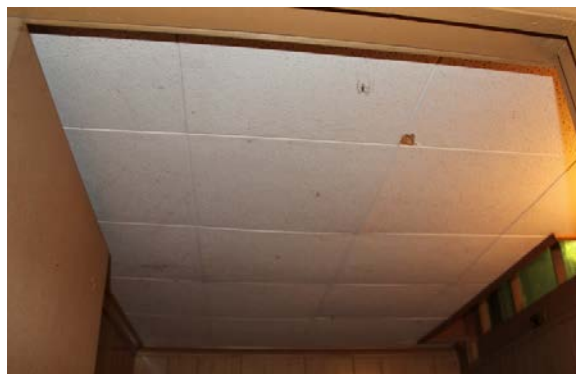
Figure 382. Acoustical ceiling tiles in Room 002 are pulling away from the substrate. Photo: HPTC (06/20/12).

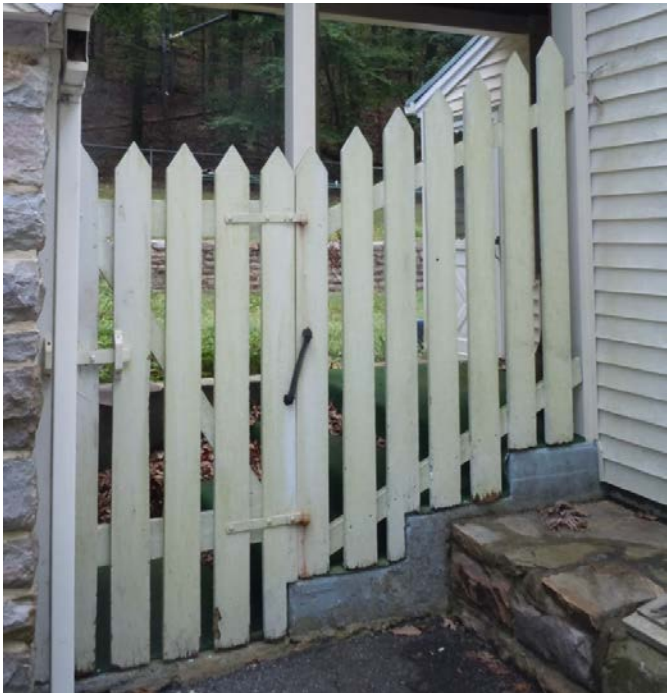
| <p>The chain-link fence is not a character-defining feature. A large portion on the eastern side was crushed by a fallen tree and had not been repaired as of the date of this report.</p> <p>The wood picket fence at the breezeway is not a character-defining feature. It is covered with biological growth (fig. 385).</p> <p>Condition Rating: Fair<br/>Deficiency Rating: Minor</p> | |
| <p><i>Figure 385. The wood picket fence is not a character-defining feature. Photo: HPTC (08/29/12).</i></p> | |

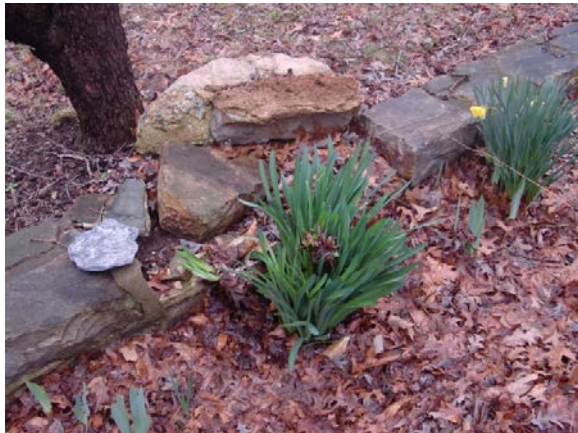
| <p>The Catoctin greenstone retaining walls are in overall poor condition.</p> <p>The western (front) wall is partially covered with biological growth or vegetative debris and larger stones have become detached from the wall (fig. 386).</p> <p>The mortar in the top horizontal face of the eastern (rear) wall is disintegrating allowing the top-course stones to shift (fig. 387).</p> <p>Condition Rating: Poor<br/>Deficiency Rating: Minor</p> | |

Figure 386. The front retaining wall has dislodged stones and is partially overgrown with vegetation. Photo: HPTC (03/21/12).

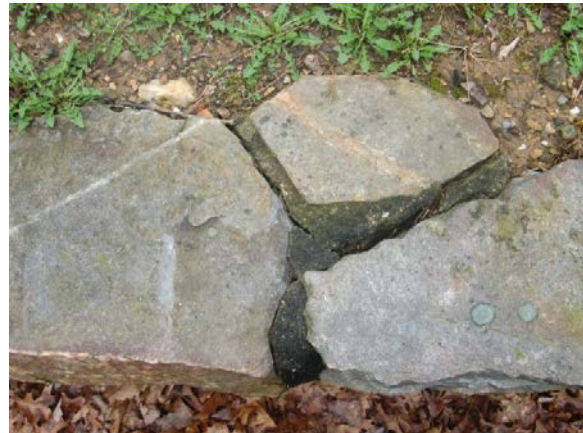
Figure 387. The rear retaining wall has degrading mortar and easily-moveable stones. Photo: HPTC (03/21/12).

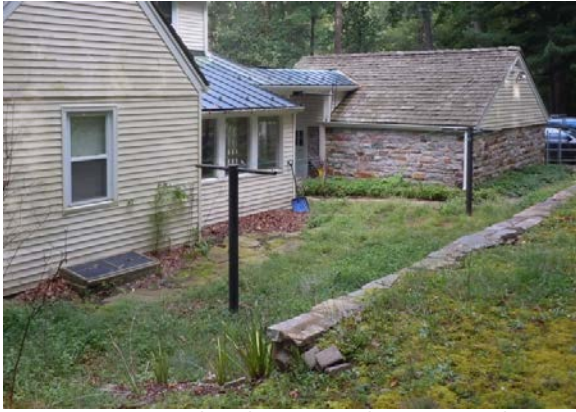
| <p>Neutral and negative drainage can be seen on all elevations of Quarters 1 (fig. 390). These conditions cause ponding and allow water to collect at the base of the buildings walls seeping into the foundations. Water damage (including mold, staining, spalling, etc.) will occur to interior and exterior faces of the buildings' foundations.</p> <p>The basement window wills are composed entirely of concrete and do not allow for water drainage (fig. 391). This condition has exacerbated the problems described above.</p> <p>Condition Rating: Poor<br/>Deficiency Rating: Critical</p> | |

*Figure 390.* Neutral and negative drainage can be seen across the rear elevation. Photo: HPTC (08/29/12).

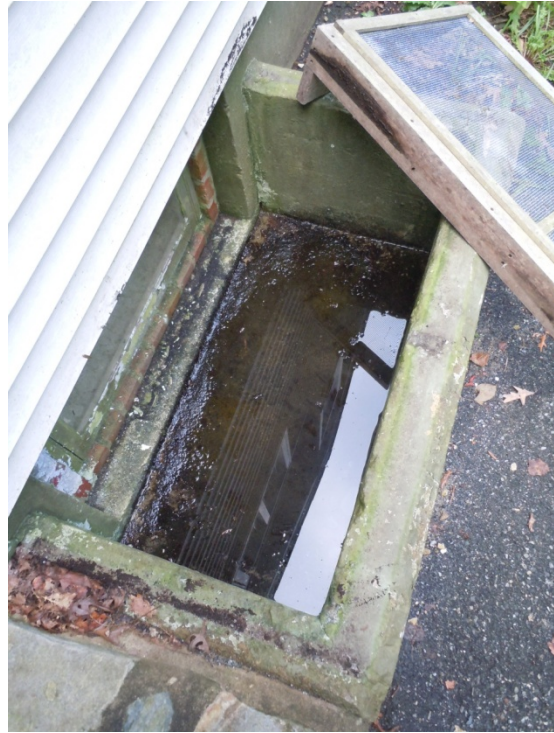
*Figure 391, right.* Water has no way of draining from the concrete basement window wells. Photo: HPTC (08/29/12).
