# Old Stone House

## Historic Structure Report FINAL DRAFT

Rock Creek Park  
Washington, DC

April 2013

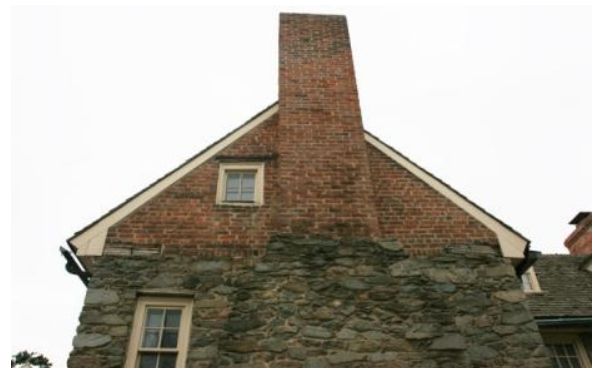
**Figure 25.** Chimney to stone transition on the east elevation of the main block. (NPS)

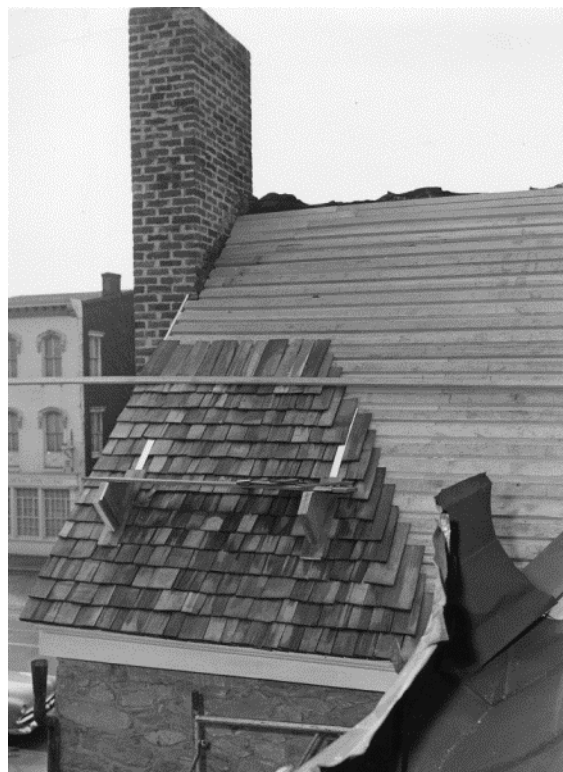
**Figure 46.** Reroofing the main block with square-butt wood shingles; note the former metal roof in the foreground. (NPS, 1956)

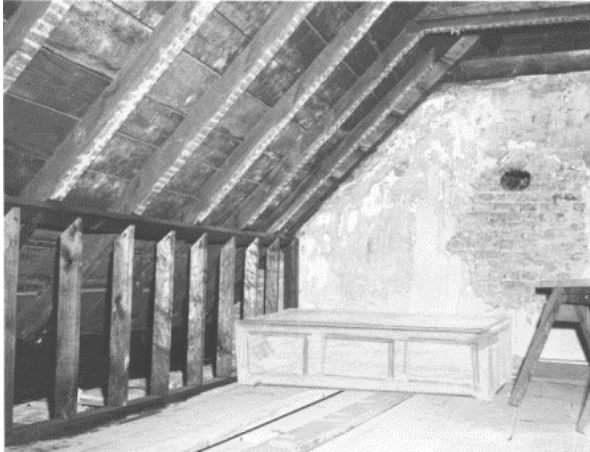
**Figure 53.** Room 303 in 1956, after lath and plaster was removed from the interior wall surfaces. (NPS)

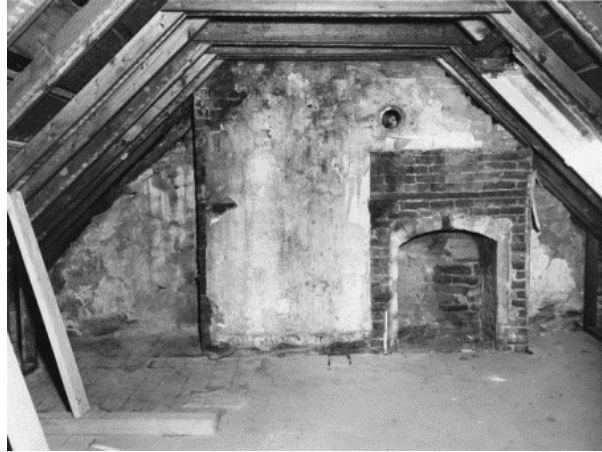
**Figure 54.** Room 304 in 1956, after lath and plaster was removed from the interior wall surfaces; note the removal of the fireplace surround. (NPS)

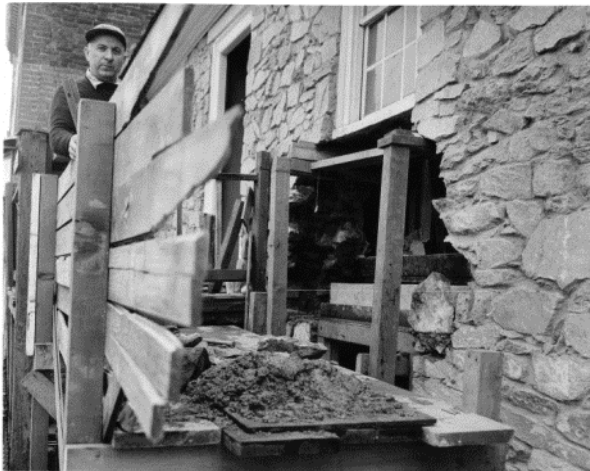
**Figure 55.** Repairing the stone masonry walls on the front elevation in 1957. (NPS)

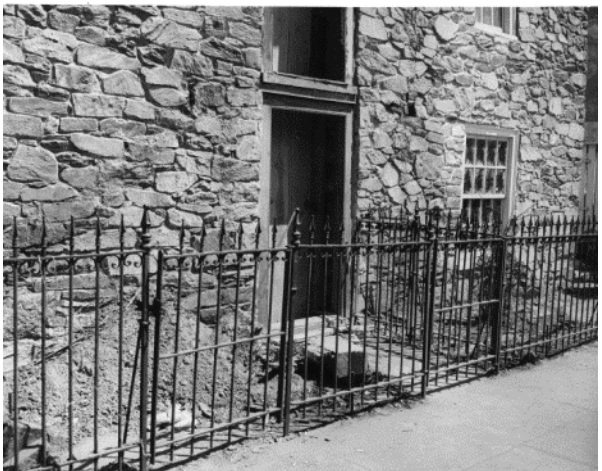
**Figure 56.** The front elevation after the porch and stair were removed. (NPS, 1957)

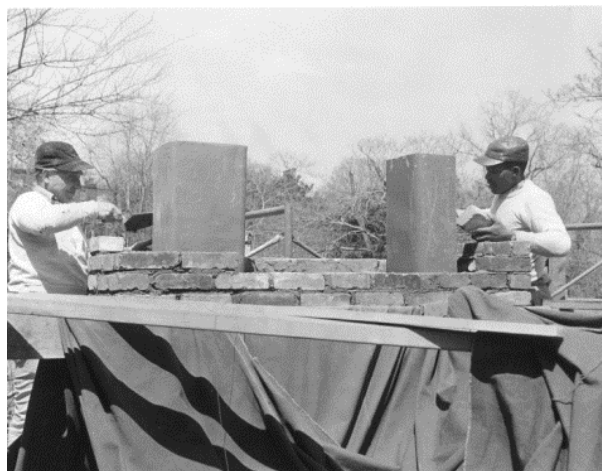
**Figure 58.** Reconstruction of the north addition chimney with terra cotta flue liners. (NPS, 1957)

A red brick patch with a concave joint, on the north elevation of the south wing of the main block, was planned to be replaced with stone during the 1950s restoration; however the brick has remained (fig. 102). The north chimney is red brick and was rebuilt in 1957 (fig. 103).

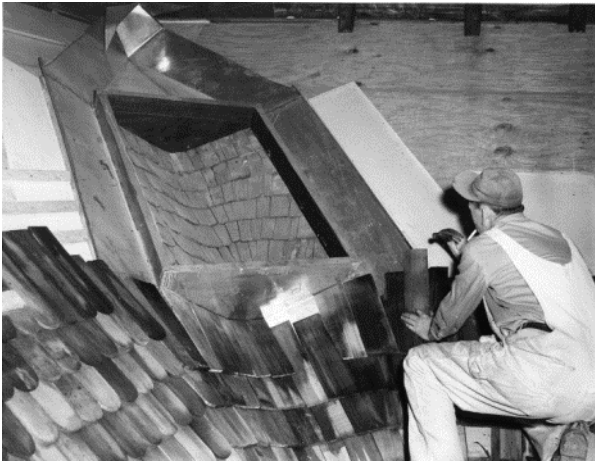
**Figure 61, above.** Installing a skylight over original roof shingles at the junction of the main block and the north addition, while the shed roof is still extant. (NPS, 1957)

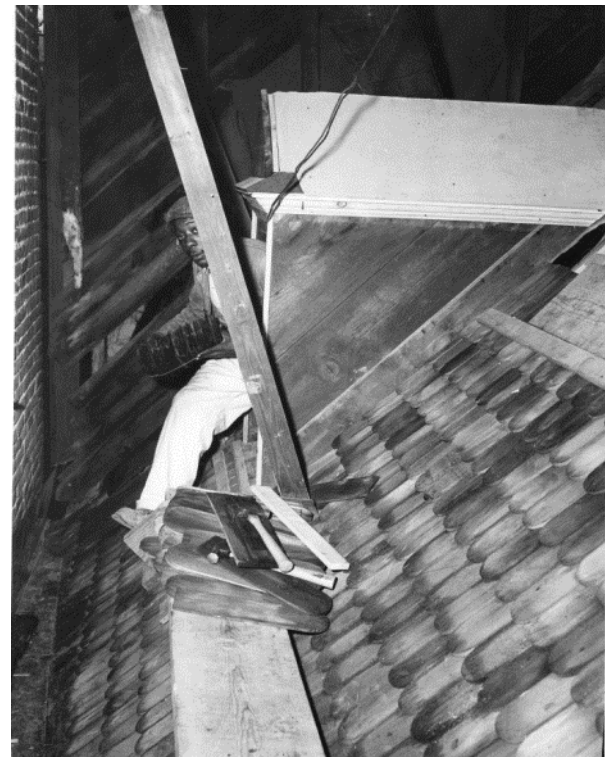
**Figure 62, right.** The installation of new wood roof shingles on the west slope of the north addition, while the shed roof is still extant. (NPS, 1957)

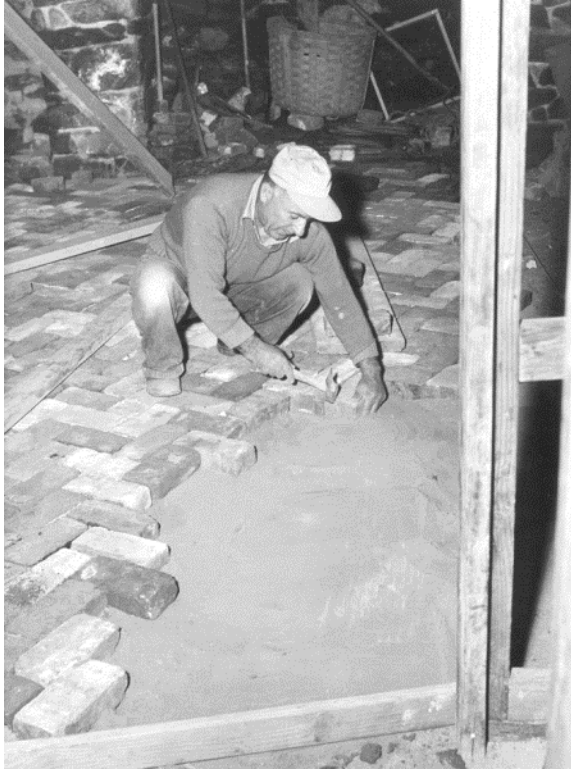
**Figure 67.** Laying brick over concrete slab-on-grade in Room 102 in 1957. (NPS)

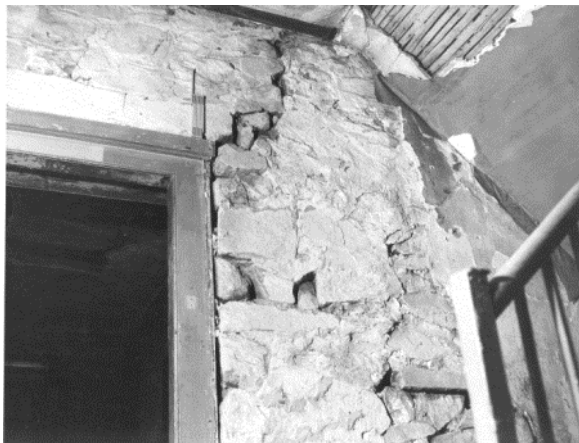
**Figure 69.** Open mortar joints ready for repointing in Room 201B. (NPS, 1957)

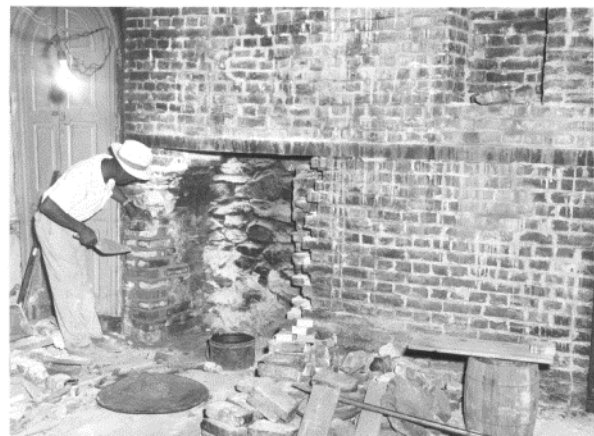
**Figure 70.** Repairing brick walls in Room 204 after interior wood paneling was temporarily removed. (NPS, 1957)

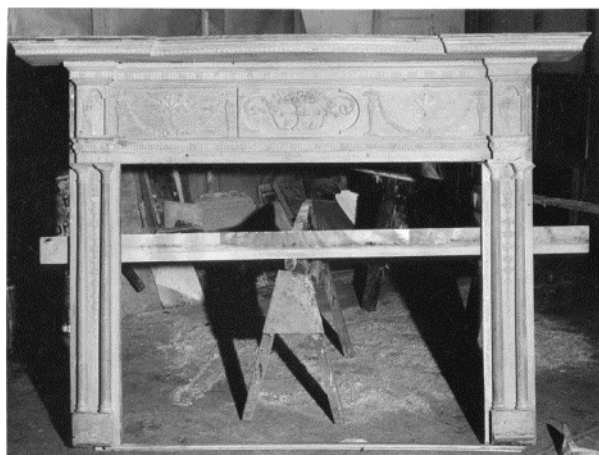
**Figure 71, above.** Room 203's fireplace surround removed for repair. (NPS, 1957)

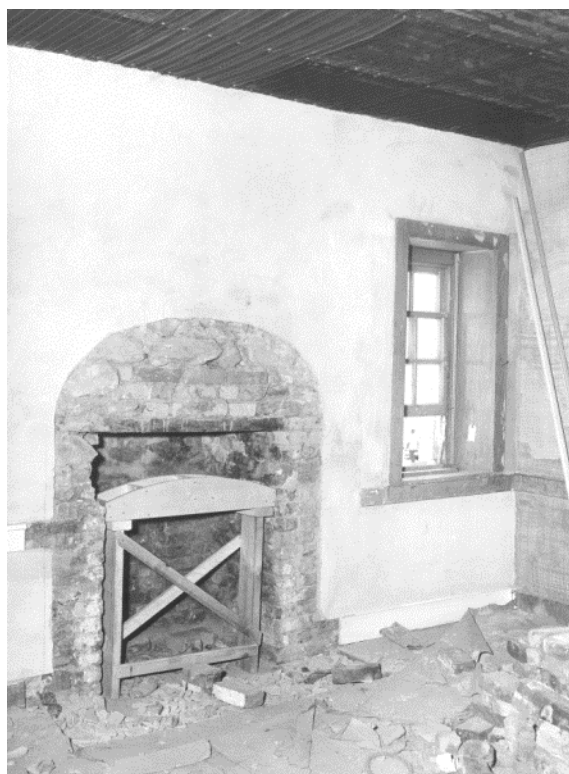
**Figure 72, right.** Room 203's fireplace without surround in place. (NPS, 1957)

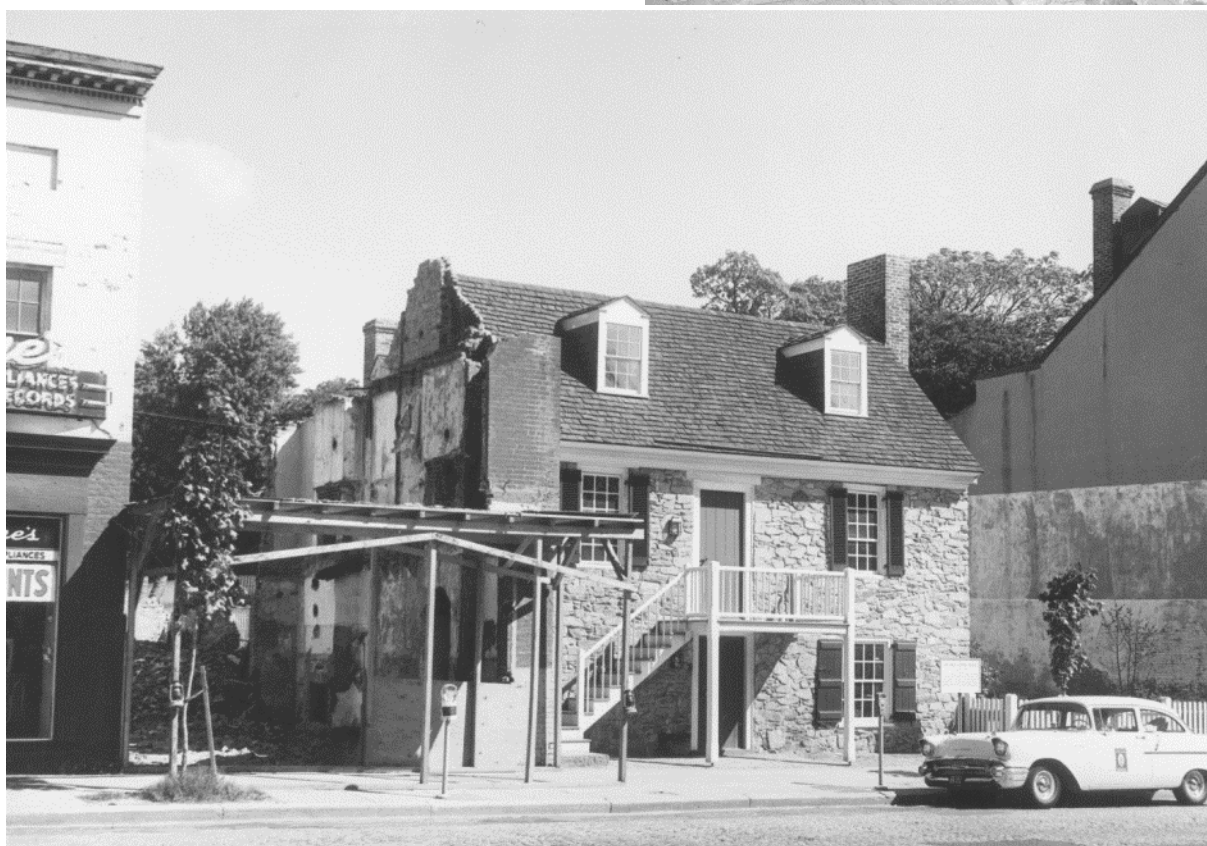
In 1958, the building to the west of the house was demolished and a new stone wall was erected (fig. 73-75).

**Figure 73.** After the adjacent west building was removed, the shared wall was temporarily kept in place in order to properly reconstruct the west wall. (NPS, 1958)

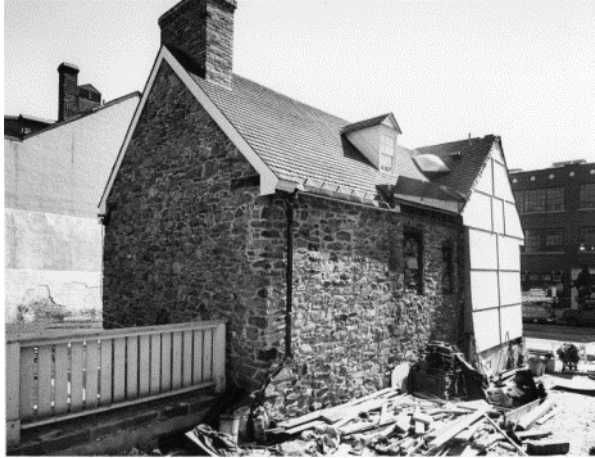
**Figure 74.** The west elevation of Old Stone House after the removal of the shared wall. (NPS, 1958)

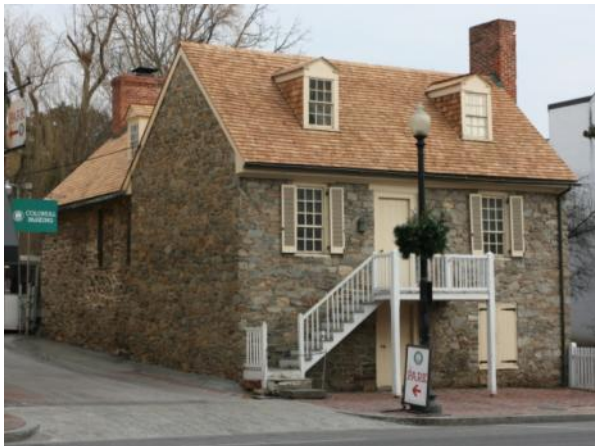
**Figure 80.** South and west elevations of the house after the new roofs were installed. (NPS, 2009)

Since the major renovations throughout the 1950s, the National Park Service has made some changes to the house. These changes include the installation of new roofs in 2009 (figs. 80-81), the construction of a replacement front porch in 2011 (figs. 82-83), and selected repointing to exterior stonework on south, east, and north elevations in 2012 (fig. 84-91).

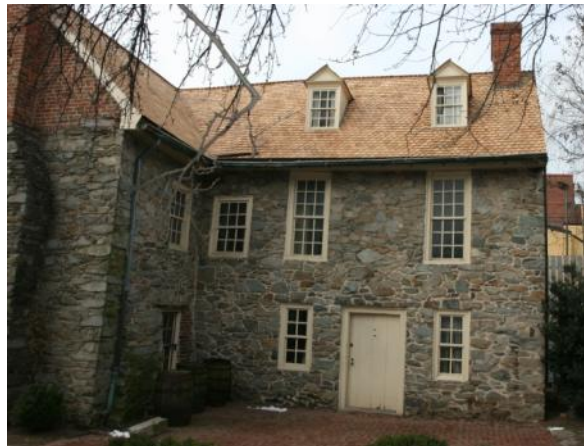
**Figure 81.** North and east elevations of the house after the new roofs were installed. (NPS, 2009)

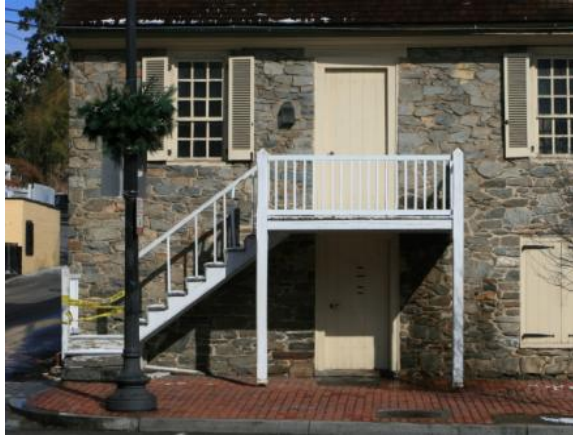
**Figure 82.** The front porch and stair prior to reconstruction. (NPS, 2011)

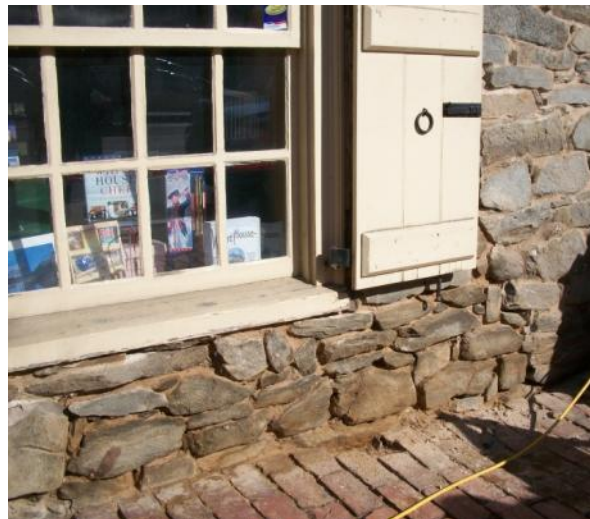
**Figure 88.** The stonework underneath W101 prior to repointing. (NPS, 2012)

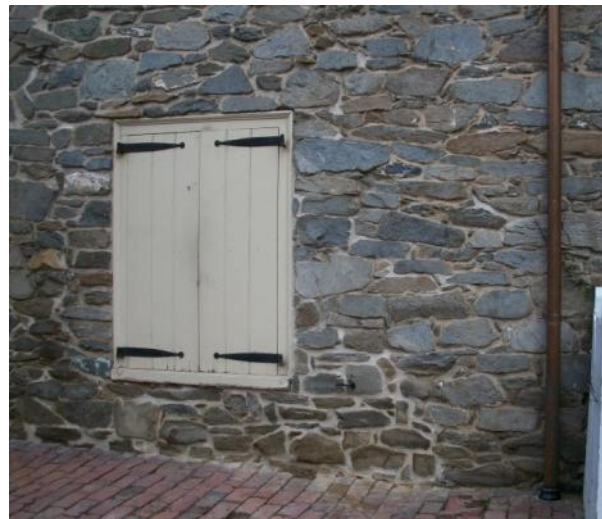
**Figure 89.** The stonework underneath W101 after repointing. (NPS, 2012)

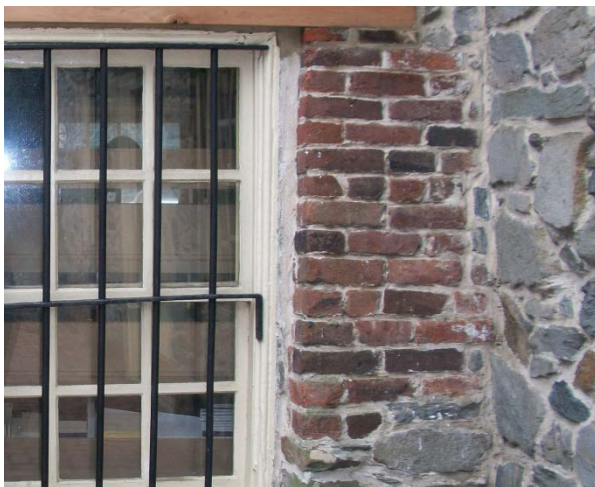
**Figure 102.** Brick patch on north elevation adjacent to W103. (NPS)

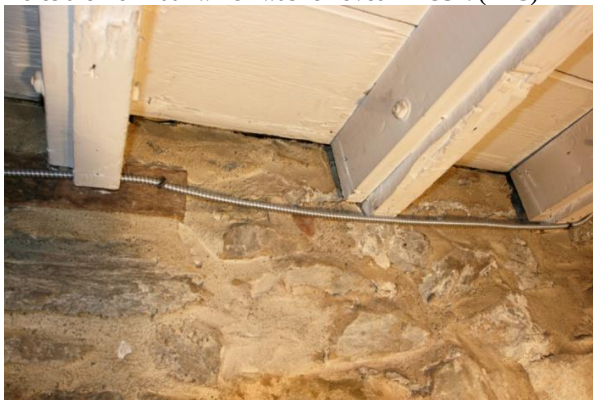
The joists are in good condition. 2 x 6 fir joists were sistered to many of the joists in Room 101 during the 1957 renovation (fig. 108). They were attached using zinc-coated matching bolts. The joists in Room 101 were given additional support by the addition of a steel I-beam which runs the entire width of the room; the steel is encased in a lumber box (fig. 109). Noticeable deflection is not present and the system is assumed to be in good condition.

**Figure 108.** Sistered joists in Room 101.

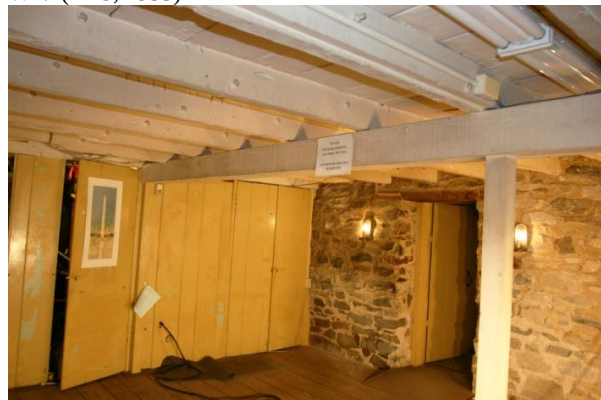
**Figure 109.** Room 101 joists and support system.

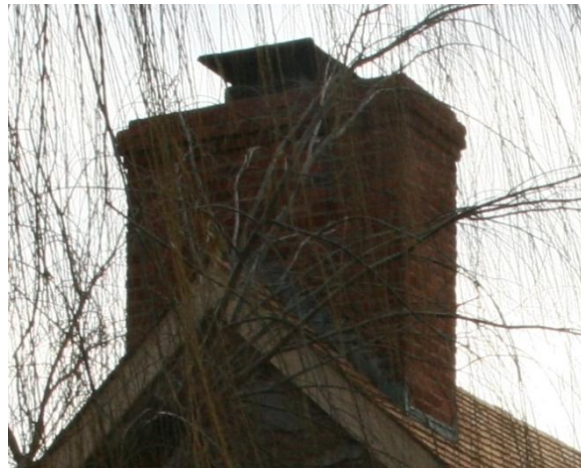
**Figure 119.** Chimney 2's partial cap today. (NPS)

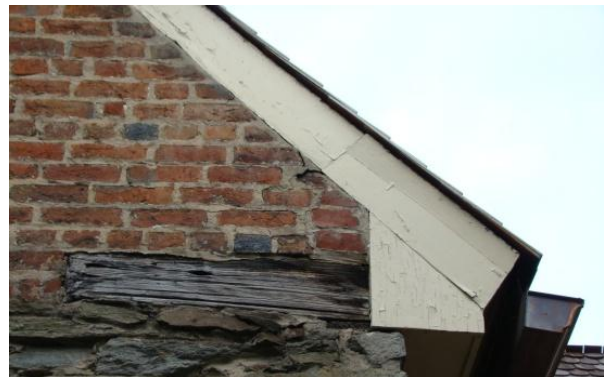
Overall, the trim is generally in good condition with only minor deficiencies. Gable trim on the east elevation of the main block is severely deteriorated and should be stabilized.

**Figure 146.** Detail of east elevation main block showing gable finish and trim.

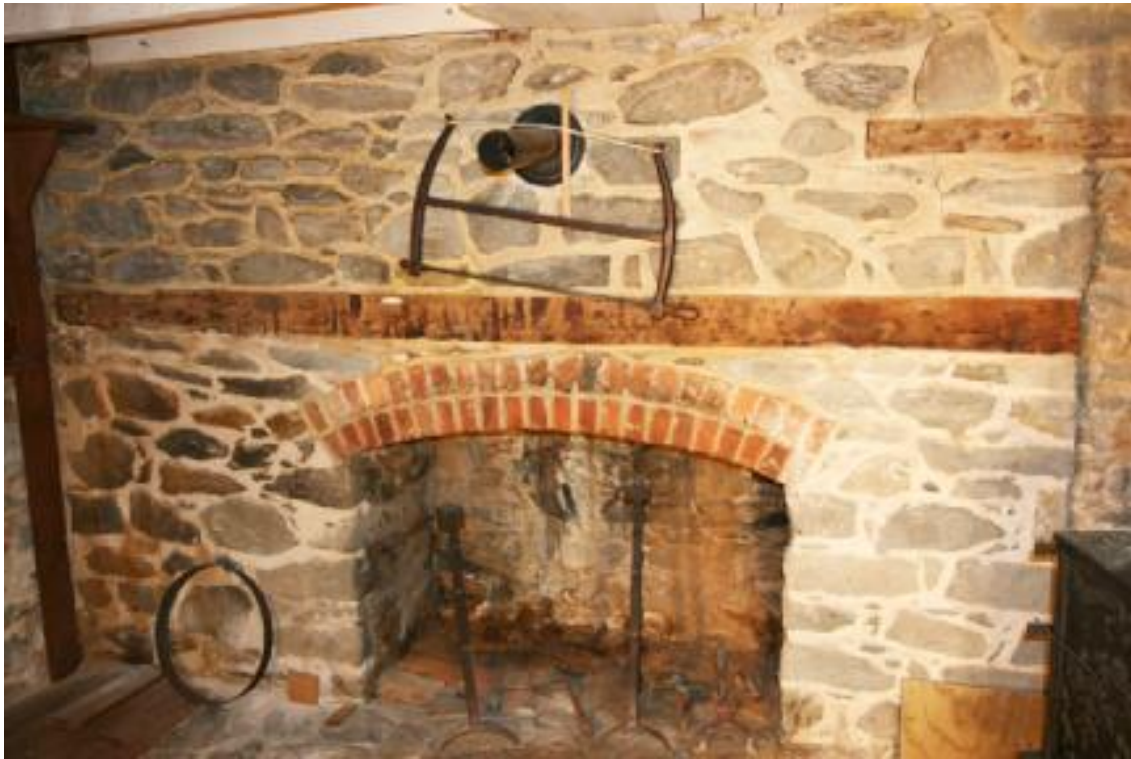
**Figure 161.** Fireplace A in Room 101. (NPS)

The fireplaces are in good condition, with no visual deficiencies. The fireplaces were functional as recently as the 1990s; their current functionality is unknown.

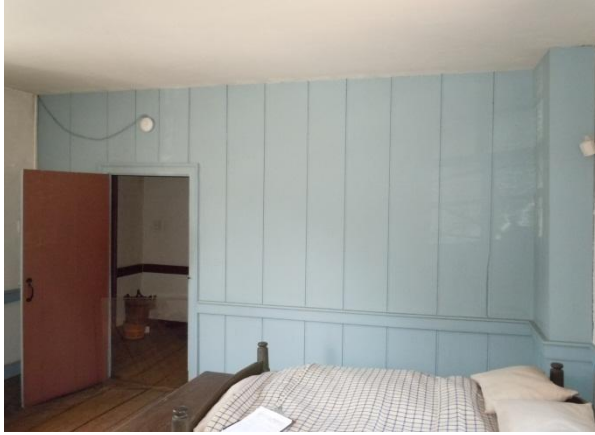
Walls in Room 203 are in good condition except for a few cracks in the plaster on the east wall, which correspond with former exterior wall cracks (remediated in 2011).

**Figure 192.** The painted wood board wall in Room 203. (NPS, 2013)

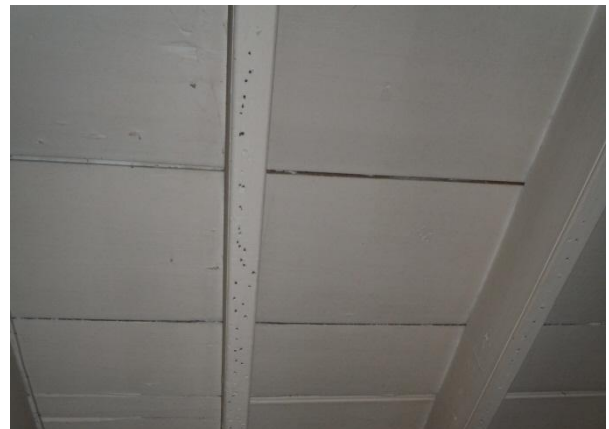
When the NPS acquired the house in the 1950s, the plaster ceilings throughout the house were either failing or, as in the case of Rooms 203 and 204, had been replaced with suspended acoustical ceilings. The original ceilings were plaster over wood lath, typical of the period of construction. These ceilings were documented in the 1950s NPS photographs of the reconstruction. The ceilings of the second and third floors were replastered with the exception of Hall 201A, in which the plaster was removed and the joists were left exposed (not considered a sensitive change to the interior; figs. 202-203).

**Figure 203, right.** Exposed painted wood floor framing at ceiling in Room 201A would likely not have been exposed historically. Plaster was removed during 19050s restoration. (NPS, 2013)

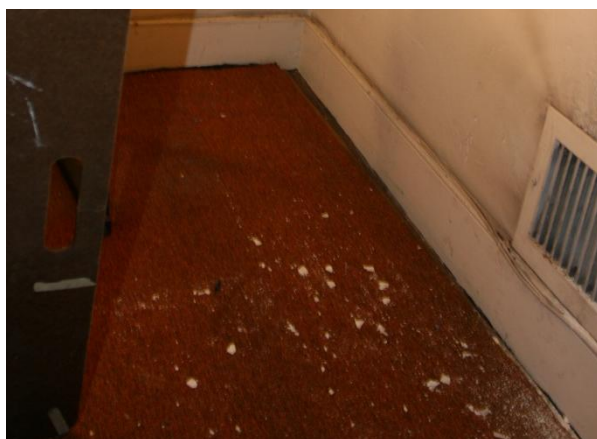
The wood flooring in Room 302 is covered by carpet, therefore the condition is unknown (fig. 206).

**Figure 206.** Carpet covers wood floors in Room 302. (NPS)
