Re: Miller Bridge Piers, Horseshoe Bend National Military Park  
Documentation for stabilization and repair scenarios  
WJE No. 2018.4595

This letter report and the accompanying conceptual drawings and cost estimate provide documentation of the stabilization and repair scenarios for the Miller Bridge Piers identified by the National Park Service for further evaluation.

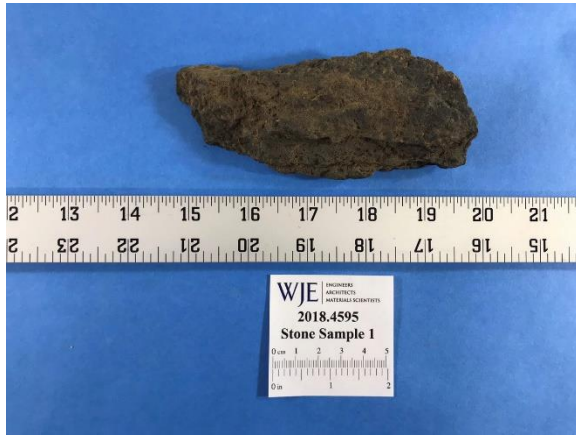
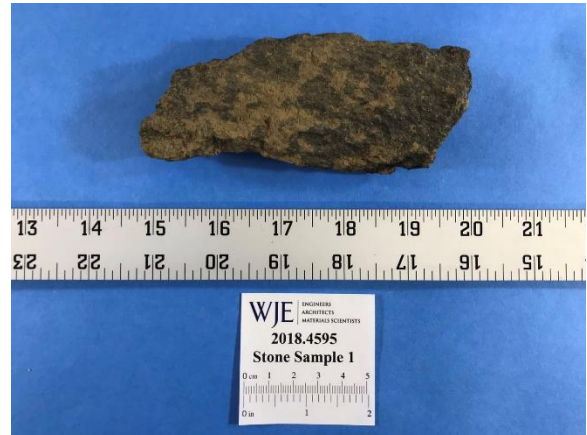
The appearance of the two submitted stone samples is shown in Figure 5 and Figure 6. The stone samples appeared black on their exterior surfaces, due to biological growth and dirt accumulation.

*Figure 5. Images of Stone Sample 1, as-received. Note the overall dark brown to black appearance of the samples.*

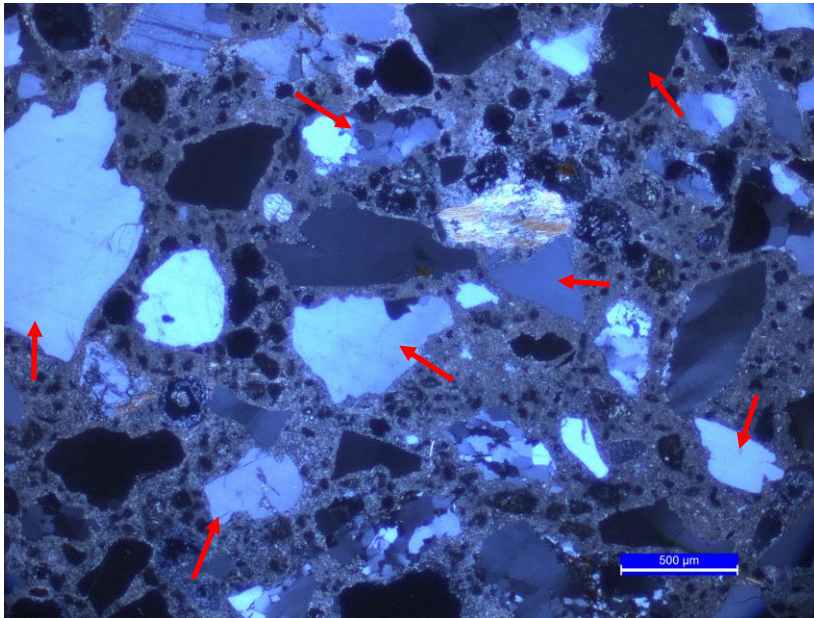
In each examined sample, the sand volume in the examined mortar samples appears normal to slightly undersanded, compared to modern requirements. Major constituents of the sand, which is subangular in shape, are quartz, quartzite, and biotite mica minerals (Figure 9). Trace amounts of burnt wood and other rock particles are observed. The mortars contain entrapped air voids, but do not exhibit spherical air voids due to the use of a chemical air entraining agent.

*Figure 9. Overview of Mortar Sample 3, showing the distribution of sand grains (red arrows point to some sand grains). XPL image.*

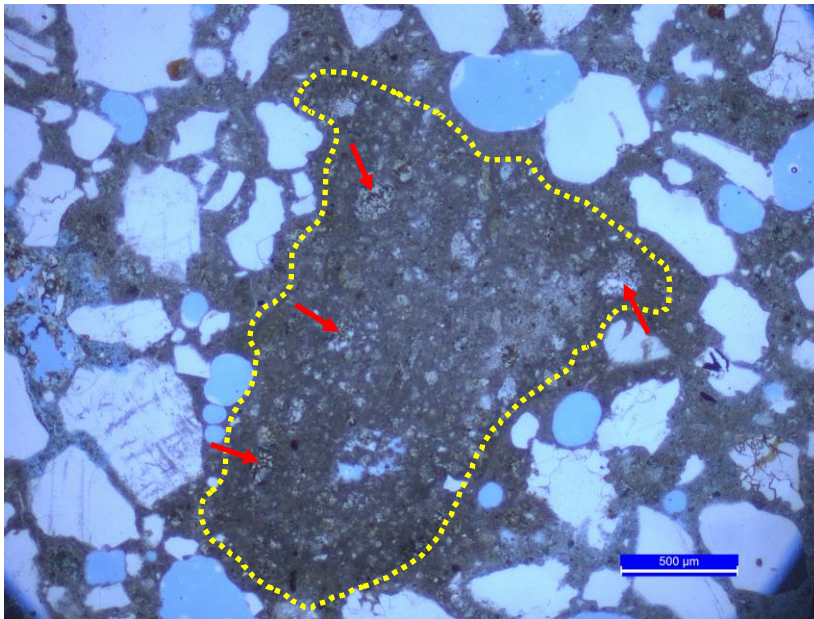
Sample 1 contains abundant cement lumps, measuring up to 7 mm in diameter. The cement lumps are large collections of portland cement and hydration products and do not contain sand grains (Figure 10). No hydrated lime lumps were detected. The matrix is fully carbonated, and secondary deposits of calcite are

*Figure 10. PPL image of Mortar Sample 1, showing one of the smaller cement lumps observed in the matrix (outlined with yellow dotted line, red arrows point to some of the coarser cement particles in the lump).*

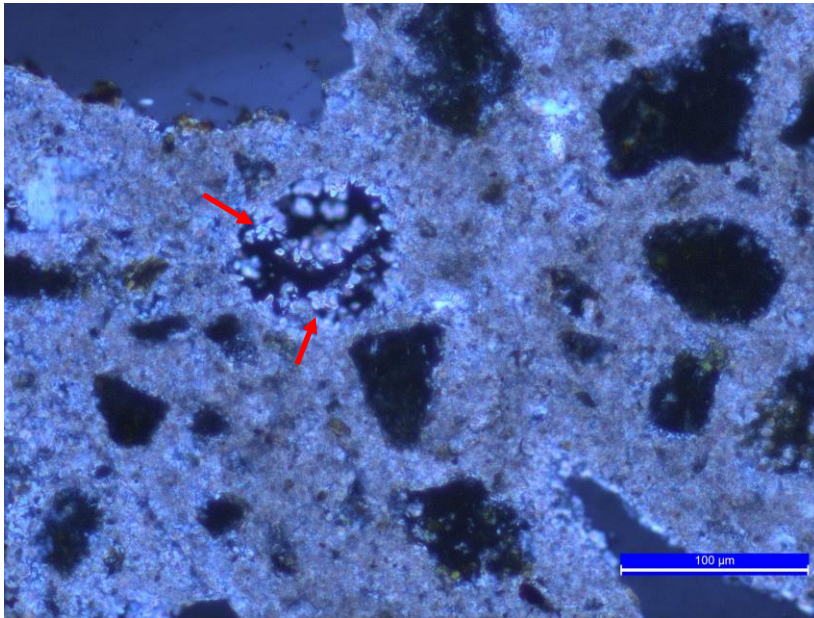
observed filling voids in the paste, due to dissolution and reprecipitation of calcium-based products in the matrix (Figure 11).

*Figure 11. XPL image of Mortar Sample 1, showing the fully carbonated matrix and secondary deposits of calcite in an air void (red arrows).*

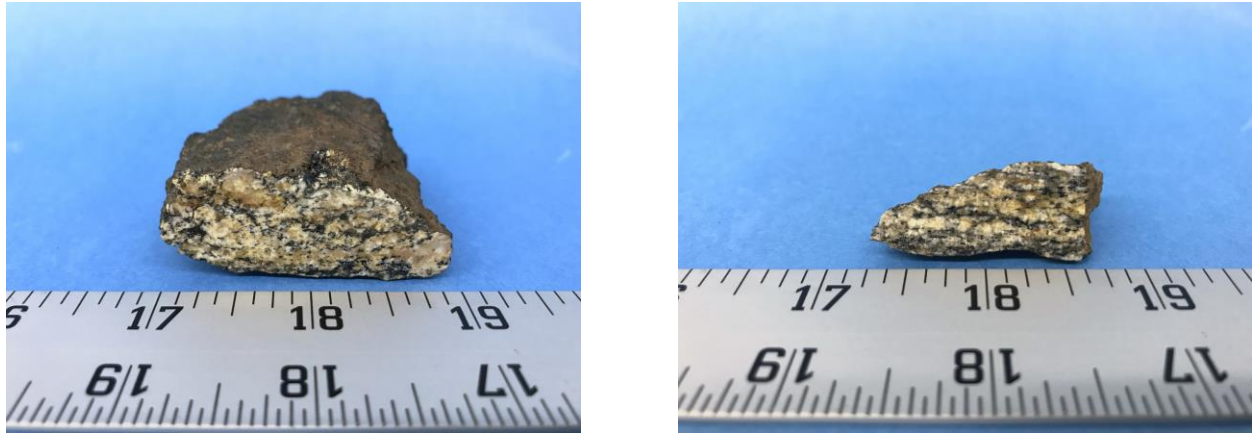
The stone samples examined are classified as quartz monzonite in composition and texture, with gneissic foliation. The particles show distinct foliation (banding, Figure 13 and Figure 14). The stones are composed mainly of light colored quartz and feldspar (albite and microcline) minerals, with foliation highlighted by the dark brown to black banding of biotite mica. Orange coloration within the lapped cross sections and coating the samples is due in part to iron bound within minerals, as well as oxidation of iron minerals within the stone. The exterior surfaces of the stones contains a combination of oxidation products, biological growth, and dirt accumulation.

*Figure 13. Lapped cross sections of Stone Sample 1 (left) and Stone Sample 2 (right) showing the distinct foliation of the stone. Note the discolored exterior surfaces of the stone.*

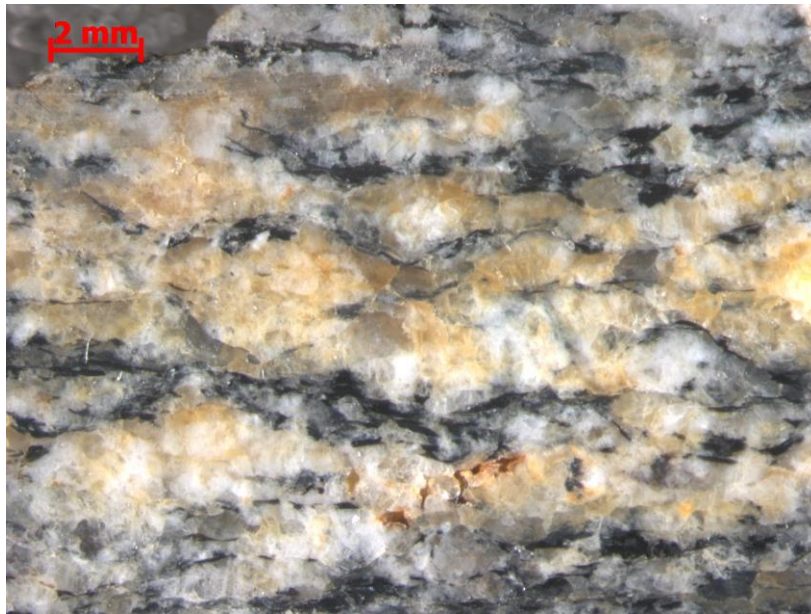
*Figure 14. Magnified image of Stone Sample 2 showing the foliation highlighted by black biotite.*
