Manassas National Battlefield Park  
Manassas, Virginia

# The Stone House—Historic Structure Assessment Report

## *Manassas National Battlefield Park*

2015

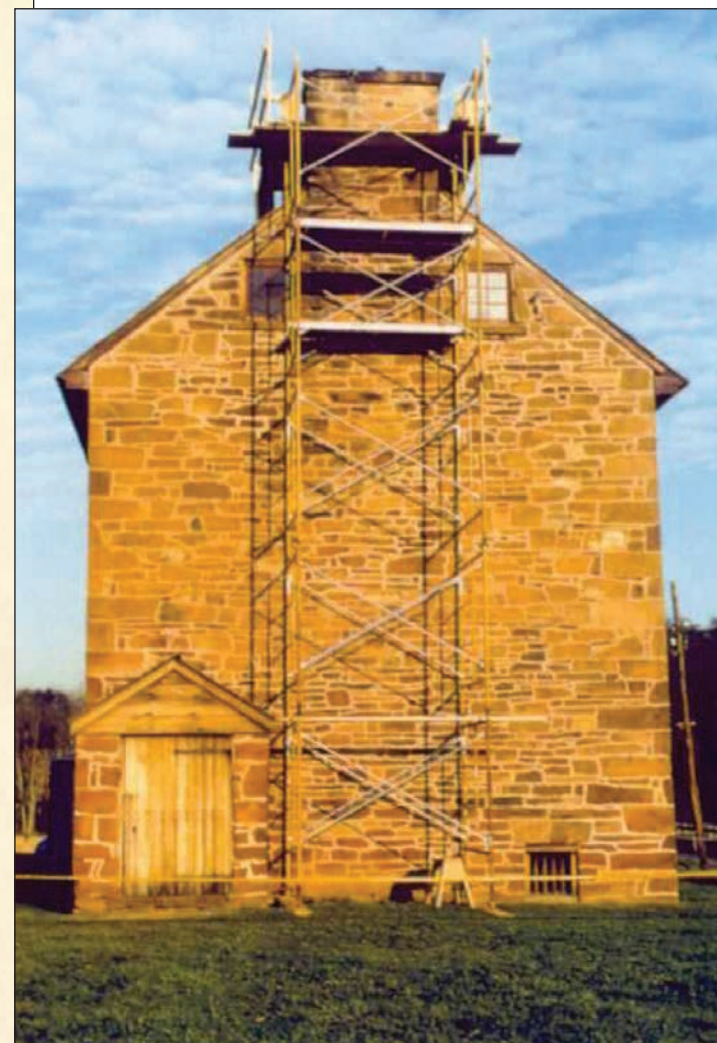
Figure 41: (left) Old Stone House chimney repair and reroofing project report, 1993; (above) Stone House west chimney prior to installation of blue stone chimney cap.

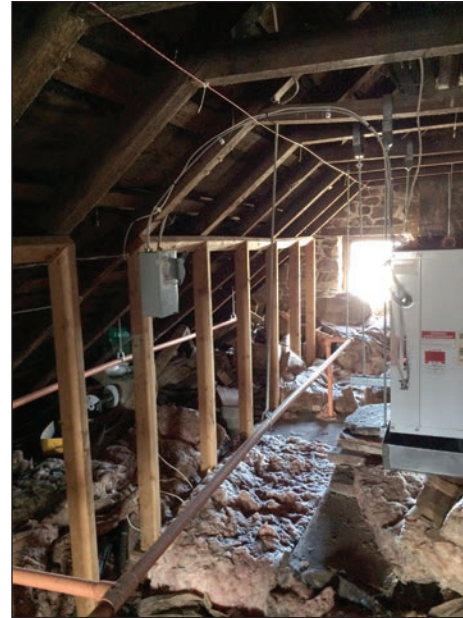
Figure 62: 2015 east gable end with rafter bracing.

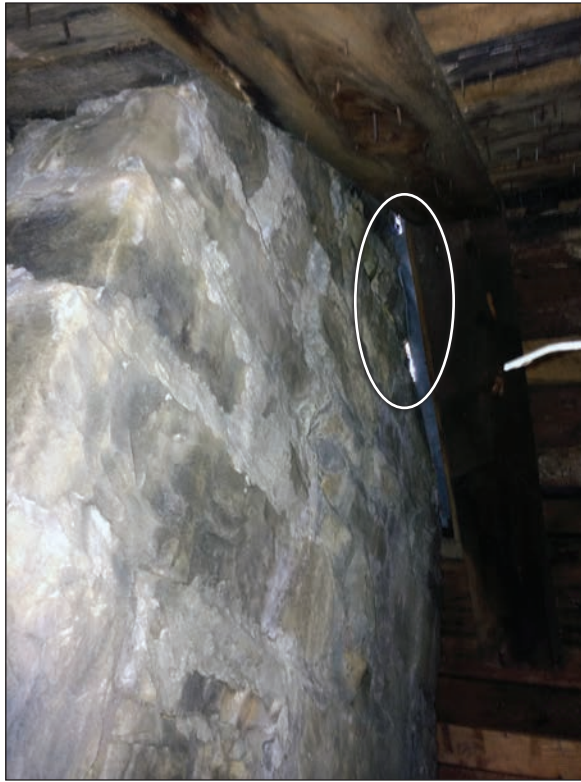
Figure 63: Daylight between roof and east chimney.

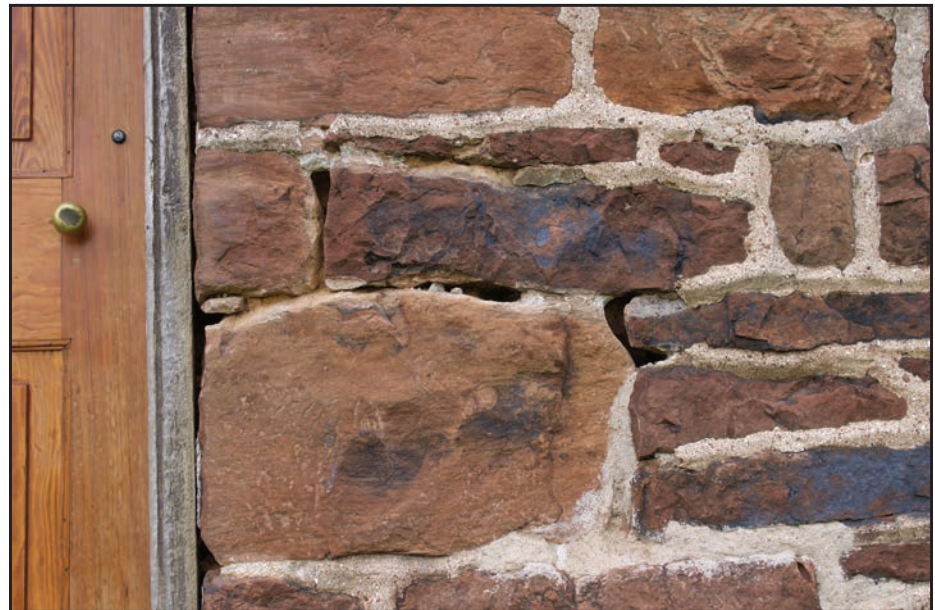
Figure 69: North elevation detail – mortar lost.

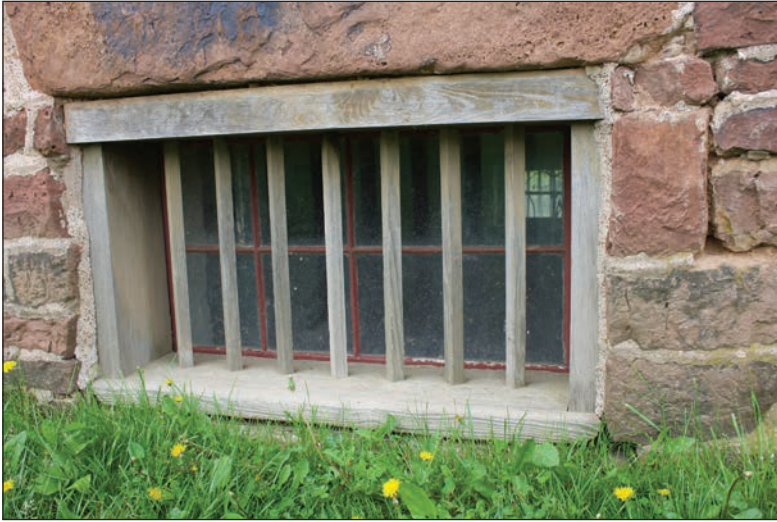
Figure 70: North elevation, window 004 – mortar lost.

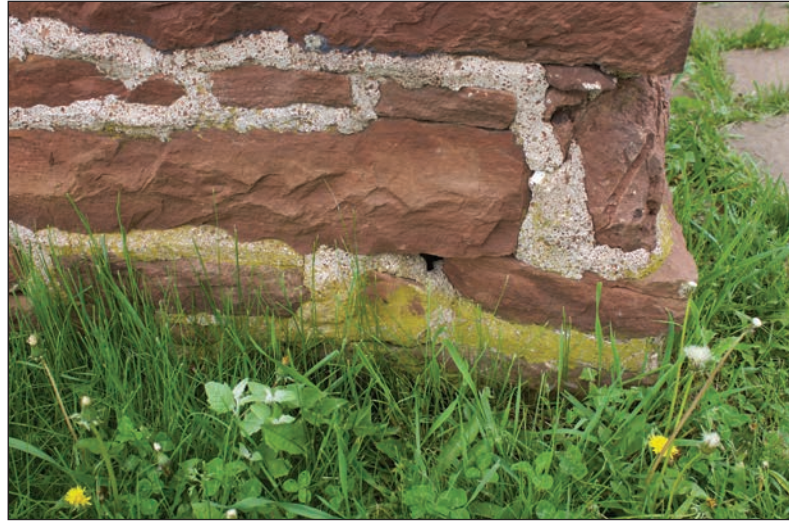
Figure 71: Northwest corner – mortar lost.

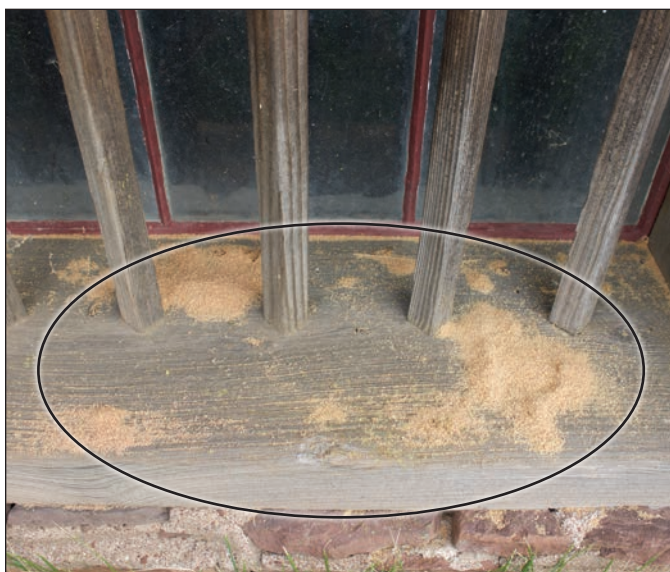
Figure 75: South elevation – window 002—sawdust accumulation.

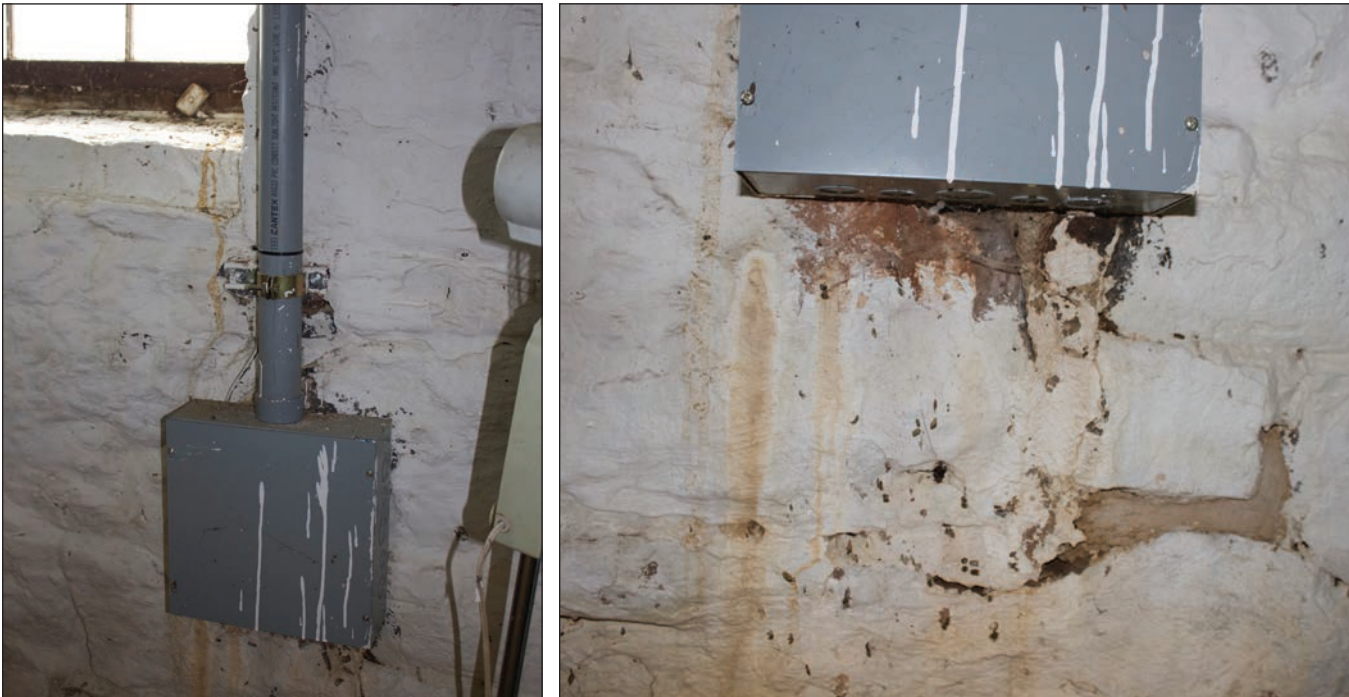
The basement walls in both the west and east rooms are in good condition with minor deficiencies. They are of masonry construction with white paint applied. At the location of the electric power box on the inside of the south elevation wall, some water staining is noted.

Figure 79: Electric junction box mounted on south wall of the basement, east side, 002.

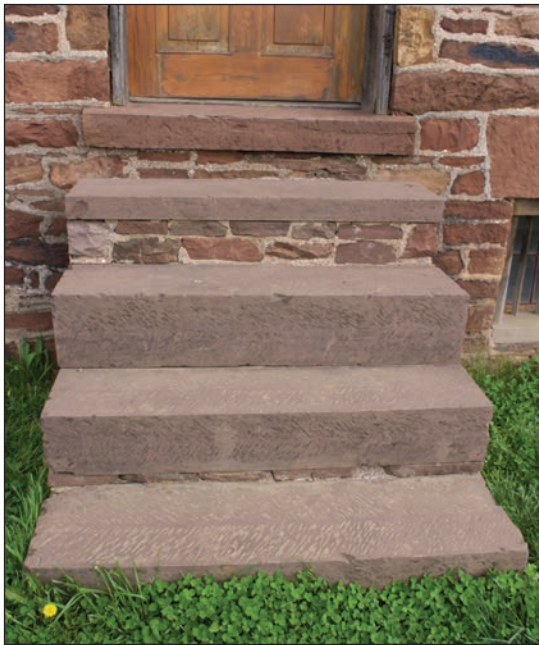
Both north and south exterior stairs are constructed of dressed stone and are in good condition. Some mortar repointing of the masonry under the threshold stone may be necessary. The roof construction is in good condition. Care should be taken to preserve the rafters, collar ties and knee-walls of the roof construction while the roof is being re-shingled.

**Figure 89:** South exterior stairs.

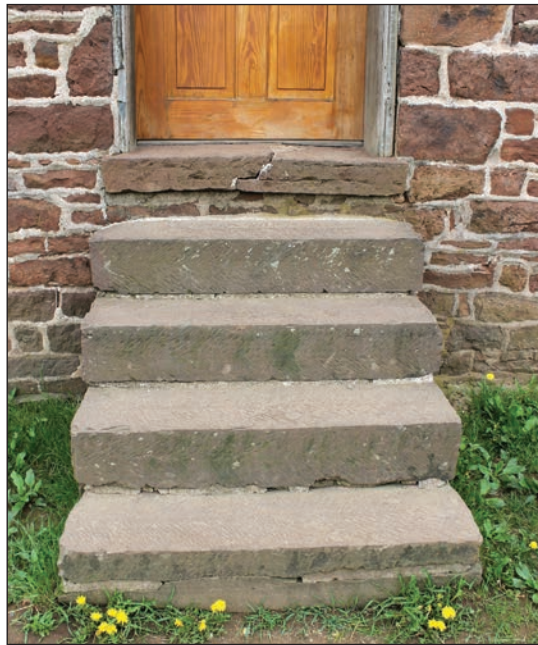
**Figure 90:** North exterior stairs.

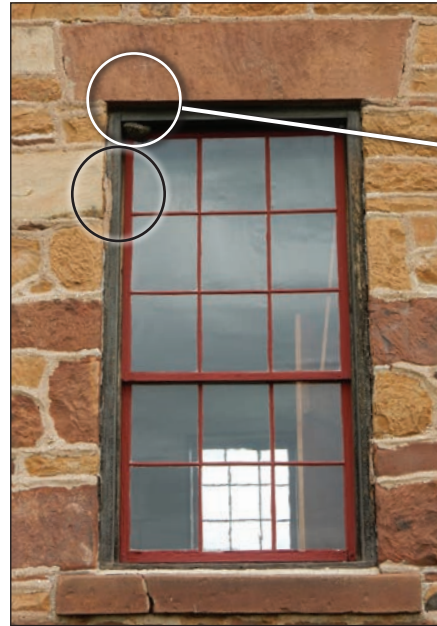
Figure 94: Window 102, first floor, south elevation. Only remaining mortar flashing (circled).

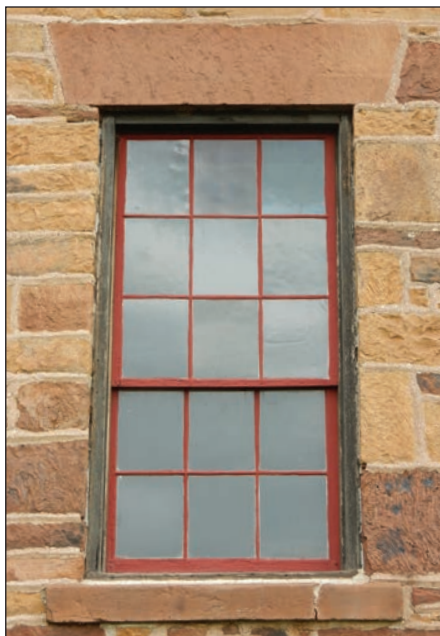
**Figure 96:** Window 103, first floor, south elevation. Lost mortar flashing.

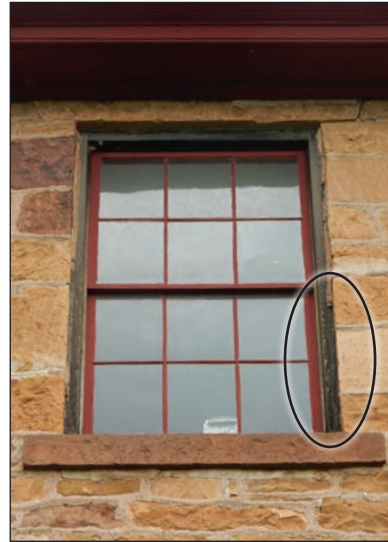
**Figure 102:** Window 202, second floor. Incomplete mortar flashing (circled).

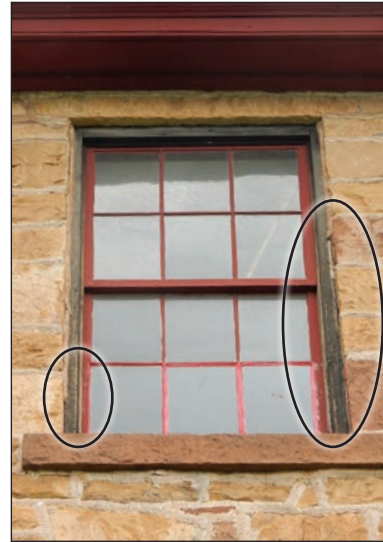
**Figure 103:** Window 203, second floor. Incomplete mortar flashing (circled).

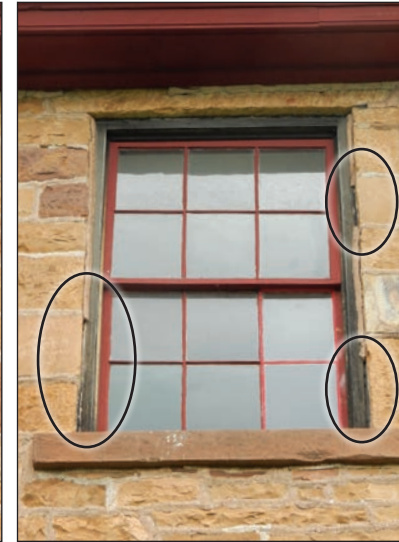
**Figure 104:** Window 204, second floor. Incomplete mortar flashing (circled).

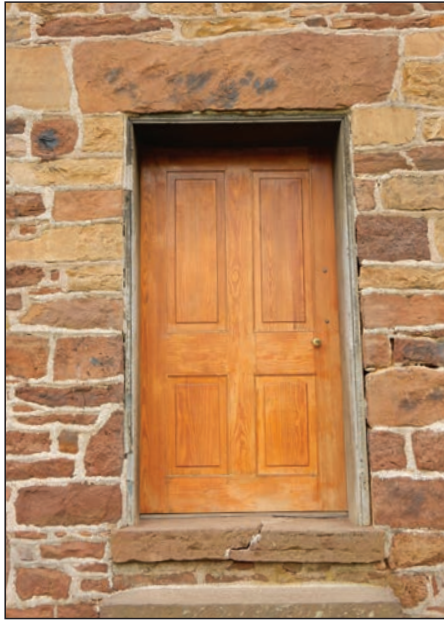
Figure 113: Door 101B, north elevation.

The exterior doors of the Stone House are in good condition without any major deficiencies. The main and rear entrances are four-paneled doors without lights. The main entrance door is recessed with a three-light transom window flush to the exterior wall. The basement access door is board and batten with large hand-wrought, iron strap hinges and a thumb latch opener.

**Treatment Recommendation:** Routine maintenance should be sufficient to sustain the current condition. The basement access door requires staining to protect the wood.***B2030 Doors***

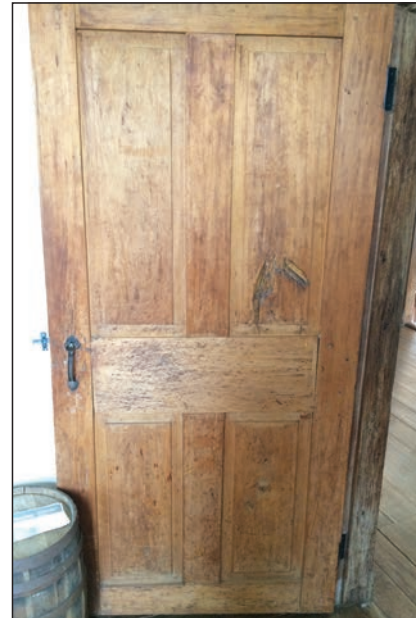
Figure 119: Dining Room door 103A.

The doors on the interior of the Stone House are not original to the construction of the house but were in place at the time of the 1960 Historic Structure Report by Orville Carroll. The first floor doors to the two east rooms are four-paneled. The basement door and tavern room door are board and batten. All four doors are stained walnut and have walnut casings. The hardware found in the house consists of T-strap hinges on the board and batten doors and butt hinges on the paneled doors. Earlier use of T-strap hinges on all doors is evident by the markings left

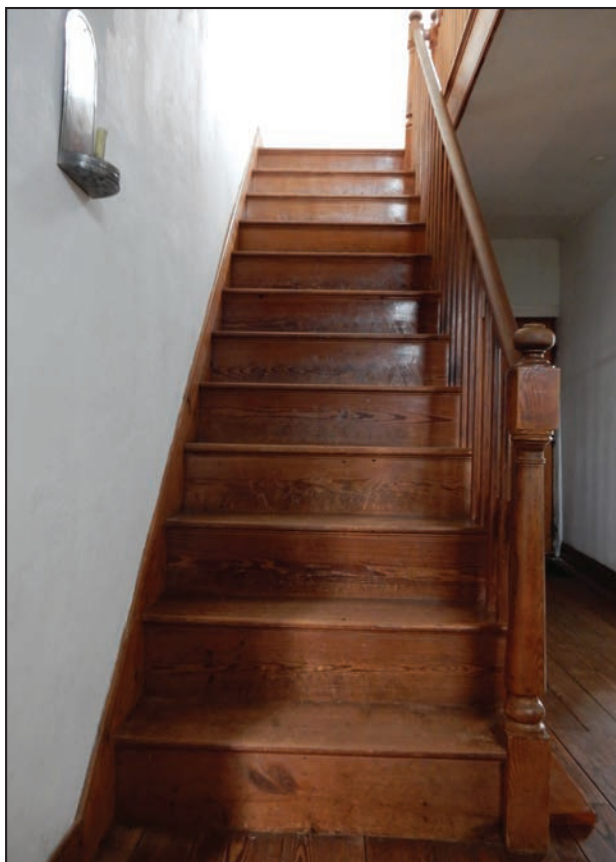
Figure 120: First floor stairs.

The basement stairs and first floor stairs date to the restoration of the Stone House completed by the Park Service in 1961. The first floor stairs, including the treads, risers, stringers, balusters, rail, and newel post were returned to their original configuration. They are in excellent condition.

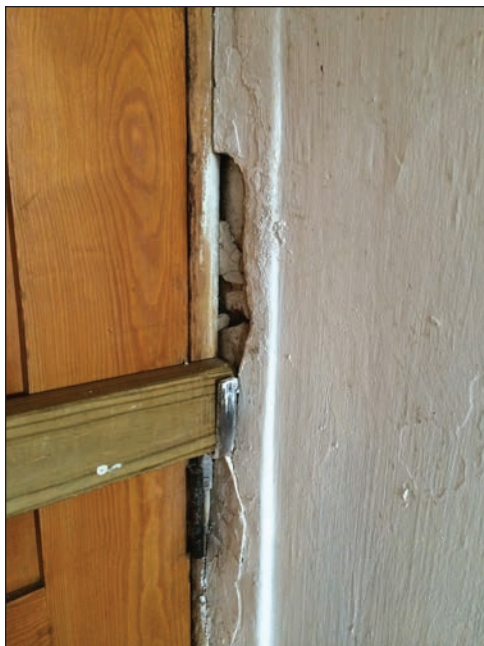
The floor, ceiling and wall finishes in the Stone House are in good condition without major deficiencies. The basement walls are whitewashed. The walls of the living spaces are whitewashed on top of plaster. In some places, plaster is cracked or delaminating to the scratch coat. However, none of these locations are very large and most are around window or door openings. The basement floor is constructed of flag stone and concrete and left in its natural state. The wooden floors in the living spaces of the stone house are waxed annually. The first floor joists and decking are exposed overhead in the basement and are painted white. With the exception of the second

Figure 124: Plaster delaminating around rear entrance door 101B.

**Deficiency:**    *Minor***Treatment Recommendation:** Routine maintenance should be sufficient to sustain the current condition.***D2040 Rain Water Drainage***

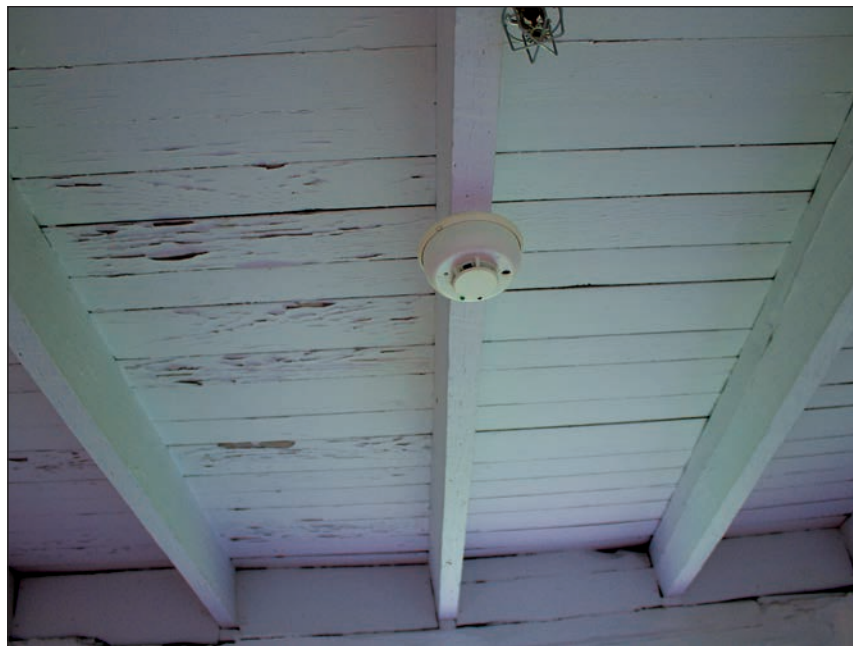
floor, Bedroom 303, the ceilings are all lath and plaster. The ceiling of room 303 has exposed floor joists and attic decking above and are painted white. An architectural investigation prior to the 1961 restoration of the Stone House completed by the National Park Service found that the attic decking of this room was pine, cut with a circular saw blade. No other lumber used in the original construction has this mark. Interestingly, at the present time the paint on the west side of the ceiling is consistently peeling, while the paint on the east side is intact. The cause of this is unknown, unless only half of the ceiling has been recently painted.

Figure 125: Ceiling of Bedroom 303. West side paint is peeling, east side is not.

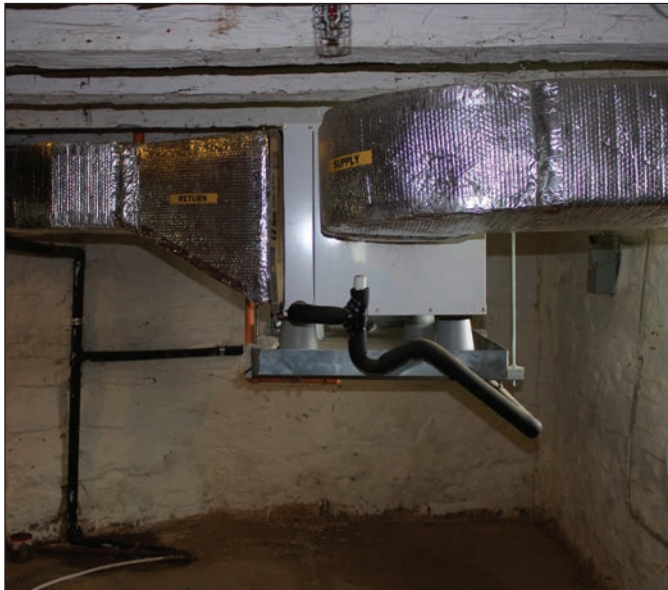
Figure 126: HVAC Distribution system in the basement.

The distribution system for heated and cooled air is composed of insulated sheet metal ductwork that originates in the basement and uses the existing chimney flues and fireplace openings as vents. The geothermal HVAC system dates to 2003. It is in excellent condition.

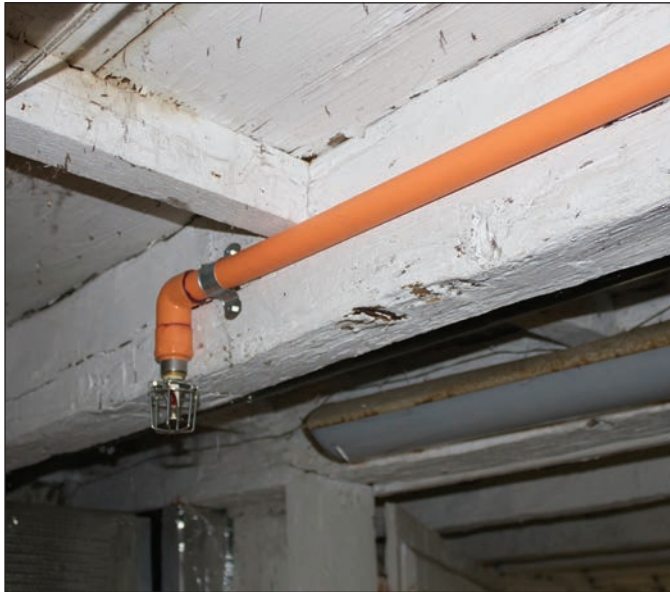
Figure 128: Sprinkler head in basement.

The fire protection systems in the Stone House, including sprinklers and smoke detectors, are in excellent condition. The fire suppression system was installed in 2007. In the basement and attic, the sprinkler heads project from the ceiling and the pipes are surface-mounted. In the living areas of the Stone House, the sprinkler heads are almost flush with the ceiling and the pipes are concealed within the ceiling.

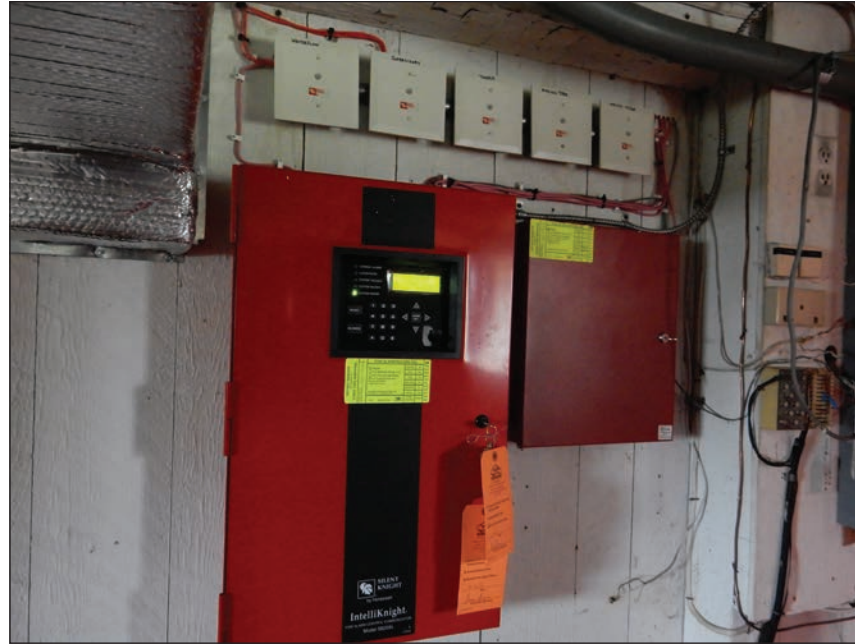
Figure 131: Fire alarm enunciation panel.

The electrical service in the Stone House is fed via underground cable that enters the basement at the south elevation. There is an overhead light on both the east and west sides of the basement and in the stairwell leading to the first floor. The main electrical distribution panel (MDP) is located on the partition wall of the east side of the basement. The fire alarm enunciator panel is also located on the partition wall, as are the thermostats. All of these services are in excellent condition.
