# Hatteras Light Station Oil House

## Historic Structure Report

Cape Hatteras National Seashore  
Hatteras Light Station  
Oil House  
**Historic Structure Report**

December 2017

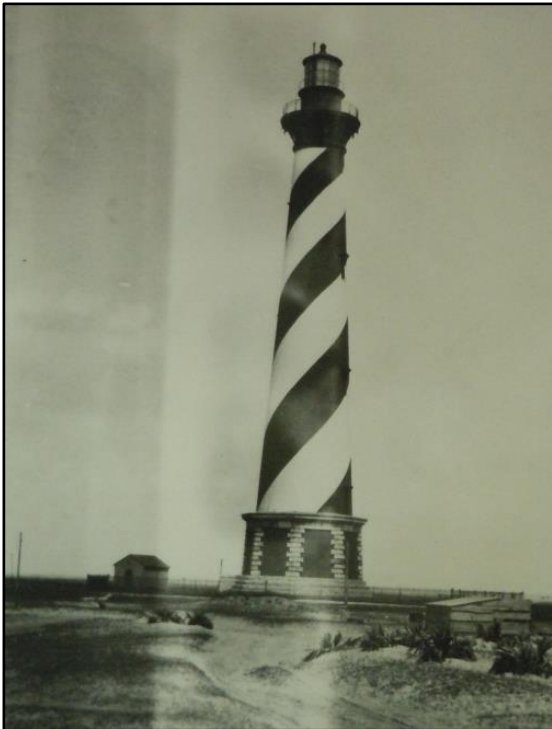
**Figure 9.** The oil house sometime before ca.1920 (the year the cast iron fence around the base of the lighthouse was replaced). The oil house shows no window on the south elevation. Photo: Cape Hatteras National Seashore Archives. Cropped by author.

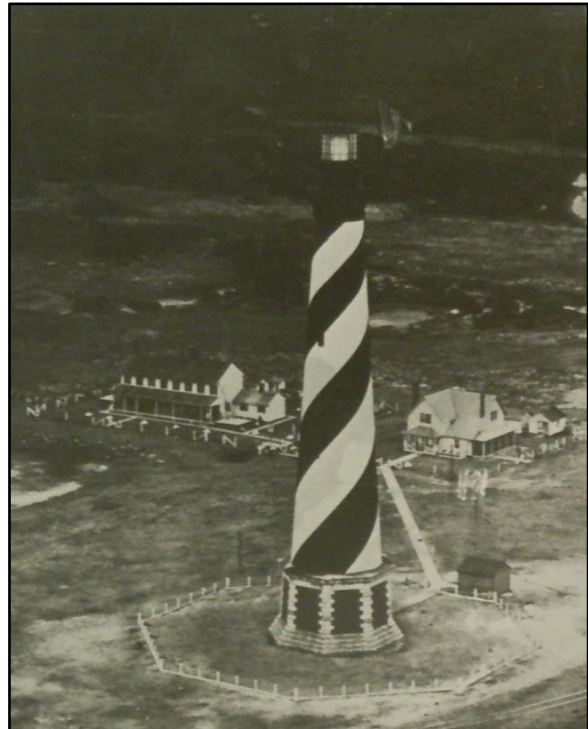
**Figure 10.** The south and east elevations of the oil house in 1932, from an Army Air Corps plane. No windows are yet located in the oil house. Photo: Hatteras National Seashore Archives. Cropped by author.

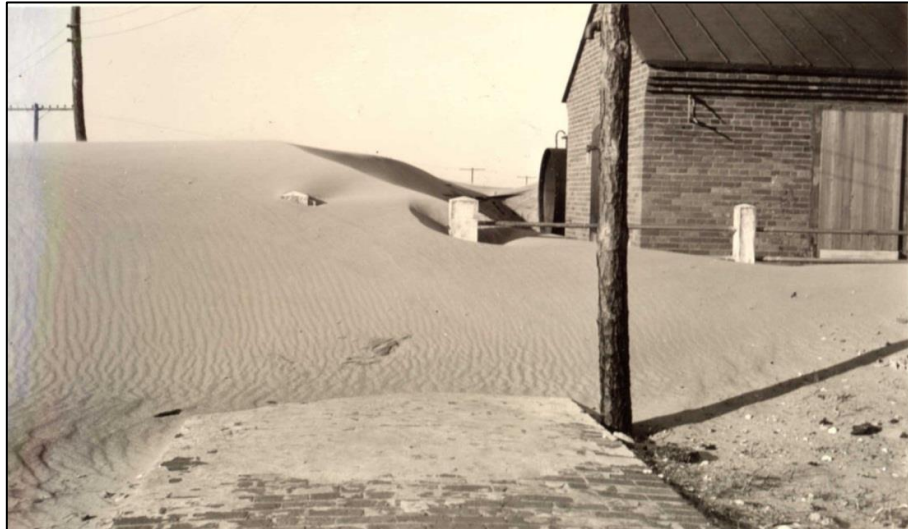
Simultaneously in 1934, a “Report on Cape Hatteras Ocean Beach Project” was completed for the Director of the NPS. It included a partial photograph of the Oil House. It shows a window opening, covered with plywood, on the south elevation, a standing-seam metal roof intact, the original iron door with strap hinges intact, and a large tank (for kerosene?) located on the north side of the building (fig. 11).

**Figure 11, right.** The condition of the Oil House in ca. 1934. Windows had been added by this time, but the original door and roof covering remained. Photo: Cape Hatteras National Seashore

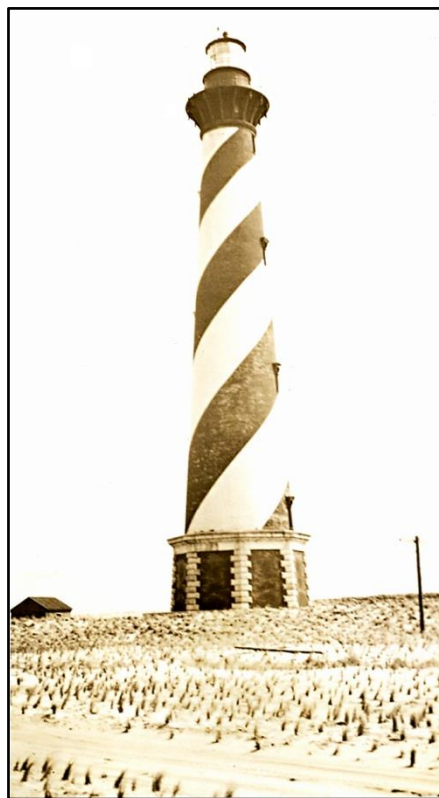
The Brick Oil House near the base of the lighthouse, primarily used for oil storage, but later used to house an electric generating plant, apparently is the original structure, because of the similarity of brick sizes, type of character of brick and methods of laying. This structure is at present in fair condition, but it is felt that a certain amount of reconditioning would be advisable. Window sash and glass should be replaced, the roof repaired, and a new door provided. The interior should be cleaned of accumulated sand and debris, and possibly the old oil drum racks reconstructed. The grading around this

**Figure 12.** The Lighthouse and part of the Oil House, March 15-18, 1937. Photograph included as part of "A Field Investigation at Cape Hatteras Lighthouse" by Charles W. Porter, Assistant [illegible]. Photo: Cape Hatteras National Seashore Archives.

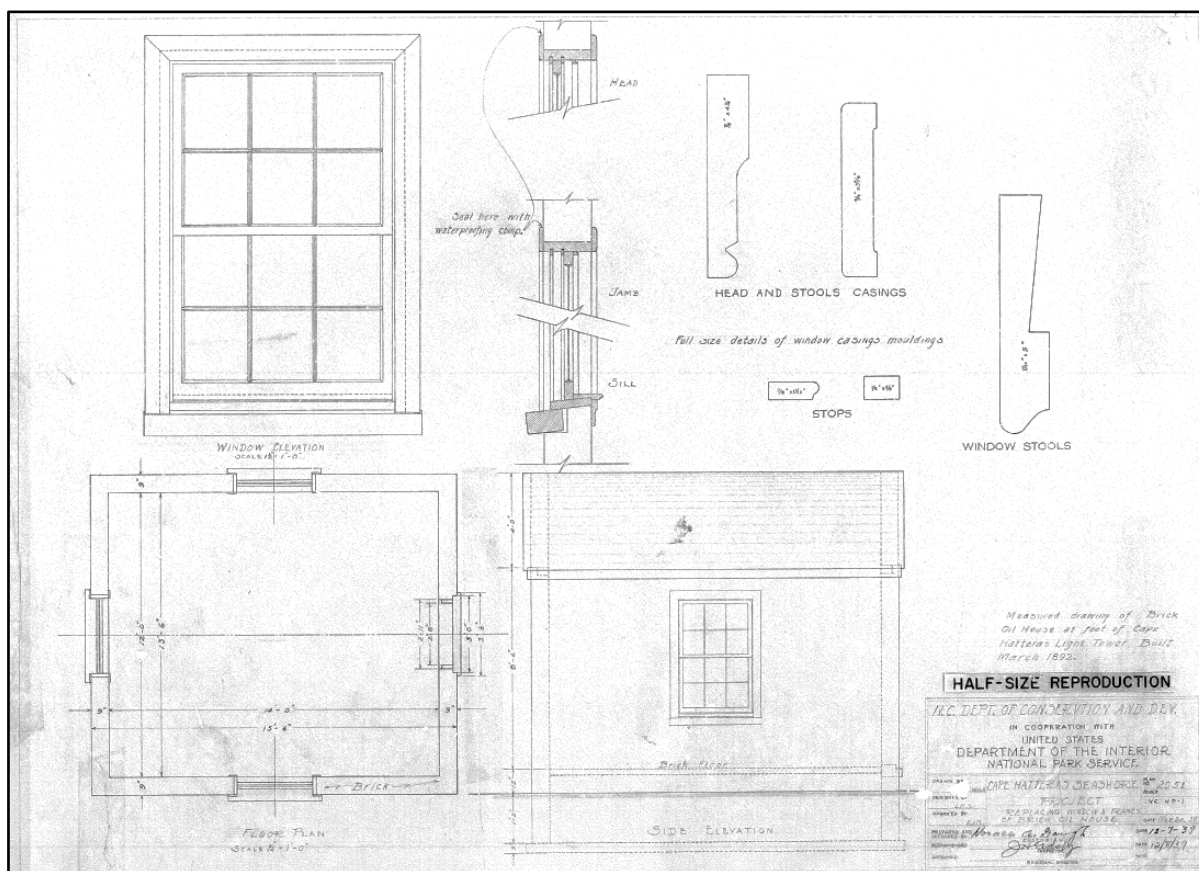
In August 1939, Byrum provided a summary of work at the CCC camp. With regards to the Oil House, he noted that the three windows were recently removed and replaced with square-top window frames and that arch-top frames had originally been in place. At the time of the summary, the new frames were decayed and should be replaced with arch-topped frames.<sup>28</sup> It is known that the window openings were added to the oil house between 1932 and 1934. It is unknown who originally installed the window openings, but it is likely that they were ever arch-topped (see fig. 11).

Drawings for the replacement of the windows and frames in the Oil House were approved by Dough on December 8, 1939. The drawings show square-topped frames and windows, with sections of moldings to be replicated (fig. 13).<sup>29</sup>

**Figure 13.** The November 20, 1939 drawing depicting the CCC-era repairs to the Oil House windows. Drawing: NPS DSC eTC No. CAHA 603 2051 Z1.

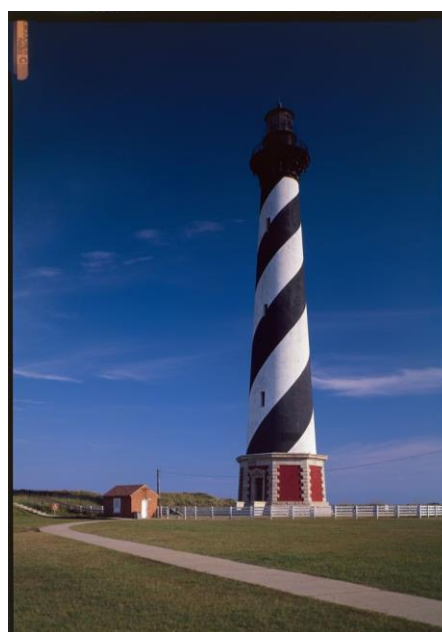
The Historic American Building Survey documented the Hatteras Light Station in September 1989 (fig. 17). The Oil House is seen with a louvered vent in the north elevation window opening, a non-historic door in the west elevation door opening, and an asphalt shingle roof.

**Figure 17.** The exterior of the oil house in 1989. Photo: HABS, <https://www.loc.gov/item/nc0432/>.

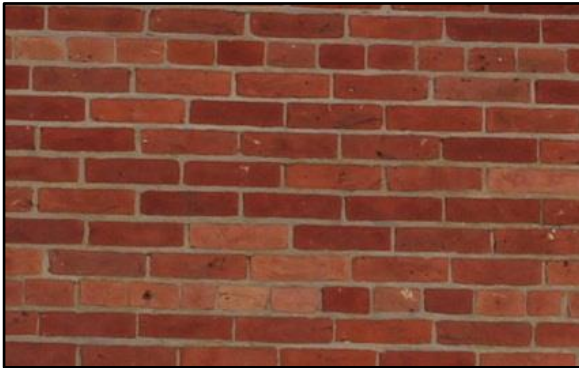
The brick exterior walls of the Oil House are original. The walls are 0'-9" thick (about 3 withes); the brick is laid in 7:1 common bond (seven rows of stretchers to one row of headers). The walls have always been unpainted on the exterior (fig. 51). At the top of the walls, four rows of brick step out to create a simple cornice (fig. 52). The interior faces of the walls exhibit several layers of paint (fig. 53). The exterior and exposed interior mortar joints have been repointed with a Portland cement-based mortar (see fig. 53).

**Figure 51.** The exterior walls of the Oil House are constructed of unpainted brick laid in a 7:1 common bond. Photo: HPTC, 05/12/16.

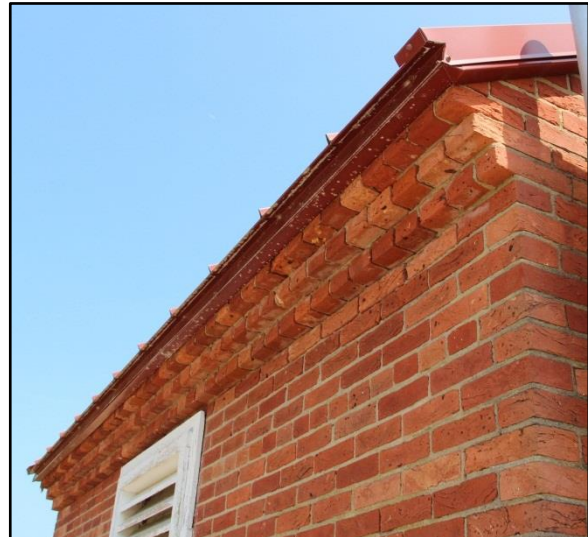
**Figure 52, right.** The brick cornice at the top of the exterior walls. Photo: HPTC, 05/12/16.

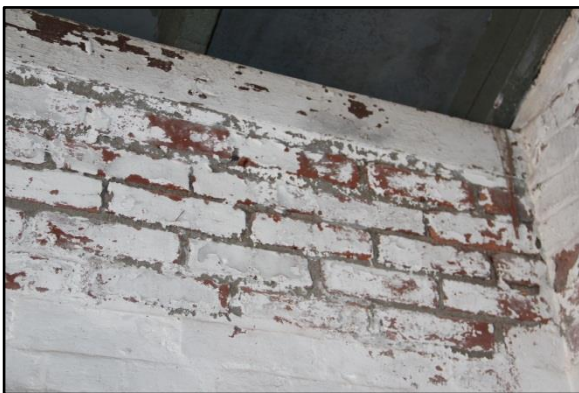
**Figure 53.** The interior faces of the exterior walls have been painted. Note the presence of Portland cement-based mortar. Photo: HPTC, 05/12/16.

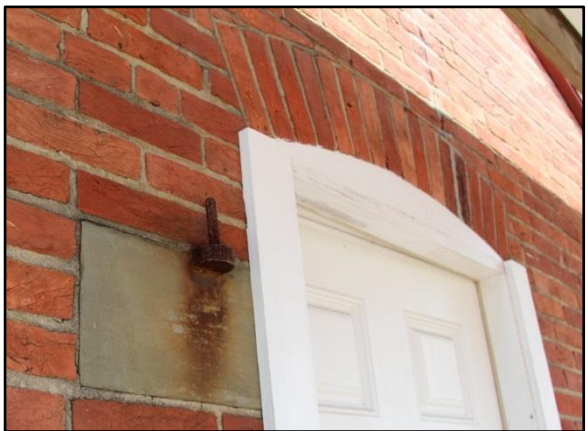
A brick jack arch is located over the 1892 exterior door opening (fig. 54); the sill is composed of slate (fig. 55). In addition, slate hinge blocks are located at the north side of the door openings, and retain historic pintels (see fig. 54).

**Figure 54.** A brick jack arch located at the exterior door entrance. Note also the slate embedded into the wall which holds a historic pintel for the original door. Photo: HPTC, 05/12/16.

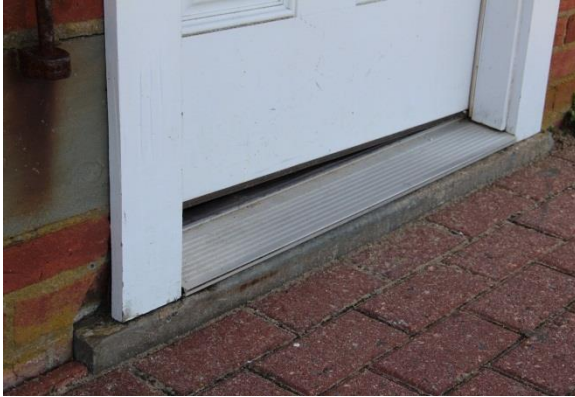
**Figure 55.** The slate door threshold is covered with a modern metal threshold. Note the slate block embedded in the exterior wall and metal pintel. Photo: HPTC, 05/12/16.

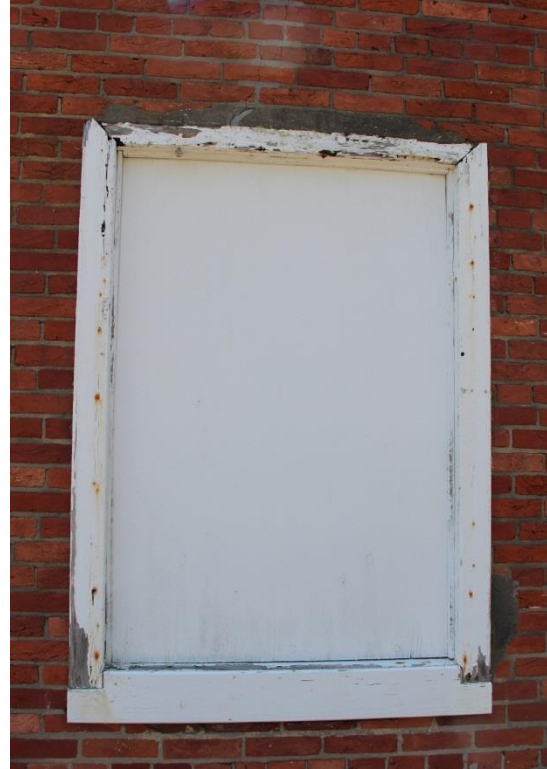
The ca. 1930s window openings have what are likely steel lintels and wood sills (fig. 56).

**Figure 56, right.** The ca. 1930s window openings have steel lintels covered with wood trim and wood sills. Photo: HPTC, 05/12/16.

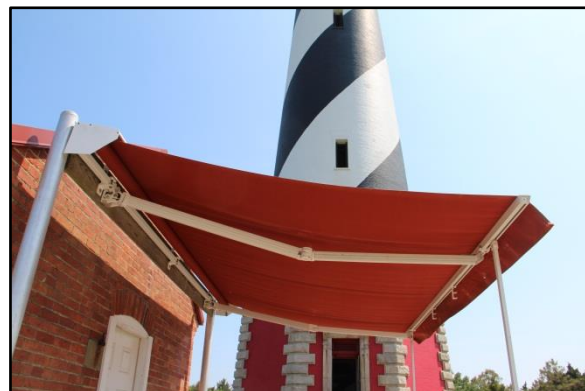
A modern metal and canvas awning is located on the west elevation (fig. 57). This non-character-defining feature was added to the building sometime after July 2005.

**Figure 57, right.** The modern awning located on the west elevation of the Oil House. Photo: HPTC, 05/12/16.

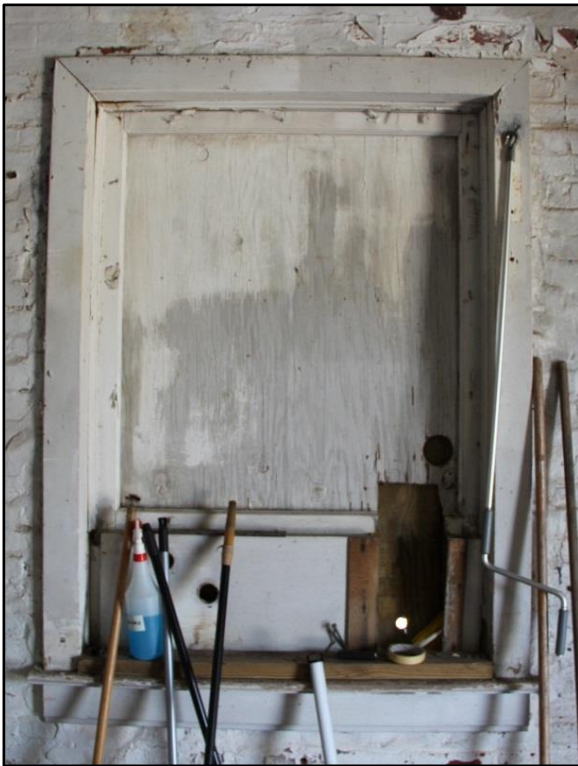
W101 (south elevation) is covered with painted plywood on the exterior. On the interior, the opening exhibits a non-original, oversized upper sash (no glass extant) and plywood infill below (fig. 59).

**Figure 59** The interior of W101. Photo: HPTC, 05/12/16.

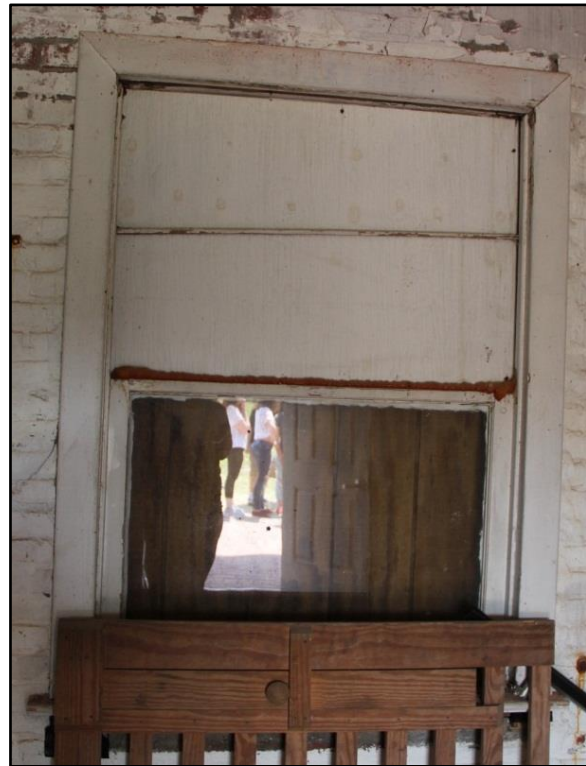
W102 (east elevation) is covered with painted plywood on the exterior. On the interior, the opening exhibits a painted plywood panel above a ca. 1950s single-lite wood sash (glass intact) (fig. 60).

**Figure 60.** The interior of W102. Photo: HPTC, 05/12/16.

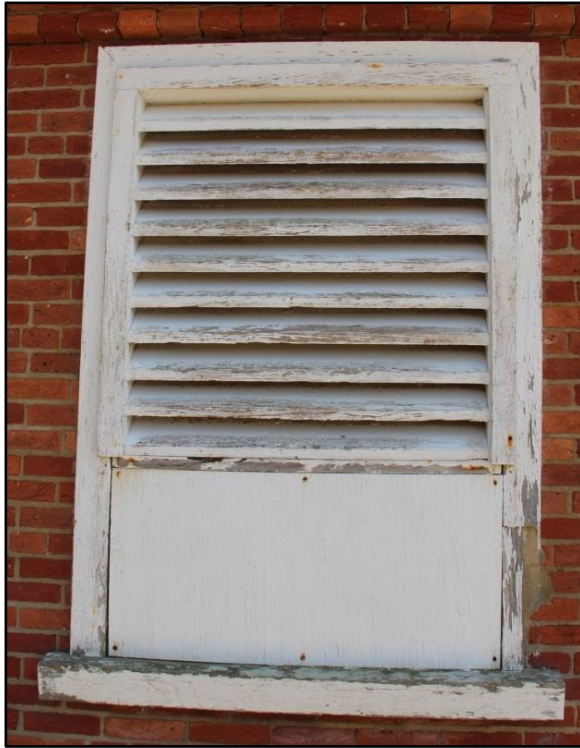
W103 (north elevation) exhibits a wood louvered vent above a painted plywood panel on the exterior (fig. 61). On the interior, a plywood panel houses a metal vent (fig. 62).

**Figure 61.** The exterior of W103. Photo: HPTC, 05/12/16.

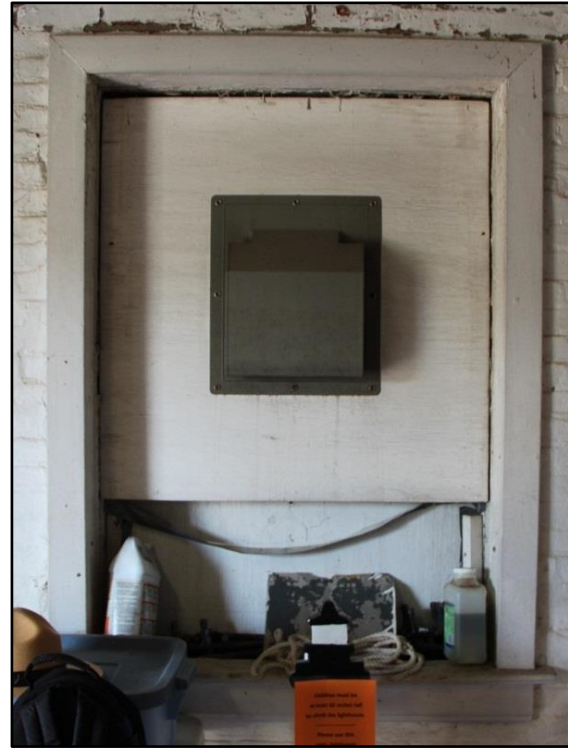
**Figure 62.** The interior of W103. Photo: HPTC, 05/12/16.

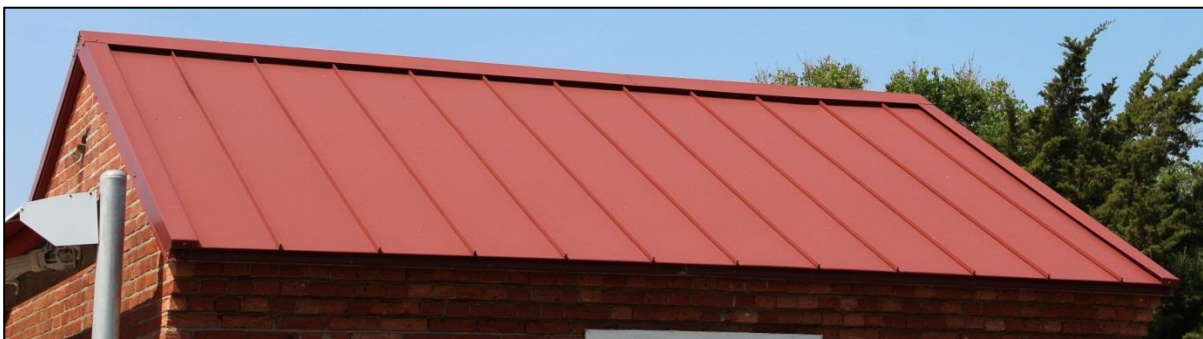
The Oil House was originally covered with a standing-seam metal roof: photographs from 1893, 1932, and 1934 show standing-seam metal extant. Asphalt singles were installed on the roof in ca. 1952, likely by the USCG; asphalt shingles were extant on the building through at least July 2005. The current painted standing-seam metal roof was installed since then (fig. 66).

**Figure 66.** The standing-seam metal roof atop the Oil House was installed sometime since July 2005. Photo: HPTC, 05/12/16.

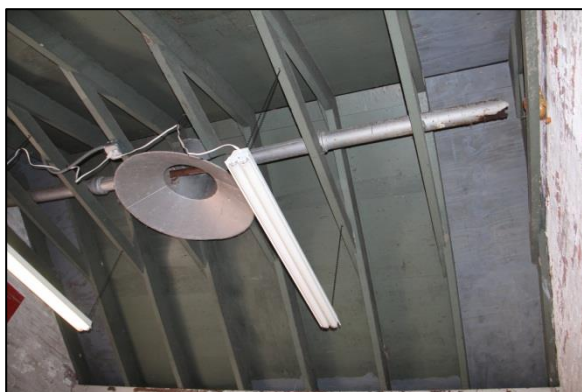
Metal components are located within the roof framing system (fig. 67). Their exact use is unknown, but is likely related to the USCG's use of the building as an auxiliary power generator. Similarly, prior to the building's move, a brick and concrete pedestal was located within the structure, which was used to support the USCG's generator (fig. 68). The pedestal was removed prior to the move; it is unknown if this feature has been retained in storage. Prior to this modern equipment, oil storage containers would have been located in the building. It is unknown when the containers were removed.

**Figure 67.** Metal components leftover from the Oil House's use as an auxiliary power generator. Photo: HPTC, 05/12/16.

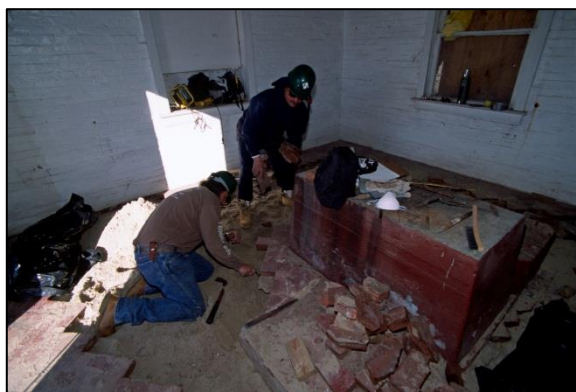
**Figure 68.** A concrete and brick pedestal was still extant in the building prior to its move. Photo: Cape Hatteras National Seashore Archives, 01/19/99.

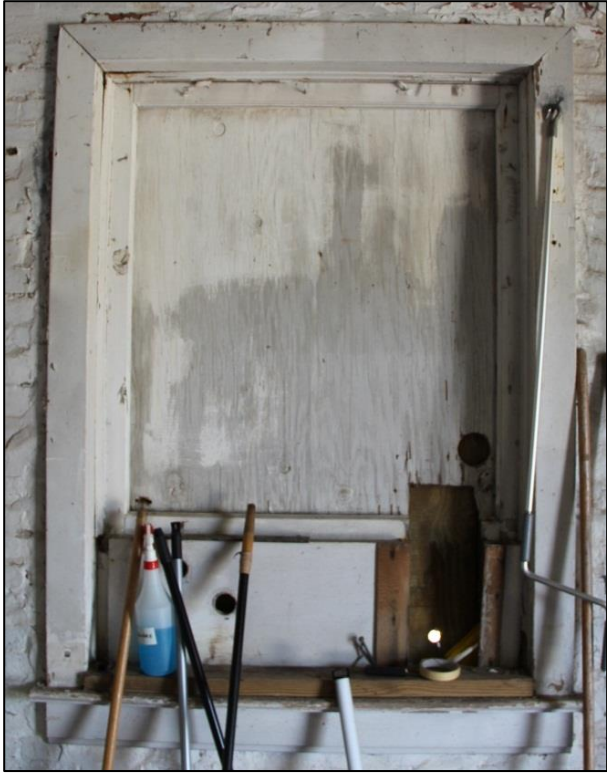
Simple painted interior wood trim is located around all of the windows (fig. 69). The door remains unfinished on the interior (fig.70). There are no other types of trim located in the interior of the building. The trim is likely original, as it matches that depicted on the 1939 window replication drawings.

**Figure 69.** Simple interior wood trim at one of the windows. Photo: HPTC, 05/12/16.

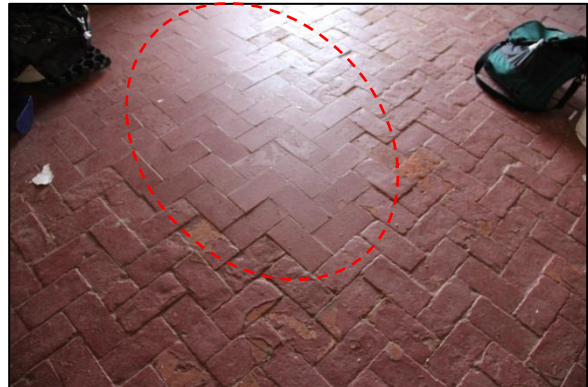
The brick herringbone interior floor is laid over the modern concrete slab on grade (1999 move) and a layer of paver setting sand. The bricks of the floor were removed systematically and numbered and reinstalled in their exact location (fig. 71). New bricks were installed in the center of the room where a pedestal was located.

**Figure 71, right.** Historic bricks were relaid in their exact original location. Modern bricks were used as infill (within dotted area). Photo: HPTC, 05/12/16.

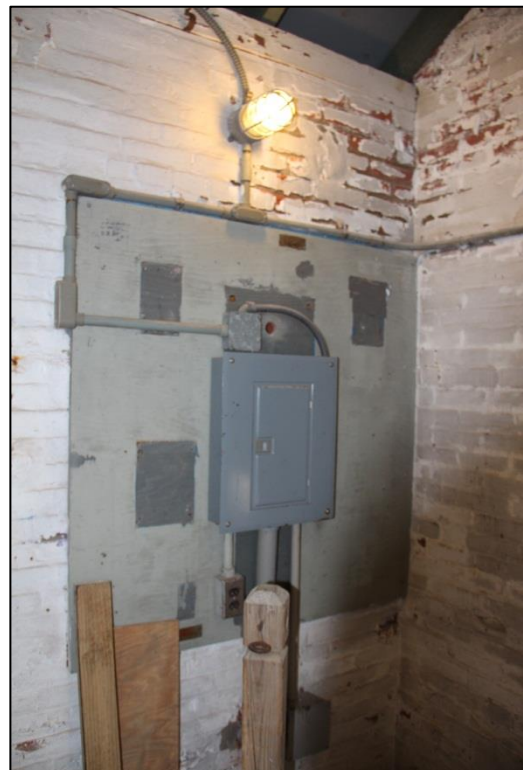
The modern electrical system, including panel, wiring, outlets, switches, and lighting appear to be in good condition (fig. 72).

**Figure 72, right.** The modern 200-amp electrical panel and a light. Photo: HPTC, 05/12/16.

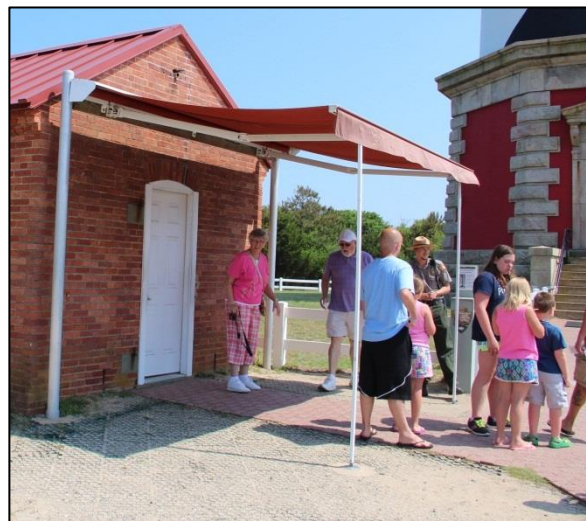
The modern brick-paved walkway leading to the exterior door was installed after the building's move in 1999 (ca. 2000) (fig. 73).

**Figure 73, right.** The modern brick sidewalk leading to the exterior door of the Oil House. Photo: HPTC, 05/12/16.

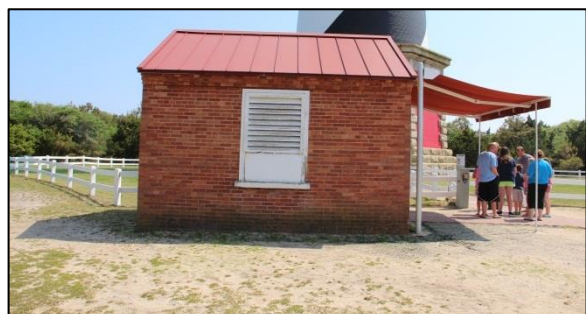
The site drainage around the dwelling is neutral, meaning draining water can remain pooled around the building rather than draining away (fig. 74).

**Figure 74, right.** Neutral drainage around the Oil House. Photo: HPTC, 05/12/16.

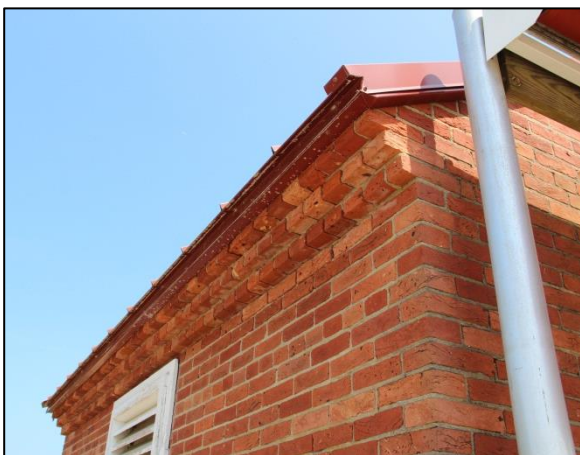
**Figure 76.** The projecting brick stepped cornice is original and character defining. Photo: HPTC, 05/12/16.

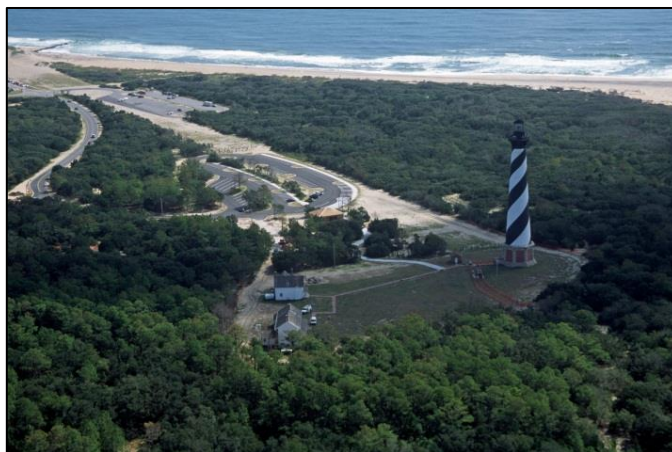
**Figure 78.** After the building's move, the Oil House retained its coastal setting and its relation to other historic buildings on site. Photo: Cape Hatteras National Seashore Archives, 09/00.

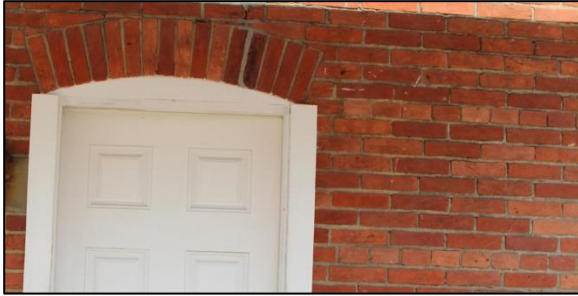
**Figure 79.** The brick arch over the door opening and common-bond brickwork are original and character defining. Photo: HPTC, 05/12/16.

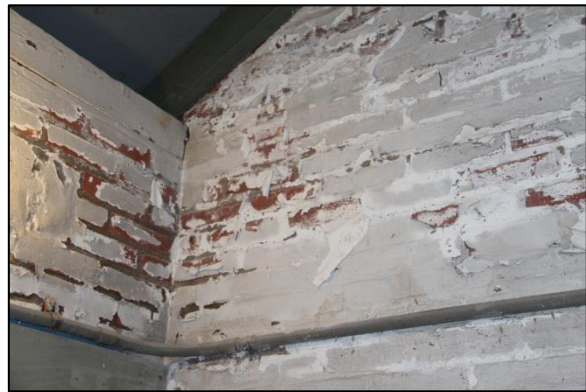
**Figure 81.** Painted brick walls seen on the interior of the building. Photo: HPTC, 05/12/16.

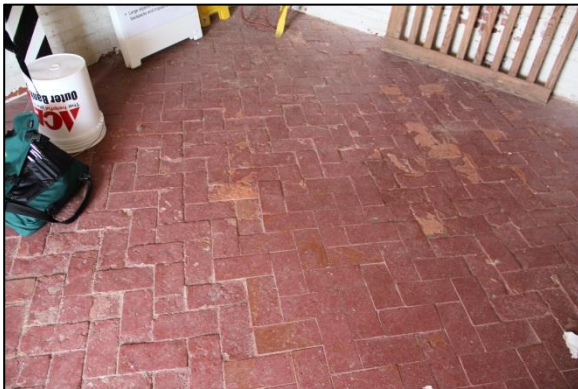
**Figure 82.** Character-defining brick floors were re-laid and patched after the building's move. Photo: HPTC, 05/12/16.

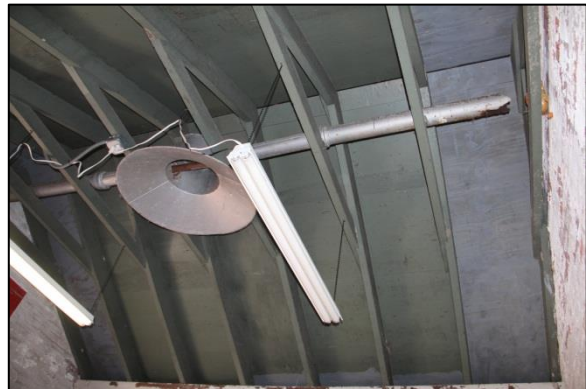
**Figure 83.** The roof framing is exposed on the interior of the building. Photo: HPTC, 05/11/16.
