**Martin Luther King Jr. Birth Home**  
**501 Auburn Avenue, NE**

# **Historic Structure Report Amendment**

**September 2019**

**Martin Luther King Jr. Birth Home**  
**501 Auburn Avenue, NE**  
**Martin Luther King, Jr. National Historical Park**  
**Atlanta, Georgia**

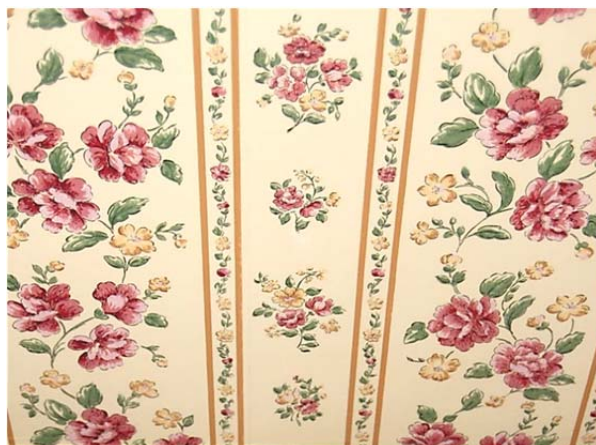
The currently installed wallpaper in the home appears to be the paper selected by Mrs. (Alberta) King during the 1974 renovation. The wallpaper in the living room (F-3) and dining room (F-5) is an off-white paper with a pink and yellow floral pattern and vertical gold stripe (Figure 50). The wallpaper in the master (Williams-King) bedroom (F-4) is also an off-white floral pattern with a vertical gold stripe, but with a more muted and delicate design than the bold floral pattern in the living and dining rooms (Figure 51). The wallpaper installed in Christine's bedroom (F-7) has a medium pink background with a vertical, white floral and vine pattern (Figure 52). Wallpaper in the second-floor front bedroom (S-3) has the same pink floral pattern as the first floor, but with a blue tinted background and purple stripe (Figure 53). The birth room (S-4) wallpaper has a gold tinted background with gold and pink vertical bars with pink and blue flowers and coiled vines (Figure 54).

**FIGURE 50.** Wallpaper at living room (F-3) and dining room (F-5).

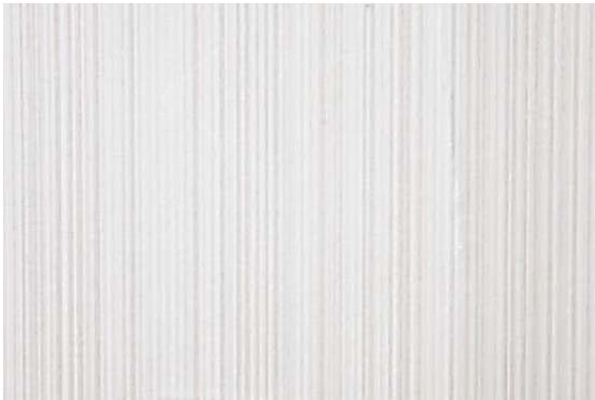
Wallpaper in the halls on both floors appears to have been recently replaced with a contemporary vertical stripe pattern (Figure 55). The design can be seen against what is likely the previous vertical stripe pattern at isolated locations where devices have been removed since the installation of the newer wall covering (Figure 56).

**FIGURE 55.** Typical wallpaper at foyer, stair, and halls (F-1, F-2, S-1, S-2).

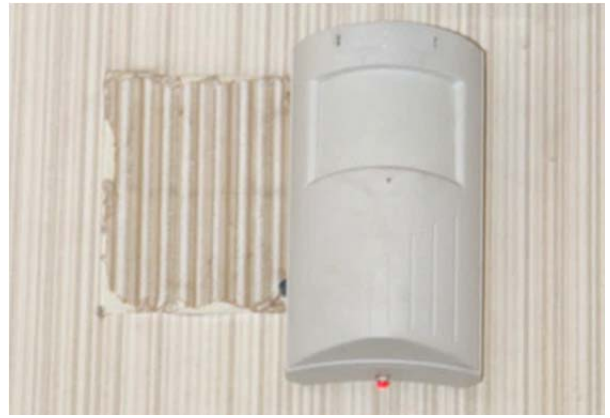
**FIGURE 56.** Exposure of previous wallpaper at wall mounted device in hall.

- It was observed that wallpaper in the hallways on both floors was recently replaced with a vinyl wall covering (refer to Figure 56). Additional stock of this new wall covering was stored in the spare bedroom (S-6) on the second floor.

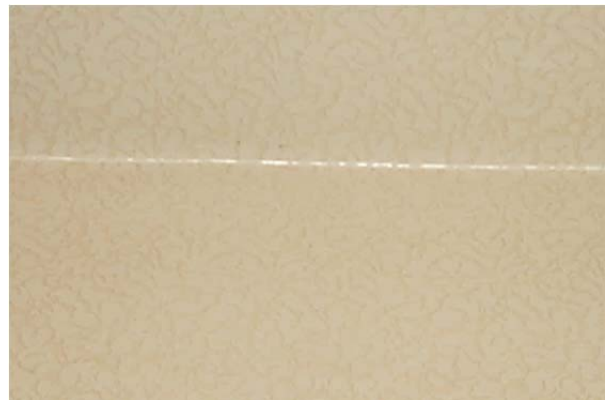
**FIGURE 57.** Typical wallpaper at ceiling and frieze.

The ceiling wallpaper is typically continued down the frieze panel, above the picture rail. The pattern is an organic gold print on a cream-colored background (Figure 57). This print is typical in all rooms. The age of the ceiling fabric is not known given the available documentation or photographic information.

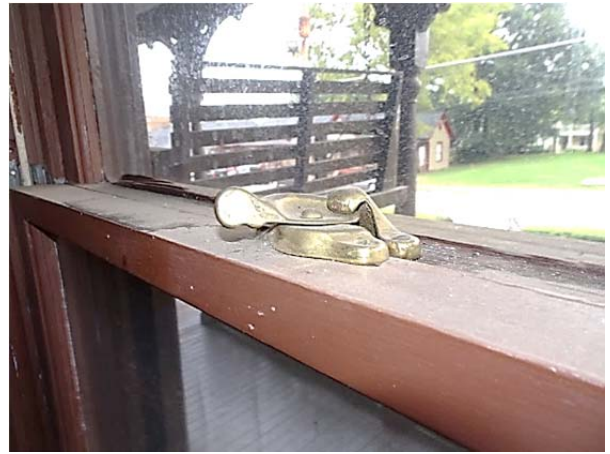
**FIGURE 62.** Typical brass sash lock at window meeting rail.

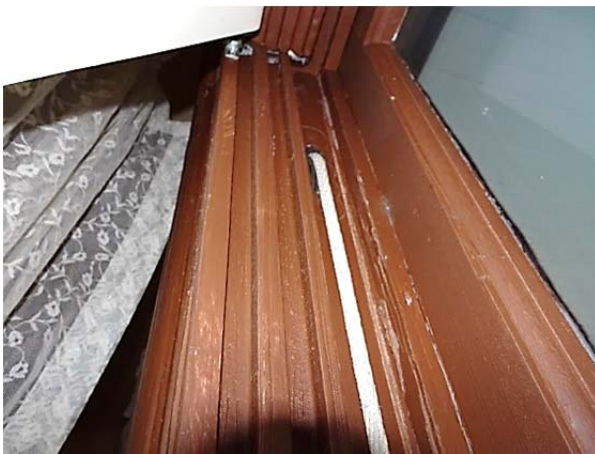
**FIGURE 61.** Typical rope chord at lower sash track.

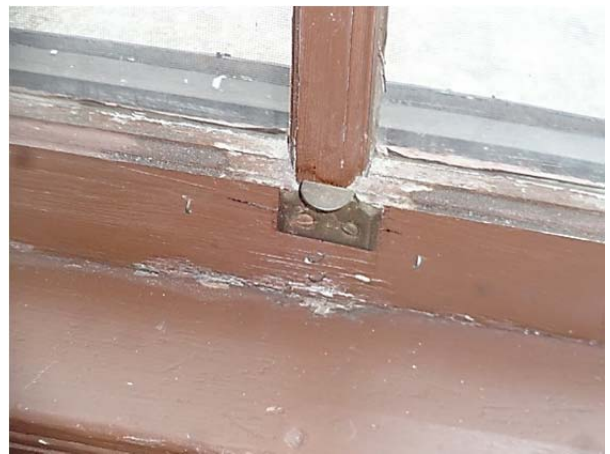
**FIGURE 63.** Typical surface-mounted brass lift at bottom rail.

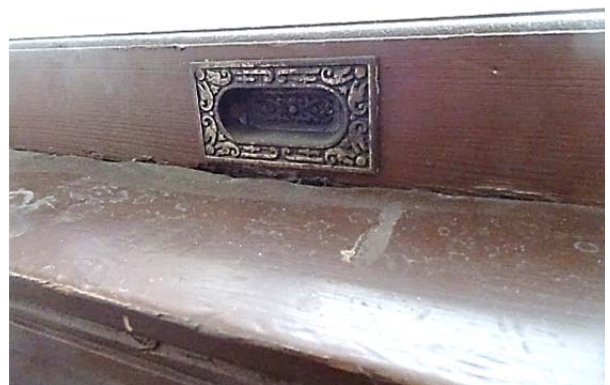
**FIGURE 64.** Decorative brass inset lift pocket at bottom rail.

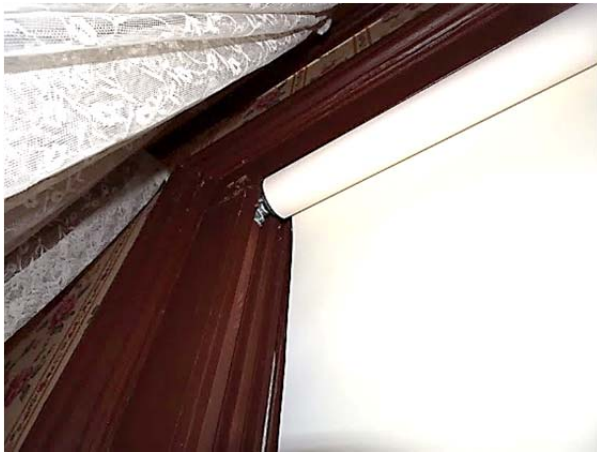
**FIGURE 65.** Typical roller shade at window opening.

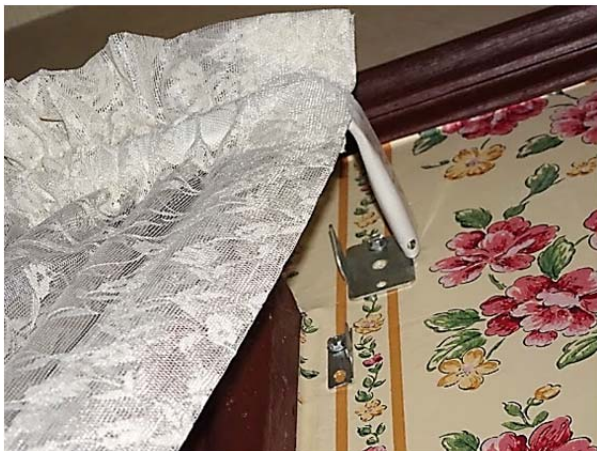
**FIGURE 66.** Curtain rod anchored to wall.

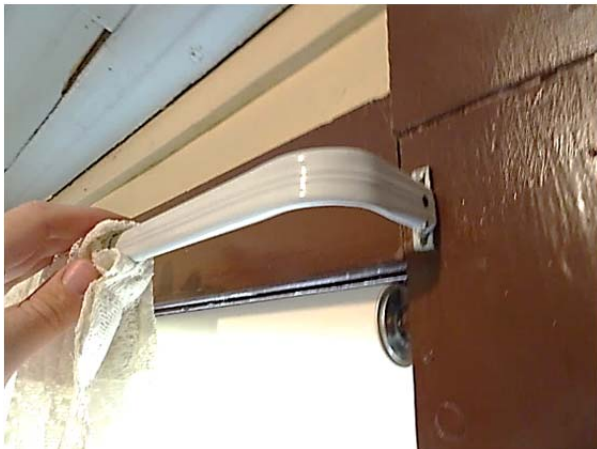
**FIGURE 67.** Curtain rod anchored to wood trim.

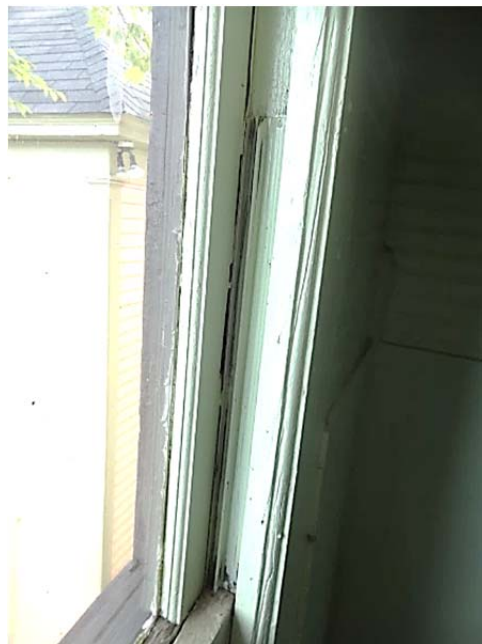
The window in the second-floor bathroom is located at the south end of the west elevation. The opening measures 24 inches wide by 52 inches tall, and has a flat wood casing with 1/2 inch beaded molding between the casing and jamb (Figure 75). The window has a wood stool measuring 2-3/4 inches deep that projects approximately 1 inch beyond the face of the wall, and extends 1 inch beyond the edges of the casing. There is no apron below the stool. There is no sash for the lower, operable sash (Figure 76). The window frame, sash and trim are painted light green.

**FIGURE 76.** Sash pocket showing the aluminum sash track. Note that there is no sash chord. This window is likely not original.

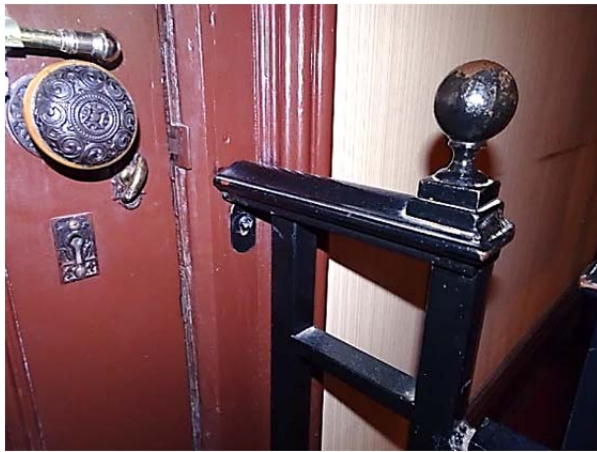
The side door on the first floor is located on the west elevation, and opens into the stair hall (F-2) from the west side of the wrap-around porch. The door has compound wood casing consisting of two profiles of beaded molding fitted together and measuring 5-5/8 inches by 1-3/4 inches. The metal railing that surrounds the floor hatch leading to the basement is mounted to the wood casing (Figure 85).

**FIGURE 85.** Detail showing the interface between the wood casing and metal railing.

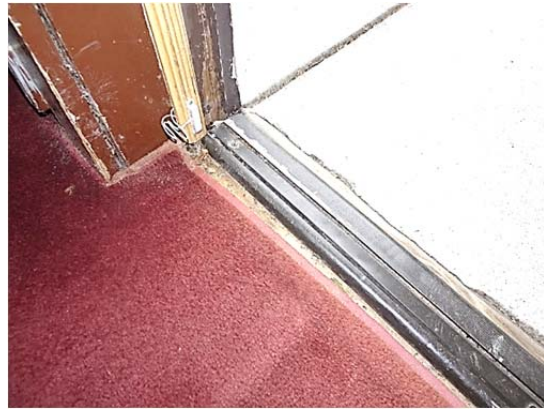
Non-original wood doors are located at the back porches on the first and second floors of the Birth Home. The door on the first floor has flat wood trim measuring 3-1/2 inches wide inside and 5-1/2 inches outside. It has a wood sub-sill with a modern aluminum threshold (Figure 90). The six-panel door measures 36 inches wide by 76-5/8 inches tall by 1-3/4 inches thick (Figure 91). It is hung on a pair of painted five-knuckle ball-tipped hinges that are painted brown like the door and the trim. To comply with egress requirements of the local building code, it swings out to the exterior. Hardware includes a non-original deadbolt lock, and push bar panic exit device. There are no operable door knobs, but there is a cast brass dummy knob on the exterior side of the door, a decorative brass escutcheon on the interior, and a contemporary double cylinder dead lock to secure the door (similar to Figure 92).

**FIGURE 90.** Door sill and threshold at south exit.

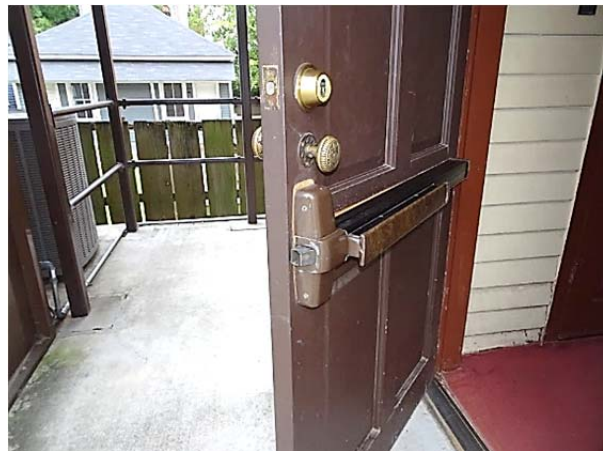
Similar to the non-original first-floor door, the second-floor door is a six-panel, wood-framed door hung on two hinges. A non-original aluminum threshold, deadbolt lock, push bar panic exit device, and cast bronze dummy door knob complete the door (Figure 92 and Figure 93). The door measures 30-1/2 inches wide by 76 inches tall and is a left hand door that swings out to the exterior. On the interior, it has beaded molding perimeter trim similar to the casings on the front and side doors on the floor below. The exterior side has flat wood casing that is 6 inches wide. Both rear doors are painted brown.

**FIGURE 92.** Hardware on second-floor rear exit door.

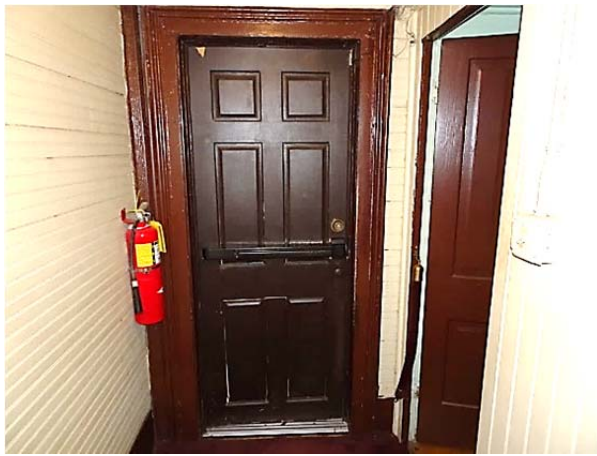
**FIGURE 93.** Hardware at second-floor exit at south elevation.

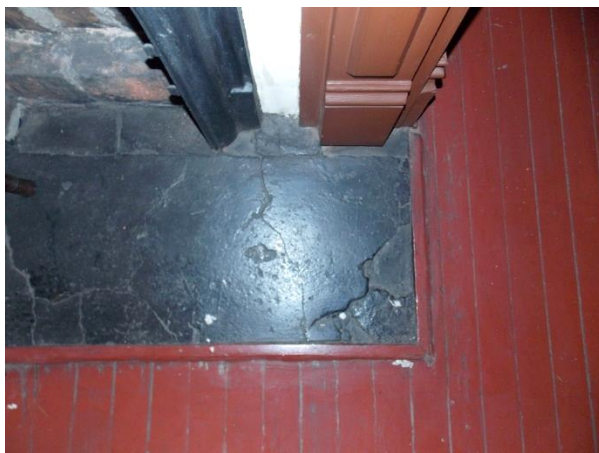
**FIGURE 143.** Cementitious fireplace hearth in Martin, Jr.'s and A.D.'s room.

The mantel appears to have been painted with a brown enamel or dark stain, matching the adjacent woodwork. The cementitious hearth is cracked and spalled but appears to be stable (Figure 143).

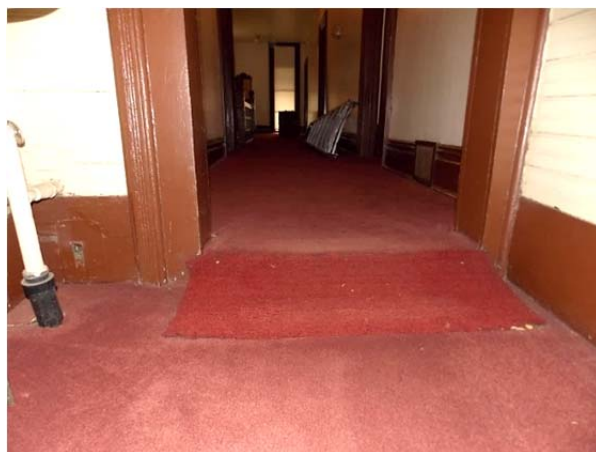
Carpeting continues into the back porches on both floors where there are exit doors for tour groups. The level of the back porch at the second floor is lower than the main floor, so small carpeted ramp was installed at the cased opening at the end of the hall. The ramp height appears to exceed the maximum rise allowed under the guidelines of the Architectural Barriers Act (ABA) (Figure 154).

**FIGURE 154.** Carpeted ramp at upstairs rear porch.

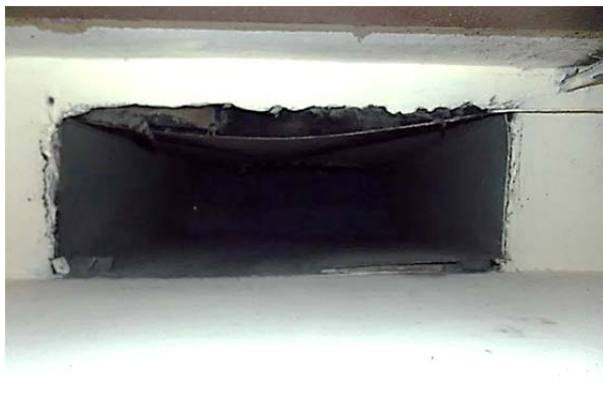
- The closet in the southeast corner of Martin Jr. and A.D.'s room serves as a return air plenum, collecting air through a grille in the door and returning it to an open duct that extends into the attic (Figure 165). The penetration around the duct at the ceiling of the closet is not fully sealed and could result in humid air from the attic being drawn into the closet. It is not known if the free area of the return grille in the door is sufficient to provide adequate air flow to the duct above (Figure 166).

**FIGURE 165.** Return air opening in closet of Martin Jr. and A.D.'s room. Grille was removed when duct was cleaned.

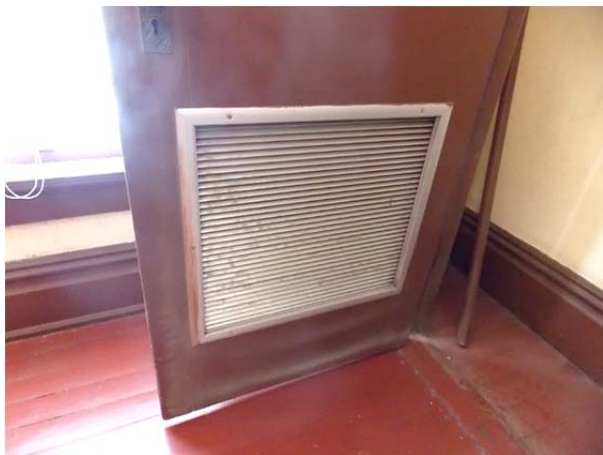
**FIGURE 166.** Return air grille in the door to of the closet in Martin Jr. and A.D.'s bedroom.

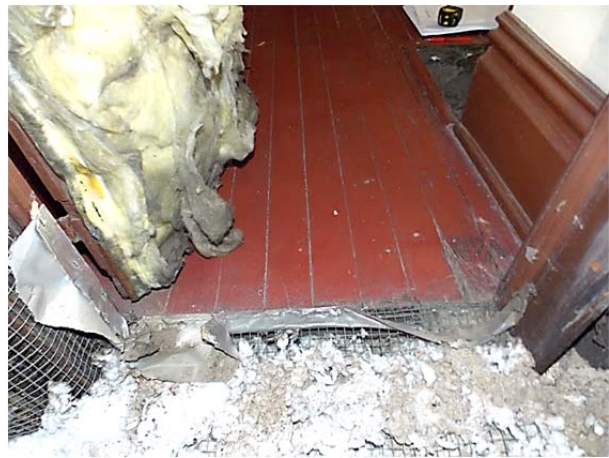
- The low attic over the kitchen is accessed from a door at the southwest corner of Martin Jr. and A.D.'s bedroom. The door was observed to have some thermal insulation added to the attic side. However, no door seal or weather stripping was provided (Figure 167). The high temperature in the attic exacerbates the extremely humid air that gradually percolates into the air conditioned spaces upstairs and increases moisture content. This path for hot, humid attic air is likely to be a main source of moisture that has to be removed by the portable dehumidifiers.

**FIGURE 167.** Access door to low attic from Martin Jr. and A.D.'s bedroom.

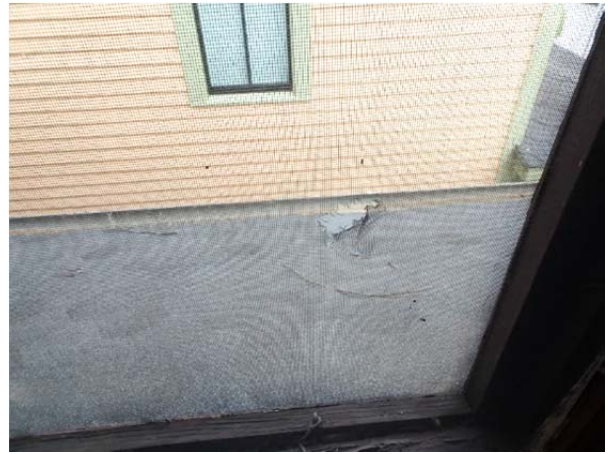
**FIGURE 179.** Tear in the window screen at west elevation.

- Moisture staining and evidence of water infiltration were observed on the plaster above the first-floor bathroom window (Figure 178). The staining and delamination are signs of moisture infiltration from above.
- One window opening on the west elevation has a hole in the exterior window screen (Figure 179). The hole is approximately 1 inch in diameter.
- A previous dutchman repair was made to the stool of a window on the second floor on the east side (Figure 180). The dutchman joint extends across the full width of the stool and is open.

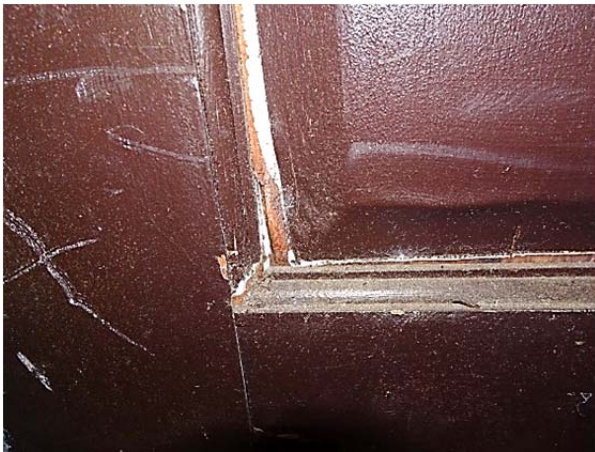
- A displaced recessed wood panel was observed at one location on the second-floor door (Figure 185). The panel was displaced approximately 3/8 inch. The most significant displacement was located at the bottom corner, adjacent to a deteriorated wood rail.

**FIGURE 185.** Displacement of recessed wood panel on the first-floor rear door.

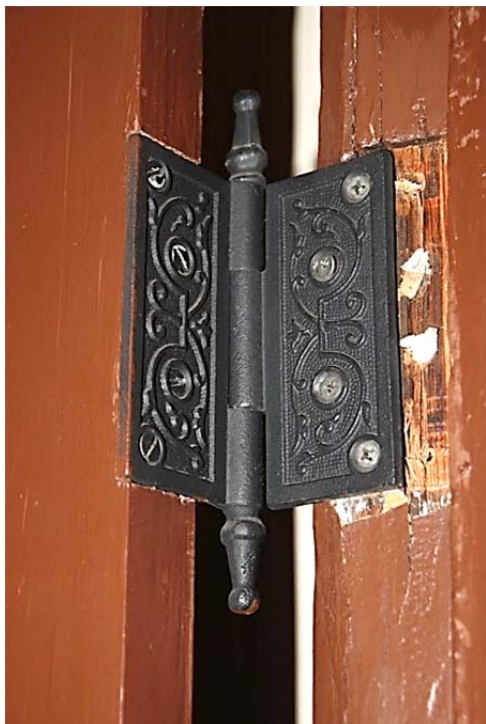
- On the first floor, the original upper hinge of the unique door between the hall and the back porch is displaced (Figure 191). The hinge leaf is not set fully into the mortised jamb, probably because the screws for the new hinge did not have sufficient solid wood for a snug installation as a result of the screw holes from the original hinge.
- One glass pane in the French doors at the entrance hall is cracked (Figure 192).

**FIGURE 191.** Displaced door hinge. Note the white wood filler in the screw holes of the original hinge.

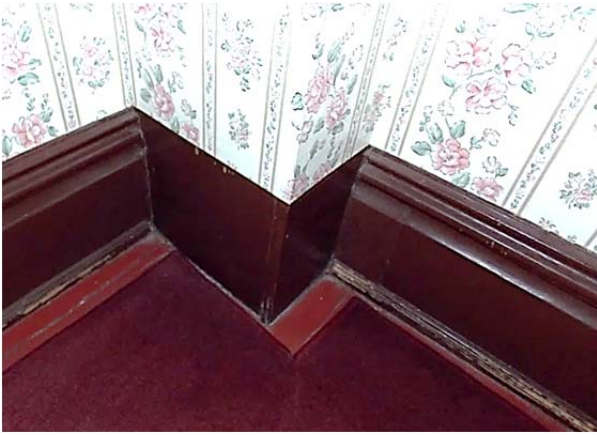
- Where risers for fire protection lines were installed and then concealed behind furring and gypsum board, the gypsum board is finished to match the room, but the baseboard does not continued around the new furred wall. Instead, the bottom of the gypsum board is painted brown to the height of the adjacent baseboard (Figure 206 and Figure 207).

**FIGURE 206.** Non-original furred enclosure in the dining room, bottom painted brown to match trim but with no actual wood trim.

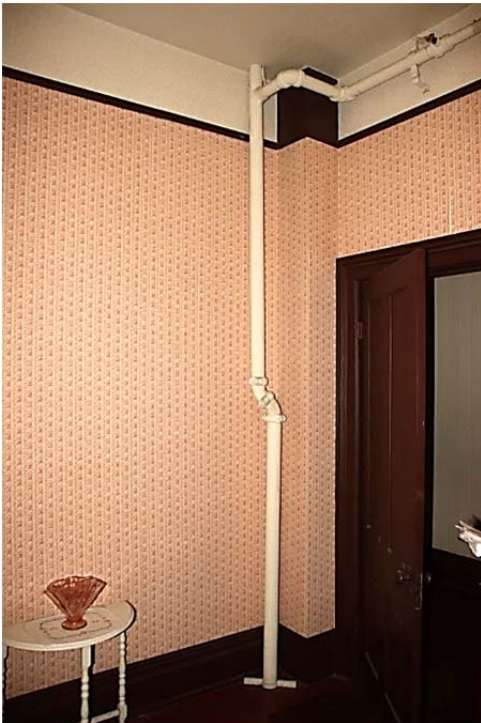
- Other pipes installed in the house are exposed to view and have been painted. Typically, these pipes are installed in the rooms rather than in the hallways. However, due to the conspicuous nature of these pipes and the support brackets at floor penetrations, they may distract from the experience of the rooms and the exhibits (Figure 207 and Figure 208).

**FIGURE 207.** Sprinkler riser at Christine's bedroom. Furred enclosure painted brown above picture rail and at the bottom.

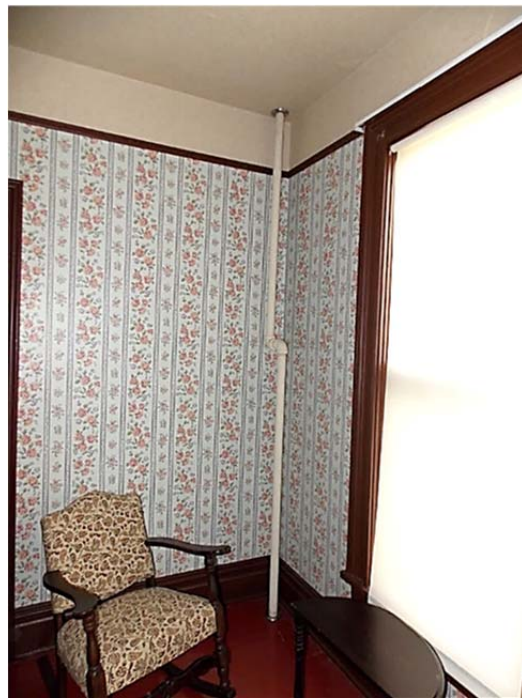
**FIGURE 208.** Sprinkler riser at front bedroom.

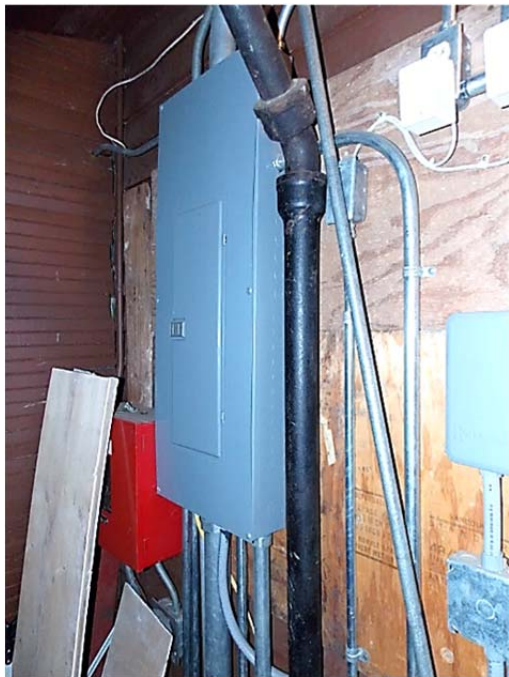
- The main panels for the electrical and security systems are located in the pantry (F-9) (Figure 209). This first-floor room is also used for secured general storage on the first floor. Items stored in this room should not block or interfere with access to the electrical and security panels and devices. Code required clearances should be maintained.
- In general, electrical and security devices are located inside the rooms so that they are not highly visible from the public areas (Figure 210). Security devices mounted on walls in public areas may distract from the visitor's experience of the interpreted spaces because they are incongruous with the period of significance (Figure 211).

**FIGURE 209.** Main electrical panel at rear porch pantry.

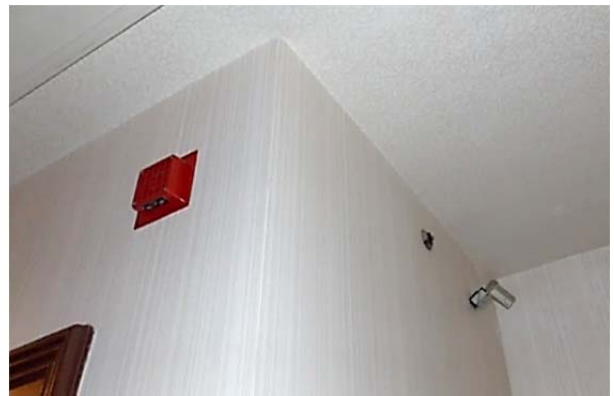
**FIGURE 211.** Typical installation of alarm and security devices in the second-floor hall.

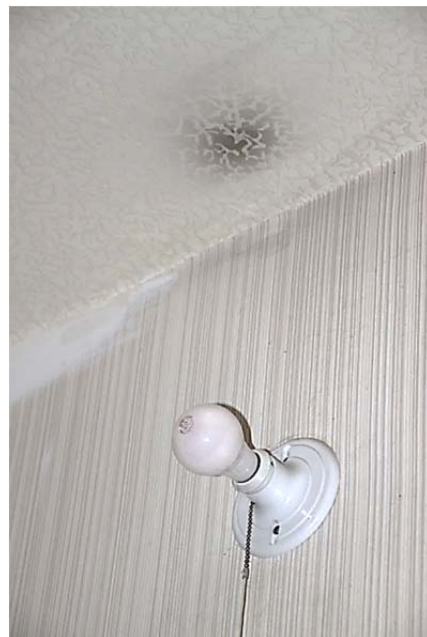
- At the stair landing, the ceiling wallpaper was discolored by excessive heat from the wall-mounted light fixture below (Figure 212).
- The 1989 Historic Furnishings Report noted that “the shadeless ceiling light, with pull chain, was restored in 1975 on Mrs. Farris’s authority.”<sup>165</sup> The current light has a brass base with a frosted globe similar to other lights added throughout the home after the restoration (Figure 213).
- Several open electrical junction boxes were observed in the interior of closets (Figure 214).

**FIGURE 212.** Discolored wallpaper above wall mounted light fixture at the stair landing.

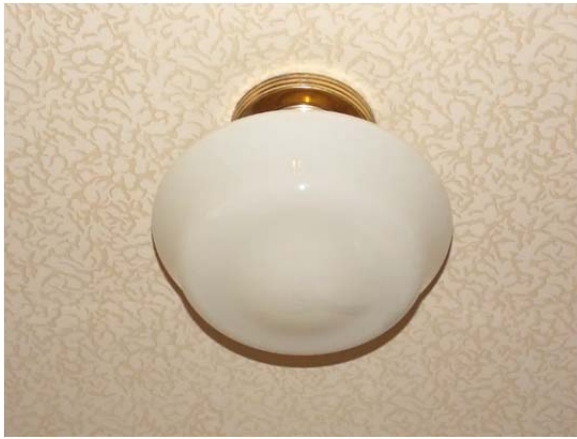
**FIGURE 213.** Typical non-original pendant fixture.

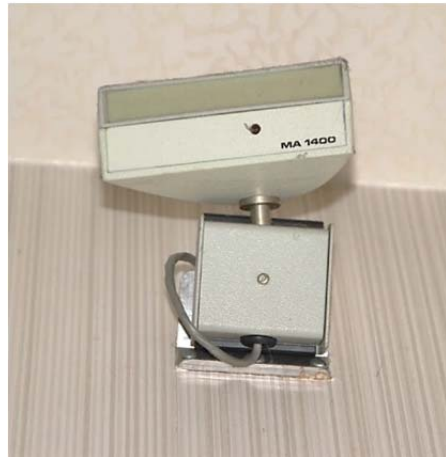
- Penetrations of electrical conduit were not fully sealed, allowing air gaps to attic and interstitial spaces (Figure 215).
- Obsolete security devices were present in interpreted areas along the tour route. Many of the devices distract from the authenticity of historical experience (Figure 216).
- No illuminated exit signage or emergency lighting was observed inside the Birth Home.
- Lighting controls are managed by main circuits rather than individual room control.

**FIGURE 216.** Security device likely obsolete.

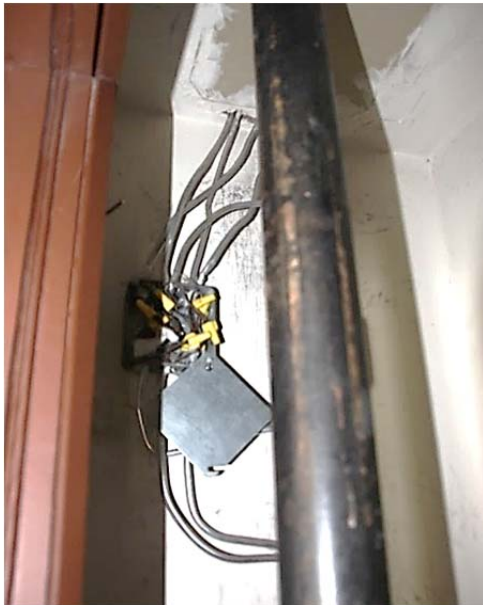
**FIGURE 214.** Open junction box in a closet.
