# Jetty Workers' House #2 Historic Structure Report

Cape Lookout National Seashore  
Harker's Island, North Carolina

February 2012

2012  
Historic Structure Report  
Jetty Workers' House #2  
Cape Lookout National Seashore

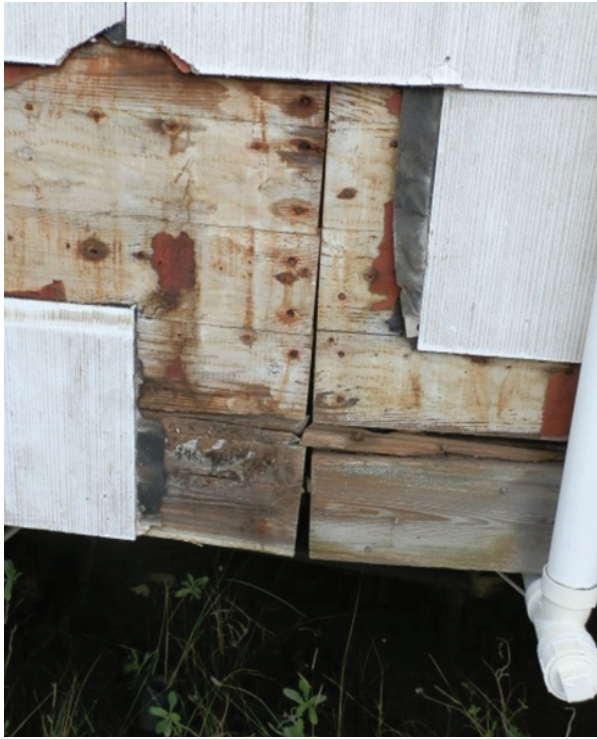
Figure 2. View of break in original siding where the south half of the present kitchen meets the main block of the house.

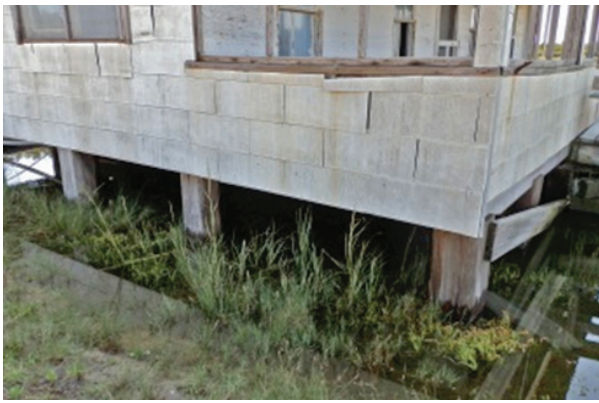
Figure 6. View of pilings at northeast side of original building.

**Foundation:** The building is set on a combination of round and square wood pilings that raise the house about two feet above grade under the original structure but as low as six inches in parts of the rear additions. The majority of the wood pilings under the original building, including the front porch, are square or rectangular, but those under the south and east porches and additions are generally round, about 12" in diameter, similar to the utility poles used for pilings in some of the other historic structures in the park. A few of the pilings are deteriorated and need replacement.

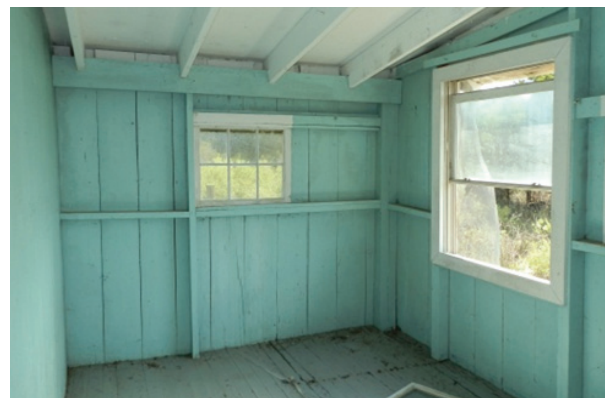
Figure 10. View of framing of Room 105, one of the modern additions to the house.

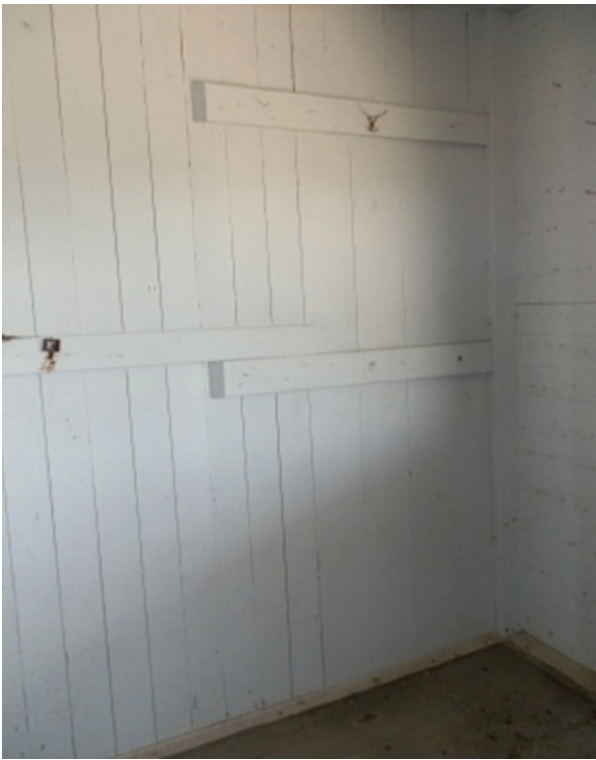
Figure 11. View of intersection of typical, unframed, interior curtain wall (left) and exterior wall (right). The horizontal members here are not structural; the vertical, tongue-and-groove paneling of the curtain wall is held in place by nailers at the floor and ceiling.

portion of the house are unframed curtain walls composed of vertical tongue-and-groove boards held in place by nailers at the floor and ceiling.

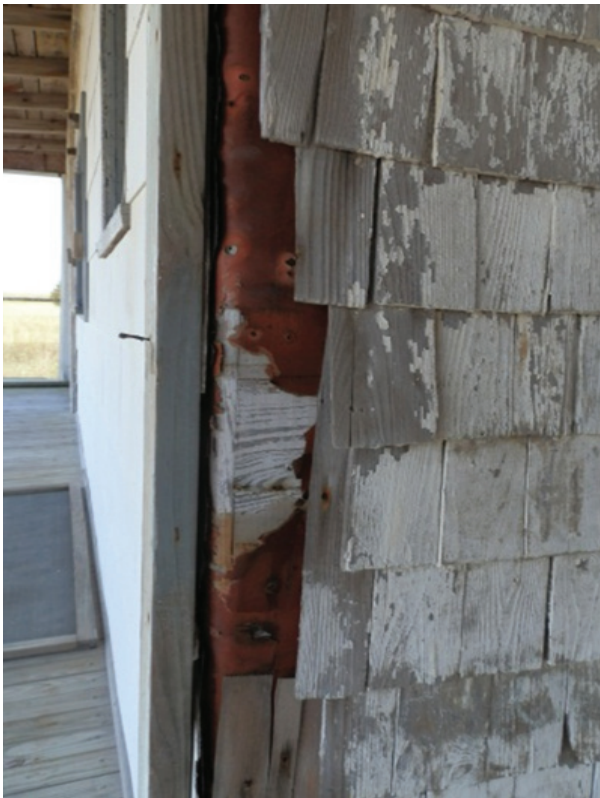
Figure 14. View of cedar shingles laid over original siding on back porch.

with felt underlayment covers the original horizontal siding. It is not clear why only a portion of the south wall was finished in this manner. On the east and west sides of the original structure, the original boards are covered by the present cement-asbestos siding, which was most likely installed sometime in the mid-twentieth century. Nearly all of the original siding appears to remain in place beneath later finishes.

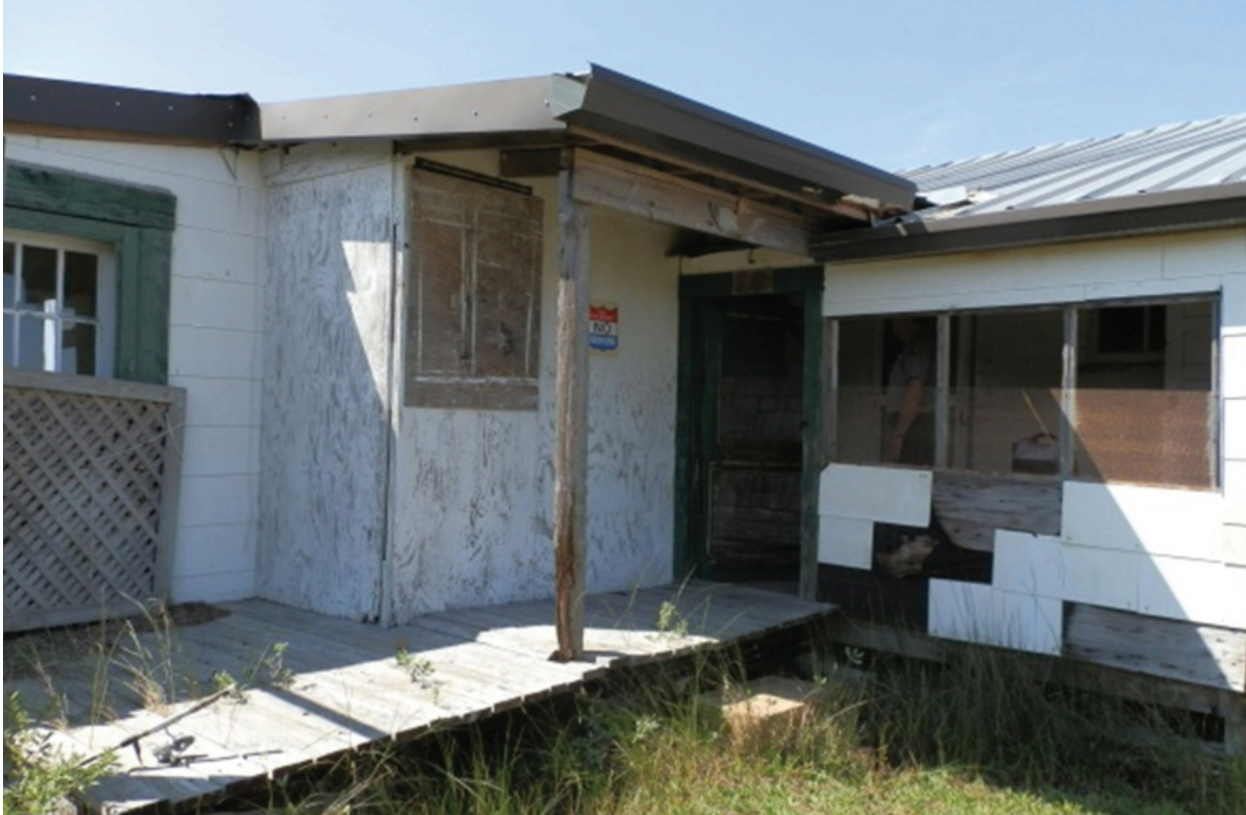
Figure 15. View of exterior finishes at rear of house. Note the plywood siding on the bathroom addition at center.

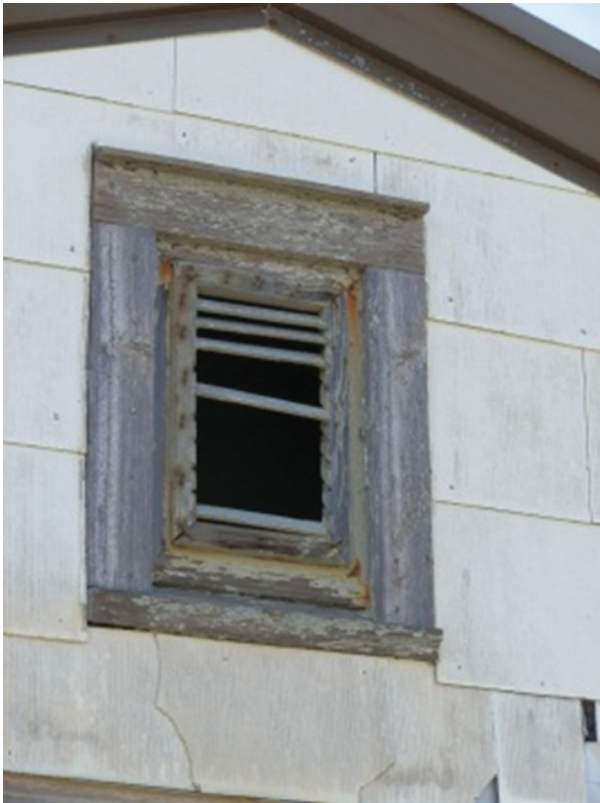
Figure 21. View of gable vent on east side of house.

All exposed historic woodwork needs to be repaired and repainted. The gable vents are in poor condition and need significant repairs. Likewise flooring on the two porches recommended for preservation require significant repairs and repainting. Because of the protection it offers and because it may date to late in the historic period, the cement-asbestos siding should be repaired and preserved. If definitive documentation can be located proving it was not added in the historic period, its removal and restoration of the underlying wood siding could be considered.\

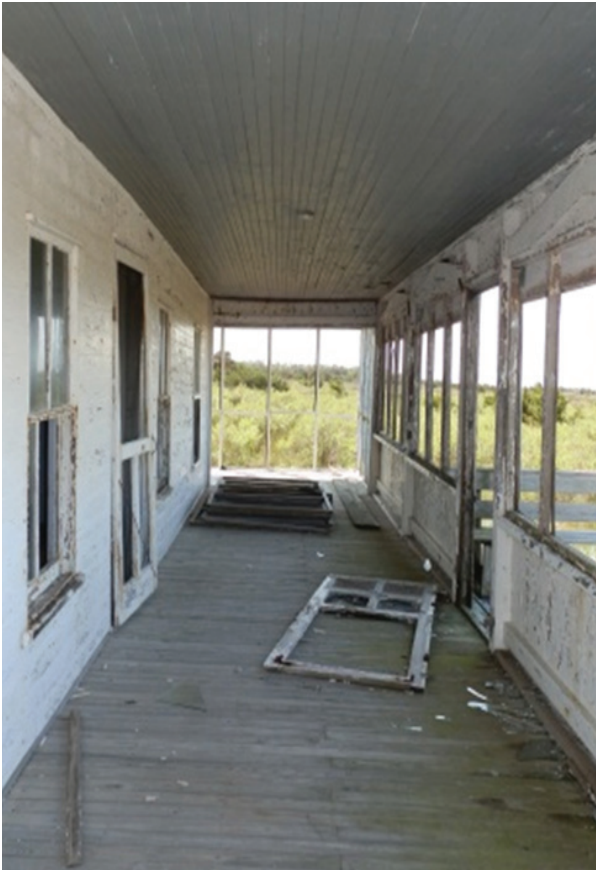
Figure 28. View west on front porch.

except where the wall was removed in connecting it with the added west porch. Both the north and west porches were originally screened, but all of the screening is now missing. The south porch was probably created along with the half bath. For reasons that are not clear, it was built a foot or so lower than the floor level of the house itself. The south porch also appears to have been originally enclosed by a low knee wall with screening above similar to the front porch. On the east side of Room 105 is an open deck that was apparently created along with construction of the full bathroom,

The missing knee wall at the western end of the front porch should be reconstructed to match the original walls on the north and east end of the porch. Knee walls should also be reconstructed on the back porch, with accommodation to allow access to the two rooms and half bath added around 1940. Both porches should be screened.

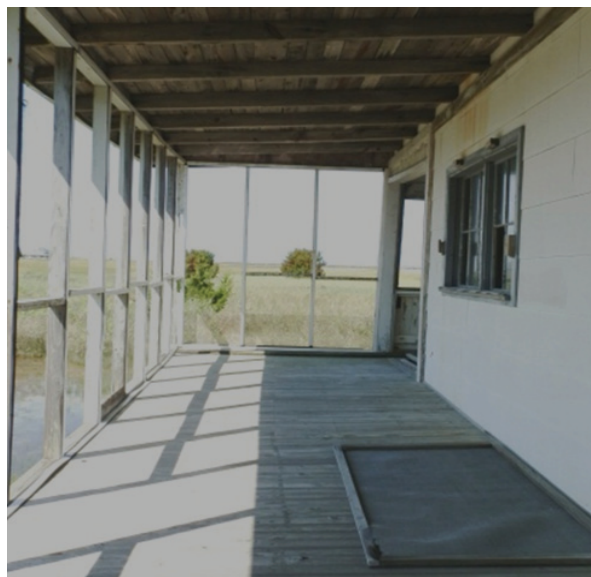
Figure 36. View north on west porch.

The late-twentieth century alterations and additions to the porches are in poor condition. The west porch and the open deck on the east side of the rear additions should be removed completely. The original configuration of the back porch has not been precisely identified but should be ap-

The modern porch on the west side of the house should be removed along with the open deck on the east side of the rear addition. Knee walls and screening were original features on both the front and back porches and should be reconstructed where missing.

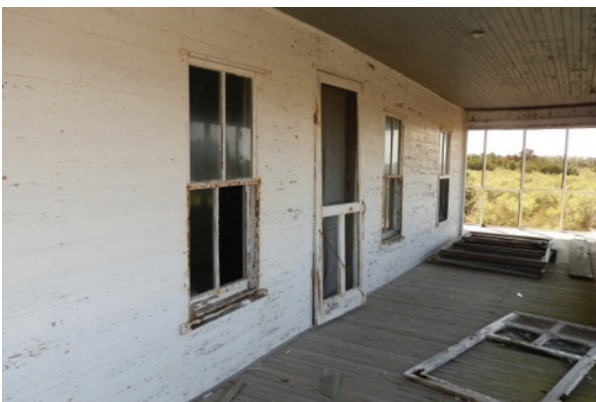
Figure 37. View west on front porch.

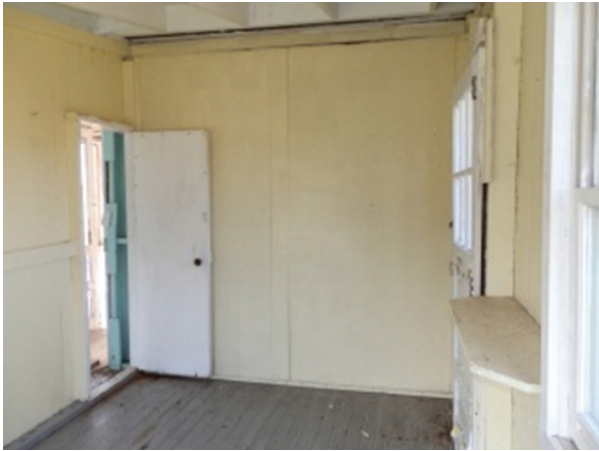
Figure 59. View north in Room 105.

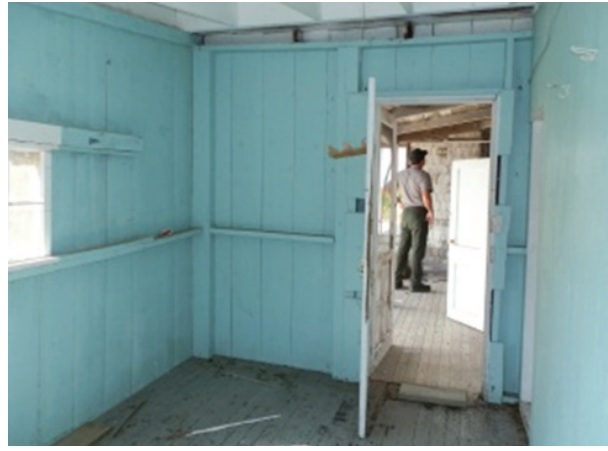
Figure 61. View northwest in Room 106.

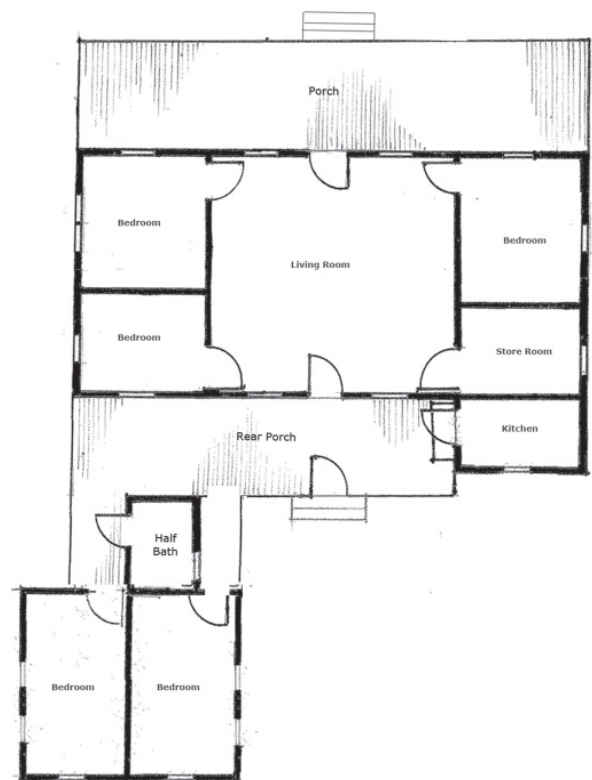
Figure 1. Plan for recommended restoration of house.

When the modern rear shed of the roof is removed, the roof line of the historic roof can be determined. If there are more than two layers of asphalt shingles, that would be an indication that

asphalt shingles were present near the end of the historic period and asphalt roofing could be used for re-roofing. Otherwise, wood shingles would be appropriate.
