REPORT FOR:

RE: FORT HAYS BLOCK HOUSE  
HAYS, KANSAS

CFS No. 18-1042

DATE : MAY 17, 2018

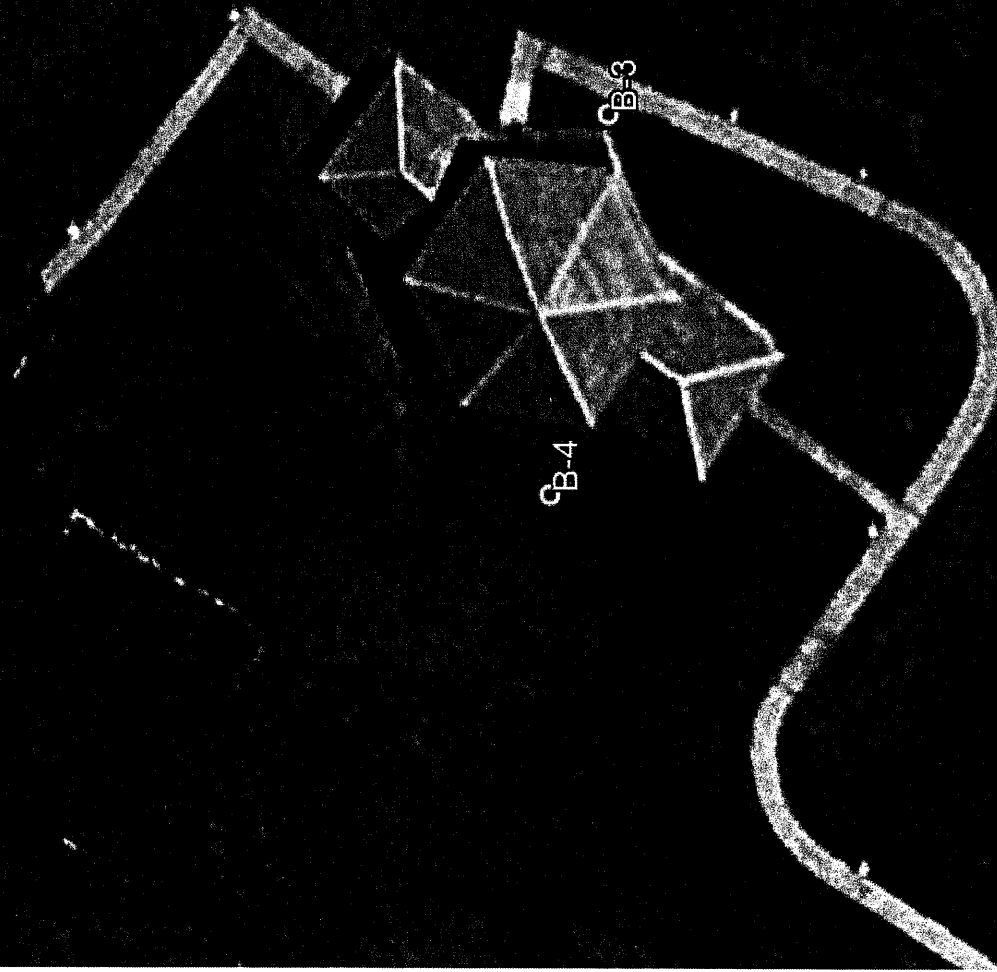
# Boring Location Plan

The topography around the Block House is flat. Four borings were taken, one in the fairway, one between the dry line and the fairway, and two adjacent to the Block House. These soils were identified, classified, and evaluated by the Geotechnical Engineer. In addition, all samples were tested for water content in the laboratory. Humidity readings were also taken in the crawl space of the Block House (see enclosed geotechnical report).
