FINAL PROJECT REPORT

1. Project title/name: St. Mary's Art Center Building and Site Assessment project
2. NPS grant number(s) **NV-17-10001**
3. National Register property name/address (If applicable): **55 North R Street, Virginia City, NV 89440.**

## **Condition Assessment and Repair Recommendations**

for the  
**St. Mary's Art Center**  
**Virginia City, Nevada**

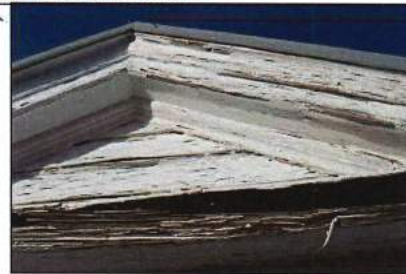
PHOTO 3

Photo 3- South Gable deterioration

The building has a standing seam metal hip roof with (4) gables on each elevation and two brick chimneys. The metal roof appears to be in good condition. The east, west and north gables are in generally good condition and only need re-painting. The south gable is deteriorated and needs to be reconstructed. The chimneys are relatively tall and unbraced and their condition could not be observed. Some bricks have fallen from the chimneys.

Remove loose paint and repaint existing gables on the east, west and north elevations. Reconstruct existing south gable with wood to match size and color of existing.

Repair the Gable on the South Elevation by removing all existing trim and boards and replacing with new in kind to match existing. Prime and paint entire gable.

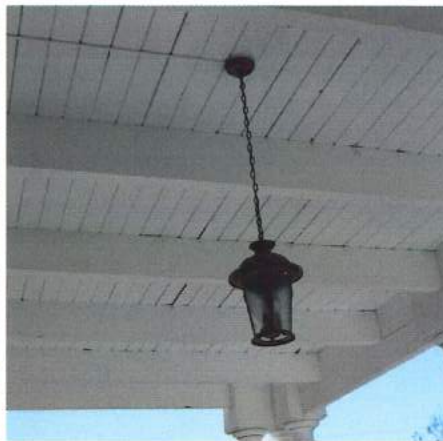
Photo 7 - 2nd Floor Porch Ceiling

The third floor porch currently has a worn and insufficient waterproof membrane. It is placed over the finish decking layer directly over the existing 1x deck boards. This is seen as the finish ceiling of the second floor porch below. The third floor porch has little slope for positive drainage. The framing members of the third floor porch are significant and visible. The columns are round and tapered. The beams at the

Remove the existing finish surface and underlayment (if any) and leave the existing 1x boards in place. Provide new plywood substrate and walkable waterproof membrane surface. At each front column remove 2" from the top to provide a 2" positive slope across the entire length of the deck. Replace the existing 3- 2x beam with new 6x12 beams. The existing 4x floor joists and 1x boards are to remain. Remove and replace the existing metal gutter and downspouts with new galvanized metal

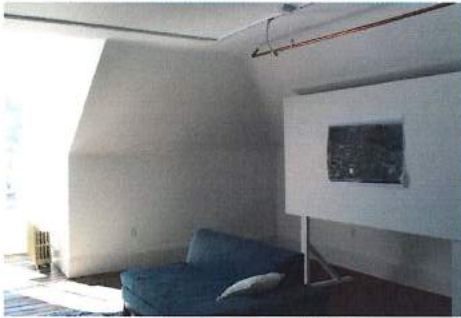
Photo 22 - Gallery space on 4th floor

The fourth floor usable interior space has sloped walls due to the hip roof slopes.

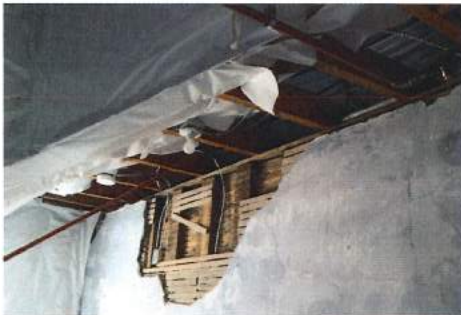
Photo 23 - Attic wall showing plaster over wood stud framing; Ceiling joists above

The fourth floor transverse wall construction changes to wood stud framing above the other three floors where the transverse walls are masonry.

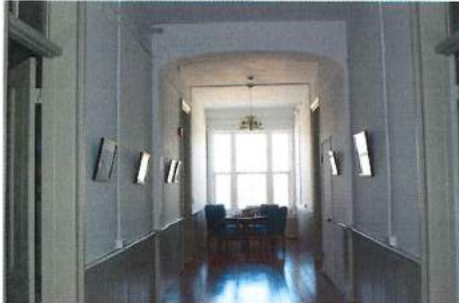
Photo 24 - 2nd Floor Hallway showing masonry transverse wall arched

The first, second and third floors have masonry transverse walls, evident in the hallways as arched and protruding from the main hallway walls.

No recommendations

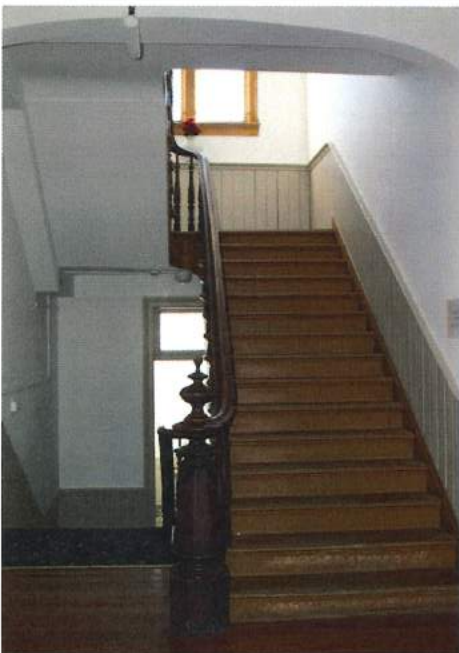
Photo 25 - Main Stair Interior, 2nd Floor Landing

The main stairs run from the first floor to the fourth floor, in the center of the building on the east side and are in good condition. The secondary stairs to the north of the main stairs are

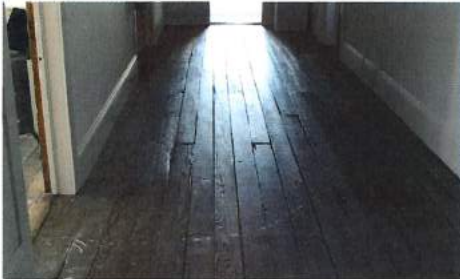
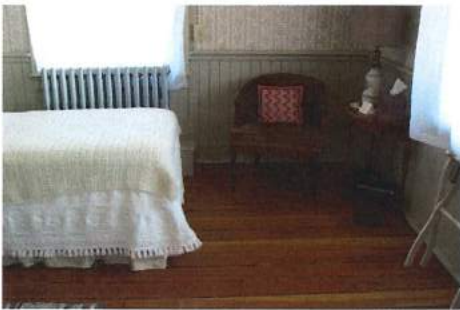
Photo 27 - 4th Floor (Attic) Floor

Photo 28 - 2nd Floor Bedroom Floor

The fourth, third and second floors have 1x boards. The wood floor looks to be in good condition. Some patching has occurred in places.

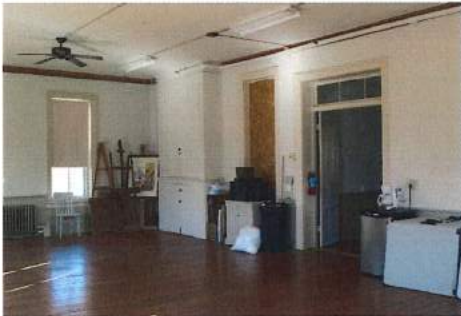
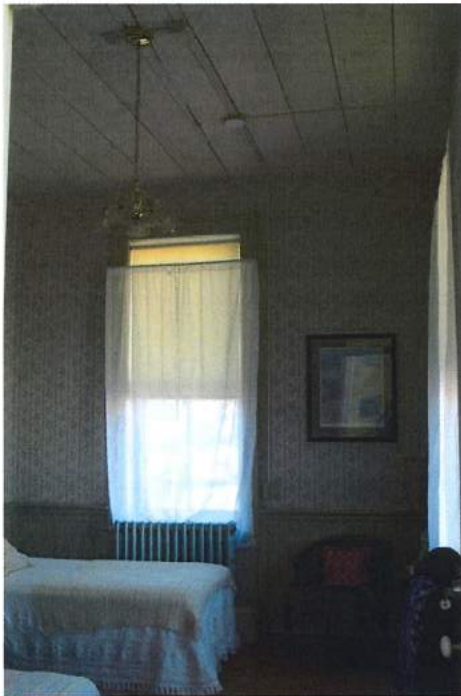
Photo 30 - 3rd Floor Studio space with plaster ceiling and surface-mounted fixtures

Photo 31 - 2nd Floor Bedroom showing exposed 1x deck boards as the ceiling finish.

Some rooms have plaster finish ceilings. Some rooms have exposed deck boards from the space above. The majority of the ceilings are painted, regardless of material.
