# DANFORTH MEMORIAL LIBRARY | PRESERVATION PLAN

SEPTEMBER, 2018

## I. EXECUTIVE SUMMARY

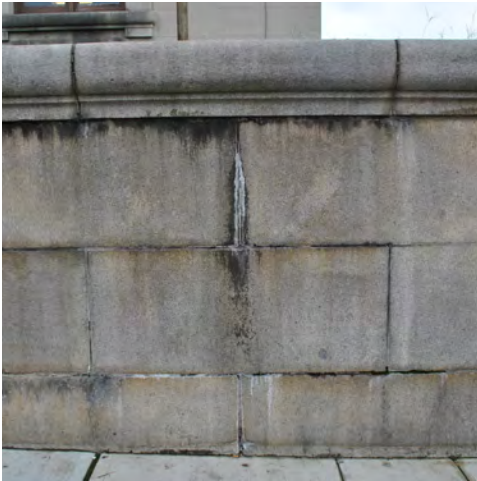
P1: Open mortar joints, mold and efflorescence typical at granite retaining walls.

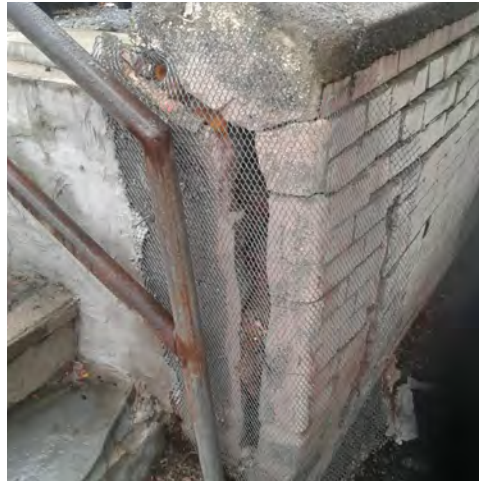
P2: Temporary repair at buckling brick retaining wall.

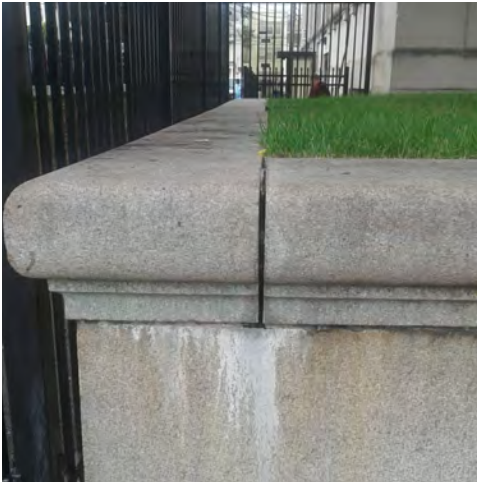
| Feature | Description | Period | Condition | CDF | Priority and Recommendation |
|---|---|---|---|---|---|
| BASE AND WATER TABLE ALONG N ELEVATION P7-P12 | Granite | Original | Good to Fair - Stone requires cleaning and repointing. Some small cracks. | Yes | Long Term - Clean and repoint stone. Carefully patch cracks to match the existing. |

P7: Mortar missing at retaining wall cap, NE corner.

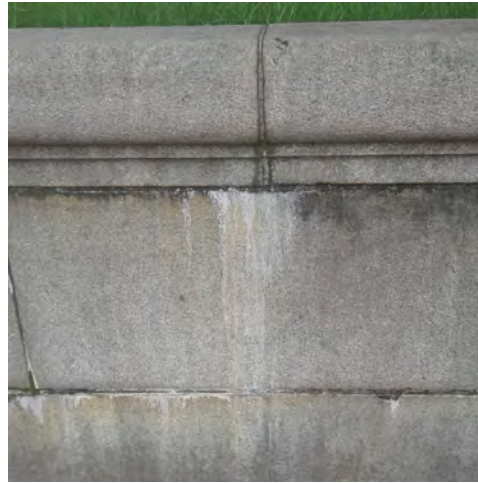
P8: Efflorescence/water infiltration at granite retaining wall, N elevation

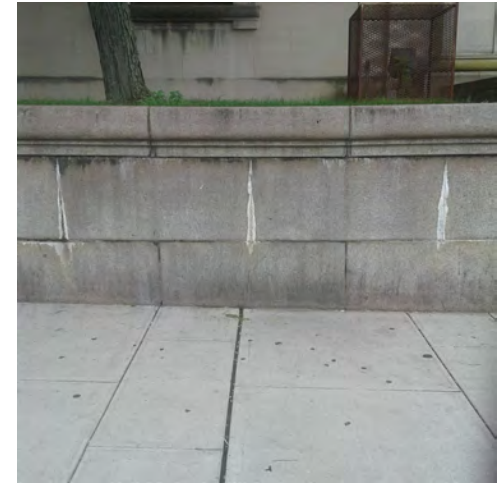
P9: Efflorescence/water infiltration at granite retaining wall, N elevation

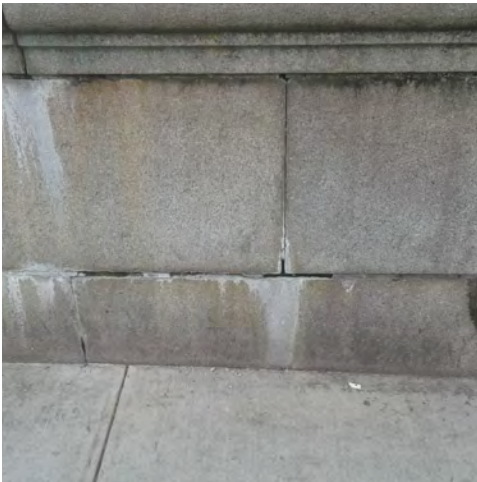
P10: Missing mortar and staining

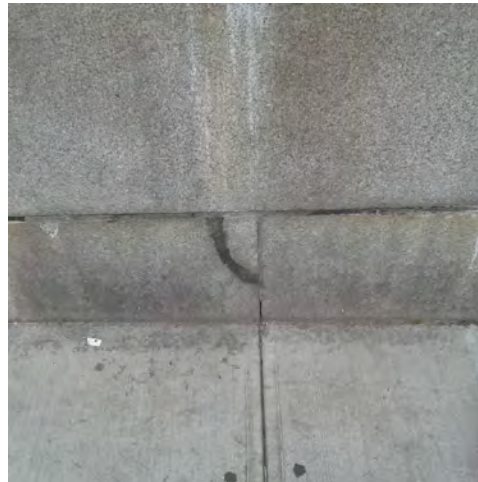
P11: Previous repair of cracked stone

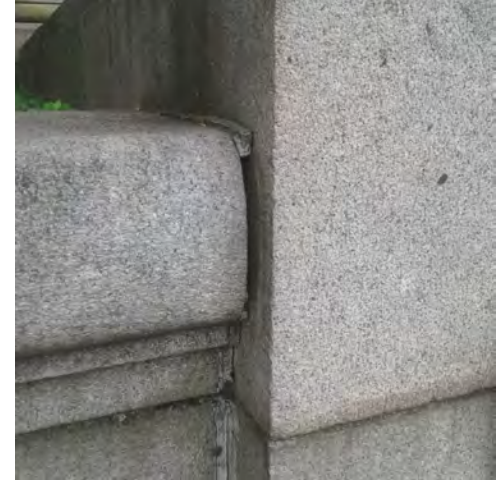
P12: Missing mortar adjacent to main entry stairs

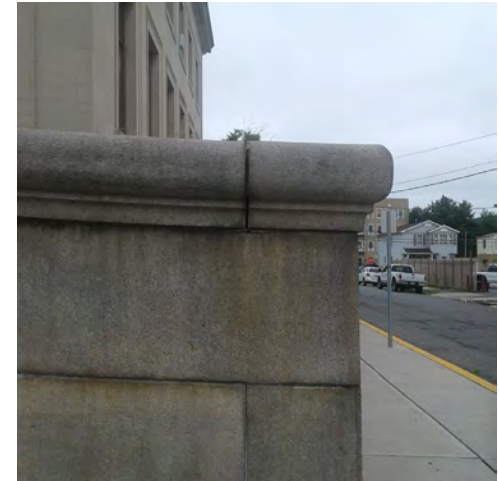
| Feature | Description | Period | Condition | CDF | Priority and Recommendation |
|---|---|---|---|---|---|
| BASE AND WATER TABLE ALONG N ELEVATION P15-P18 | Granite | Original | Good to Fair - Stone requires cleaning and repointing. Some small cracks. | Yes | Long Term - Clean and repoint stone. Carefully patch cracks to match the existing. |

P15: Mortar missing at NE corner of main entry steps

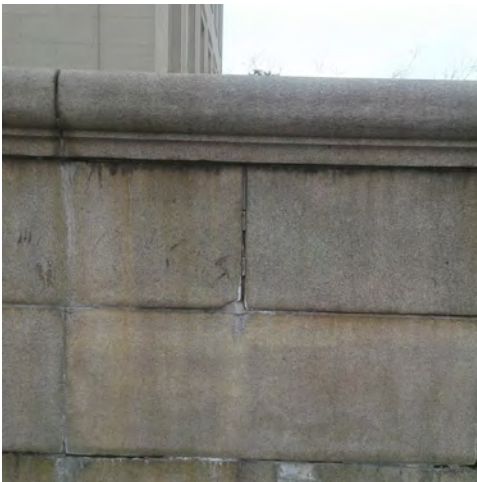
P16: Missing Mortar

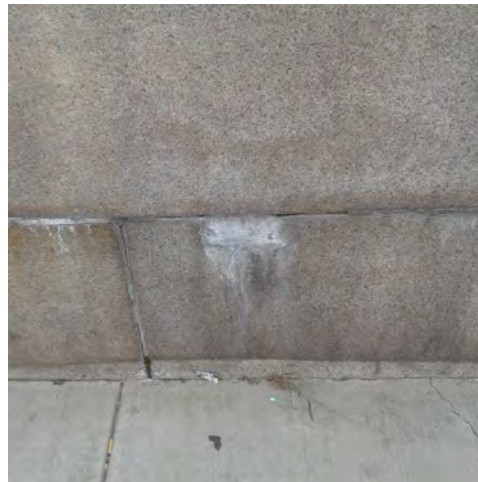
P17: Spalling at base of main entry steps, NW side.

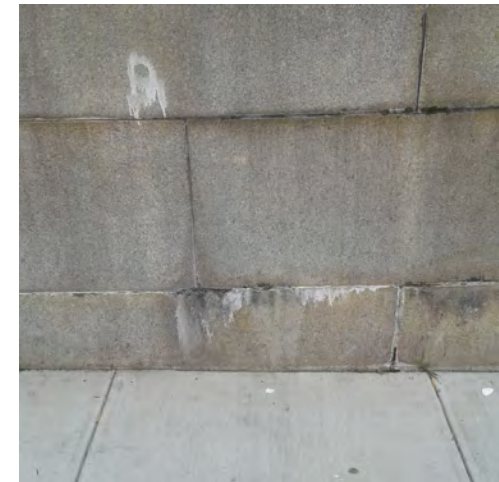
P18: Efflorescence/water infiltration at granite retaining wall.

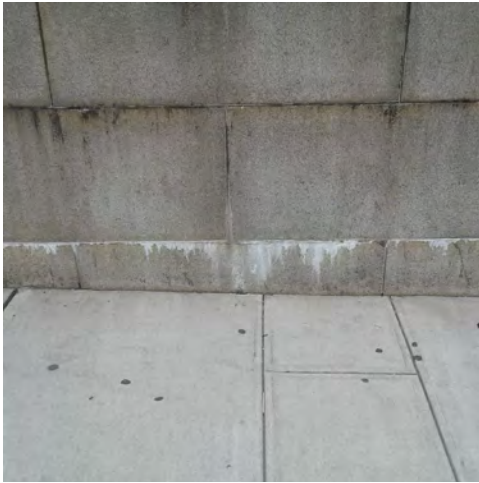
| Feature | Description | Period | Condition | CDF | Priority and Recommendation |
|---|---|---|---|---|---|
| BASE AND WATER TABLE ALONG N ELEVATION P19, P20 | Granite | Original | Good to Fair - Stone requires cleaning and repointing. Some small cracks. | Yes | Long Term - Clean and repoint stone. Rout and patch cracks. |

P19: Efflorescence/water infiltration at granite retaining wall, N elevation

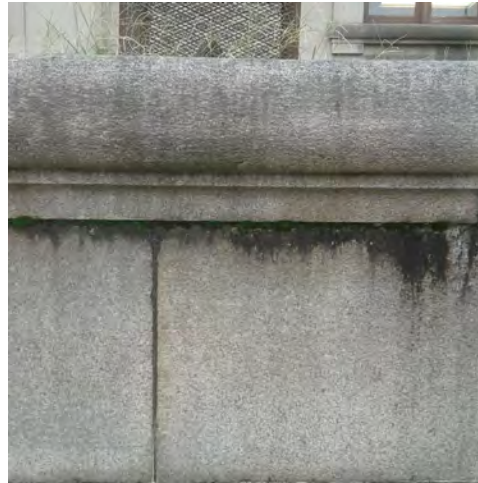
P20: Biological growth and staining under retaining wall cap, N elevation to right of main entry.

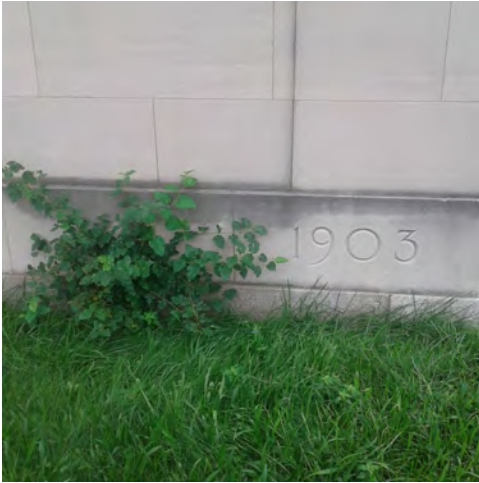
| Feature | Description | Period | Condition | CDF | Priority and Recommendation |
|---|---|---|---|---|---|
| BASE AND WATER TABLE ALONG N ELEVATION P25 | Granite | Original | Good to Fair - Stone requires cleaning and repointing. Some small cracks. | Yes | Long Term - Clean and repoint stone. Carefully repair cracks to match existing stone. |

P25: Biological growth at limestone base, NW corner

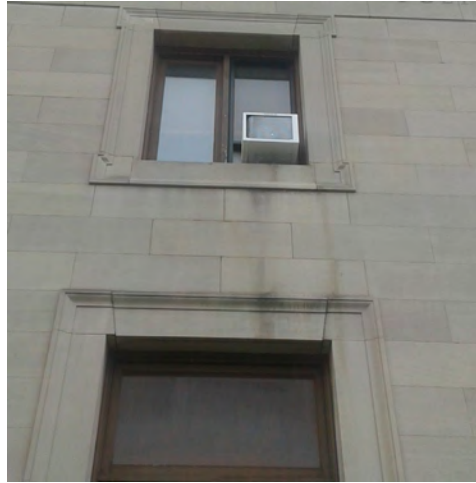
| Feature | Description | Period | Condition | CDF | Priority and Recommendation |
|---|---|---|---|---|---|
| LIMESTONE EXTERIOR WALLS P26, P27 | Limestone | Original | Good to Fair: Stone requires cleaning and repointing, some small cracks and spalling some locations. | Yes | Long Term - Clean and repoint stone. Carefully repair cracks to match existing stone. |

P26: Limestone staining from window a.c. unit, typ.

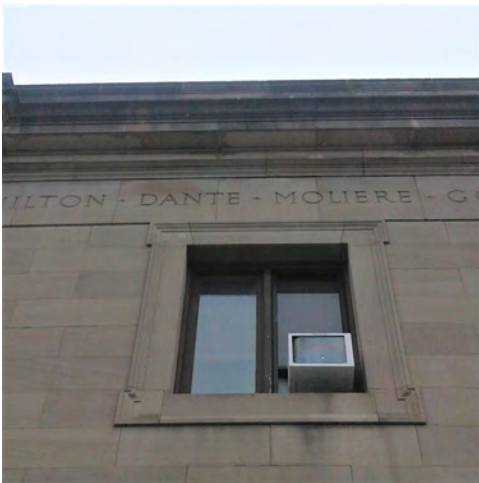
P28: AC unit installed in existing window, damaging the panel, typ. Window frame is damaged, and needs to be repaired and repainted. NE corner of the front elevation.

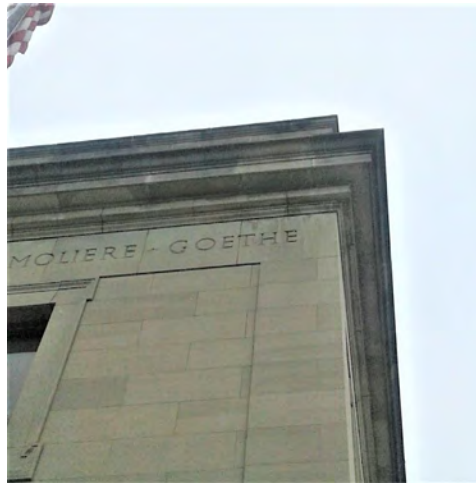
P29: Staining and saturation at cornice, typical.

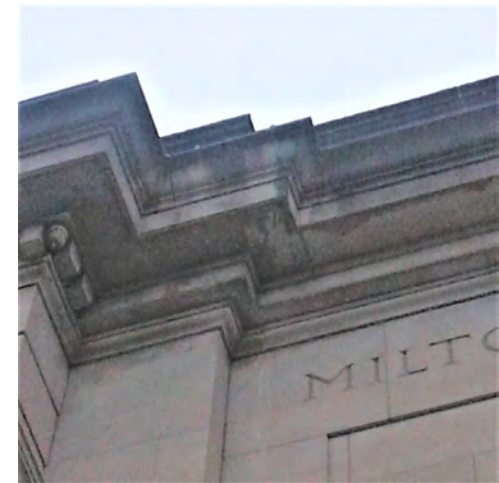
P30: Staining at front cornice, typ.

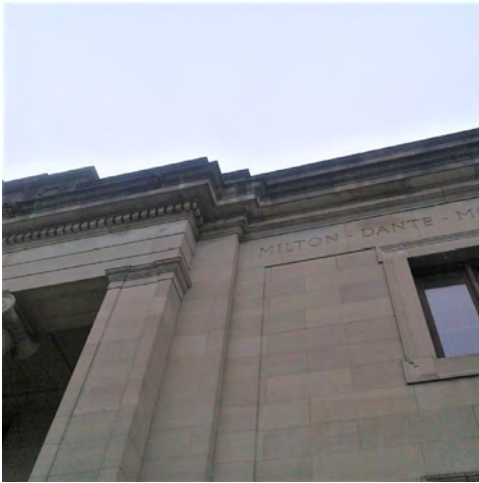
| Feature | Description | Period | Condition | CDF | Priority and Recommendation |
|---|---|---|---|---|---|
| LIMESTONE CORNICES<br>P31 | Limestone | Original | Good to Fair: Stone requires cleaning and repointing, some small cracks and spalling some locations. | Yes | Long Term - Clean and repoint stone. Carefully repair cracks to match existing stone. |

P31: Previously repaired cracked stone at cornice to right of main entry.

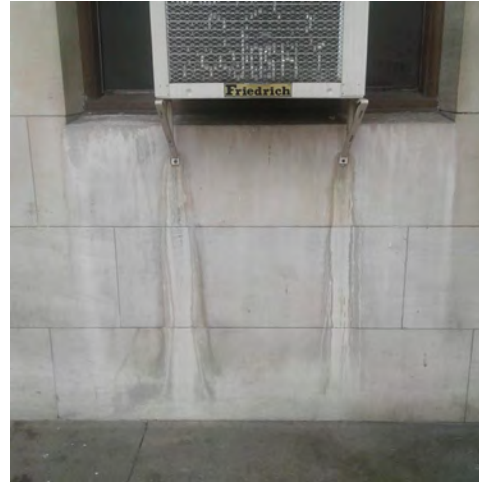
| Feature | Description | Period | Condition | CDF | Priority and Recommendation |
|---|---|---|---|---|---|
| LIMESTONE ELEVATIONS<br>P32, P33 | Limestone | Original | Good to Fair: Stone requires cleaning and repointing, some small cracks and spalling some locations. | Yes | Long Term - Clean and repoint stone. Carefully repair cracks to match existing stone. |

P32: Staining from a.c. window unit to right of main entry.

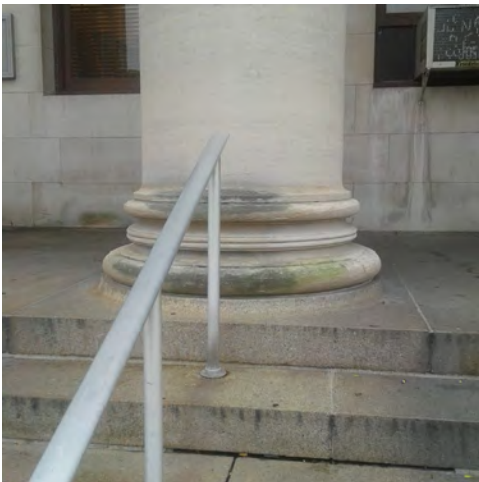
| Feature | Description | Period | Condition | CDF | Priority and Recommendation |
|---|---|---|---|---|---|
| LIMESTONE COLUMNS<br>P34-P36 | Limestone | Original | Good to Fair: Stone requires cleaning and repointing, some small cracks and spalling some locations. Occasional graffiti | Yes | Long Term - Clean and repoint stone. Carefully repair cracks to match existing stone. |

P34: Biological growth at limestone column base.

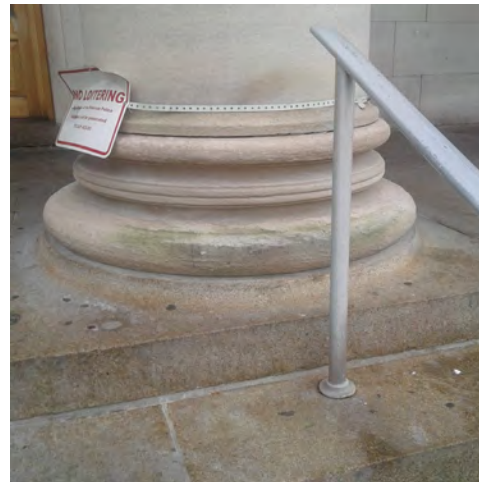
P35: Biological growth at limestone column base.

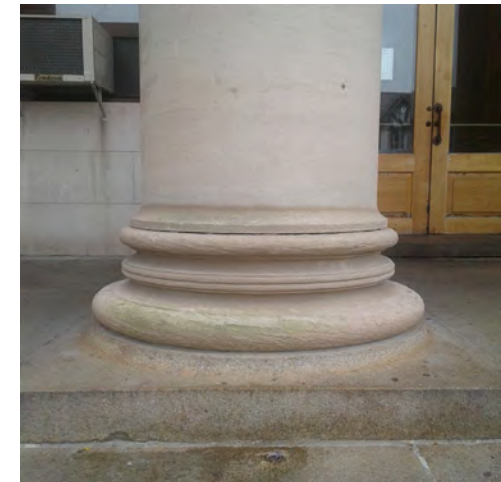
P36: Missing mortar, typical at column bases. Staining at limestone column base.

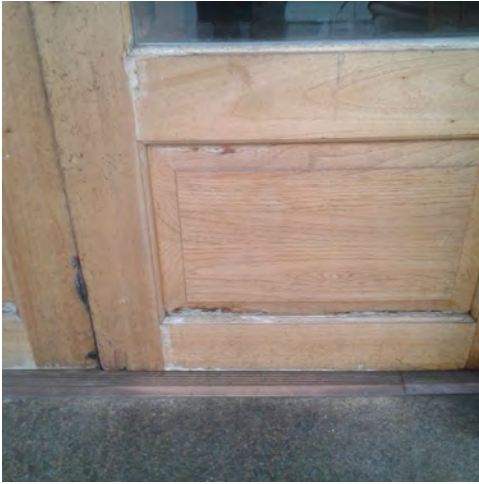
| Feature | Description | Period | Condition | CDF | Priority and Recommendation |
|---|---|---|---|---|---|
| MAIN ENTRY DOORS<br>P37, P38 | Stained Wood | Unknown (replacement compatible with the design of the building) | Fair - Some water damage and deterioration of finish | No | Short Term - Patch, repair and refinish existing doors. |

P37: Water damage at wood front entry doors.

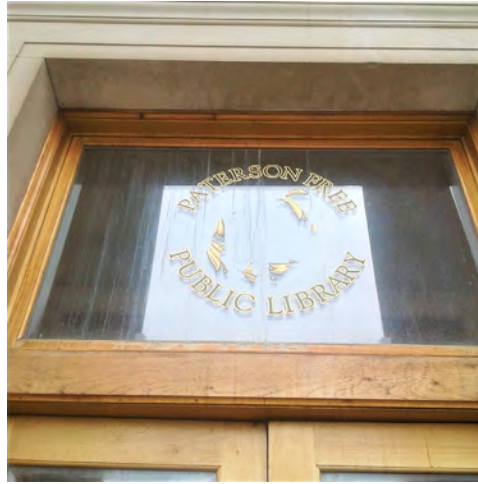
P38: Water damage at wood front entry doors.

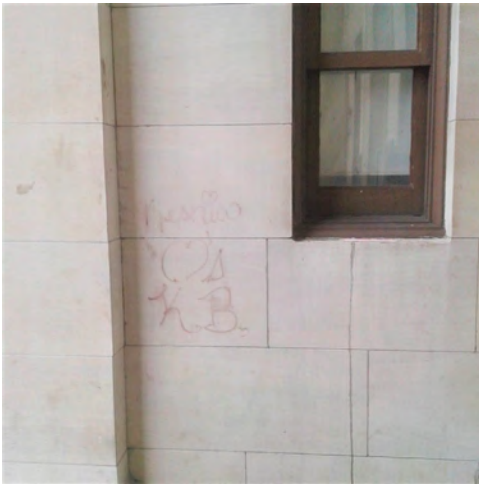
| Feature | Description | Period | Condition | CDF | Priority and Recommendation |
|---|---|---|---|---|---|
| LIMESTONE ELEVATIONS<br>P39-P42 | Limestone | Original | Good to Fair: Stone requires cleaning and repointing, some small cracks and spalling some locations. Occasional graffiti | Yes | Long Term - Clean and repoint stone. Carefully repair cracks to match existing stone. |

P40: Graffiti on side wall of portico.

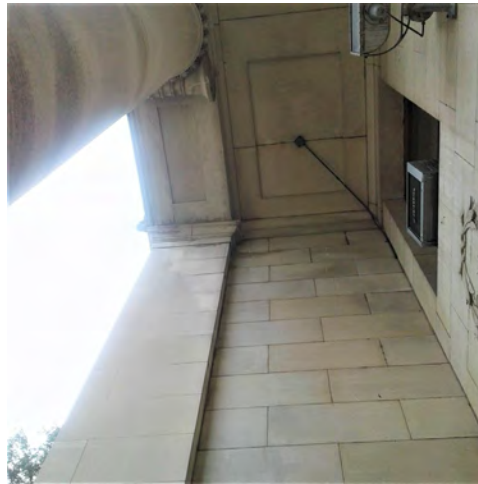
P41: Water intrusion saturation at top of portico.

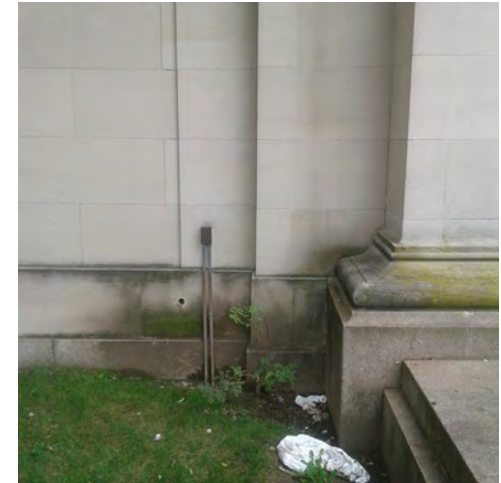
| Feature | Description | Period | Condition | CDF | Priority and Recommendation |
|---|---|---|---|---|---|
| LIMESTONE ELEVATIONS P43-P45, P48 | Limestone | Original | Good to Fair: Stone requires cleaning and repointing, some small cracks and spalling some locations. Occasional graffiti | Yes | Long Term - Clean and repoint stone. Carefully repair cracks to match existing stone. |

P45: Staining at base to left of main entry.

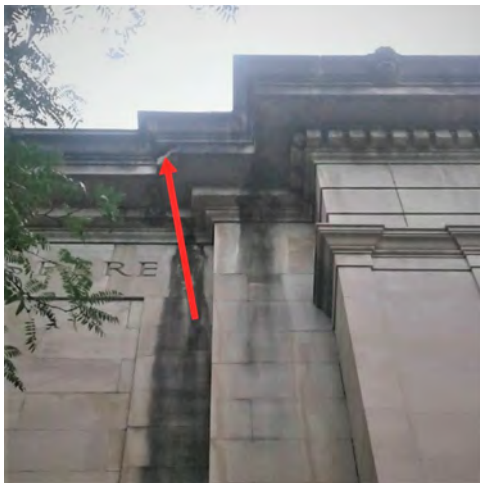
| Feature | Description | Period | Condition | CDF | Priority and Recommendation |
|---|---|---|---|---|---|
| LIMESTONE CORNICES P46, P47 | Limestone | Original | Good to Fair: Stone requires cleaning and repointing, some small cracks and spalling some locations. | Yes | Long Term - Clean and repoint stone. Carefully repair cracks to match existing stone. |

P46: Heavy staining/saturation at cornice extending down to ground level. Broken/Missing stone at cornice.

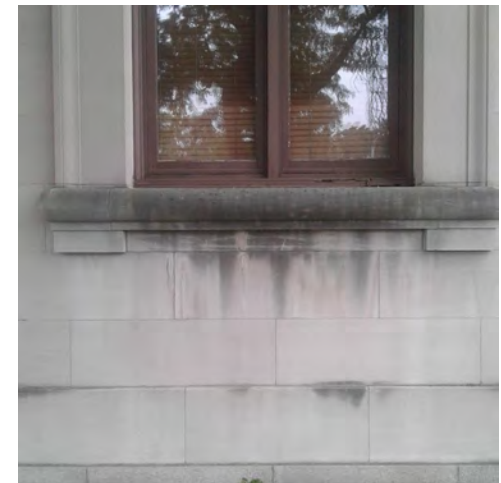
P48: Staining at window sill, first floor to right of main entry. Window needs to be repaired and repainted.

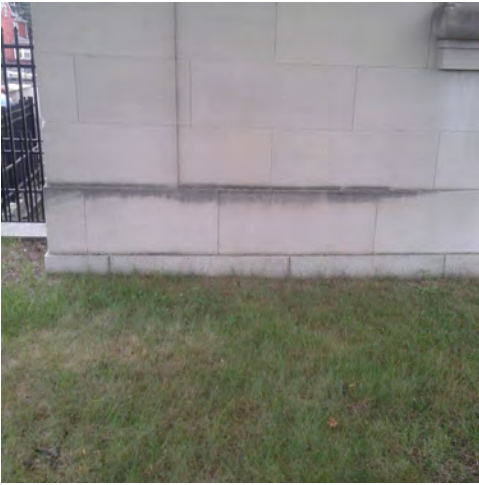
| Feature | Description | Period | Condition | CDF | Priority and Recommendation |
|---|---|---|---|---|---|
| LIMESTONE ELEVATIONS P49-P51 | Limestone | Original | Good to Fair: Stone requires cleaning and repointing, some small cracks and spalling some locations. | Yes | Long Term - Clean and repoint stone. Carefully repair cracks to match existing stone. |

P49: Staining at limestone base, NE corner.

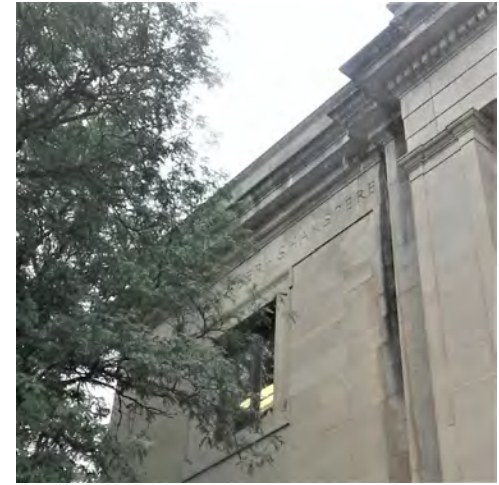
P51: Corrosion from previous repair copper straps, left side of N elevation.

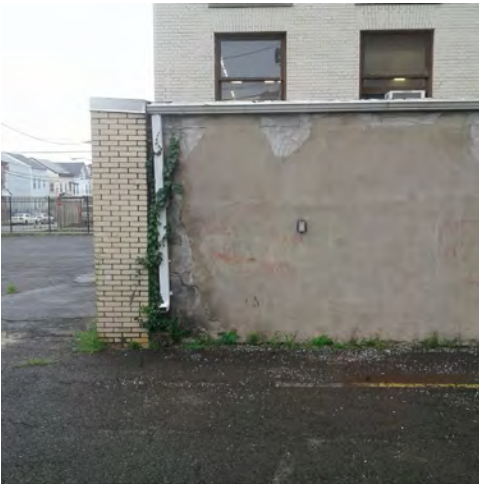
| Feature | Description | Period | Condition | CDF | Priority and Recommendation |
|---|---|---|---|---|---|
| WALLS AT REAR GARAGE P52-P54 | CMU & Stucco | Likely 1967 | Fair to Poor with water infiltration, cracked stucco and some damage to CMU. | No | Immediate - Stop water infiltration at roof, remove vegetation, patch and repair stucco. This building will likely be replaced during a later phase. |

P52: Stucco damage at garage addition located at the S elevation.

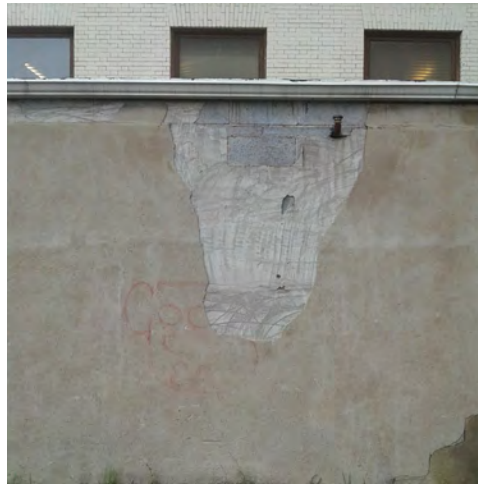
P53: Detail of stucco damage on E elevation of the garage addition.

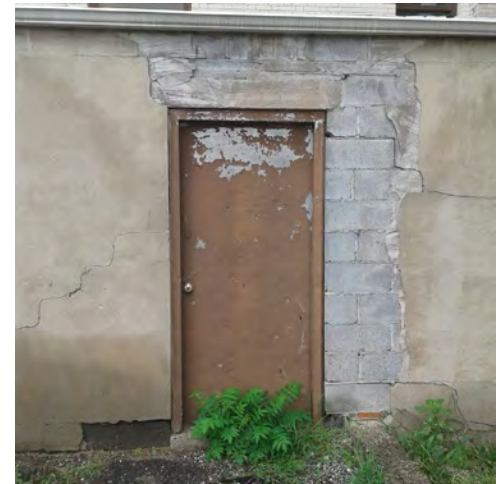
P54: Concrete spalling at garage addition.

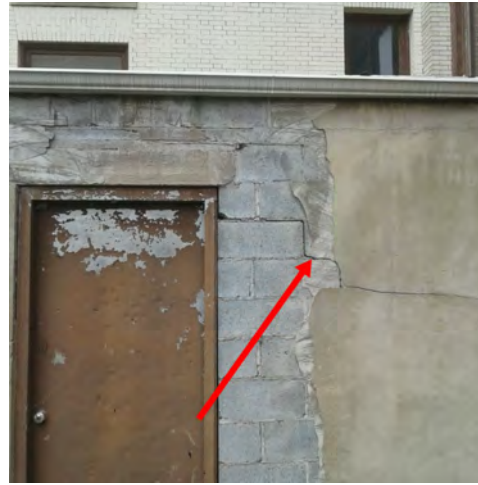
| Feature | Description | Period | Condition | CDF | Priority and Recommendation |
|---|---|---|---|---|---|
| WALLS AT REAR GARAGE P55, P56 | CMU & Stucco | Likely 1967 | Fair to Poor with water infiltration, cracked stucco and some damage to CMU. | No | Immediate - Stop water infiltration at roof, remove vegetation, patch and repair stucco. This building will likely be replaced during a later phase. |

P56: Stepped cracking at cmu on the garage addition.

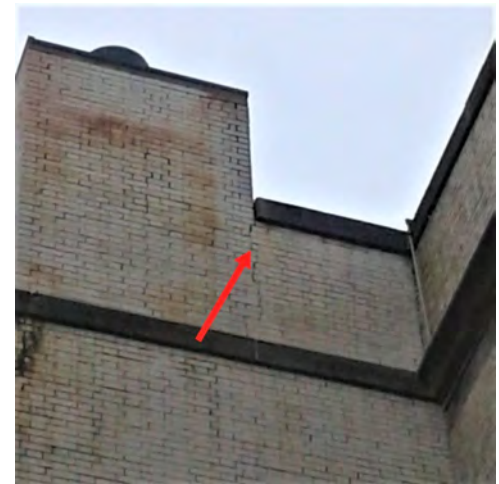
| Feature | Description | Period | Condition | CDF | Priority and Recommendation |
|---|---|---|---|---|---|
| GLAZED BRICK ELEVATIONS P57-P60 | Glazed Brick | Original | Fair - Staining, missing mortar, some cracking | Yes | Long Term - Clean and repoint brick. Carefully repair cracks to match existing brick. |

P60: Cracked and stained brick at rear wing.

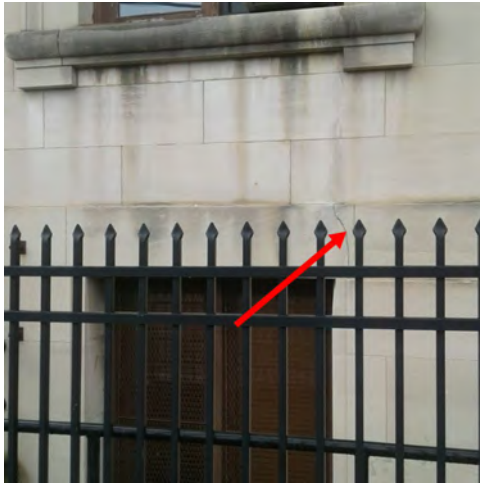
| Feature | Description | Period | Condition | CDF | Priority and Recommendation |
|---|---|---|---|---|---|
| LIMESTONE ELEVATIONS P61-P66 | Limestone | Original | Good to Fair: Stone requires cleaning and repointing, some small cracks and spalling some locations. | Yes | Long Term - Clean and repoint stone. Carefully repair cracks to match existing stone. |

P61: Cracked limestone on E elevation.

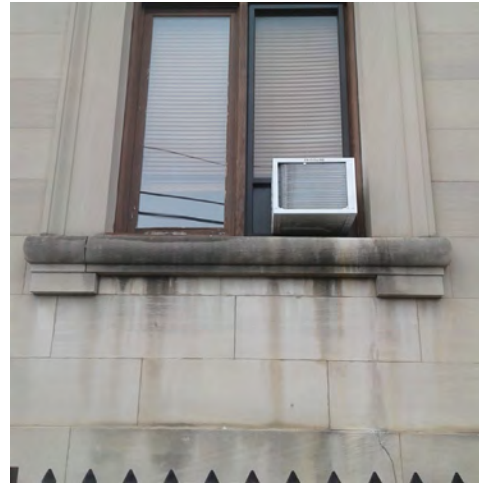
| Feature | Description | Period | Condition | CDF | Priority and Recommendation |
|---|---|---|---|---|---|
| WINDOWS P62, P64-P66 | Painted Wood | Mid 1980's | Fair to Poor: Paint is peeling leaving bare wood exposed and rotting in some areas. 20% of windows have been blocked up. There is water and air infiltration in many locations. | Yes (replacement) | Short Term - Replace most windows with new, historically appropriate windows that are insulated and function properly. |

P62: Staining at window sill, typical. (E. elevation)

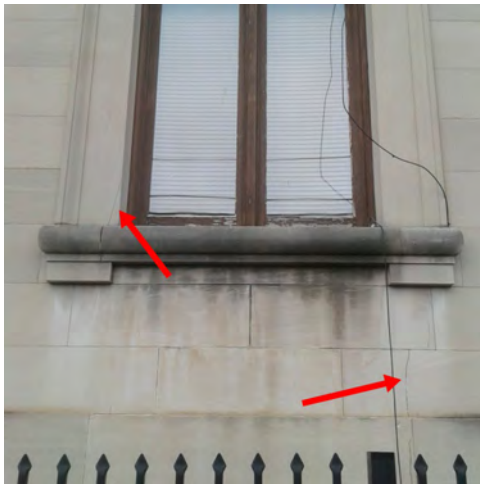
P64: Cracked limestone at first floor window at E elevation.

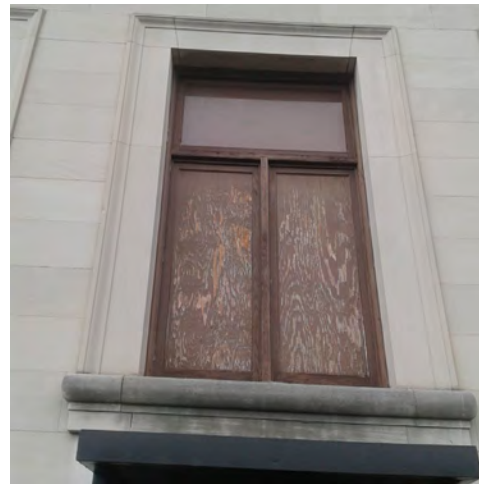
P65: Blocked windows, missing glass at E elevation.

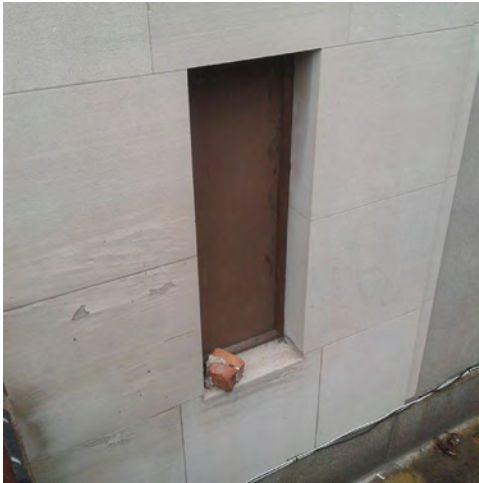
| Feature | Description | Period | Condition | CDF | Priority and Recommendation |
|---|---|---|---|---|---|
| WINDOWS P67, P68 | Painted Wood | Mid 1980's replacement | Missing | Yes (replacement) | Short Term - Replace most windows with new, historically appropriate windows that are insulated and function properly. |

P67: Window boarded near elevator entry, E elevation.

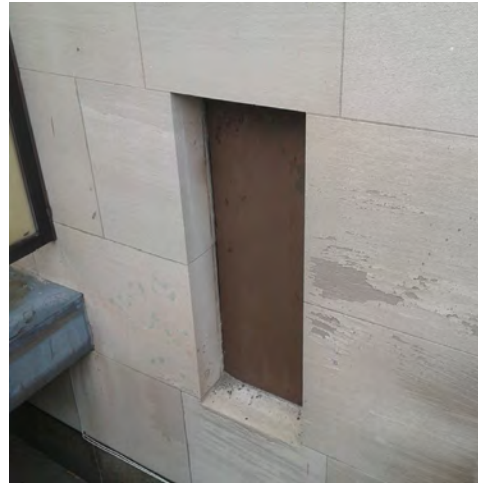
P68: Window boarded

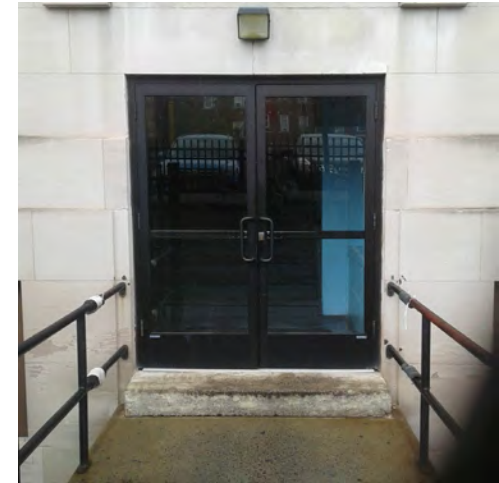
| Feature | Description | Period | Condition | CDF | Priority and Recommendation |
|---|---|---|---|---|---|
| EXTERIOR DOORS P69 | Painted Metal | 1967 or later | Fair | Yes | Short Term - Replace with doors more in keeping with the character of the building. |

P69: Location of entry to stairs at E elevation. Stone is stained and concrete damaged.

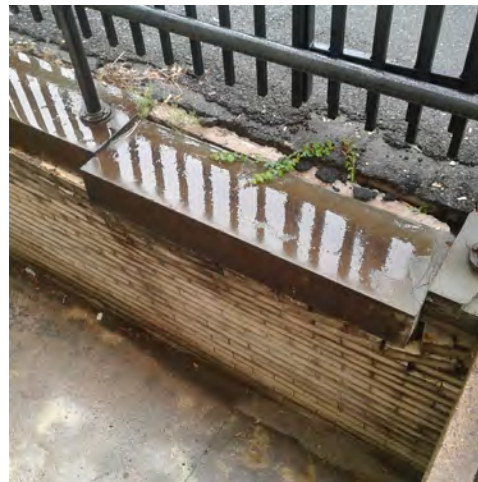
| Feature | Description | Period | Condition | CDF | Priority and Recommendation |
|---|---|---|---|---|---|
| RETAINING WALLS | Galzed brick, concrete structure, bluestone cap, steel fencing | Original with later repairs and changes | Poor - Cracking, water damage, capstones have shifted | Yes | Immediate - Repair and replace the walls to match existing as required. |

P71: Dislodged and buckling bluestone caps at retaining wall on the E side of the building.

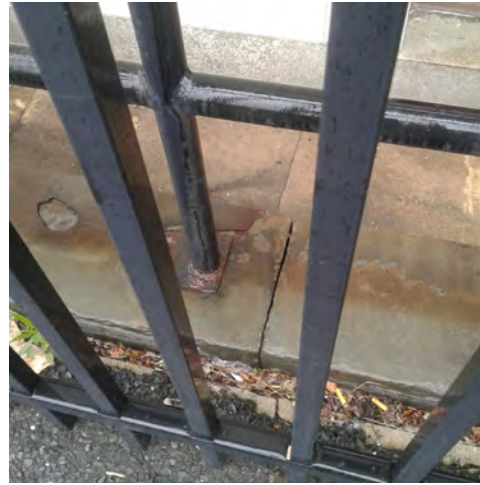
| Feature | Description | Period | Condition | CDF | Priority and Recommendation |
|---|---|---|---|---|---|
| AREAWAYS P73, P74 | Concrete floor with masonry walls | Original | Fair | No | Long Term - Remove vegetation and repair any cracks. Cut out and replace highly damaged areas. |

P74: Cracked limestone at fending on the E elevation..

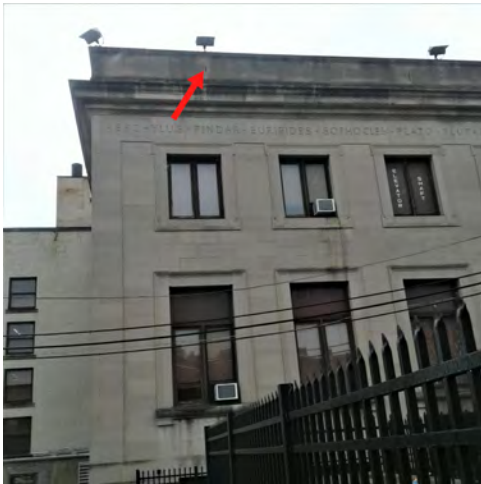
| Feature | Description | Period | Condition | CDF | Priority and Recommendation |
|---|---|---|---|---|---|
| LIMESTONE CORNICE P75, P76, P78 | Limestone | Original | Good to Fair: Stone requires cleaning and repointing, some small cracks and spalling some locations. | Yes | Long Term - Clean and repoint stone. Carefully repair cracks to match existing stone. Remove lighting from top of coping. |
| LIMESTONE ELEVATIONS P76, P77, P78 | Limestone | Original | Good to Fair: Stone requires cleaning and repointing, some small cracks and spalling some locations. | Yes | Long Term - Clean and repoint stone. Carefully repair cracks to match existing stone. |

P76: Spalled limestone at cornice at rear of E elevation.

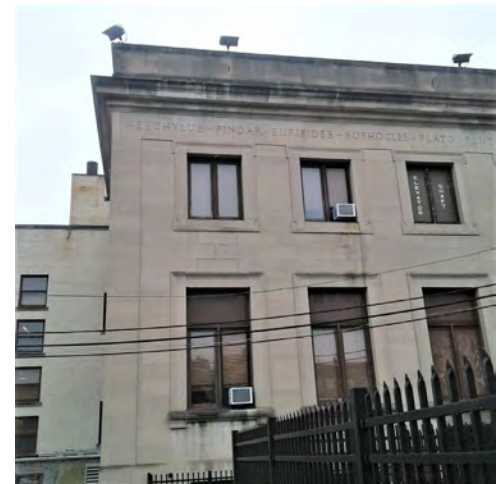
P78: Staining from a.c. window unit, typ. E. elevation.

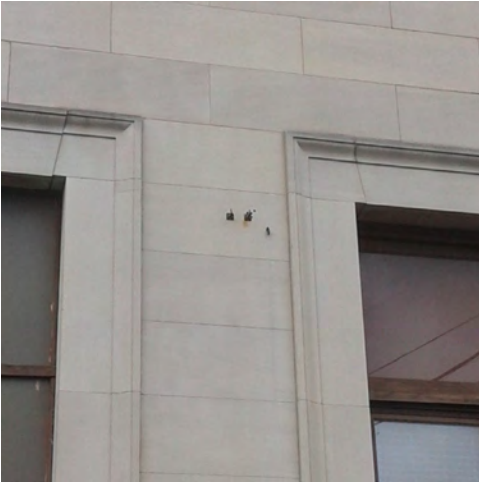
| Feature | Description | Period | Condition | CDF | Priority and Recommendation |
|---|---|---|---|---|---|
| LIMESTONE ELEVATIONS P79, P80 | Limestone | Original | Good to Fair: Stone requires cleaning and repointing, some small cracks and spalling some locations. | Yes | Long Term - Clean and repoint stone. Carefully repair cracks to match existing stone. Remove metal pieces and patch to match the existing stone. |

P79: Utility anchors abandoned in place, E. elevation.

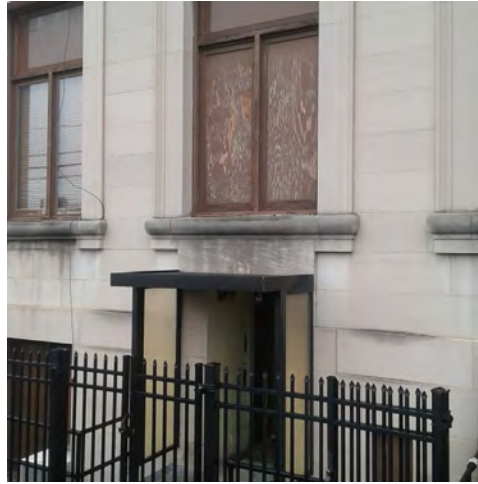
P80: Staining above entry canopy for elevator, E elevation.

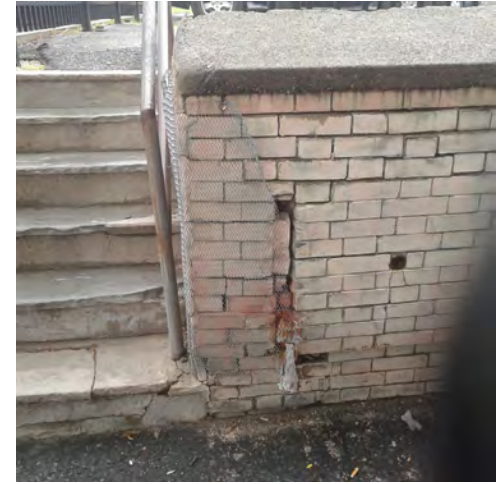
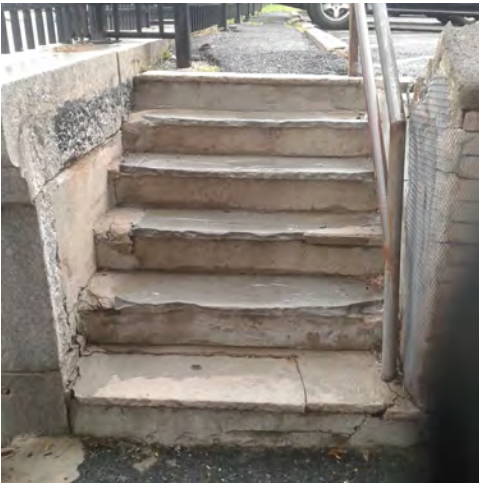
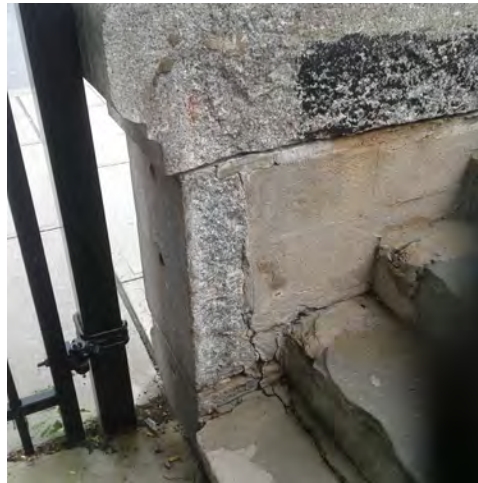
| Feature | Description | Period | Condition | CDF | Priority and Recommendation |
|---|---|---|---|---|---|
| EXTERIOR STAIRS | Concrete | Unknown | Poor - Concrete is spalling and failing | No | Immediate - Repair/ replace concrete with new steps and railings. |

P81: Damaged steps and retaining wall from E. elevation to parking.

P82: Damaged steps and retaining wall from E. elevation to parking.

P83: Damaged steps and retaining wall from E. elevation to parking.

P84: Damaged steps and retaining wall from E. elevation to parking.

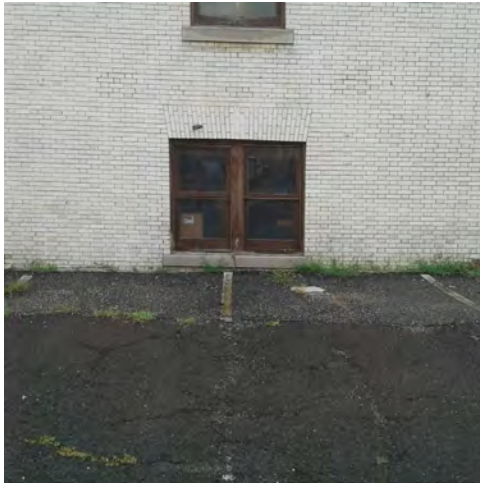
| Feature | Description | Period | Condition | CDF | Priority and Recommendation |
|---|---|---|---|---|---|
| GLAZED BRICK ELEVATIONS P91-P96 | Glazed Brick and Standard Brick at base | Original | Fair to Poor - Staining, missing mortar, some cracking; standard brick at the base is spalling and deteriorating. | Yes | Long Term - Clean and repoint brick. Carefully repair cracks to match existing brick. Replace damaged brick at the base |

P91: Previous entry removed, S elevation, center of the rear wing.

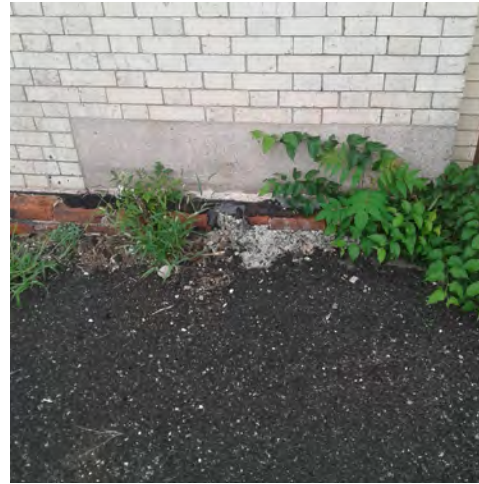
P92: Damaged brick at the base of the rear wing, SE corner.

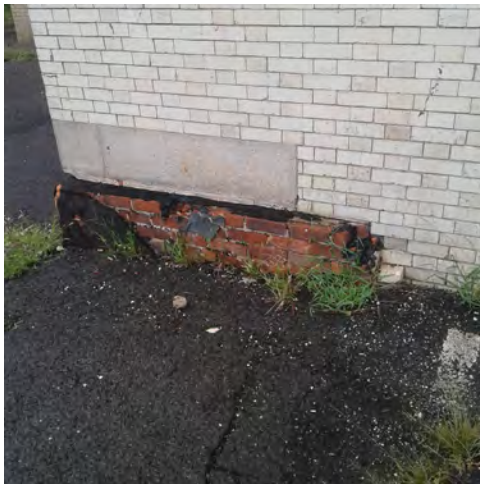
P94: Damage at the base of the rear wing, SW corner.

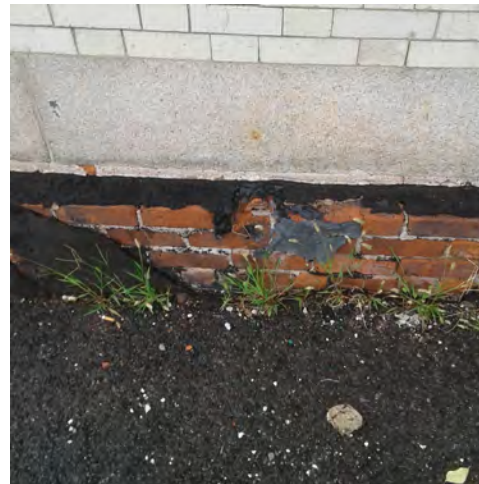
P95: Crumbling brick at foundation of rear wing.

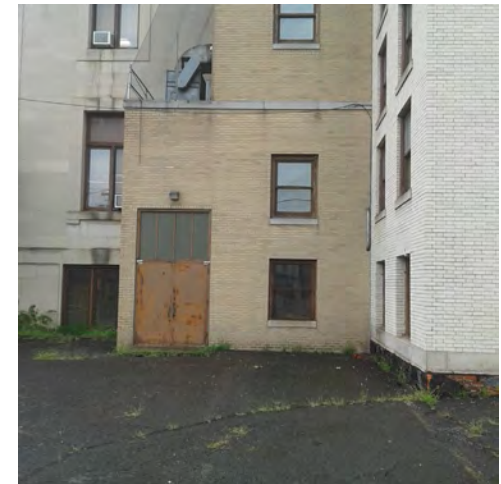
P96: Egress stair addition on the W side of the rear addition.

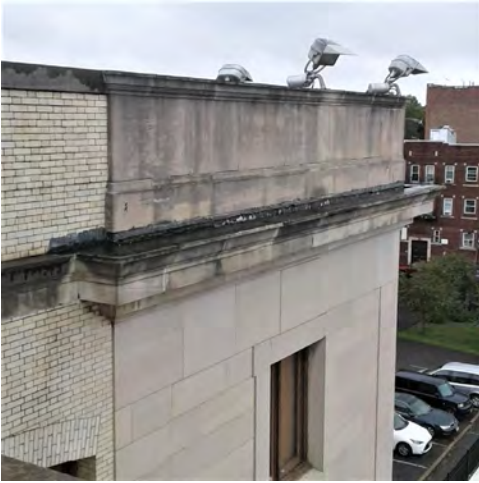
| Feature | Description | Period | Condition | CDF | Priority and Recommendation |
|---|---|---|---|---|---|
| LIMESTONE CORNICE P <sub>97</sub> | Limestone | Original | Good to Fair: Stone requires cleaning and repointing, some small cracks and spalling some locations. | Yes | Long Term - Clean and repoint stone. Carefully repair cracks to match existing stone. Remove lighting from top of coping. |

P97: Severe staining at cornice, rear (S) elevation, E corner.

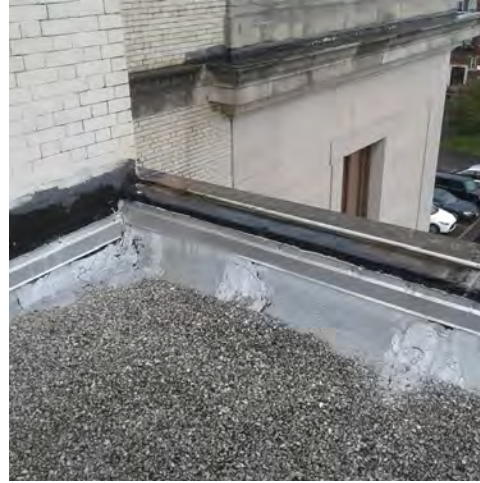
| Feature | Description | Period | Condition | CDF | Priority and Recommendation |
|---|---|---|---|---|---|
| ROOFING P <sub>98</sub> , P <sub>99</sub> , P <sub>101</sub> , P <sub>102</sub> | Ballasted built-up roofing with metal flashings and copings. Aluminum siding is used to protect walls and parapets. | 10-25 years old | Fair to poor: Evidence of periodic leaking inside and patching on the roof. Siding that protects the parapets and some walls at the roof is badly damaged, some has blown away. | No | Short Term - Install a new, high quality roof that is reflective and that provides adequate insulation to reduce energy usage. Add overflow scuppers and adequate drainage. |

P98: Typical roof conditions.

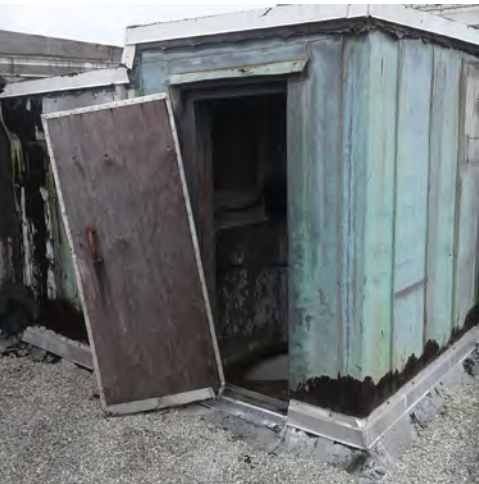
| Feature | Description | Period | Condition | CDF | Priority and Recommendation |
|---|---|---|---|---|---|
| ROOF ACCESS AND EXTERIOR DOOR P <sub>100</sub> | Copper and steel | Original roof access and replacement door. | Fair to poor: The exterior door is non operable, and the copper on the roof access has been damaged by tar and inadequate repairs. | No | Immediate - Install a new exterior door that is operational and prevents water infiltration. Short Term - Install new roof access. |

P100: Roof access door is damaged and off its hinges. Note the tar on the copper, causing corrosion.

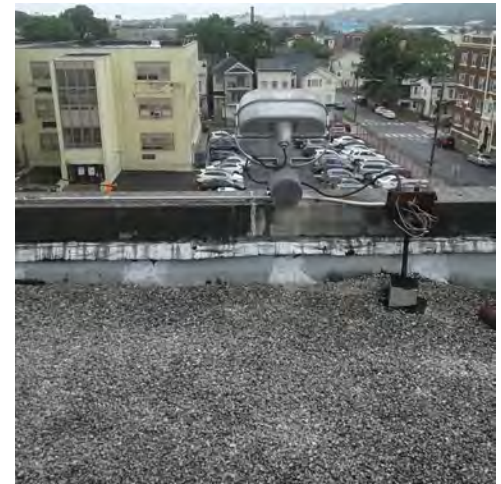
P102: Lighting attached to roof parapet.

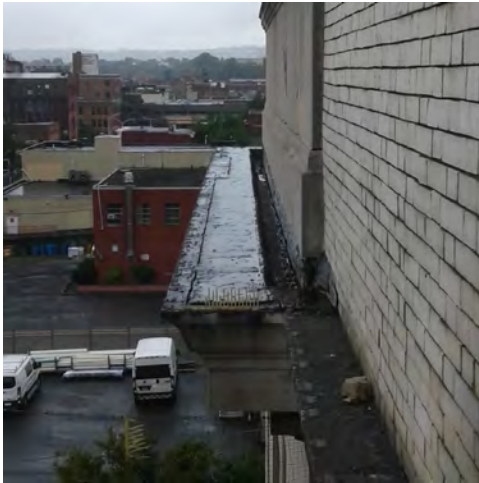
Pro3: View of top of cornice at SW corner.

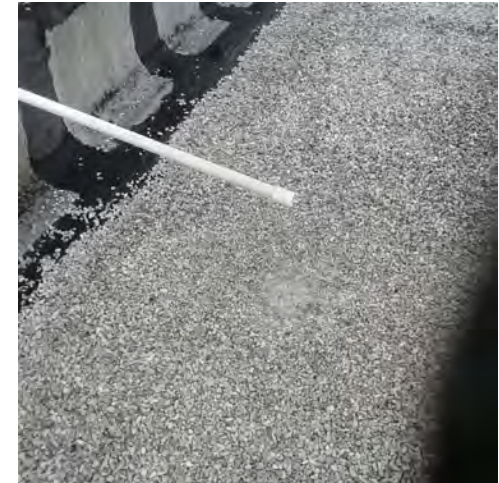
Pro5: Condensate drain from rooftop equipment flowing directly onto roof surface.

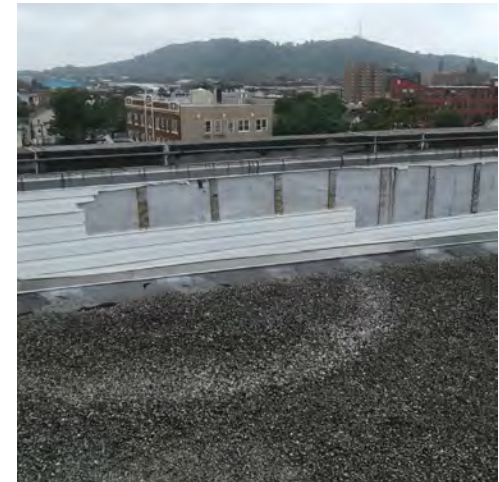
| Feature | Description | Period | Condition | CDF | Priority and Recommendation |
|---|---|---|---|---|---|
| ROOFING P103 - P108 | Ballasted built-up roofing with metal flashings and copings. Aluminum siding is used to protect walls and parapets. | 10-25 years old | Fair to poor: Evidence of periodic leaking inside and patching on the roof. Siding that protects the parapets and some walls at the roof is badly damaged, some has blown away. Note the poor condition of the rooftop HVAC equipment. | No | Short Term - Install a new, high quality roof that is reflective and that provides adequate insulation to reduce energy usage. Add overflow scuppers and adequate drainage. |

Pro8: Damaged material protecting the roof parapet, typical.

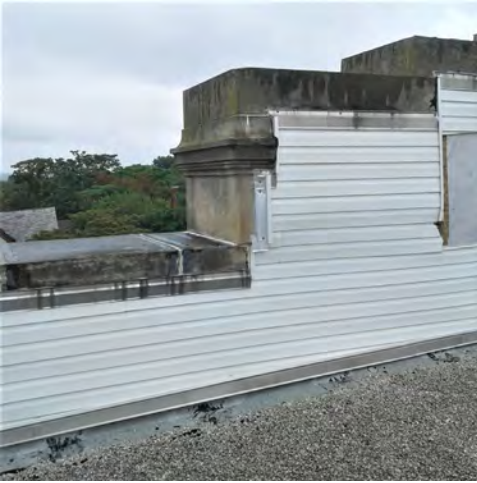
| Feature | Description | Period | Condition | CDF | Priority and Recommendation |
|---|---|---|---|---|---|
| ROOFING P109 - P114 | Ballasted built-up roofing with metal flashings and copings. Aluminum siding is used to protect walls and parapets. | 10-25 years old | Fair to poor: Evidence of periodic leaking inside and patching on the roof. Siding that protects the parapets and some walls at the roof is badly damaged, some has blown away. | No | Short Term - Install a new, high quality roof that is reflective and that provides adequate insulation to reduce energy usage. Add overflow scuppers and adequate drainage. |

P109: Damaged siding at roof parapet behind main entry.

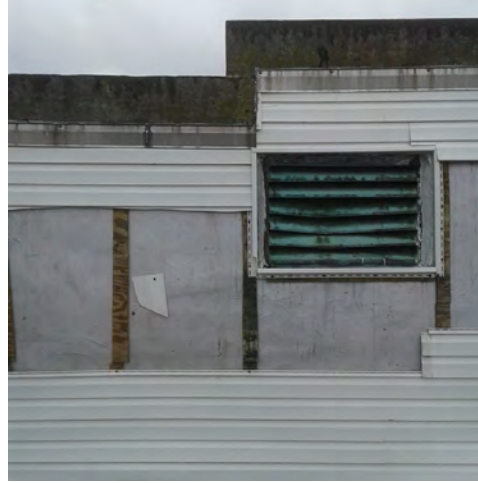
P110: Typical damage to material at the parapet.

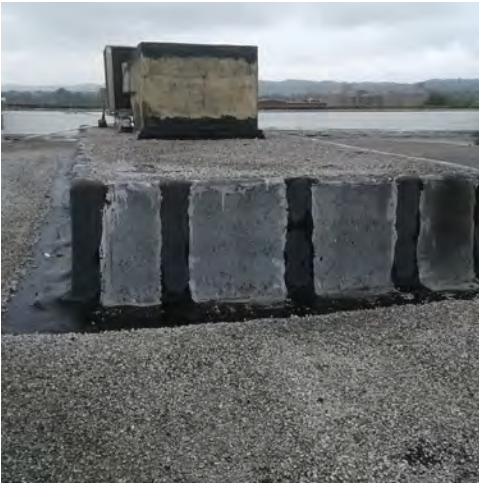
| Feature | Description | Period | Condition | CDF | Priority and Recommendation |
|---|---|---|---|---|---|
| ROOFING P115 - P120 | Ballasted built-up roofing with metal flashings and copings. Aluminum siding is used to protect walls and parapets. | 10-25 years old | Fair to poor: Evidence of periodic leaking inside and patching on the roof. Siding that protects the parapets and some walls at the roof is badly damaged, some has blown away. | No | Short Term - Install a new, high quality roof that is reflective and that provides adequate insulation to reduce energy usage. Add overflow scuppers and adequate drainage. |

P115: Typical condition at changes in roof elevation, showing repairs at seams.

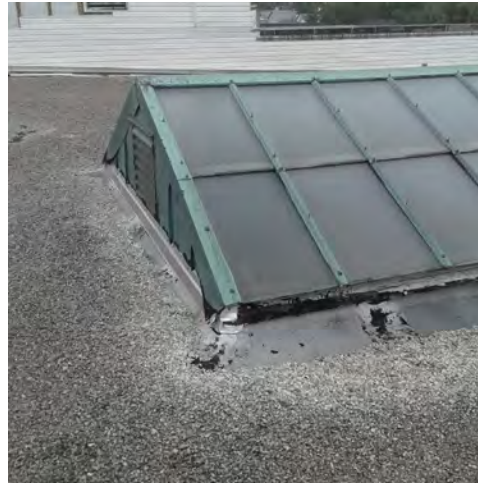
| Feature | Description | Period | Condition | CDF | Priority and Recommendation |
|---|---|---|---|---|---|
| SKYLIGHT P122 - P126 | Shed skylight with copper frame and muntins and wireglass glazing | Original | Fair - Some of the glass is cracked or has been replaced; tar has been used on the copper causing some of it to deteriorate. It has been blocked from below. | No (from the exterior);<br>Yes (from the interior) | Short Term - When replacing the roof, repair or replace the skylight and make it visible in the main stair hall below. |

P122: Existing skylight over the main entry hall and stairs; blocked from below.

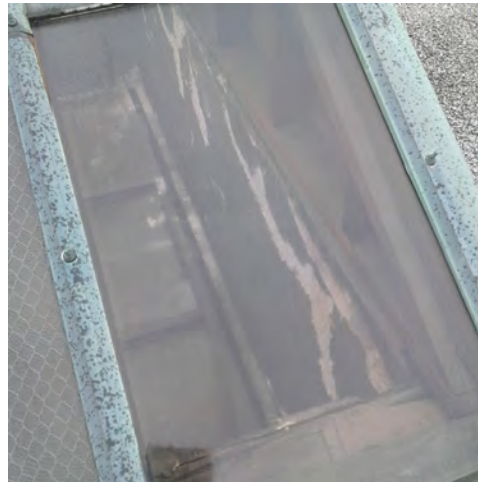
P125: Replacement glass in the skylight.

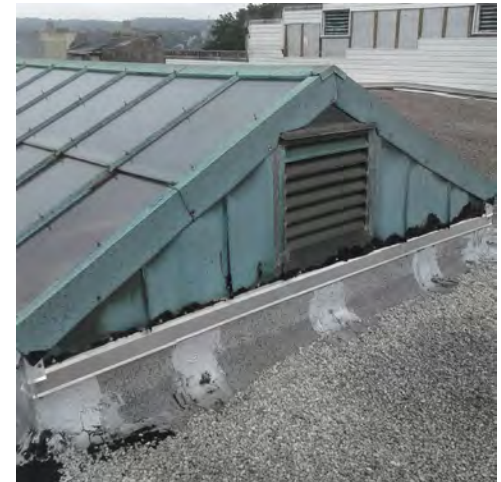
P126: Dissimilar metals at the new roof flashing and the historic skylight.

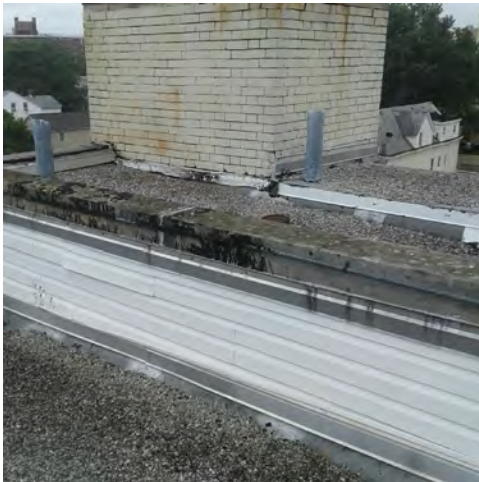
| Feature | Description | Period | Condition | CDF | Priority and Recommendation |
|---|---|---|---|---|---|
| ROOF P127 - P132 | Ballasted built-up roofing with metal flashings and copings. Aluminum siding is used to protect walls and parapets. | 10-25 years old | Fair to poor: Evidence of periodic leaking inside and patching on the roof. Siding that protects the parapets and some walls at the roof is badly damaged, some has blown away. Note the extremely poor condition of the rooftop HVAC equipment | No | Short Term - Install a new, high quality roof that is reflective and that provides adequate insulation to reduce energy usage. Add overflow scuppers and adequate drainage. |

P130: Failing siding at parapet; damaged and stained brick at the exhaust chimney.

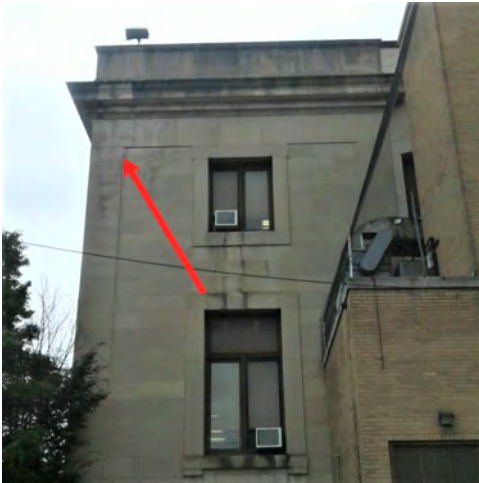
| Feature | Description | Period | Condition | CDF | Priority and Recommendation |
|---|---|---|---|---|---|
| LIMESTONE ELEVATIONS P133-P137 | Limestone | Original | Good to Fair: Stone requires cleaning and repointing, some small cracks and spalling some locations. | Yes | Long Term - Clean and repoint stone. Carefully repair cracks to match existing stone. Remove lighting from top of coping. |

P133: Evidence of water infiltration, S elevation near E corner.
