# DANFORTH MEMORIAL LIBRARY | PRESERVATION PLAN

SEPTEMBER, 2018

## I. EXECUTIVE SUMMARY

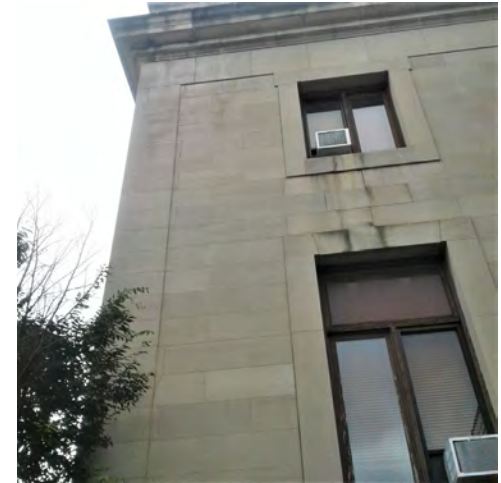
| Feature | Description | Period | Condition | CDF | Priority and Recommendation |
|---|---|---|---|---|---|
| LIMESTONE ELEVATIONS P133-P137 | Limestone | Original | Good to Fair: Stone requires cleaning and repointing, some small cracks and spalling some locations. | Yes | Long Term - Clean and repoint stone. Carefully repair cracks to match existing stone. Remove lighting from top of coping. |
| WINDOWS P135, P138 | Painted Wood | Mid 1980's replacement windows. | Fair to Poor: Paint is peeling leaving bare wood exposed and rotting in some areas. 20% of windows have been blocked up. There is water and air infiltration in many locations. | Yes (replacement) | Short Term - Replace most windows with new, historically appropriate windows that are insulated and function properly. |

P135: Staining on limestone, blocked windows, and window AC units, S elevation near E corner.

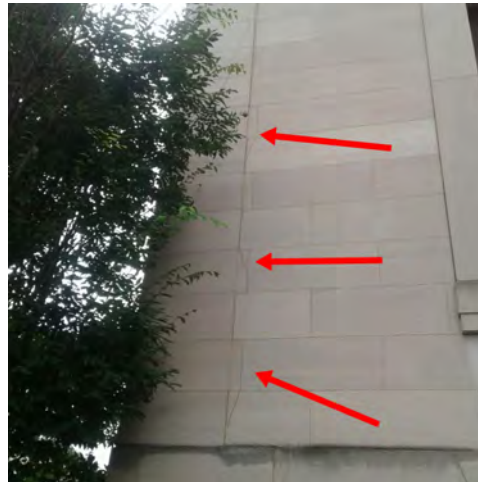
P 137: Cracked limestone

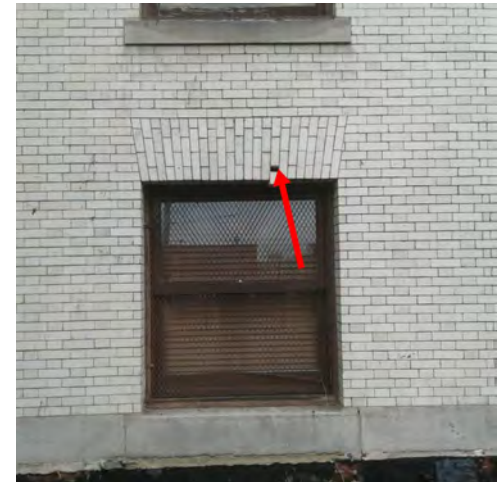
P138: Loose brick at header at E side of rear wing.

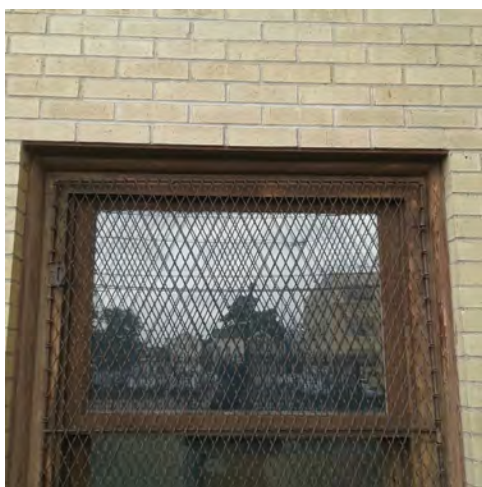
| Feature | Description | Period | Condition | CDF | PRIORITY AND RECOMMENDATIONS |
|---|---|---|---|---|---|
| WINDOWS P139, P141, P144 | Painted Wood | Mid 1980's replacement | Fair to Poor: Paint is peeling leaving bare wood exposed and rotting in some areas. 20% of windows have been blocked up. There is water and air infiltration in many locations. | Yes (replacements) | Short Term - Replace most windows with new, historically appropriate windows that are insulated and function properly. |

P139: Deterioration of wood windows on the rear addition, typ.

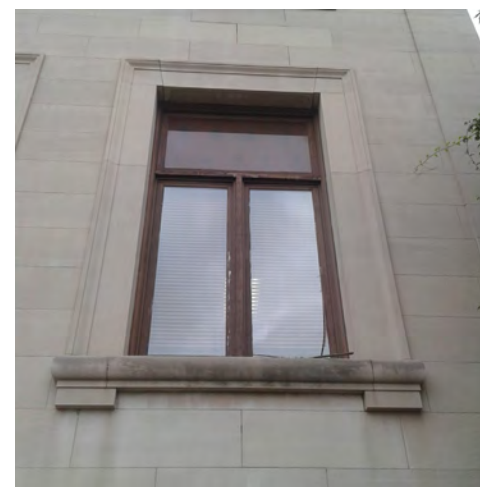
P141: Deterioration of wood windows, typ. W elevation.

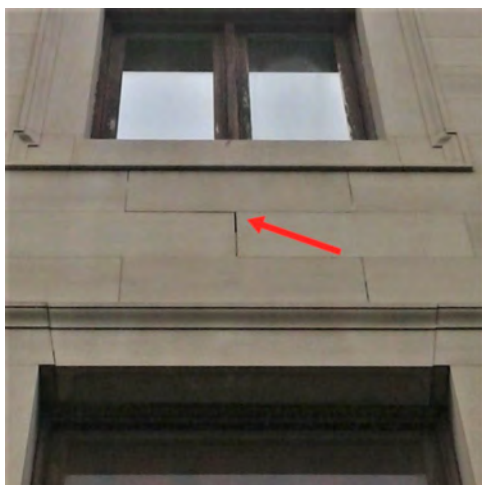
P142: Mortar missing over side entry door on W Elevation.

| Feature | Description | Period | Condition | CDF | PRIORITY AND RECOMMENDATIONS |
|---|---|---|---|---|---|
| LIMESTONE ELEVATIONS P141, P142-P144 | Limestone | Original | Good to Fair: Stone requires cleaning and repointing, some small cracks and spalling some locations. | Yes | Long Term - Clean and repoint stone. Carefully repair cracks to match existing stone. |

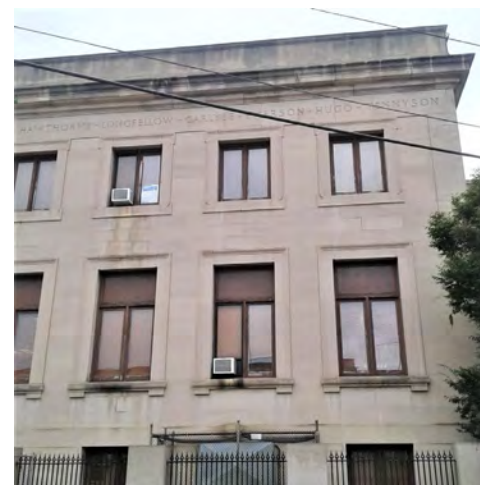
P144: General view of rear of W elevation. Note partially boarded windows, window units, etc.

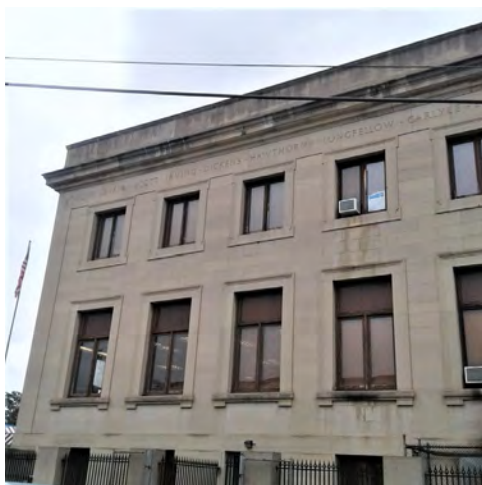
P145: Heavy staining at cornice on the W elevation.

| Feature | Description | Period | Condition | CDF | Priority and Recommendation |
|---|---|---|---|---|---|
| LIMESTONE ELEVATIONS P145 - p150 | Limestone | Original | Good to Fair: Stone requires cleaning and repointing, some small cracks and spalling some locations. | Yes | Long Term - Clean and repoint stone. Carefully repair cracks to match existing stone. |

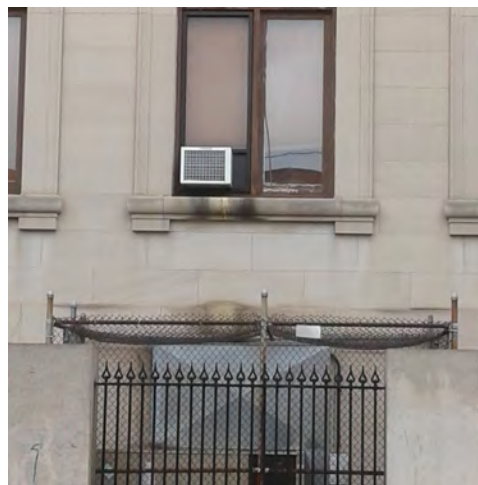
P146: Staining from a.c. window unit, and blocked opening from large HVAC unit at ground floor, W elevation.

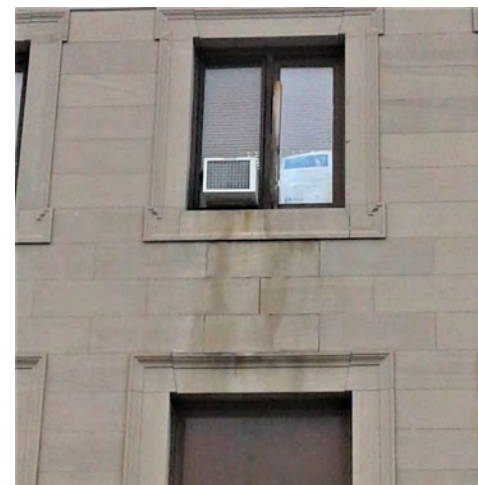
P147: Staining from a.c. window unit.

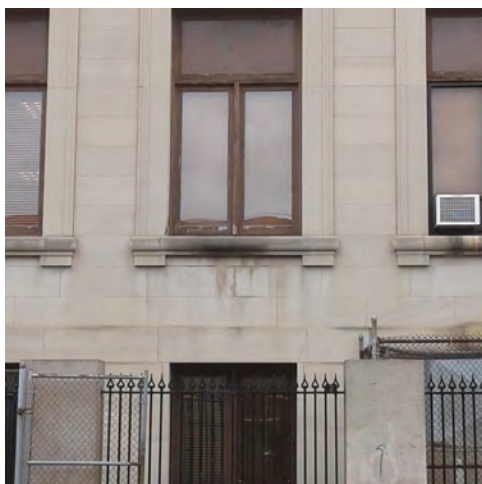
P148: Staining mold at window sill over Children's Library entry on the W elevation.

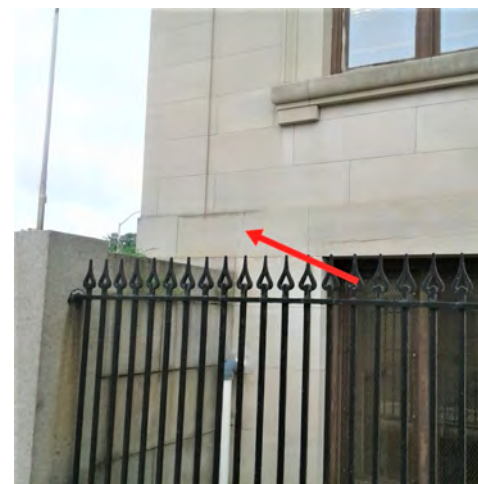
P 150: Cracked limestone at NW corner.

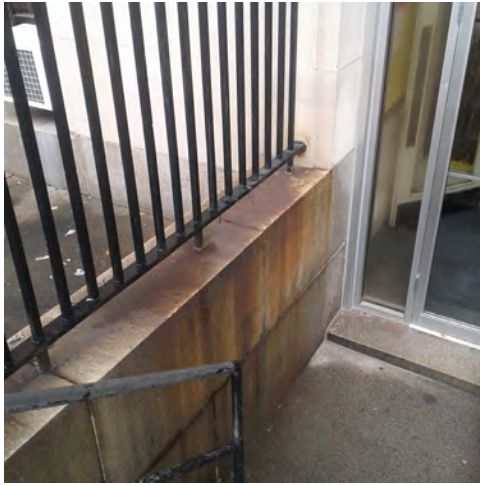
| Feature | Description | Period | Condition | CDF | Priority and Recommendation |
|---|---|---|---|---|---|
| EXTERIOR STEPS<br>AT ENTRY TO THE<br>CHILDREN'S LIBRARY<br>P151- P156 | Granite with steel railing | Original | Fair - Stone is stained from rust, mortar missing at some locations, railing is rusty. | Yes | Short Term - Clean and repoint stone. Prep and repaint handrails. |

P151: Staining and rust at stairs to Children's Library entry.

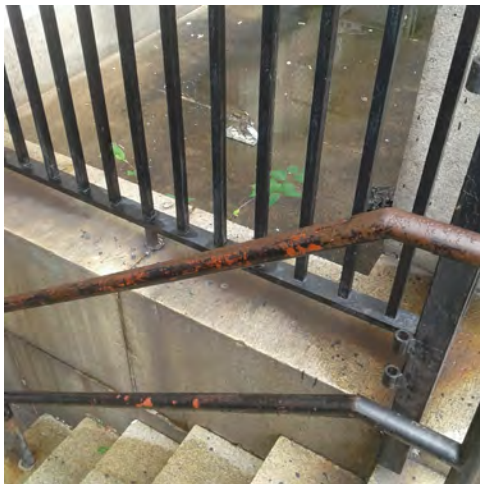
P154: Heavy staining at granite retraining walls.

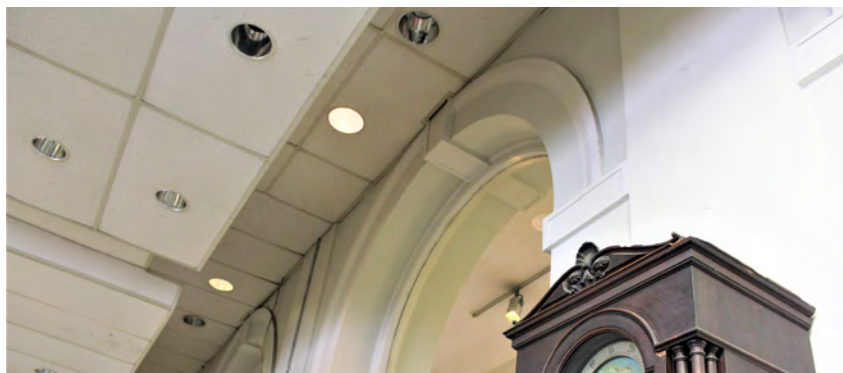
Photo 12: The drop ceilings obscure much of the original architectural details

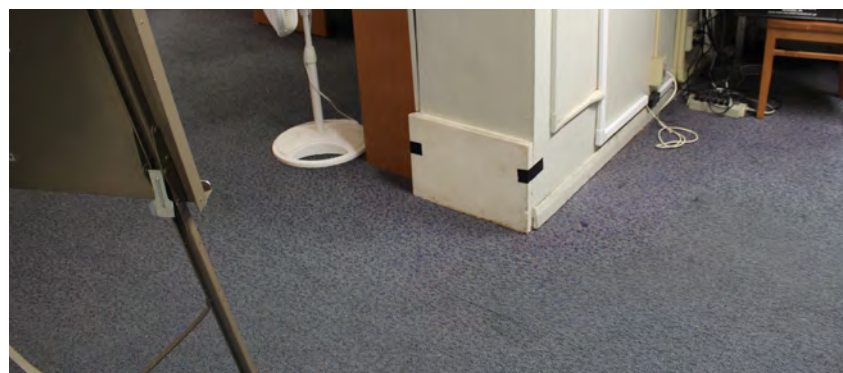
| Feature | Description | Period | Condition | CDF | Priority and Recommendation |
|---|---|---|---|---|---|
| Baseboard | Marble visible on N, E, S walls | Original | Good except behind circ. desk in opening to 105, the baseboard is held up by tape | Yes | Clean as needed. Affix loose marble baseboard at opening to 105 |

Photo 16: The original marble baseboard is now being held up by tape. This should be remedied immediately.

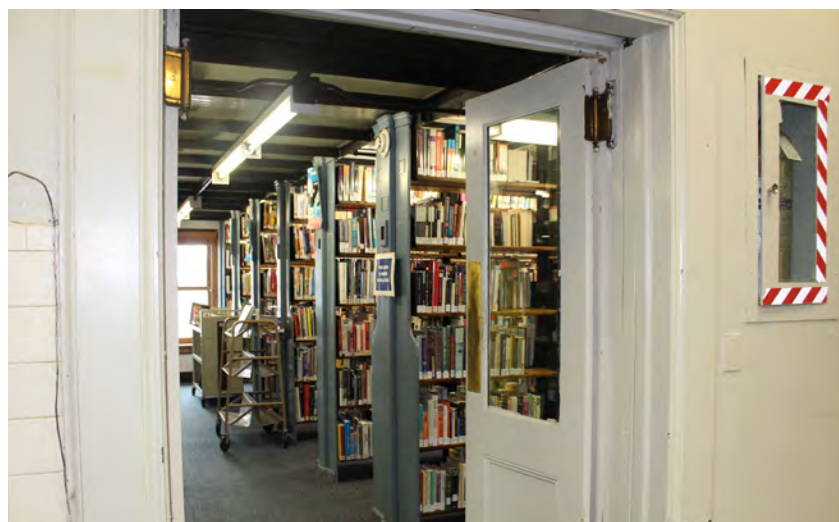
Photo 26: The original doors remain in situ

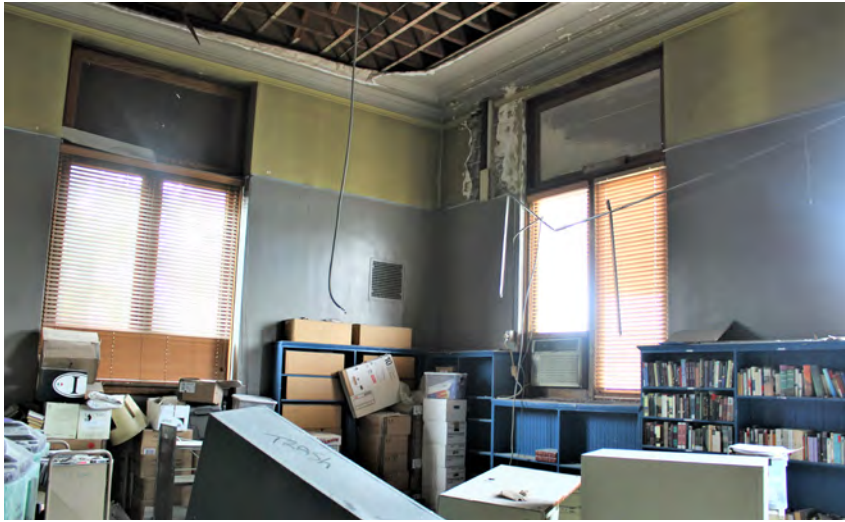
| Feature | Description | Period | Condition | CDF | Priority and Recommendation |
|---|---|---|---|---|---|
| Walls | Plaster | Original | Fair | Yes | Immediate: Damage in upper areas where the ceiling fell. Repair and restore |

Photo 35: The NE corner of Room 109. The ceiling fell in the spring

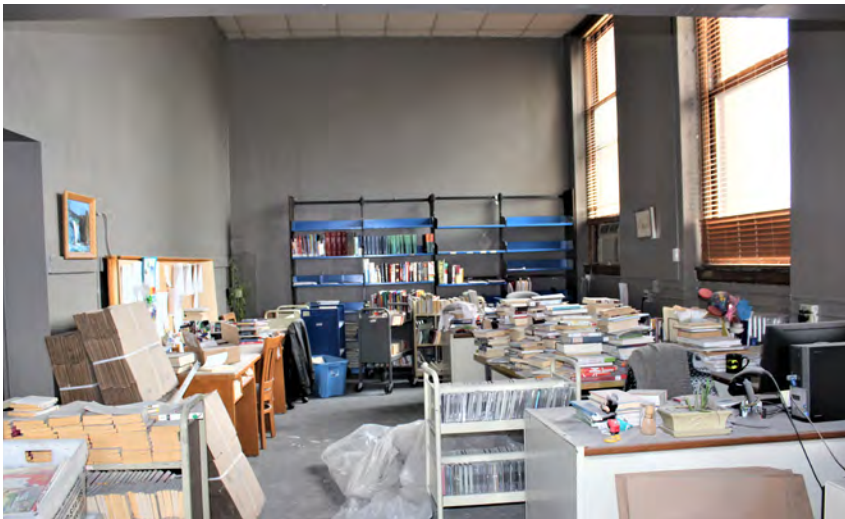
Photo 37: The room to the west. The hung ceiling remains in place

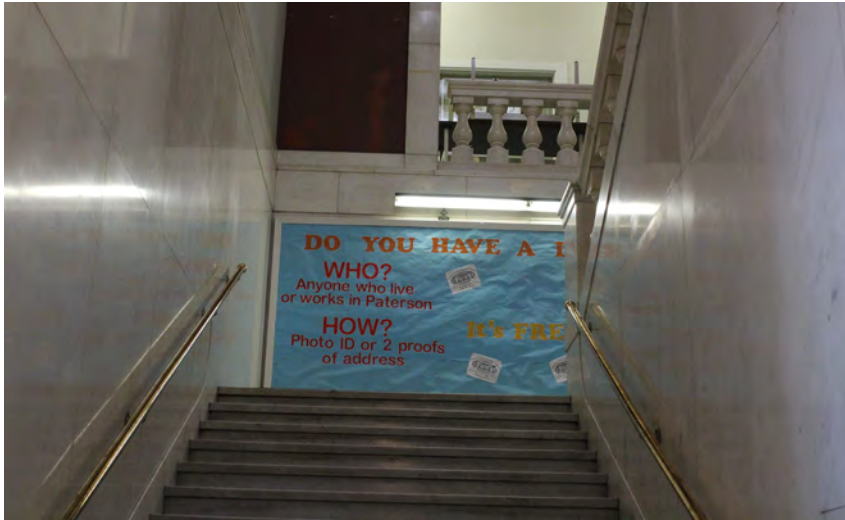
Photo 39: The stairs going up are remarkably intact

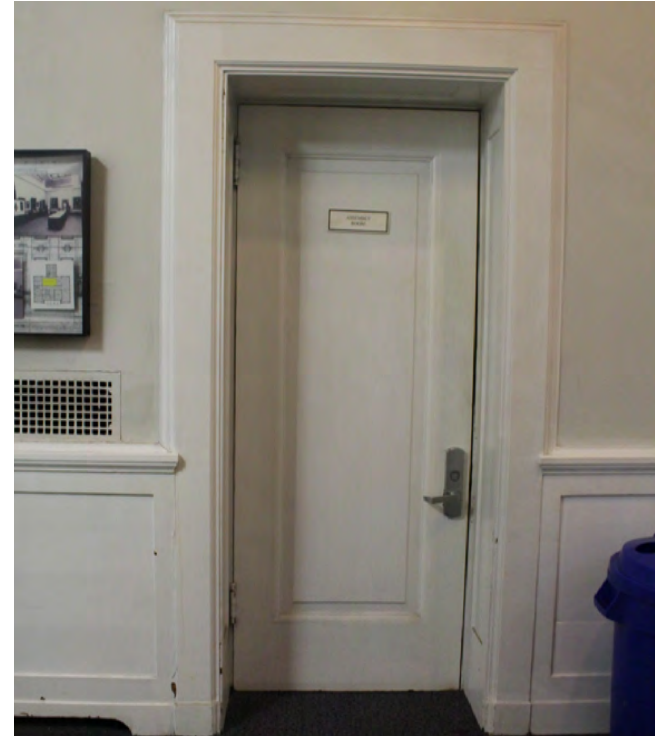
Photo 48: An original door and surround leading to 207. Originally the finish on both was clear as was the wainscot. Restoration of the finishes of this space should be a long term.

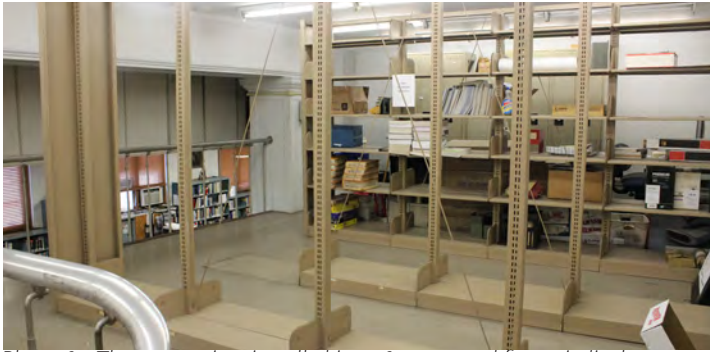
Photo 61: The mezzanine, installed in 1961, was used for periodicals

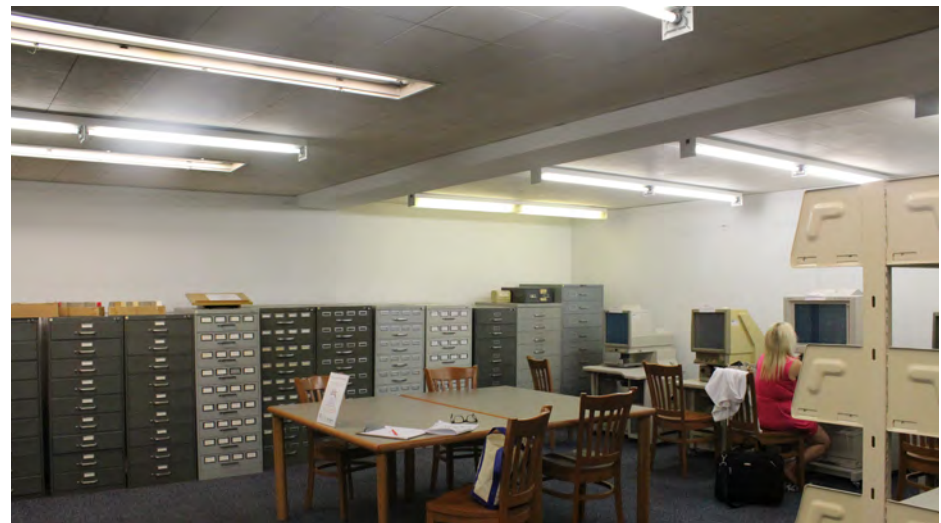
Photo 64: The space under the mezzanine is dark and cramped

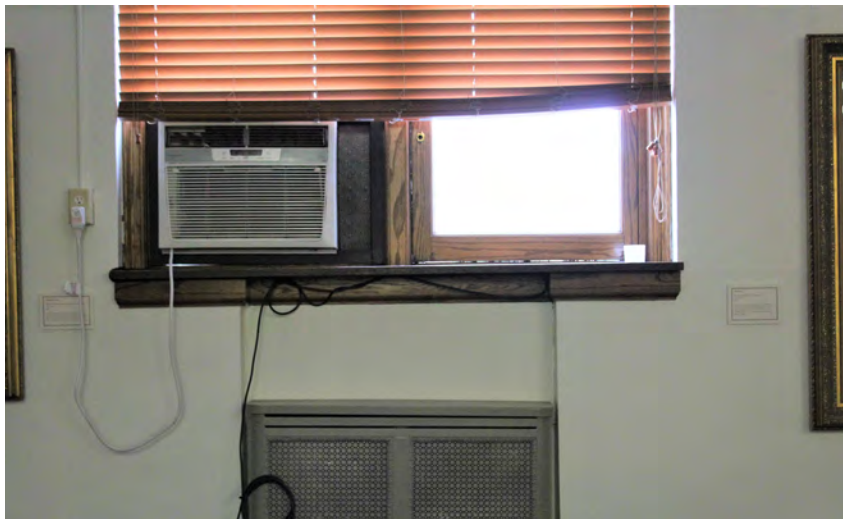
| Feature | Description | Period | Condition | CDF | Priority and Recommendation |
|---|---|---|---|---|---|
| Windows | Replacement wood casements below dropped ceiling | 1986<br>Original | Good | No | Short Term: Most of the casements need to be reglazed but generally appear sound. |

Photo 71: Looking west

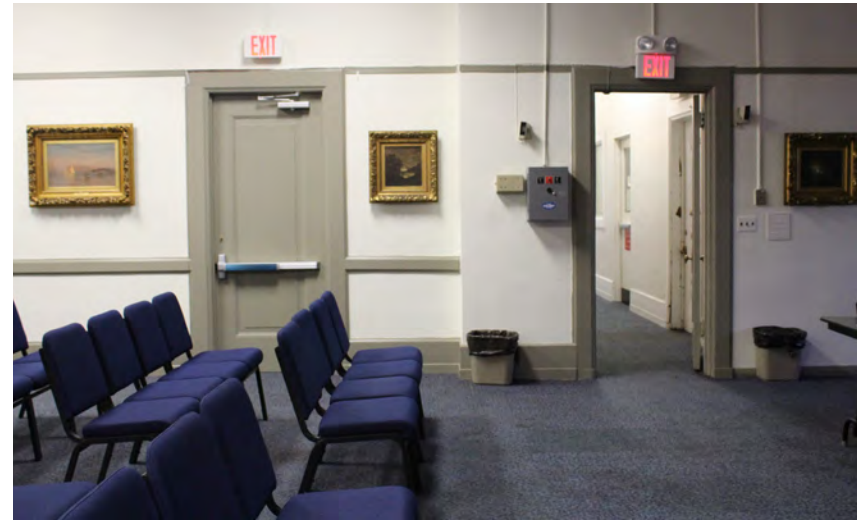
Photo 74: The original chair rail is on the north wall. The west rear wall dates to 1967

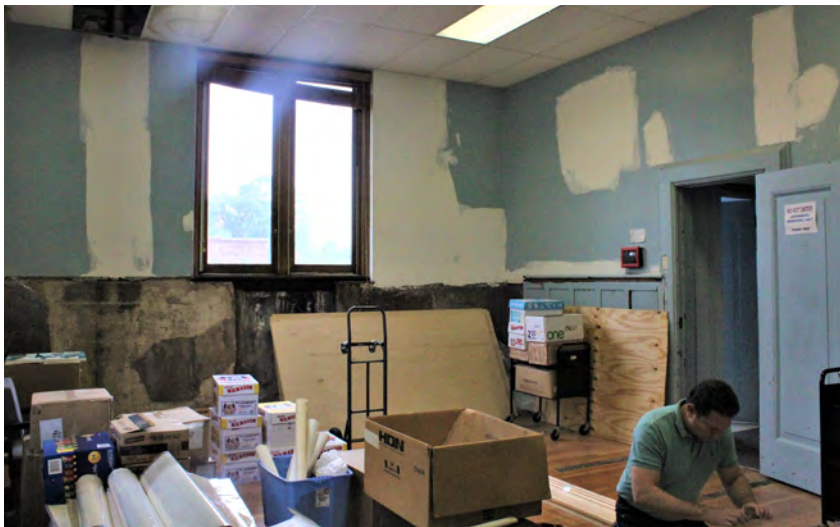
Photo 76: Room 208 is under construction

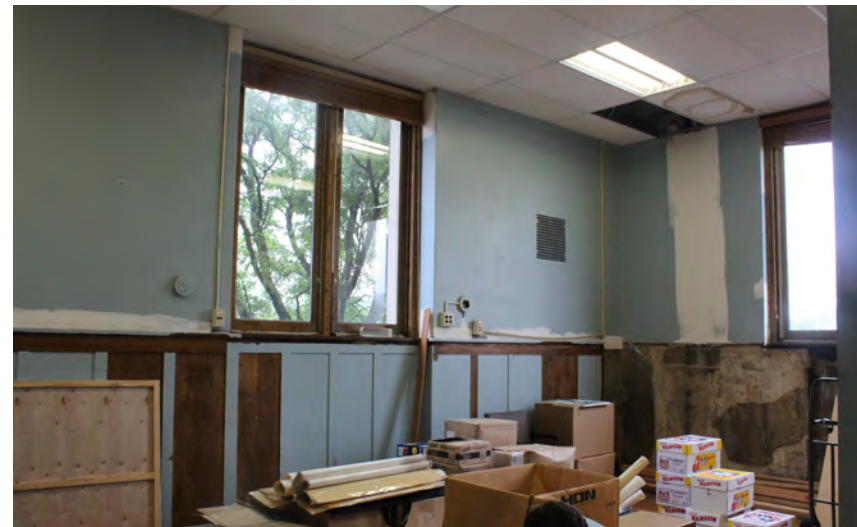
| Feature | Description | Period | Condition | CDF | Priority and Recommendation |
|---|---|---|---|---|---|
| Baseboard and wainscot | Narrow plain base with paneled wainscot | Original | Poor missing in places esp. the east wall. Paint removed on some panels | Yes | Complete restoration. Replicate missing panels |

Photo 77: It retains original wainscot. Some of the paint has been removed

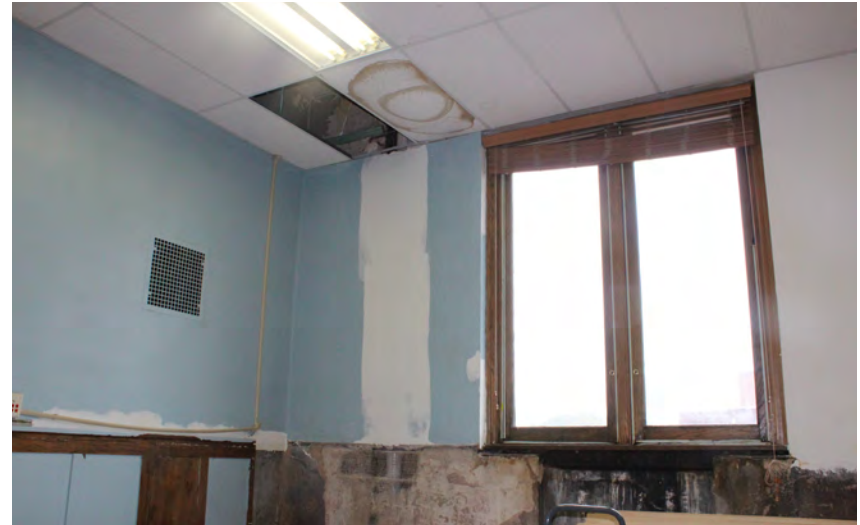
*Photo 79: The wainscot is missing on the east wall*

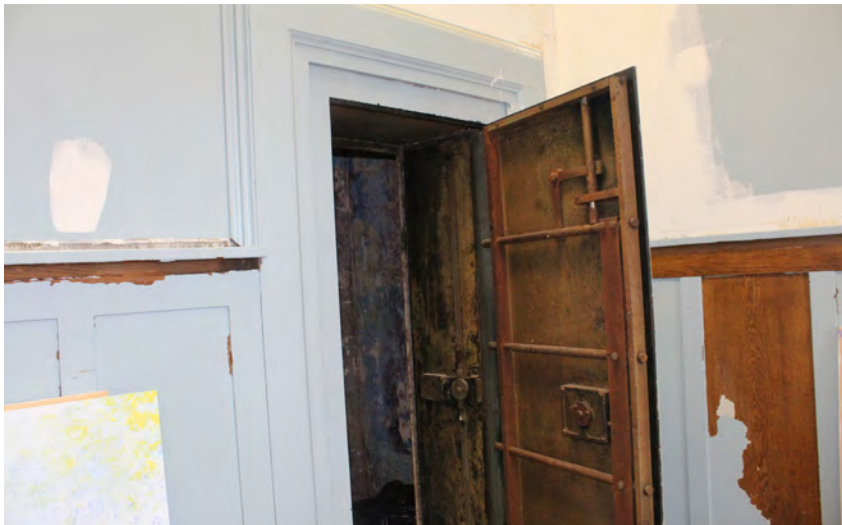
| Safe | In NW corner of room | Original | Poor | Yes | <p>Immediate: Ensure the leak is no longer active Remove all plaster</p> <p>Restore</p> |
| | | | Long term exterior leak has made it very moldy | | |

*Photo 80: There is an original safe in the NW corner*

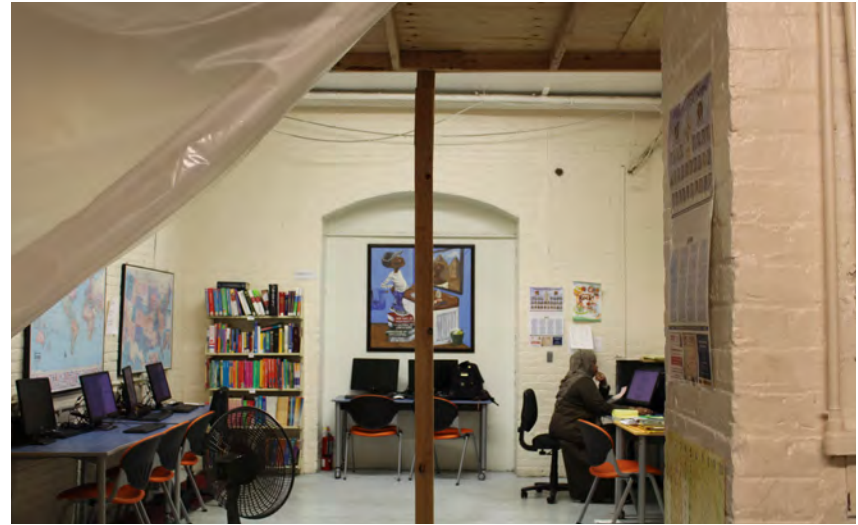
Photo 108: Room 007, looking east

| Feature | Description | Period | Condition | CDF | Priority and Recommendation |
|---|---|---|---|---|---|
| Walls | Painted brick including arches of 006 | Original | Fair A crack that runs along the north wall of 007 to the ceiling has expanded. Maintenance people installed scaffolding for protection | Yes | Immediate: Repair crack. Prep and paint |

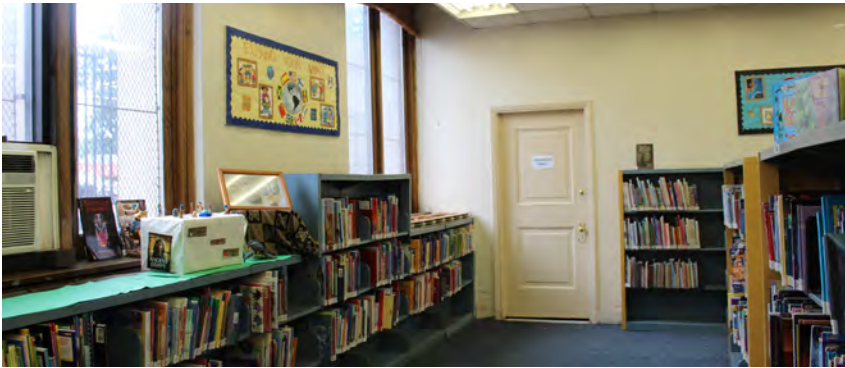
Photo 115: The Children's Room has two small bathrooms

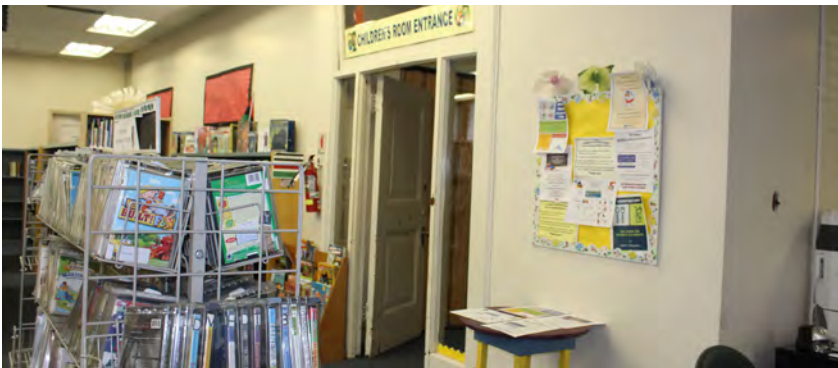
Photo 117: An original door and transom remain

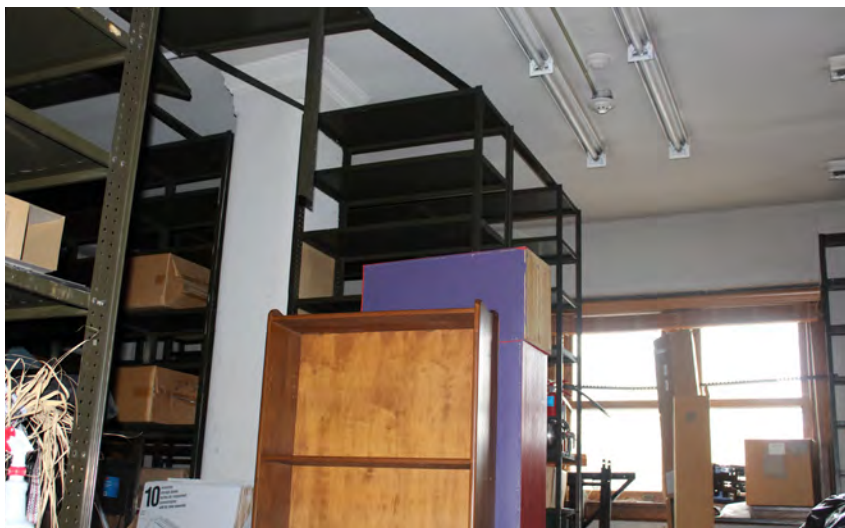
*Photo 121: The basement stack room is used for storage*

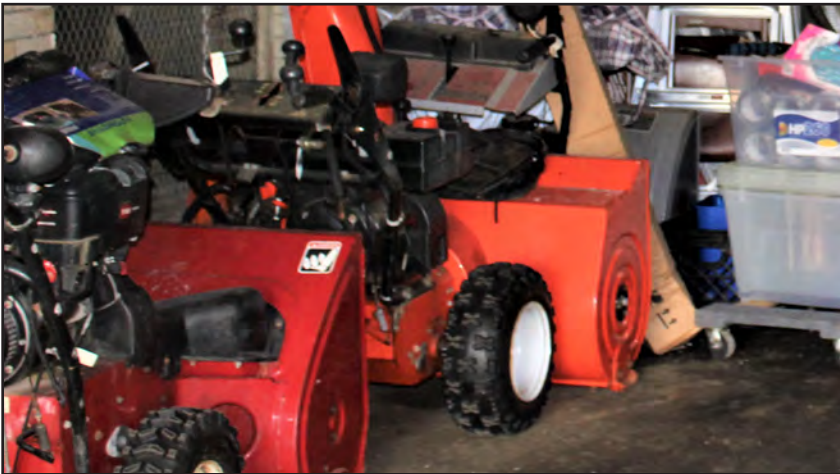
| Feature | Description | Period | Condition | CDF | Priority and Recommendation |
|---|---|---|---|---|---|
| Walls | Concrete block | 1967 | Poor | Yes | Immediate: Repair |

Photo 125: Room 013, a garage added in 1967

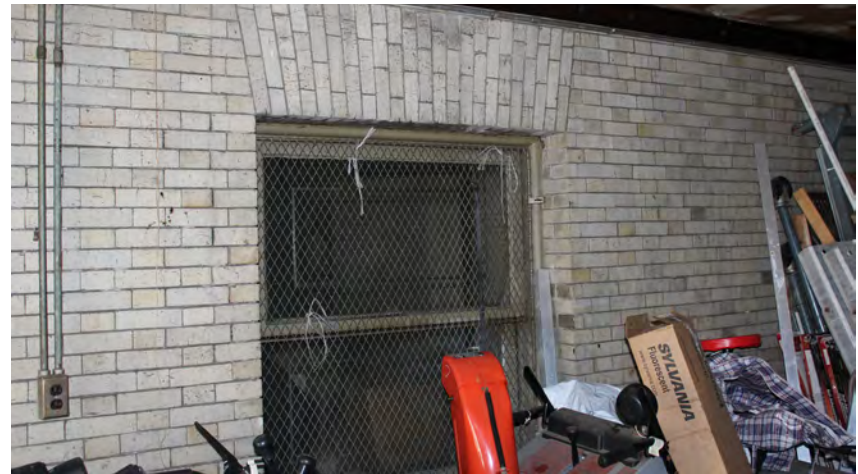
Photo 126: This is likely an original window

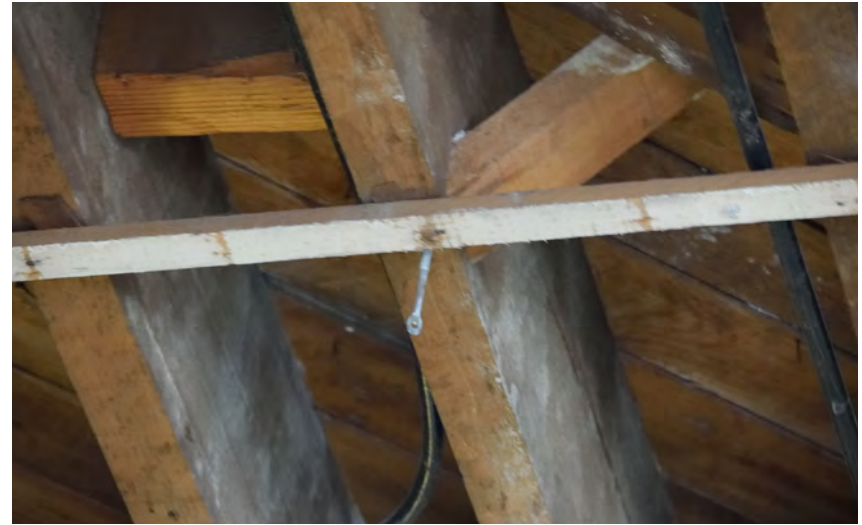
*Photograph #2 – One of the Few Drop Ceiling Anchors Installed in a Floor Joist*

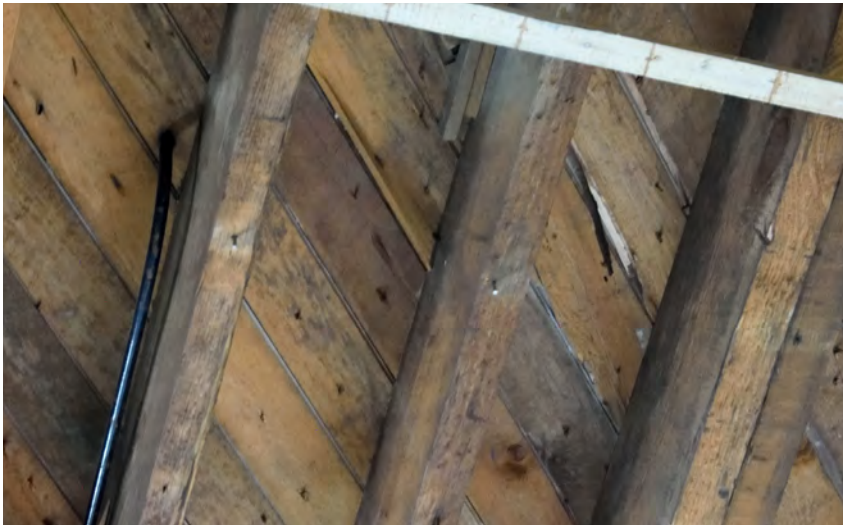
*Photograph #3 – Furring Fasteners Pulled Out/Furring Pulled Over Fasteners*

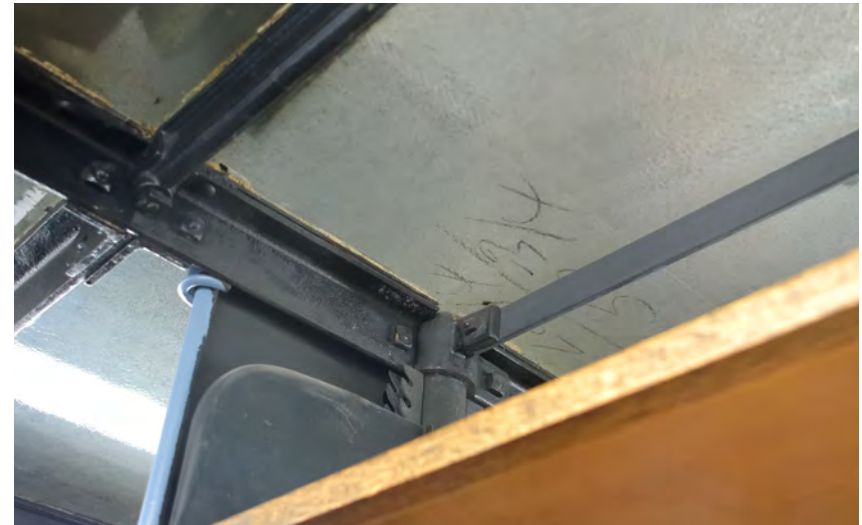
2. The library stack steel structure appears to be in good condition (Photograph #4). Several of the glass floor panes have been replaced with plywood

*Photograph #4 – Library Stack Structure*
