# **Big Four Depot** Master Plan Options

for the City of Galion, Ohio

**JULY 20, 2018**

Big Four Depot | 127 North Washington St., Galion, Ohio 44833

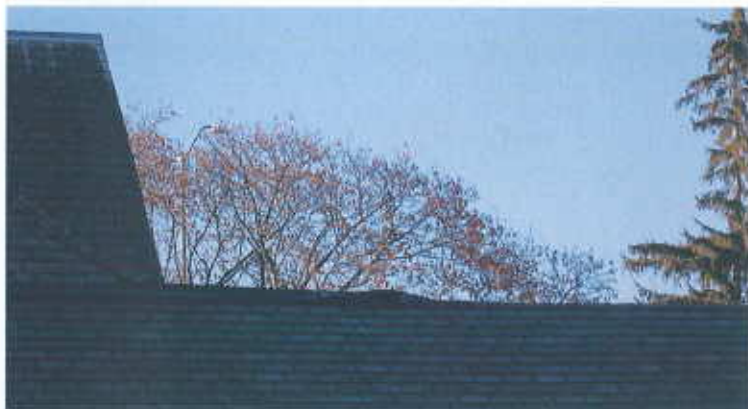
The roofing and gutters appear to be in serviceable condition with isolated locations of distress at the canopy ridge cap, the west elevation gable ridge cap, and the top roof ridge cap. Isolated transite shingles are missing. Close-up, hands-on survey of the roof was not part of the scope of work.

**8.** Bent ridge at canopy roof, east elevation.

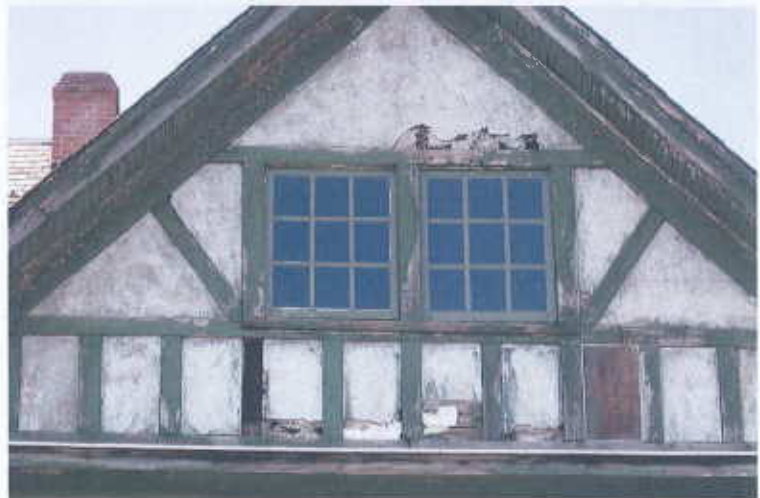
The most pronounced peeling paint is located on the east elevation northern section. At this northern section, there is deteriorated plaster/stucco in the half-

**12.** Detail, east elevation. Deteriorated stucco and peeling paint.

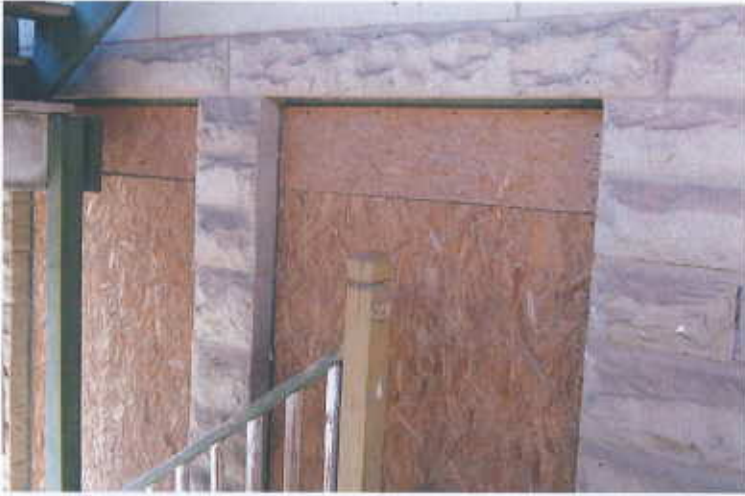
timbered gable, revealing the wood lath beyond. At the southeast corner is a non-original exterior stair. Where the railing of this exterior stair meets the building, the area adjacent to the interface has been left unfinished: the wood outriggers formerly supporting a flared detail are left exposed, as the wood siding is missing here.

**13.** Detail, east elevation. Voids in brick masonry, boarded windows, peeling paint at altered stairs.

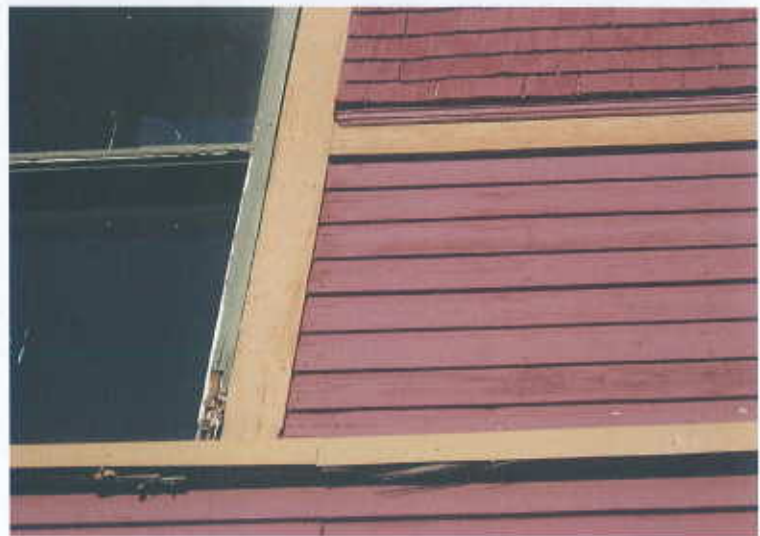
18. Detail, west elevation. Rotted storm window sash and different siding styles.

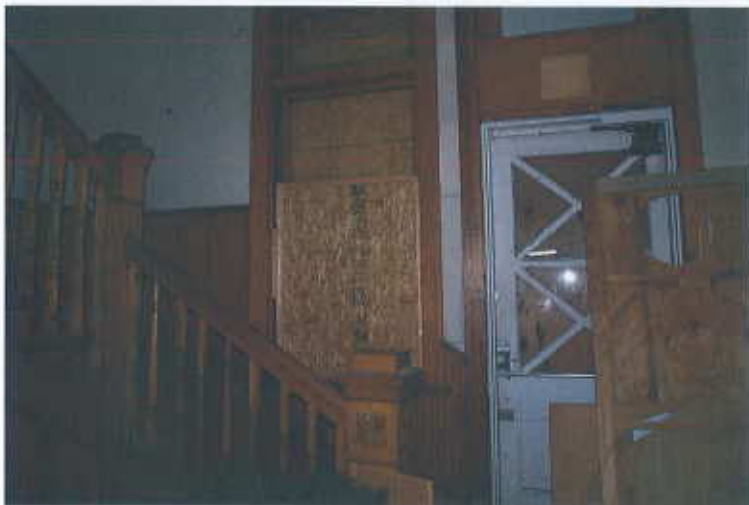
**102.** Room 107, boarded door and window, and historic staircase.

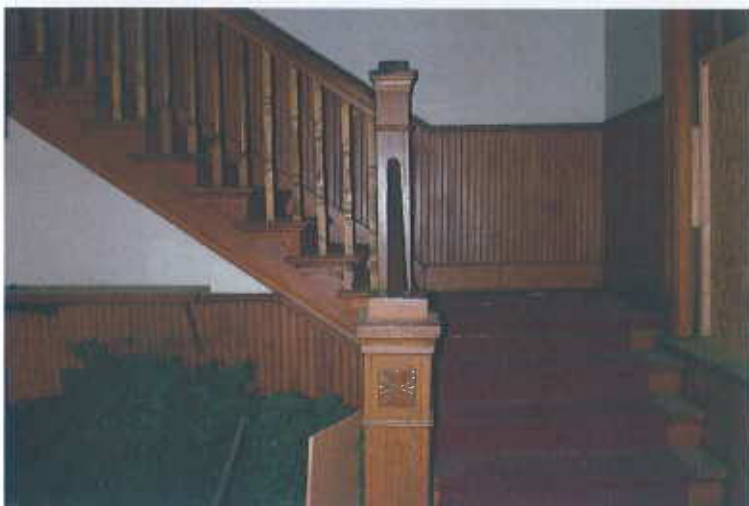
**103.** Room 107, historic staircase and wainscoting.

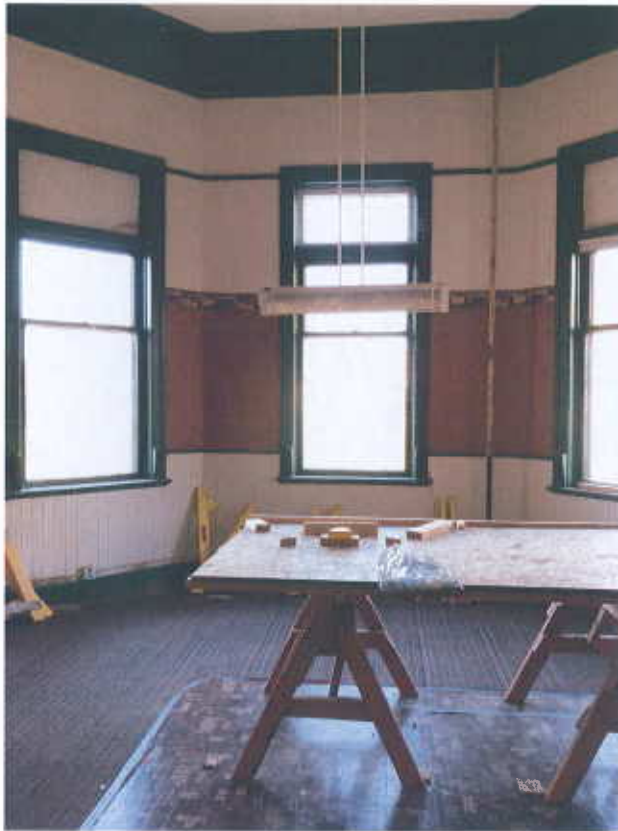
**119.** Room 103, historic wood base, wainscoting, trim, and cornice.

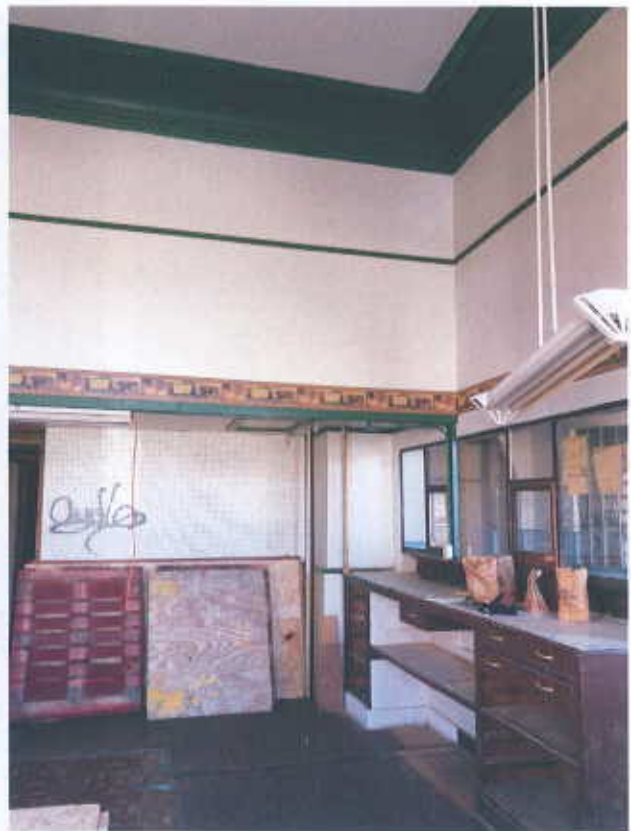
**120.** Room 103, non-historic ticket counter.

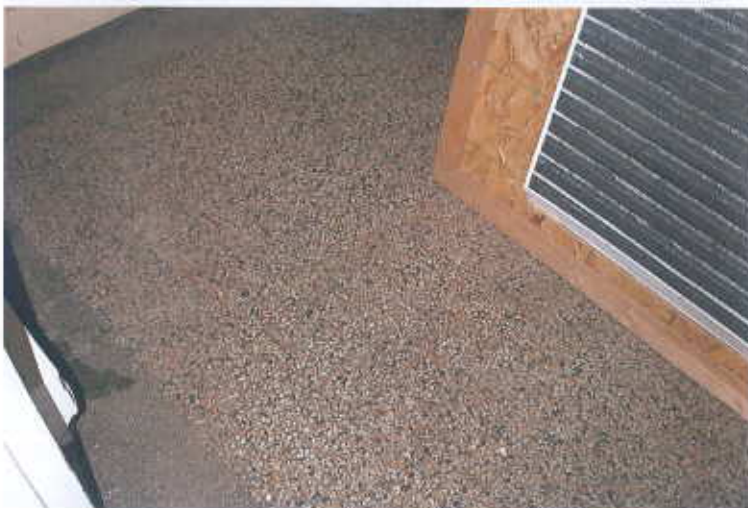
**121.** Room 104, historic terrazzo flooring.

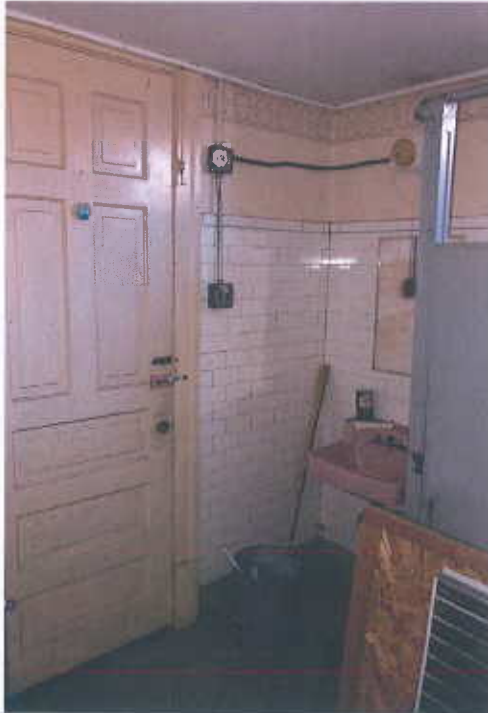
**122.** Room 104, historic tile wainscoting and wood door.

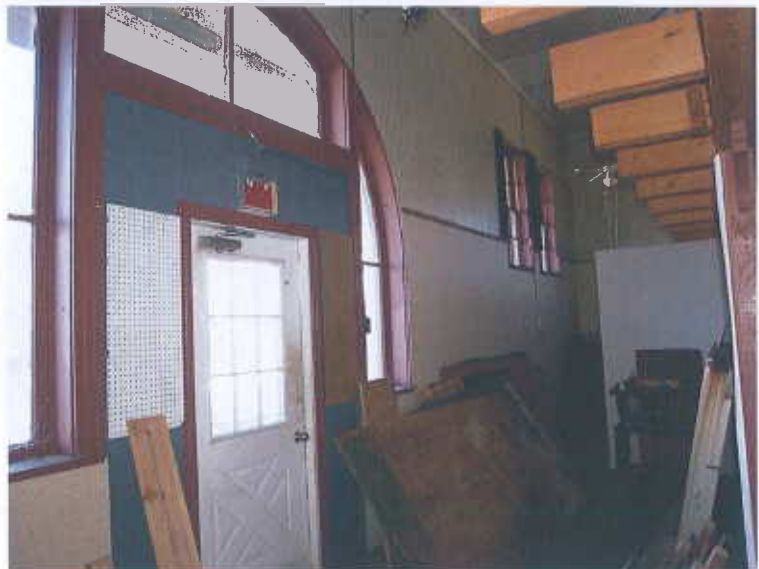
**124.** Room 106, infilled original arched door opening.

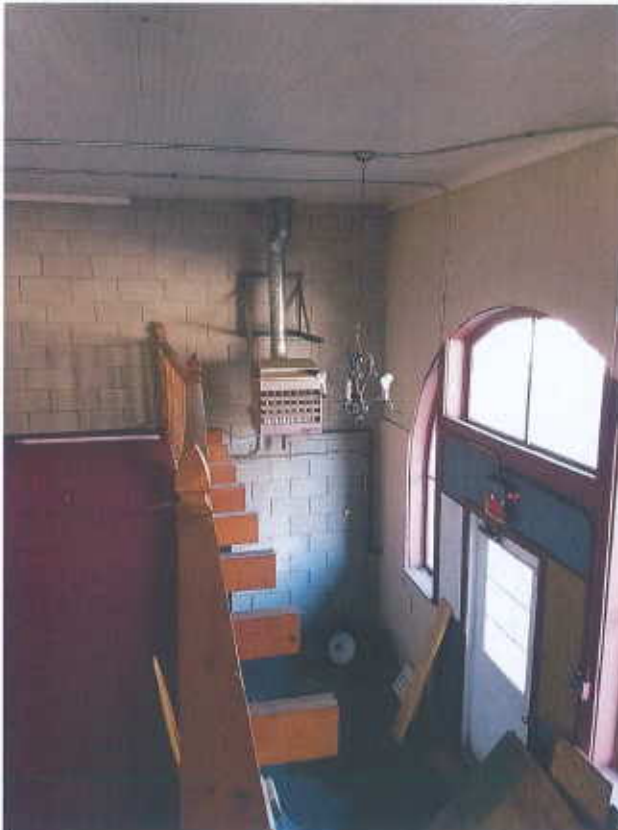
**126.** Room 106, infilled original arched door opening.

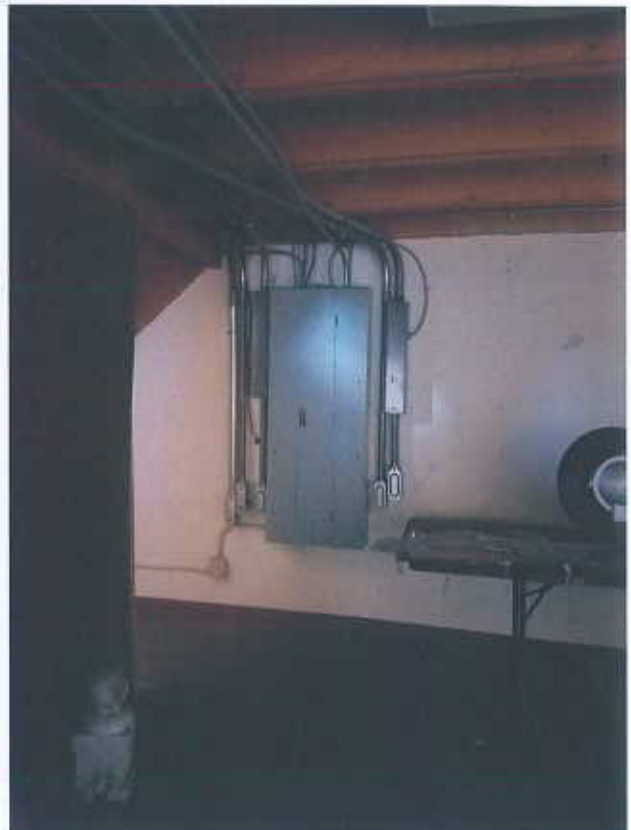
**127.** Electrical service located at the north end of the freight wing.

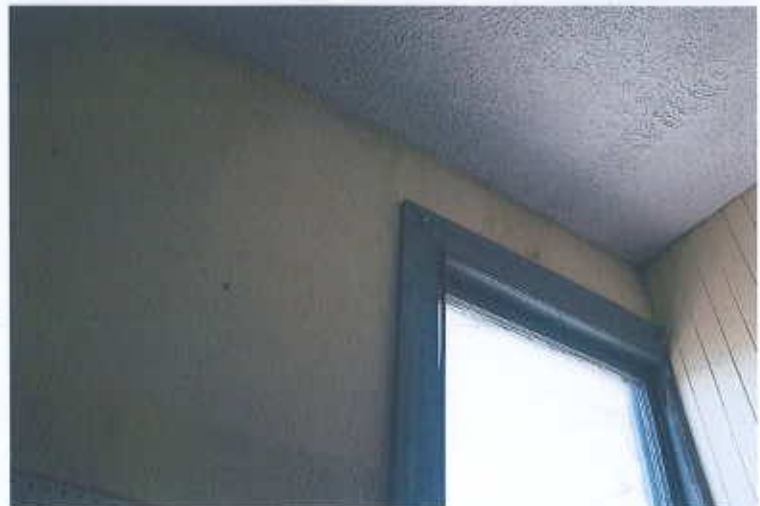
**206.** Room 203, water infiltration exhibited at ceiling line.

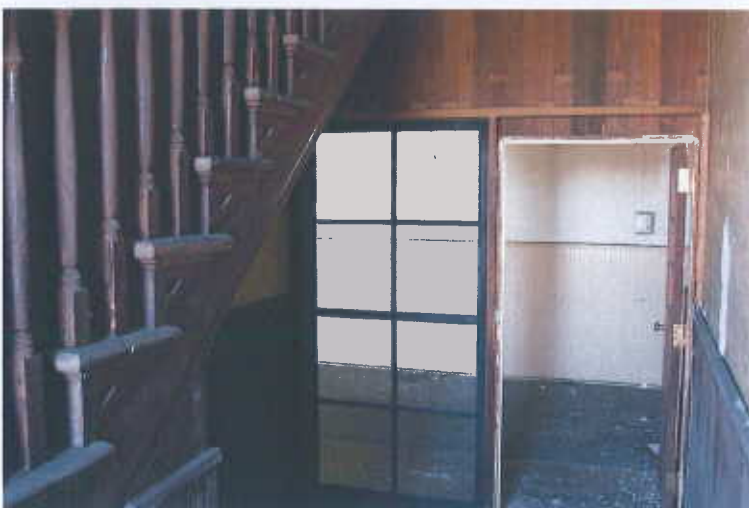
**208.** Room 205, peeling paint at plaster above historic wood floor, stair, and wainscoting.

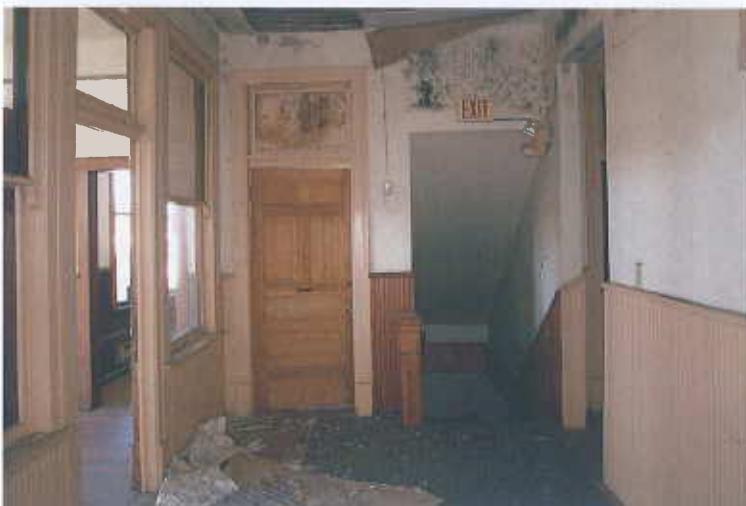
**215.** Room 210, historic corridor is in poor condition due to damaged ceiling and mold.

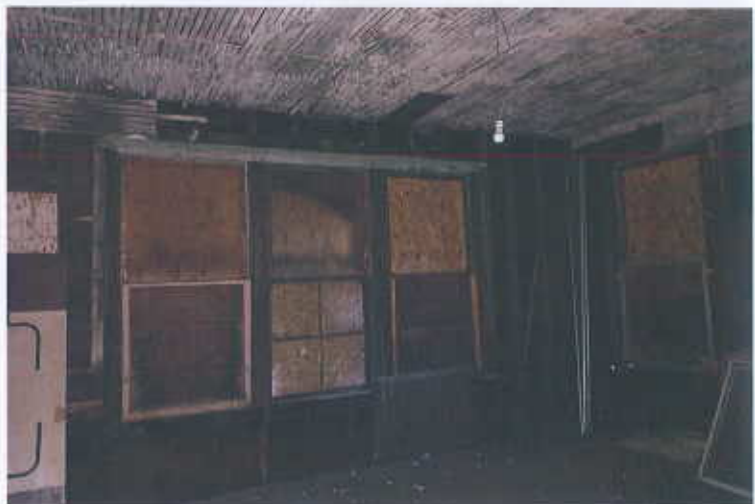
**218.** Room 211, exposed lath at ceiling and wood studs at walls, and windows are boarded.

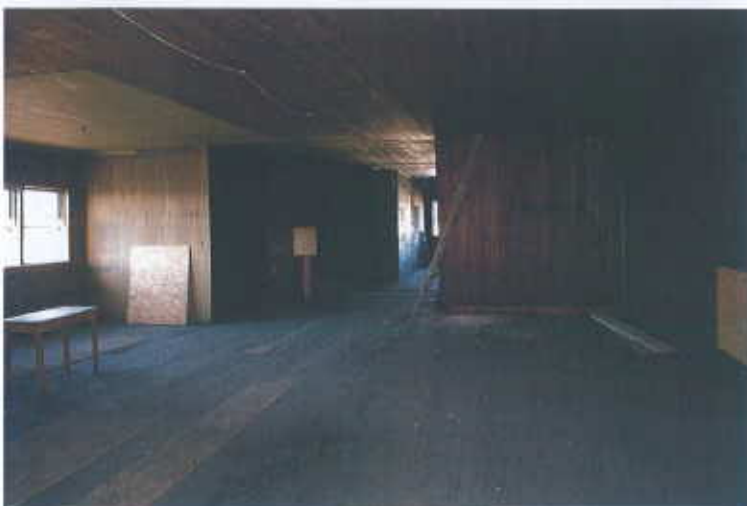
**303.** Attic, beadboard ceiling and walls, wood tongue and groove flooring.
