# Dayton Station Rehabilitation Study

Dayton, Oregon

August 31, 2018

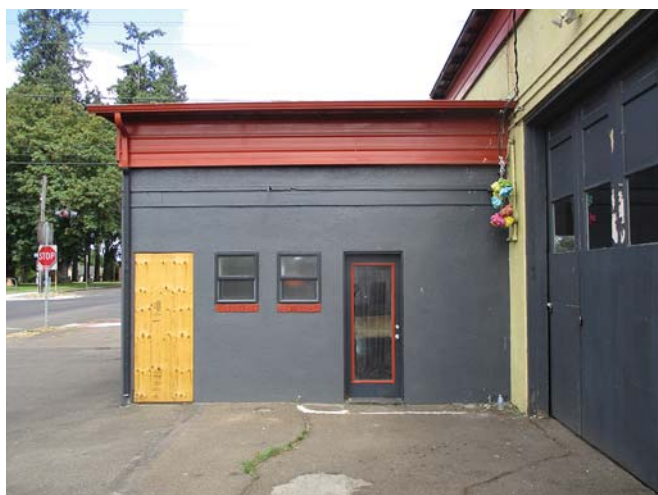
The south elevation of the office, location of the historic bathroom

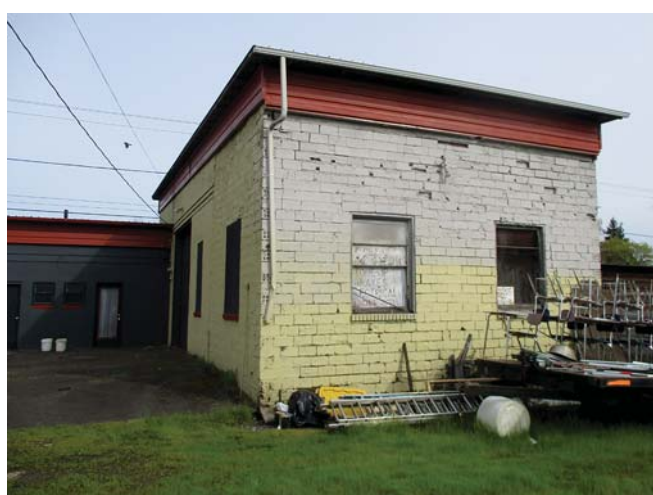
The south elevation of the garage, showing the pre-1940 addition

The masonry exterior walls are to be repaired as required, with missing details such as the projecting brick coursing and wall signs returned. Various treatments of the pre-1940 addition are shown in the three design concepts, ranging from retaining and patching, to demolition and reconstruction. Reconstruction should provide a wall surface similar to the main garage, and incorporate a parge coated finish.

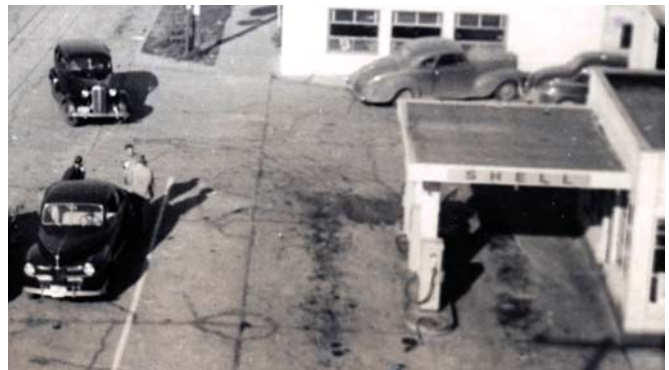
*Early image of the original canopy and its roof*

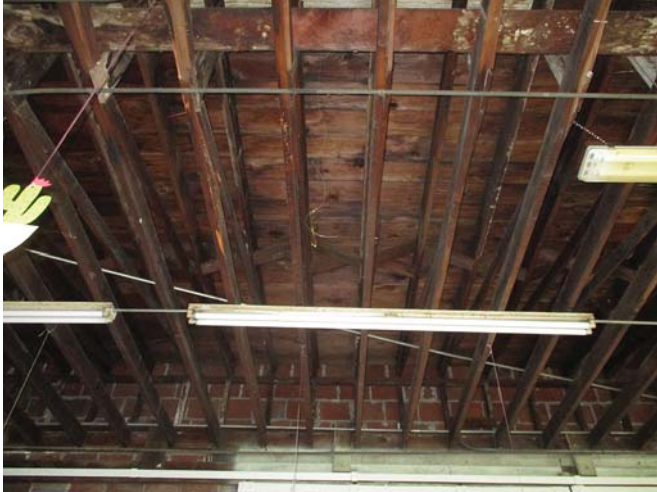
The garage roof structural system is of dimensional wood lumber, spanning the 22 foot short dimension of the building. Roof rafters and ceiling joists are installed 16 inches on center, and are stiffened by diagonal boards intersecting at the center of the span, where a vertical board is also positioned. 8-inch wide decking, assumed to be 2 inches thick, comprise the roofing surface. This wood system is attached to the masonry wall by use of ledger boards and a pony wall. It is presumed that the office roof structure employs a similar, yet more simplistic type of system.

*The roof framing of the garage*
