## SQUIRE POPE CARRIAGE HOUSE PRESERVATION PLAN

PREPARED FOR:  
THE TOWN OF BLUFFTON  
20 BRIDGE STREET  
BLUFFTON, SC 29910

PREPARED BY:  
MEADORS, INC.  
PO BOX 21758  
CHARLESTON, S.C. 29413

DATE: 09.30.2019

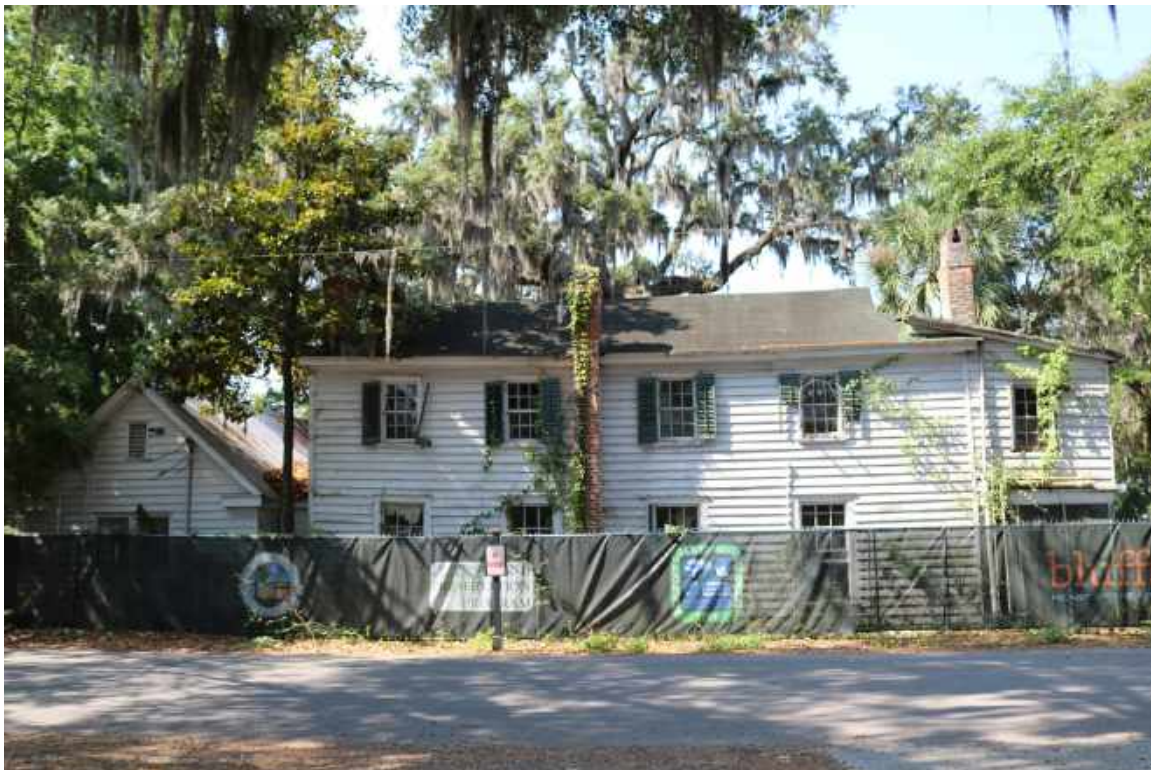
Figure 29: North Elevation.

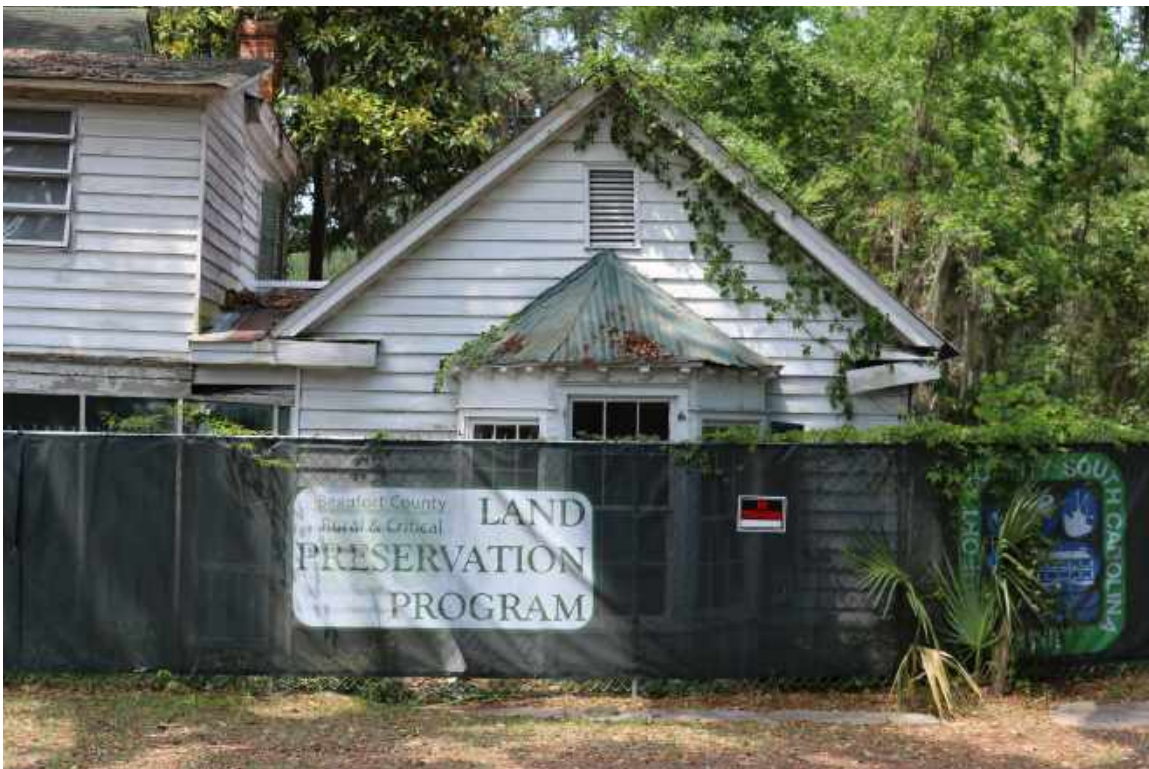
Figure 36: South Elevation, One-Story Building. A small hyphen connects the two individual structures.

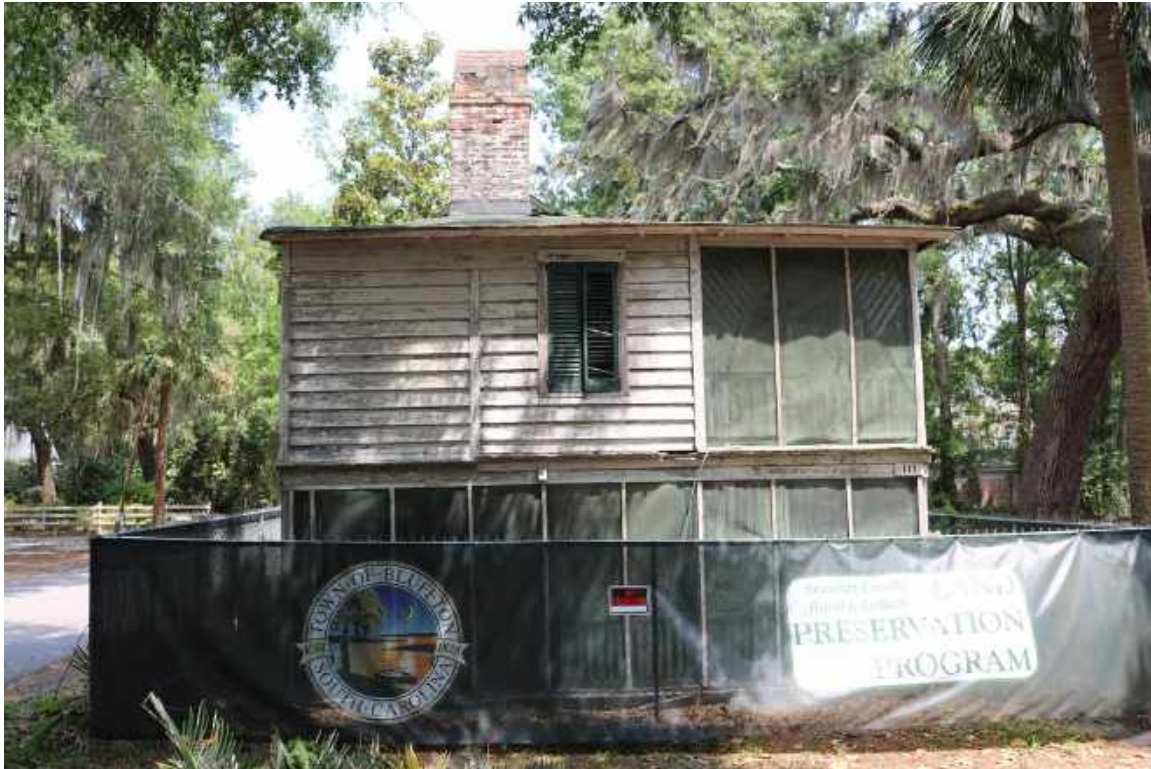
Figure 41: West Elevation.

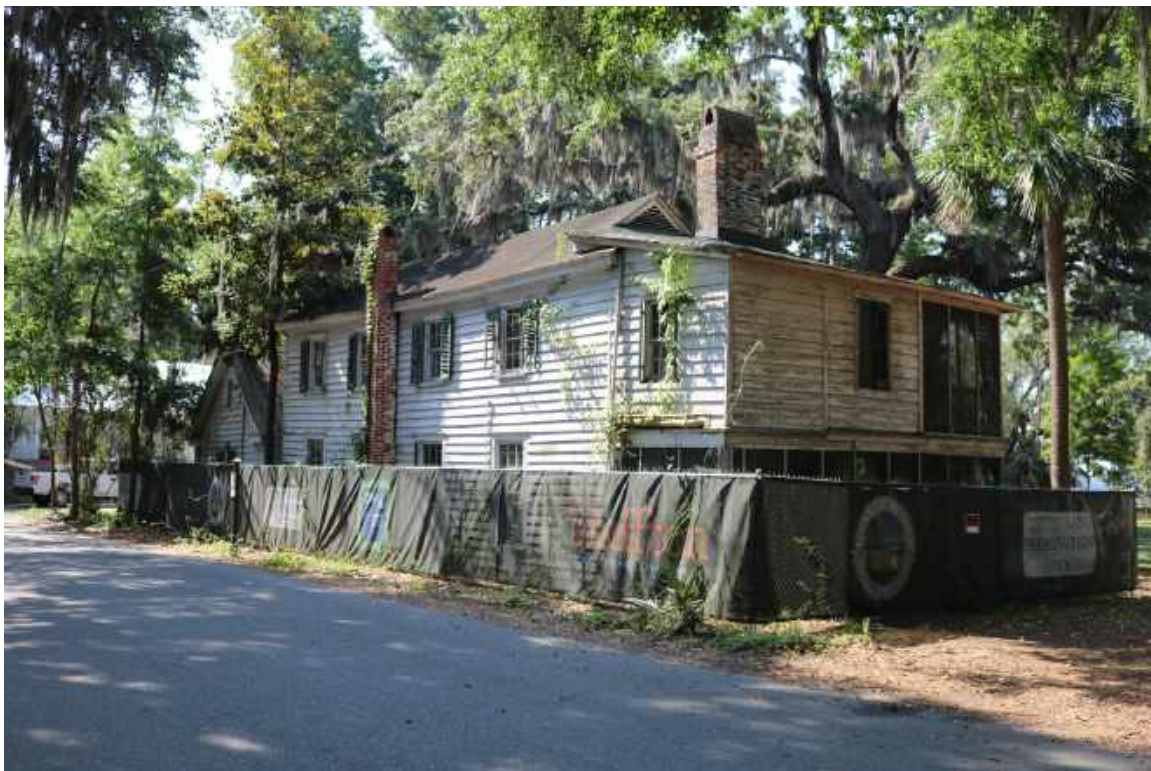
Figure 42: View of northwest corner.

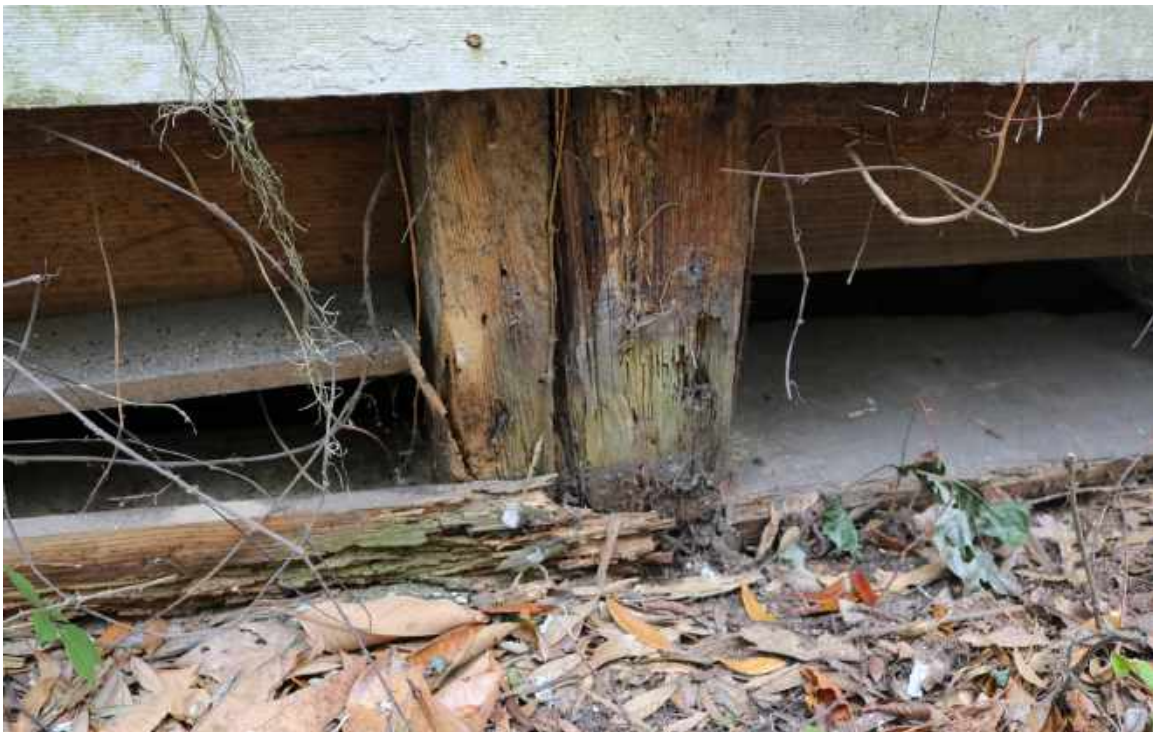
**Figure 46:** North Elevation of Two-Story Section: Detail of Eastern “Corner Post” with an additional stud added to the east (at left). The right vertical member appears to be the original corner post for the smaller structure prior to enlargement.

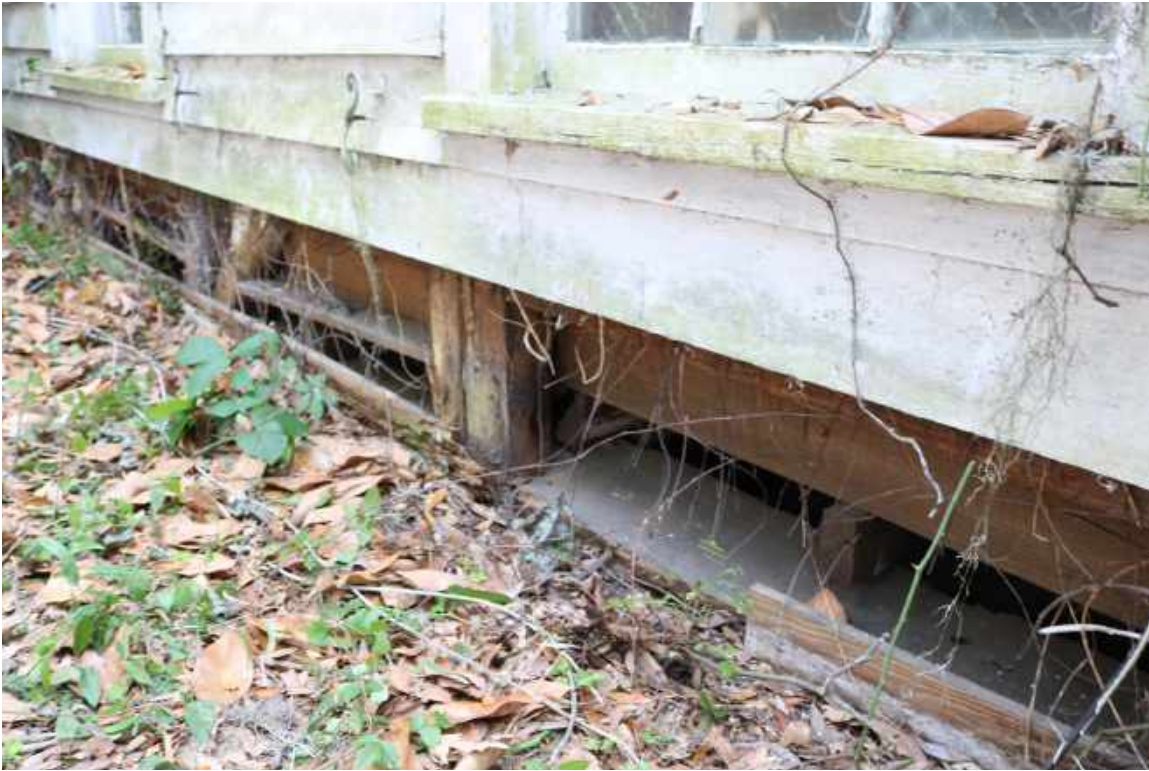
**Figure 47:** North Elevation of Two-Story Section: Detail of framing members at grade level to the west of the north chimney.

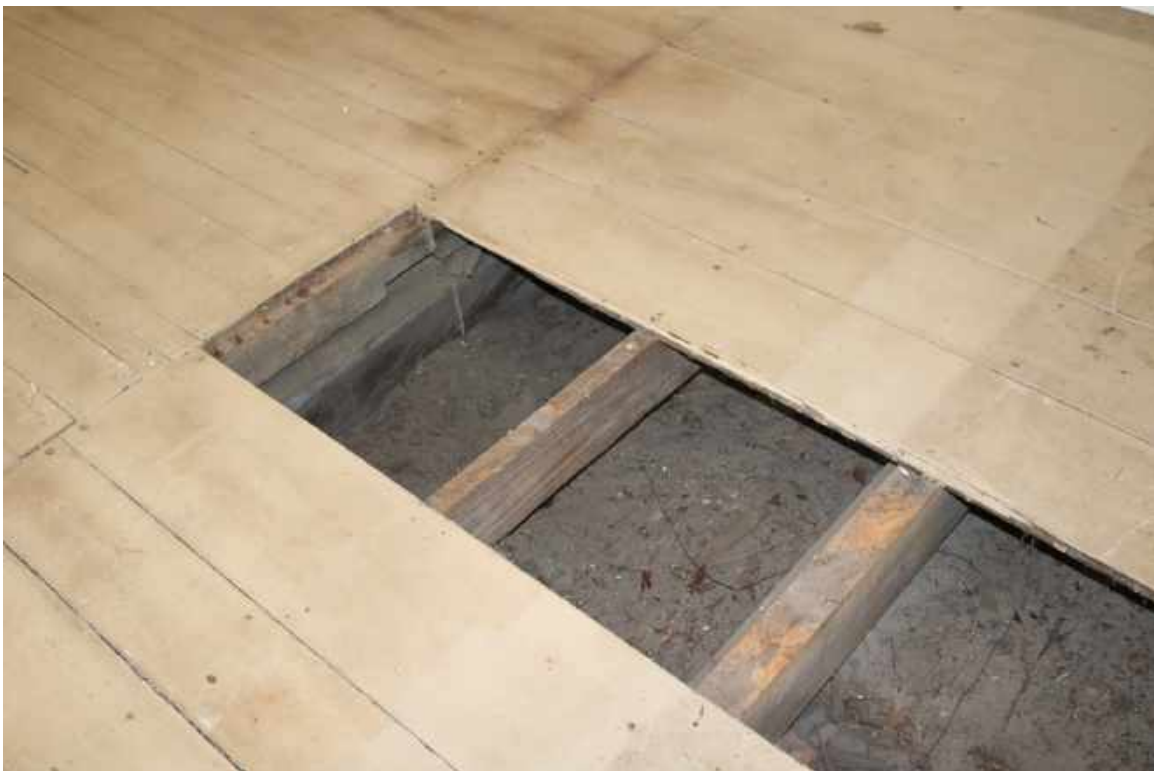
**Figure 57:** Crawlspace Below Room 103: Overview of differently sized floor joists.

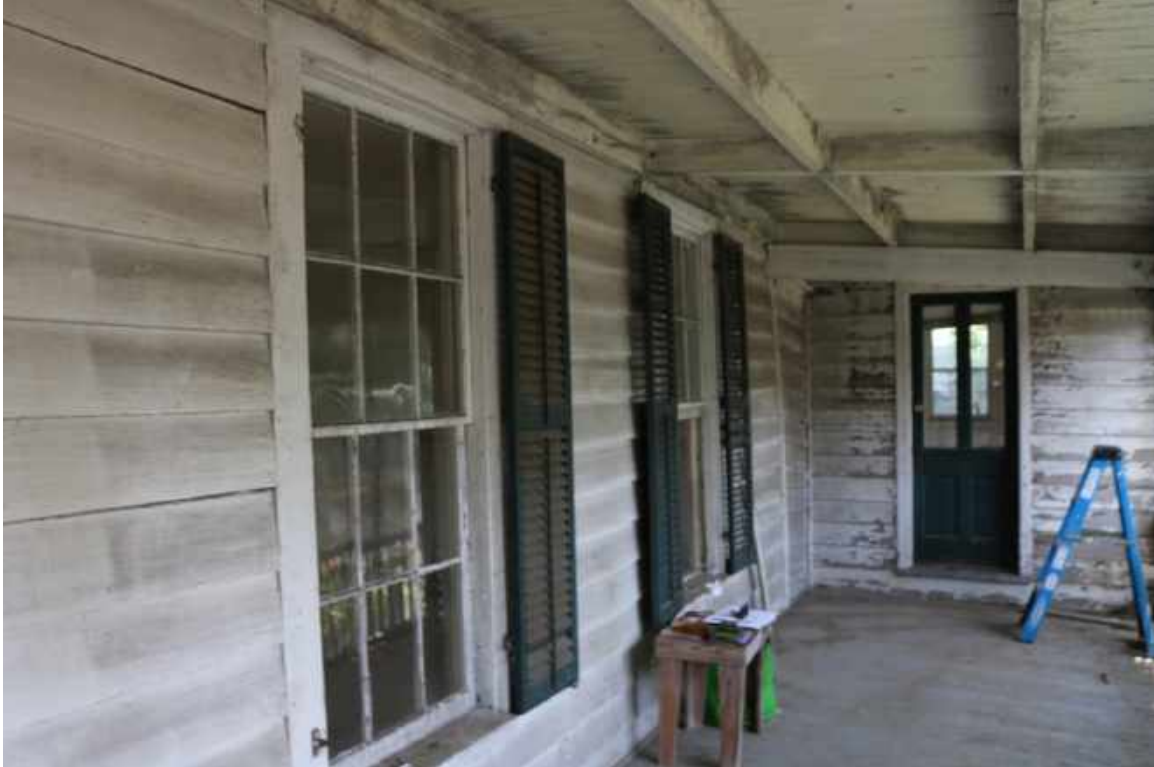
**Figure 61:** South Elevation of Two-Story Section: Overview of the historic first-floor single hung gunstop windows and louvered shutters.

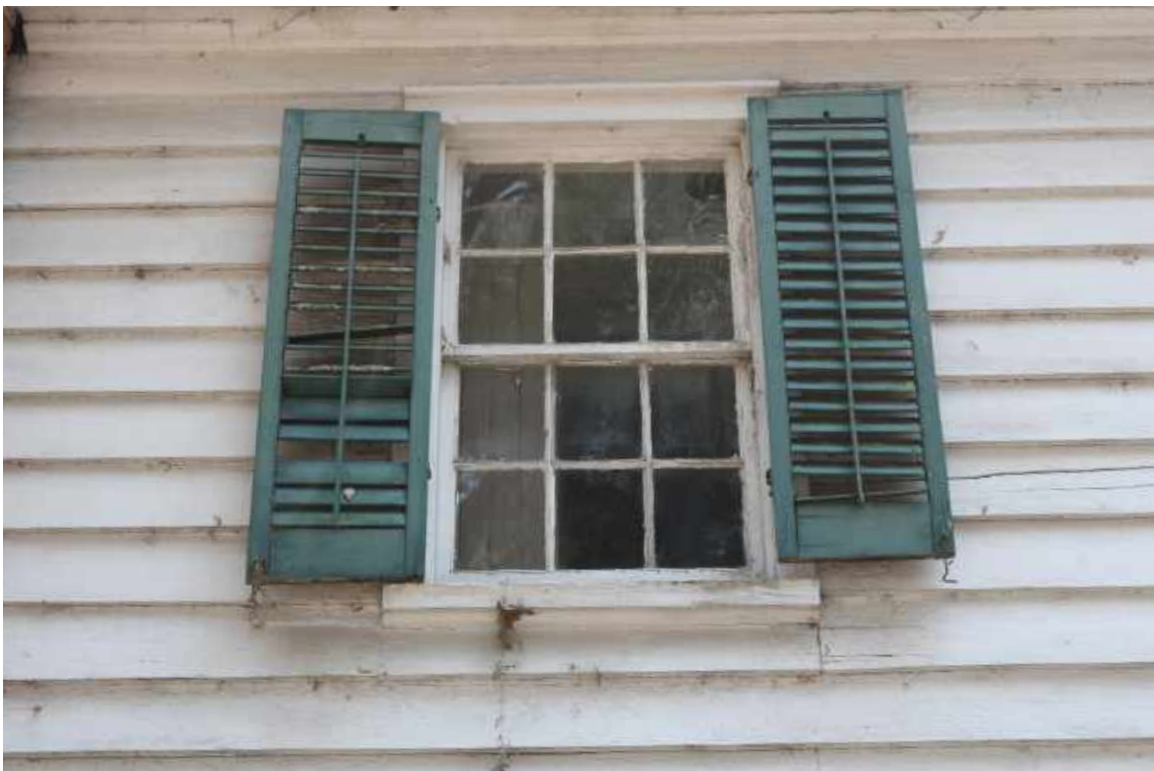
**Figure 62:** North Elevation of Two-Story Section: Overview of the historic second-floor single hung gunstop windows and louvered shutters.

On the north elevation, the gunstop windows and louvered shutters are in poor condition. The sills are extensively rotten. The casing generally appears sound, but the window sashes are beginning to separate. Multiple muntins were observed to be broken or missing. Older glass panes are also present in several windows. One window has been repaired with caulk on the upper and lower sashes. Biogrowth is present on the horizontal window surfaces throughout this elevation.

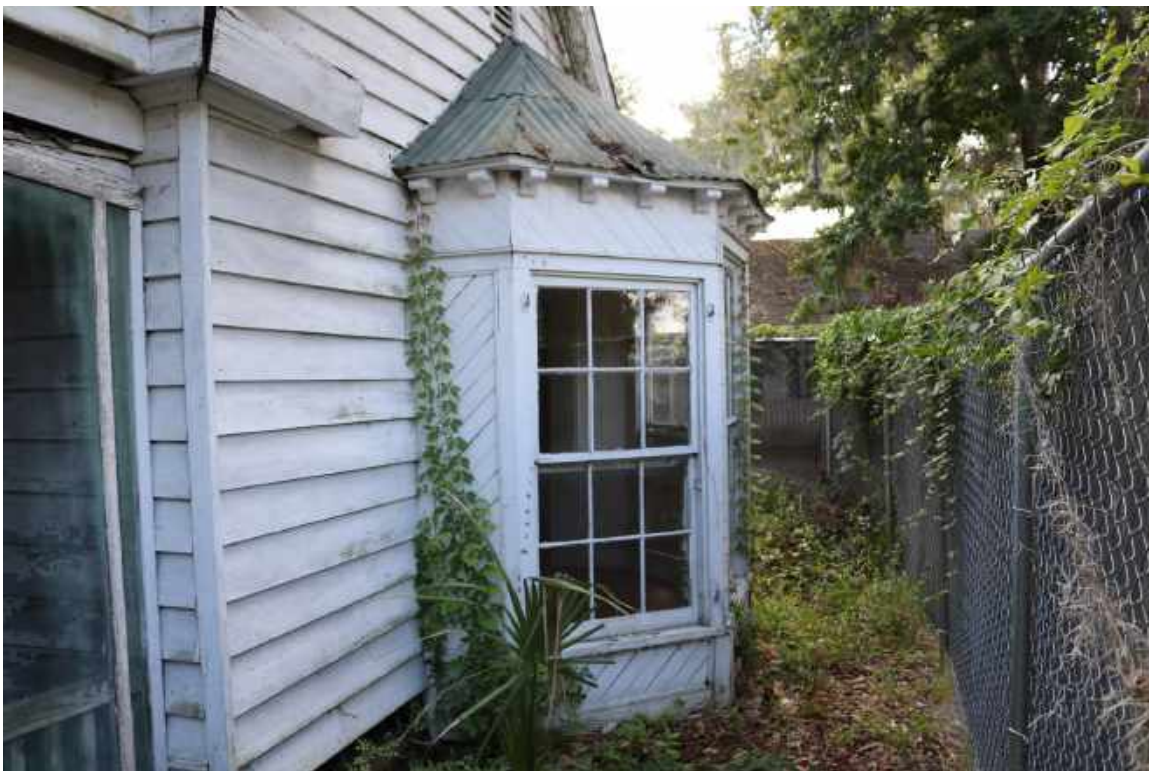
Two casement windows are present on the first-floor porch bay window. The sashes are heavily weathered but are in fair condition. The windows no longer open due to the settlement on this façade. The casement windows likely postdate the single hung gunstop windows throughout the structure.

**Figure 63:** South Elevation, One-Story Building: Detail of bay window. The older corrugated roof visible on the historic photographs remains on the bay window.

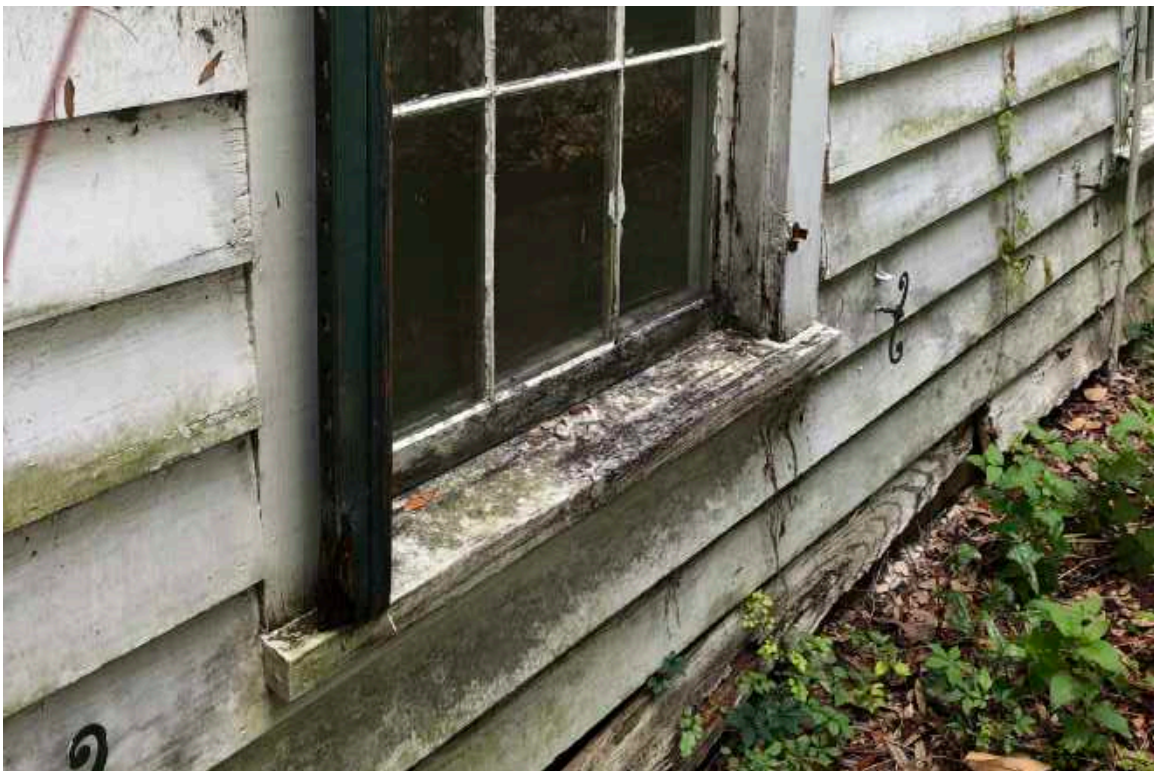
**Figure 65:** North Elevation of Two-Story Building: Detail of sill conditions.

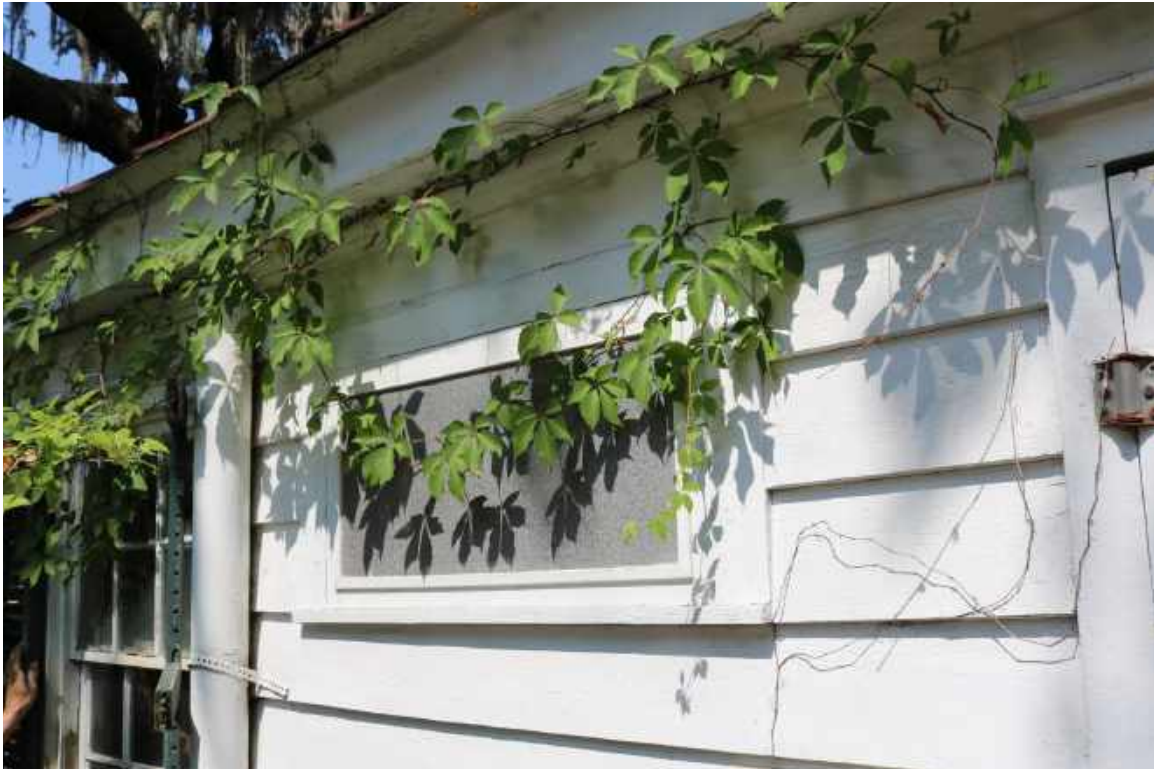
**Figure 66:** East Elevation of One-Story Building: Detail of transom window.

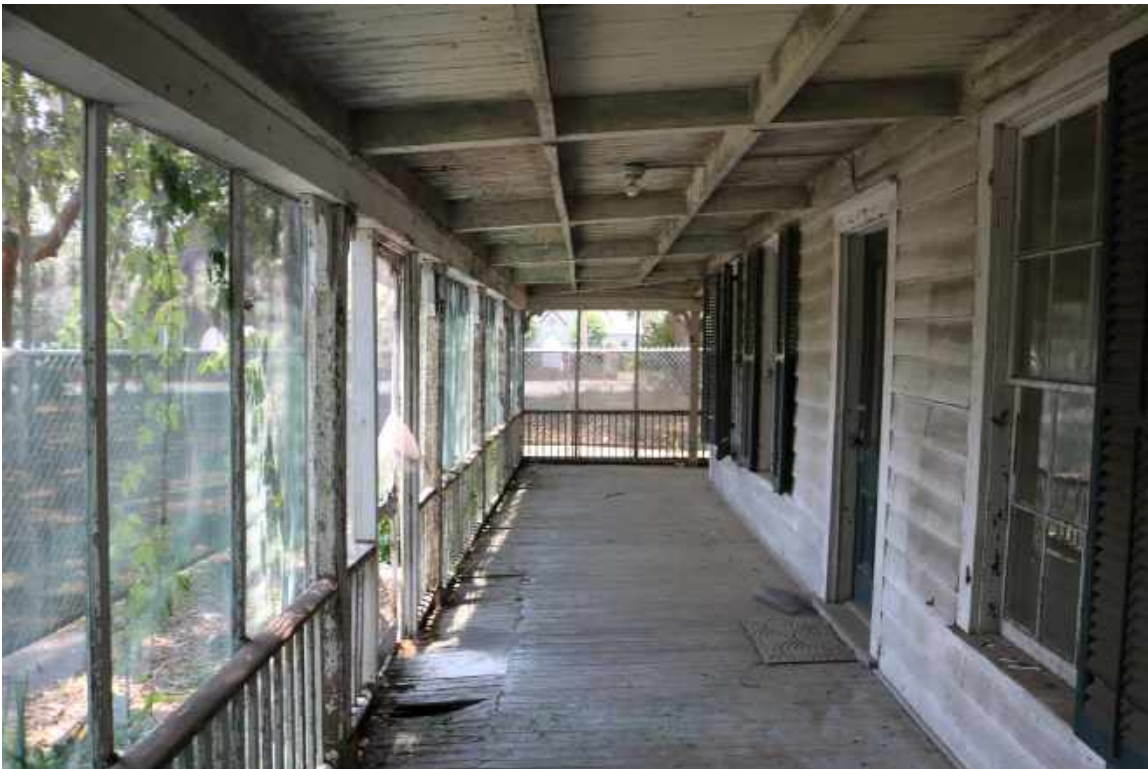
Victorian porch brackets are present on each column. On the first floor, the chamfered porch columns are deteriorated at the base on the eastern side and southwest corners. Several bases have been previously repaired. The porch balusters are toenailed directly into the posts. Portions of the carved baluster handrails have been replaced with square 2x4. A decorative lattice Gothic arch is present on the west elevation of the second floor. The lattice is in fair condition with extensive paint loss.

The porch foundation has collapsed, and the framing is sitting on the ground. Excavation below several columns indicates the porch originally rested on two to three courses of brick. Much of the decking on the first floor is deteriorated at the ends and several areas have been previously repaired in front of the south door. Previous repairs to the decking at the front entrance have now collapsed due to settlement of the floor.

**Figure 71:** South Porch of the Two-Story Building: Overview of the first-floor porch looking west. The porch framing does not appear to date to the construction of the building.

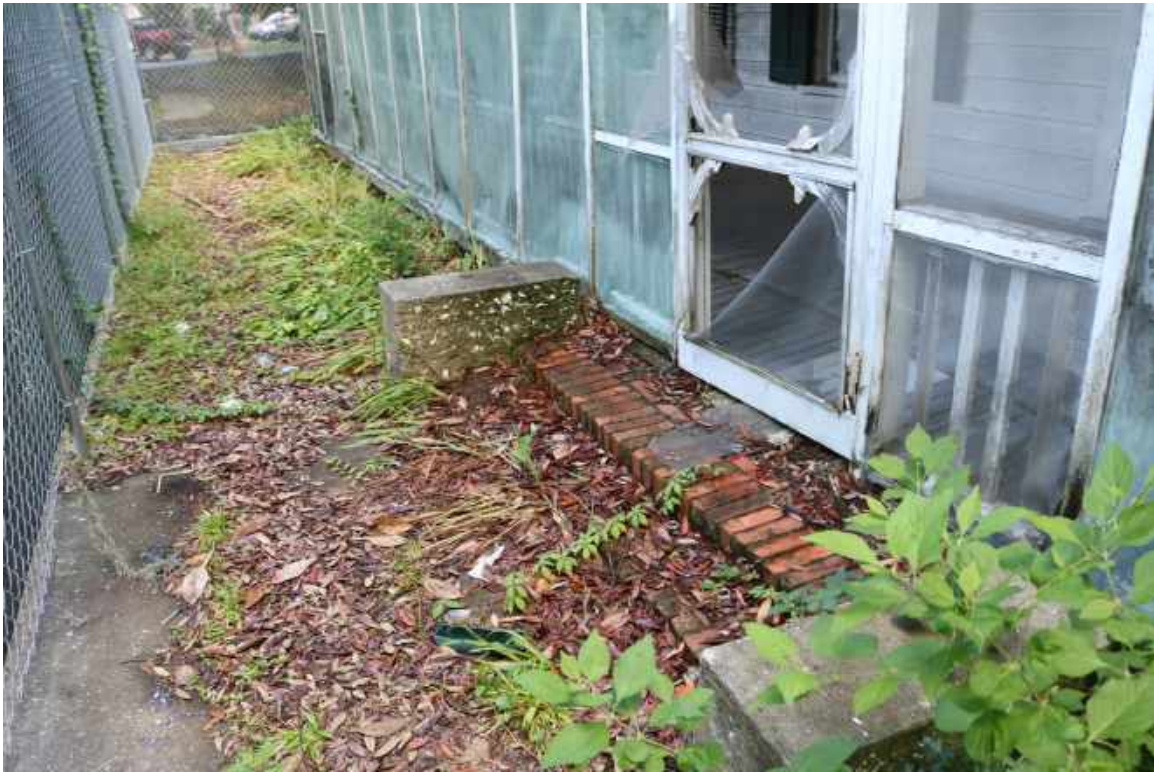
**Figure 72:** South Elevation of the Two-Story Building: Overview of the first-floor porch entrance concrete tabby and masonry steps.

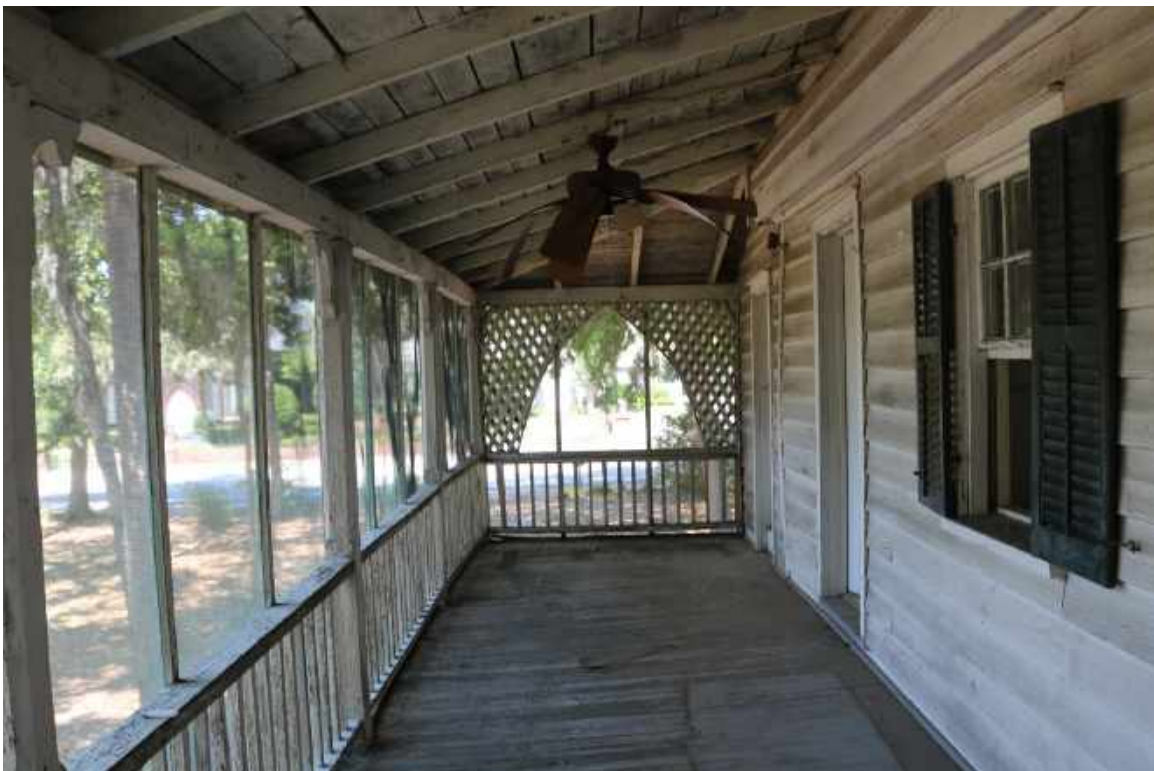
**Figure 75:** South Elevation, Second Floor Looking West: Overview of existing porch conditions.

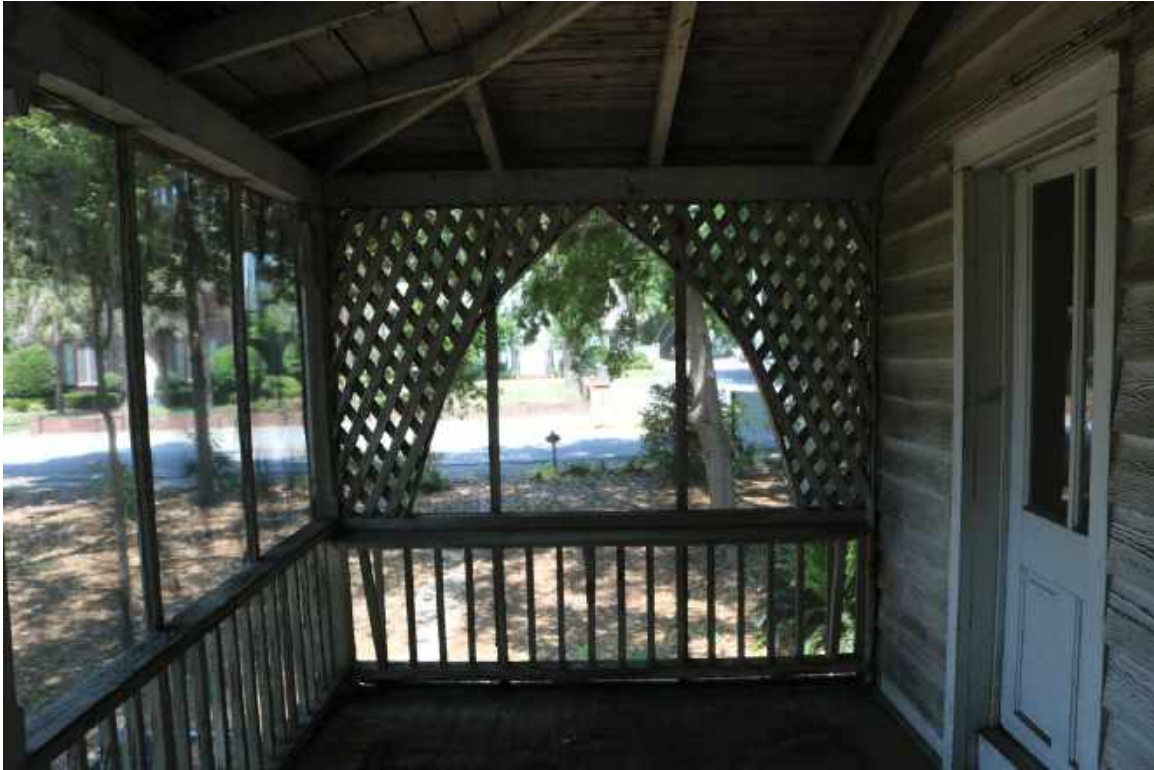
Figure 76: South Elevation, Second-Floor Porch: Detail of decorative lattice on the west end.

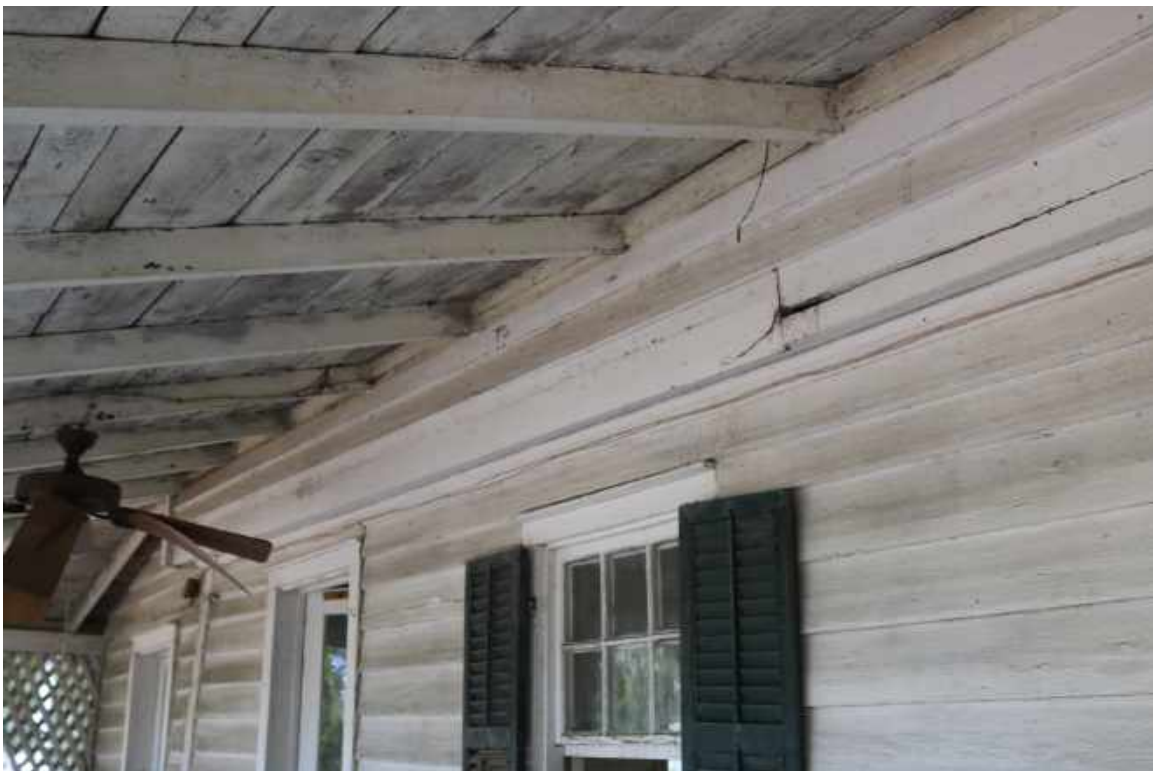
Figure 77: South Elevation, Second-Floor Porch: Detail of the modified soffit detail below the porch roof framing.

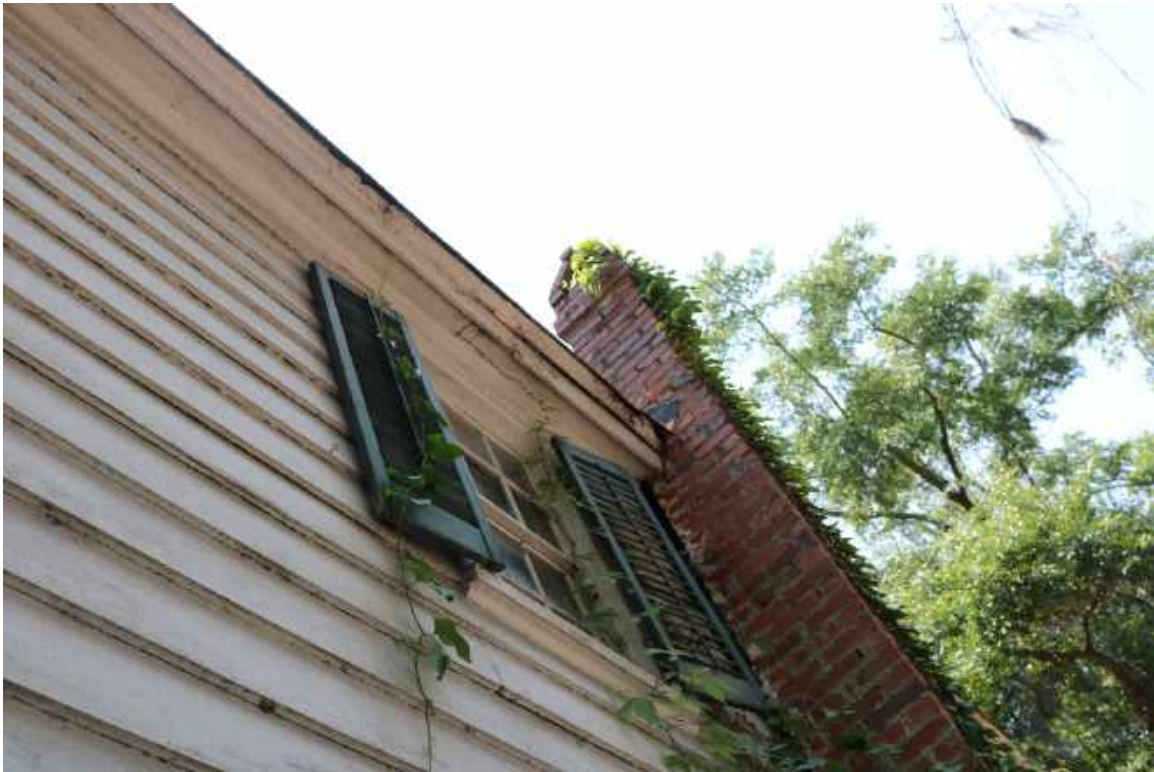
The north chimney placed on the exterior of the structure is leaning heavily to the north

**Figure 78:** North Elevation of the Two-Story Building: Detail of the north chimney. The chimney is currently leaning away from the structure.

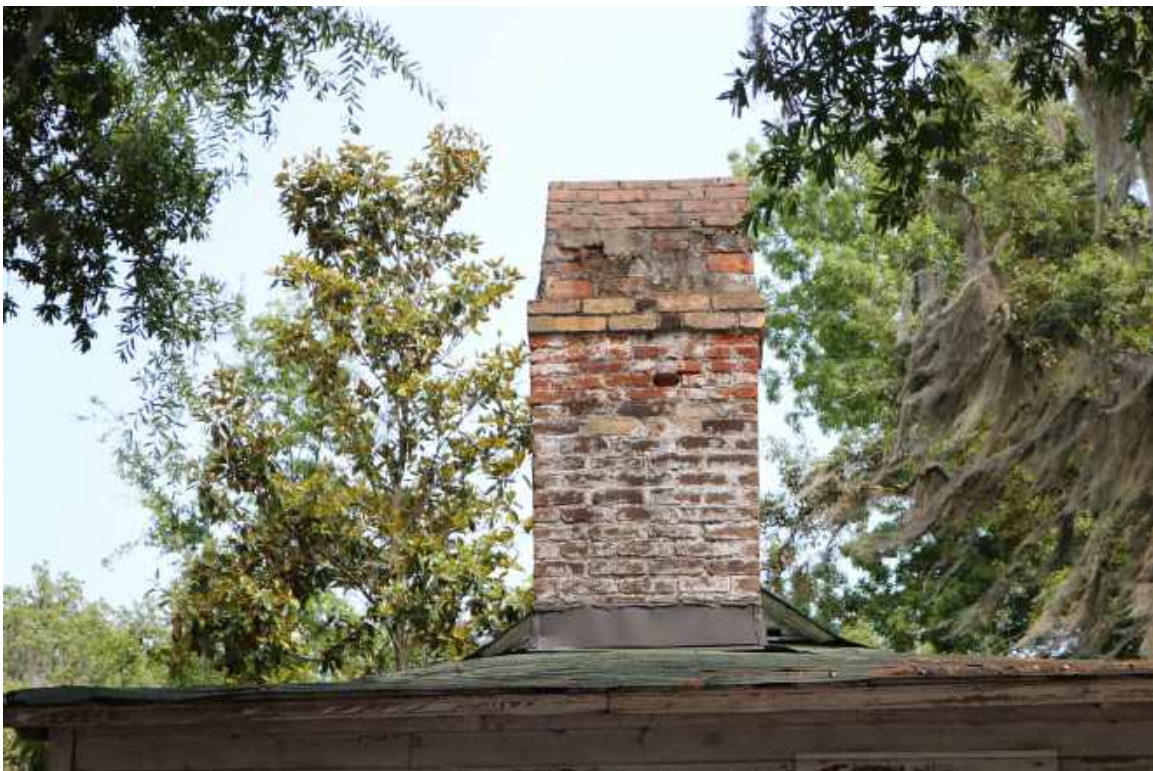
**Figure 79:** West Elevation of the Two-Story Building: The chimney at this elevation is believed to be the oldest on the house. The upper cap has been modified as evidenced by the change in brick color.

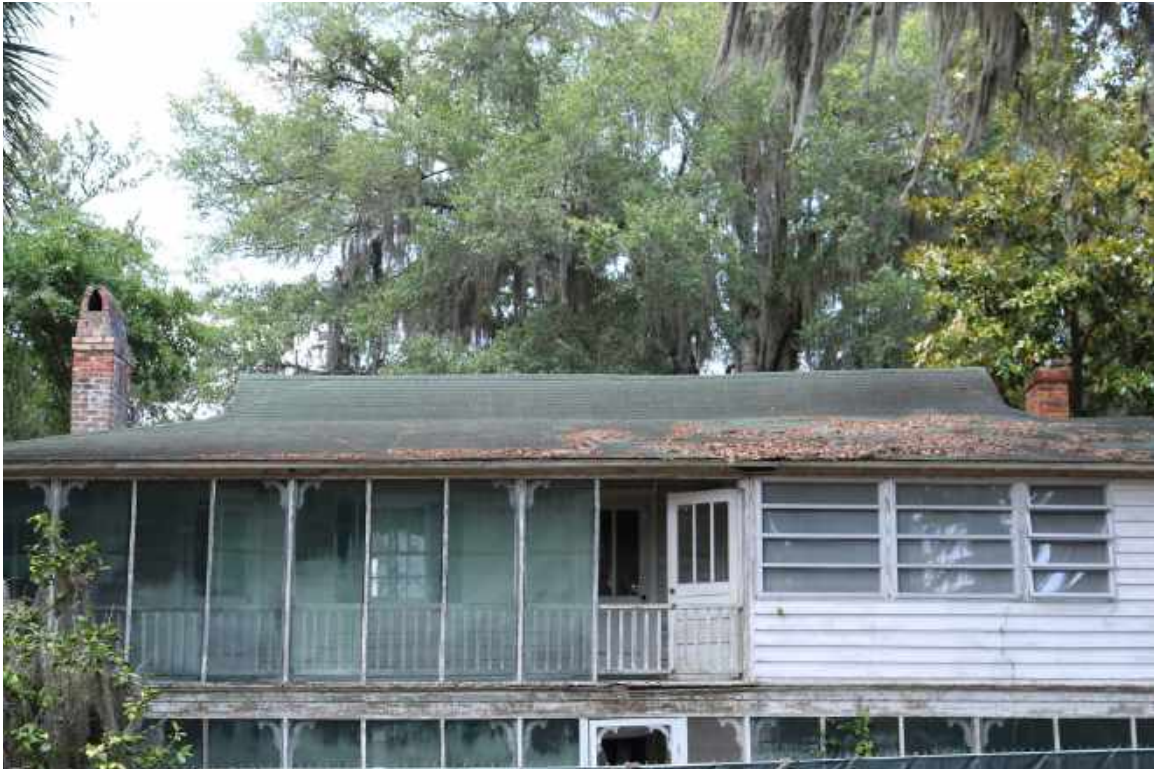
**Figure 80:** Two-Story Building Roof: The roof is covered with modern green asphalt shingles. The roof has reached the end of its usable service life. Leaf debris commonly accumulates on the low sloped portions of the roof.

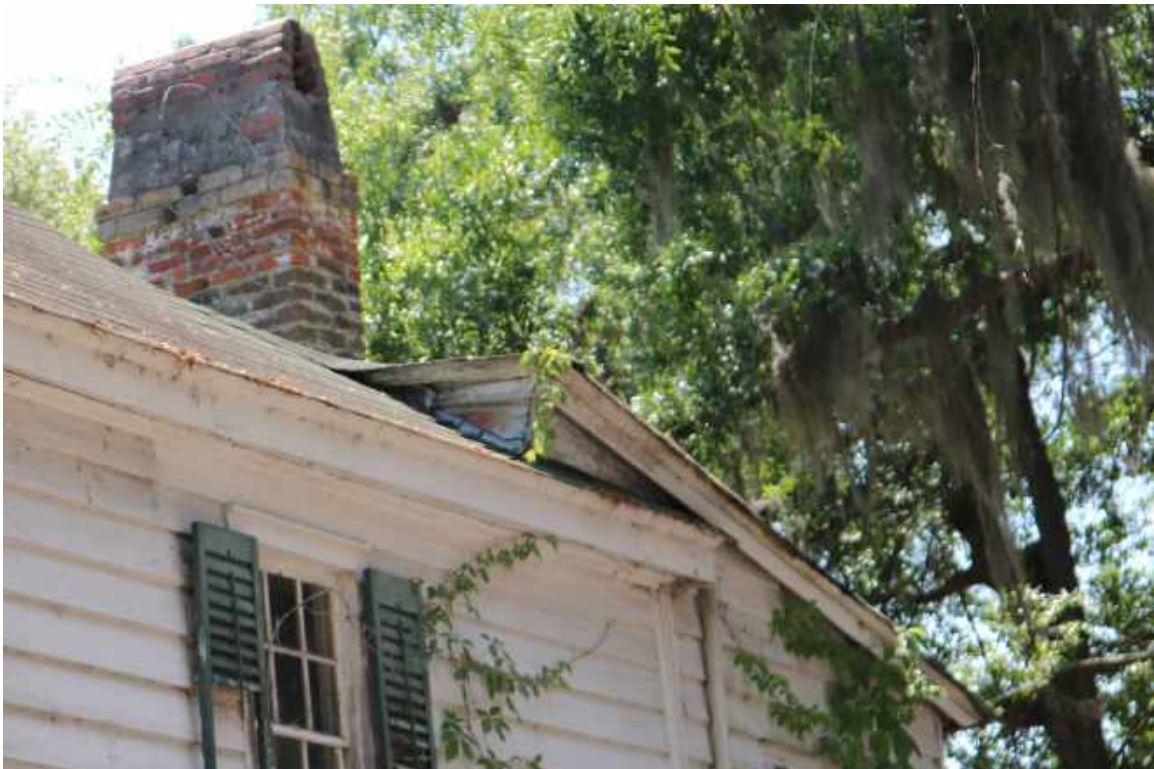
**Figure 81:** Northwest Corner of the Two-Story Building: Overview of the porch and infill roof detail where the roof intersects the original roof framing. This detail is also seen on the southeast corner of the building.

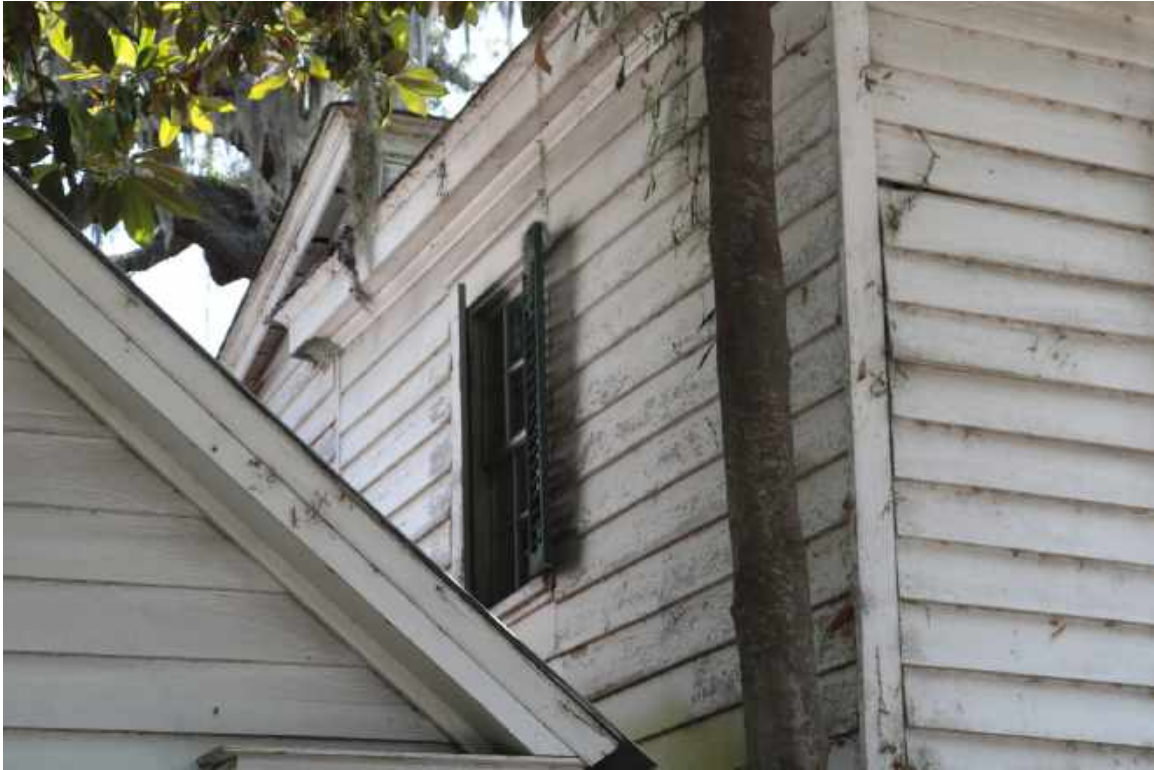
**Figure 82:** East Elevation of the Two-Story Building: Detail of the porch roof detail where it intersects the main roof at the southeast corner.

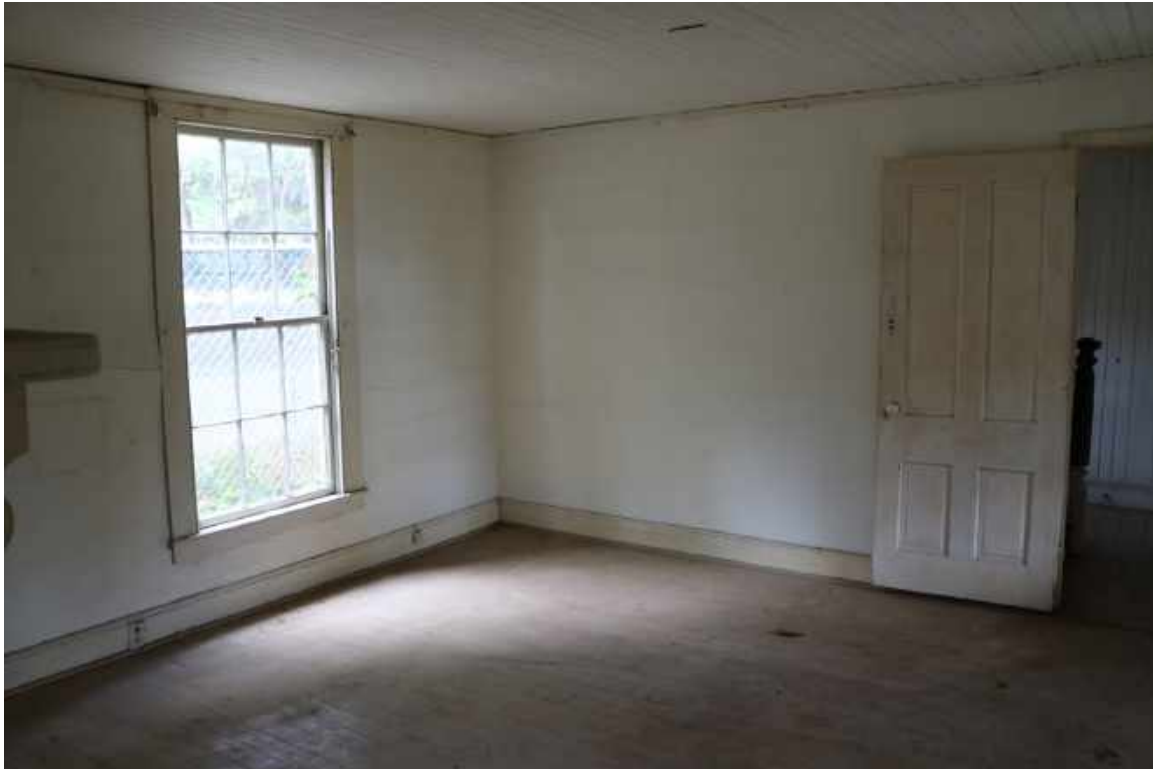
Figure 86: Room 101, Northeast Corner: Detail of interior conditions and the interior door.

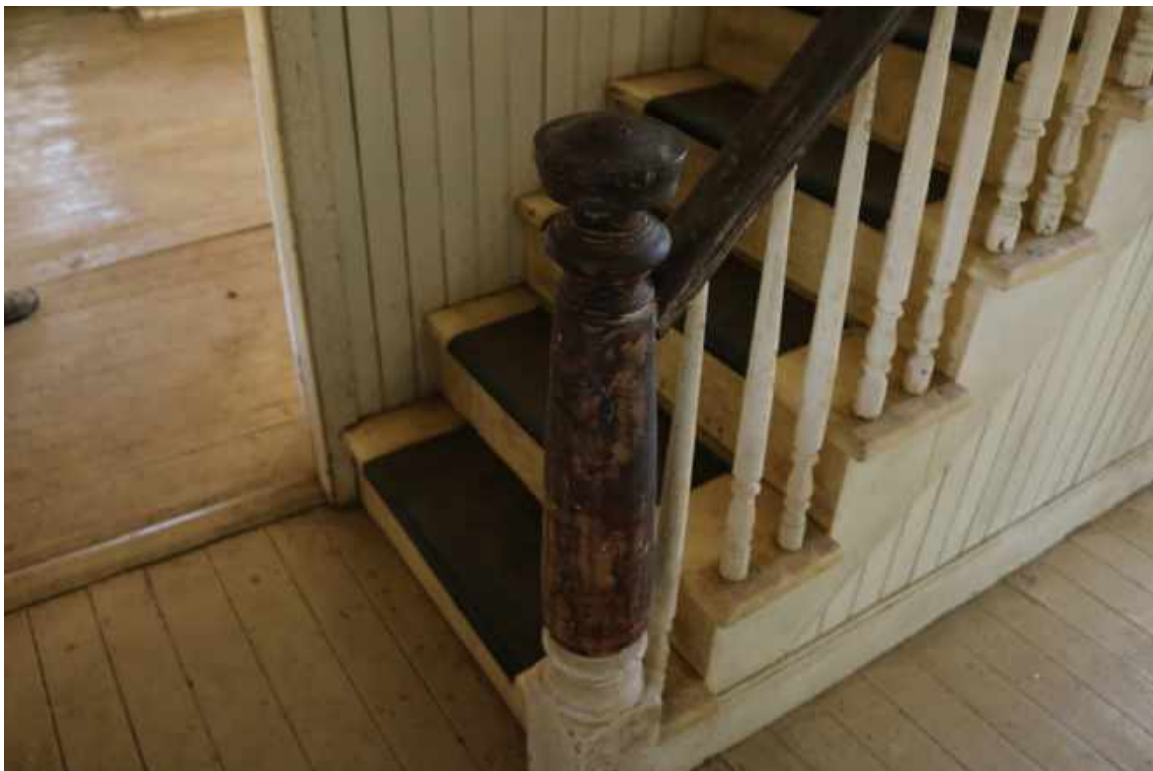
Figure 87: Room 102, Stair-Hall: Detail of the newel post and balustrade.
