## SQUIRE POPE CARRIAGE HOUSE PRESERVATION PLAN

PREPARED FOR:  
THE TOWN OF BLUFFTON  
20 BRIDGE STREET  
BLUFFTON, SC 29910

PREPARED BY:  
MEADORS, INC.  
PO BOX 21758  
CHARLESTON, S.C. 29413

DATE: 09.30.2019

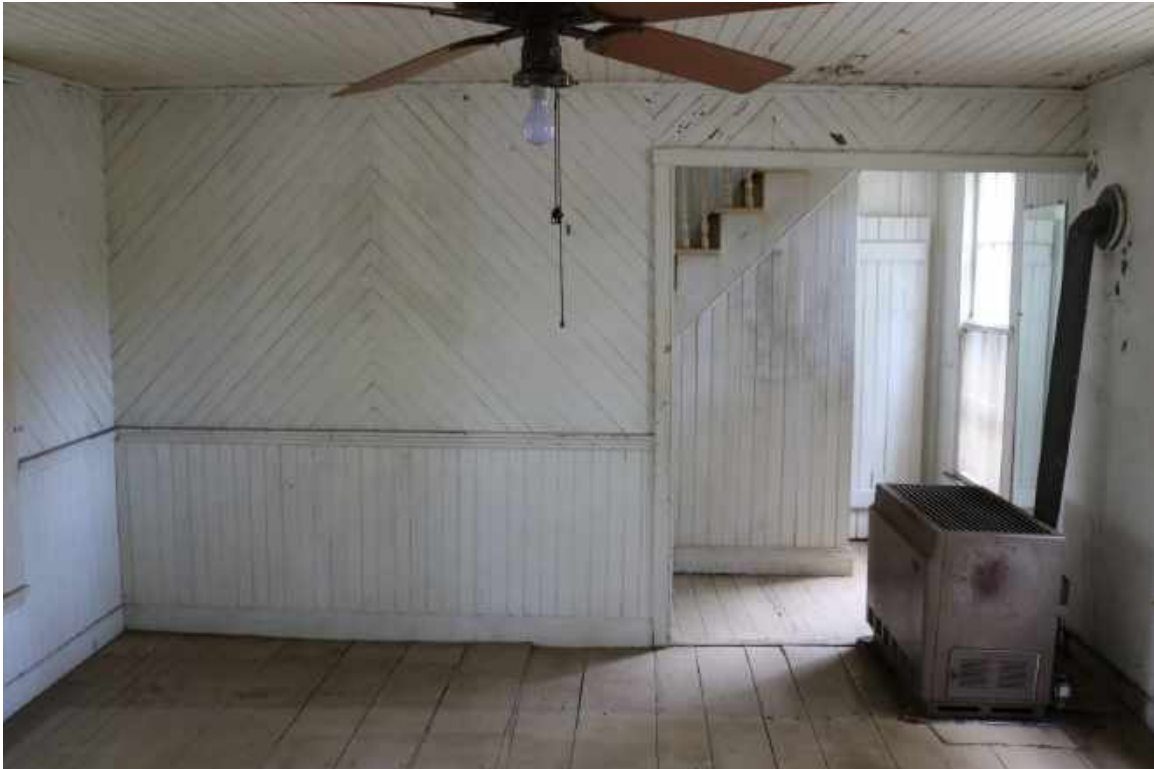
**Figure 88:** Room 103, Looking West towards the Stair-Hall. The opening between the rooms has been enlarged towards the north.

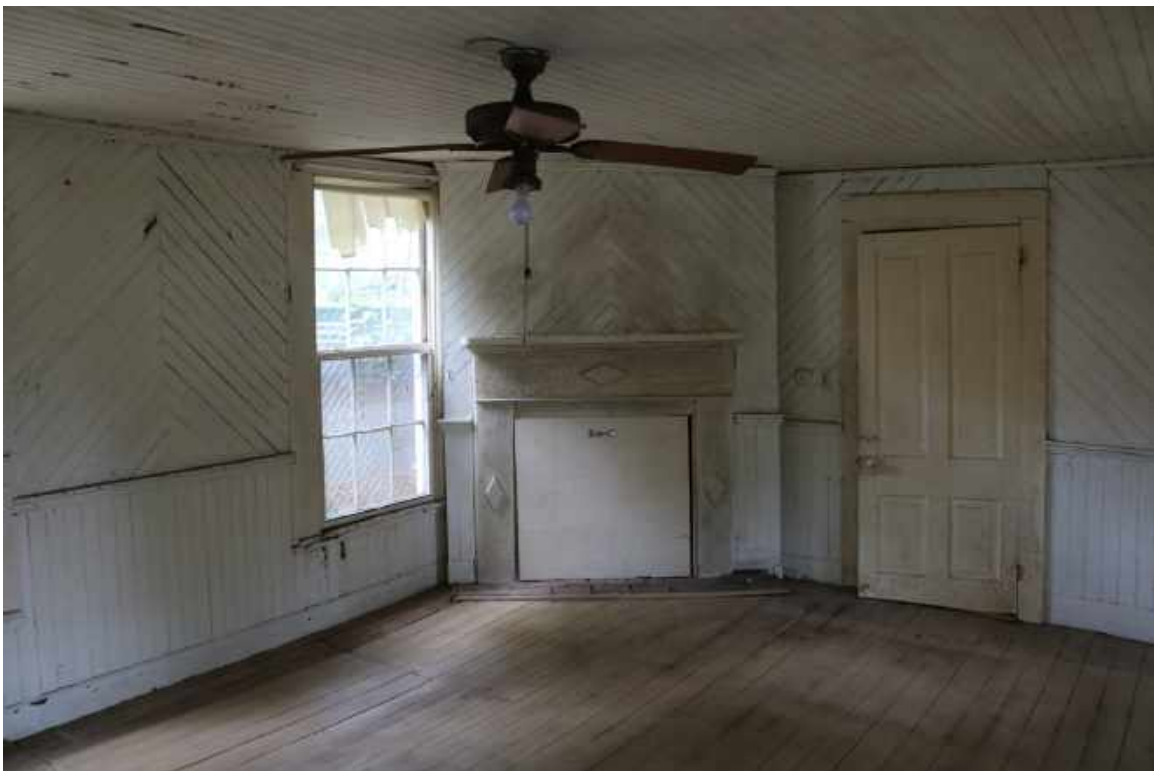
**Figure 89:** Room 103, Northeast Corner: Overview of the decorative interior paneling and the corner fireplace.

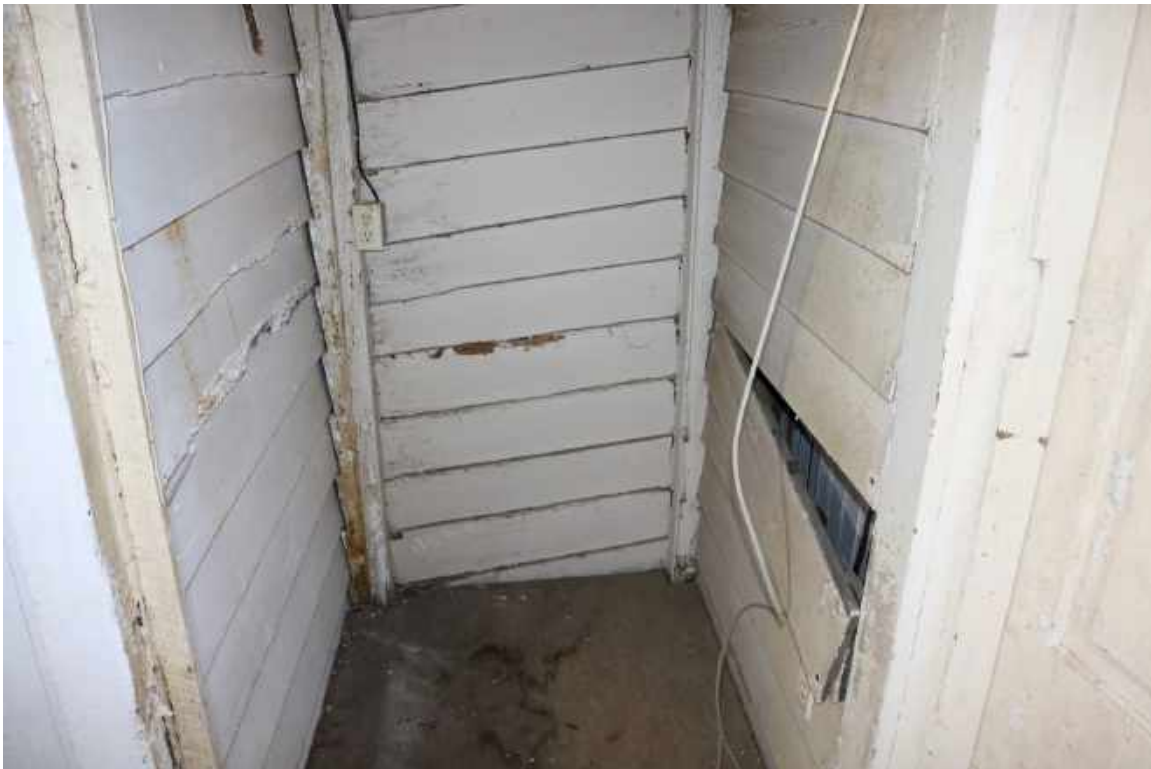
The interior of the hyphen is in poor condition due to the excessive settlement and destabilization of the structure. 2-3/4" wide beadboard is installed on the ceiling. The original exterior clapboard of both structures is exposed to the interior of the structure further illustrating the history of these buildings. Whitewashed framing is visible in areas where the enclosed clapboards are dislodged. There is evidence of excessive water intrusion at the ceiling.

**Figure 90:** Room 104 (Hyphen) Looking South: The exterior clapboard of both structures remain exposed.

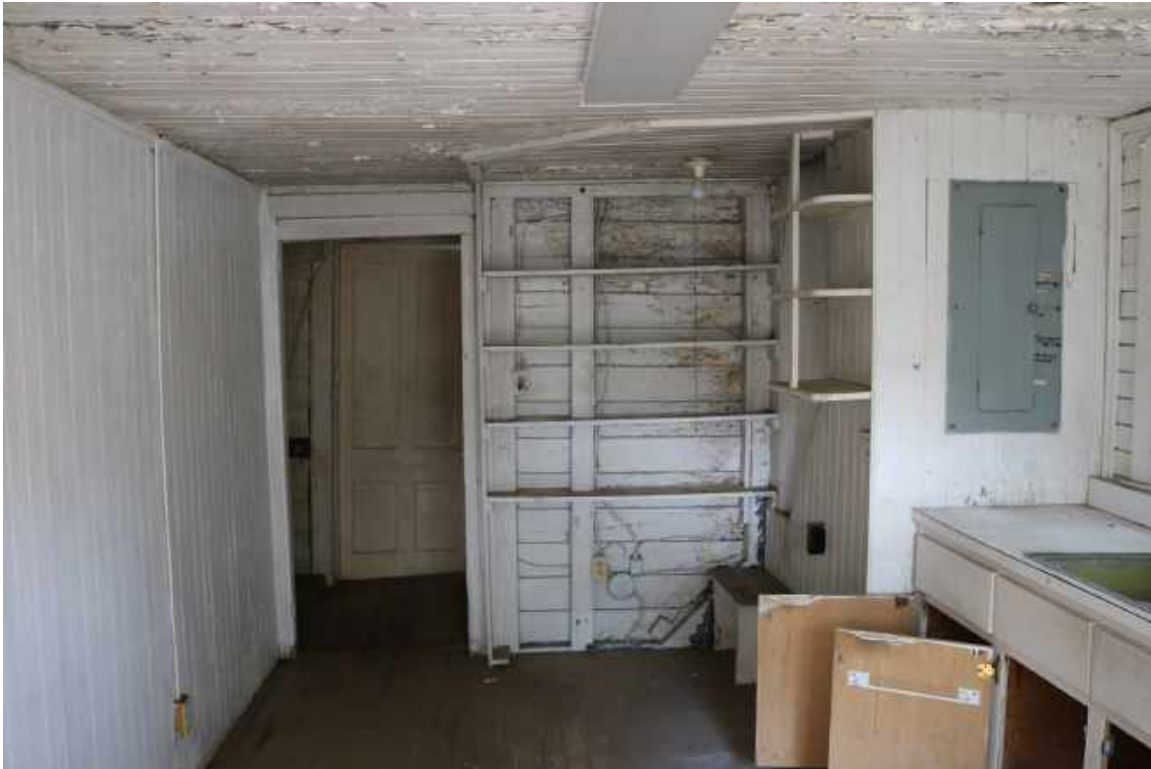
**Figure 91:** Room 105 (Kitchen), Looking West: Attic access is present at right. A variety of interior wall finishes are present throughout this space.

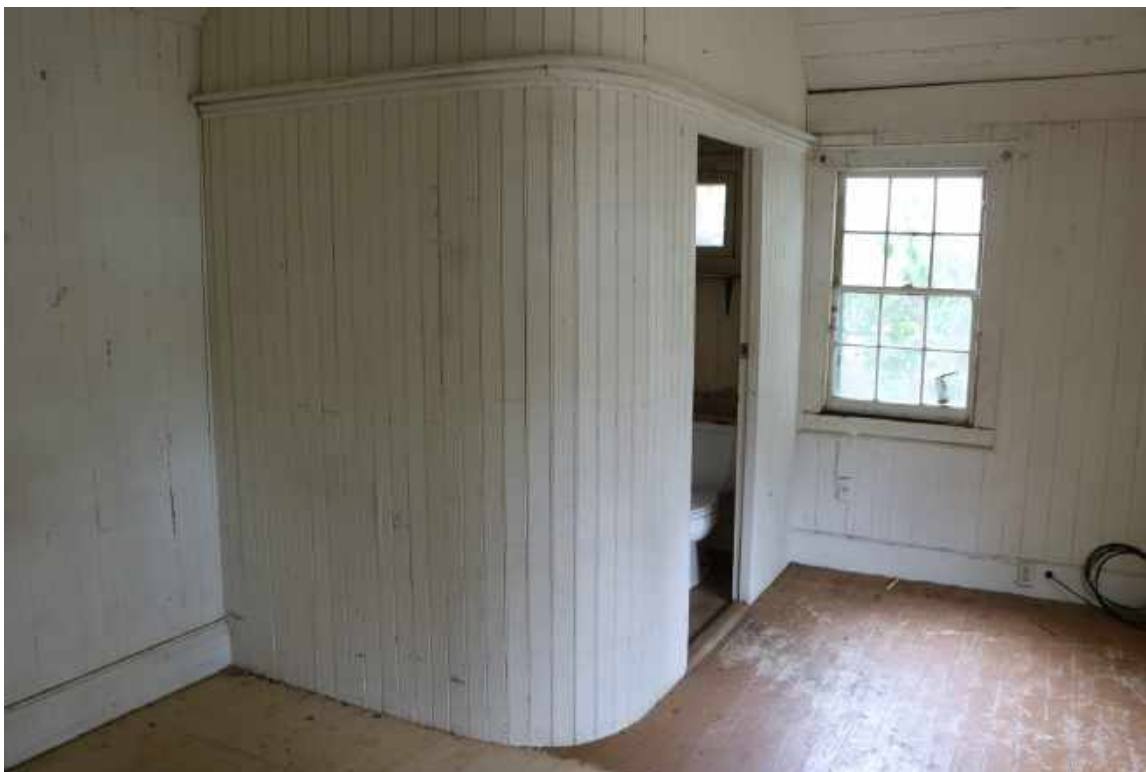
**Figure 93:** Room 107, Looking Northeast: View of the curved paneled wall between Rooms 106 and 107.

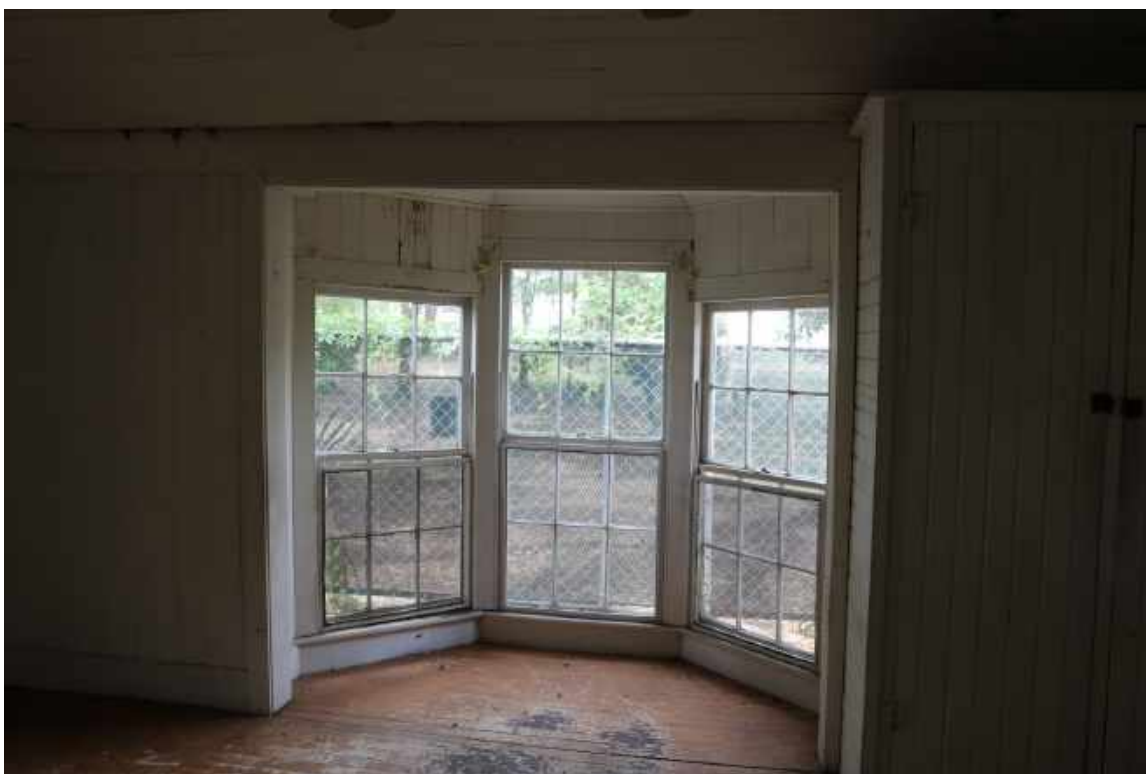
A gap has formed within the interior of the south bay window indicating differential movement between the window structure and the rest of the building. This movement is likely induced by the failure of the foundation. Additional vertical separation was noted within at the interior southeast corner of Room 107.

**Figure 94:** Room 107, Looking South: Detail of interior of the bay window. Note the separation of the floor below the windows.

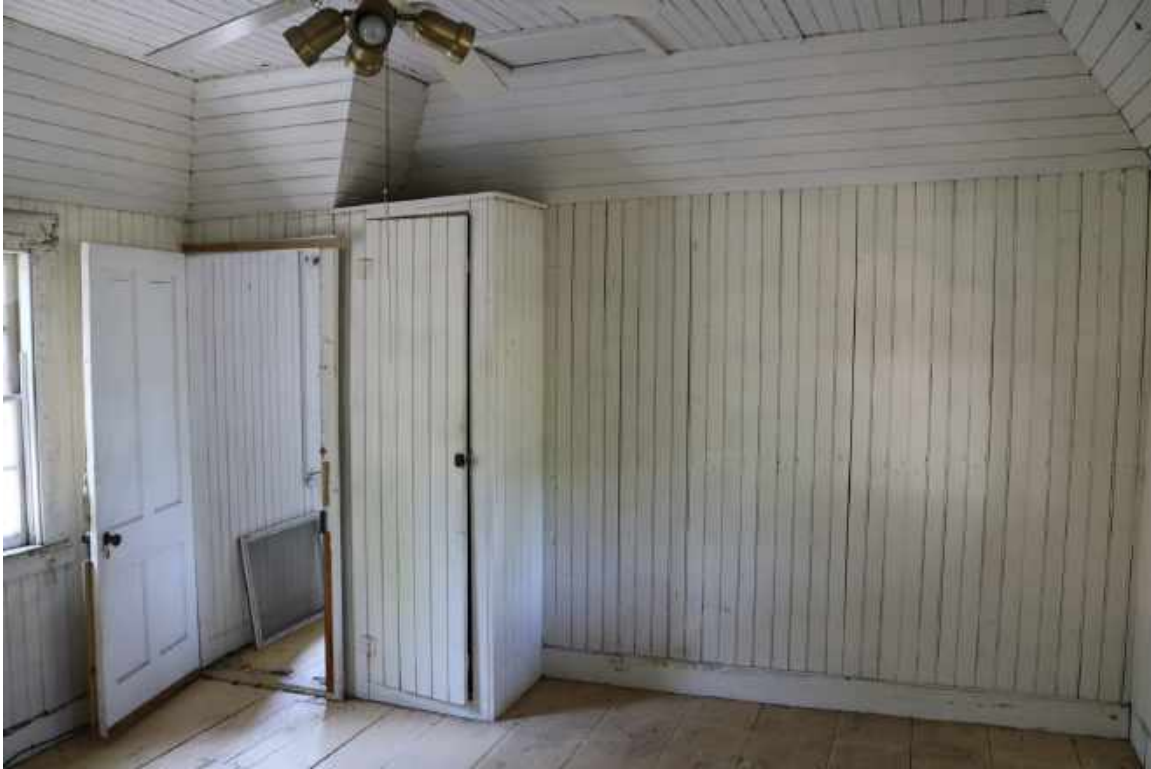
**Figure 97:** Room 202, Looking Northeast: Many of the rooms on the second floor feature a canted ceiling with beadboard installed at an angle. Note the differences in profile and size between the vertical and angled ceiling paneling.

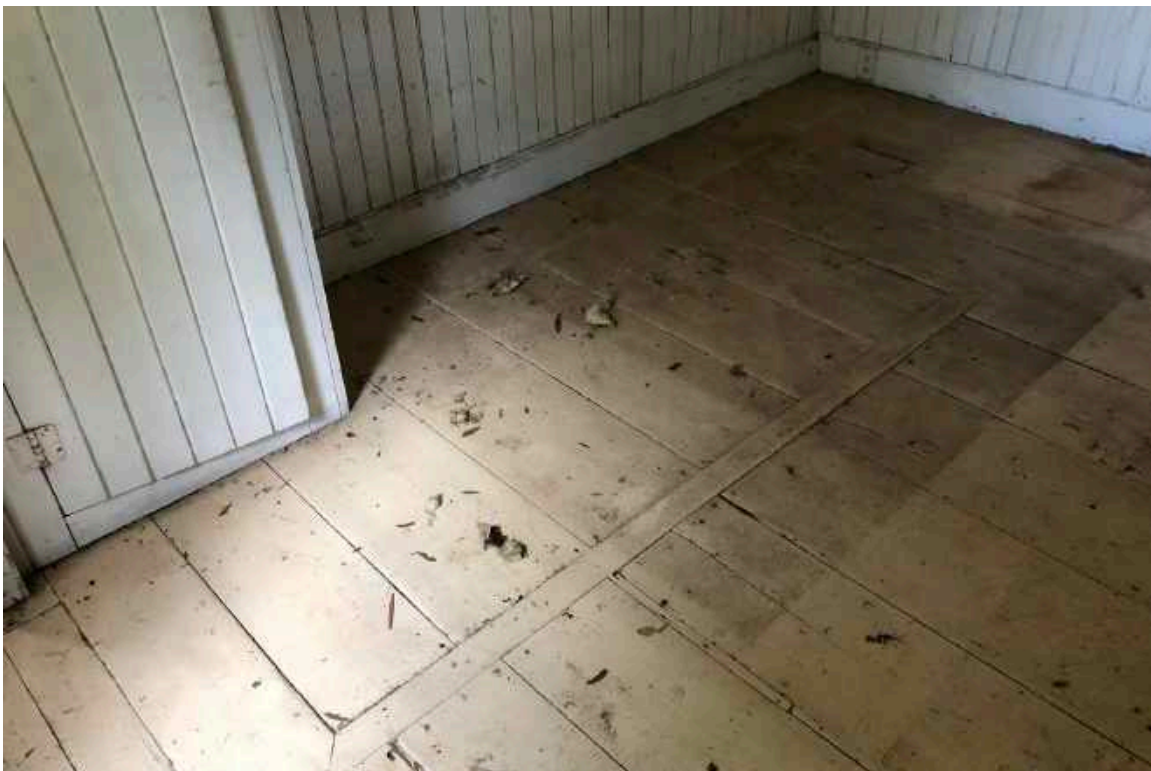
**Figure 98:** Room 202: Detail of historic wide plank flooring. The notch within the flooring and trim is a typical detail used adjacent to masonry hearths.

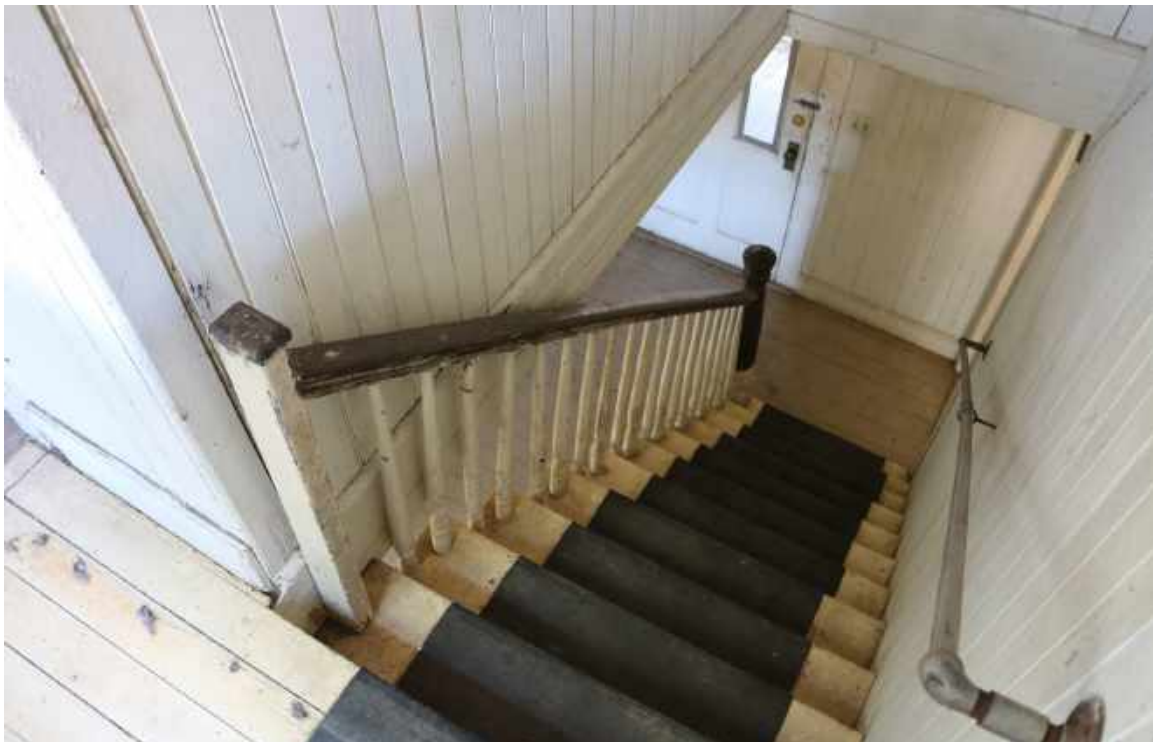
**Figure 99:** Room 203, Stair-Hall: The landing on the second floor is narrow. Thinner tongue and groove floors are installed over older flooring boards.

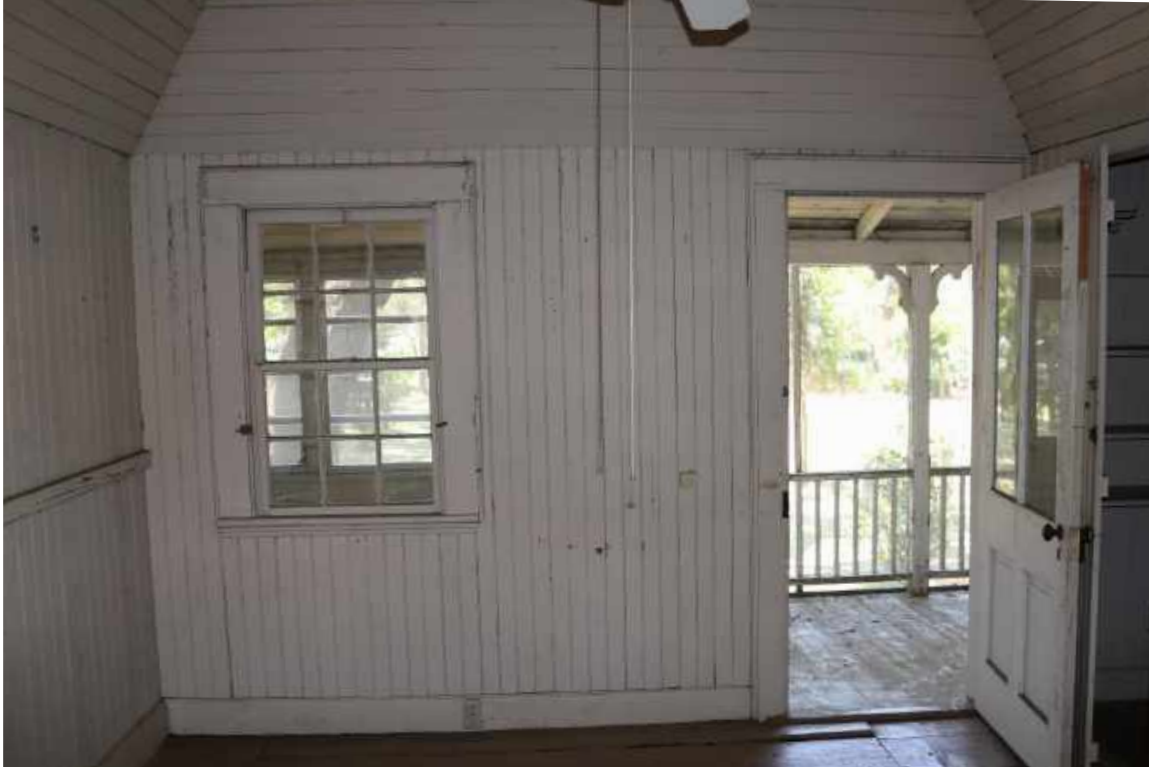
**Figure 100:** Room 204, Looking South Towards Porch: This room is finished in a similar fashion to Rooms 202 and 205.

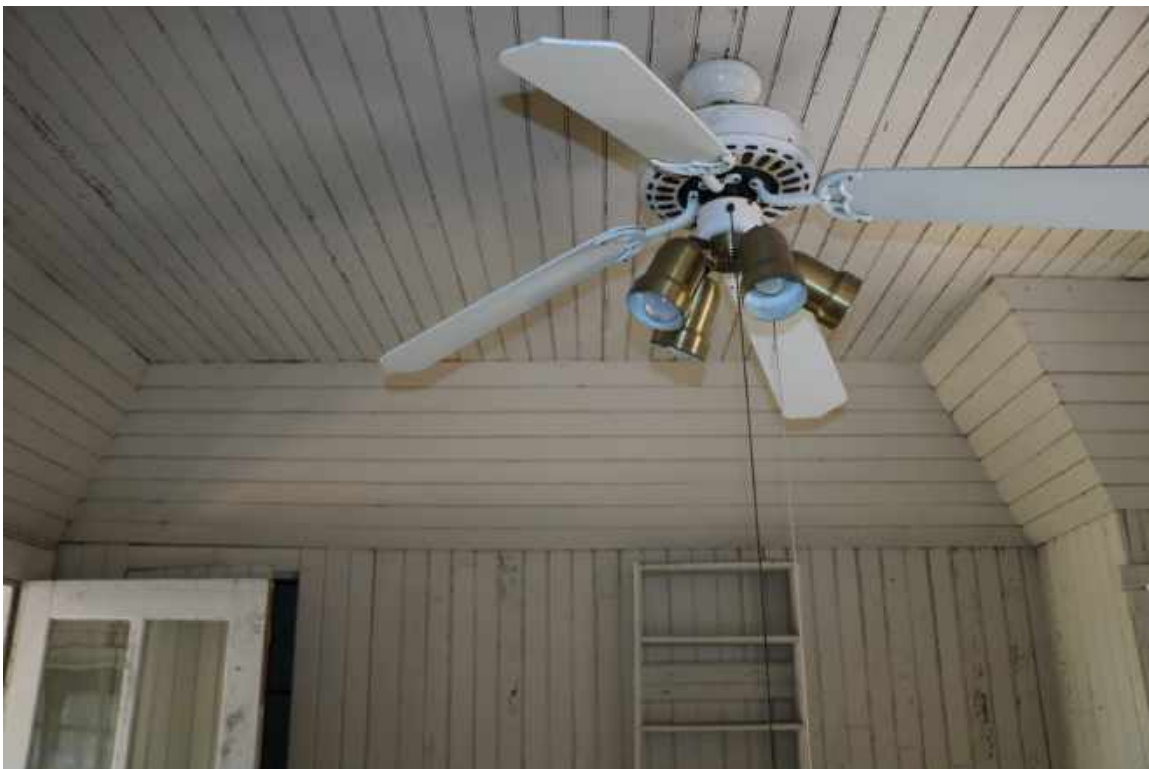
**Figure 101:** Room 204, Looking West: Detail of ceiling paneling.

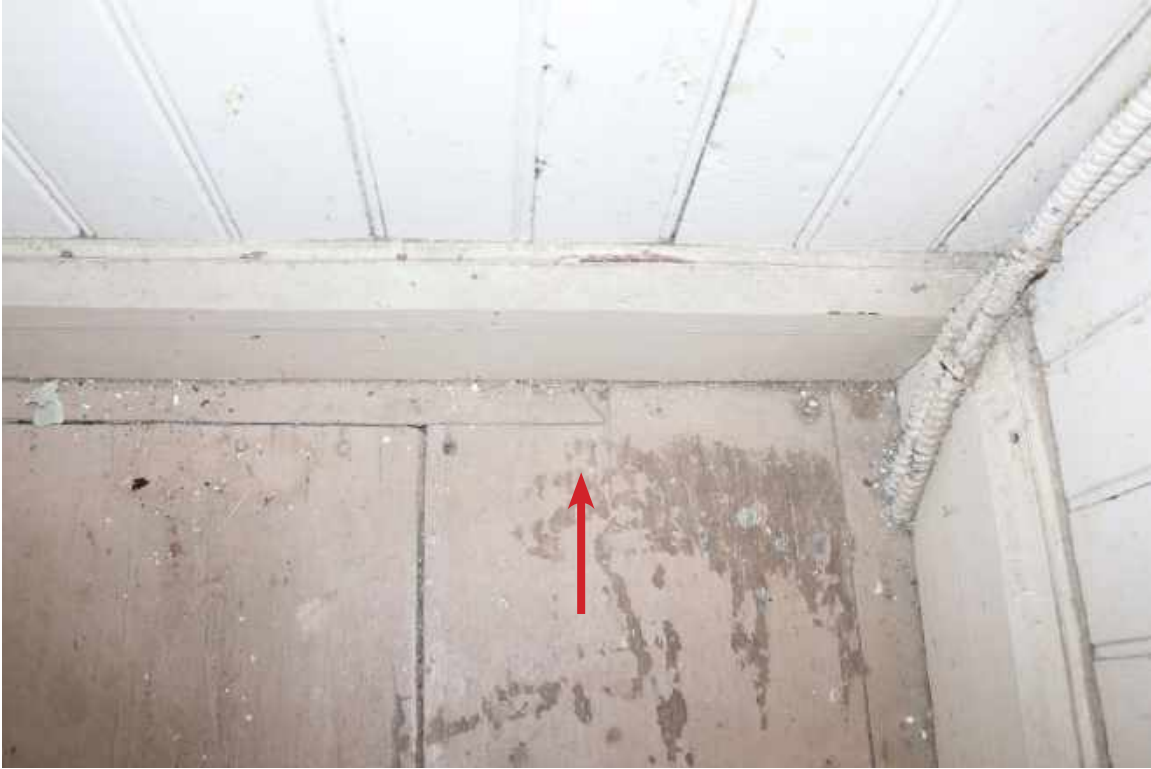
**Figure 102:** Room 204: Detail of matching floor detail found in Room 202 (arrow). All four corners of the second floor opening were identified, indicating there was likely a central opening in the structure.

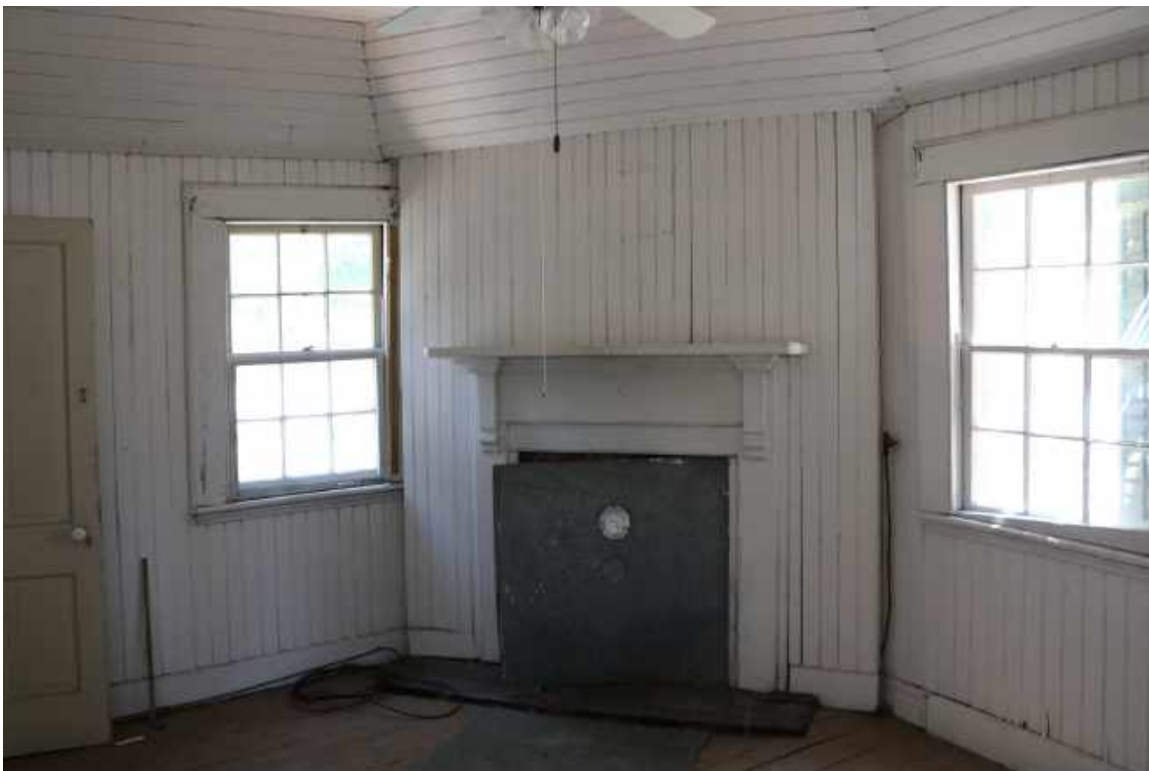
**Figure 103:** Room 205, Northeast Corner: Detail of the interior finishes within this room.

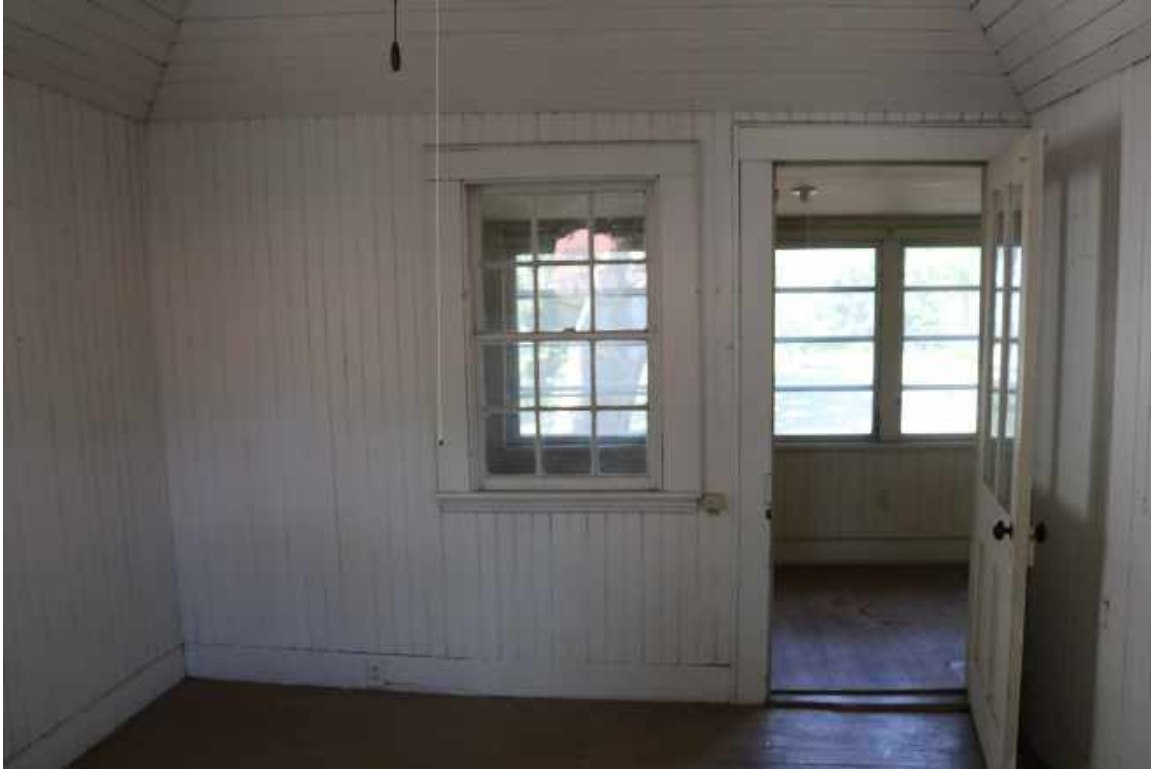
**Figure 104:** Room 205, South Elevation: Detail of the interior finishes within this room looking towards Room 206.

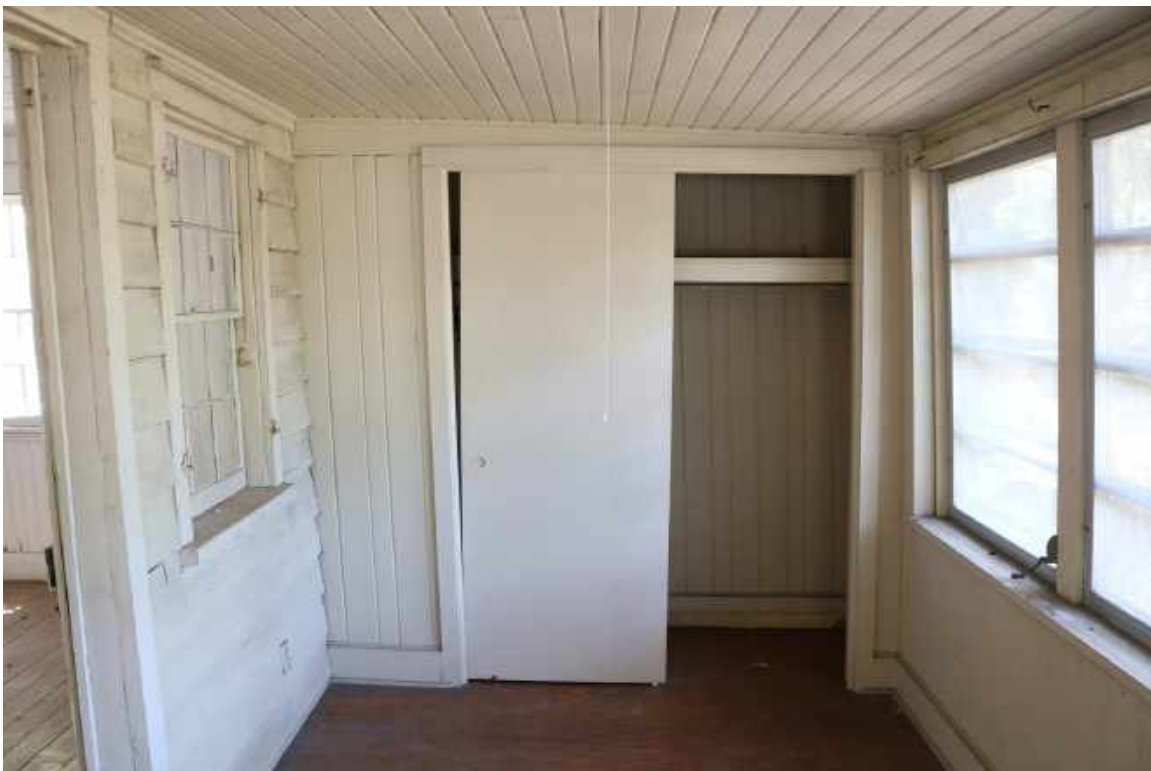
**Figure 105:** Room 206 (Porch infill) Looking East: The original siding and windows remain in place (at left).

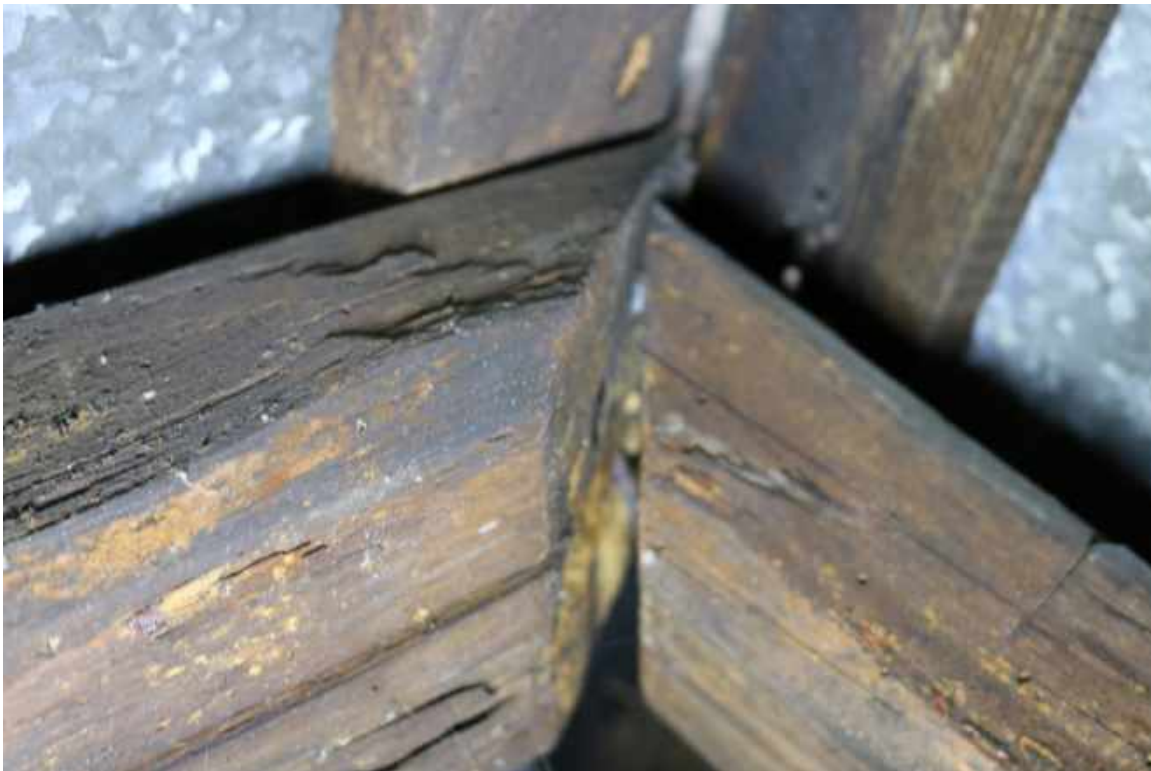
**Figure 106:** Attic of the One-Story Building, Rafters: Detail of toe-nailed rafters.

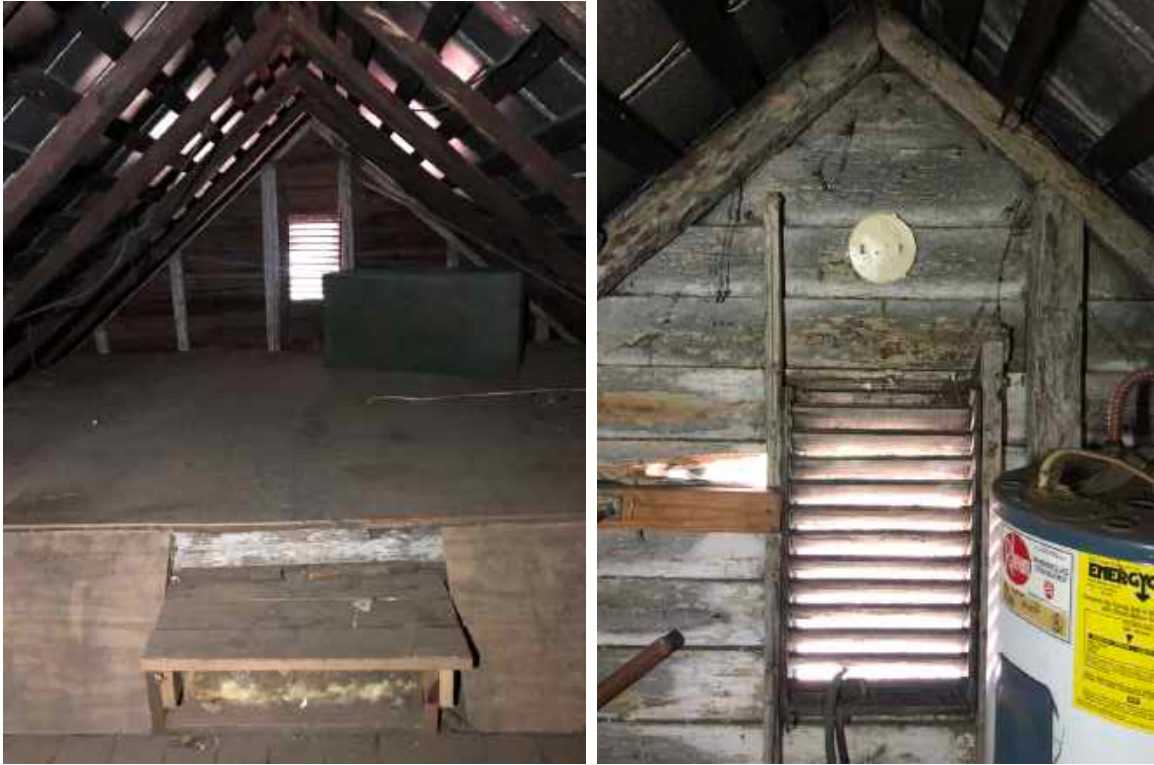
**Figure 107:** Attic of the One-Story Building: Overview of the roof framing looking south (at left) and north (at right).

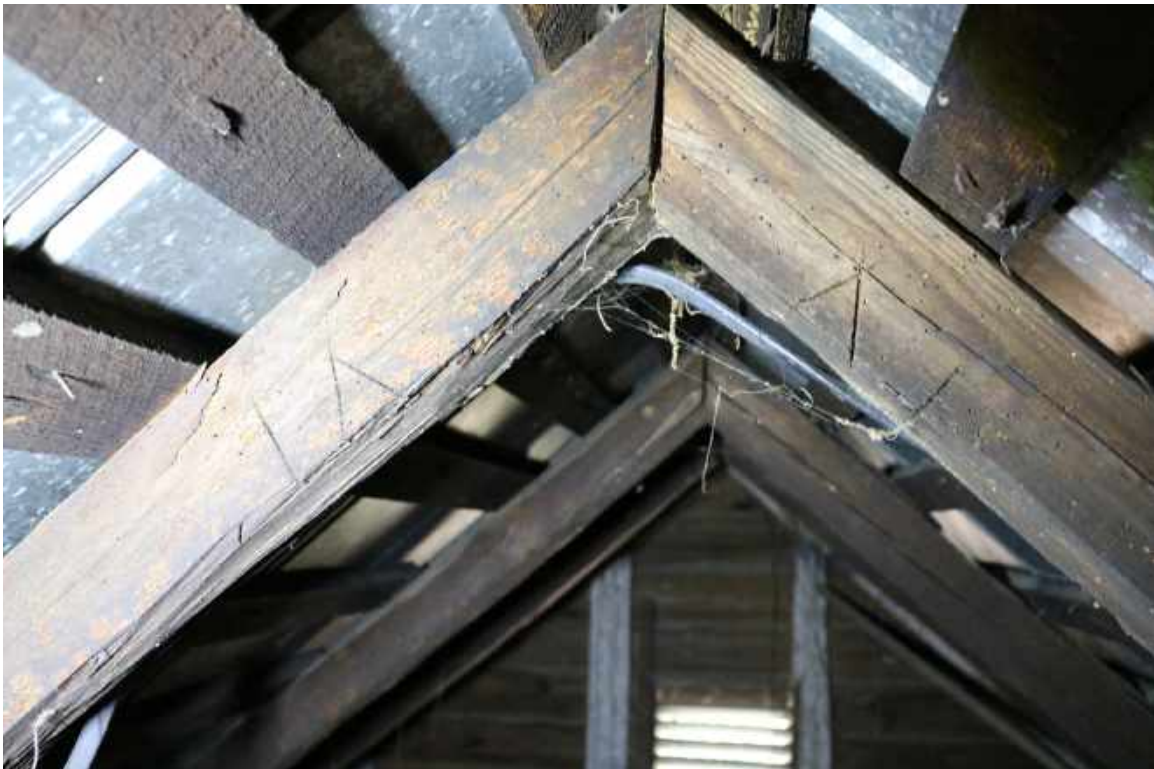
**Figure 108:** Attic of the One-Story Building, Looking North: Detail of matching carpenter's marks.

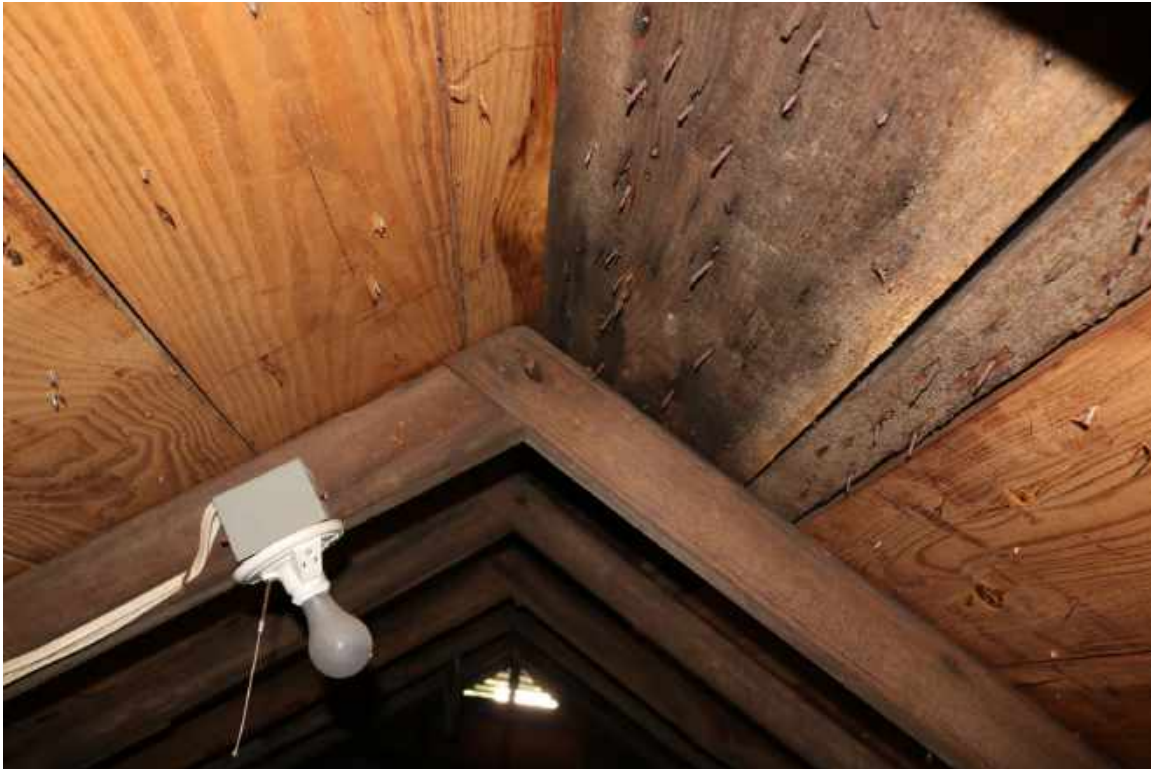
**Figure 109:** Attic of Two-Story Building: The western rafters are joined together with pegs at the ridge. Much of the roof decking has been replaced.

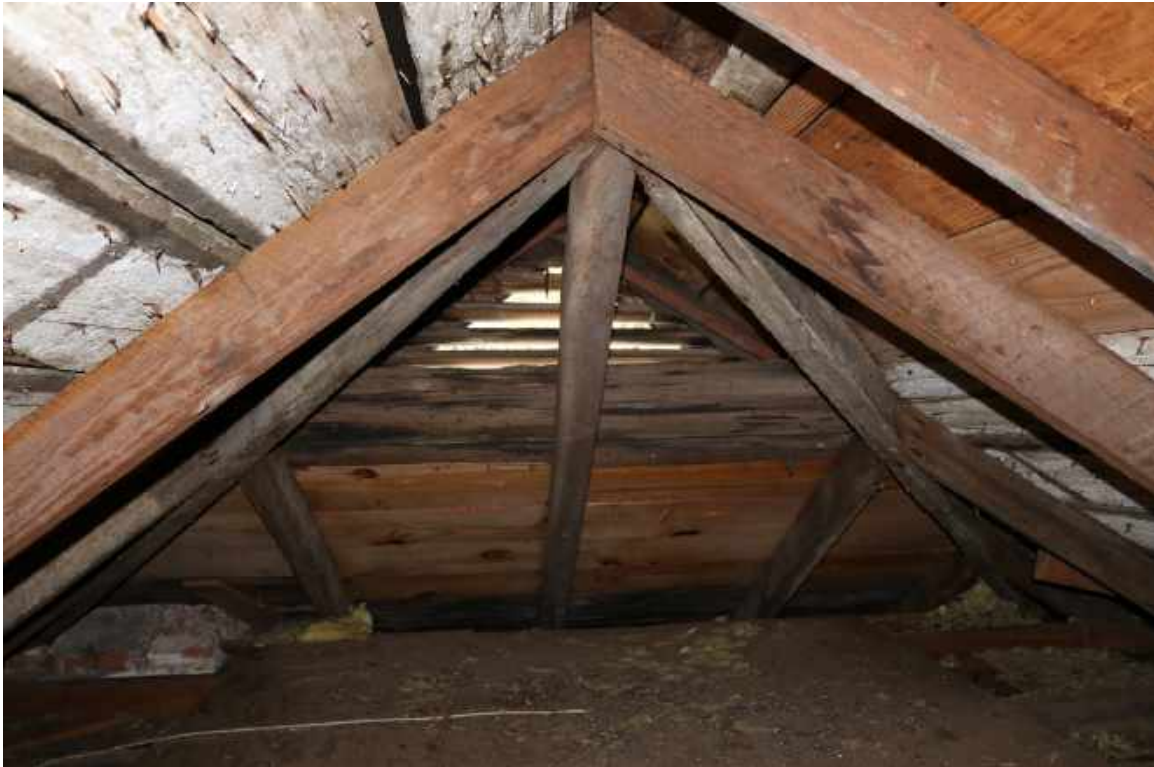
**Figure 111:** Attic of Two-Story Building, Eastern End: Detail of roof framing at gable vent. Note the absence of pegs at the rafter ridge.

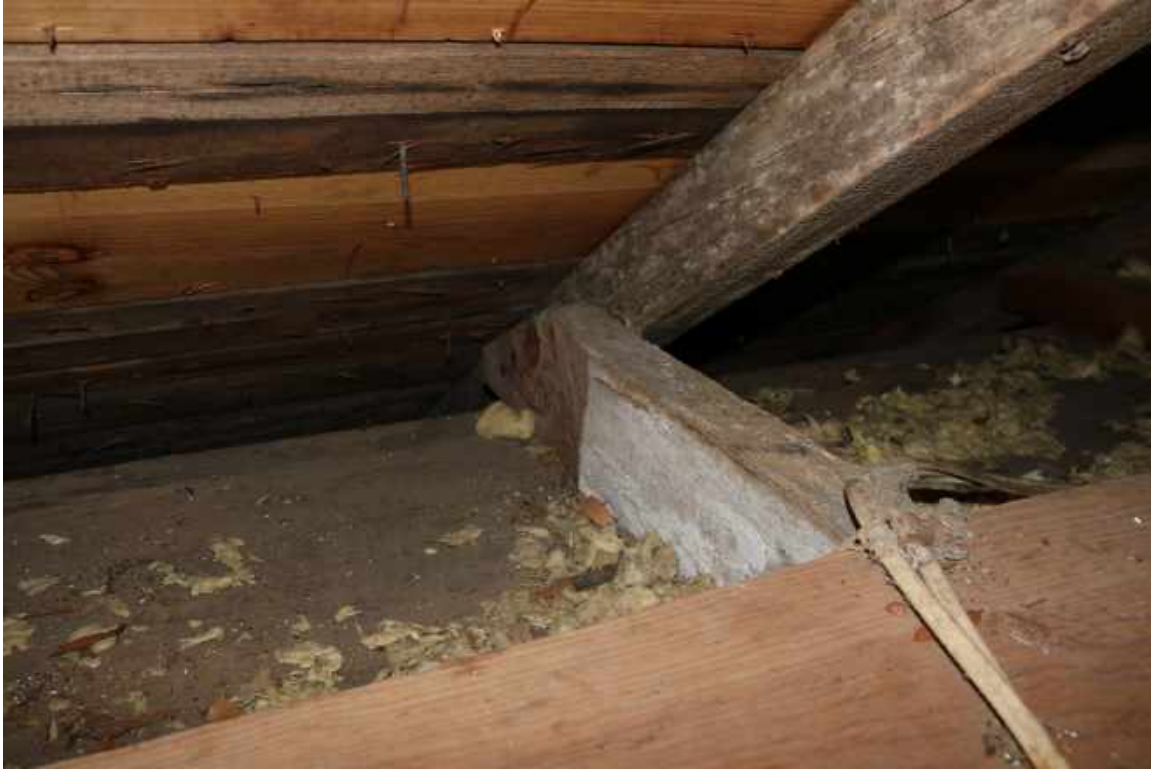
**Figure 113:** Attic of Two-Story Building: Modern plywood has been installed over whitewashed collar ties

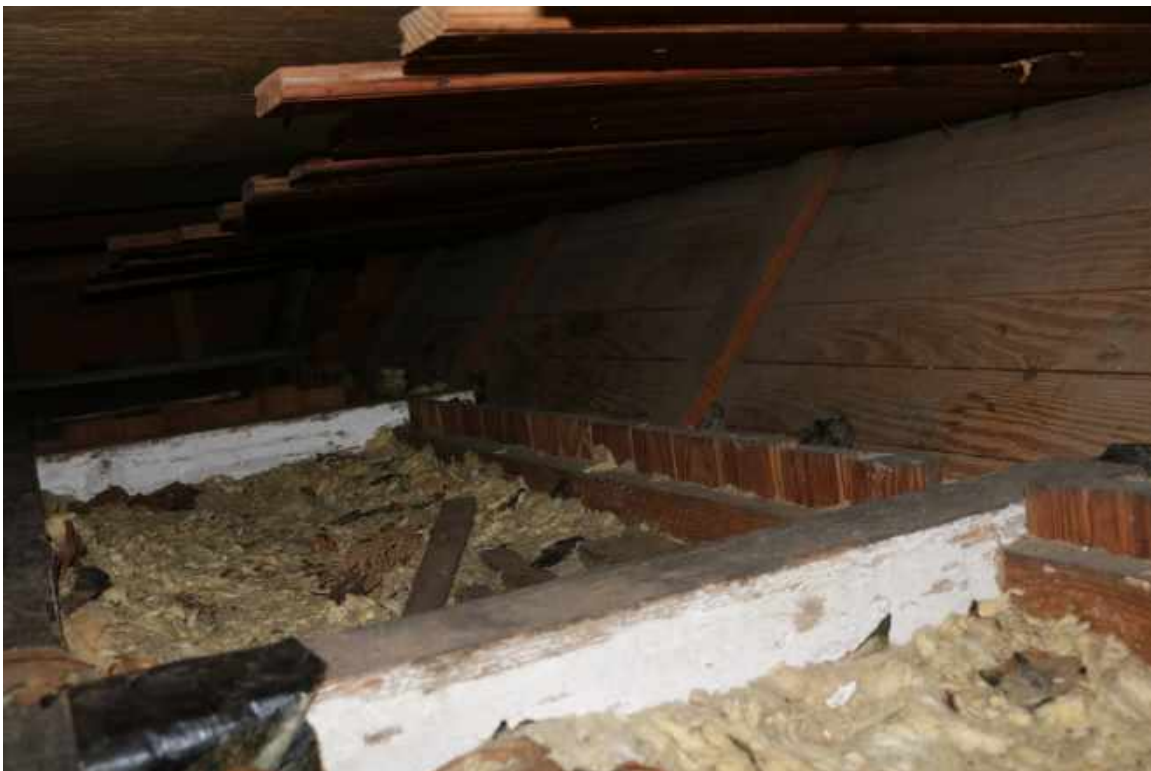
**Figure 114:** Attic of Two-Story Building, Beneath Plywood Floor: The second-floor ceiling joists have been cut to accommodate the installation of the cant ceiling.

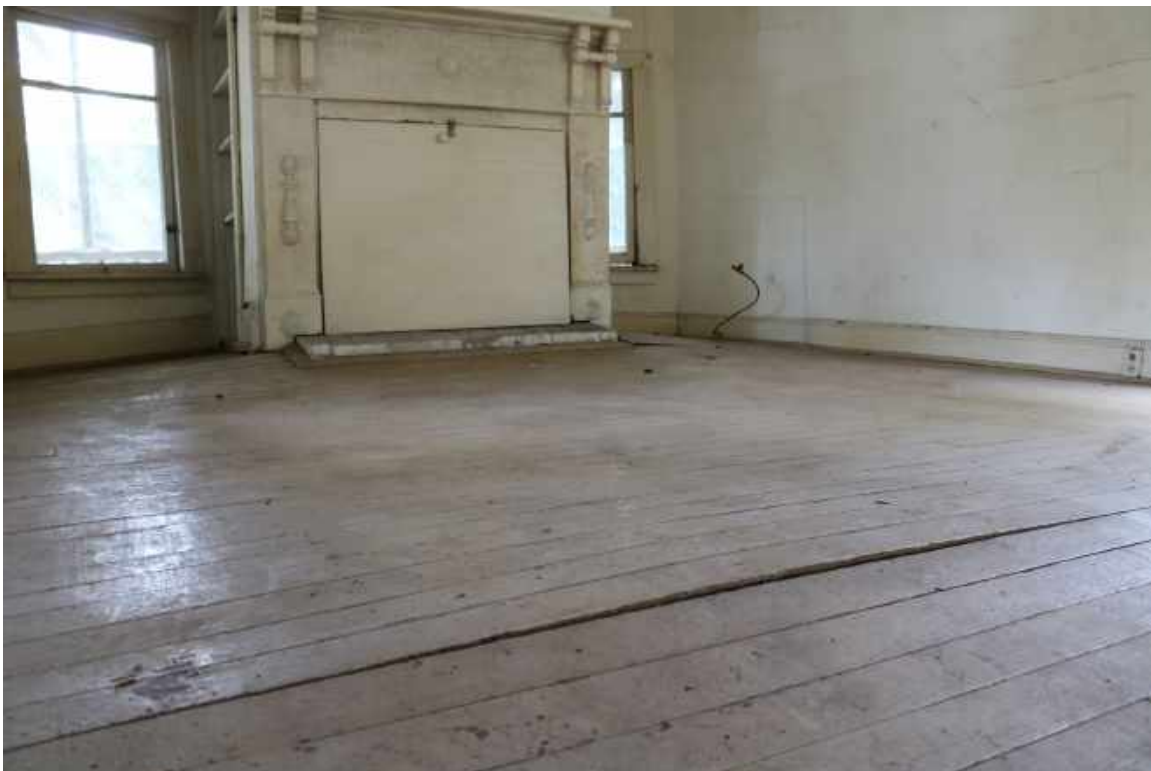
Selective demolition was performed in three locations within Room 101. The first area of interest was located at the center of the room at a noticeable upward bulge within the hole. Thin tongue and groove flooring were delicately removed at the location of the bulge to investigate the underlying conditions. The area of investigation occurred directly above a north-south floor joist and at the seam between the flooring.

**Figure 115:** Room 101: Detail of flooring conditions prior to selective disassembly.

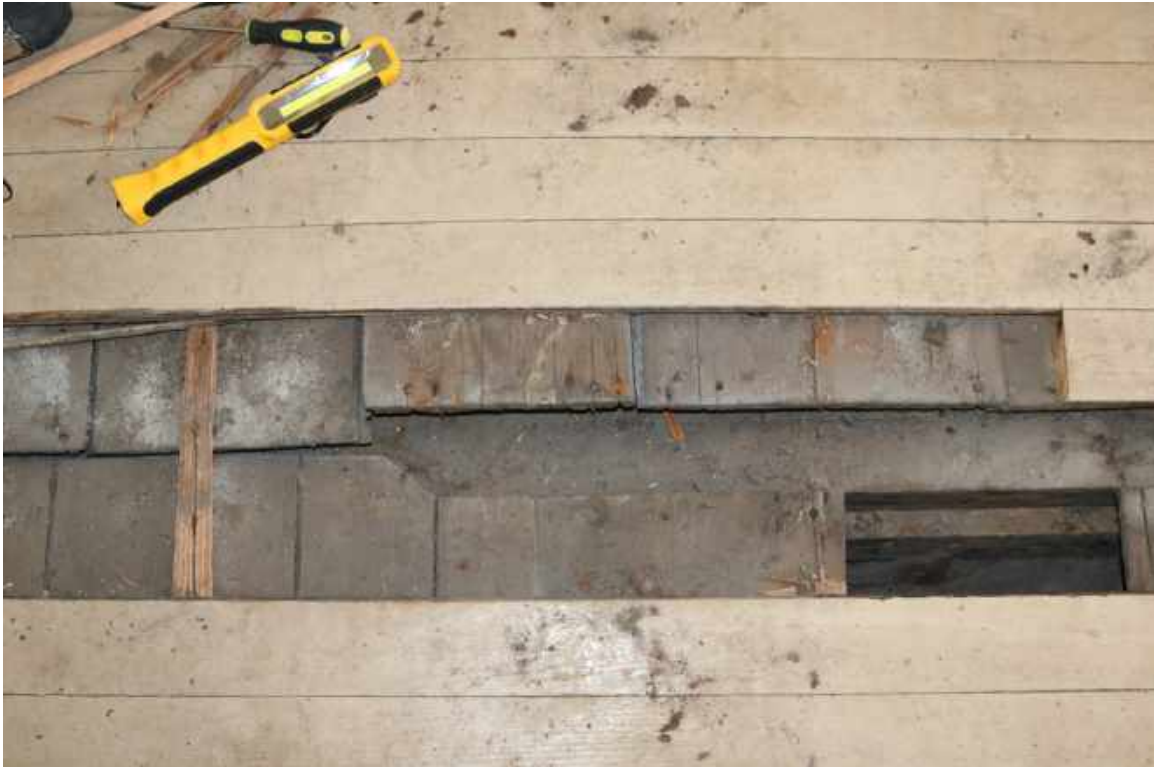
**Figure 116:** First Floor, Room 101: Large wide plank flooring was uncovered directly beneath the existing small plank flooring. The underlying floor is fastened directly to the joists and is interpreted to be original.
