## SQUIRE POPE CARRIAGE HOUSE PRESERVATION PLAN

PREPARED FOR:  
THE TOWN OF BLUFFTON  
20 BRIDGE STREET  
BLUFFTON, SC 29910

PREPARED BY:  
MEADORS, INC.  
PO BOX 21758  
CHARLESTON, S.C. 29413

DATE: 09.30.2019

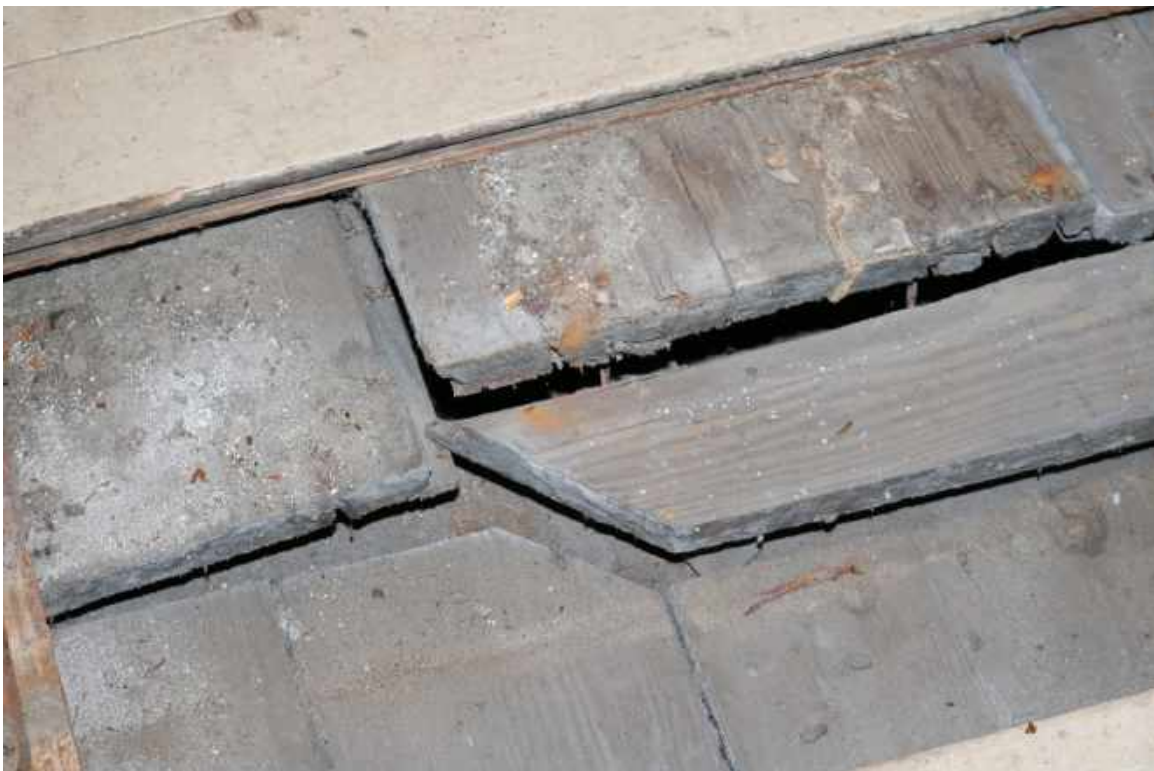
**Figure 117:** First Floor, Room 101: A similar flooring detail to that found in Rooms 202 and 204 was found at this location. This may indicate that the center of the original structure once contained a large two-story opening.

The bulge is caused by the structural settlement on the west side of the room and the downward deflection of the underlying original plank flooring at this area. The first-floor framing within the room also appears to rest directly above grade. No foundation piers were located directly beneath the exposed flooring joists. However, a single deteriorated wood stump was uncovered between two floor joists. It is unknown if this is a remnant of the original foundation piers.

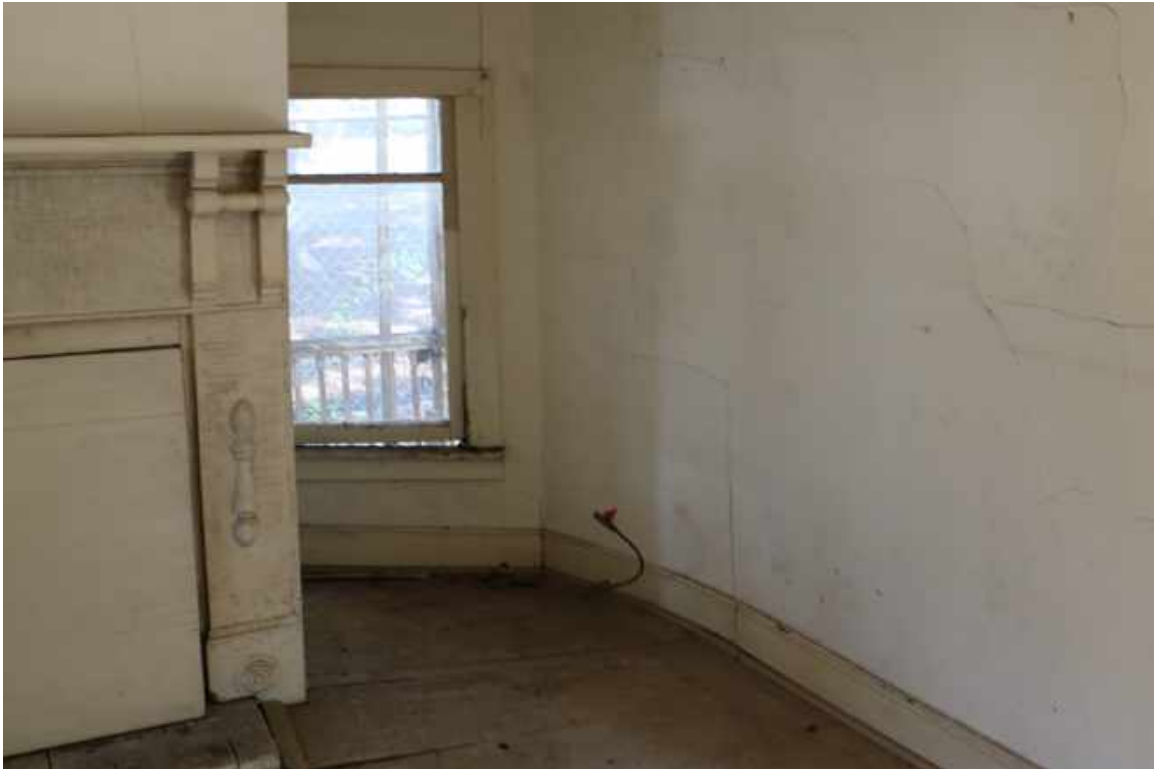
**Figure 119:** First Floor, Room 101 Northwest Corner: Detail of location #2.

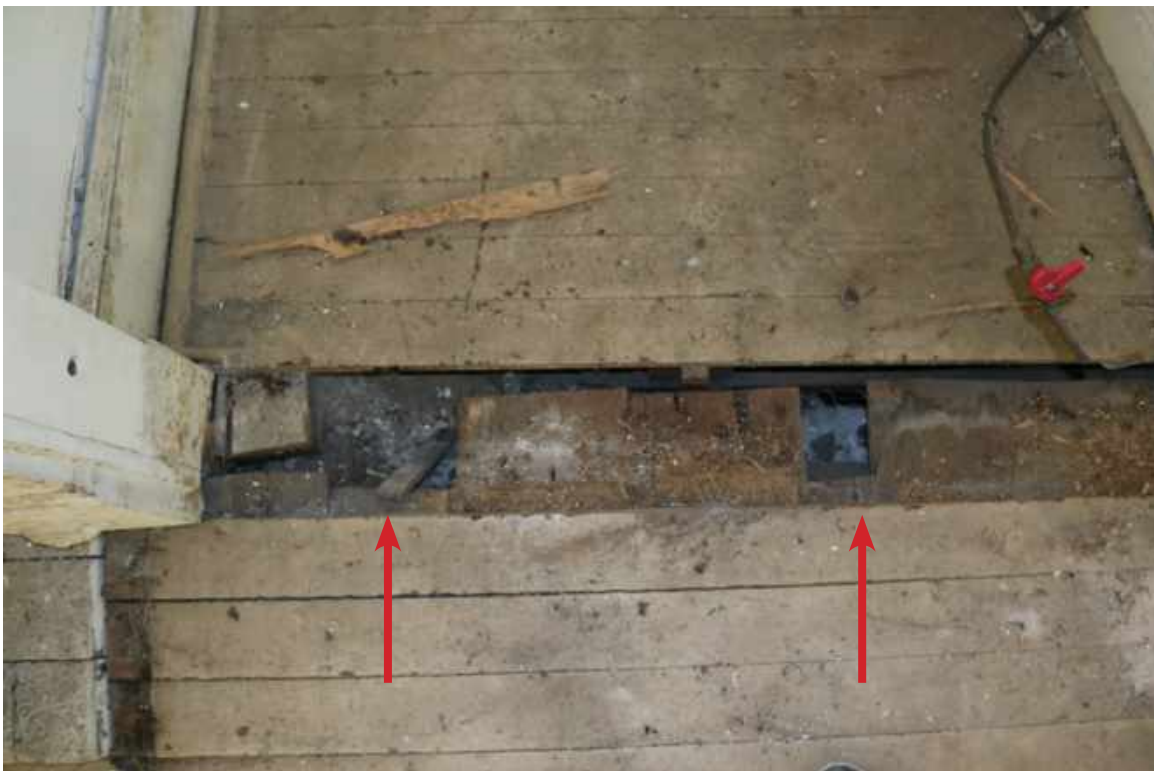
**Figure 120:** First Floor, Room 101 Northwest Corner: Detail of the underlying floor following removal of the thinner boards. Square cuts in the underlying floor are the locations of the vertical studs for the original west wall.

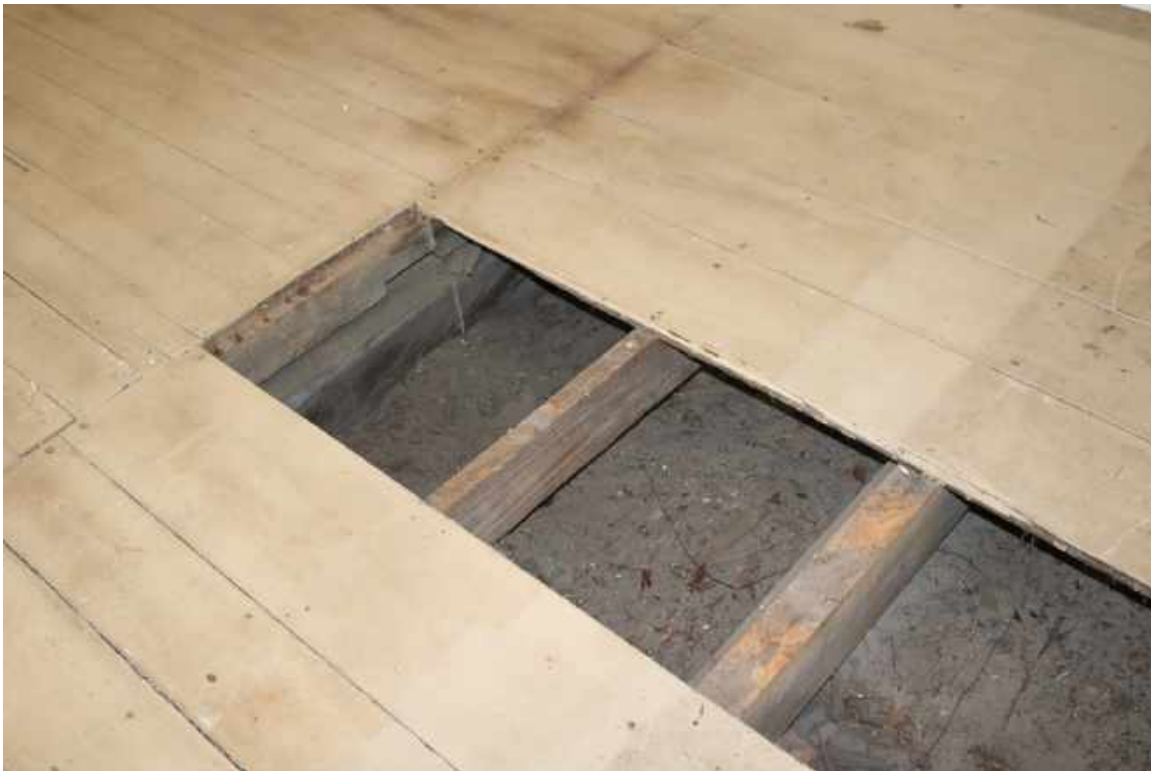
The original exposed wide plank flooring was removed in the center of Room 103 in a location where the boards had been previously cut and the fasteners were dislodged. Within this space, the original floor joists rest either at grade or directly above. As discussed in the framing assessment, a large sill was found to the east of this area and is interpreted as the eastern side of the original structure. Later repairs were also noted in this location.

**Figure 121:** First Floor, Room 103: Detail of flooring removed at the center of the room, exposing the original first floor framing and later repairs.

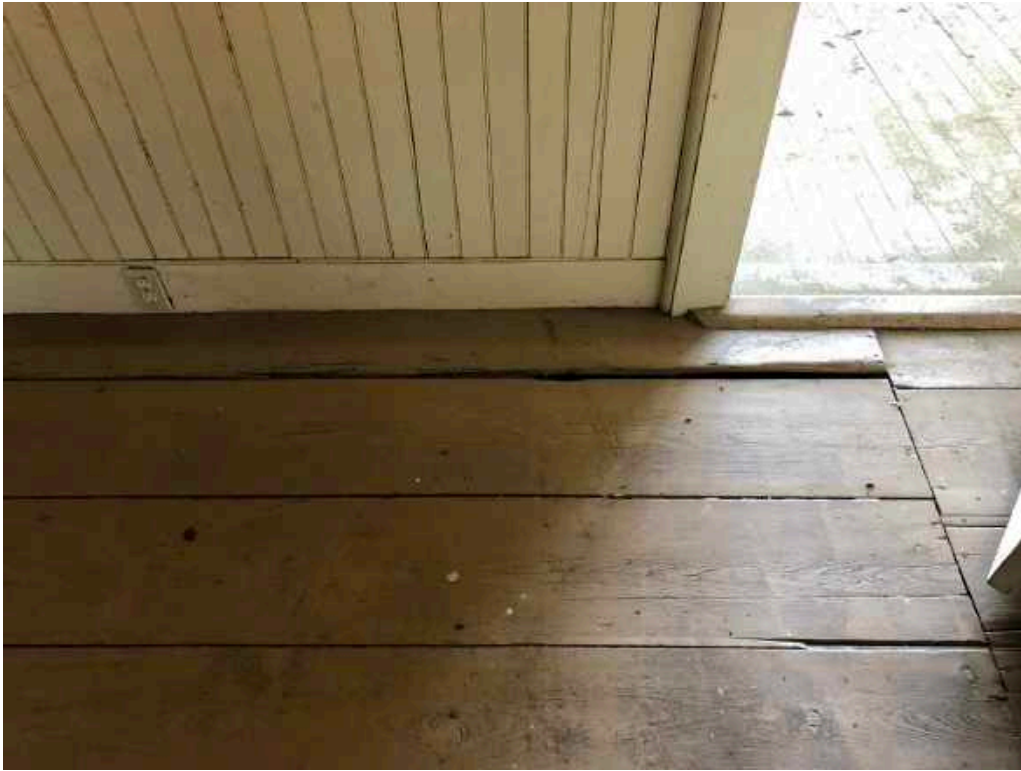
**Figure 122:** Second Floor, Room 204: Location of floor boards removed to investigate the second floor framing.

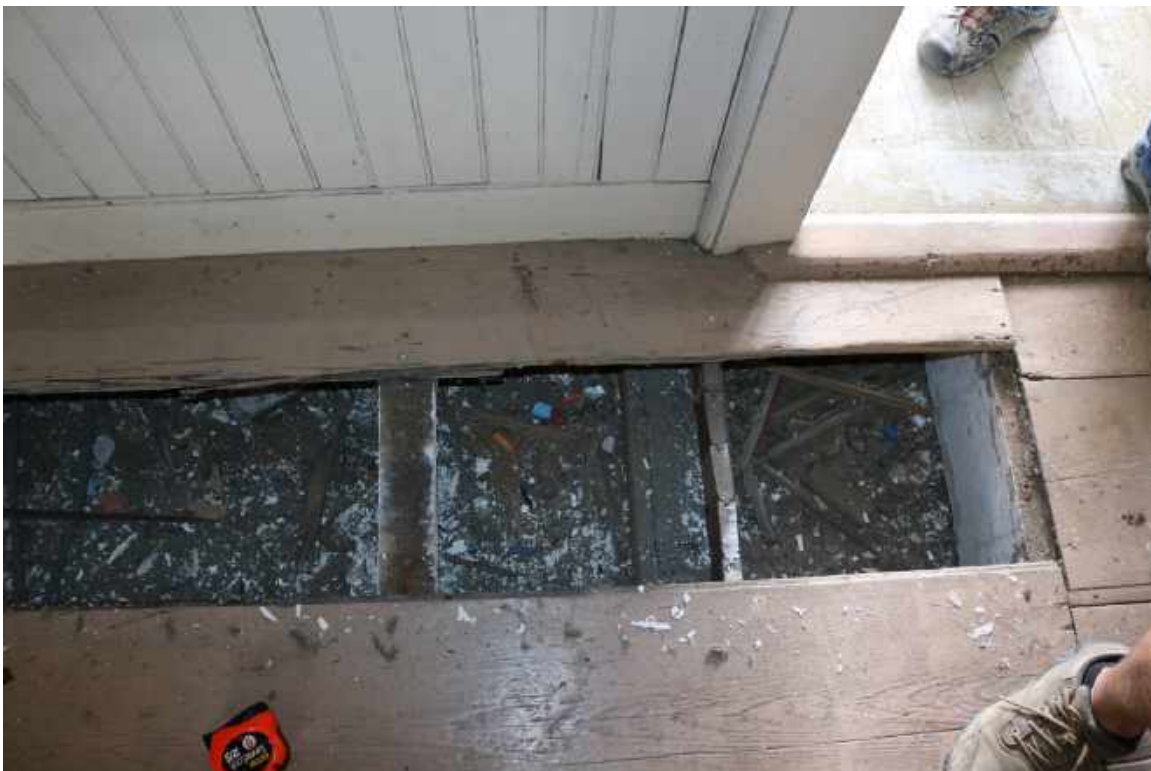
**Figure 123:** Second Floor, Room 204: Detail of framing conditions. A whitewash covers the exposed faces of the joists.

The wide plank flooring was also removed in an area on the second floor within room 204 adjacent to the porch door. The flooring was removed in this area where the boards were easily removed to investigate the condition of the second-floor framing. The framing at this location was found to be in good condition.

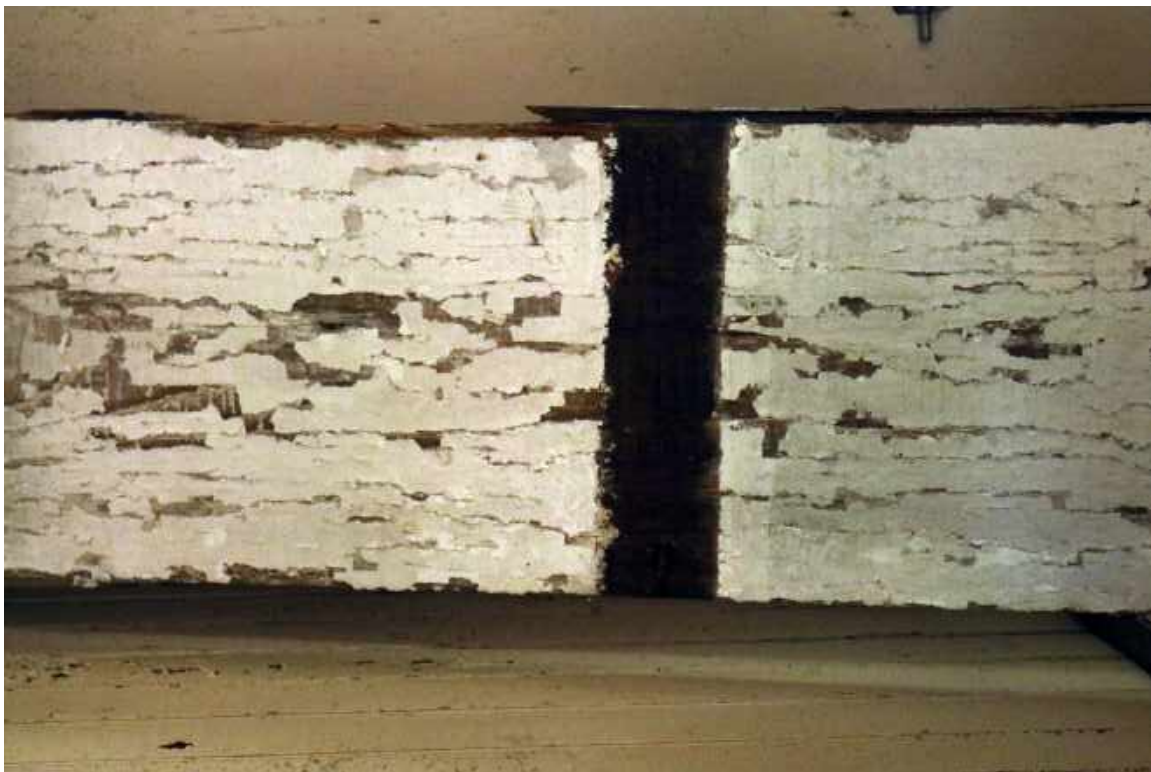
The joists and the underside of the removed boards contained a whitewash. Vertical framing members exposed at this location were also coated with a whitewash. The finish is incredibly brittle and likely dates to the construction of the building.

**Figure 124:** Second-Floor: Underside of removed floorboard containing a whitewash. The unpainted portion indicates the location of the underlying floor joist.

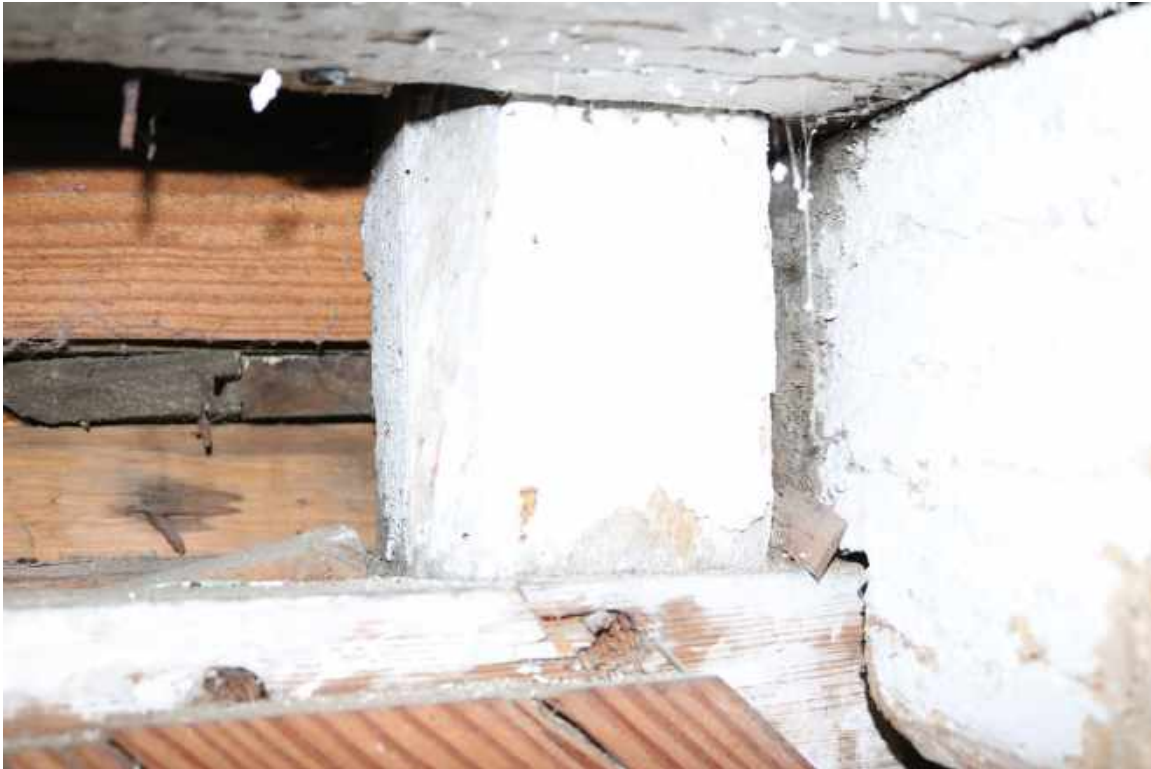
**Figure 125:** Second Floor, Room 204: Detail of a stud on the south elevation showing the presence of the whitewash on the girt, joist, and stud.

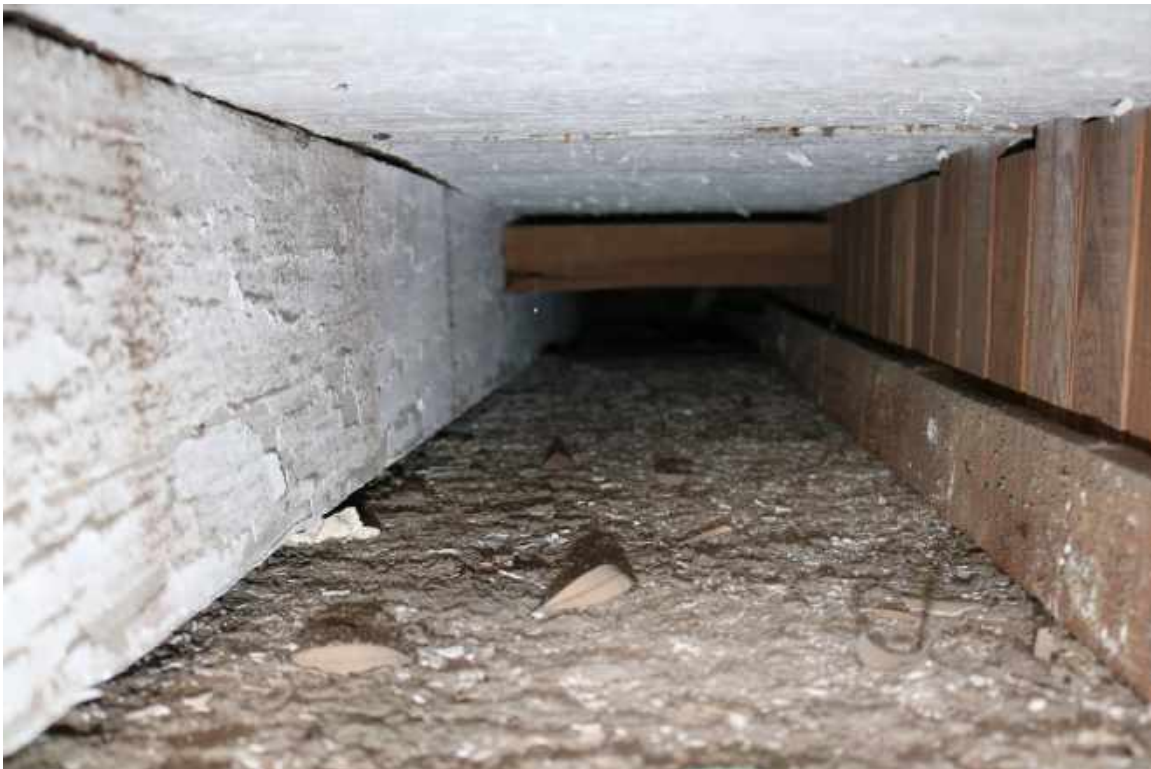
**Figure 126:** Second Floor, Room 204: Detail of the intersection between the first floor stair wall (at right) with the historic whitewashed framing material. The ceiling paneling of Room 103 is at bottom.

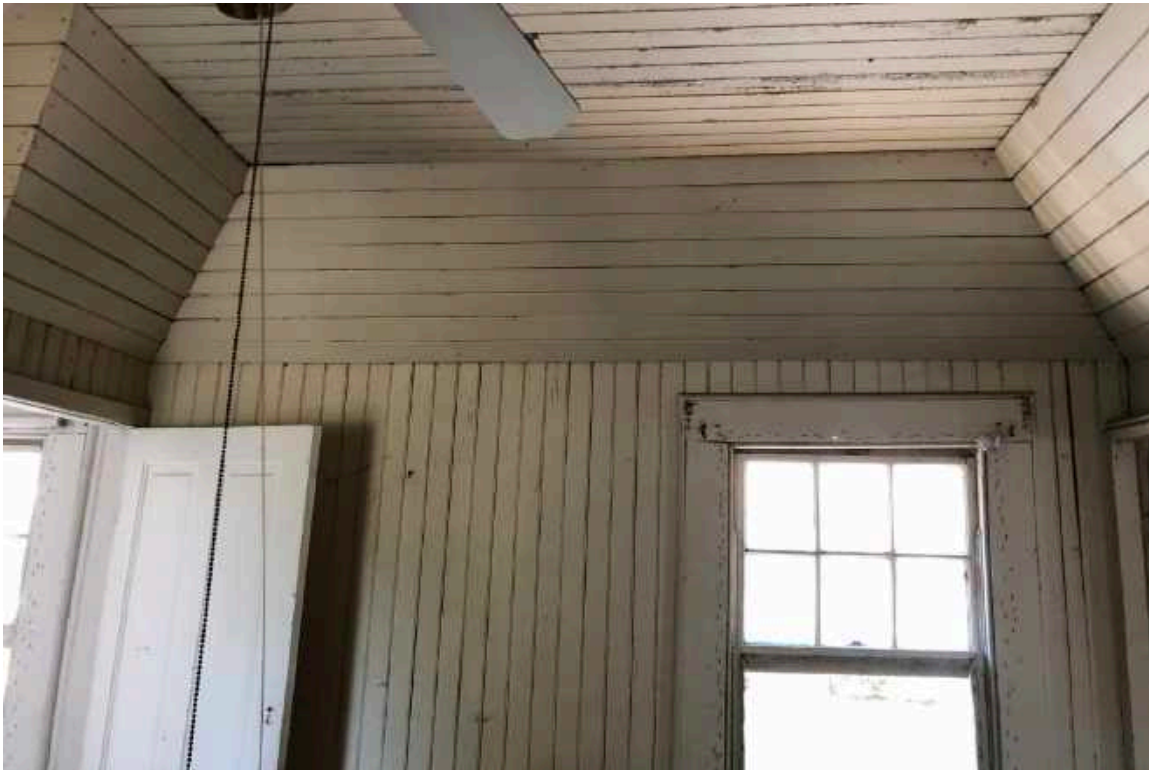
**Figure 127:** Second Floor, Room 204: The cant ceiling was removed along the north wall within this room.

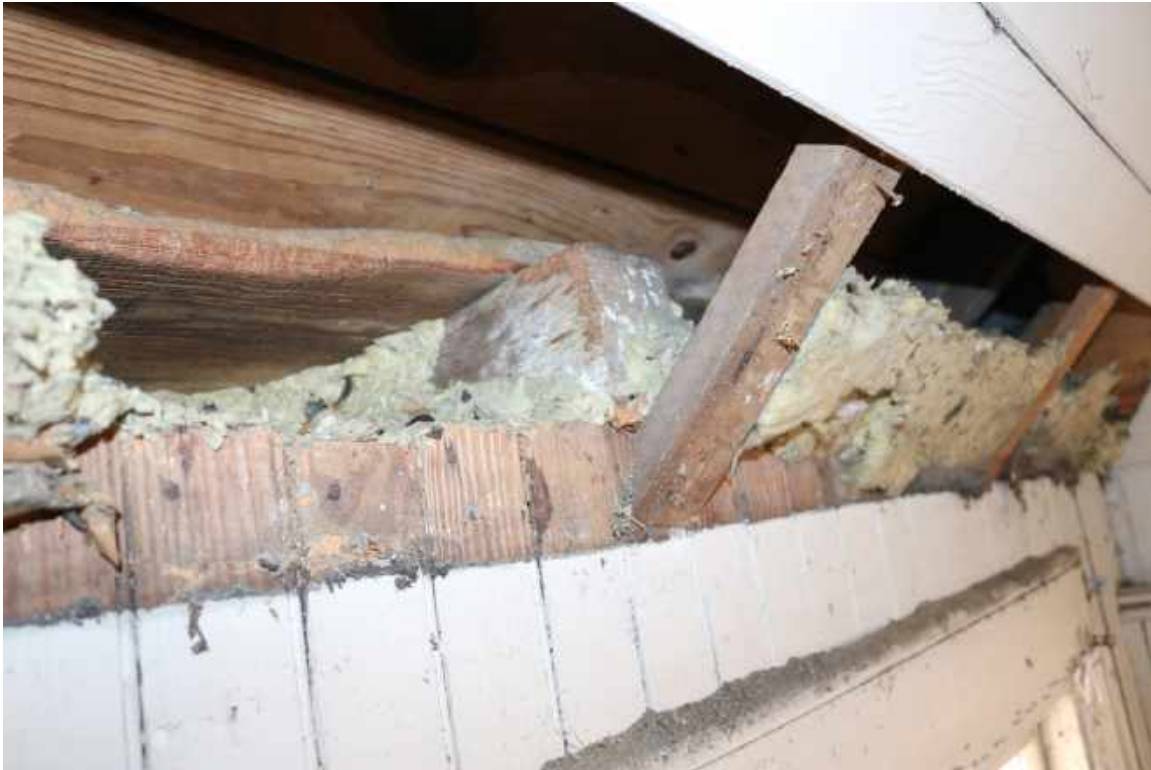
Upon selective disassembly of the wall, it was discovered that the vertical wall paneling was installed directly beneath the original ceiling joists. The paneling at this location was installed using cut nails, indicating a 19th-century construction date. The attic joists have been cut to accommodate the cant in the ceiling.

**Figure 128:** Second Floor, Room 204: Detail of the exposed framing members. The vertical wall paneling was installed up to the original whitewashed ceiling joists. The joists have been cut to accommodate the slope in the ceiling.

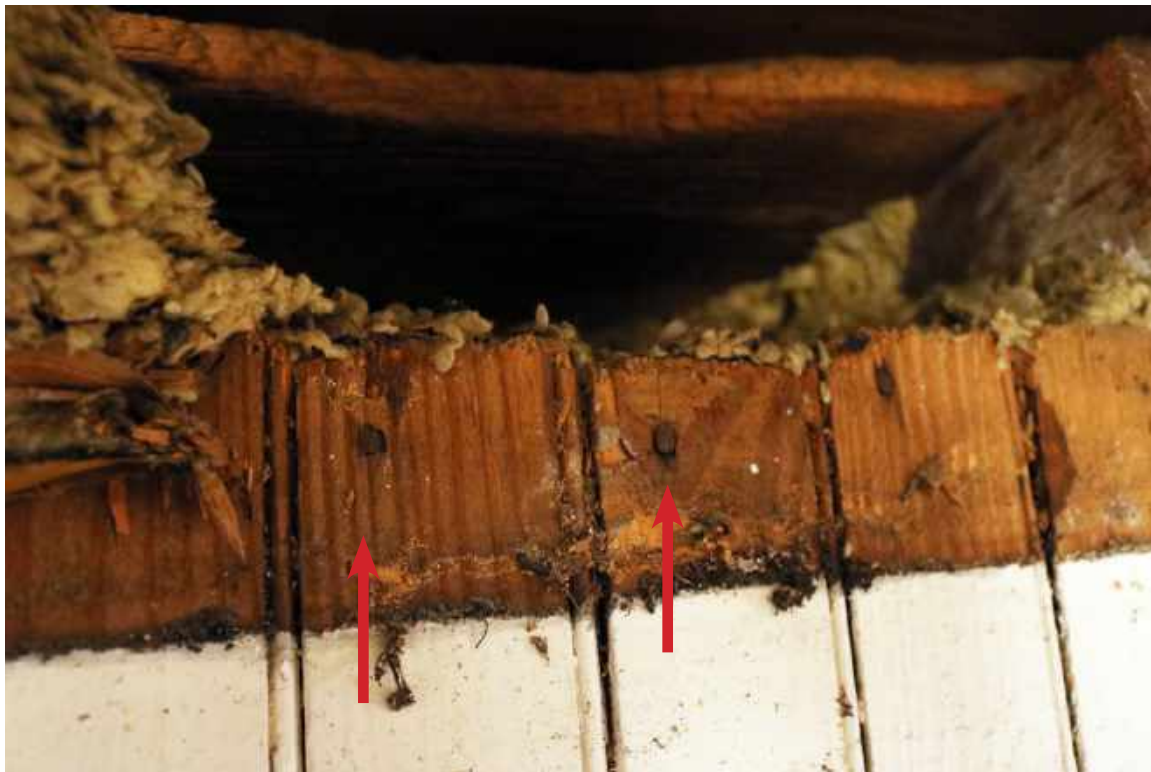
**Figure 129:** Second Floor, Room 204: Detail of cut nails in the vertical paneling (arrows).

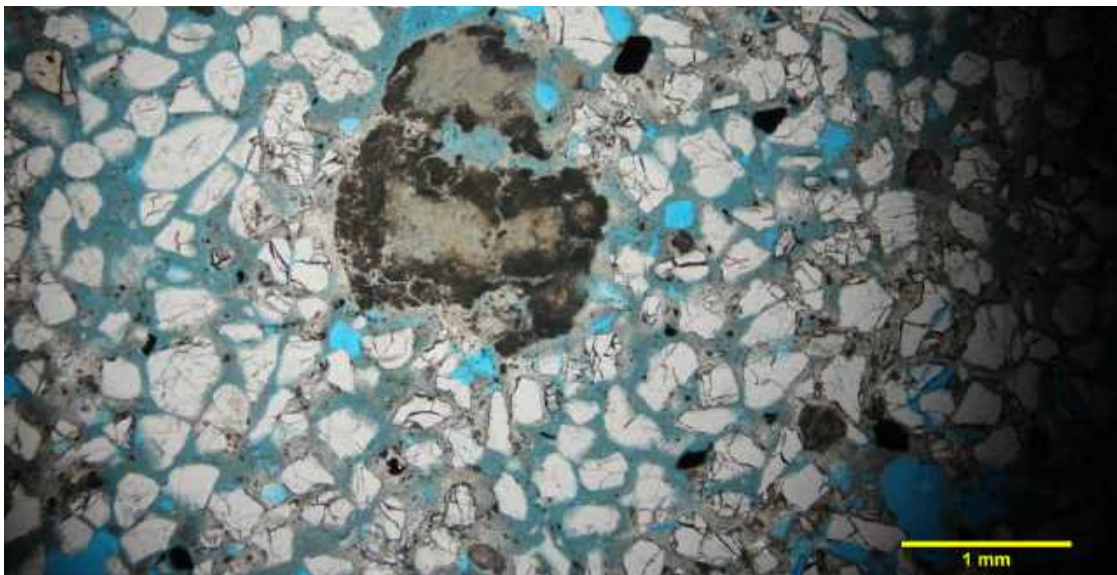
**Figure 143:** Detail of the microstructure of the mortar sample. The samples have been cast with a blue epoxy resin to easily visualize the relative permeability of each material.

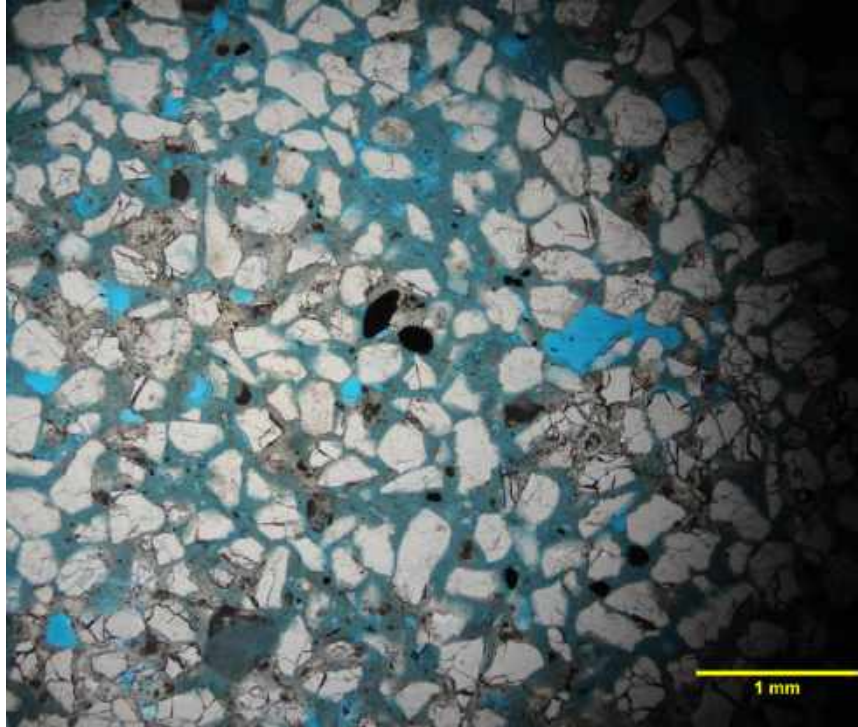
The sample contains a very high concentration of quartz aggregate and with minor concentrations of orthoclase feldspar. Where present, the quartz is subangular to subrounded silica quartz grains. Visually, the aggregate appears to be narrowly graded and the mix is oversanded. Mica particles are also present within the sample, possibly originating from the original lime source. Several particles of amphibole and clinpyroxene were also observed with the sample. Acid digestion was not performed during this analysis to isolate the individual aggregate.

**Figure 147:** Plane polarized light image of the bedding mortar sample. Small white angular quartz are frequent within the lime binder. Dark particles of charcoal are visible at the center of the slide (40x magnification).

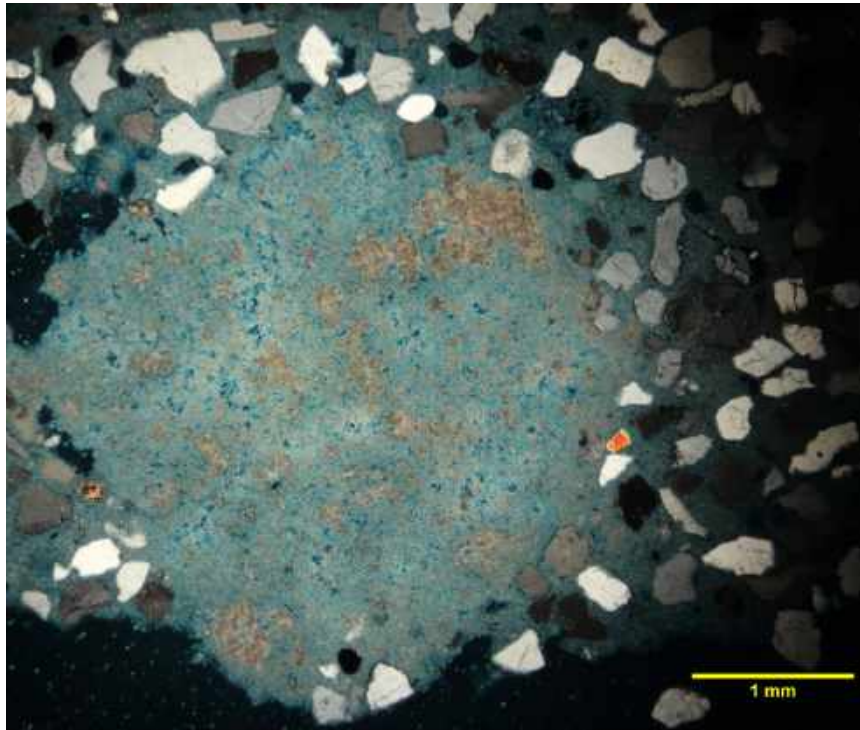
**Figure 148:** Cross polarized light image of the mortar sample. A very large lime grain is present at center (40x magnification).

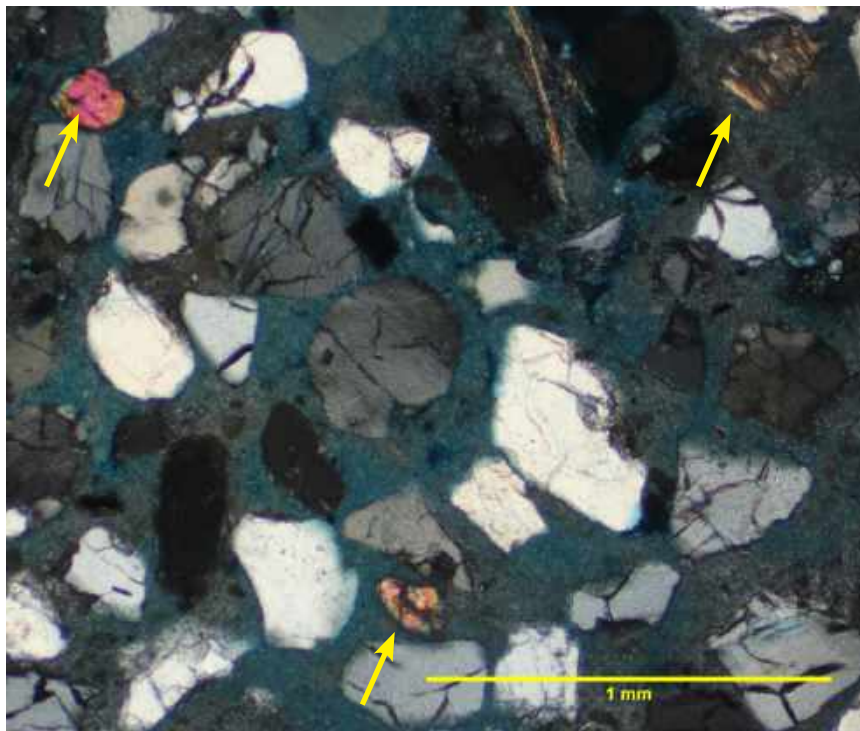
**Figure 149:** Cross polarized light image of the bedding mortar sample. Remnant grains of mica, amphibole, and clinopyroxene originating from the lime host rock are visible within the sample (arrows) (100x magnification).

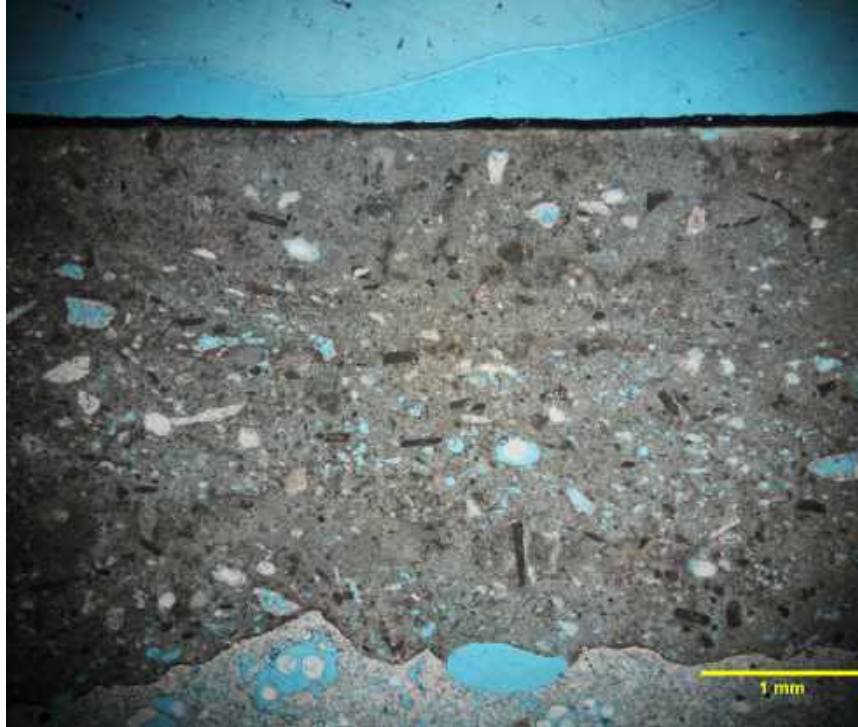
**Figure 153:** Plane polarized light image of the finish coats of the plaster sample. Quartz and other large aggregate is absent from the system. The finish coats contain a large percentage of lime as evidenced by the brown color of the binder matrix (40x magnification).

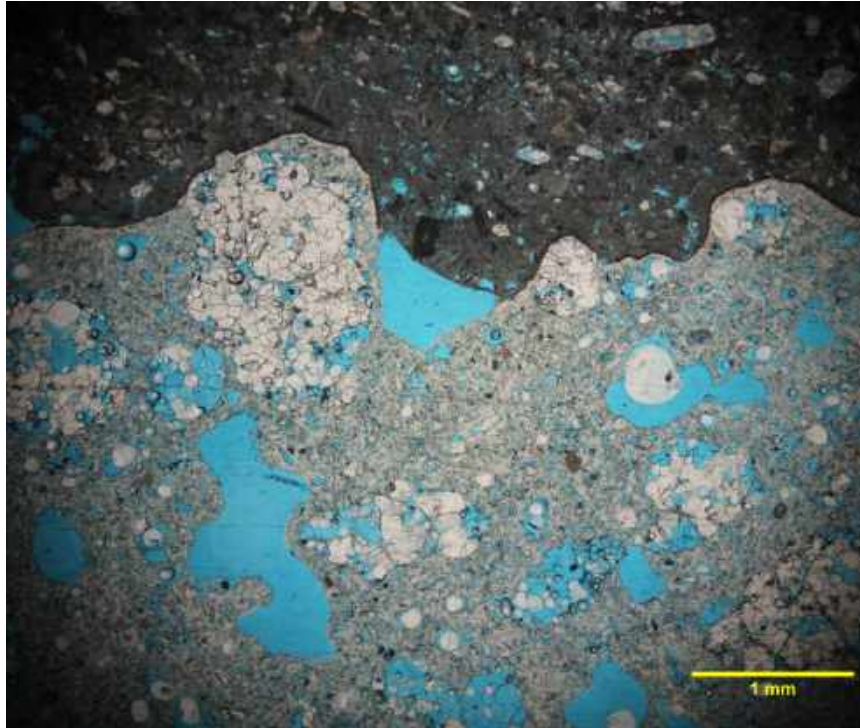
**Figure 154:** Plane polarized light image of the plaster sample. Isotropic fiber reinforcement is present throughout the scratch coat and visible as white circular areas containing many strands (40x magnification).

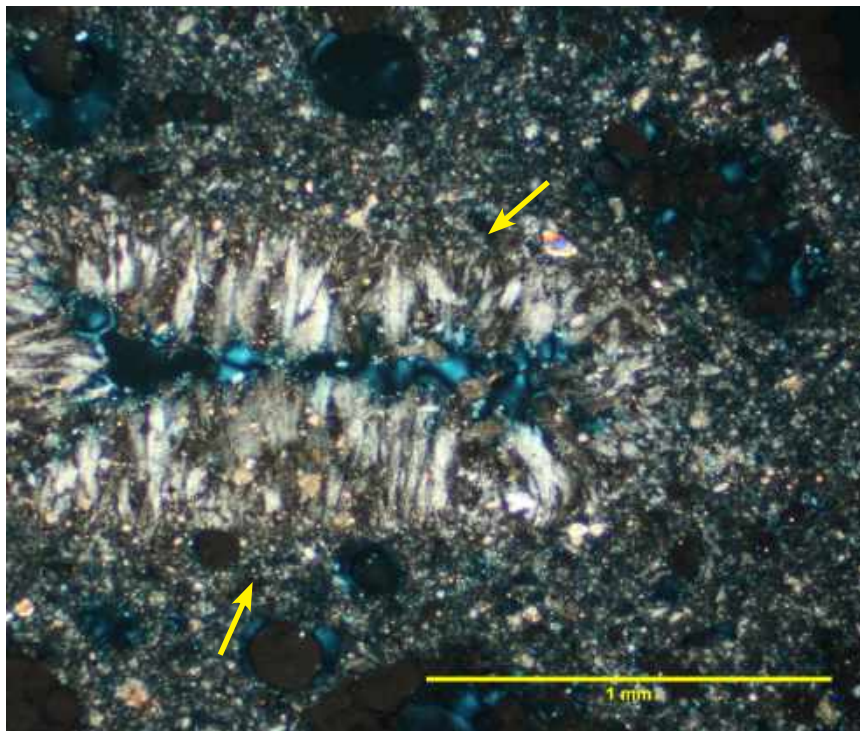
**Figure 155:** Cross polarized light image of the plaster sample. Detail of a large gypsum crystal within a pore space (arrows). Particles of anhydrite are present throughout the scratch coat (100x magnification).

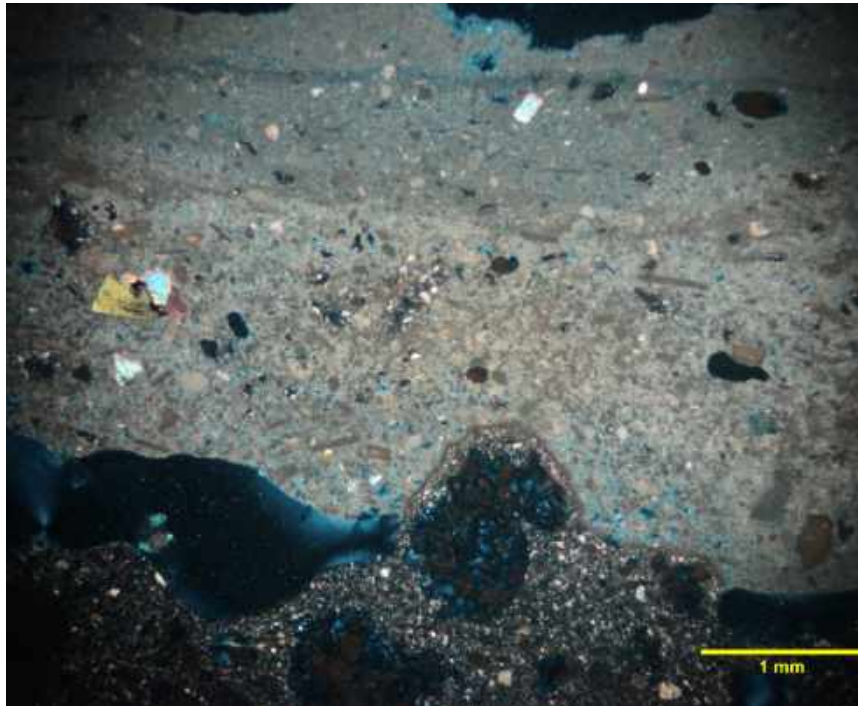
The components of the plaster are well mixed and cured. The plaster is in good condition and has only failed due to structural settlement of the building. Calcined wall plaster is rare before 1890, indicating this material dates to the 20th century.

**Figure 156:** Cross polarized light image of the plaster sample. Detail of the boundary between the base and finish coats. Note the isotropic fibers within the scratch coat. (40x magnification).

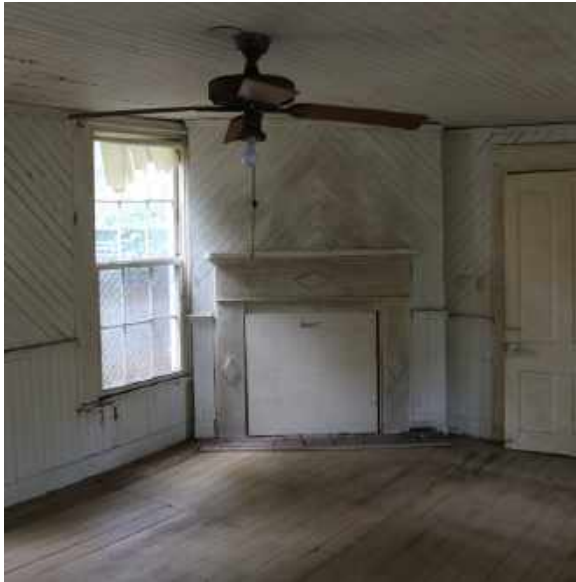
**Figure 158:** Photograph of Room 103. The fireplace mantel in the northeast corner of Room 103 was sampled to determine whether the diamond at the center of the apron was installed originally with the mantel or applied at a later date.

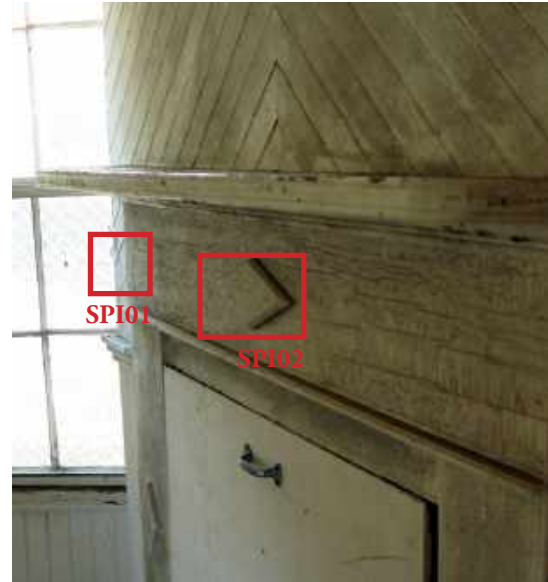
**Figure 159:** Detailed photograph of mantel in Room 103. Two paint samples were extracted from the mantel. 1) SPI01 - mantel apron, 2) SPI02 - diamond applique on mantel apron.

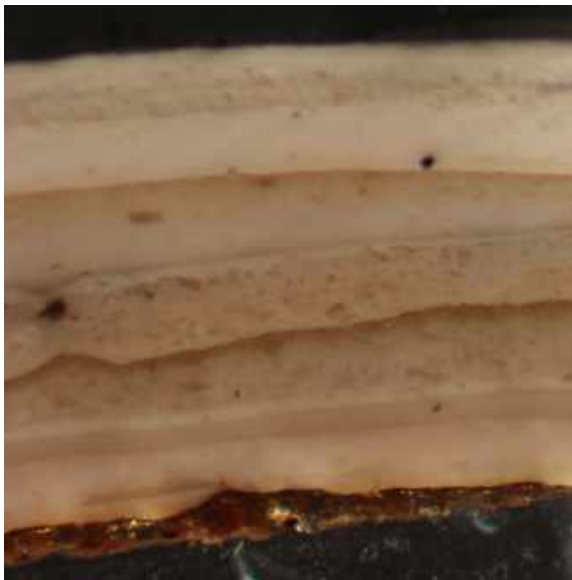
**Figure 160:** Visible Light 200x- SPI01. Based on the paint cross-sections examined, the diamond on the apron was installed at the same time as the mantel. The initial pigmented transparent finish is seen in both sample SPI01 and SPI02.

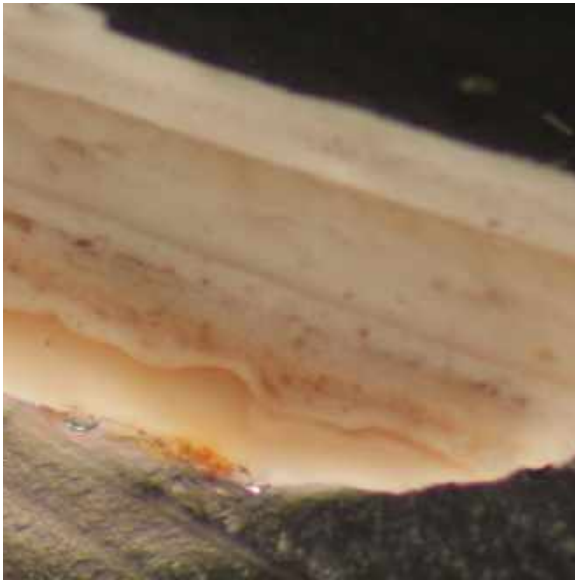
**Figure 162:** Visible Light 100x- SPI02. The mantel and diamond applique were both painted white for the duration of its history, with the exception of the original transparent finish.

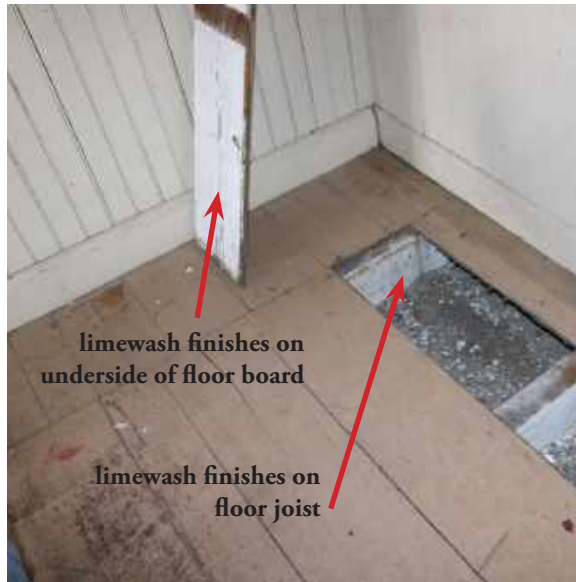
**Figure 166:** Photograph of Room 204. Limewash was found on the underside of the 2nd floor, floor boards and on the floor joists below. The presence of a coated surface indicates that the 1st floor ceiling, in this section of the building, was exposed during the early part of its history.

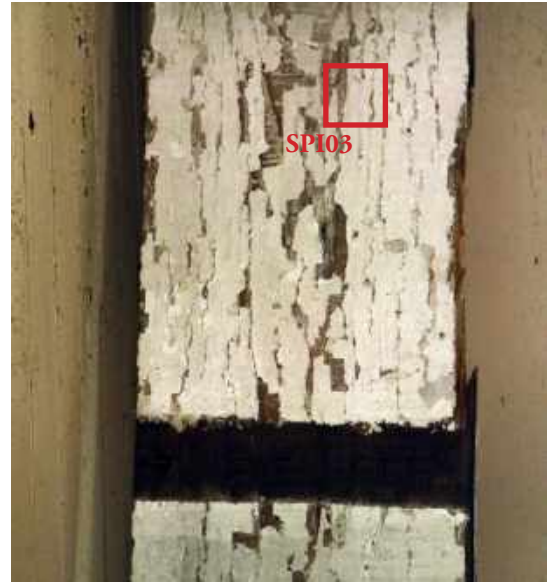
**Figure 167:** Detailed photograph of limewash finishes found on the underside of the floor board in Room 204. Note location of paint sample SPI03. The extracted paint sample was brittle and easily broken when handled.

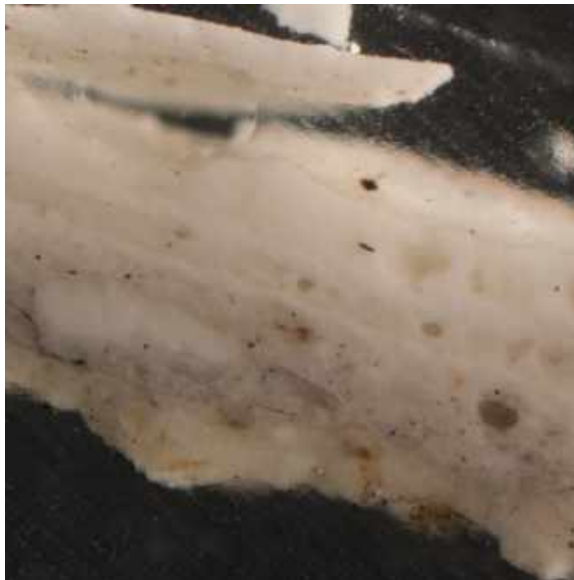
**Figure 168:** Visible Light 100x- SPI03. The coatings seen in the cross-section are unpigmented limewashes. All layers have the characteristic translucent appearance of limewash coatings.

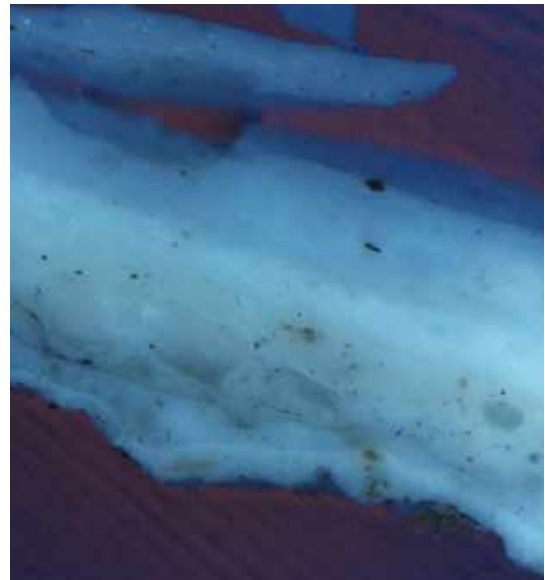
**Figure 169:** Ultraviolet Light 100x- SPI03. Note bluish autofluorescence which is characteristic of limewash coatings.

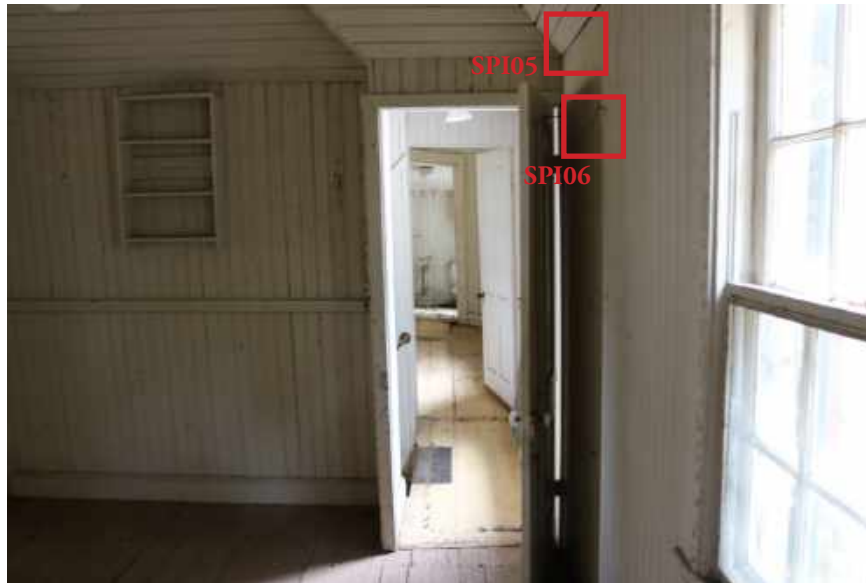
**Figure 170:** Photograph of Room 204. The wall board and ceiling cant boards were both sampled to confirm whether the cant at the upper section of the wall was installed after the wallboard. Examination of fasteners in the room appear to support this hypothesis.

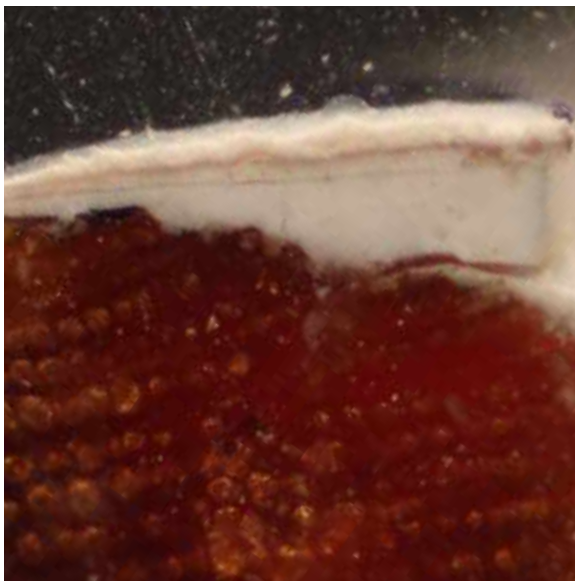
**Figure 171:** Visible Light 100x- SPI05. Three paint layers are visible in cross section. Both the cant and the wall boards have the same number of paint layers. Fasteners and paint analysis conducted in Room 202 indicate that the cant was installed after the wall board. The wood walls in this room appear to have remained unpainted initially.

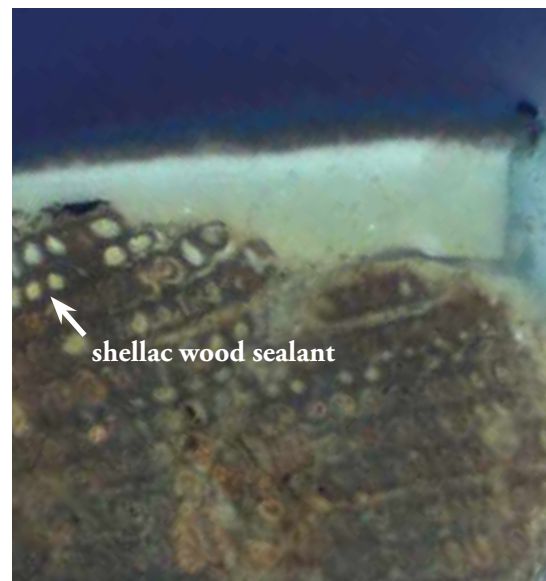
**Figure 172:** Ultraviolet Light 100x- SPI05. The substrate of the sample appears to have shellac embedded in the wood pore structure. Shellac was a commonly used sealer applied to new wood prior to the application of paint.

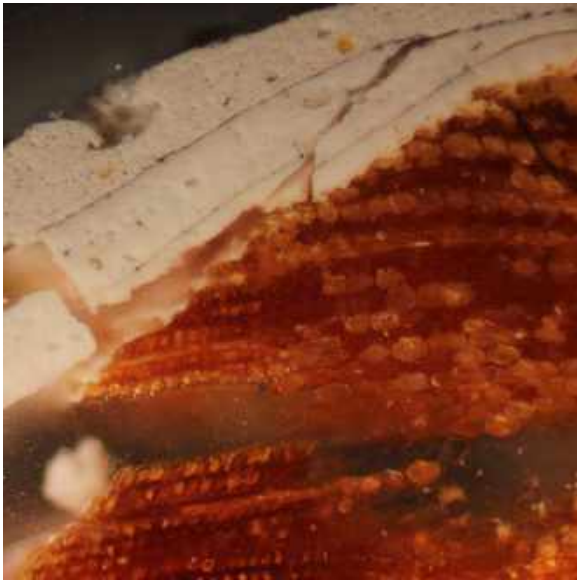
**Figure 173:** Visible Light 100x-SPI06. Three paint layers are visible in cross section.

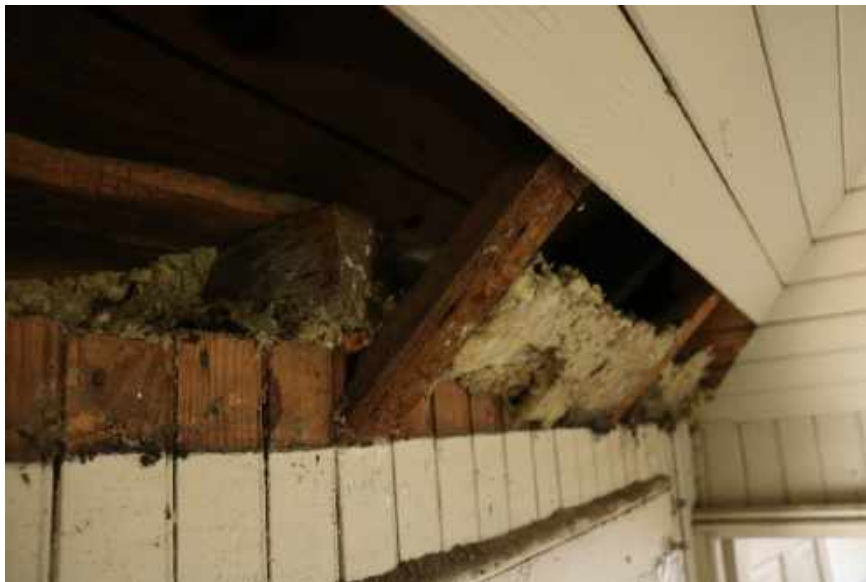
**Figure 175:** Photograph of Room 204. Detail view of transition between wall board and cant at the uppers section of the wall. The ceiling joists in this area were modified to elevate the ceiling height. A cant, at the top of the wall, appears to have been installed at this time
