## SQUIRE POPE CARRIAGE HOUSE PRESERVATION PLAN

PREPARED FOR:  
THE TOWN OF BLUFFTON  
20 BRIDGE STREET  
BLUFFTON, SC 29910

PREPARED BY:  
MEADORS, INC.  
PO BOX 21758  
CHARLESTON, S.C. 29413

DATE: 09.30.2019

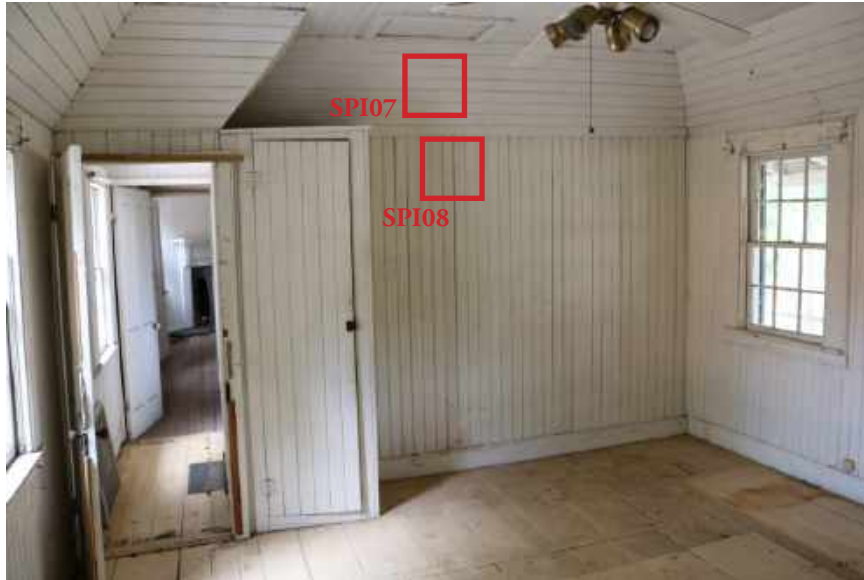
**Figure 176:** Photograph of Room 202. The wall board and ceiling cant boards were both sampled to confirm whether the cant at the upper section of the wall was installed after the wallboard. Examination of fasteners in the room appear to support this hypothesis.

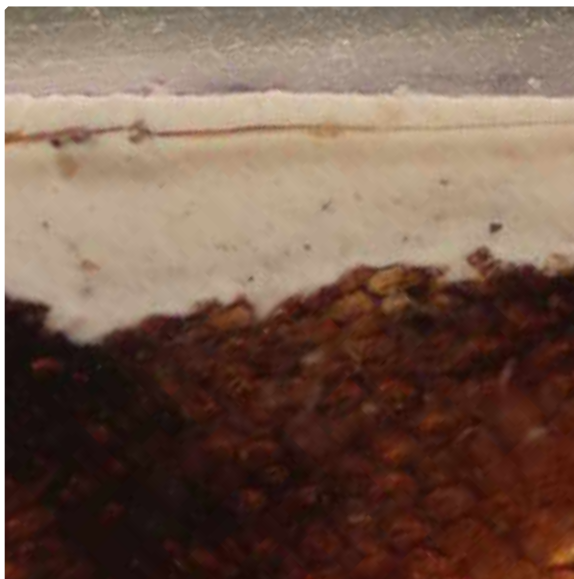
**Figure 177:** Visible Light 100x- SPI07. Two paint layers are visible in cross section. This sample substantiates the hypothesis that the wall boards were installed prior to the cant boards.

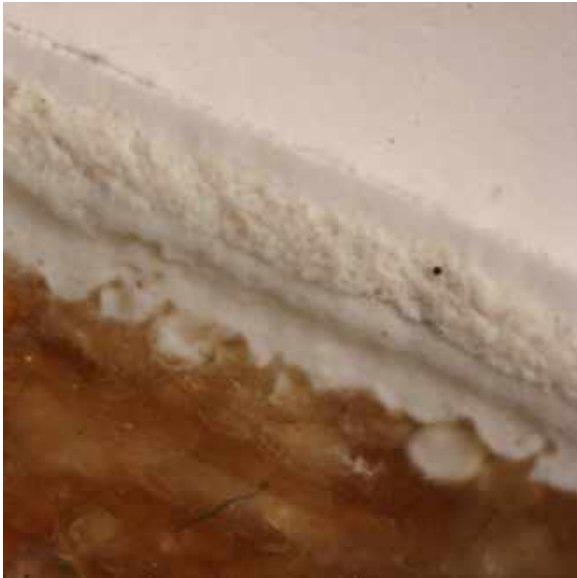
**Figure 179:** Visible Light 100x- SPI08. Four paint layers are visible in cross section. This sample substantiates the hypothesis that the wall boards were installed prior to the cant boards.

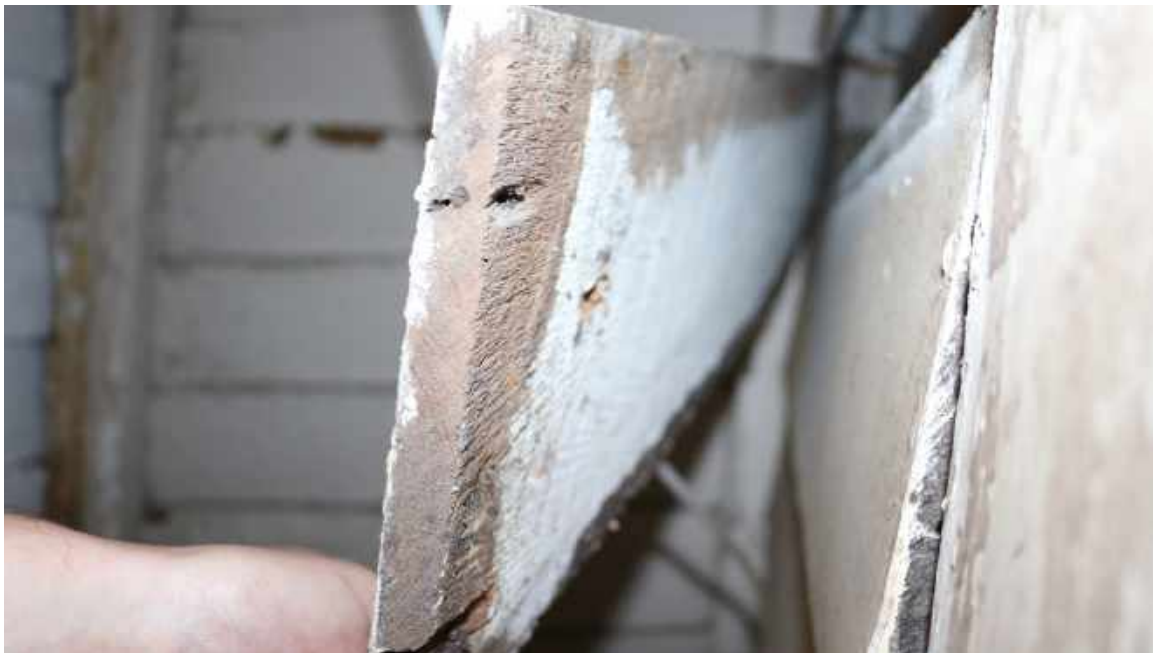
**Figure 181:** Hyphen, East Elevation of Two Story Building: Detail of whitewash on the backside of dislodged siding indicating the east enlargement of the two-story building was also whitewashed.

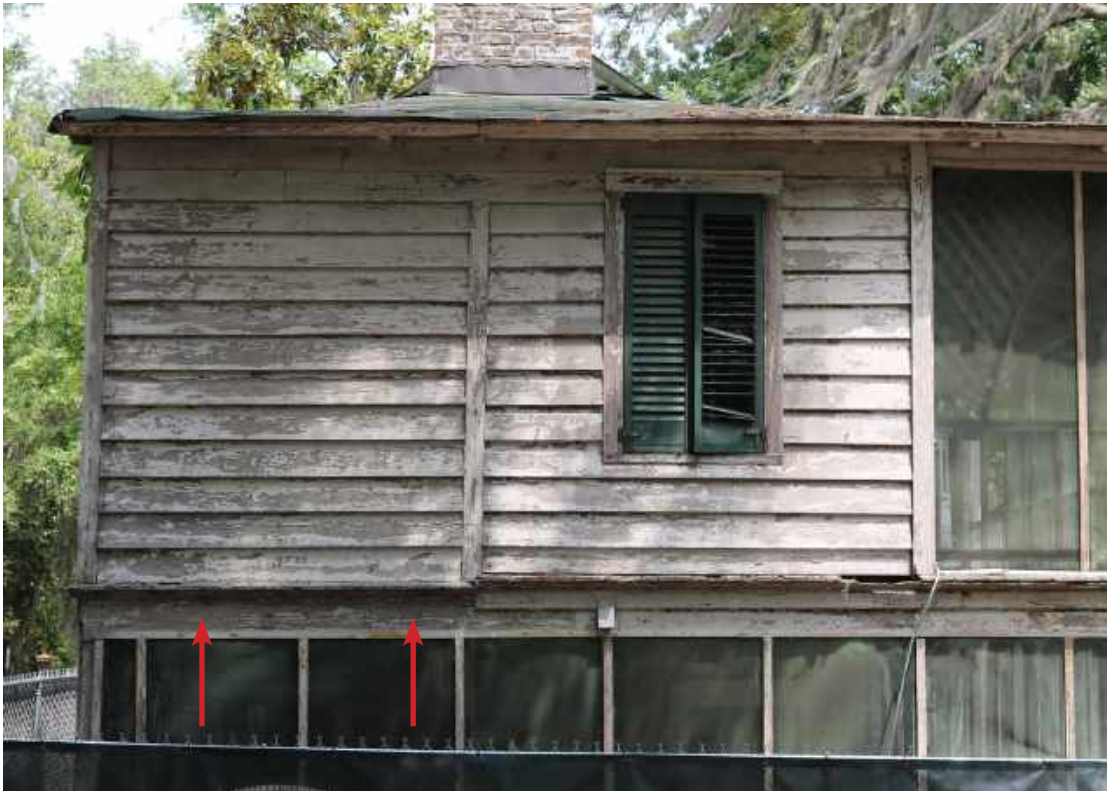
**Figure 182:** Detail of wood shake roof below the second floor bathroom infill (arrows). The corner siding boards also remain in place. The enlargement at right is later.

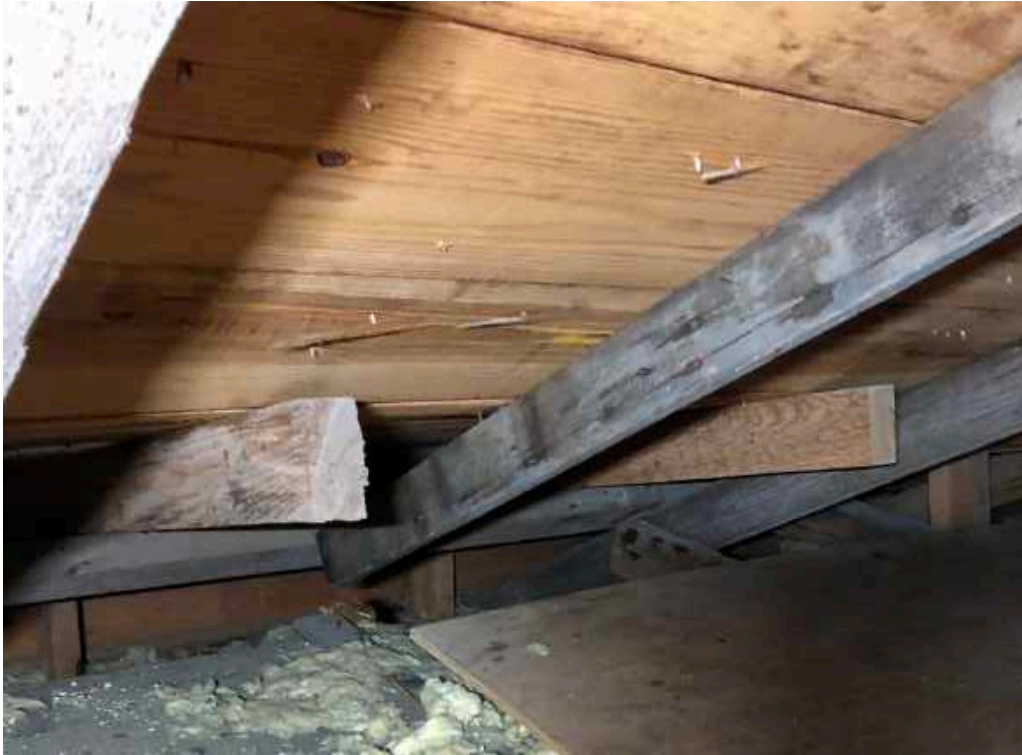
**Figure 183:** Attic: Detail of newer porch roof framing intersecting the historic rafters.

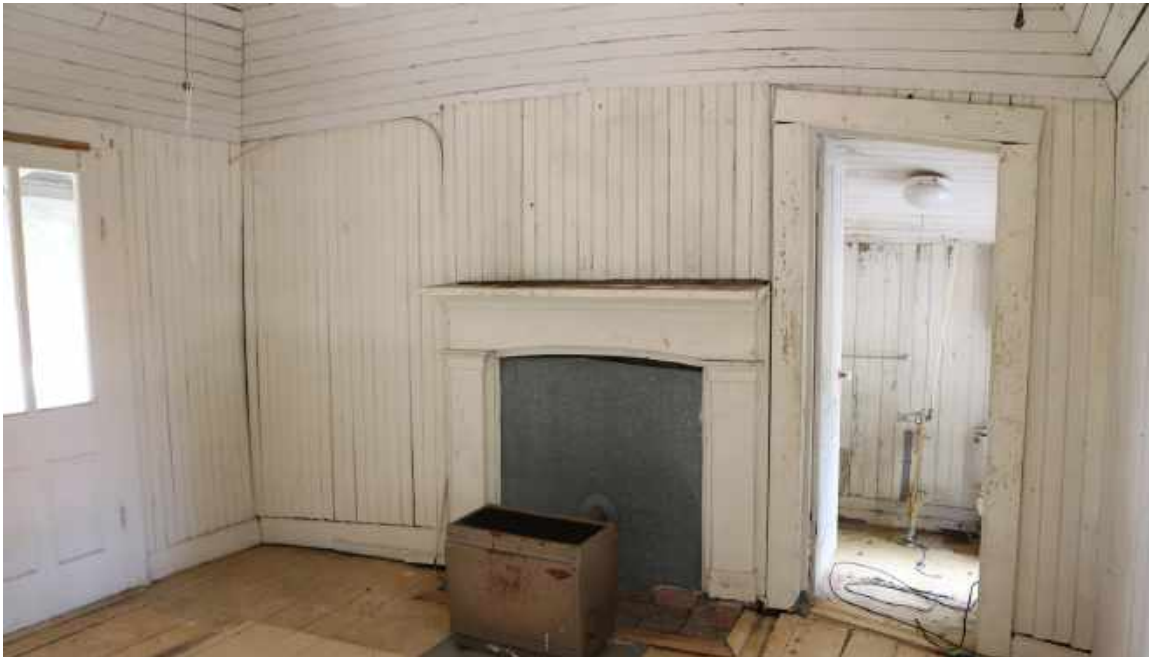
**Figure 194:** Room 202: Change over time is readily evident throughout the structure.
