# HUTCHINSON HOUSE

## Existing Conditions and Recommendations

AUGUST 23, 2019  
FINAL REPORT

Simons Young + associates  
4SE Structural Engineers  
Hillary King, Preservation Consultant

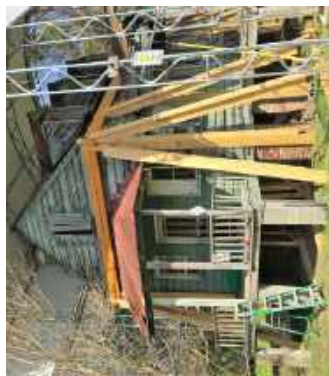
16 West porch with south porch to right

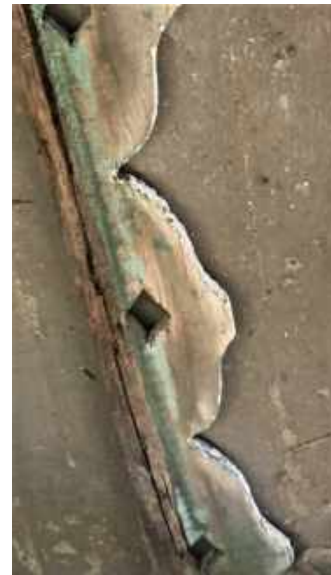
21 Detail of new trim photo taken with trim on roof

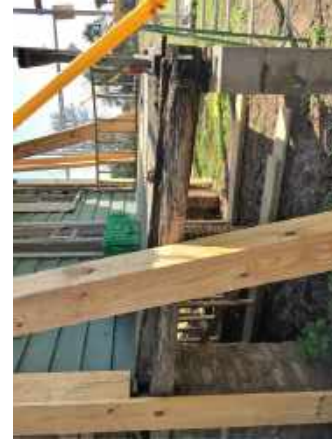
26 North wall of piers continues along west porch

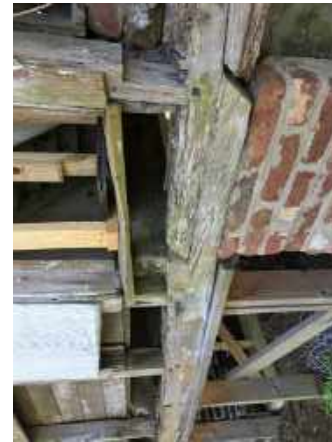
28 North wall of piers at splice with door openings above

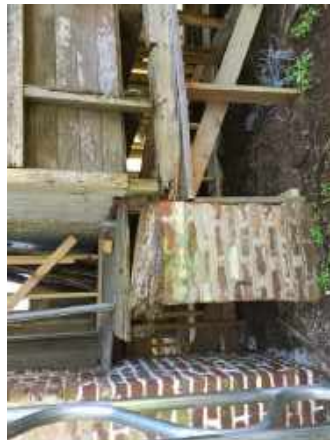
26 North wall of piers with red chimney to left and door opening above

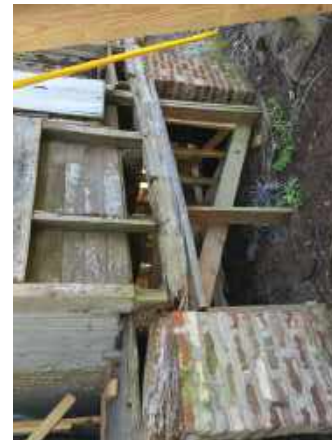
27 North wall of piers with door openings above brick piers

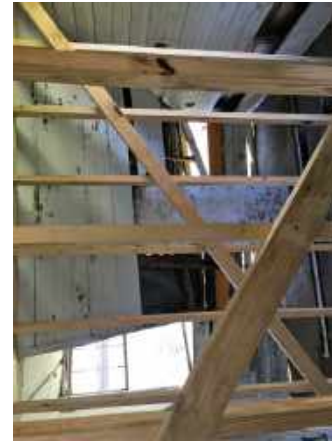
41 Second floor - west room looking north

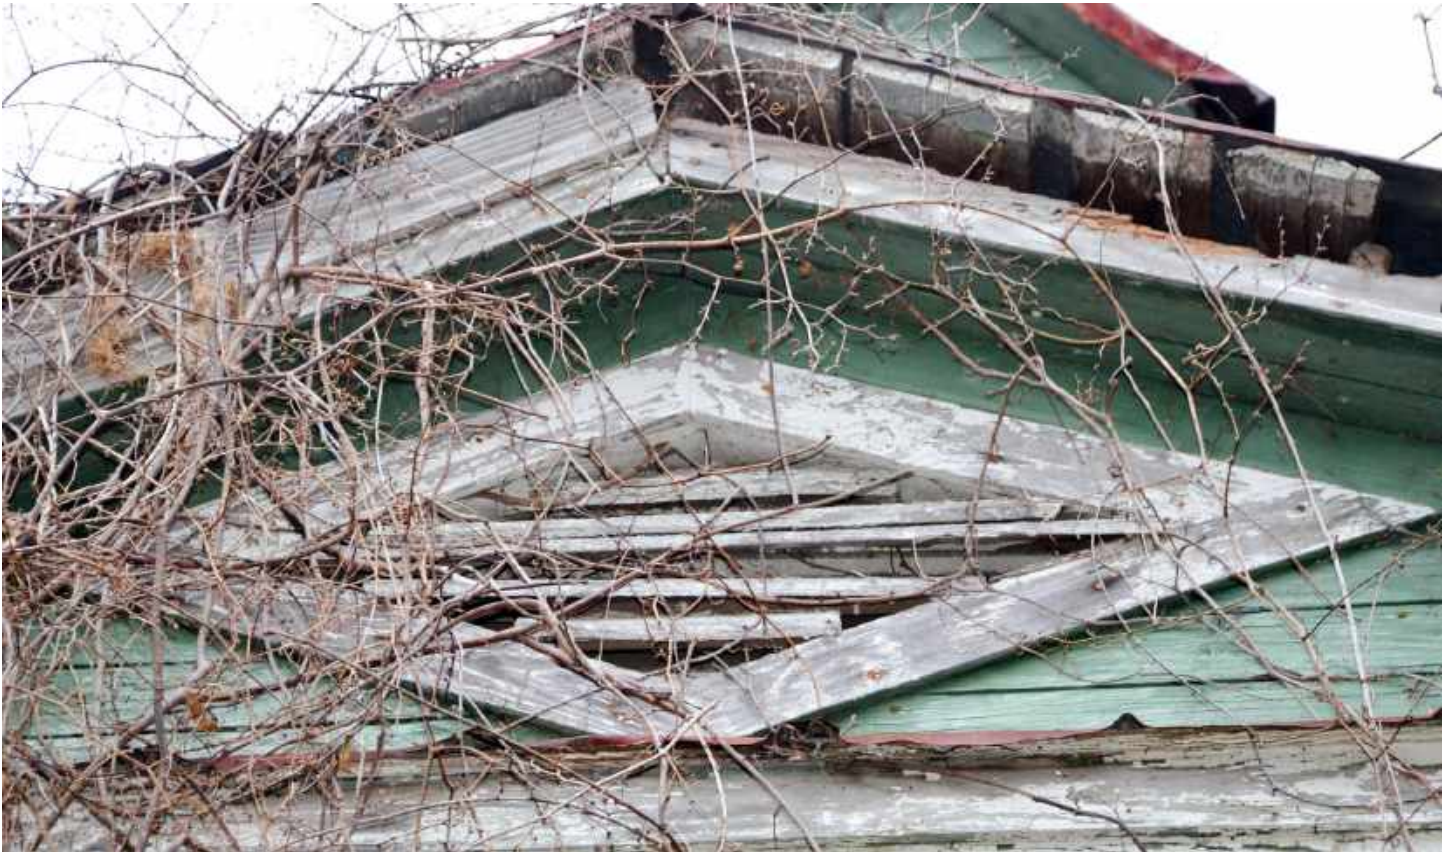
VENT AT FRONT PORCH

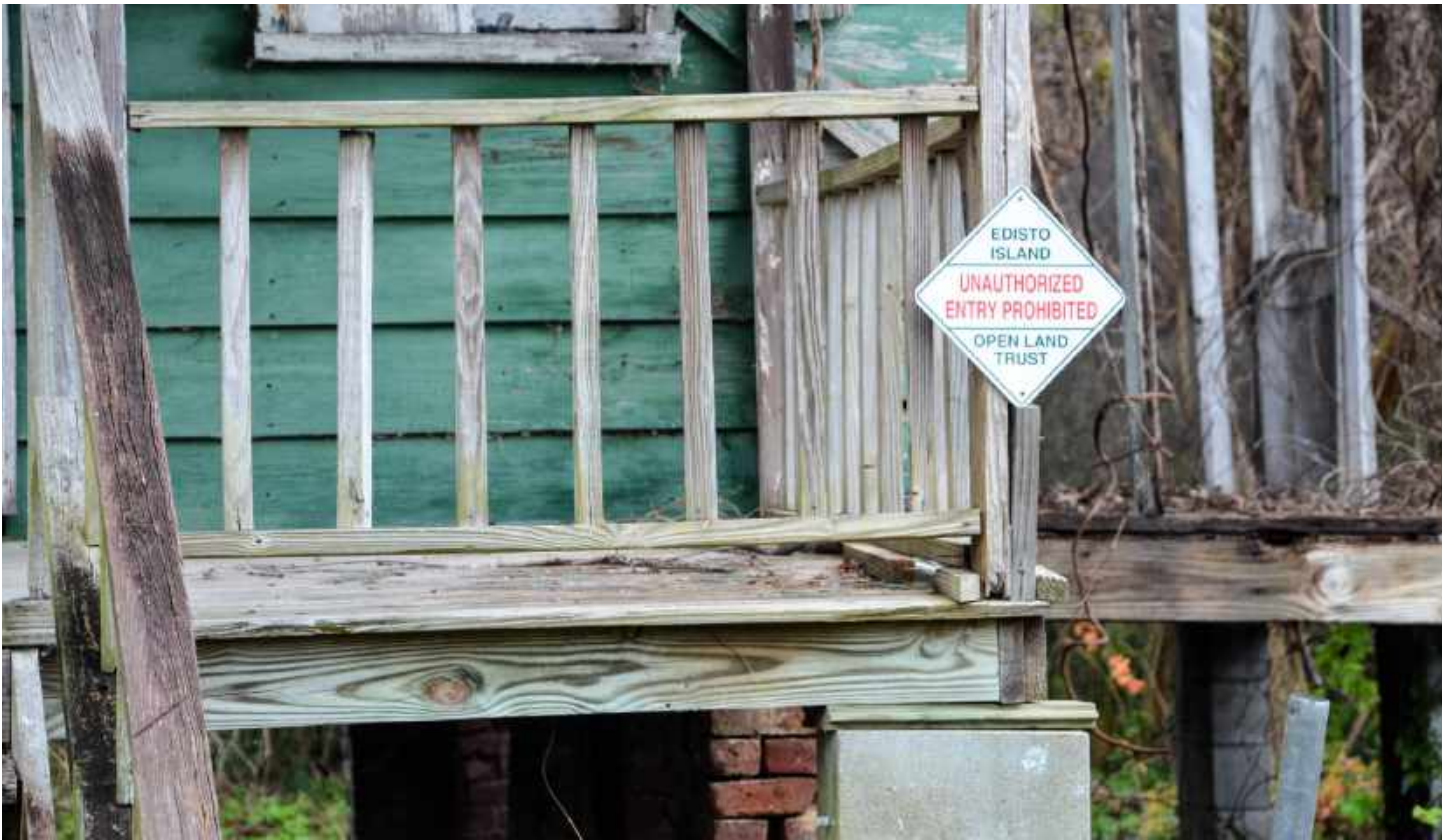
WEST PORCH RAIL, PIER, FRAMING

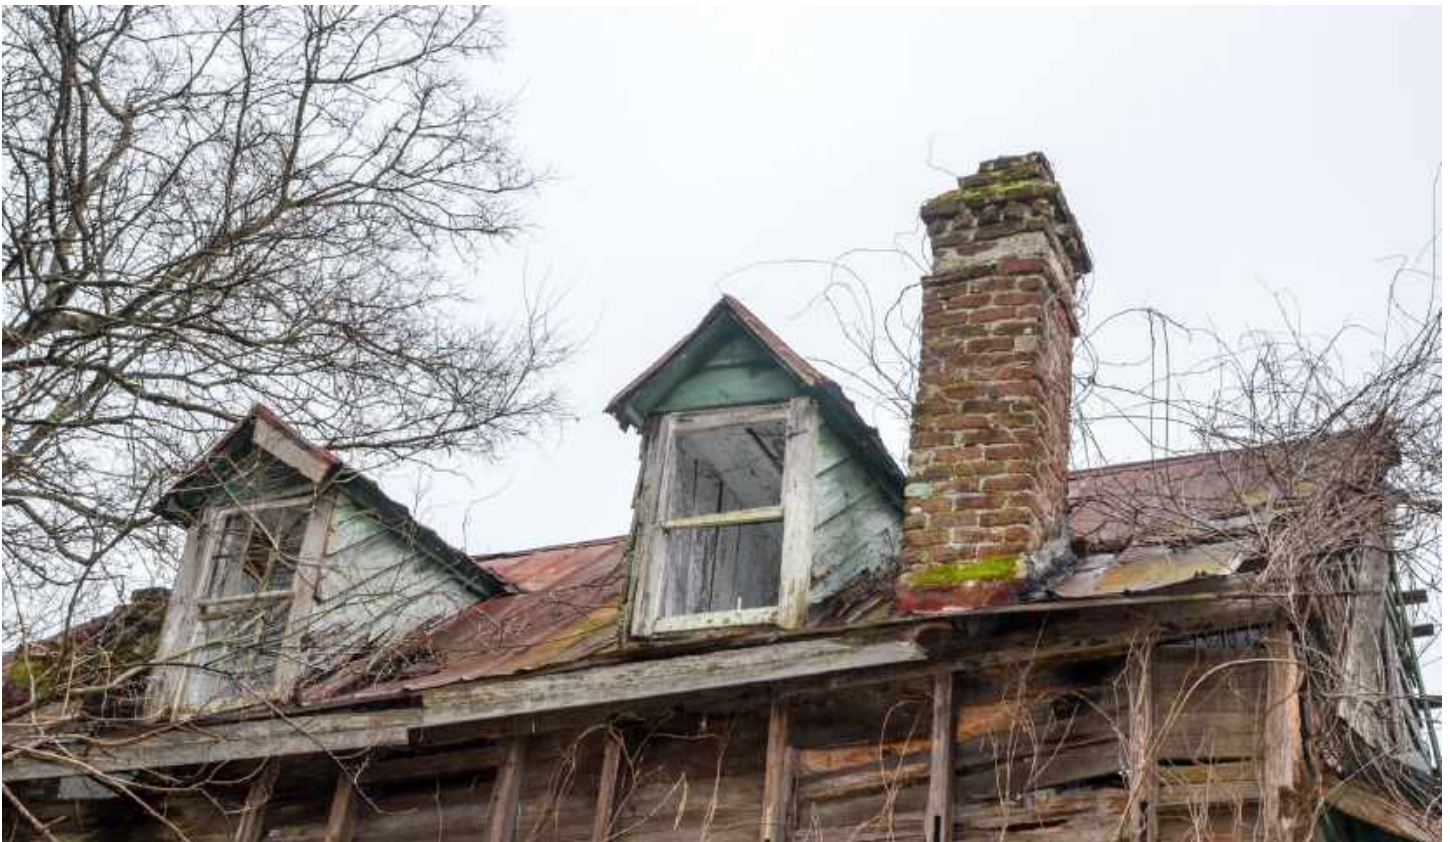
NORTH DORMERS AND CHIMNEY

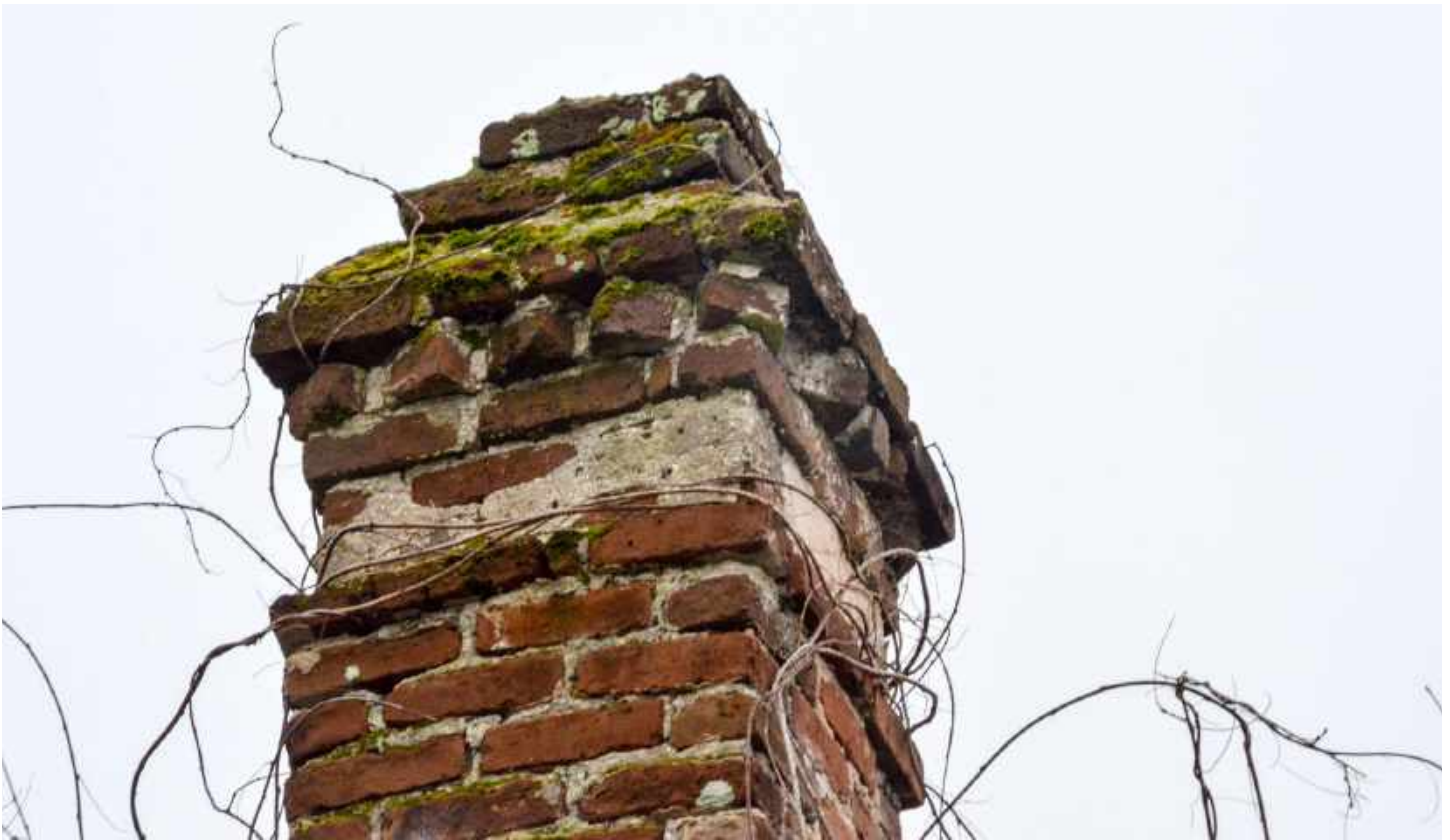
WESTERN VIEW OF CHIMNEY
