# HICKORY HILL ENGINEERING REPORT

December 19, 2018

# Hickory Hill Residence

## Structural Analysis Report

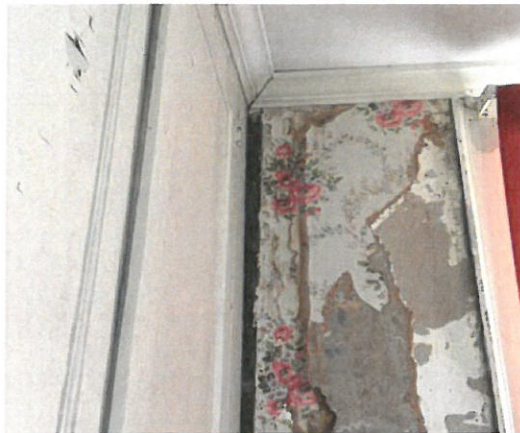
Cracking in the front right corner of the Right Wing and above and below windows of Rooms 101 and 201 has been repointed and appears to be stable. The joints from roof to ground show a slight horizontal movement in the front, and the end pointing was likely to be incidental cracking. Minor settlement in the end wall may be the cause, however corresponding cracking above and below the windows on the rear elevation are probably related to whatever movement has occurred in this portion of the building. Other possible explanations might be related to the reported earthquake in the late 1800s, or even from the added construction stress of the wood frame Kitchen addition. There are no through cracks showing on either floor, but there are cracks above the front window and the attic stair door that indicate some movement over the years. There is a peculiar separation between the right end wall built in cabinets and the plaster on both floors, with a gap in the plaster that tapers from nothing at the first floor to about 1 ½" at the ceiling, and continues on the second floor in a similar manor. This is also very similar to Room 205 at the opposite end of the house. The cornice molding at the first floor ceiling has not separated, but the cornice molding at the ceiling on the second floor cabinet has moved the same amount as the wall gap.

Dining 101 – Enlarged Cabinetry  
Separation from Plaster

Any exterior cracks which have telegraphed to the interior should also be repointed, which will require removal of damaged plaster and plaster repair to match the original. The Department of Interior Preservation Brief #21 – Repairing Historic Flat Plaster Walls and Ceilings is an excellent guide for historic plaster repairs. It is recommended that the plaster repairs be held off until exterior repointing is complete, and moisture readings in the brick walls indicate that new plaster will properly cure and bond. Hairline cracks can be repaired with joint tape and plaster skim coating.

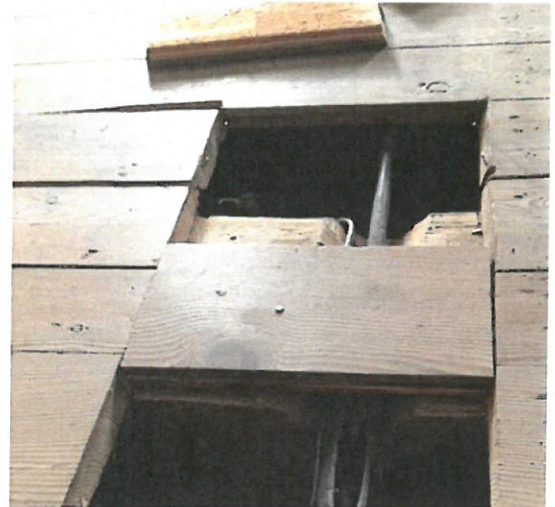
Bedroom 204 – Floor Access to Cable
