Final Report  
F-C3726

PRESERVATION OF HISTORICAL MASONRY STRUCTURES

March 14, 1974

National Park Service  
Philadelphia, Pennsylvania

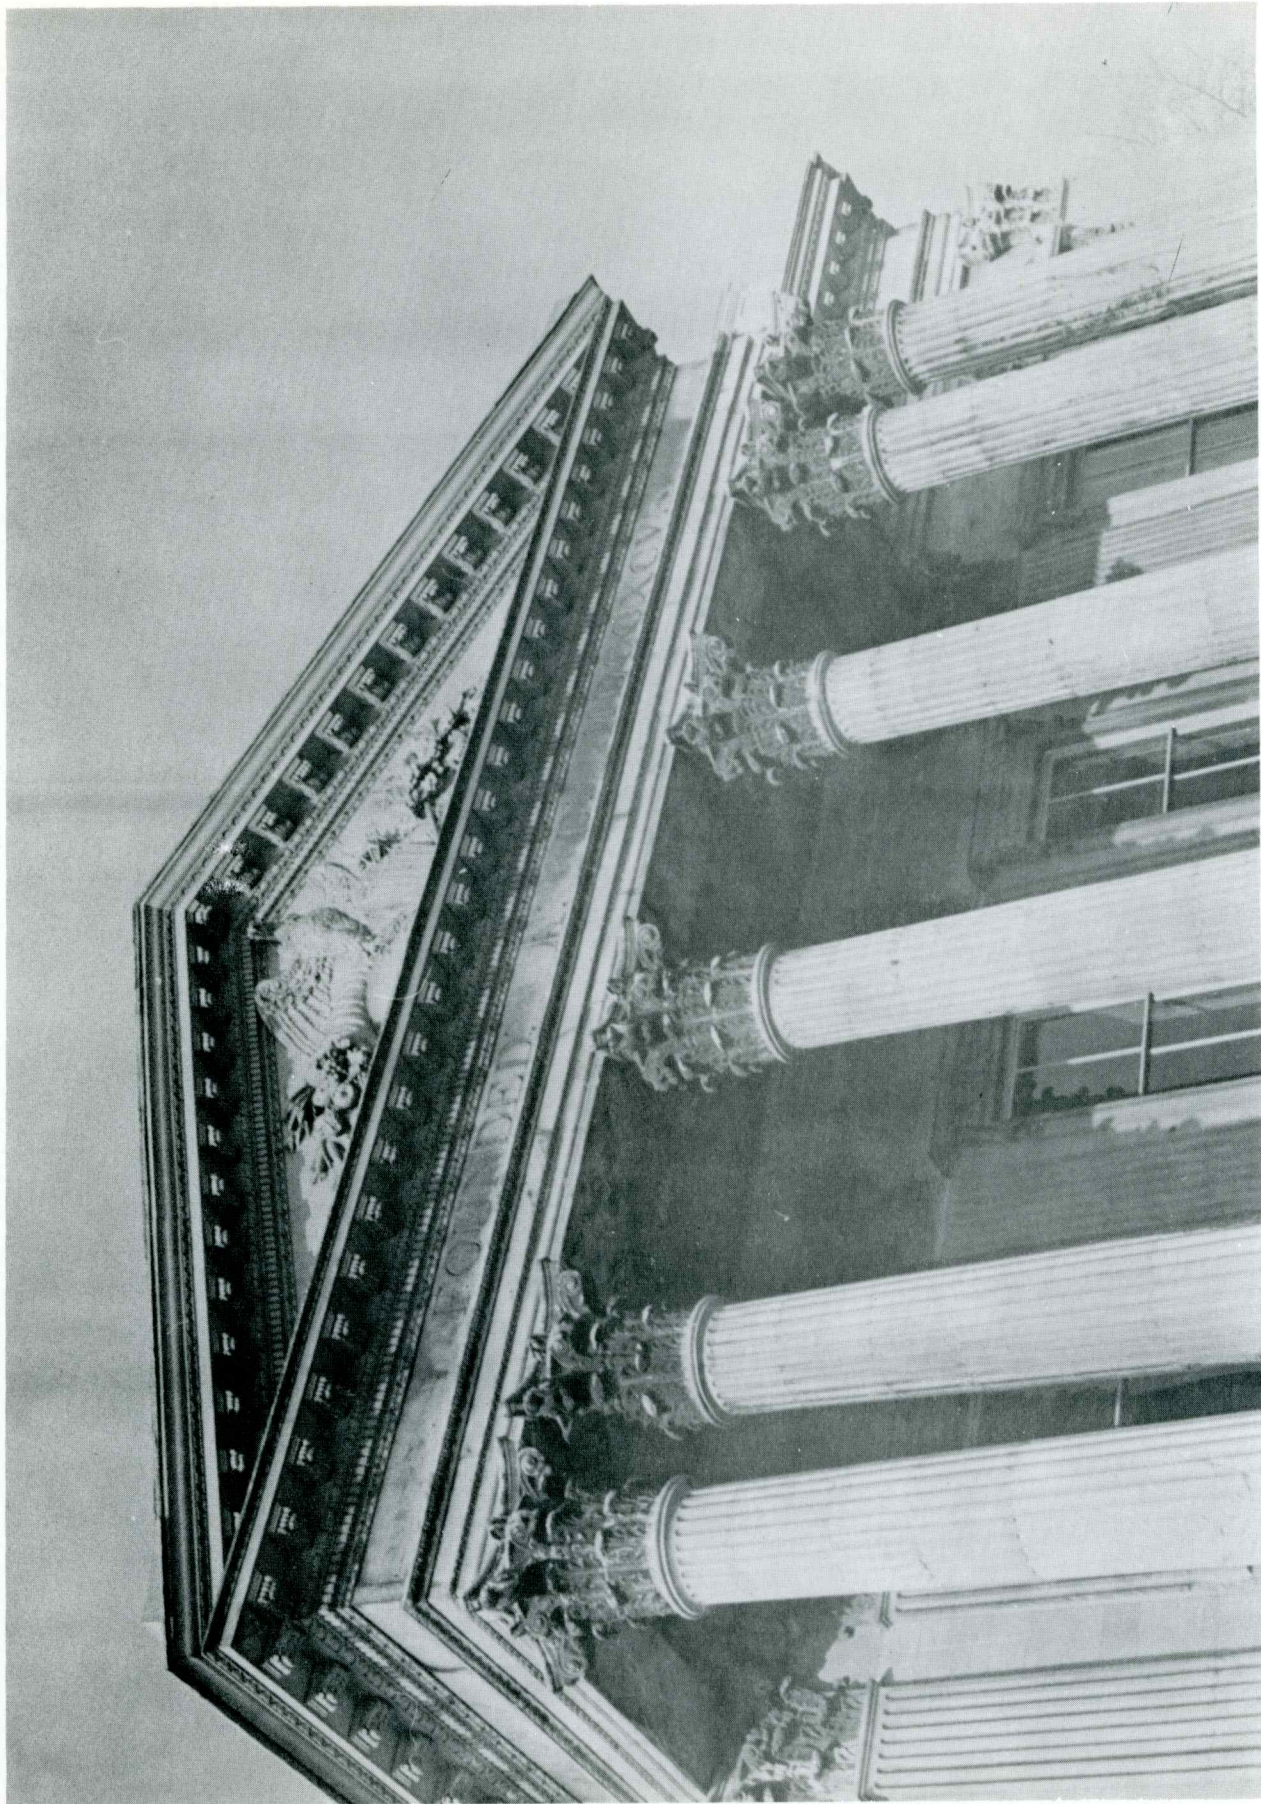
Figure 14. Portico of The First Bank of The United States.

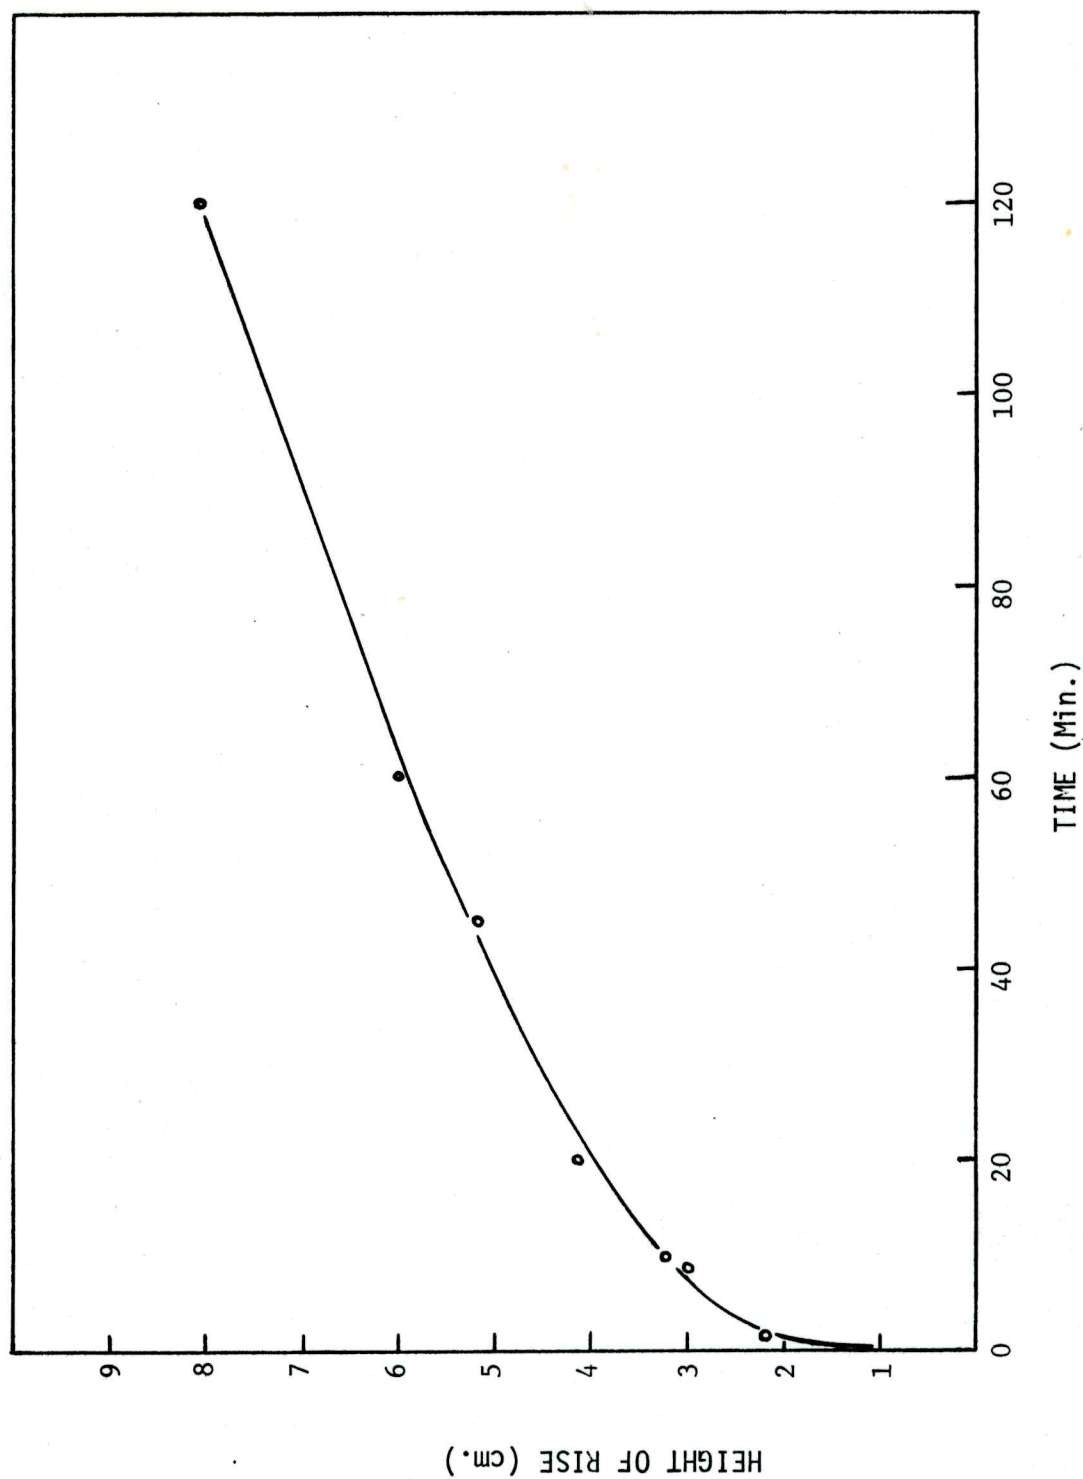
The rate of capillary water rise through a section of old hand made brick supplied by the National Park personnel was measured to determine how long it requires to completely wet a brick from it's front face. Initial absorption is very rapid, but two hours are needed for complete penetration. This is shown graphically in Figure 15.

FIGURE 15: The Rate of Capillary Rise of Water Through an Old Hand Made Brick from Independence National Historical Park.
