# Wadeable Stream Habitat Monitoring at Ocmulgee Mounds National Historical Park

## *2019 Change Report*

Natural Resource Report NPS/SECN/NRR—2020/2200

December 2020

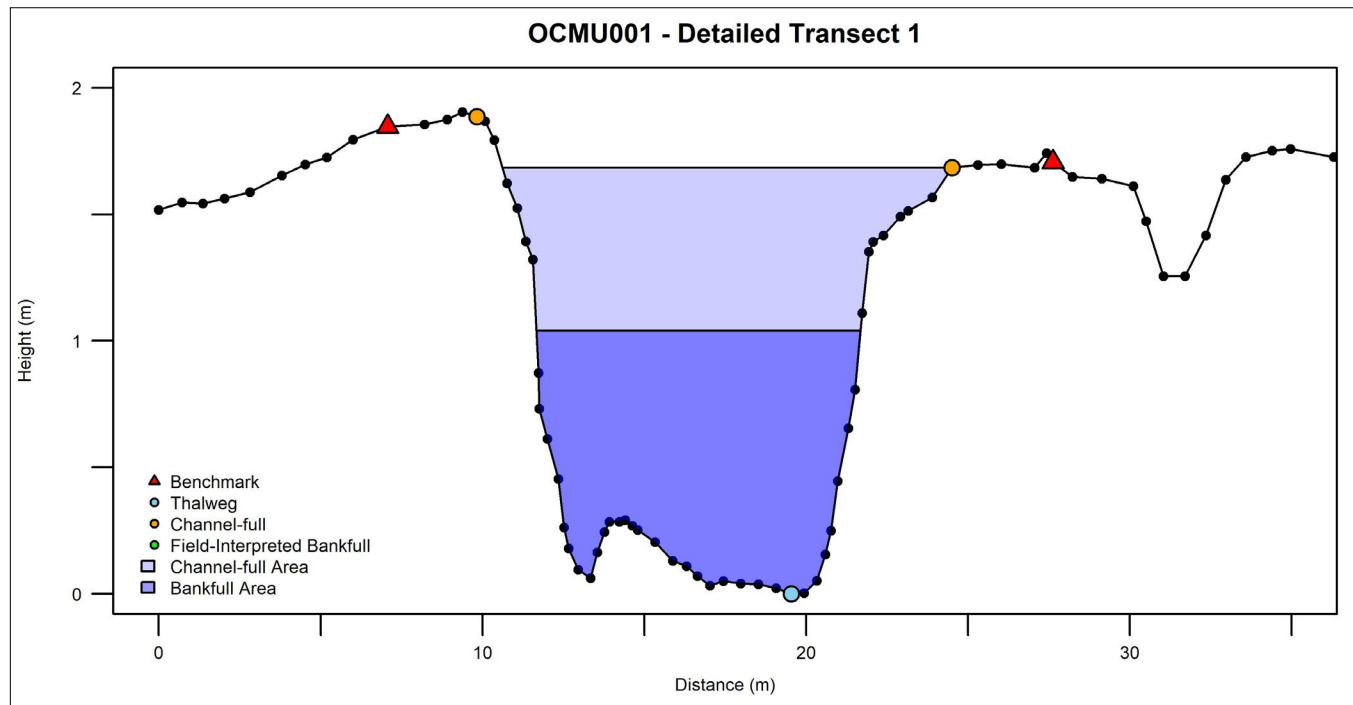
Detailed transect 1 (T1) is entrenched and no floodplains or incipient floodplain surfaces were present (Figure 8). In order for changes in the bed and bank to be quantified, bankfull cross-sectional area and width were estimated using the reach-scale average bankfull height from the 2017 survey. Bankfull cross-sectional area on detailed transect 1 decreased by 0.70 square meters (7.53 ft<sup>2</sup>) and bankfull width decreased by 0.13 meters (0.43 ft; Table 14). The thalweg on detailed transect 1 (T1) has incised slightly and the incipient mid-channel bar that was observed during 2017 has either eroded away or migrated downstream (Figure 8). A new mid-channel bar has developed on detailed transect

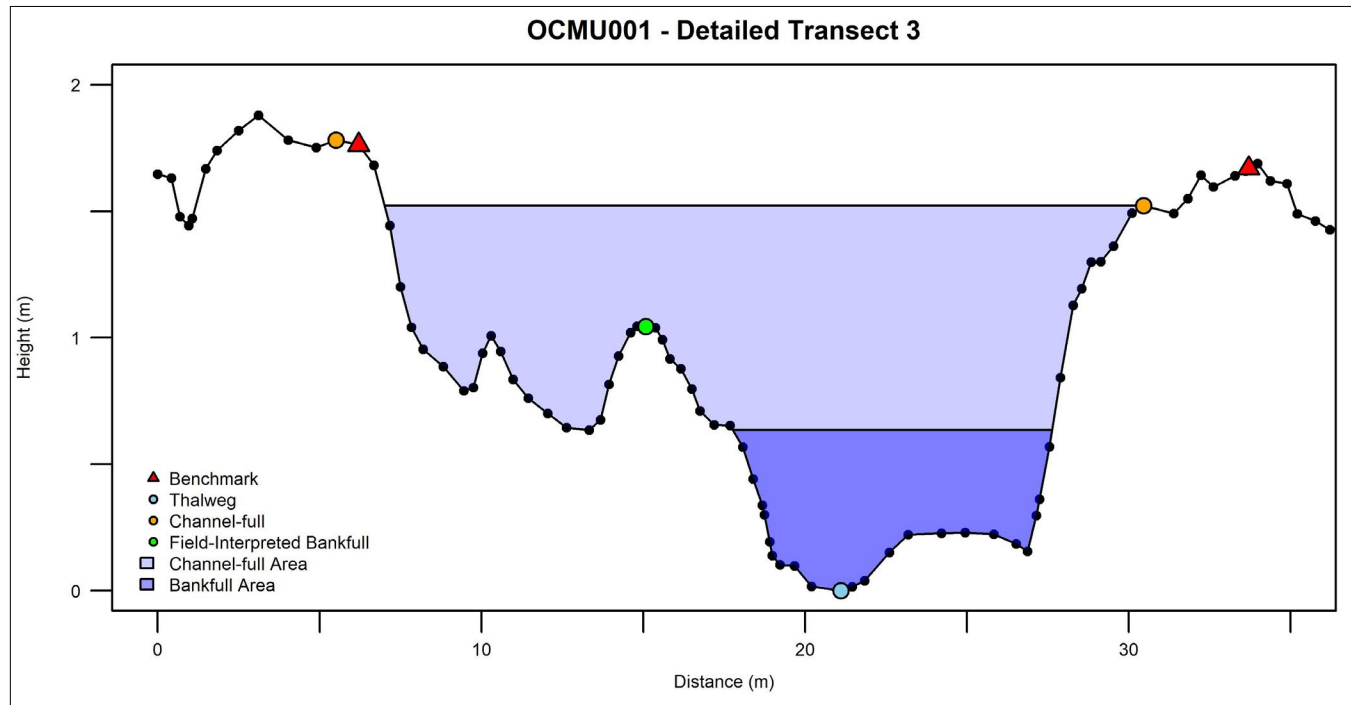
Bankfull cross-sectional area on detailed transect 3 (T11) increased by 2.00 square meters (21.53 ft<sup>2</sup>) from 2017 (2.34 square meters [25.19 ft<sup>2</sup>]) to 2019 (4.34 square meters [46.72 ft<sup>2</sup>]; Table 16). This large increase in bankfull area is due to the loss of the ‘floodplain’ surface along river right that was observed in 2017, coupled with a slight incision of the thalweg (Figure 10). Channel-full area on detailed transect 3

increased by 1.59 square meters [17.11 ft<sup>2</sup>] from 2017 (19.38 square meters [208.60 ft<sup>2</sup>]) to 2019 (20.97 square meters [225.72 ft<sup>2</sup>]; Table 16). Aggradation of sediment on the floodplain surface on river left offset some of the increase in channel-full area caused by the loss of the floodplain surface on river right (Figure 10).
