# Preservation/Restoration of Moton Field

Tuskegee Airmen  
National Historic Site  
Tuskegee, Alabama

*Historic Structure Report*  
Bath & Locker House

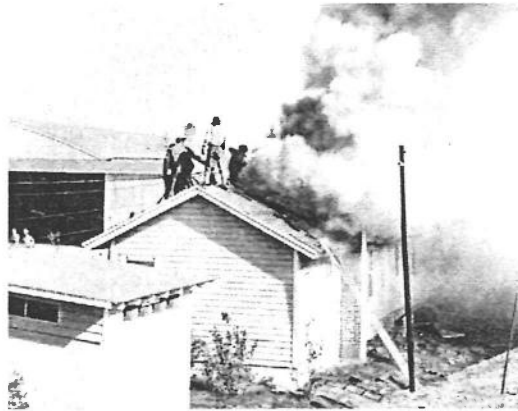
**Figure 4:** Working to put out the fire on the heater room roof circa 1944. Historic Photograph Collection, Howard University.

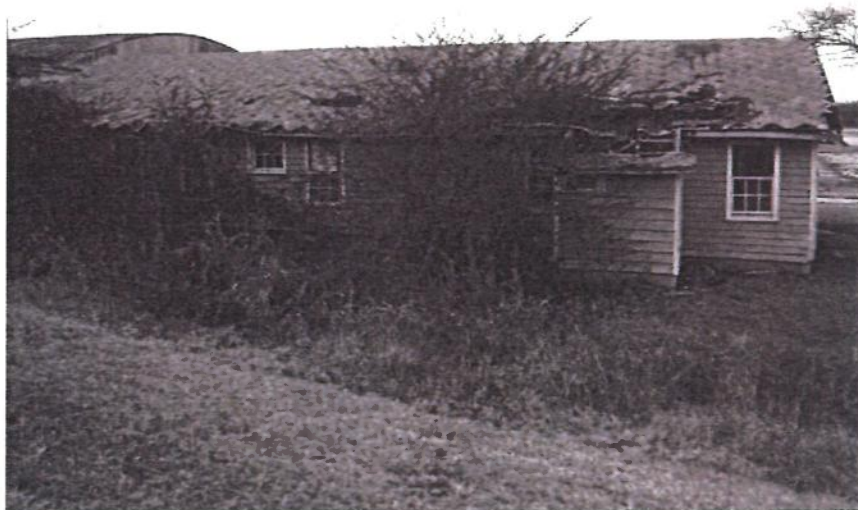
By the late 1990s the Bath and Locker House had fallen into an even greater deteriorated state. Roof shingles were damaged or missing and in several places the entire roof system was absent, which exposed the interior to the elements.<sup>39</sup> (See *Figures 6 and 7*.) Pre-stabilization drawings and photographs document the increased pace of deterioration to the point of a collapsed roof, missing shingles, and exposed rafters.<sup>40</sup> The roof and damaged south wall have been reconstructed during recent stabilization efforts to protect the interior from further deterioration. A detailed description of the existing building and the recent stabilization work is found in the *Physical Description* section.

**Figure 7:** South facade in 1997 prior to stabilization. National Park Service, SERO, Atlanta, Georgia.
