# Preservation/Restoration of Moton Field

Tuskegee Airmen  
National Historic Site  
Tuskegee, Alabama

*Historic Structure Report*  
Fire Protection Shed

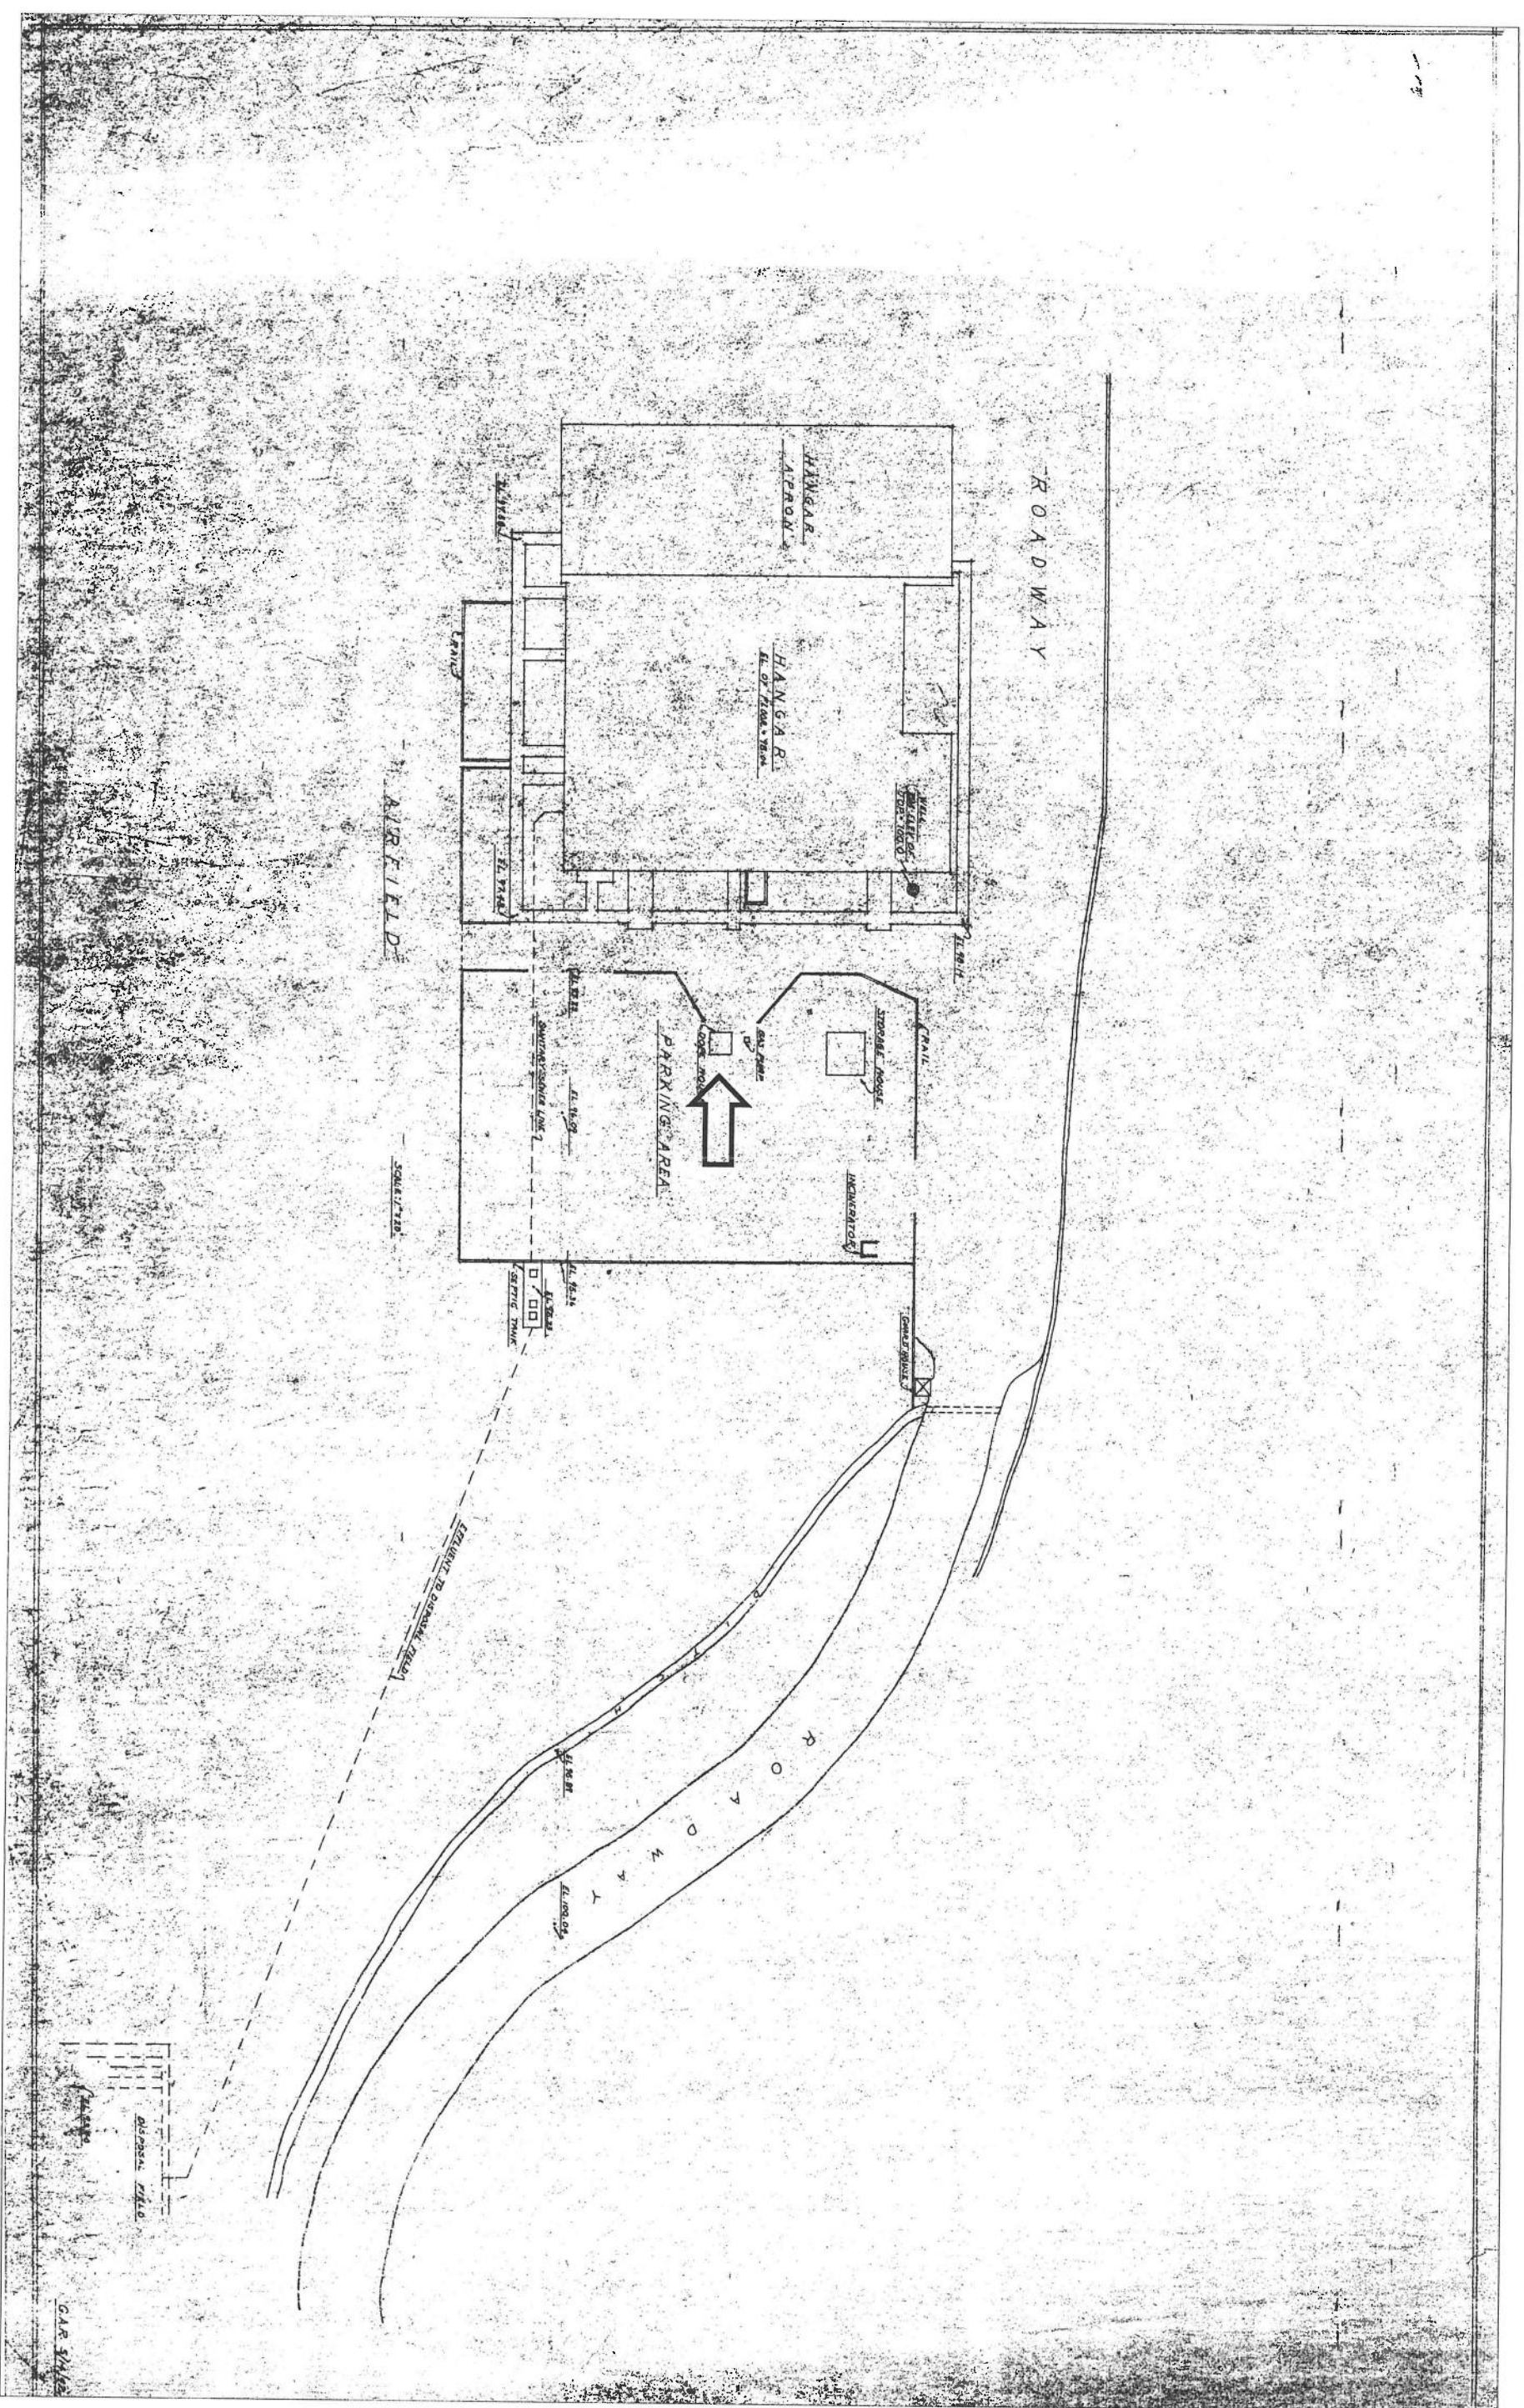
The Fire Protection Shed originally stored other items used at the airfield. On an unlabeled site plan drawn by George A. Reed and dated May 14, 1942, the structure is labeled “Dope House”.<sup>27</sup> (See *Figure 1*.) Dope, the coating applied to the fabric of an aircraft to produce tautness and increase the strength of the fabric, must have been stored in the shed at this time.

Figure 1: Site Plan drawn by George A. Reed and dated May 14, 1942 of Moton Field showing the structure as Dope Storage. Physical Plant, Tuskegee University.

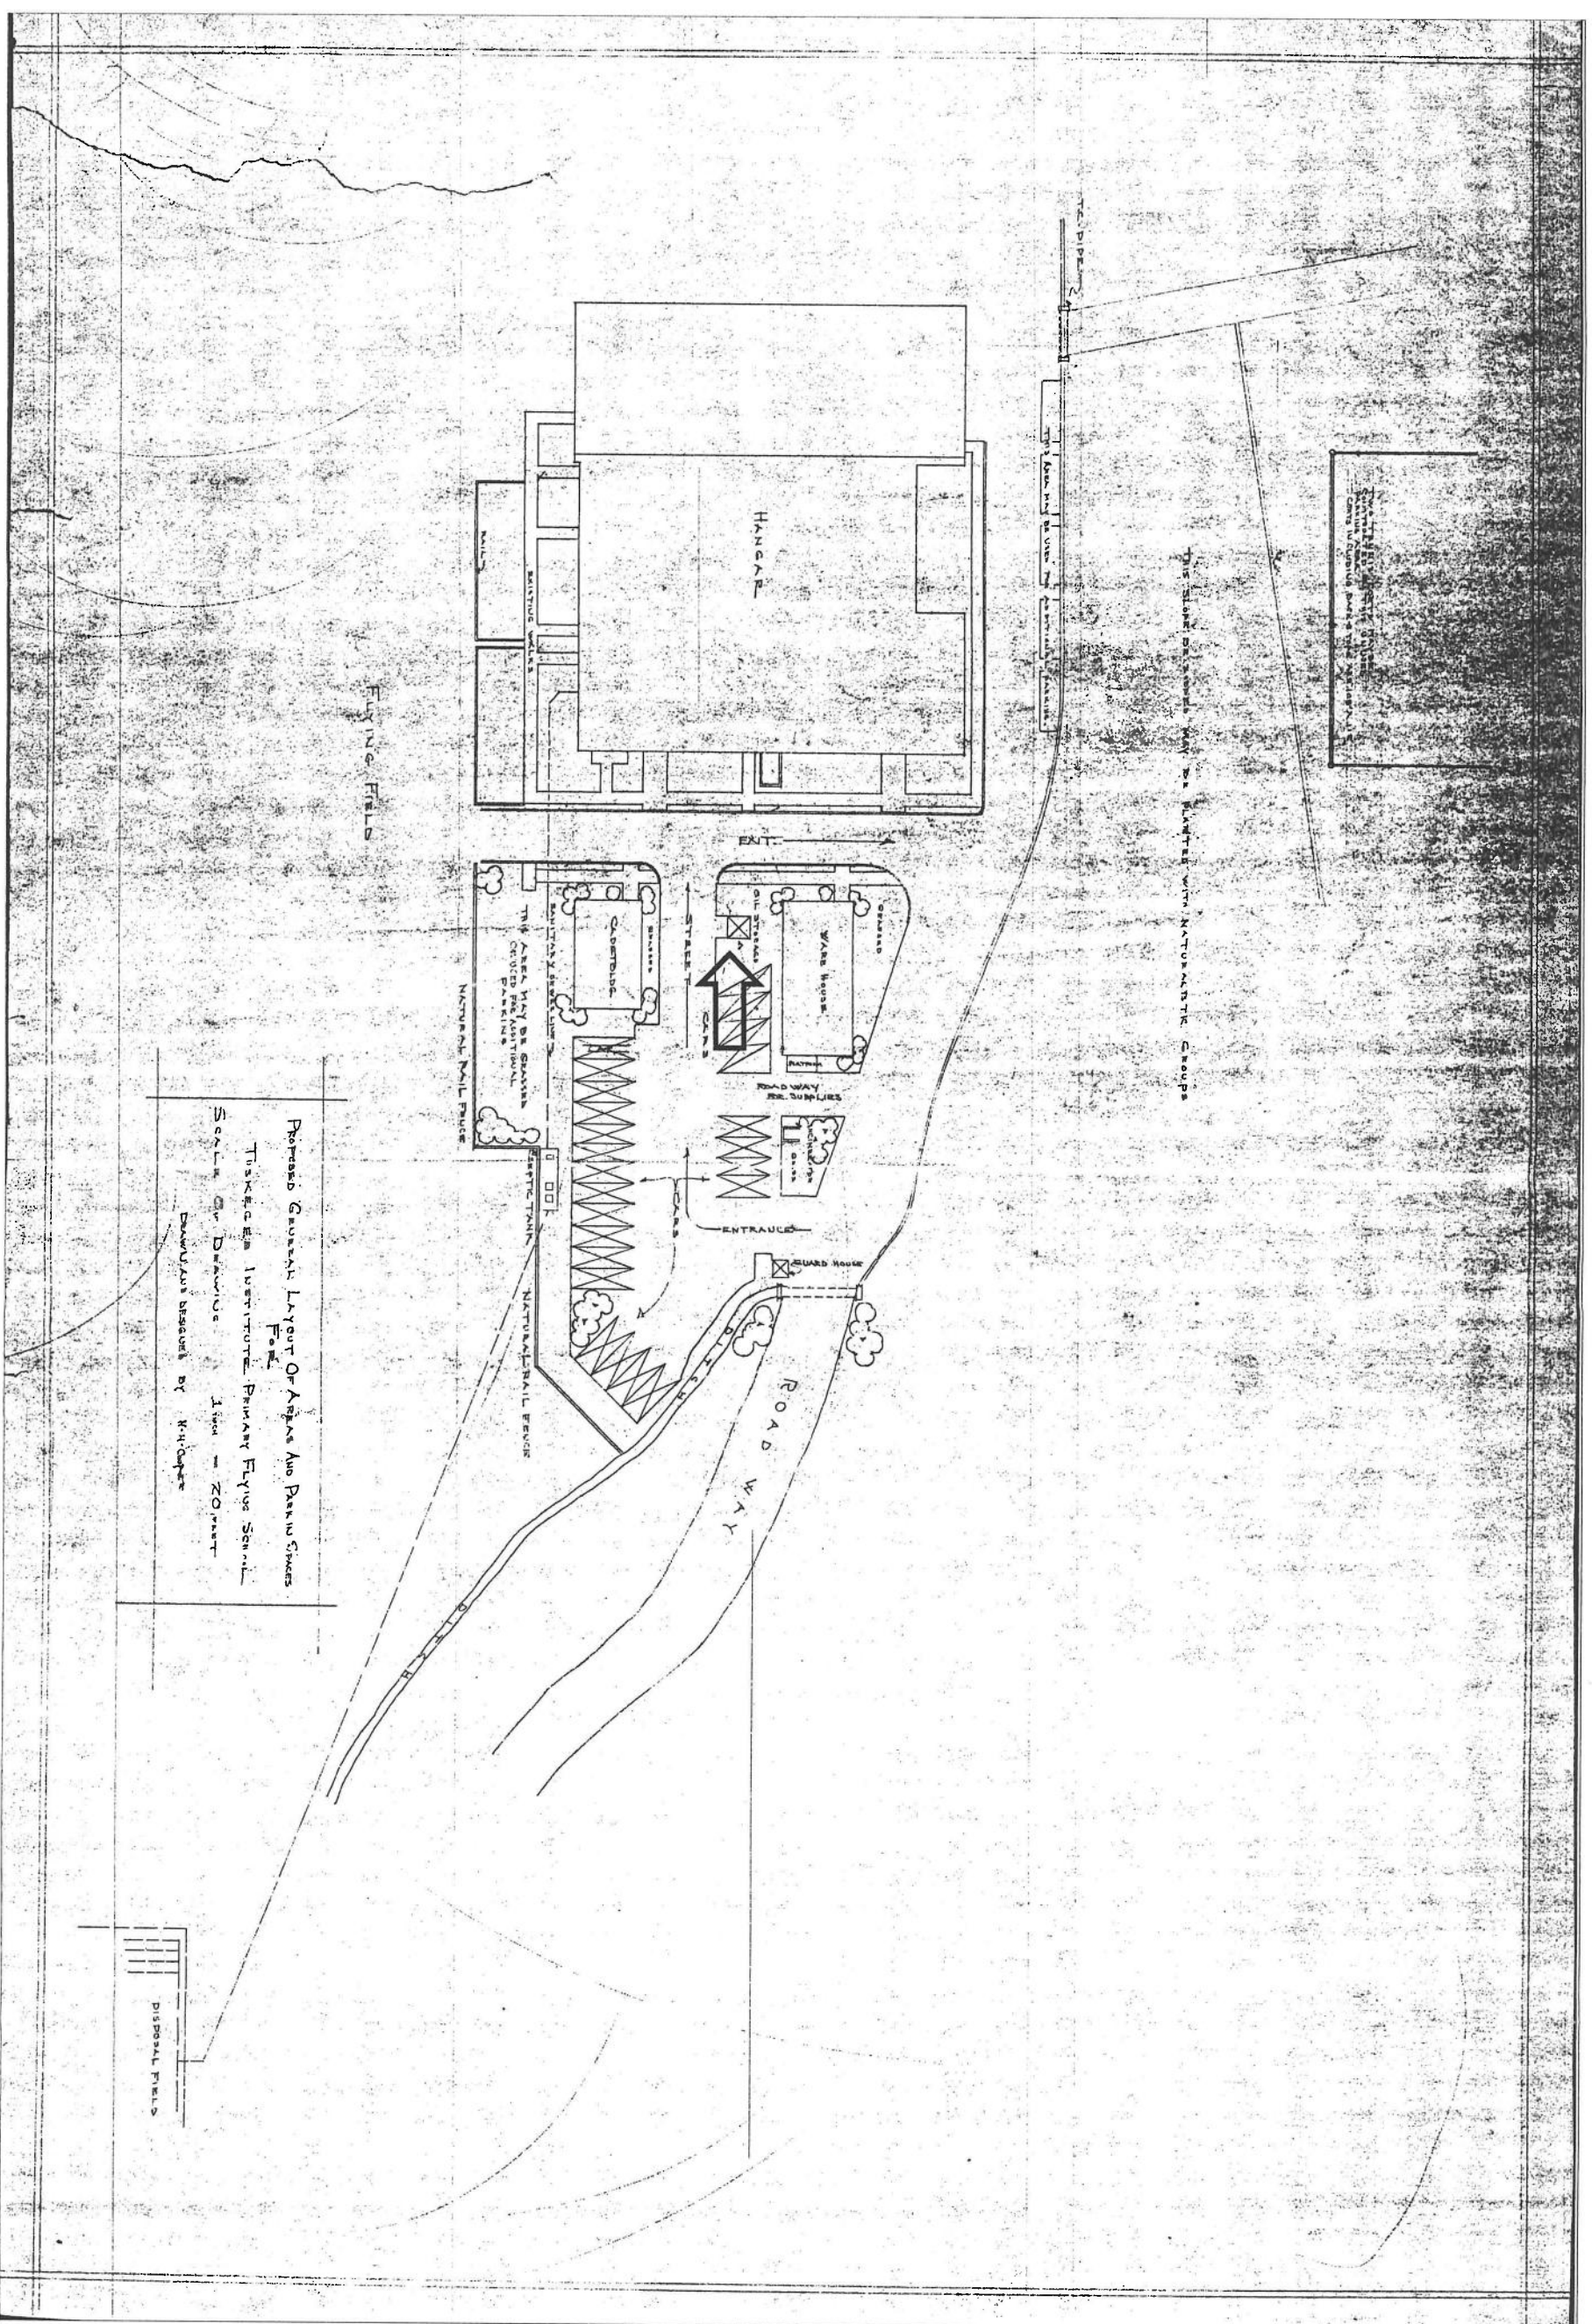
It appears that the structure may have changed storage functions shortly after May of 1942. An undated site plan drawn by H. H. Cooper labels the structure “Oil House”. (See *Figure 2*.)

**Figure 2:** Site Plan drawn by H.H. Cooper dated circa Fall of 1942 with the structure labeled Oil Storage.

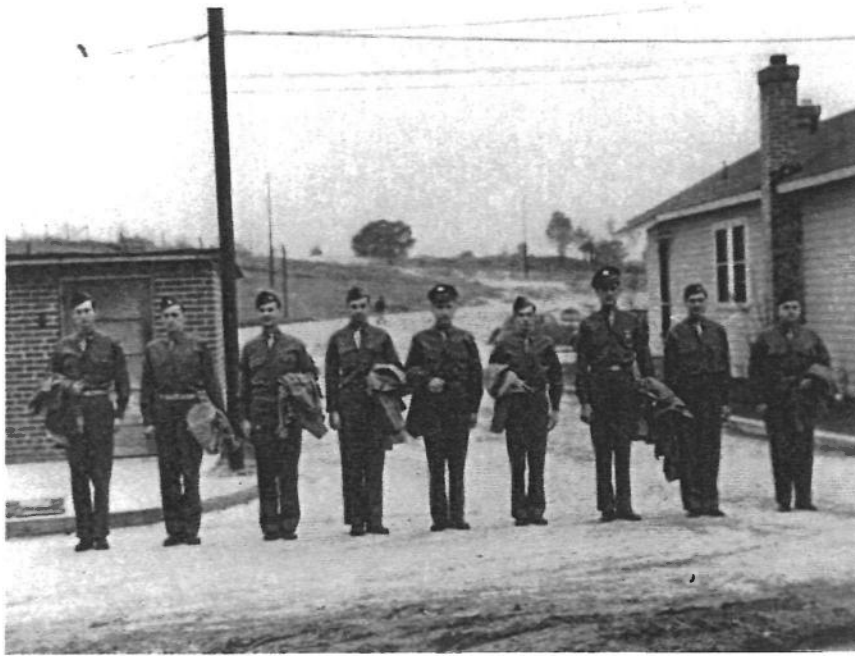
A historic photograph from 1944 shows the building in the background. This picture shows the original door to the shed as a five-paneled wood door.<sup>31</sup> (See *Figure 4*.) It is not known specifically what function the fire protection shed had as part of the fire protection system. Nor is it known what sort of items were housed inside the shed.

**Figure 4:** Historic photo with the Fire Protection Shed in the left background. AFHRA, Maxwell AFB.

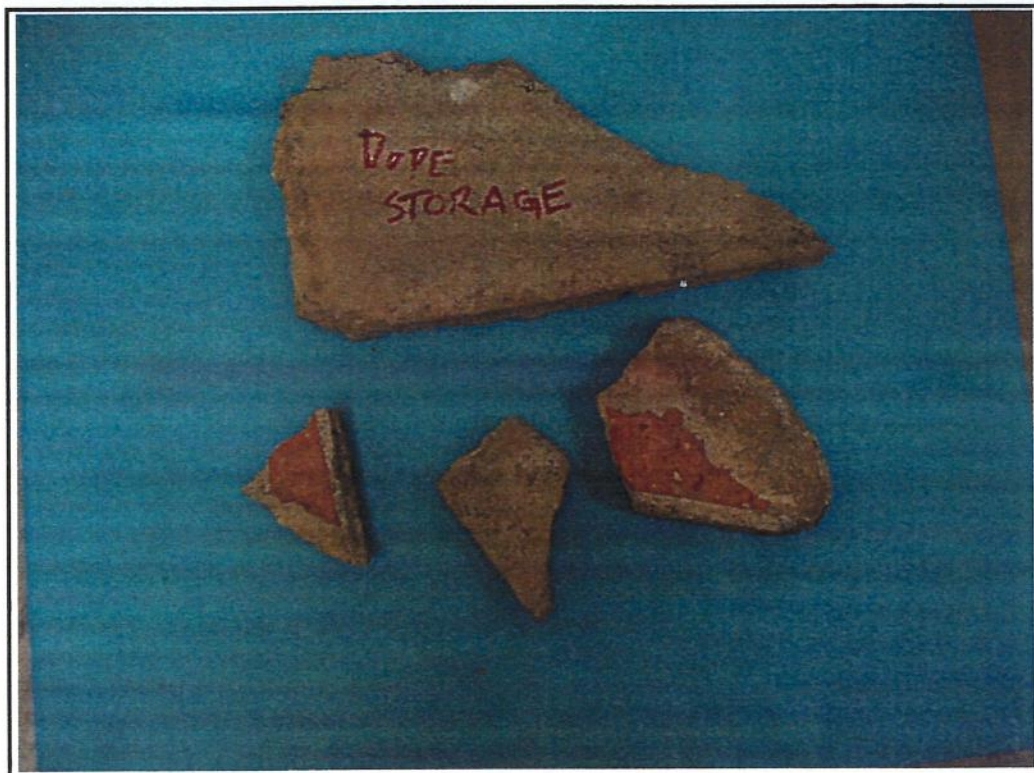
Photo 6. Mortar/Brick samples taken from interior of Dope Storage Shed

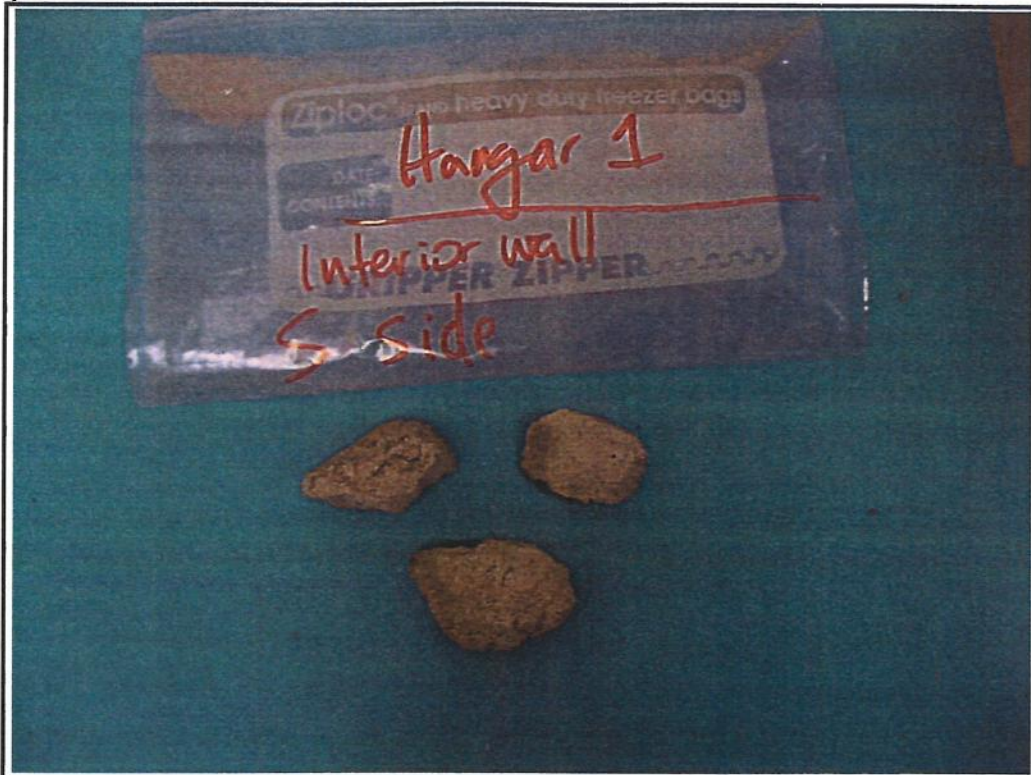
Softer mortar was observed in isolated areas of Hangar No. 1. The mortar appeared to have a higher lime content at some places than the other mortars observed. This determination was made by observation of the mortar color and the hardness of the mortar. The mortar inside Hangar No. 1 ranged from soft (easily scratched with a metal chisel) around the structural clay tile to medium hard around the brick. A section of the exterior south face of this building was re-constructed the summer of 2001. The white colored mortar with a brown surface smear coat was observed (Photo 12). The brown smear coat was applied for aesthetic reasons to match the new mortar to the existing one.

Photo 13. Hangar No. 1, Interior South Side— Mortar taken from brick

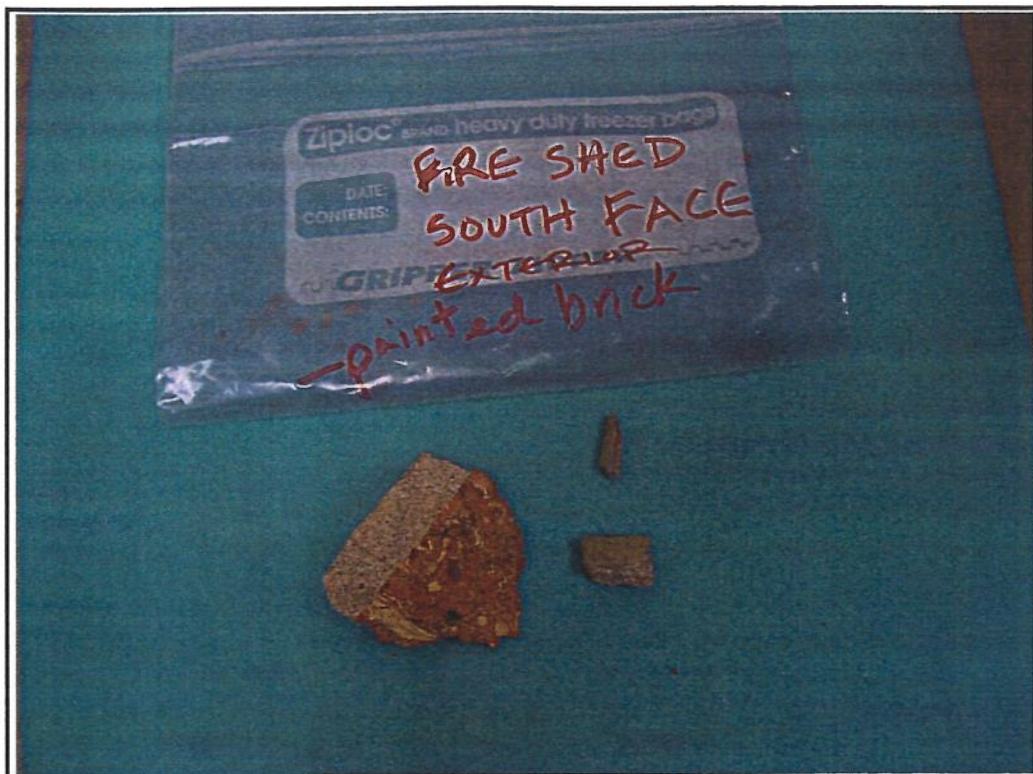
Photo 16. Fire Protection Shed – Mortar/brick samples from south face. Brick painted on side not shown.

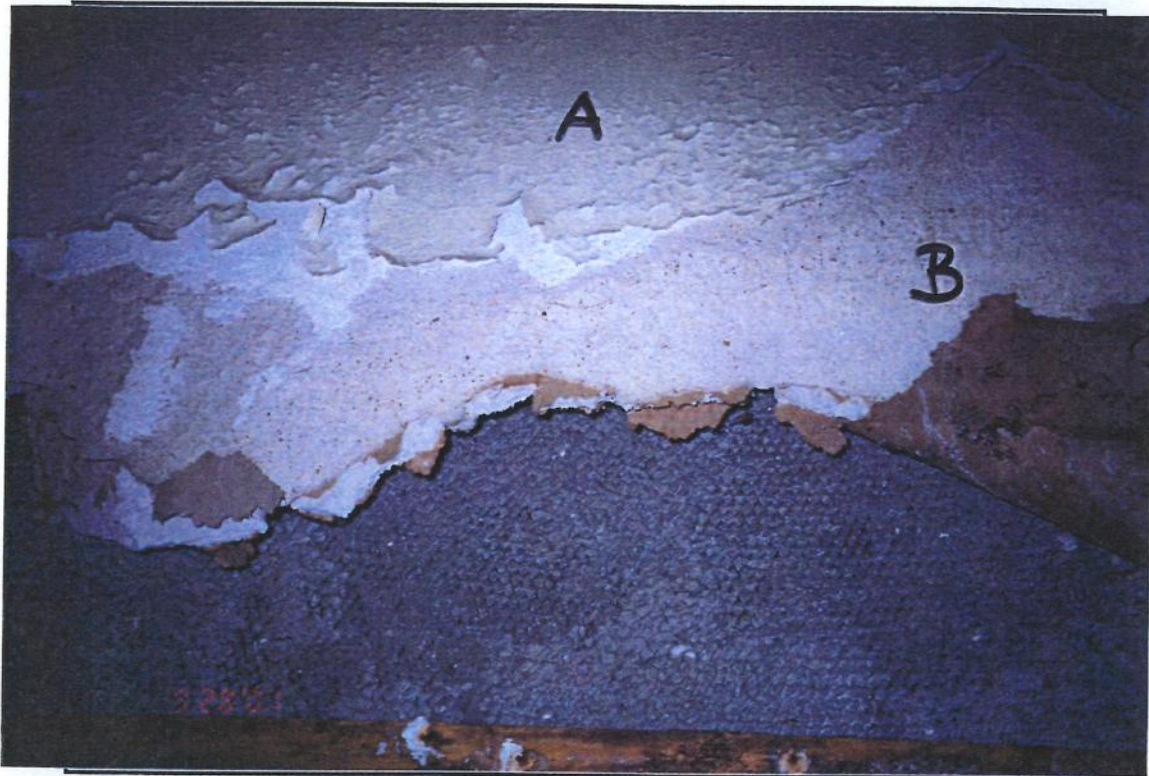
The plaster sample analyzed from the Bath and Locker House was a gypsum-based material (Photos 20 and 21 ). This is typical plaster material. The gypsum board sample was analyzed similar to the mortars. There was an indication that gypsum was present, but it was not quantified.

Photo 20. Bath and Locker House – Interior, Plaster (A) and gypsum board (B)

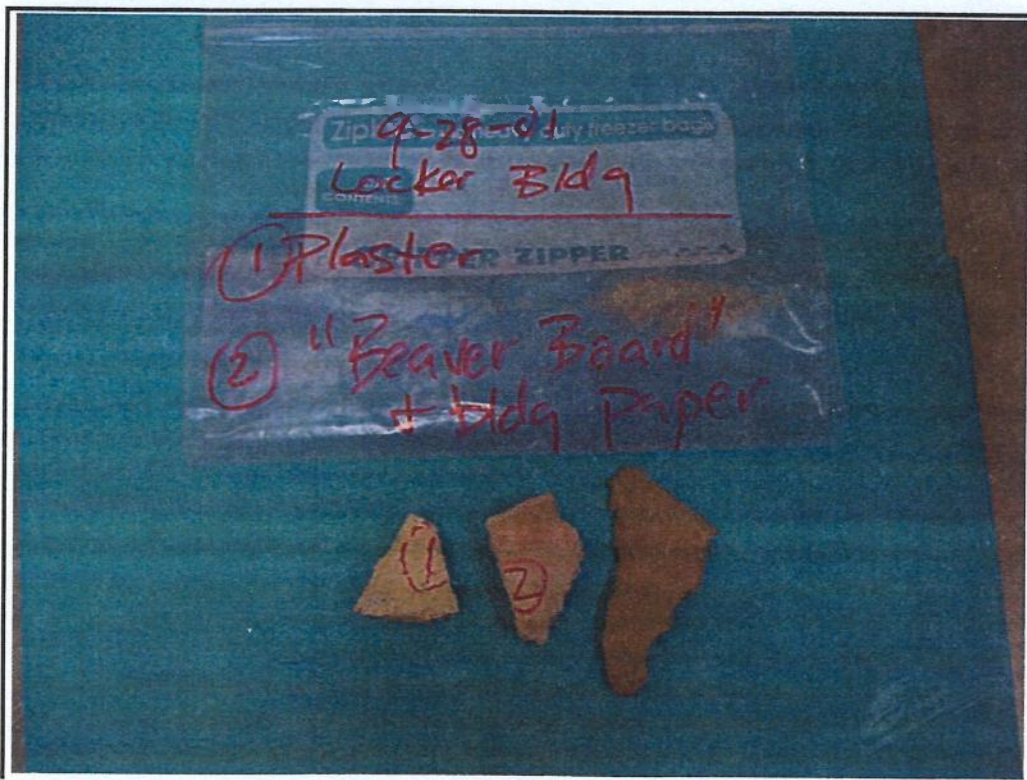
Photo 21. Bath and Locker House – Samples of Plaster (1) and gypsum board (2) with building paper (3)
