# Stafford Slave Settlement

*Cumberland Island National Seashore, Georgia*

## Masonry Materials Analysis and Testing

January 2020

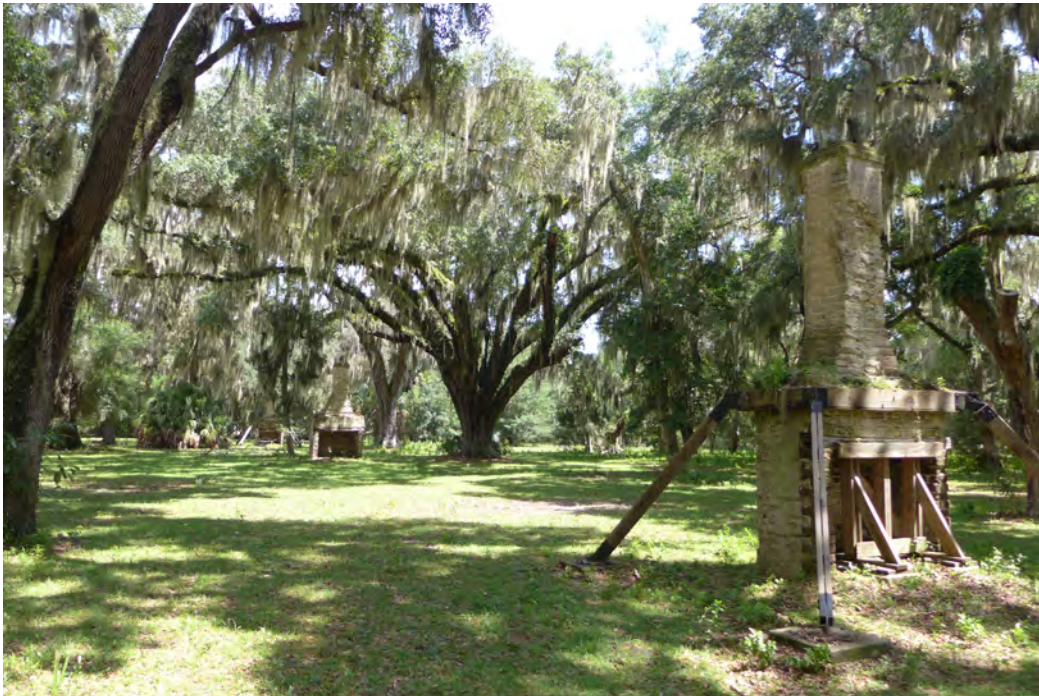
**Image 2.** General setting of the majority of the chimneys, located in a shaded tree grove in approximately the middle of the island. Some chimneys were previously stabilized in 2008.

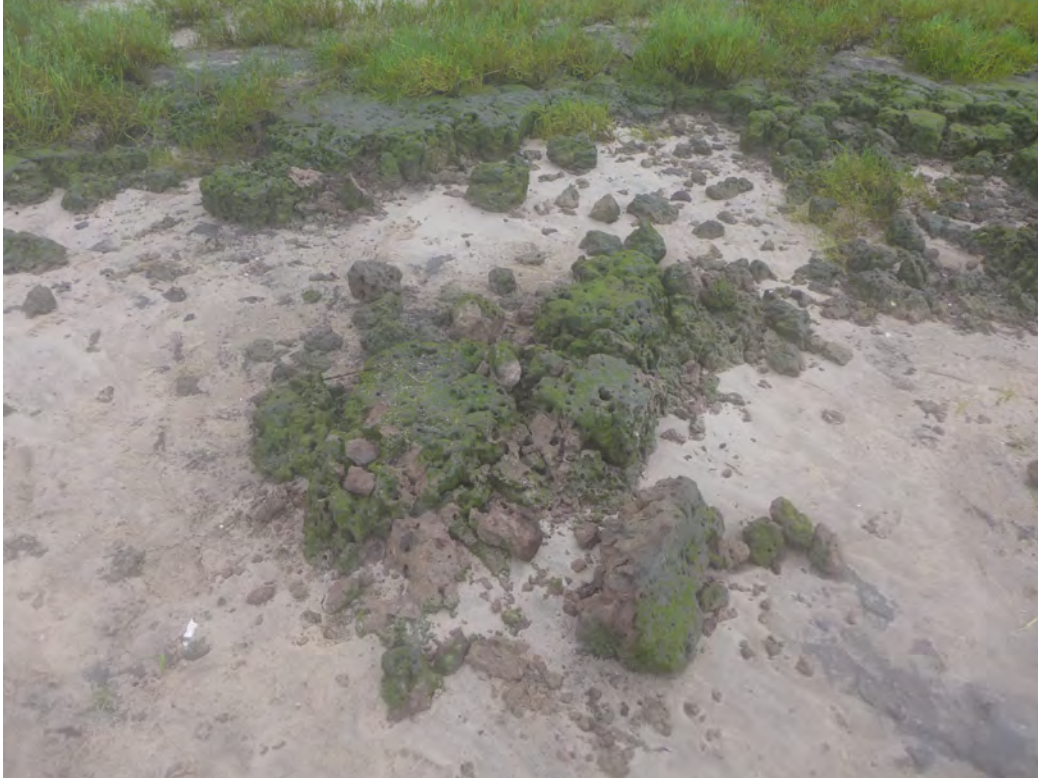
**Image 16.** Location of the sample Stafford.21, the “clay rock” or deposited sediment found along the shore of the island.

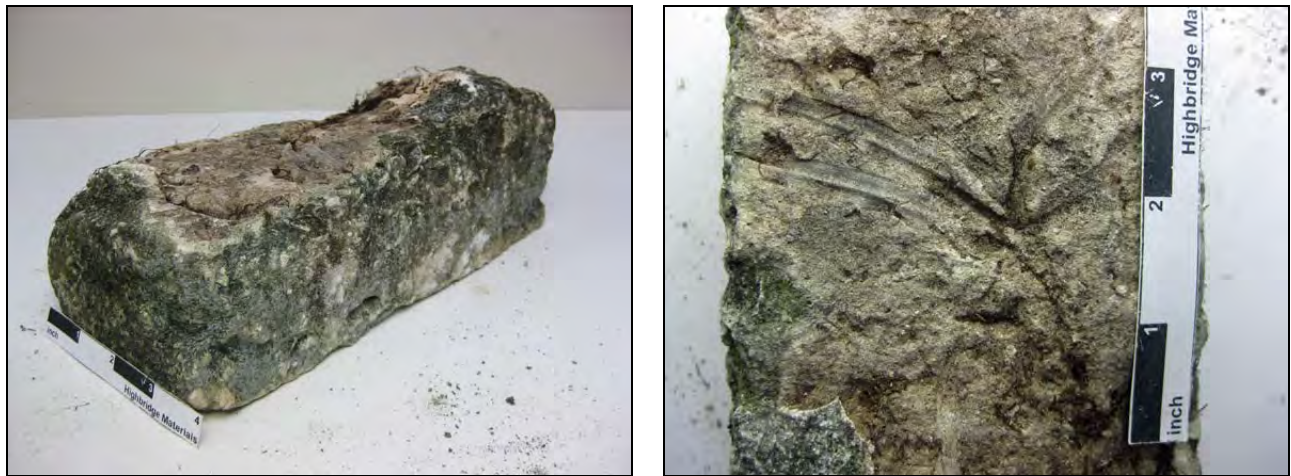
**Figure 2:** Photographs of Sample 07 used by the laboratory for the compositional analysis of the tabby brick. The whole brick is shown obliquely in the left image. A close-up of one bed surface is shown at right. There is an unusual set of tool marks on this surface

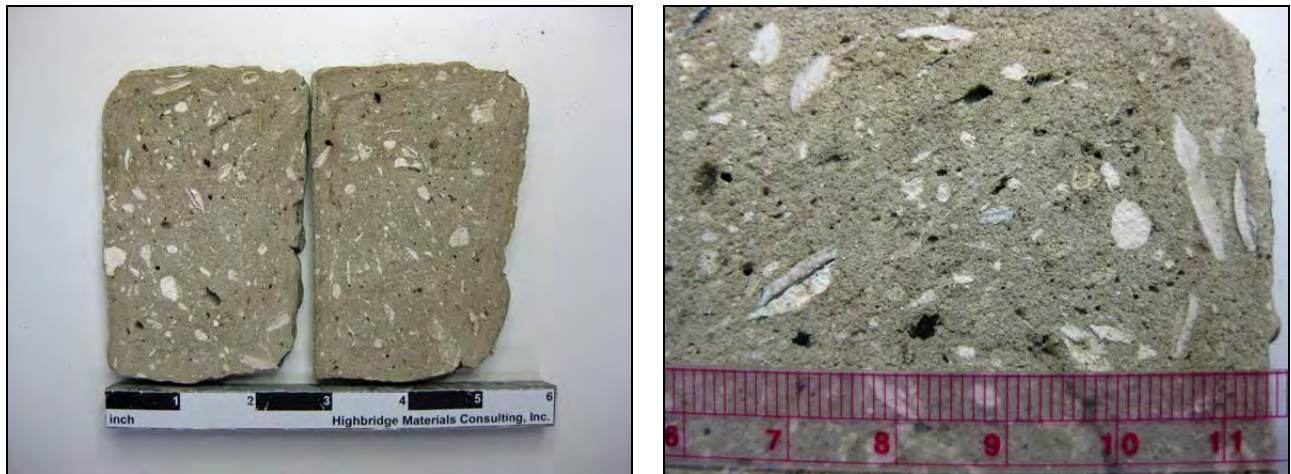
**Figure 3:** The texture of the tabby brick is shown in these images of sawn and ground cross sections. The right image is a close-up with a scale bar having units in centimeters. The matrix is a pale brown color likely due to the inclusion of trace organic impurities in the sand. Unscreened fragments of partly burned shell are evenly dispersed throughout the brick without producing a grain anisotropy.

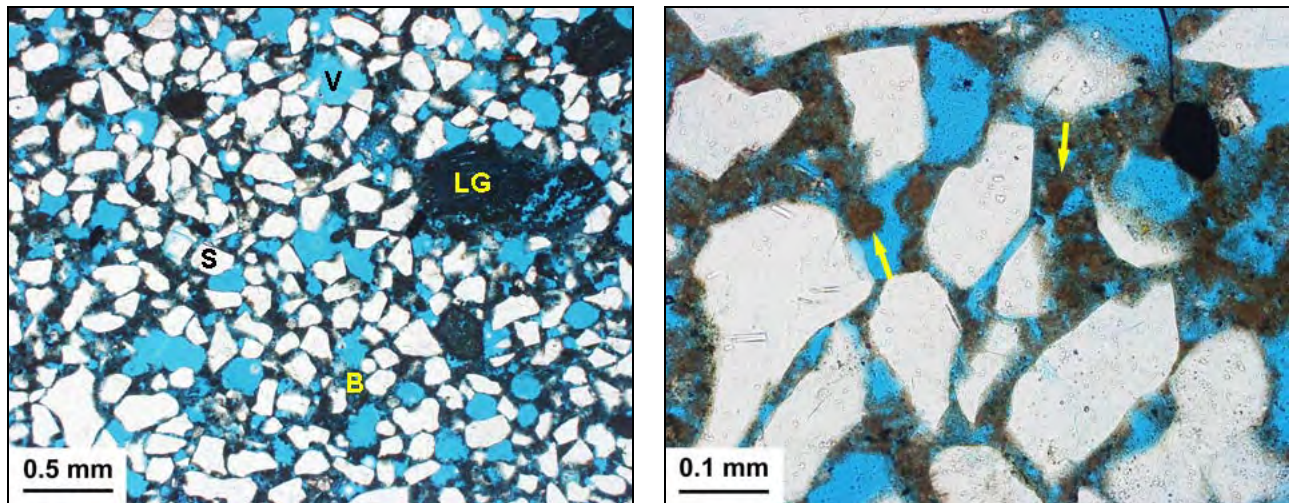
**Figure 7:** PPL photomicrographs illustrating the microtexture of the mortar. A lower magnification view is shown at left and a higher magnification view is shown at right. The binder (B) is highly permeable as shown by the strong absorption of blue-dyed epoxy used in the sample preparation. The arrows indicate microgranules of cured lime that suggest that the binder was not brought to full plasticity all at once. The sand (S) is sharp-textured and densely distributed throughout the matrix. Fine lime grains are distributed throughout the matrix (LG). While the mortar was well compacted into the mold, there is still a moderate concentration of microscopic voids (V).

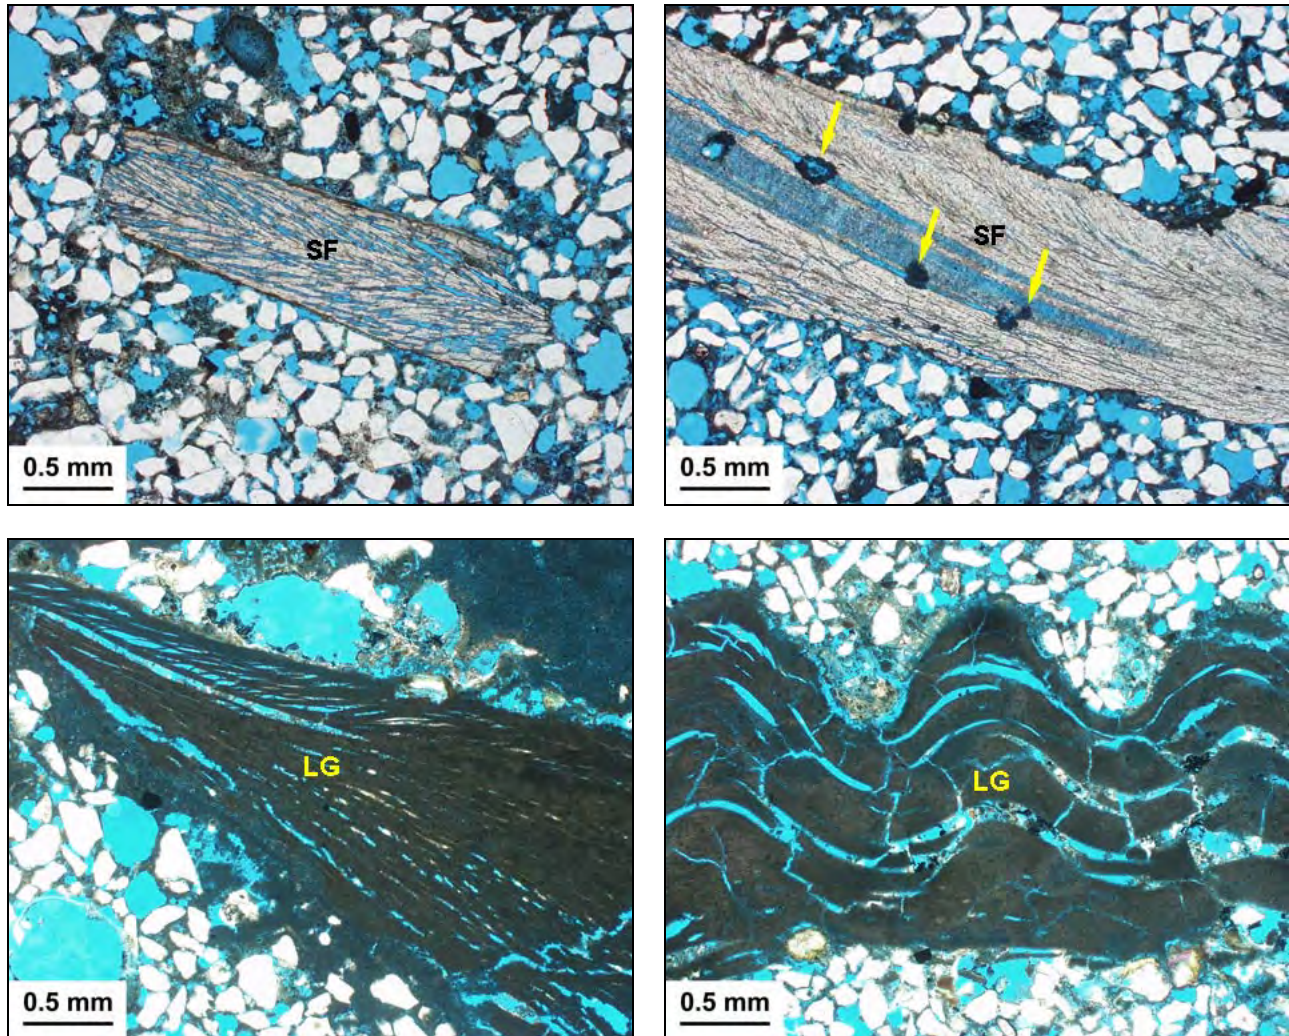
**Figure 8:** PPL photomicrographs illustrating the quality of the fired lime. (Upper left) Unburned shell fragments (SF) are typically plate-like and no more than a few millimeters in length. (Upper right) Even where apparently unburned, fine spots of carbonated lime within the shells indicate that they were fired. These are not simply crushed shell fragments. (Lower images) Fully carbonated lime grains (LG) often contain evidence of the shell source. Both images show microscopic partings within the lime grains (LG) that correspond to microtextures originally present within the shell. The grain at left is typical of oyster shell. The grain at right appears to represent some type of scallop shell.

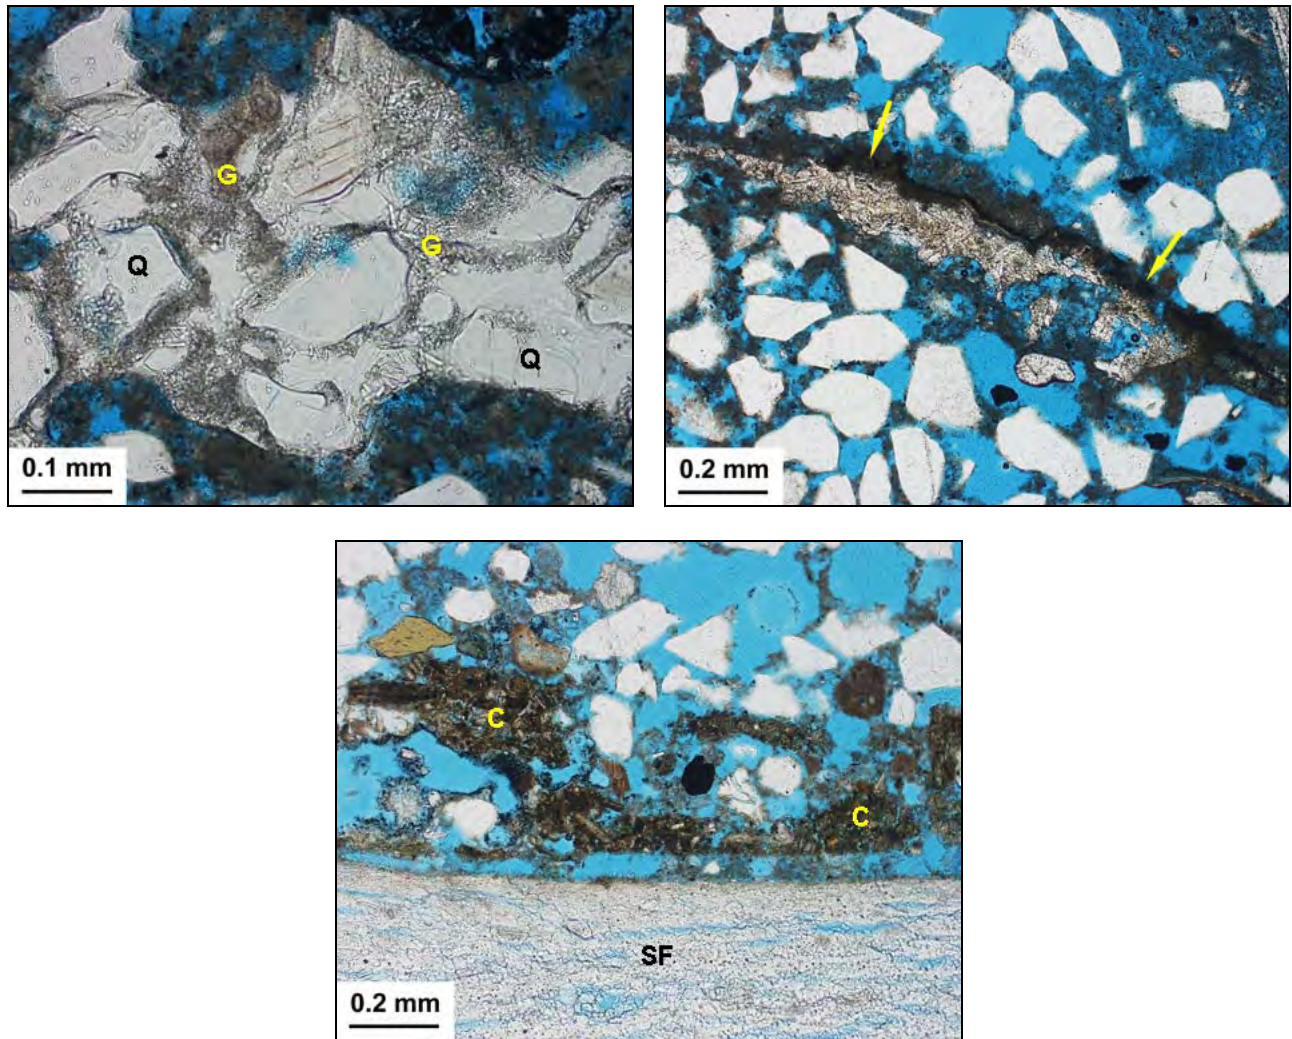
**Figure 9:** Minor impurities are also associated with the lime. These represent variously fired sand and clay residues originally adhered to the shell surfaces. (Upper left PPL image) A cluster of quartz particles (Q) are fused together with glass (G). (Upper right PPL image) The arrows indicate a thin arcuate flake of clinkered clay that maintains the negative impression of the original shell. (Lower PPL image) A residue of lightly burned clay (C) is adhered to the surface of a shell fragment (SF). This provides evidence for the source of the various impurities otherwise distributed throughout the binder.

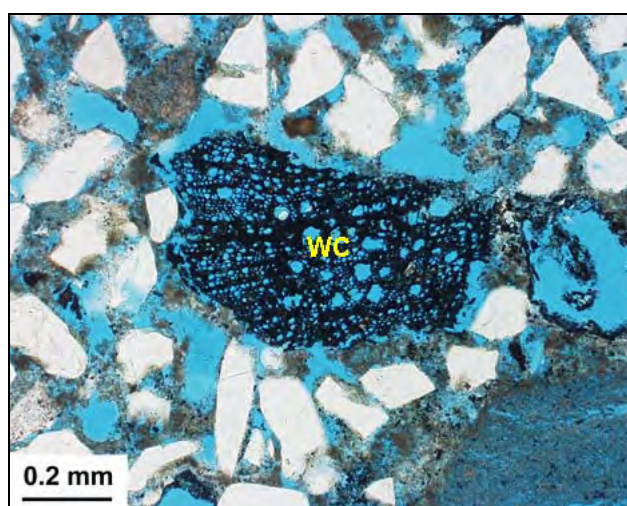
**Figure 10:** PPL photomicrograph. Traces of wood cinder (WC) represent relicts from the fuel used to calcine the lime.

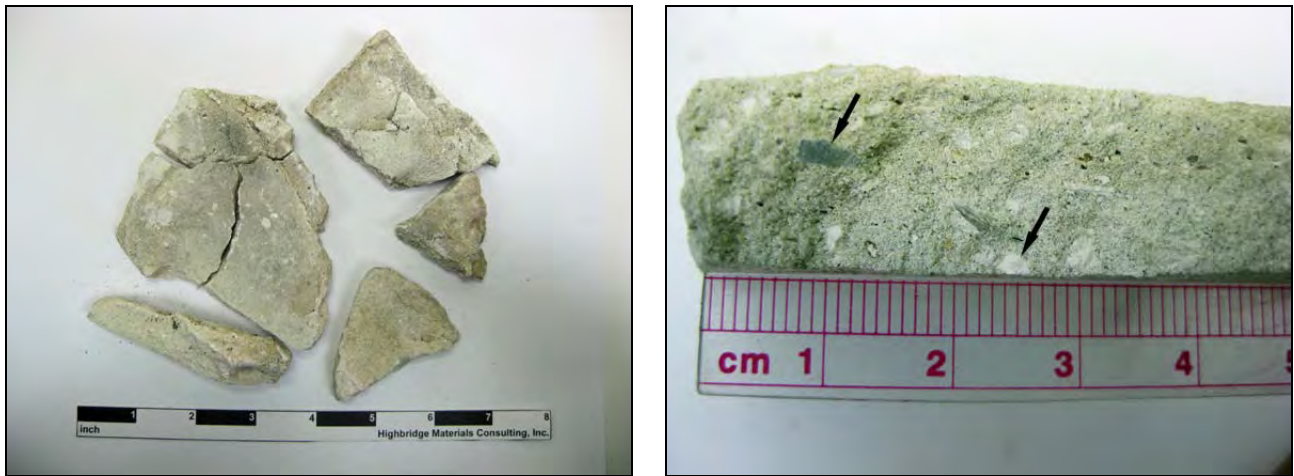
**Figure 1:** Photographs of the mortar sample received by Highbridge for examination. The total sample is shown at left. A fractured surface is shown at right. The arrows illustrate undispersed lime grains and incompletely burned shell fragments.

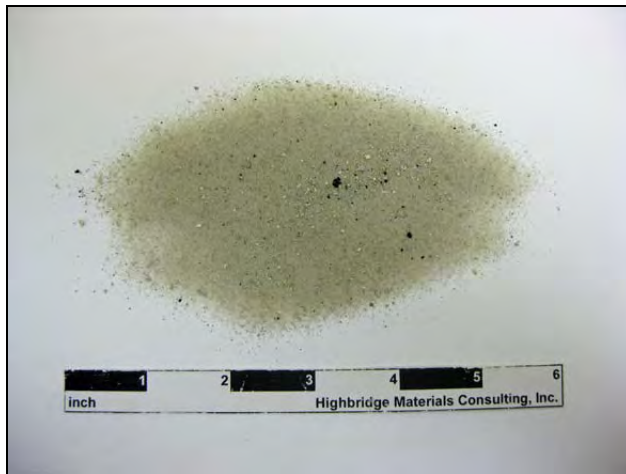
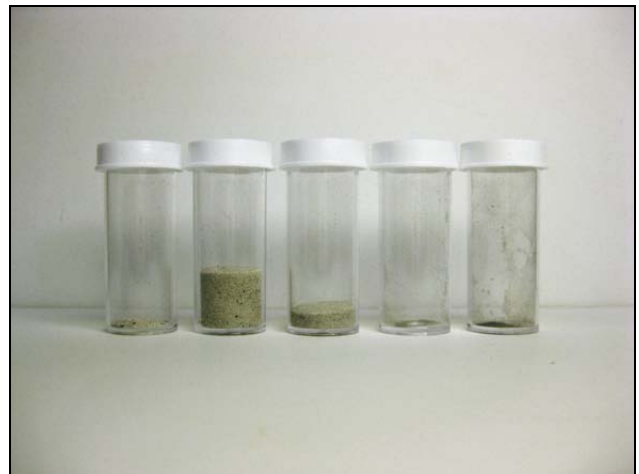
**Figure 2:** Photographs of the aggregate extracted through acid digestion. The total extraction is shown at left. The sand is uniform and light yellowish-gray in color. At right, the sand is shown after grading through a standard sieve stack. The sand is very fine and somewhat narrowly graded.

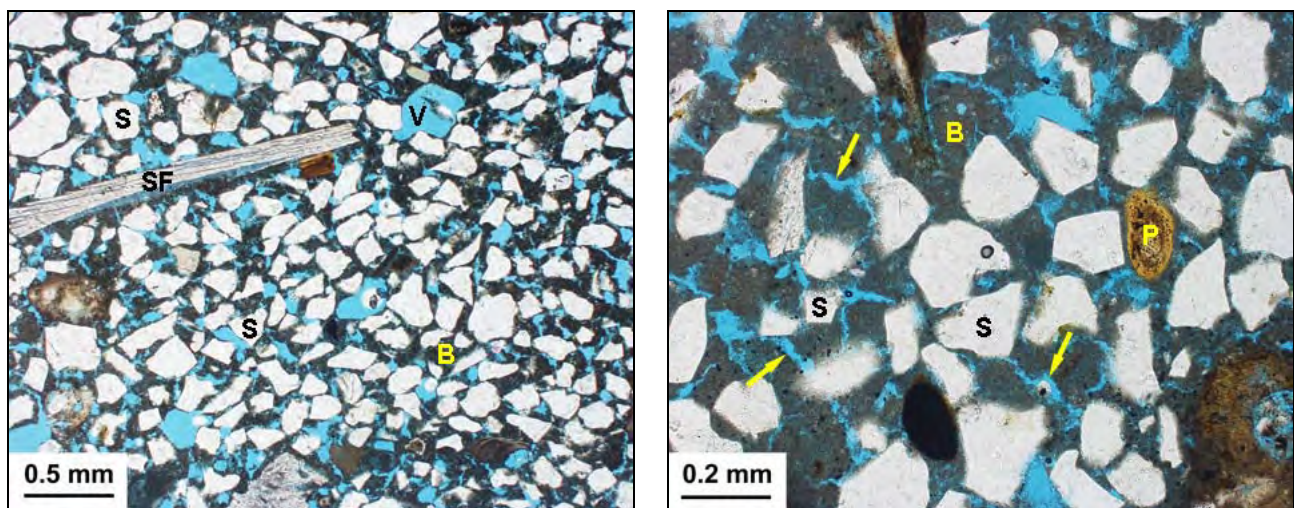
**Figure 3:** PPL photomicrographs illustrating the microtexture of the mortar. A lower magnification view is shown at left and a higher magnification view is shown at right. The binder (B) is highly permeable as shown by the strong absorption of blue-dyed epoxy used in the sample preparation. The arrows indicate microscopic shrinkage cracks that are typical of lime-based mortars. The sand (S) is sharp-textured and densely distributed throughout the matrix. Phosphate grains (P) are distinctive trace constituents. Incompletely burned shell fragments (SF) also behave as aggregate though these are only moderately abundant. The mortar is well consolidated and voids (V) are not concentrated.

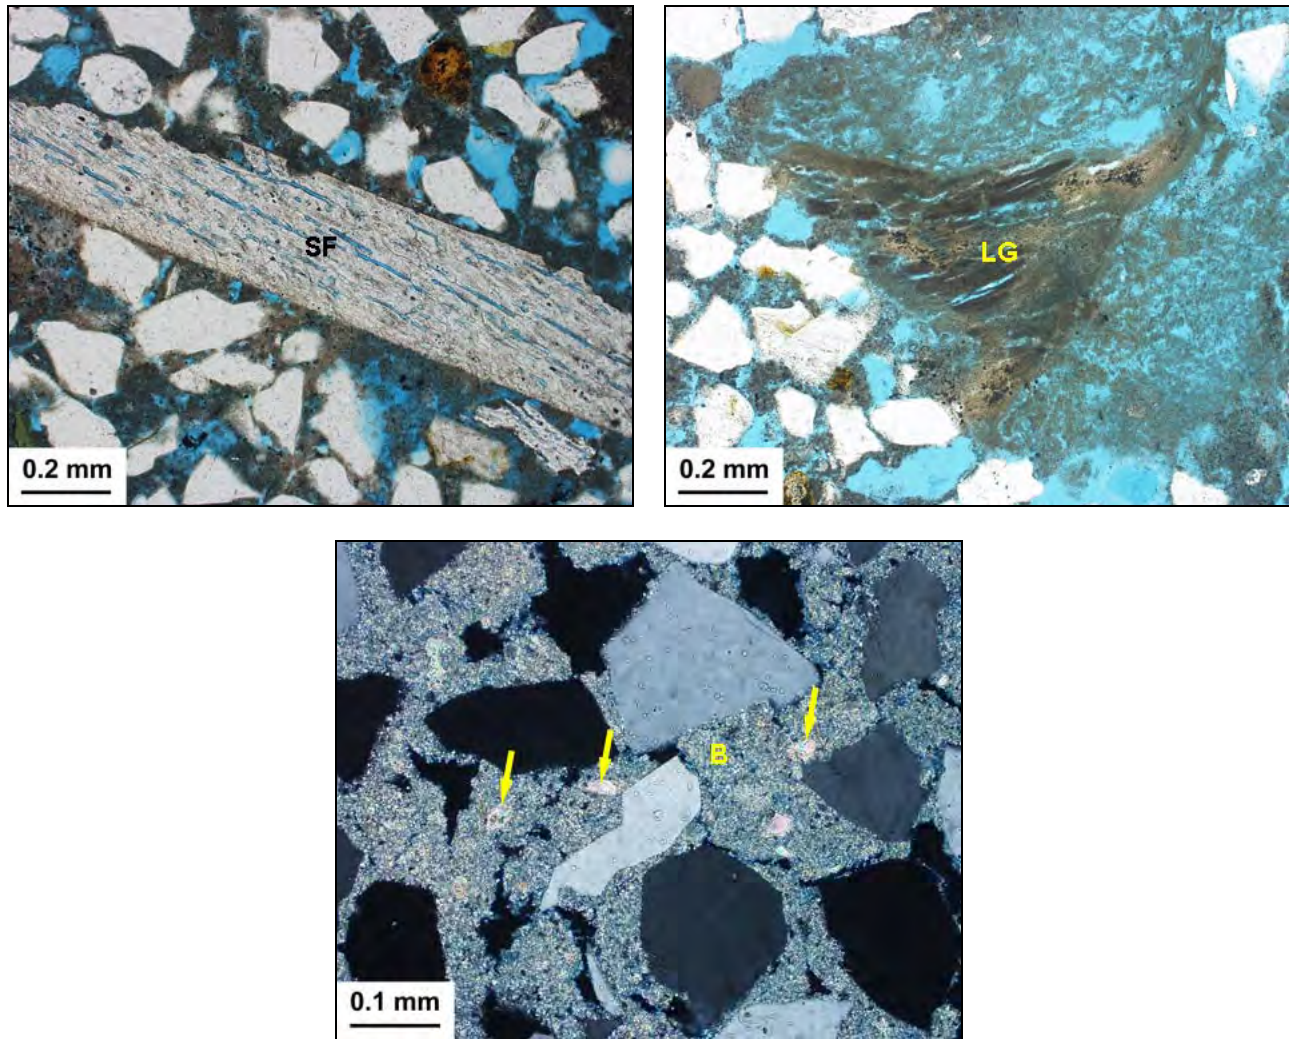
**Figure 4:** Photomicrographs illustrating the quality of the fired lime. (Upper left PPL image) Unburned shell fragments (SF) are typically plate-like and no more than a few millimeters in length. (Upper right PPL image) Carbonated lime grains (LG) often contain evidence for the shell origin. As is evident in this image, microscopic partings correspond to lamination textures originally present in the shell. (Lower XPL image) The arrows indicate very fine carbonate crystals. These represent single crystals that became disaggregated from the original shell during firing. The adjacent binder (B) is fully carbonated.

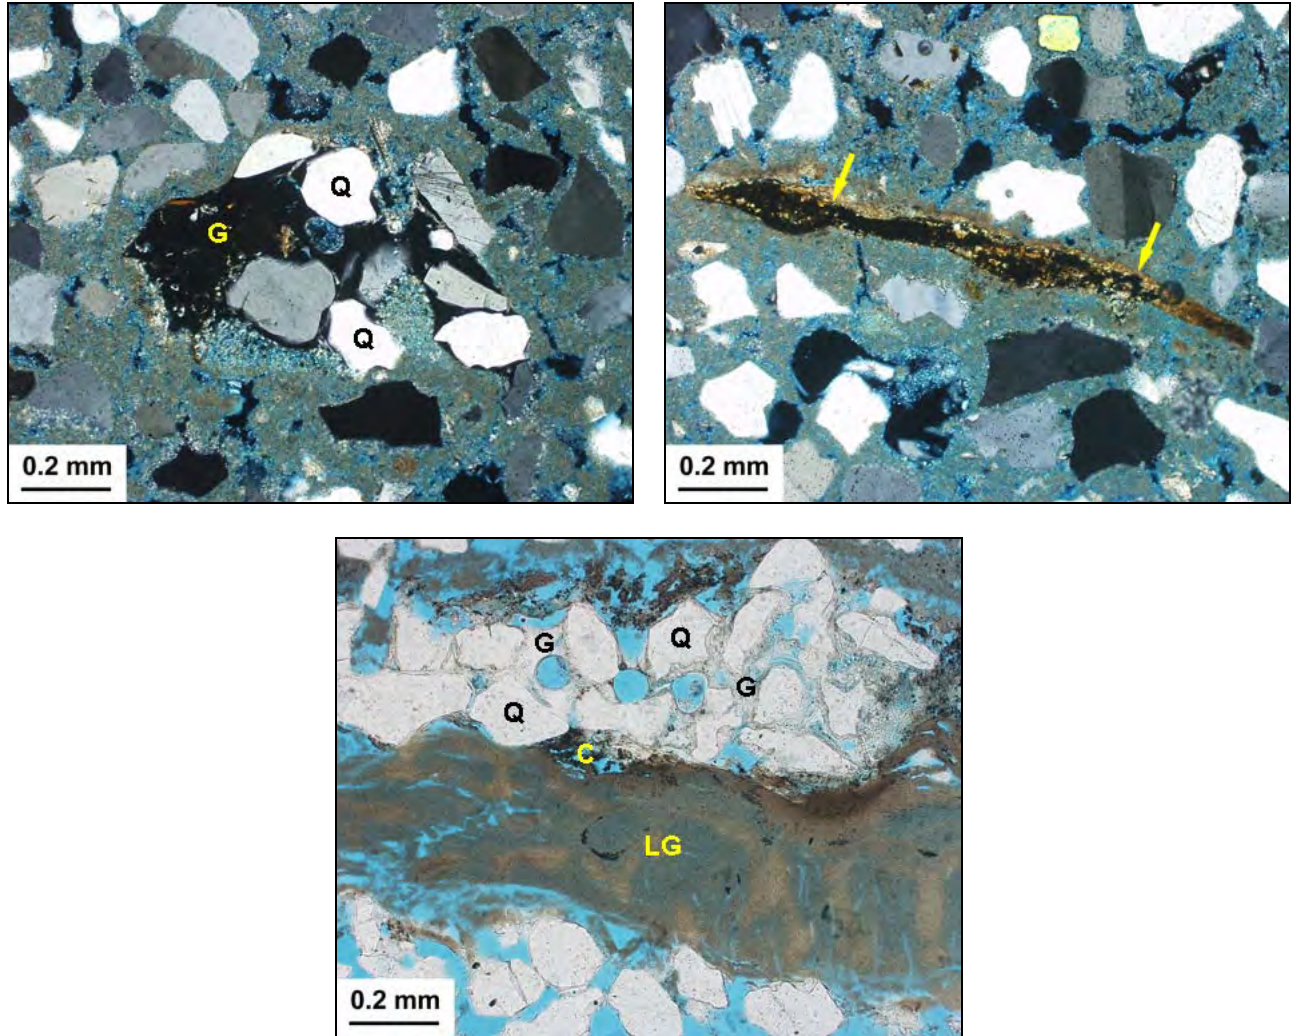
**Figure 5:** Minor impurities are also associated with the lime. These represent variously fired sand and clay residues originally adhered to the shell surfaces. (Upper left XPL image) A cluster of quartz particles (Q) are fused together with glass (G). (Upper right XPL image) The arrows indicate a thin arcuate flake of calcined clay that maintains the negative impression of the original shell. (Lower PPL image) The relationship between the shells and impurities are evident in this photomicrograph. A lime grain (LG) clearly has the shape of a former shell and is thickly lined with calcined clay (C) and quartz fused with glass (Q and G respectively).

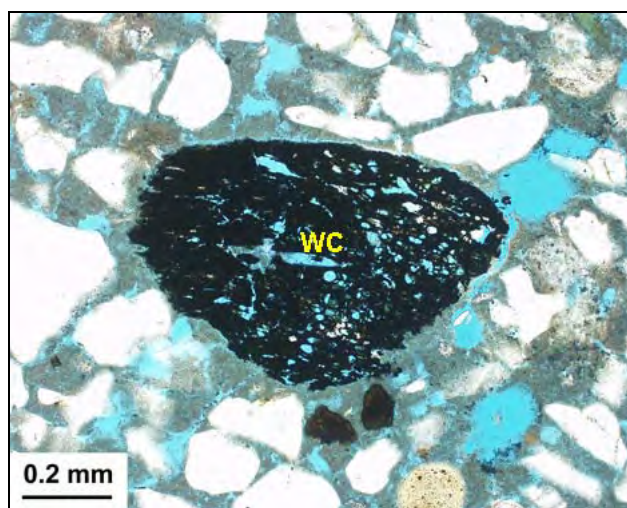
**Figure 6:** PPL photomicrograph. Traces of wood cinder (WC) represent relicts from the fuel used to calcine the lime.

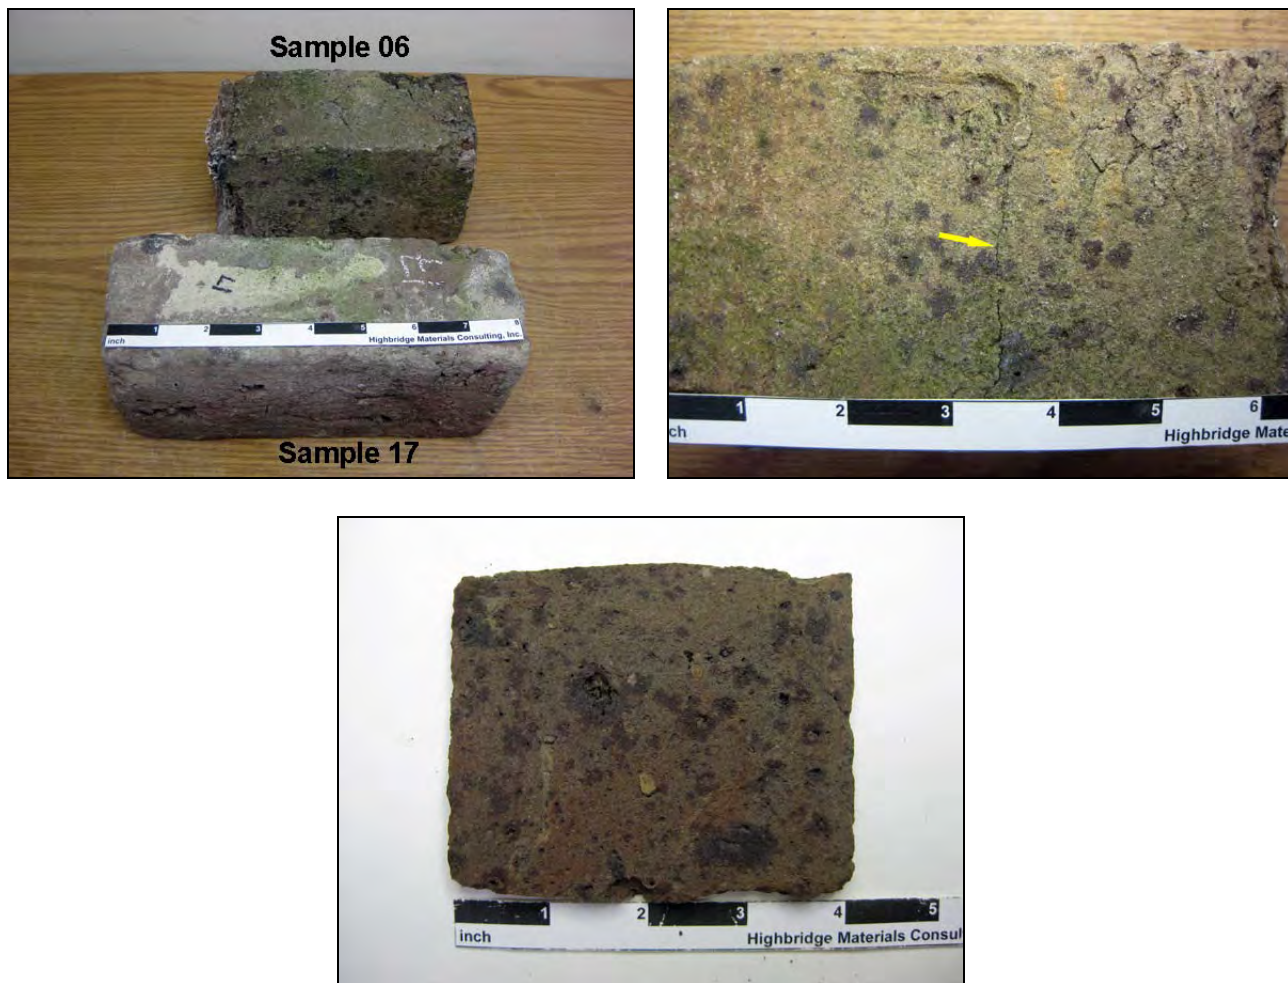
**Figure 1:** Photographs of the red clay brick provided to Highbridge for analysis. (Upper left) Two red clay bricks were delivered. Highbridge selected Sample 06 for the petrographic examination. (Upper right) A close-up of a bed surface in Sample 06 depicts one minor hairline crack that only partly transects the brick (arrow). The feature is considered minor. (Lower) Photograph of a honed cross section used in the petrographic examination. The brick is uniform in texture with a purplish-red color, and darker spots that are evenly distributed throughout the matrix.

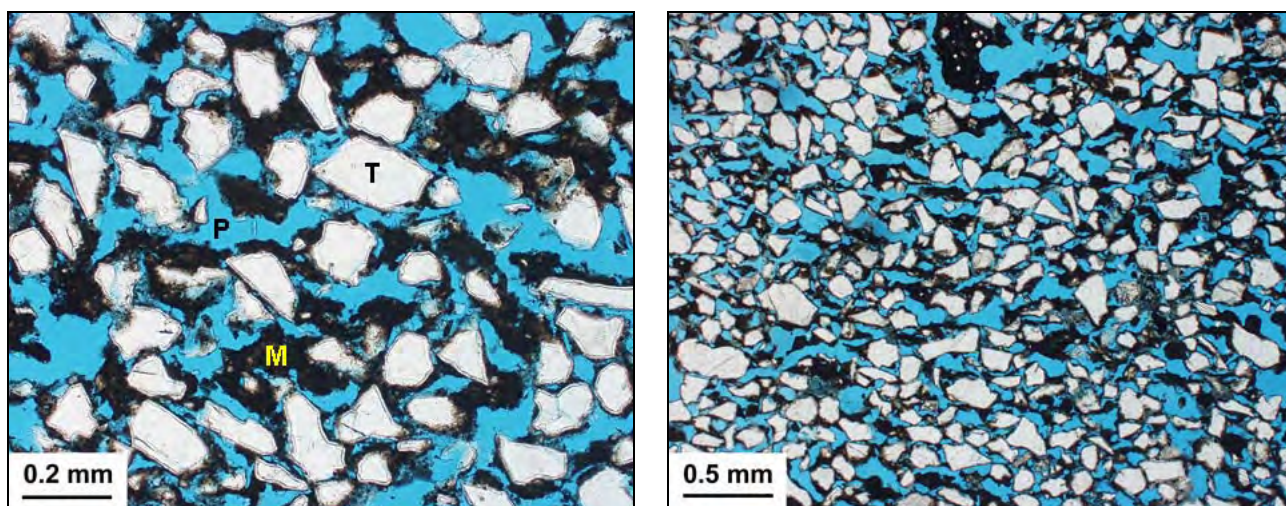
**Figure 2:** PPL photomicrographs illustrating the overall microtexture of the brick. (Left) Natural quartz temper (T) is abundant and produces a sandy texture. Note the thin reaction rims surrounding each of the temper particles. These formed during firing. A matrix of sintered clay (M) binds the temper. Bloating of the mixture during firing has resulted in abundant micropores (P) located at the interstices between sand grains. These form an interconnected permeability network. (Right) The brick texture is shown near one edge of the sample. Note that the pores (in blue) display a weak parallelism due to coalescence of the voids. This texture is only found near the edges where greater bloating has occurred.

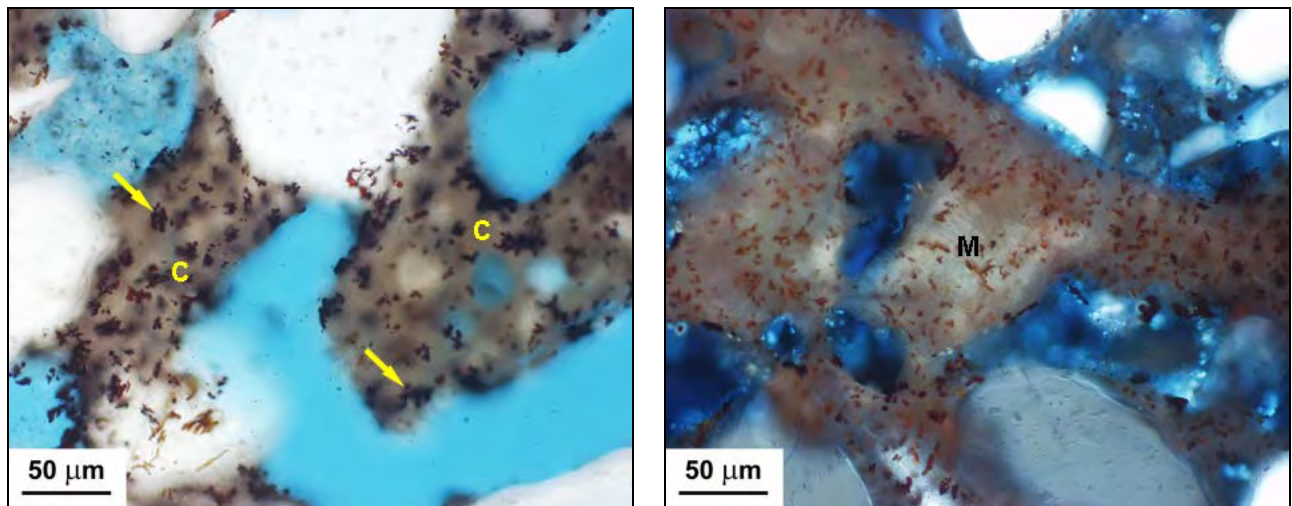
**Figure 3:** CPL photomicrographs providing high magnification views of the fired clay matrix. The arrows in the left image indicate well-formed hematite crystals dispersed throughout the sintered clay (C). At right, a brighter area in the clay represents a skeletal mullite crystal (M).

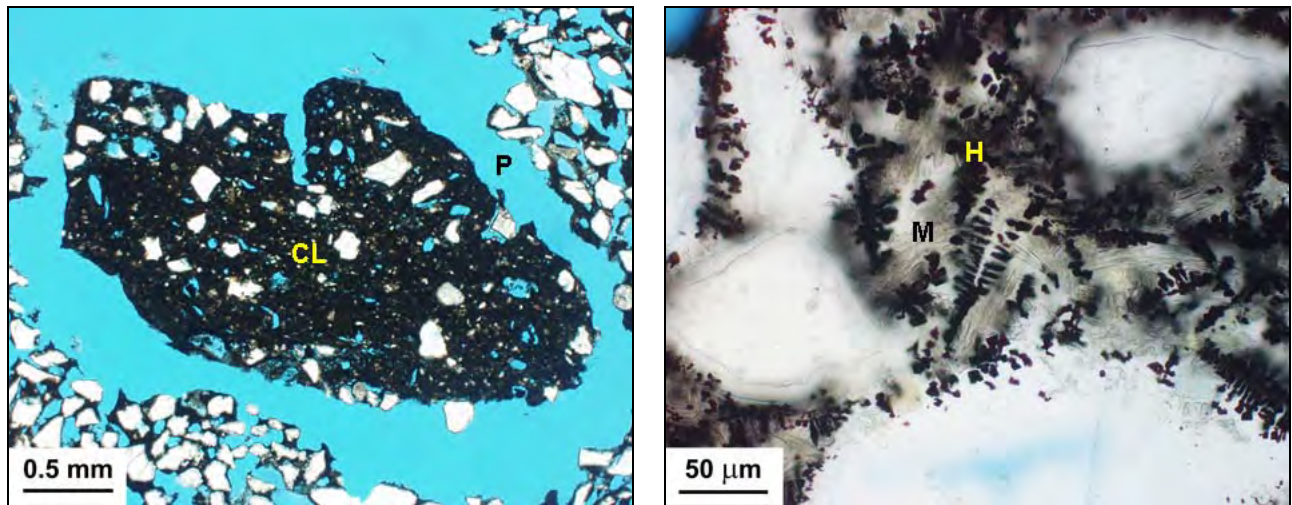
**Figure 4:** (Left PPL image) Fine clay lumps (CL) are found in minor concentration. Shrinkage of the clay-rich area has resulted in a concentric pore (P). (Right) This CPL photomicrograph was taken within the interior of one of the darker spots. The same constituents are identified. However, the hematite (H) is often coarser-grained with a dendritic texture. Additionally, the mullite (M) is sometimes more thoroughly crystallized.

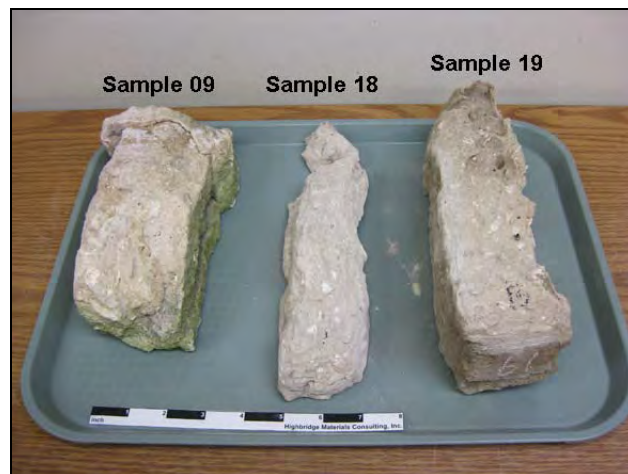
**Figure 1:** Photographs of the three tabby brick samples used for the qualitative salt determination through x-ray diffraction analysis.

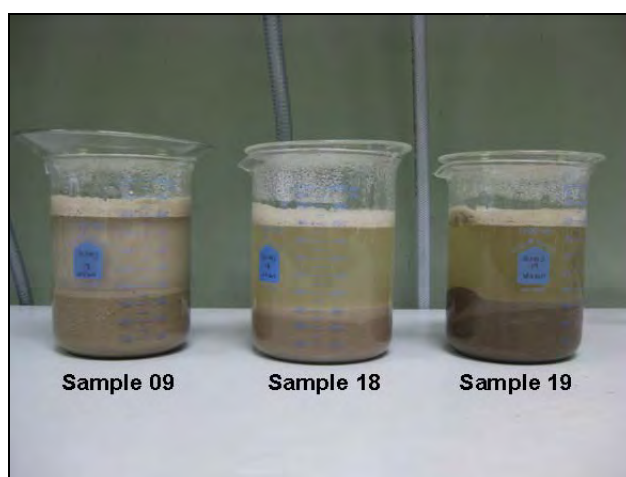
**Figure 2:** The samples are shown during the water digestion used to extract soluble salts from the crushed brick.

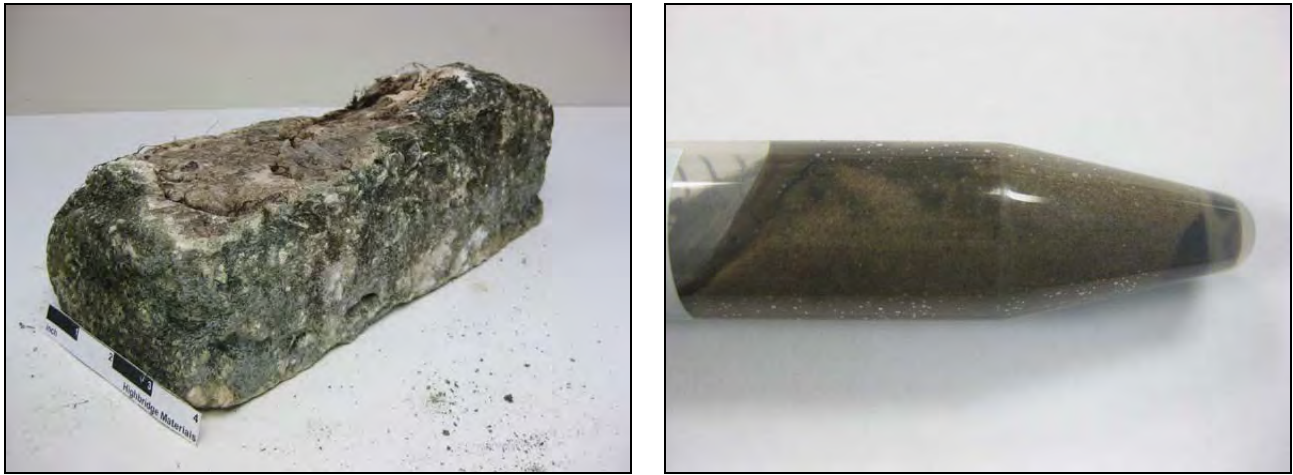
**Figure 1:** (Left) Photograph the tabby brick sample used to extract a clay sample. Sample 07 was used for this purpose. (Right) Photograph of the clays extracted from Sample 07. The extracted material is shown in the centrifuge tube.
