## **NORTH PROVIDENCE OLD TOWN HALL CONDITIONS ASSESSMENT REPORT**

2226 Mineral Spring Avenue, North Providence, RI

**May 1, 2020**

**BTGA No. 2004**

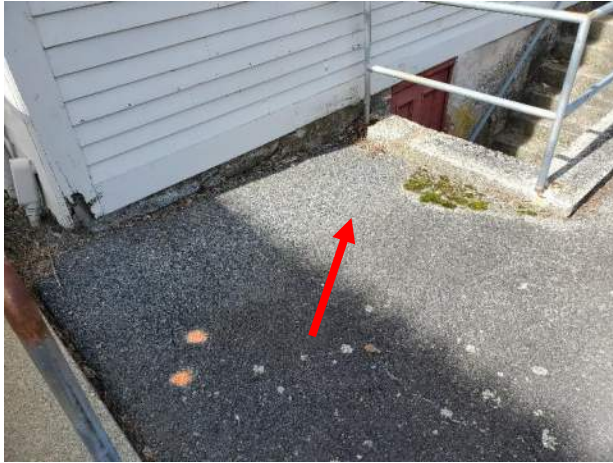
The north and south sides of the building drain well. The east side, the parking lot, has settled and ponds on either side of the stairwell to the basement. The west side is slightly sloped toward the building with the low spot along the dripline. **See Figures 3.5 – 3.9**

**Figure 3.6: Ponding south of basement stair.**

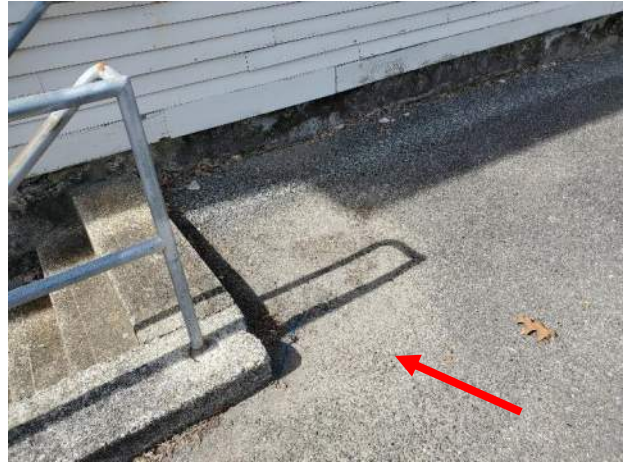
**Figure 3.7: Ponding north of basement stair.**

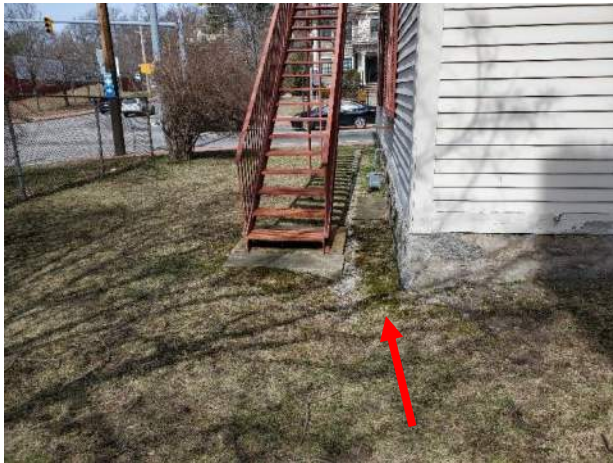
**Figure 3.8: Ponding along dripline.**

The site does not have adequate drainage which allows ponding near the foundation. When water can pond near a building moisture intrusion is inevitable.

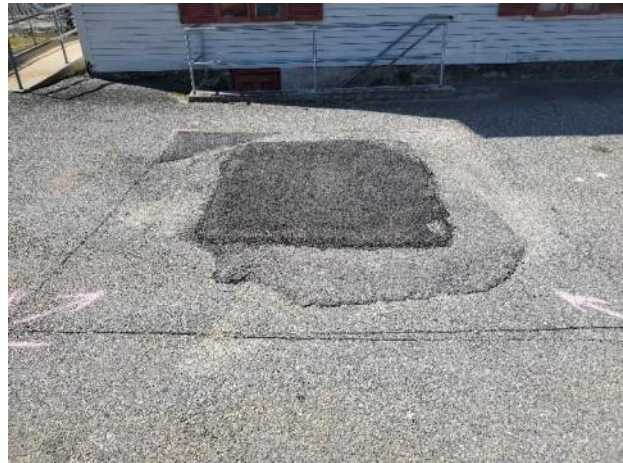
There are cuts and patches in the asphalt where unknown work was recently performed. **See Figure 3.9.**

**Figure 3.9: Recent work on Parking lot.**

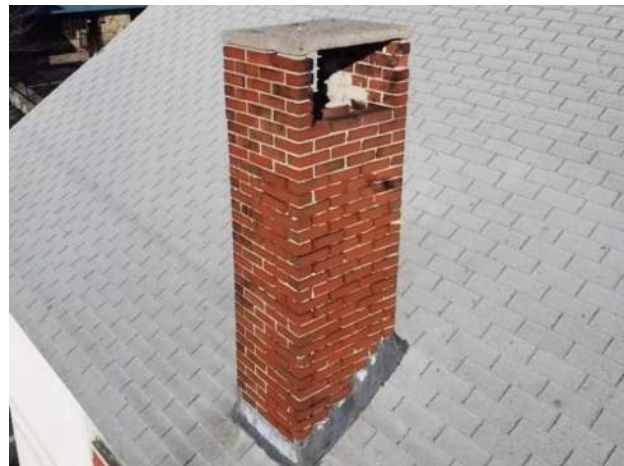
There are only 2 roof penetrations: the chimney and a plumbing vent near the east edge. Neither have proper flashing – the vent appears to only have black mastic as waterproofing while the chimney flashing, although present, is leaking copiously. There is no cricket.

The chimney masonry joints have deteriorated. The chimney may need to be demolished to the roof or further and rebuilt if beyond the point of repointing.

Figure 3.11: Chimney.

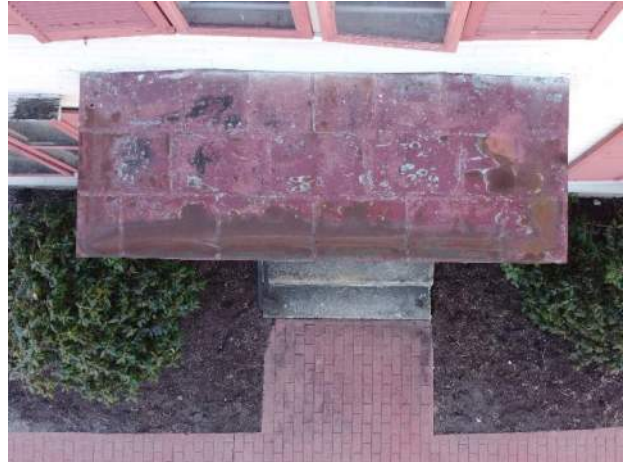
The main entrance roof appears to be made of terne metal painted red to match the shutters. No deficiencies are apparent, but wear-through is evident on the surface coatings.

Figure 3.13: Entrance Roof.

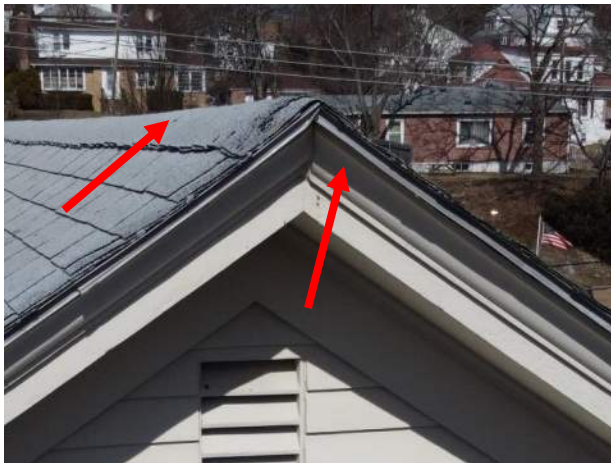
Discoloration and frayed edges indicate that the roof shingles have begun to fail. See Figure: 3.15 The roof ridge is straight and true indicating that the structure is sound. See figure 3.14

Figure 3.14: Ridge is straight, Metal edge at rake.

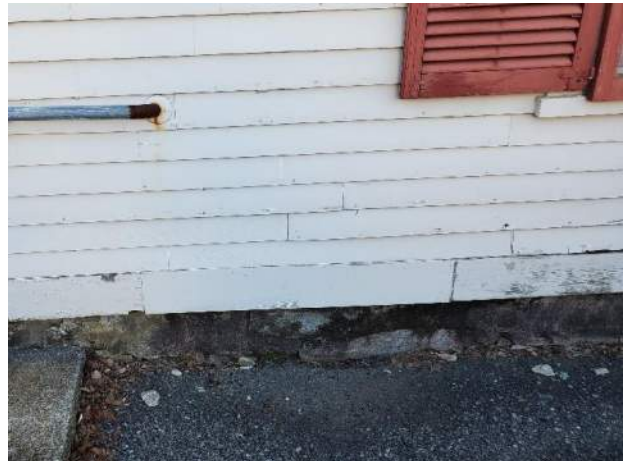
There are nail heads visible all around the building and in some cases are showing rust which is staining the siding.

Figure 3.19: Siding.

The siding has a few areas that need to be replaced. Scrape and Paint it all, including louvers in the attic.

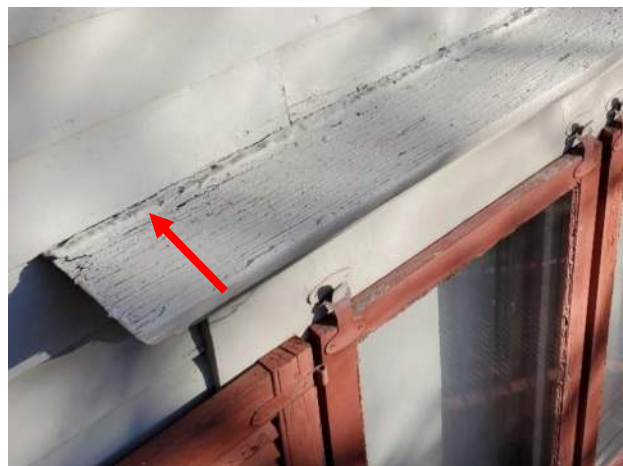
The window drip caps are painted wood without metal head flashing and some of them have the joint at the siding sealed, which directs moisture back into the wall.

Figure 3.22: Window drip cap.

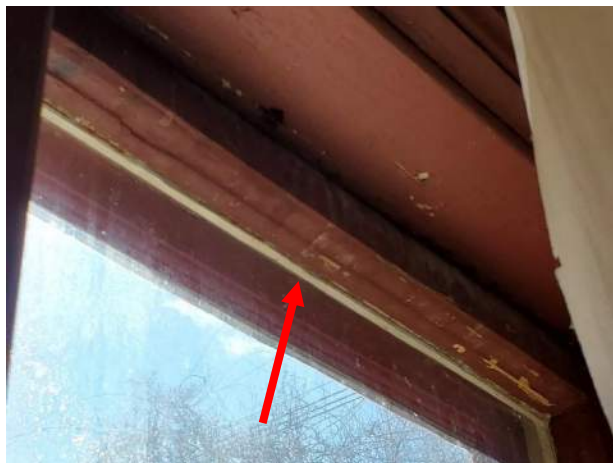
Evidence of water droplets on the top rail of this window is a sign that moisture has infiltrated the wall and found its way through the window head.

Figure 3.23: Window interior - head.

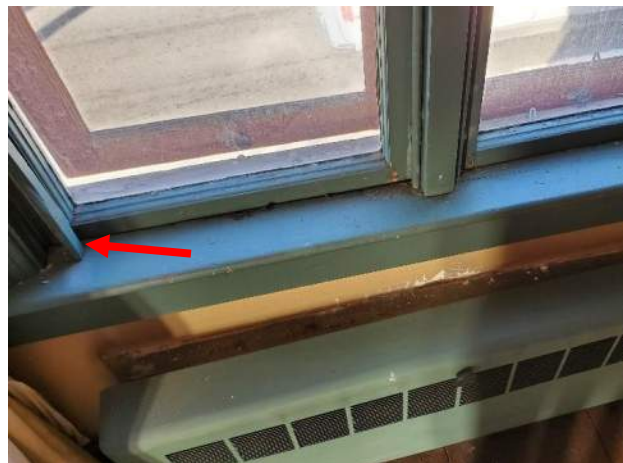
Interior stops are frequently loose and the stools, especially on south and west facing windows are damaged by moisture and UV exposure. Plaster damage around window openings is common.

Figure 3.24: Window interior - stool.

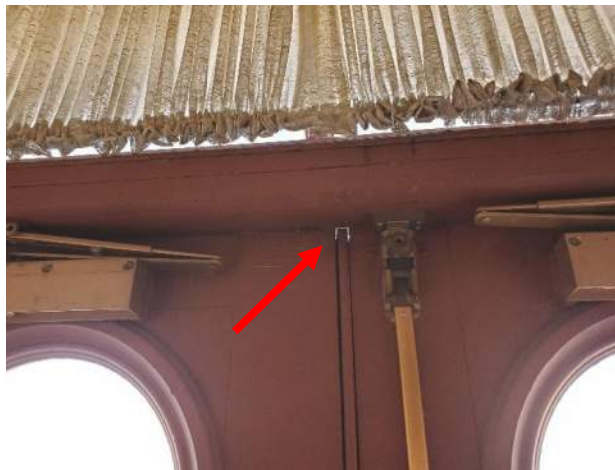
Figure 3.26: North, Front Door - Daylight.

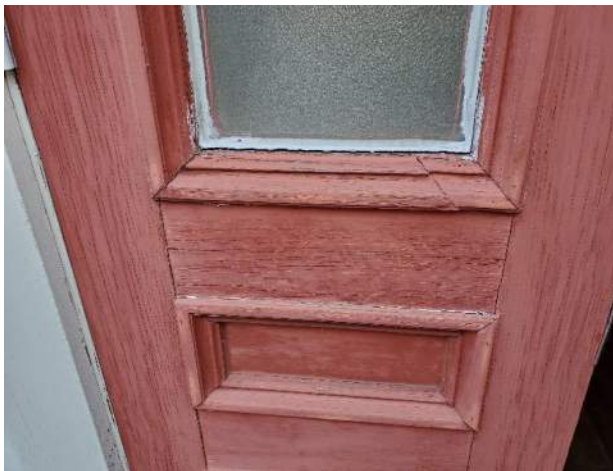
Figure 3.30: South, Back Door – Weathered paint.

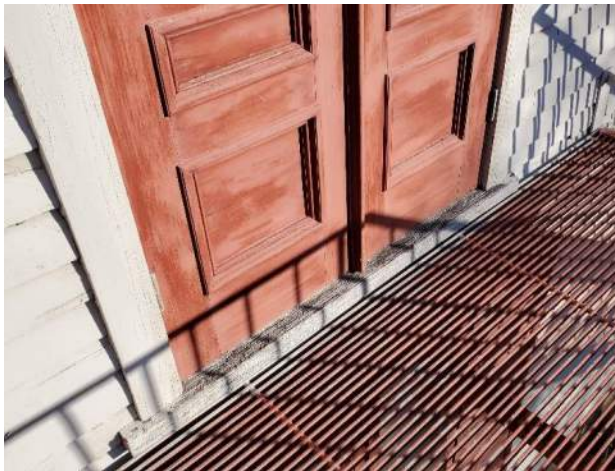
Figure 3.34: Egress Door – Weathered paint.

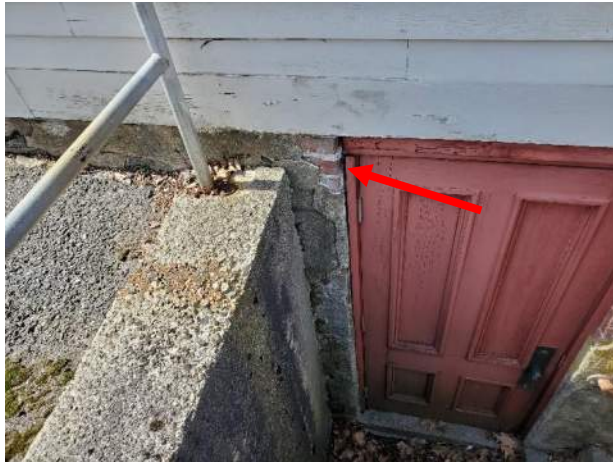
Figure 3.36: Basement Door – exposed brick.

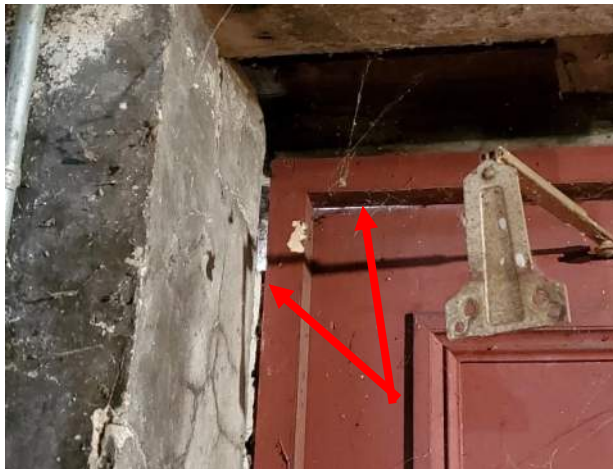
Figure 3.38: Basement Door - Daylight.

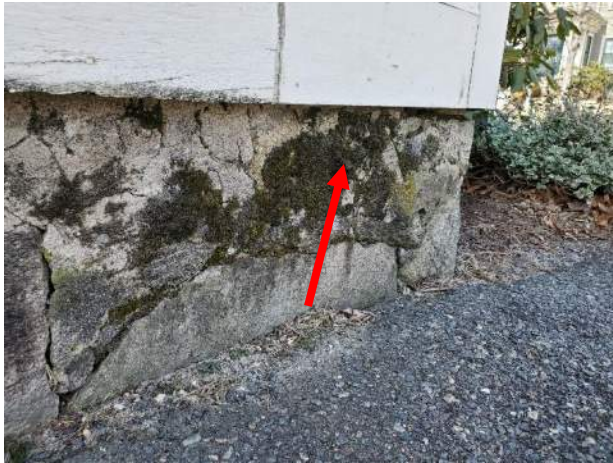
Figure 3.43: Biological growth in some areas.

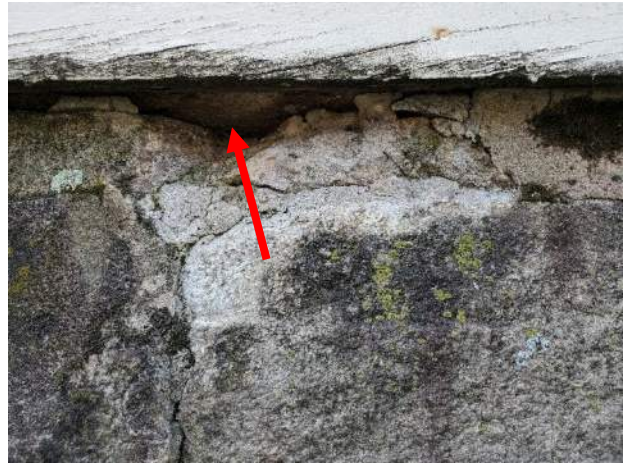
Figure 3.44: The sill plate is exposed in areas.

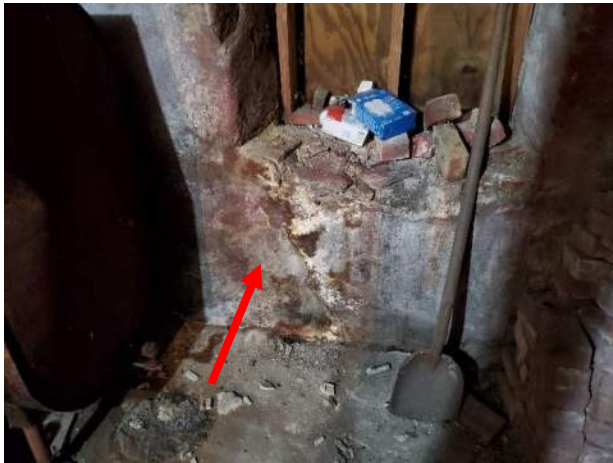
There is evidence of moisture intrusion in the basement around this opening. See figure 3.45.

Figure 3.45: Interior Coal Chute.

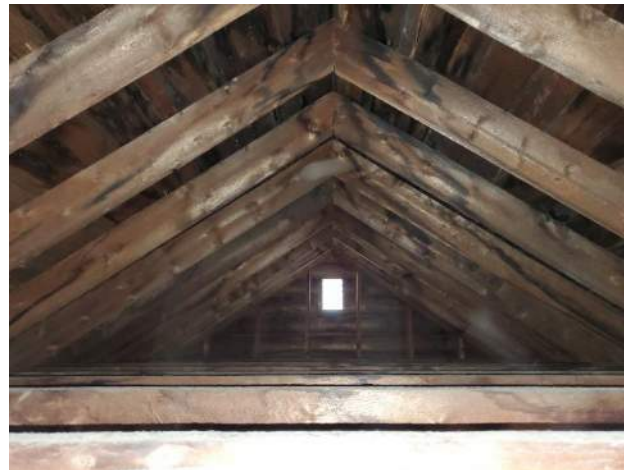
There are several places where the backside of the roof shingles is visible from inside the attic. In this photo you can see that there was a layer of roof felt in place, but over time it has become brittle and fallen away.

Figure 3.49: Attic.

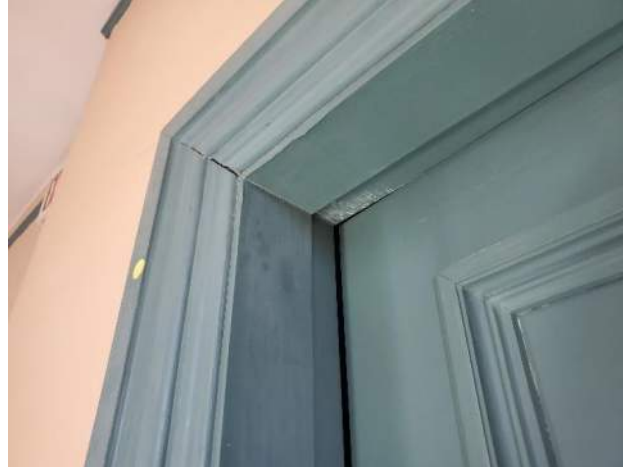
**Figure 3.56: Door 2-2 doesn't close.**

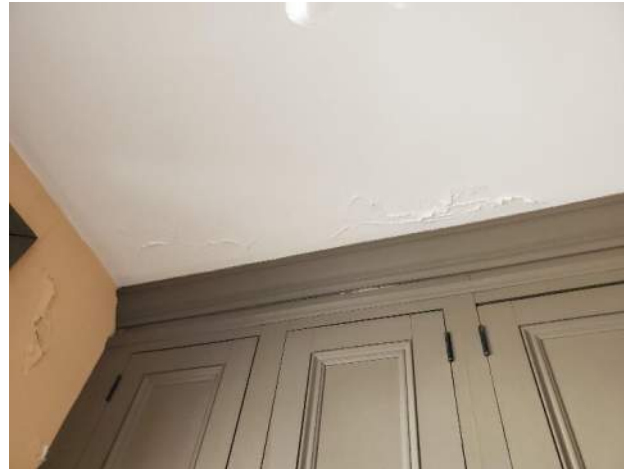
**Figure 3.69: Kitchenette ceiling.**

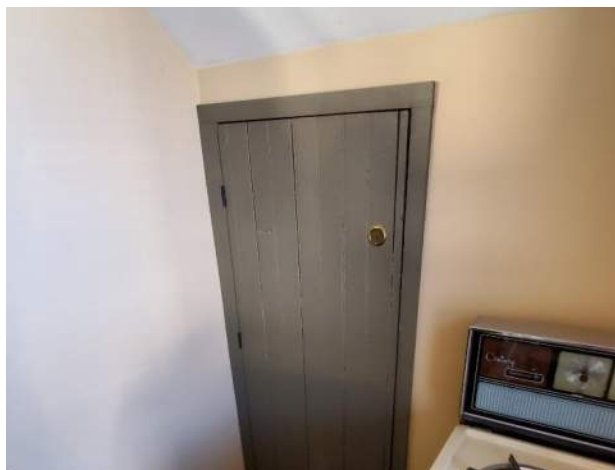
There is a dead space under the stairs only accessible by a door behind the refrigerator.

**Figure 3.71: Door behind the refrigerator.**

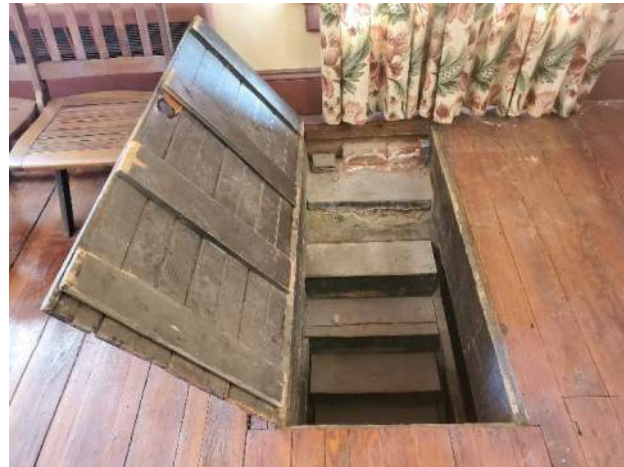
Figure 3.74: Trap Door.

The trap door to the basement is not adequate for regular use. With no landing or rails, one is forced to balance themselves while stepping down onto rickety steps, described in BUILDING INTERIOR – BASEMENT, or with nothing for stability as one pulls themselves out of the basement. This is the original access to the cell block and is designed to be restrictive in width.

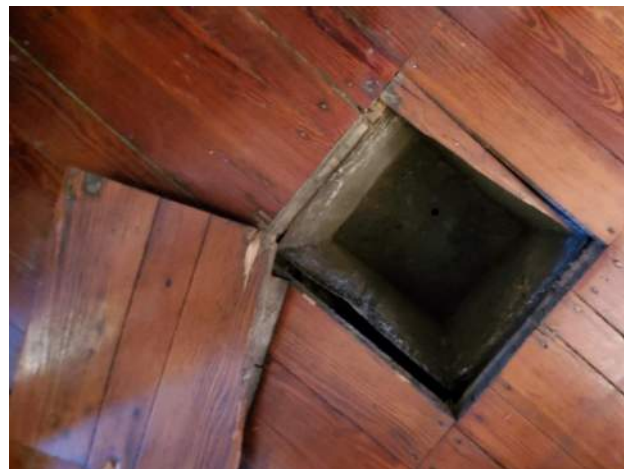
Figure 3.75: Hidden floor box.

No one knows for sure what this was for, but the most likely theory is that it was once a safety box.

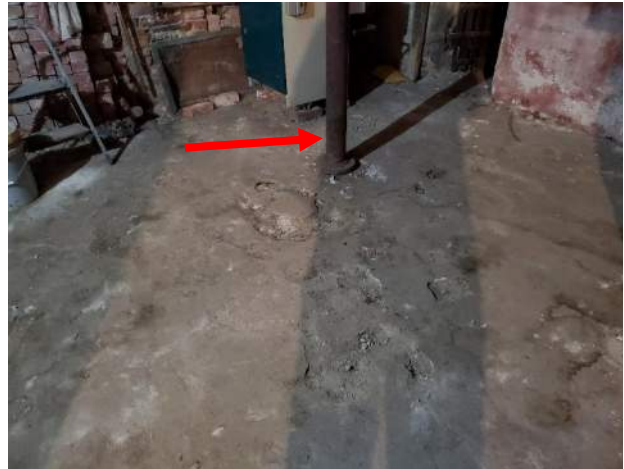
**Figure 3.80: Basement Floor.**

The basement floor is rough and pitted concrete, likely due to a lack of protection from moisture under the slab, or a poor mix.

Also shown is one of the 4 steel columns in the basement: two (2) on the east and two (2) on the west of the brick columns.

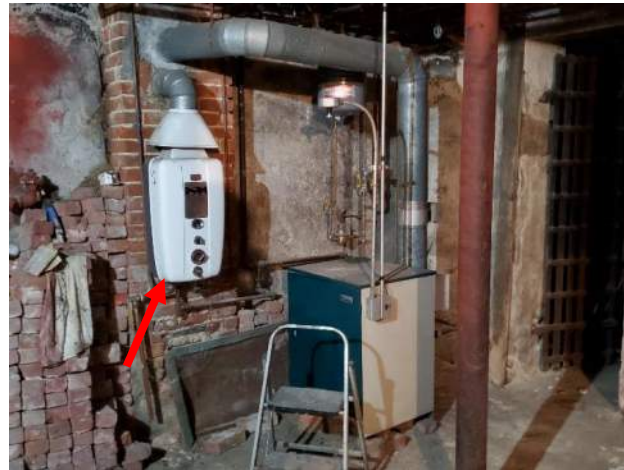
Figure 3.83: Water heater and boiler.

The building is equipped with an early-model on-demand hot water heater that appears to be nearing the end of its useful life. At the time of this observation, hot water was available at all sinks.

The Paloma gas water heater model No. PH-12A DN has been discontinued as part of the Paloma 'Legacy' Series. It was prevalent in the early 80's suggesting that it was installed during the '85 renovation.

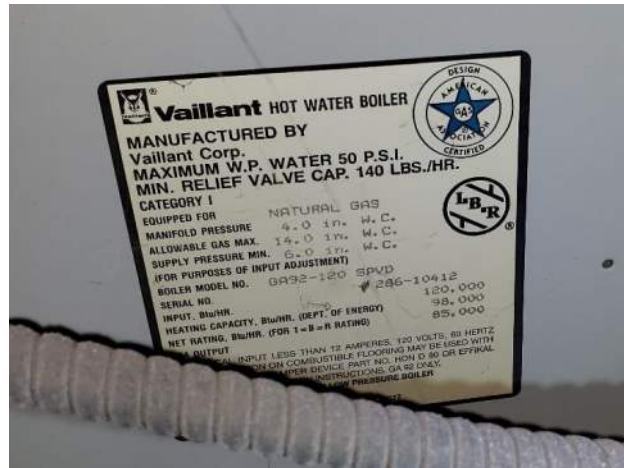
Figure 3.84: Boiler Model.

At the time of observation, the heat was active, and all convectors worked except the one on the west wall of the Council chamber; it was warm, but just barely compared to the others.

See chimney comments for liner requirements.

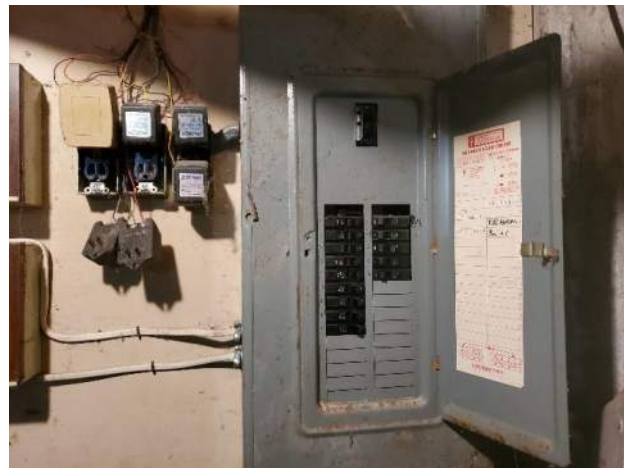
Figure 3.85: Electrical and security systems.

Portions of the building have had the wiring upgraded to modern wiring, but no evidence has been found to suggest the date of renovation. Also refer to INTERIOR CONDITIONS - ATTIC for more information.

At the time of the observation all electrical outlets were operational and all lights and switches worked except one in the hallway near the front door; Tom says that it controls the light above the front door and needs the bulb replaced to ensure that it is operational.

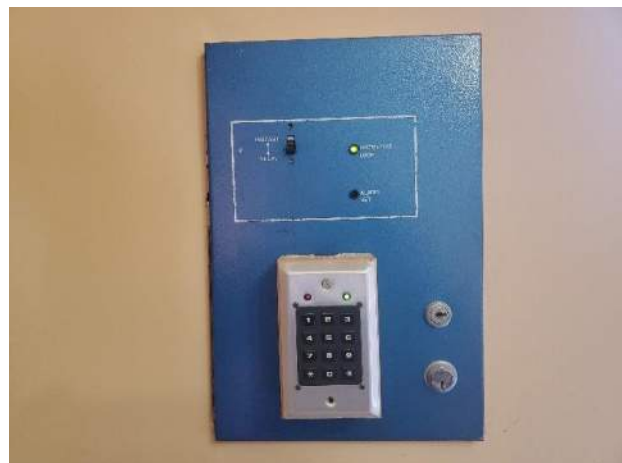
Figure 3.87: Security panel.

The security system is currently not operational, and its history is unknown. The security company is Prime Systems, Inc. of Warwick. (401) 231-9600

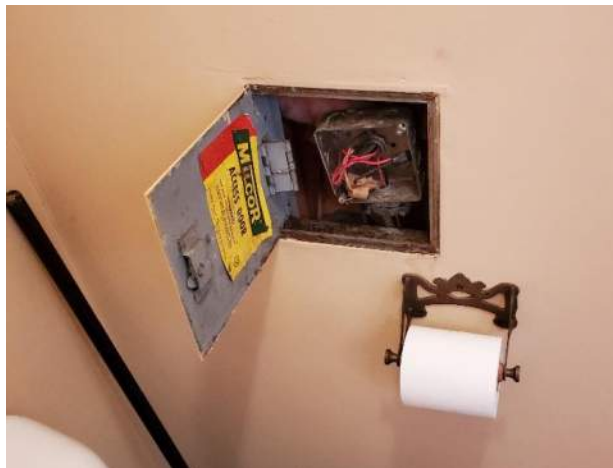
Figure 3.88: Junction box in first floor toilet room.

During attic and interior reviews, open junction boxes and non-standard wiring were observed that should be corrected immediately to avoid fire hazards.
