# CUMBERLAND TOWN HALL CONDITIONS ASSESSMENT

**45 BROAD STREET  
CUMBERLAND, RI 02864**

**ISSUED:**

18 June 2020

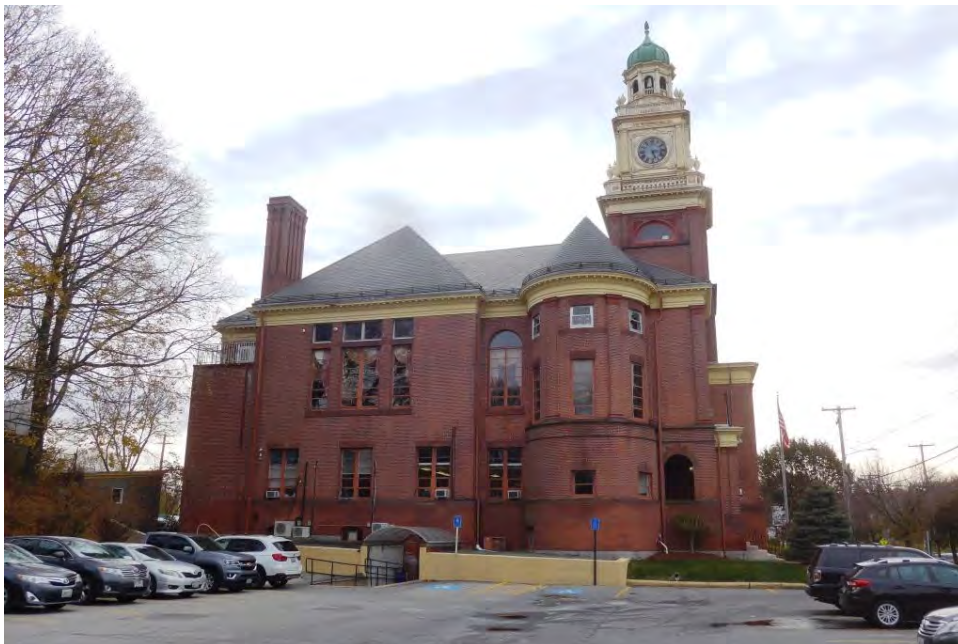
Cumberland Town Hall – Exterior Overalls  
North Elevation – Overall  
Note: Ponded water in parking lot

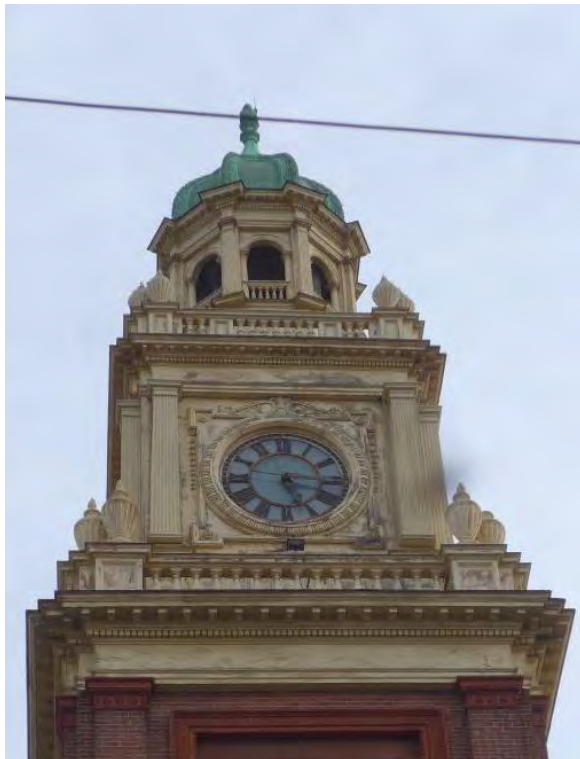
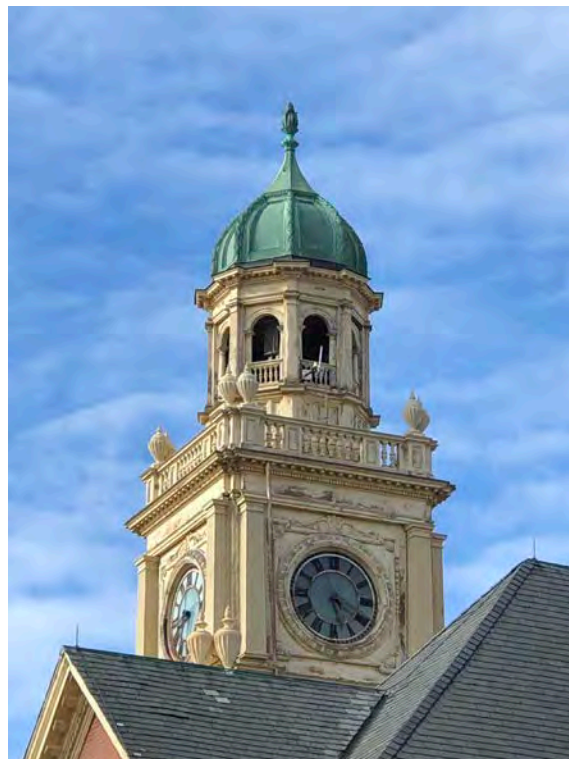
Cumberland Town Hall – Exterior Overalls – Exterior Woodwork  
Tower – Left: West Elevation; Right: East Elevation  
Note: Peeling Paint

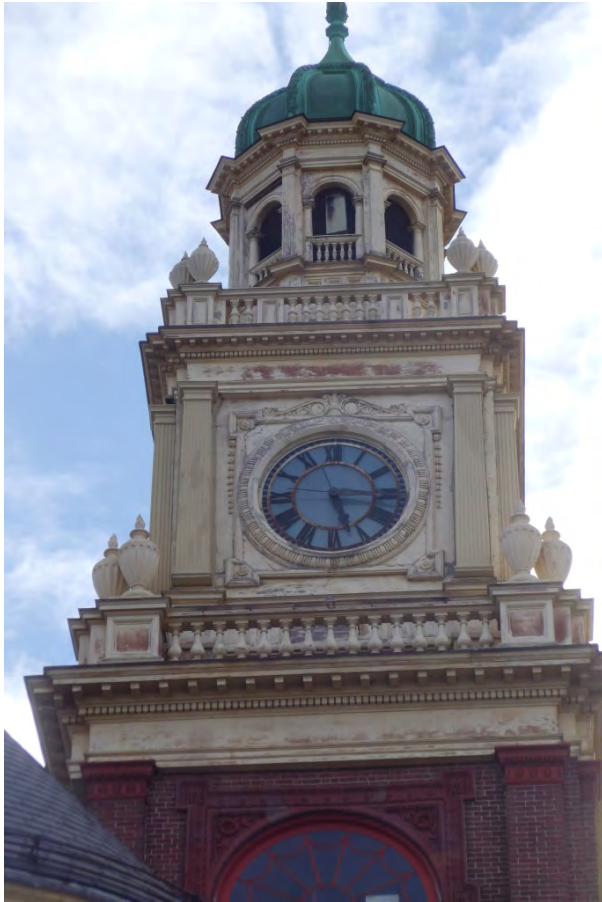
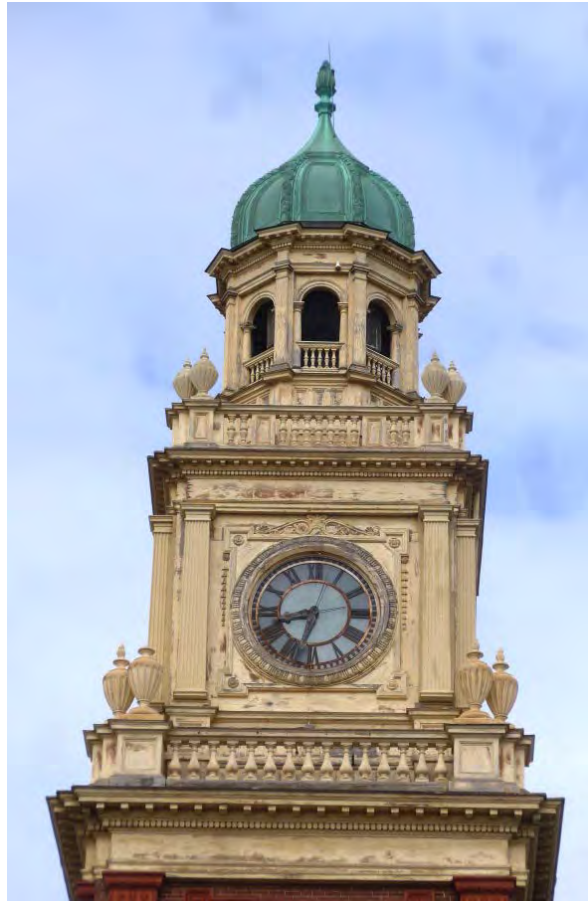
Cumberland Town Hall – Exterior Overalls – Exterior Woodwork  
Tower – Left: North Elevation; Right: South Elevation  
Note: Peeling Paint

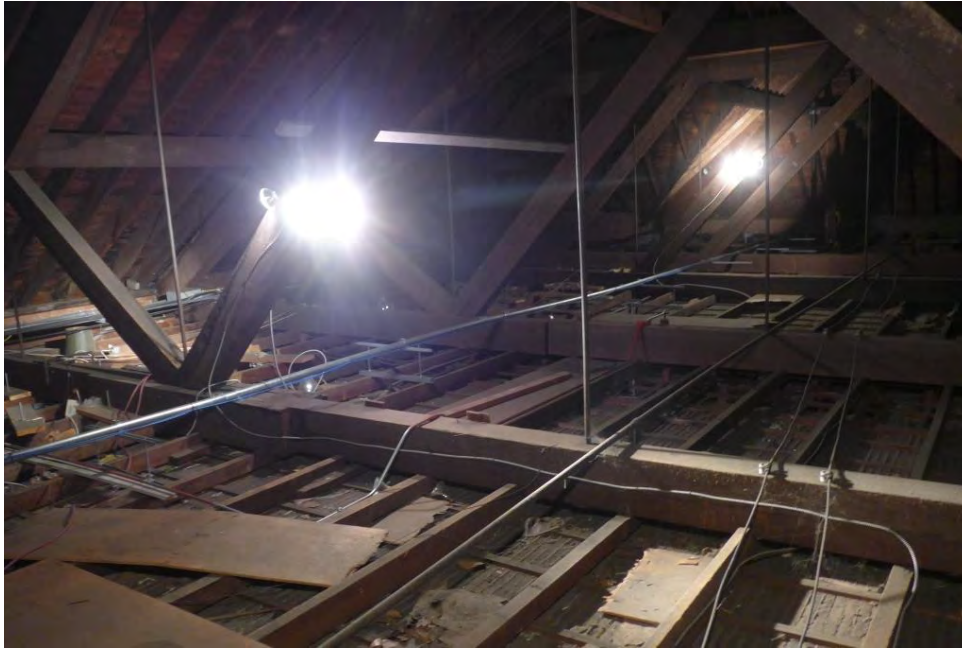
Cumberland Town Hall – Structure  
Attic – Looking East  
In Good Condition

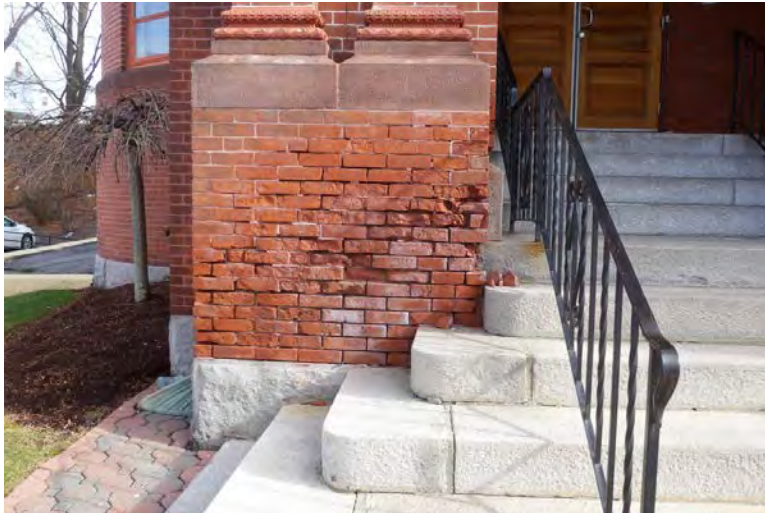
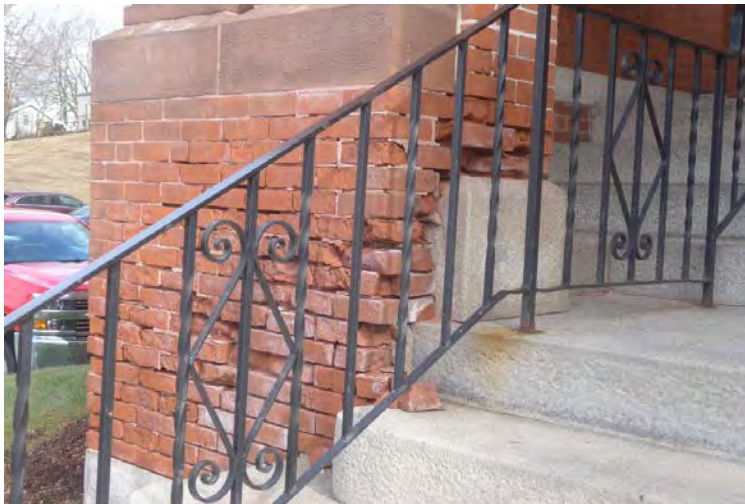
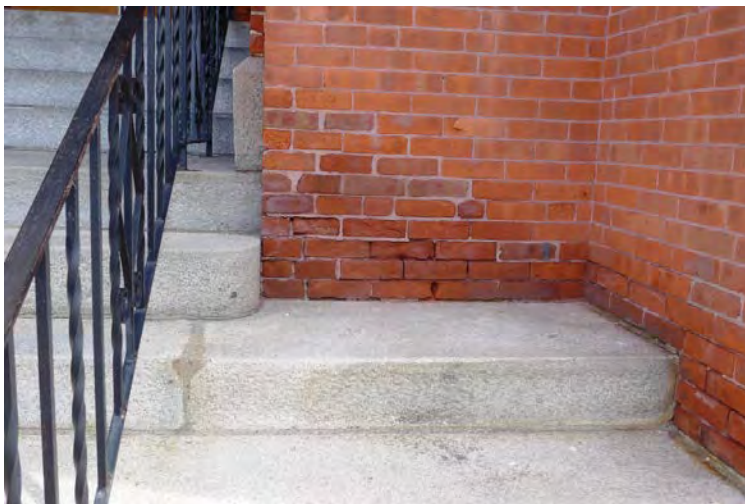
Cumberland Town Hall – Exterior - Masonry  
West Elevation – North Pavilion - Entrance - Details  
Open Joints, Eroded Brickwork Due to Salts in Ice-melting Products

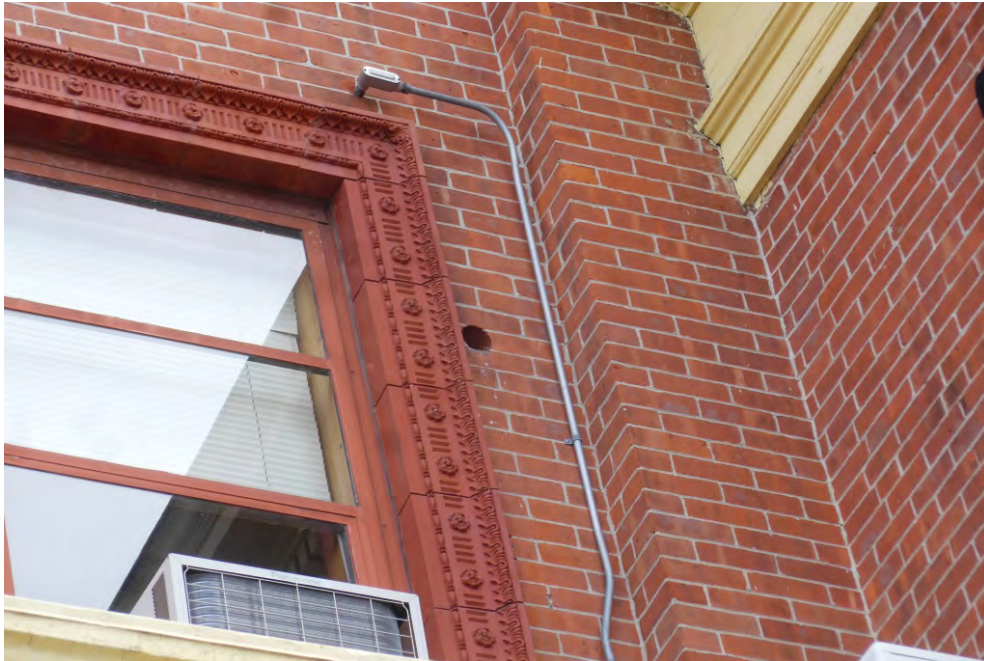
Cumberland Town Hall – Exterior - Masonry  
West Elevation – North Pavilion – South Window - Second Floor – Window above Entrance  
Open Joints, Eroded Brickwork

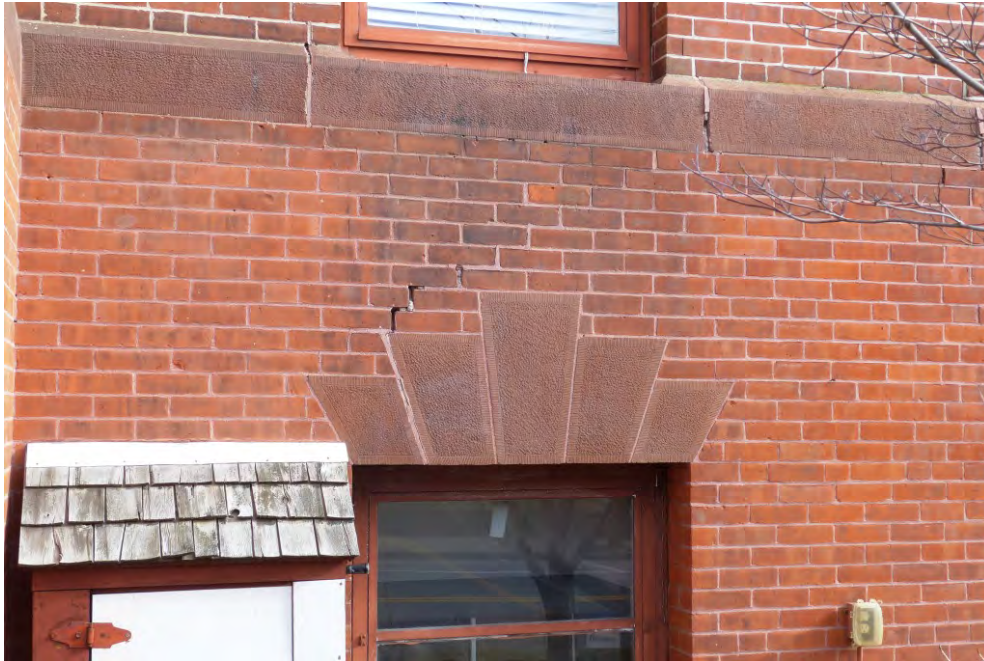
Cumberland Town Hall – Exterior - Masonry  
West Elevation – South Pavilion – North Window - Basement Level  
Open Joints, Step Crack

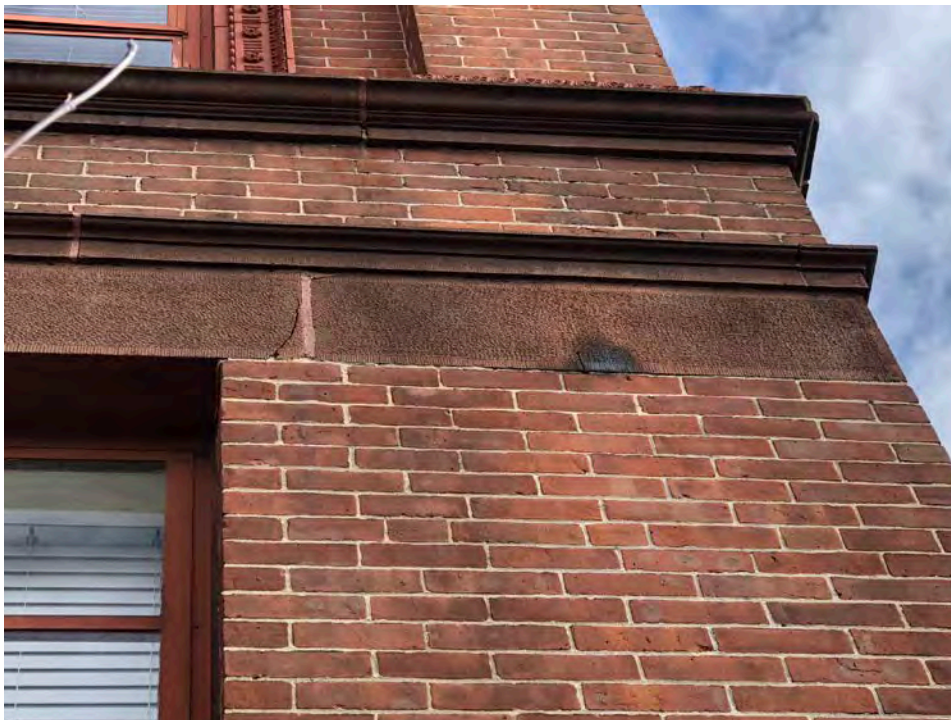
Cumberland Town Hall – Exterior - Masonry  
West Elevation – South Pavilion – South Corner - First Floor – South Corner  
Cracked Brownstone, Staining

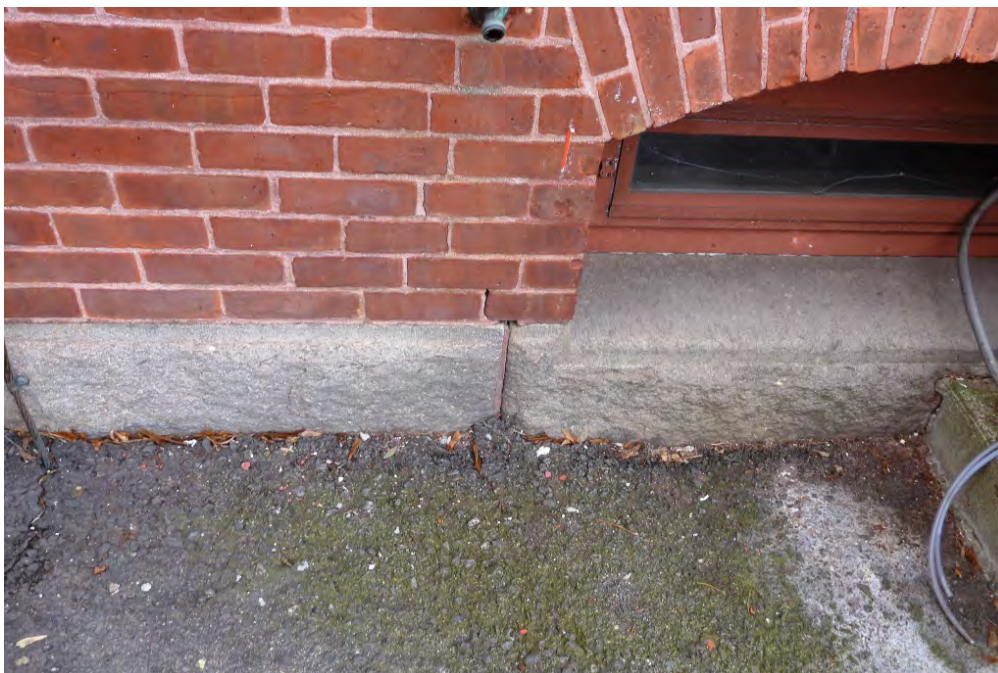
Cumberland Town Hall – Exterior - Masonry  
North Elevation – Base of Building  
Open Joints in Masonry

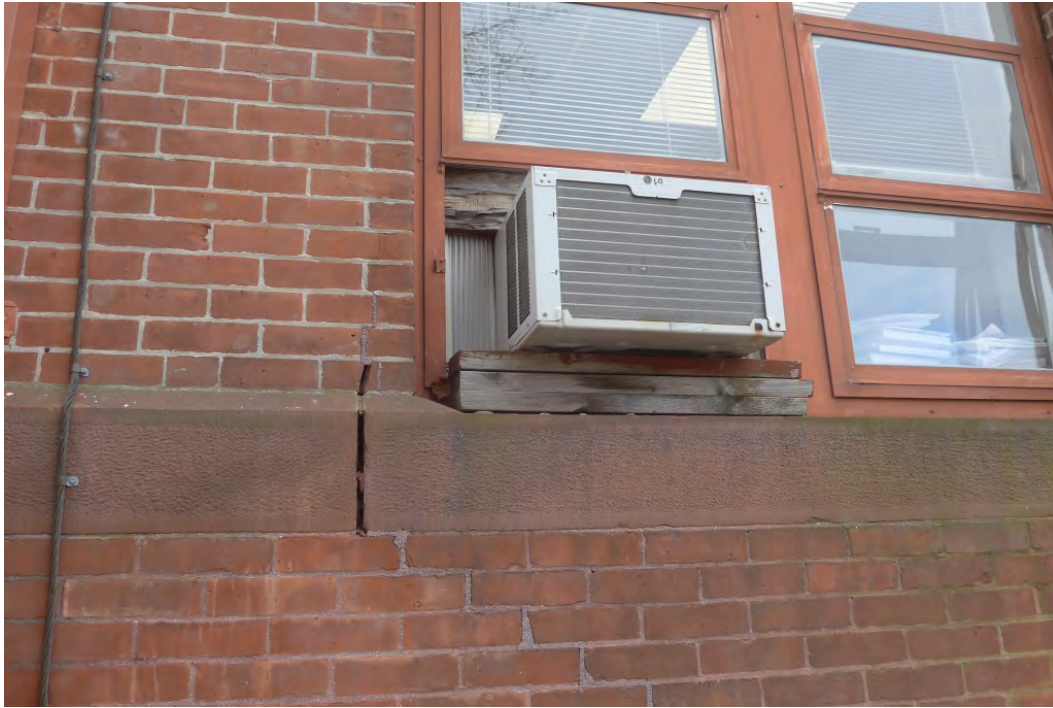
Cumberland Town Hall – Exterior - Masonry  
North Elevation – Central Pavilion – East Window  
Open Joints in Masonry

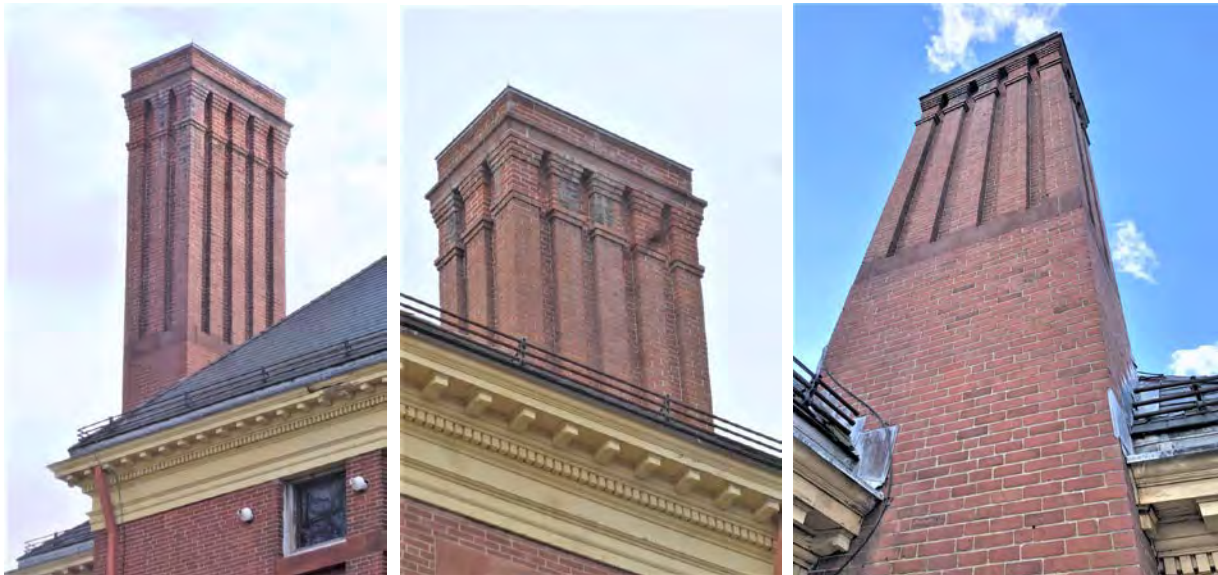
Cumberland Town Hall – Exterior - Masonry  
Chimney at Northeast Corner – Left: North and East Elevations; Center: South and East Elevations; Right: East Elevation  
In Good Condition

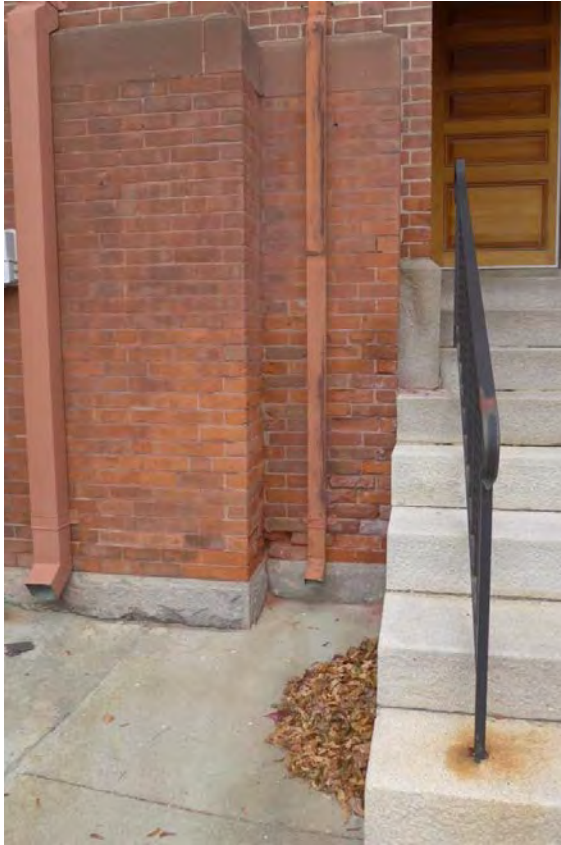
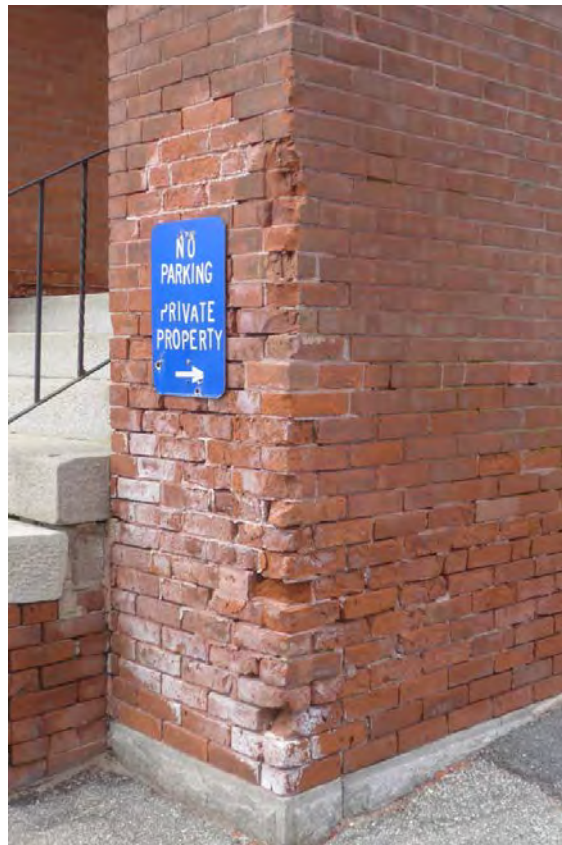
Cumberland Town Hall – Exterior – Masonry  
South and East Elevations - Southeast Corner – Entrance  
Open Joints, Deteriorated/Missing Brickwork; Staining

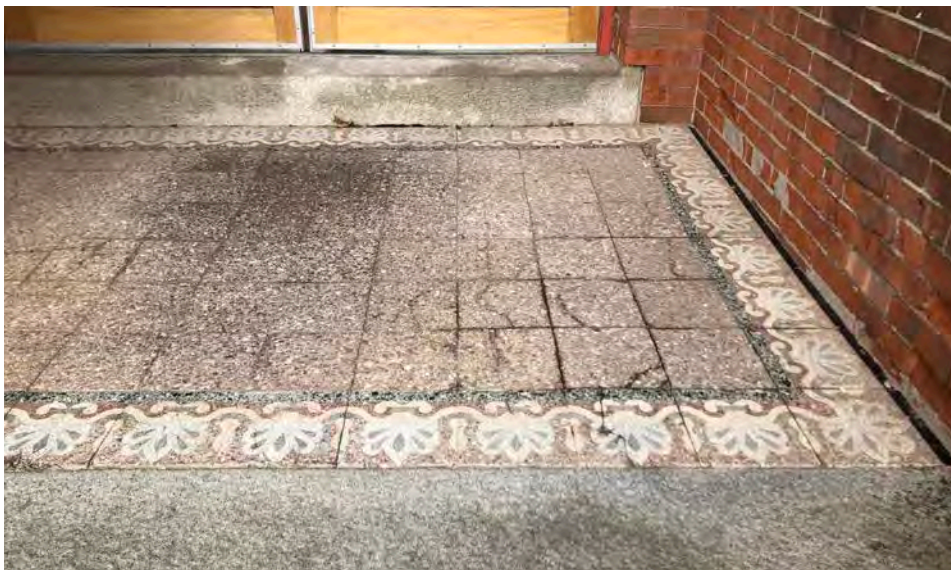
Cumberland Town Hall – Exterior - Masonry  
Southeast Corner – Entrance Porch  
Open Joints, Cracked & Deteriorated Pavers; Staining

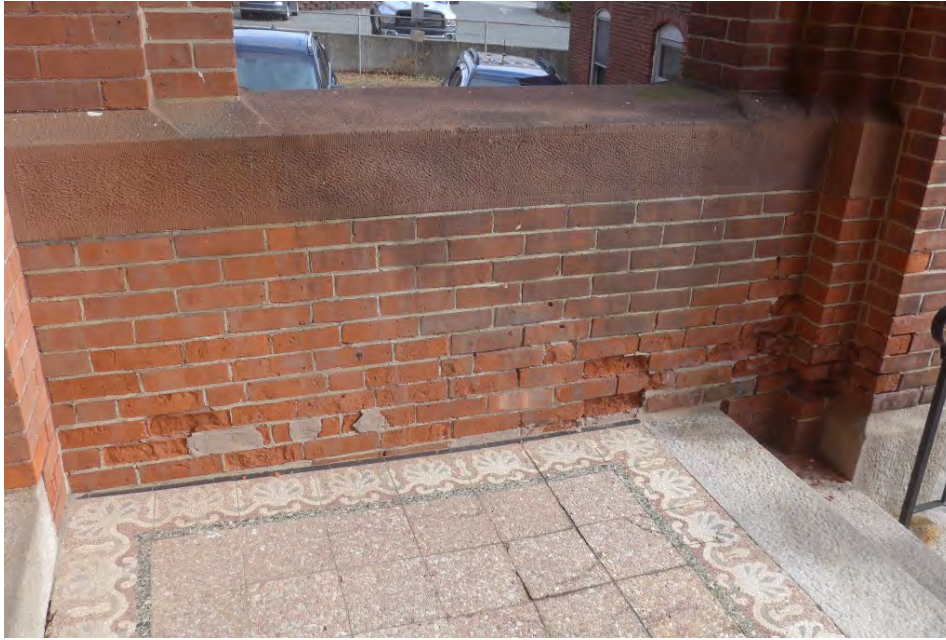
Cumberland Town Hall – Exterior - Masonry  
Southeast Corner – Entrance Porch  
Open Joints, Deteriorated/Missing Brickwork; Staining

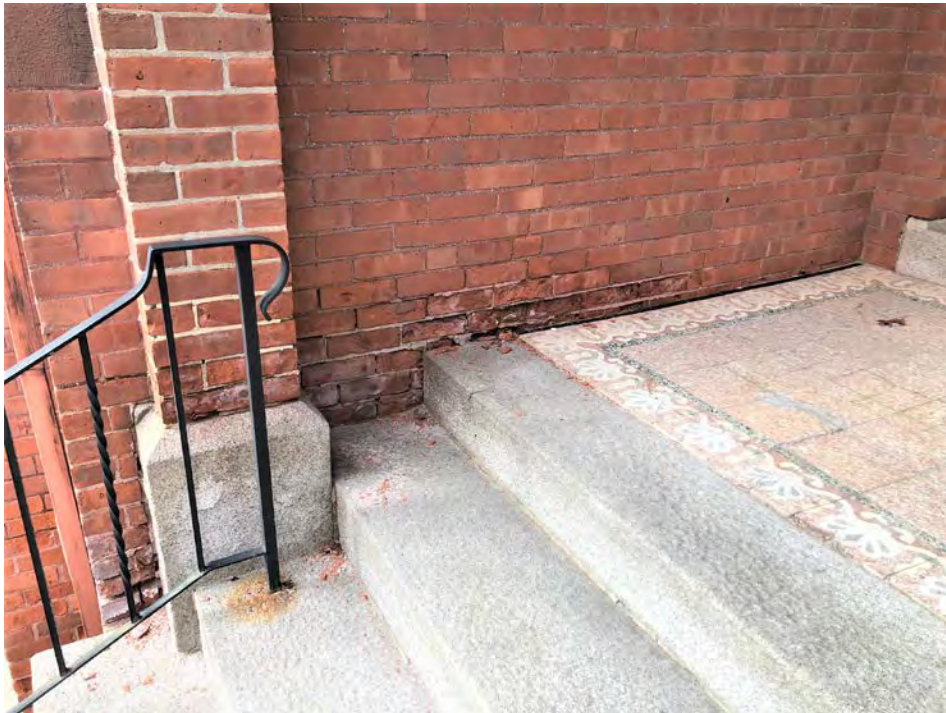
Cumberland Town Hall – Exterior - Masonry  
Southeast Corner – Entrance Porch  
Open Joints, Improperly Pointed (Hard) Mortar Joints; Deteriorated/Missing Brickwork; Staining

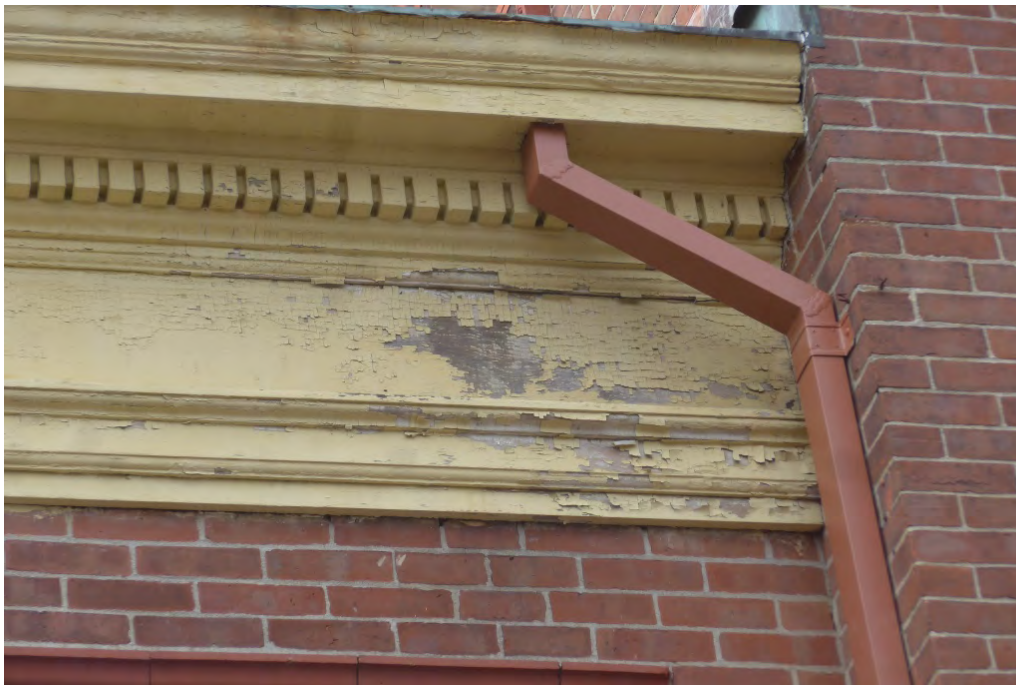
Cumberland Town Hall – Exterior – Wood Elements  
East Elevation – Above Entrance Porch  
Worn/Peeling Paint

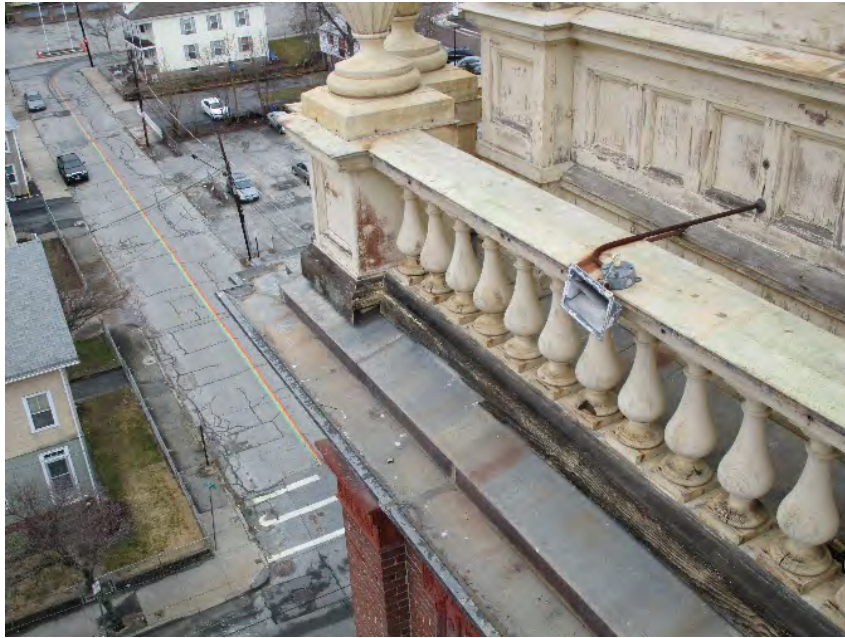
Cumberland Town Hall – Exterior – Wood Elements  
Tower – Lower Balustrade at Clock Level (Sixth Floor)  
Flaking and Deteriorated Paint , -Deteriorated Wood and Rusting Light Fixture Conduit  
Source: Town of Cumberland

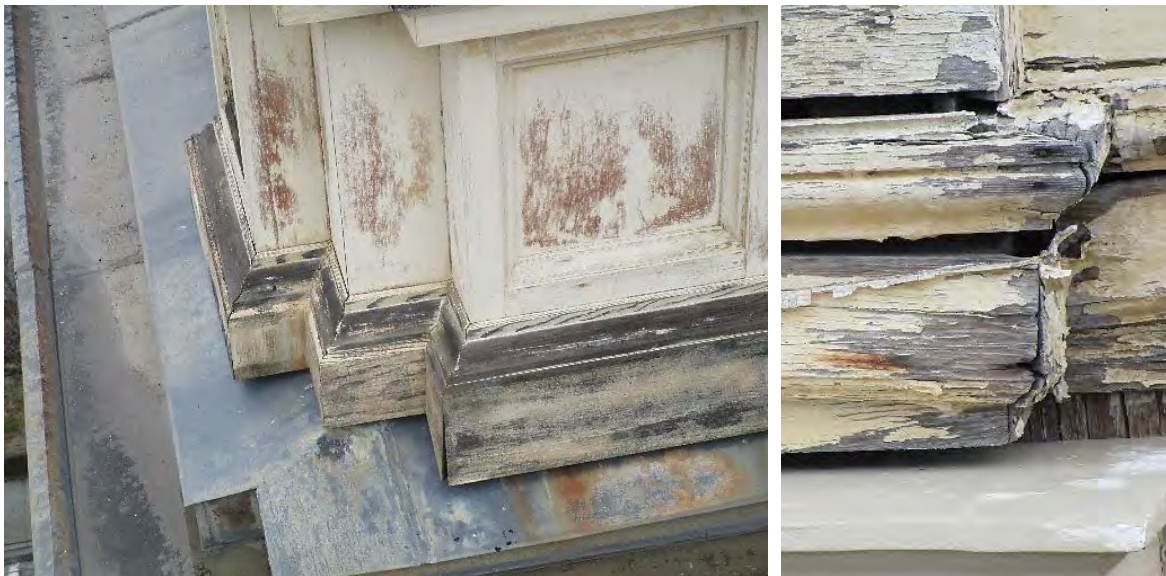
Cumberland Town Hall – Exterior – Wood Elements  
Tower – Lower Balustrade at Clock Level (Sixth Floor)  
Flaking and Deteriorated Paint – Some Deteriorated Wood  
Source: Town of Cumberland

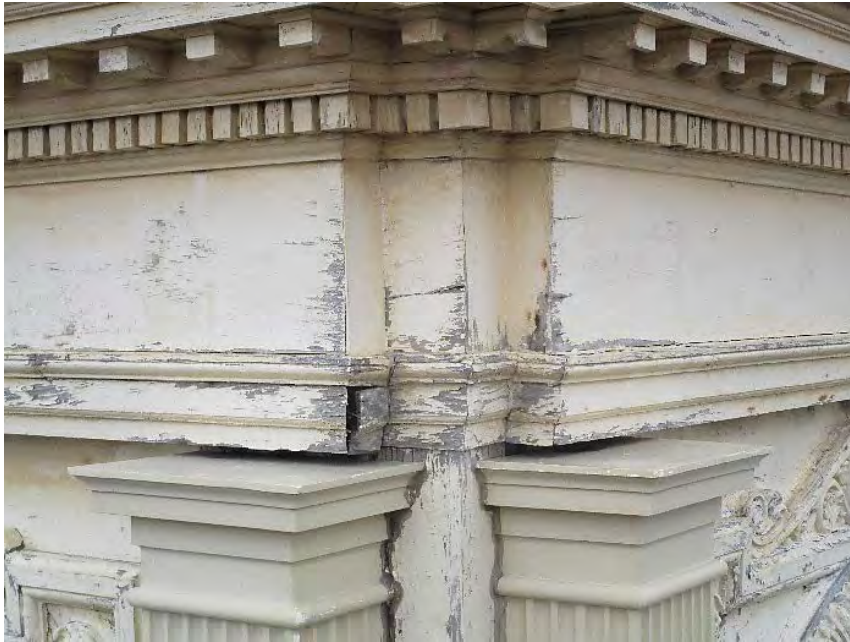
Cumberland Town Hall – Exterior – Wood Elements  
Tower – Clock Level (Sixth Floor)  
Flaking and Deteriorated Paint – Some Deteriorated Wood  
Source: Town of Cumberland

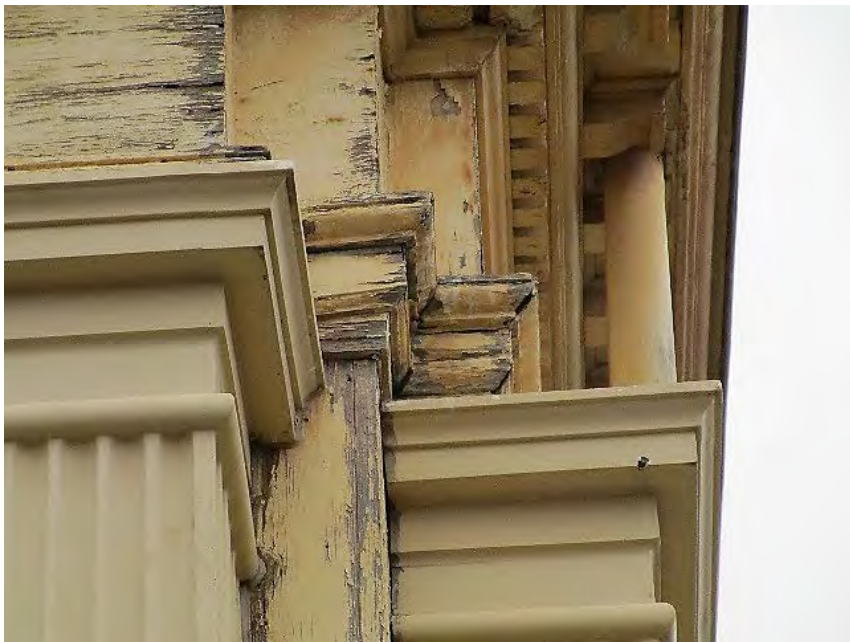
Cumberland Town Hall – Exterior – Wood Elements  
Tower – Clock Level (Sixth Floor)  
Flaking and Deteriorated Paint – Some Deteriorated Wood  
Source: Town of Cumberland

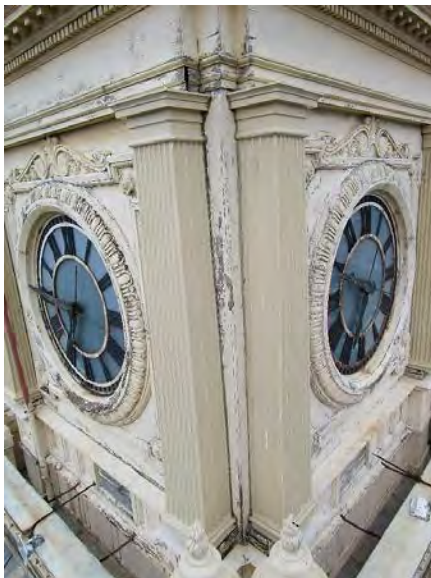
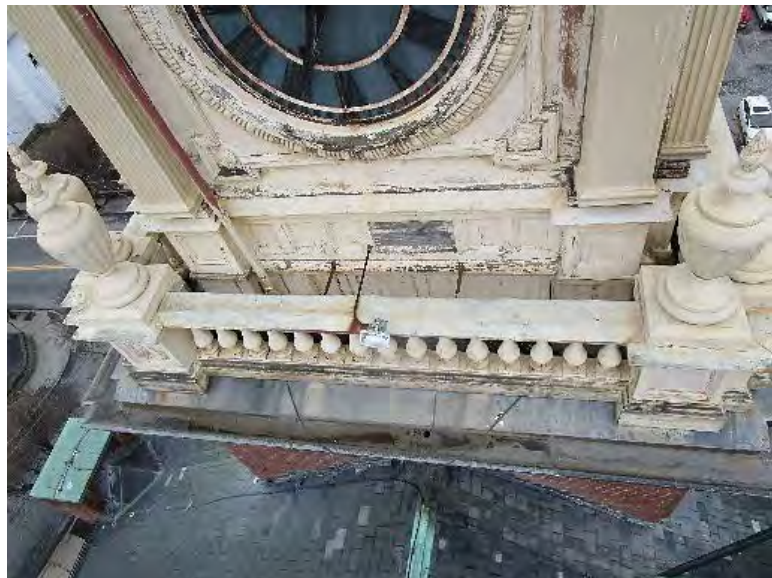
Cumberland Town Hall – Exterior – Wood Elements  
Tower – Clock Level (Sixth Floor)  
Flaking and Deteriorated Paint – Some Deteriorated Wood  
Source: Town of Cumberland

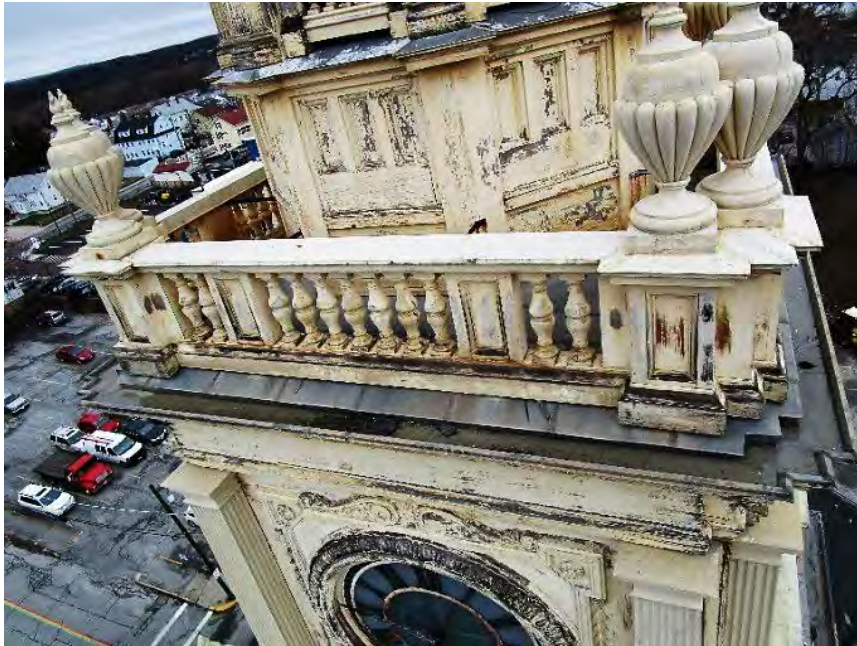
Cumberland Town Hall – Exterior – Wood Elements  
Tower – Base of Cupola and Upper Balustrade  
Flaking and Deteriorated Paint – Some Deteriorated Wood  
Source: Town of Cumberland

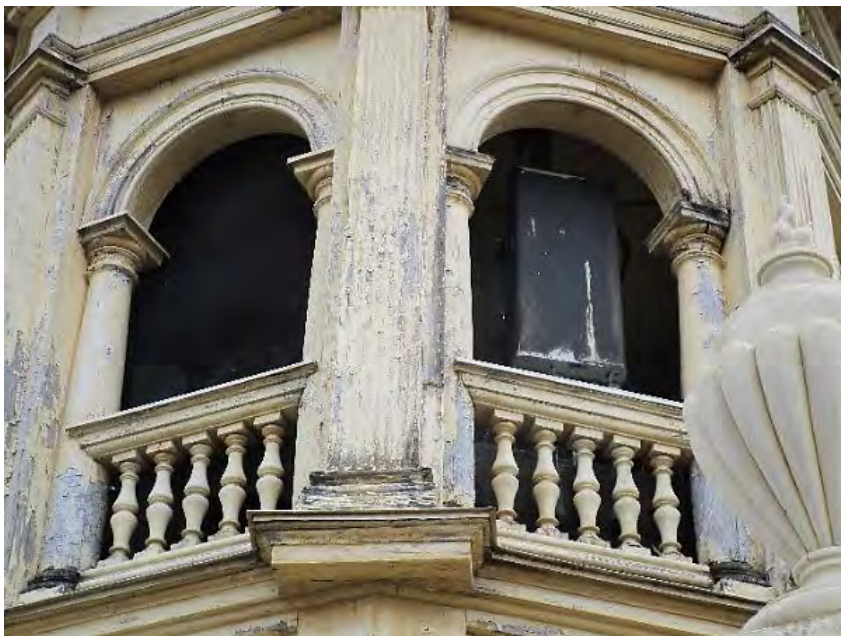
Cumberland Town Hall – Exterior – Wood Elements  
Tower – Cupola at Bell Level  
Flaking and Deteriorated Paint – Some Deteriorated Wood  
Source: Town of Cumberland

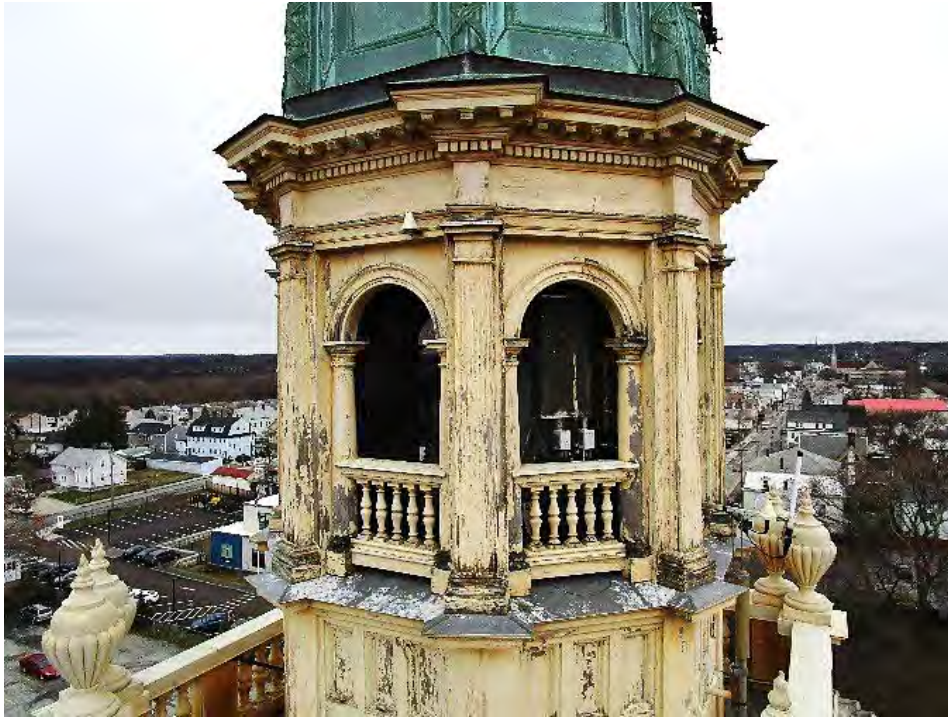
Cumberland Town Hall – Exterior – Wood Elements  
Tower – Cupola at Bell Level  
Flaking and Deteriorated Paint – Some Deteriorated Wood  
Source: Town of Cumberland

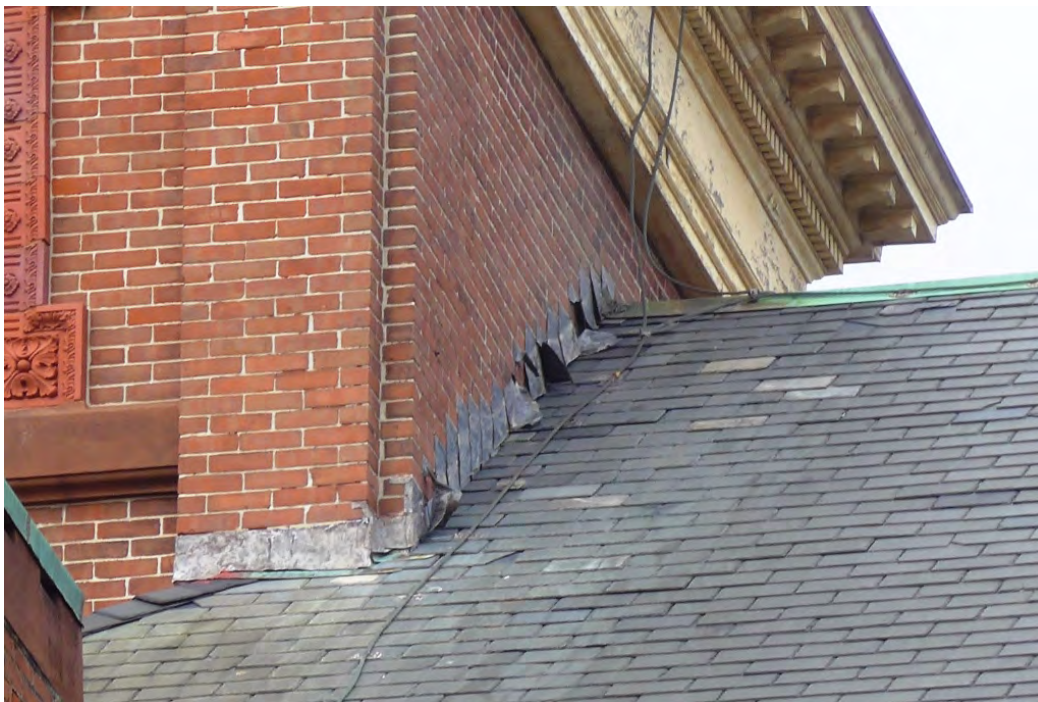
Cumberland Town Hall – Roofing, Flashing, Gutters, Leaders, Metal Trim and Roofing Elements  
Base of Tower at East Elevation  
Lifting and Damaged Step Flashing and Cracked Slates

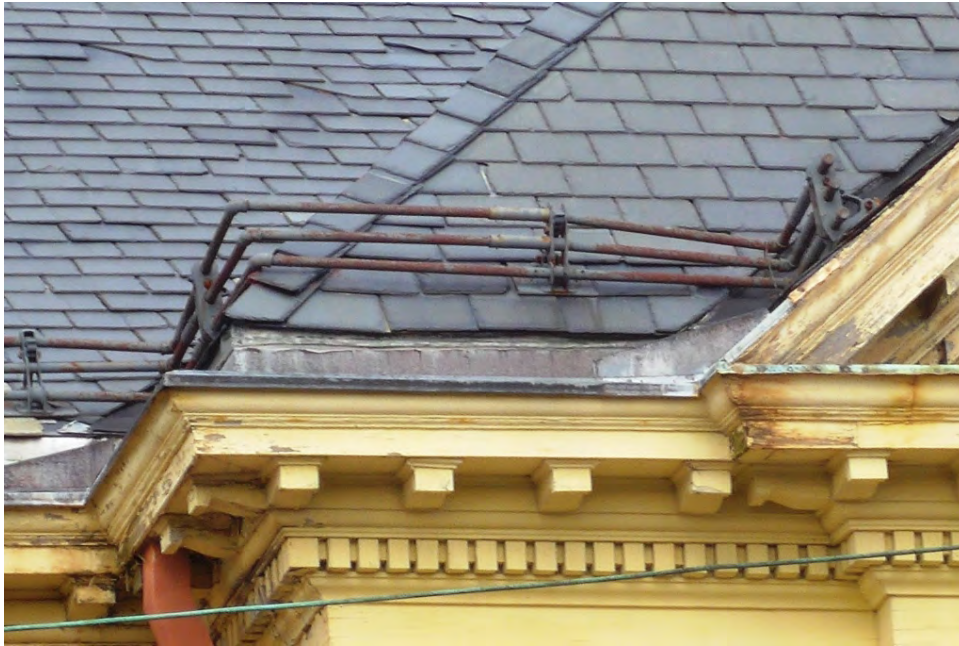
Cumberland Town Hall – Roofing, Flashing, Gutters, Leaders, Metal Trim and Roofing Elements  
South Elevation – West Corner of Central Pavilion  
Damaged Snow Guard Piping; Cracked Slates

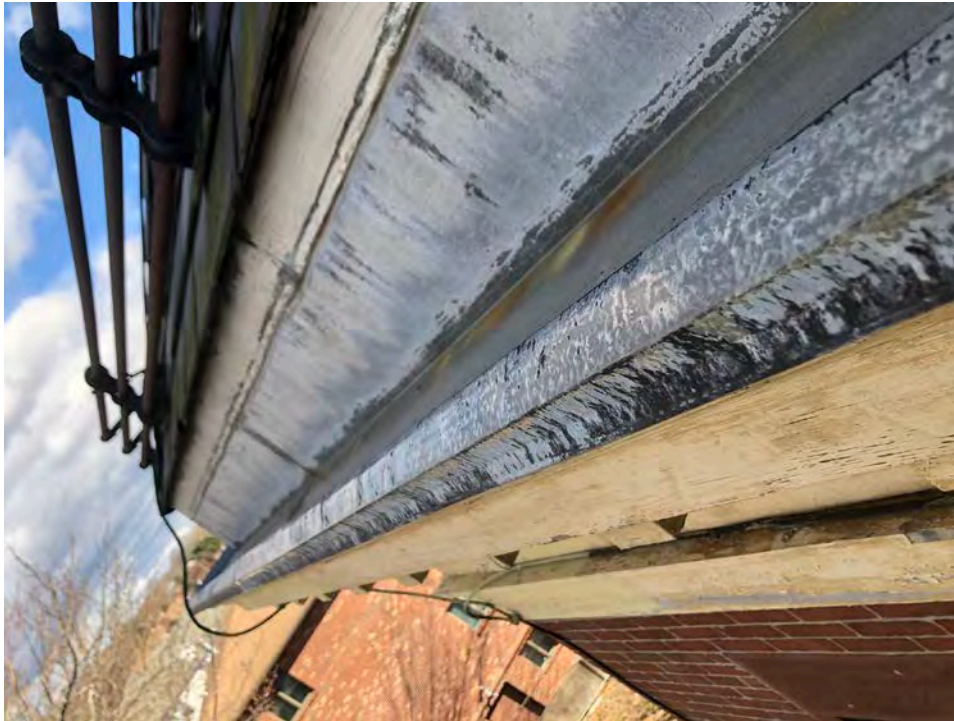
Cumberland Town Hall – Roofing, Flashing, Gutters, Leaders, Metal Trim and Roofing Elements  
North Elevation – Above Elevator Addition – Gutter built into Cornice  
Gutter too Shallow to Facilitate Lengthy Distance to Downspout

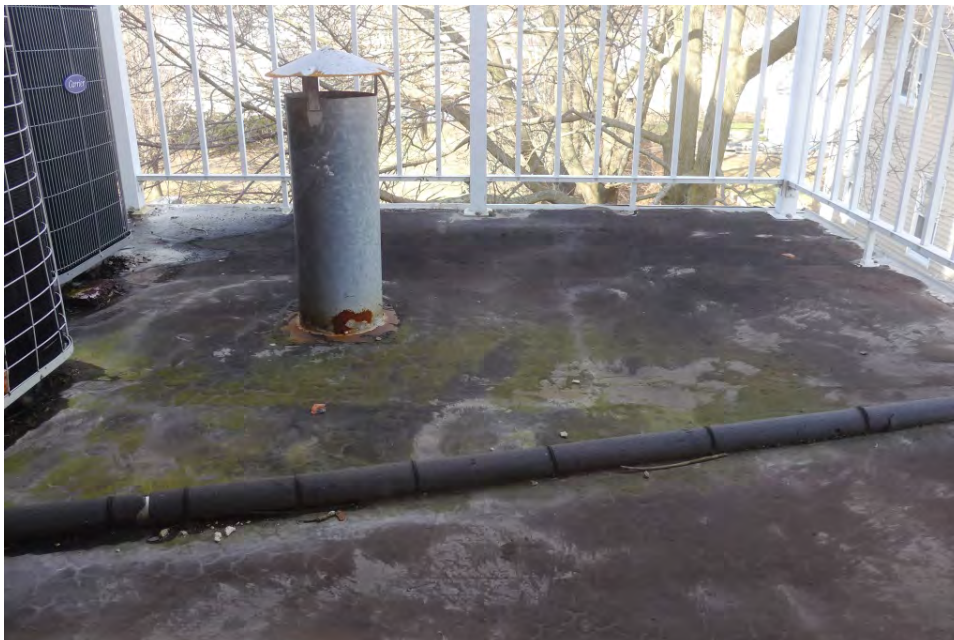
Cumberland Town Hall – Roofing, Flashing, Gutters, Leaders, Metal Trim and Roofing Elements  
Roof Above Elevator Addition  
Rubber Membrane Roof Stained and in Poor Condition; Rusting Metal Vent

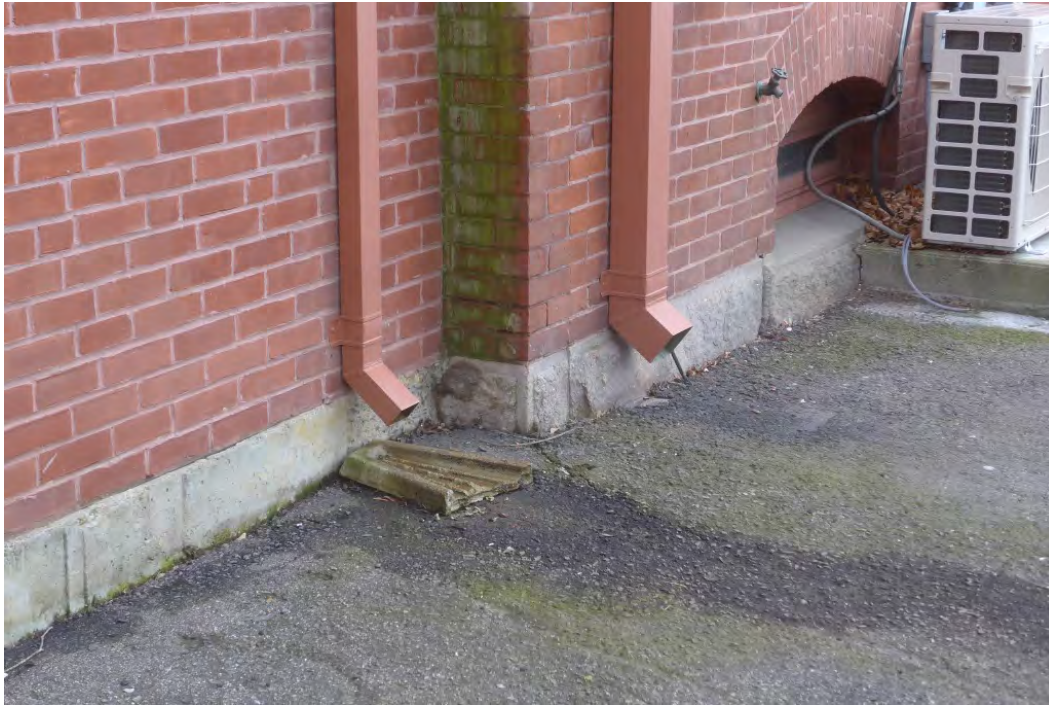
North Elevation

Missing Splashblocks; Inadequate Slope; Water Not Directed Away from Base of Building

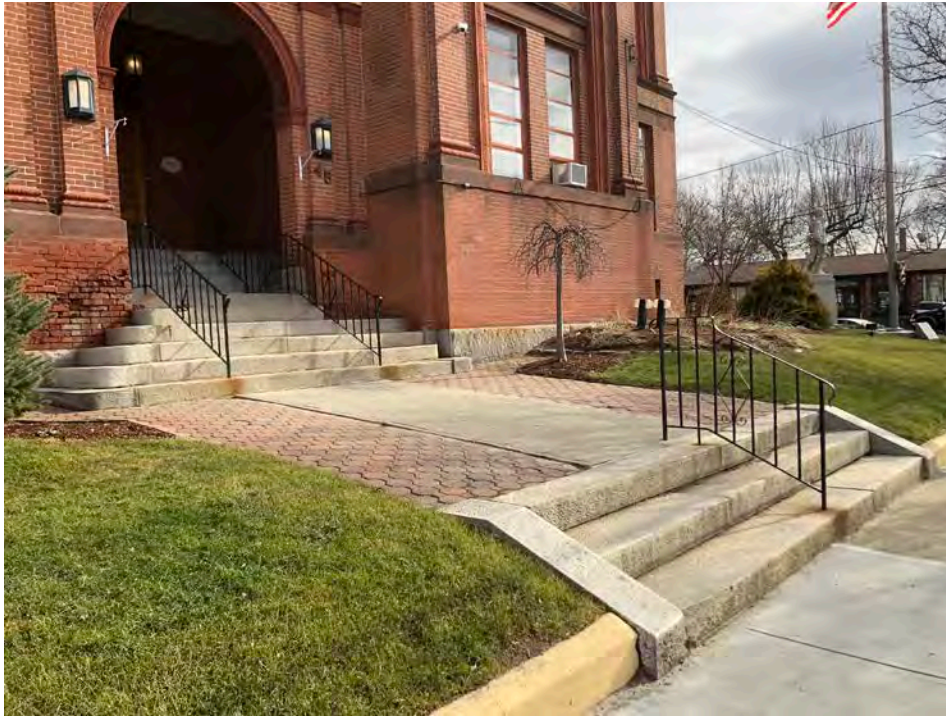
West Entrance

Overall in Good Condition; Some Settlement of Pavers Flanking Concrete Entrance Sidewalk

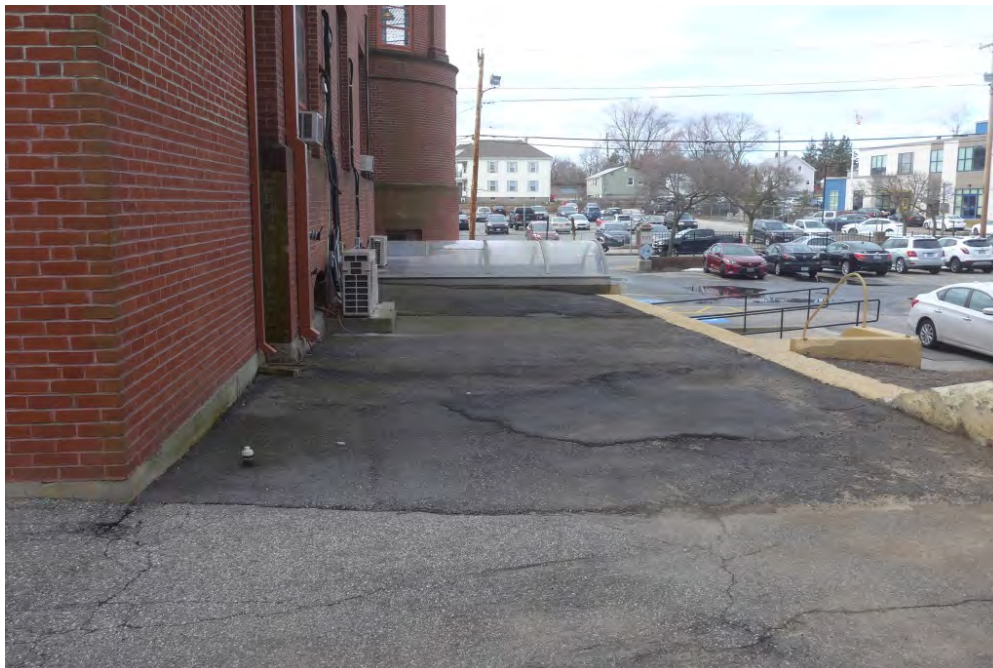
North Elevation

Raised Level Adjacent to Building is Inappropriately Paved with Asphalt
