# CUMBERLAND TOWN HALL CONDITIONS ASSESSMENT

**45 BROAD STREET  
CUMBERLAND, RI 02864**

**ISSUED:**

18 June 2020

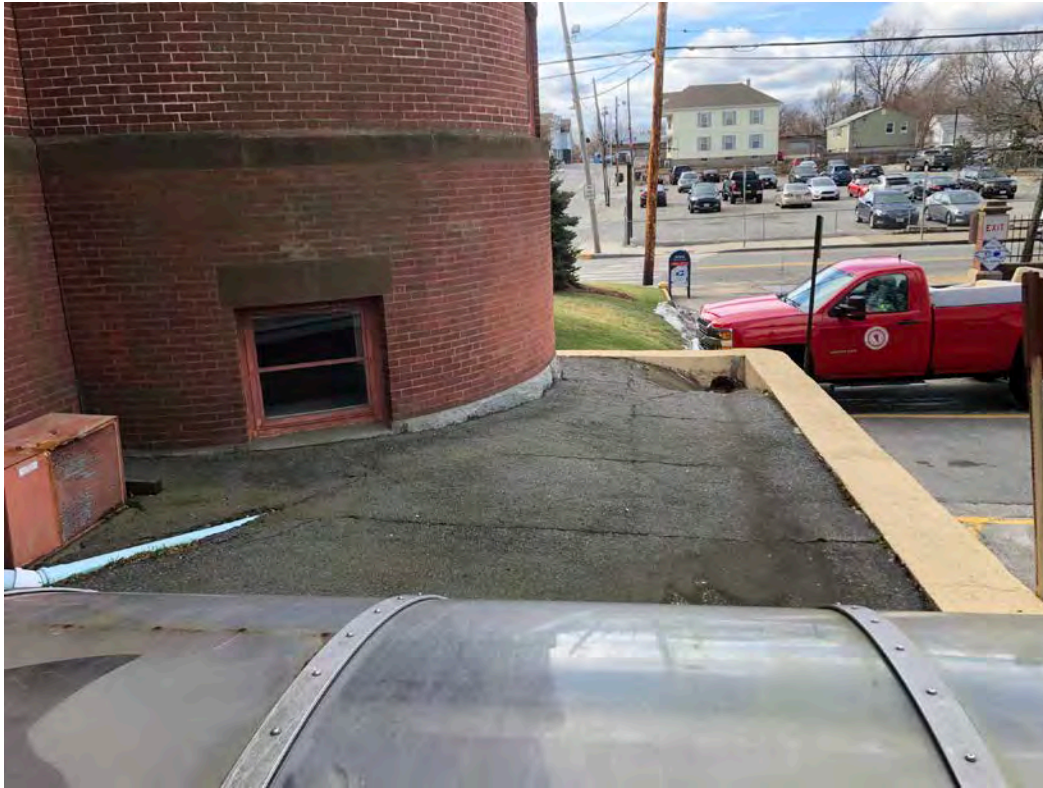
Raised Level Adjacent to Building is Inappropriately Paved with Asphalt

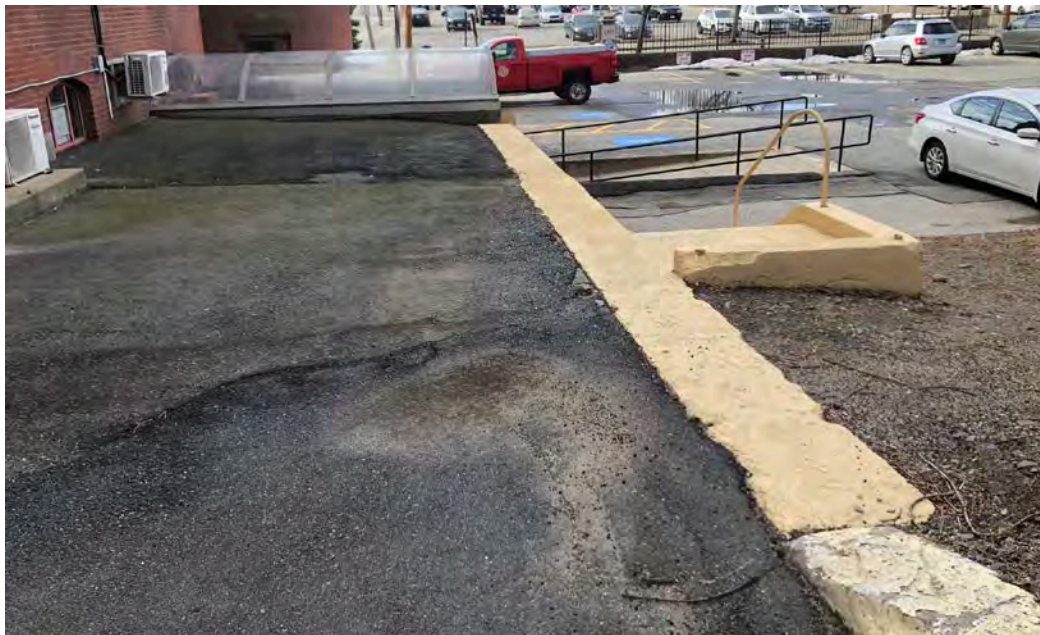
Cumberland Town Hall - Code Compliance Conditions  
North Raised Area  
No Railing along Raised Asphalt Area; Missing Railing at Stair

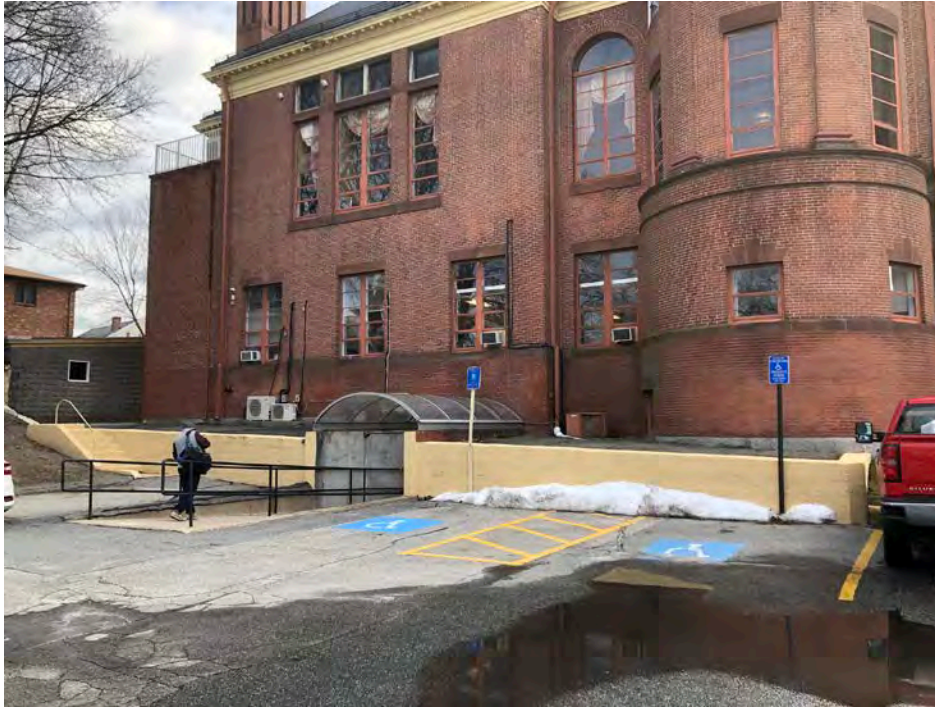
Overall View; Handicapped Parking Adjacent to Handicapped Access Ramp; Raised Area Adjacent to Building Paved with Asphalt, Ponded Water in Parking Lot

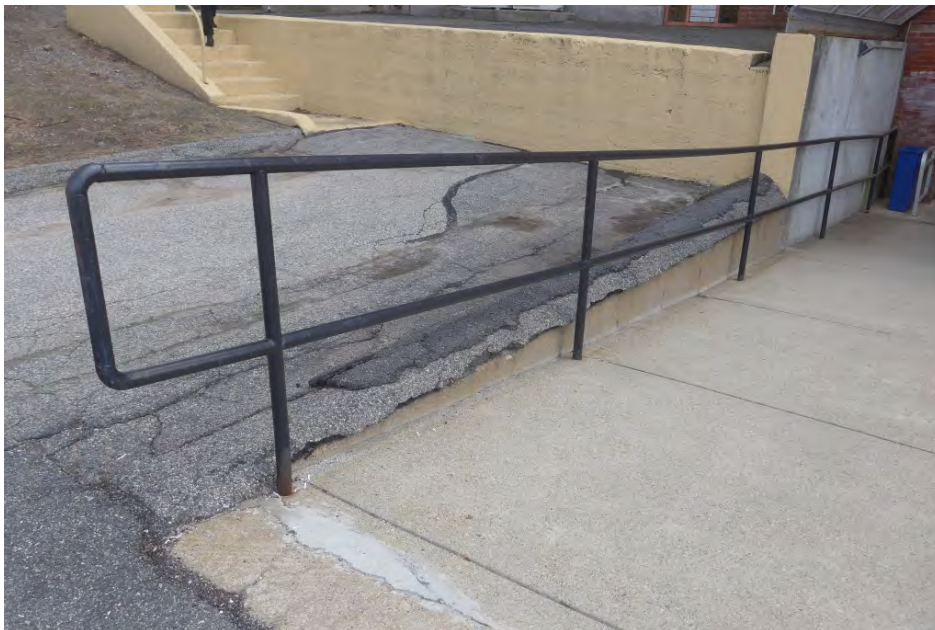
Handicapped Parking Adjacent to Handicapped Access Ramp; Adjacent Asphalt Cracked and Cracking

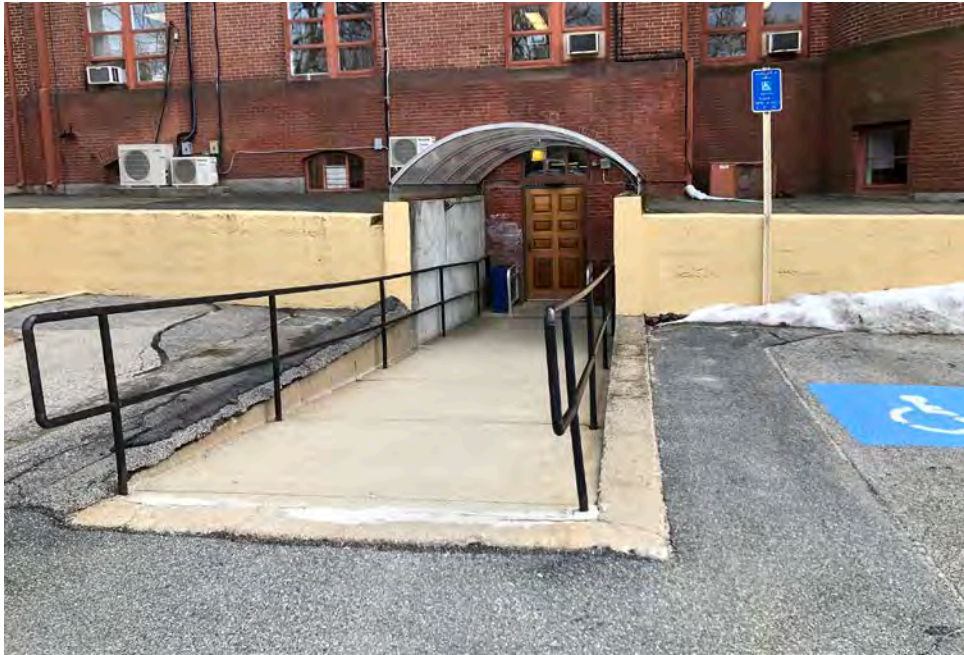
Cumberland Town Hall – Accessibility Conditions  
West Entrance at Porte Cochere  
Handicapped Parking and Code Compliant Ramp Provided

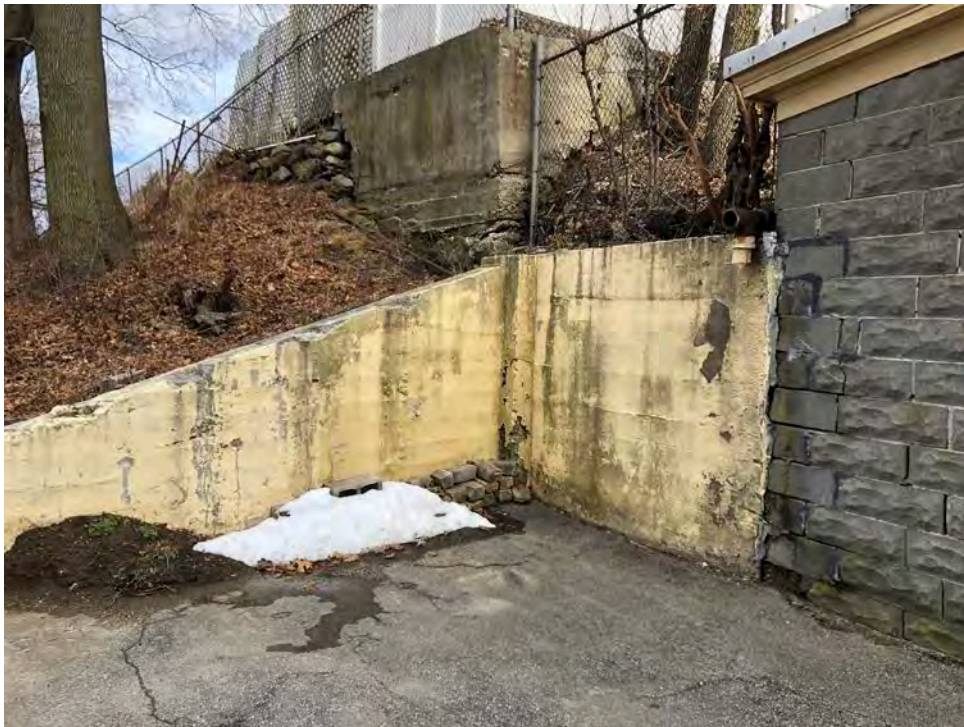
Cumberland Town Hall – Exterior – Retaining Walls, Steps, Landscaping, Asphalt Parking Area and Miscellaneous Landscaping Elements  
Northeast Corner - Retaining Wall and Wall of Garage  
Retaining Wall in Poor Condition, Step Cracks in Garage Wall

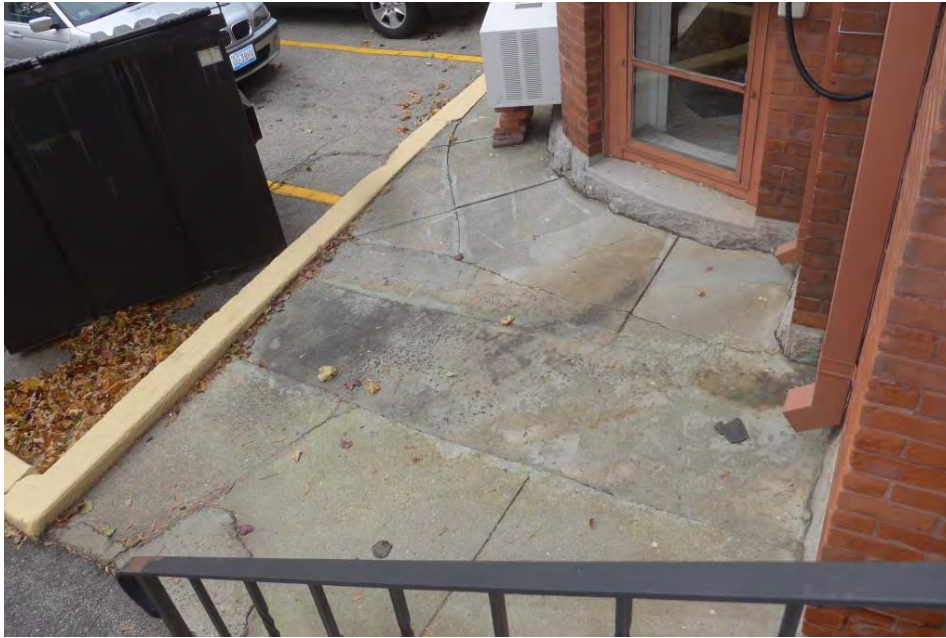
Cumberland Town Hall – Exterior – Landscaping Elements  
South Elevation – Concrete Pavement adjacent to Building  
Cracking and Settlement Overall in Good Condition; Some Cracking and Settlement of Concrete Pavement

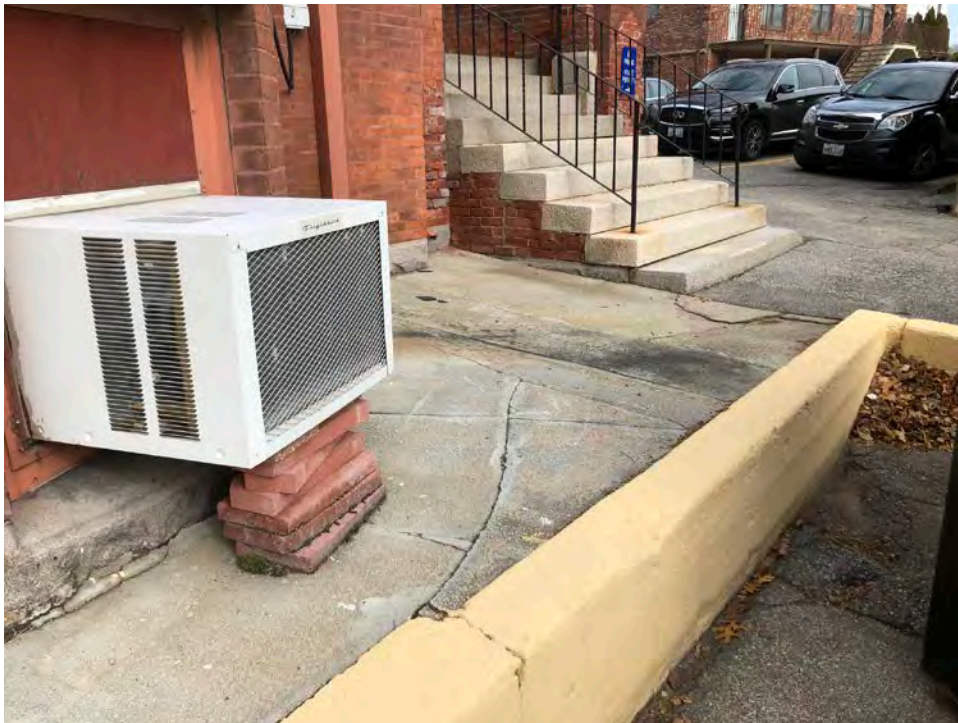
Cumberland Town Hall – Exterior – Landscaping Elements  
South Elevation – Concrete Pavement adjacent to Building  
Some Cracking and Settlement of Concrete Pavement; Pavers used to Support AC Unit

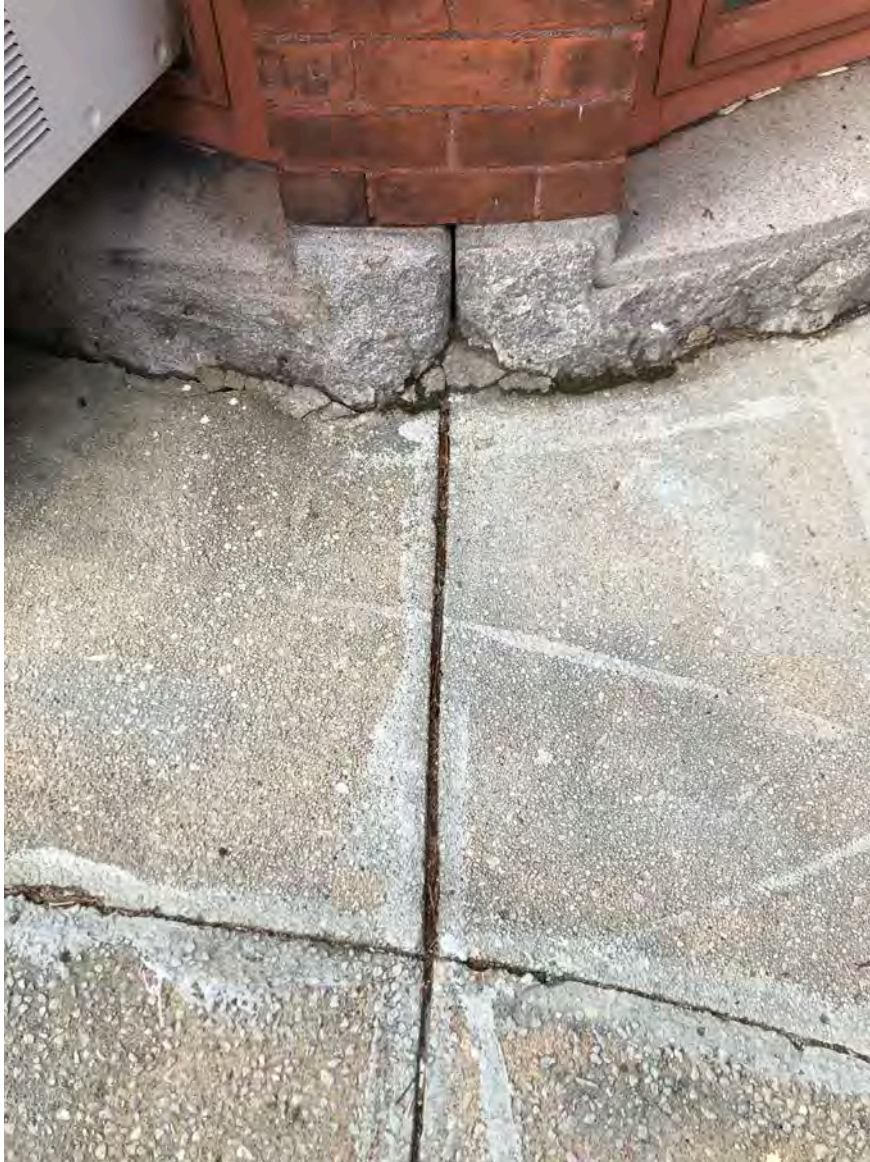
Cumberland Town Hall – Exterior – Landscaping Elements  
South Elevation – Concrete Pavement adjacent to Building  
Open Joint in Granite at Base of Building and in Concrete Pavement

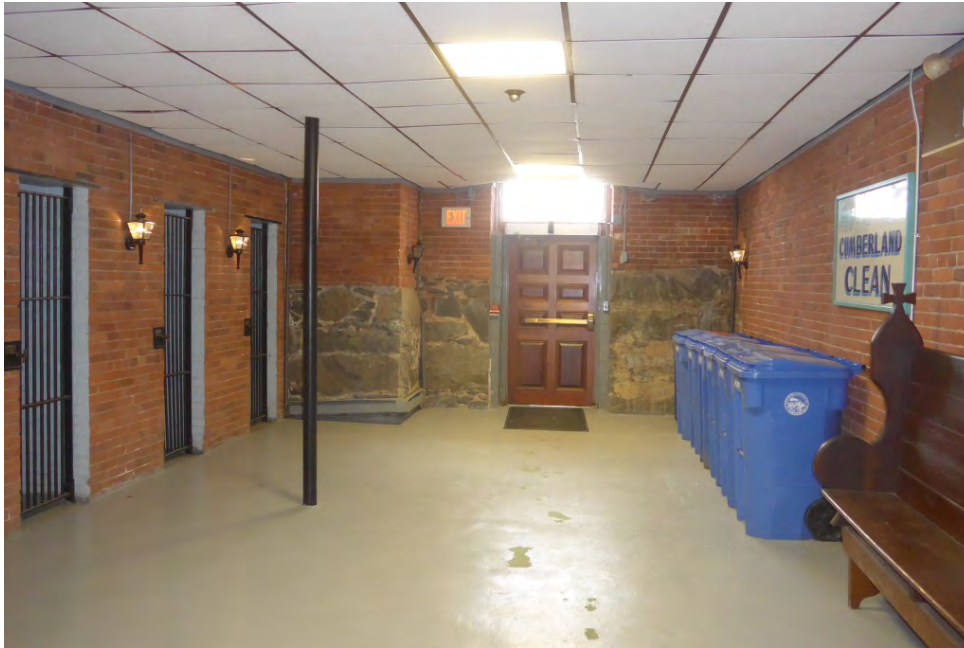
Cumberland Town Hall – Interior - Overall and Masonry  
Basement – Entrance Looking Toward Handicap Access  
Typical Conditions – Good

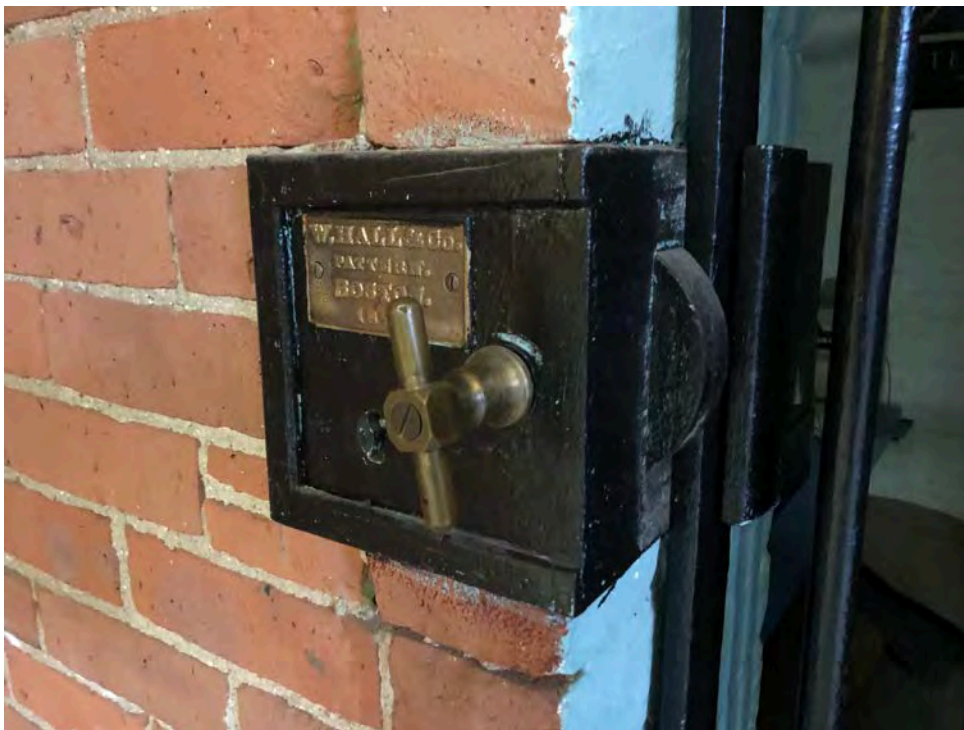
Cumberland Town Hall – Interior – Historic Finishes and Building Elements  
Basement – At Jail Cells – Original Hardware for Cell Doors  
Typical Conditions - Good

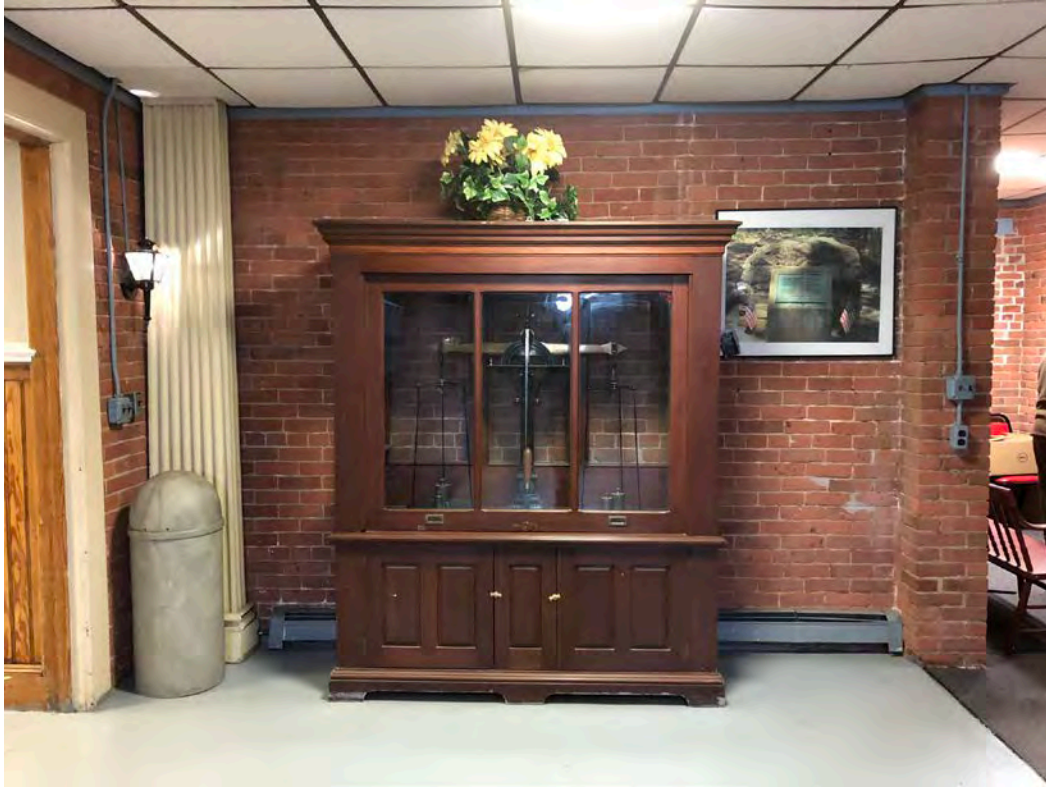
Cumberland Town Hall – Interior – Historic Finishes and Building Elements  
Basement – Basement Entrance  
Weights and Measures Cabinet

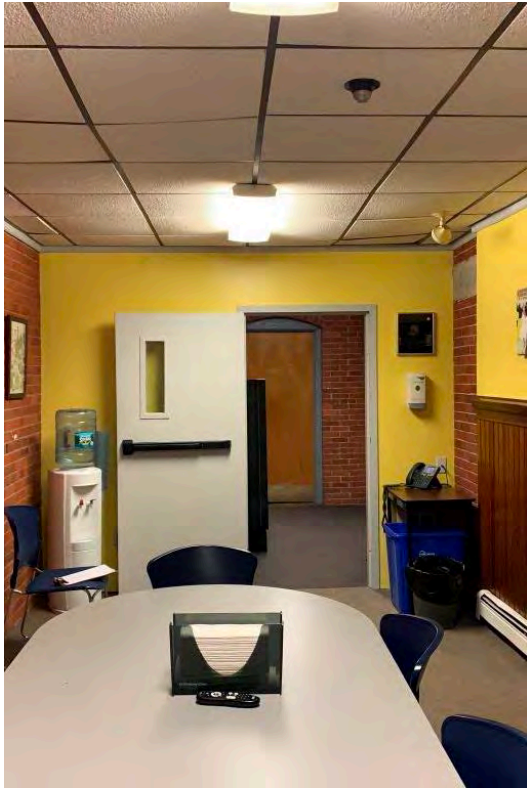
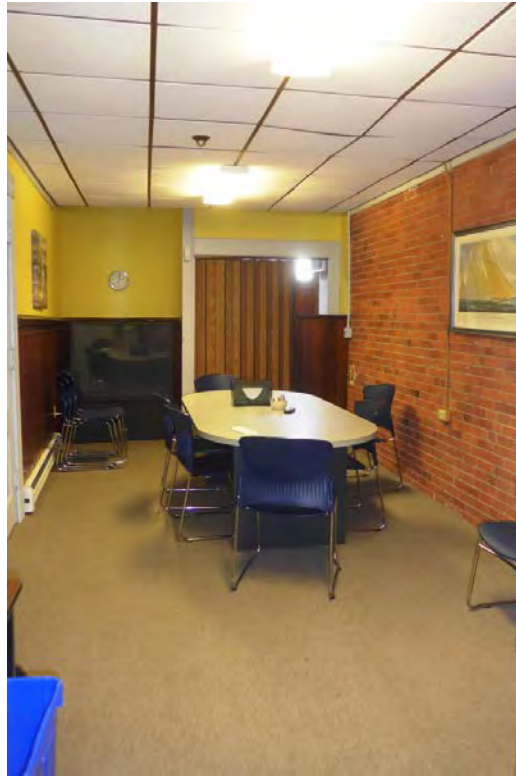
Cumberland Town Hall – Interior - Overall  
Basement – Employee Break Room  
Typical Conditions - Good

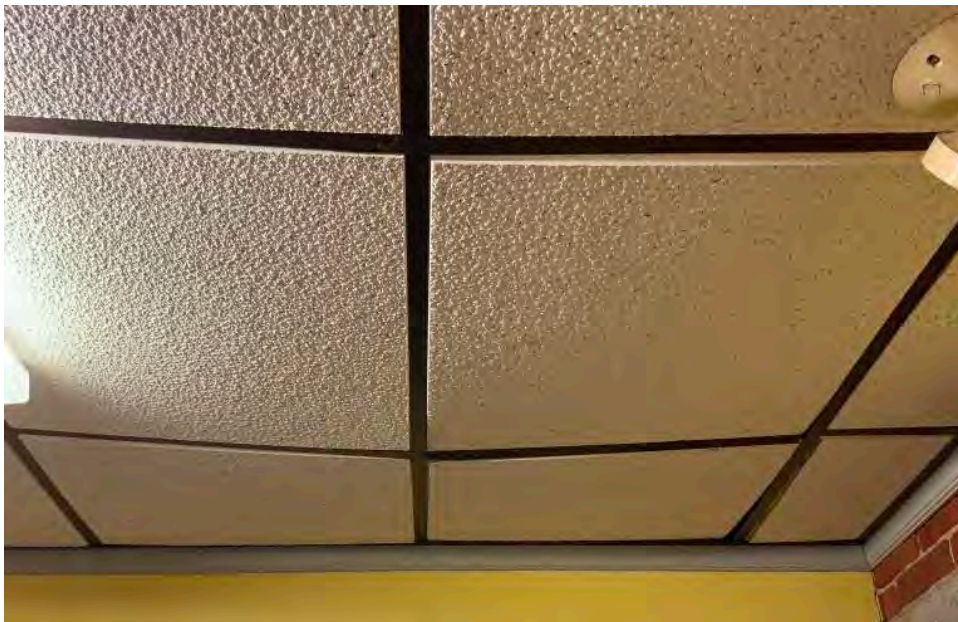
Cumberland Town Hall – Interior - Overall  
Basement – Employee Break Room  
Buckling of Dropped Acoustical Ceiling

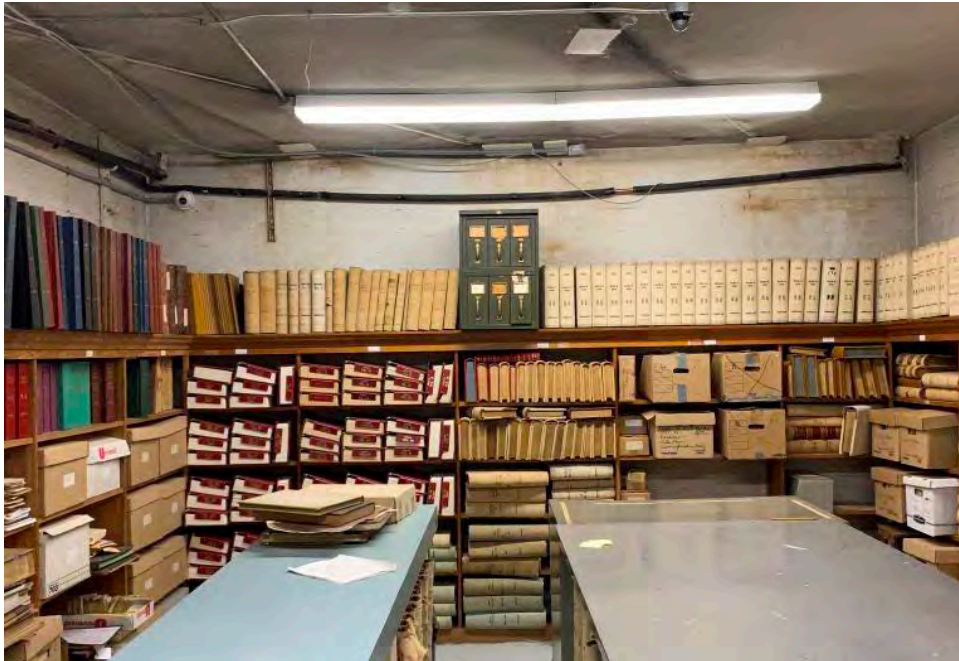
Cumberland Town Hall – Interior - Overall  
Basement – Vault under West Entrance Stair  
Typical Conditions – Fair Overall – Moisture Issues at Upper Portion of Walls and Ceiling

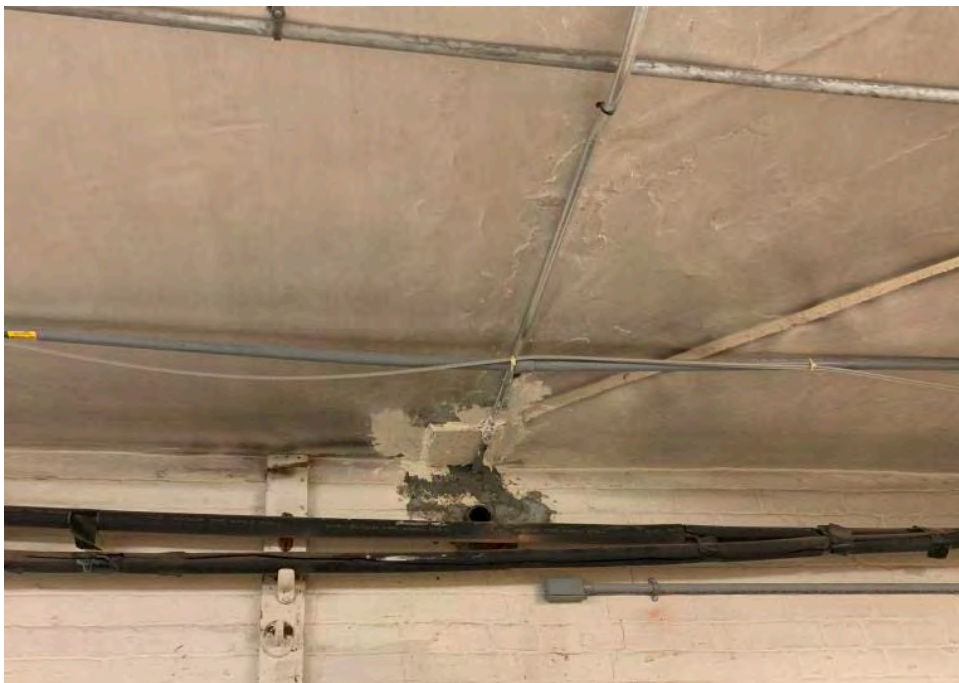
Cumberland Town Hall – Interior - Overall  
Basement – Vault under West Entrance Stair  
Moisture Issues at Upper Portion of Walls and Ceiling – Unsealed Penetration

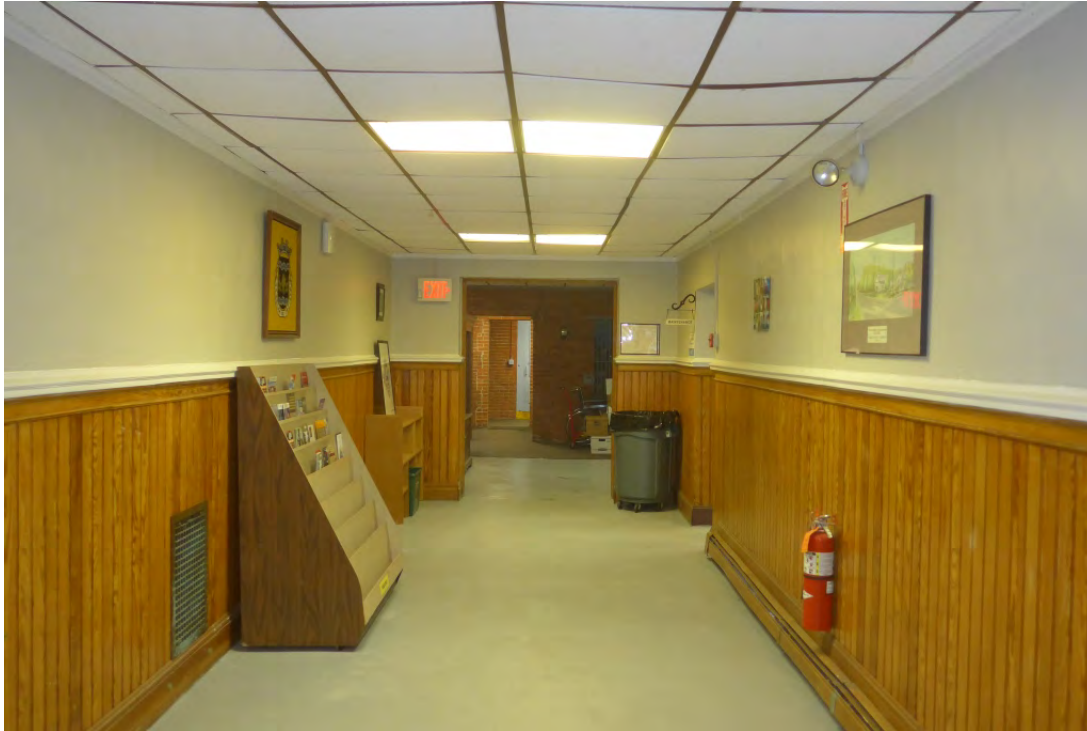
Basement – Central Hallway

Cumberland Town Hall – Interior – Overall – Historic Finishes and Building Elements - Ceilings

Typical Conditions – Good – Isolated Sagging of Dropped Ceiling; Finishes Inappropriate to Original (Vinyl Floor Tile, Dropped Ceiling); Inappropriate Ceiling Fixtures

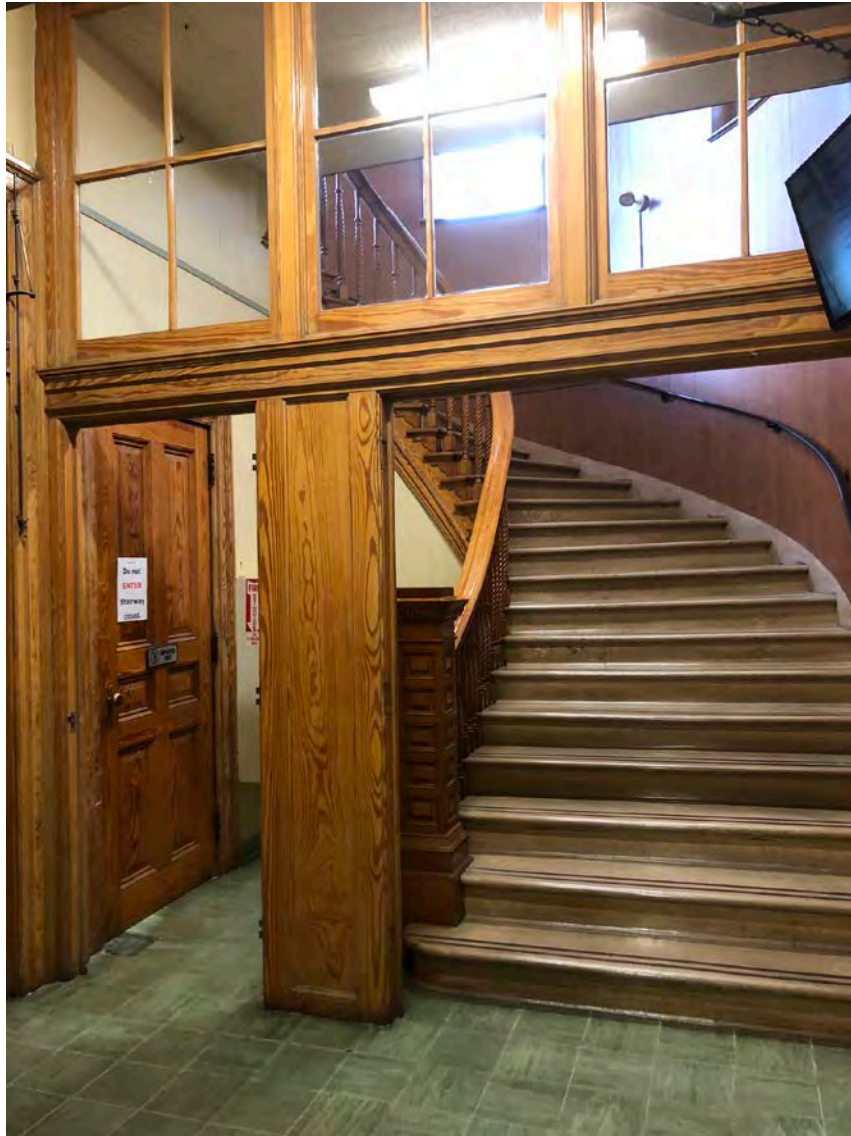
First Floor – Main Stair

Cumberland Town Hall – Interior – Historic Finishes and Building Elements

Overall Condition Good; Inappropriate Finishes (Vinyl Floor Tiles, Vinyl Stair Treads, Veneer Paneling) over Historic Material;  
Partition Wall Installed at Stair, Presumably for Fire Separation is no Longer Serving that Purpose

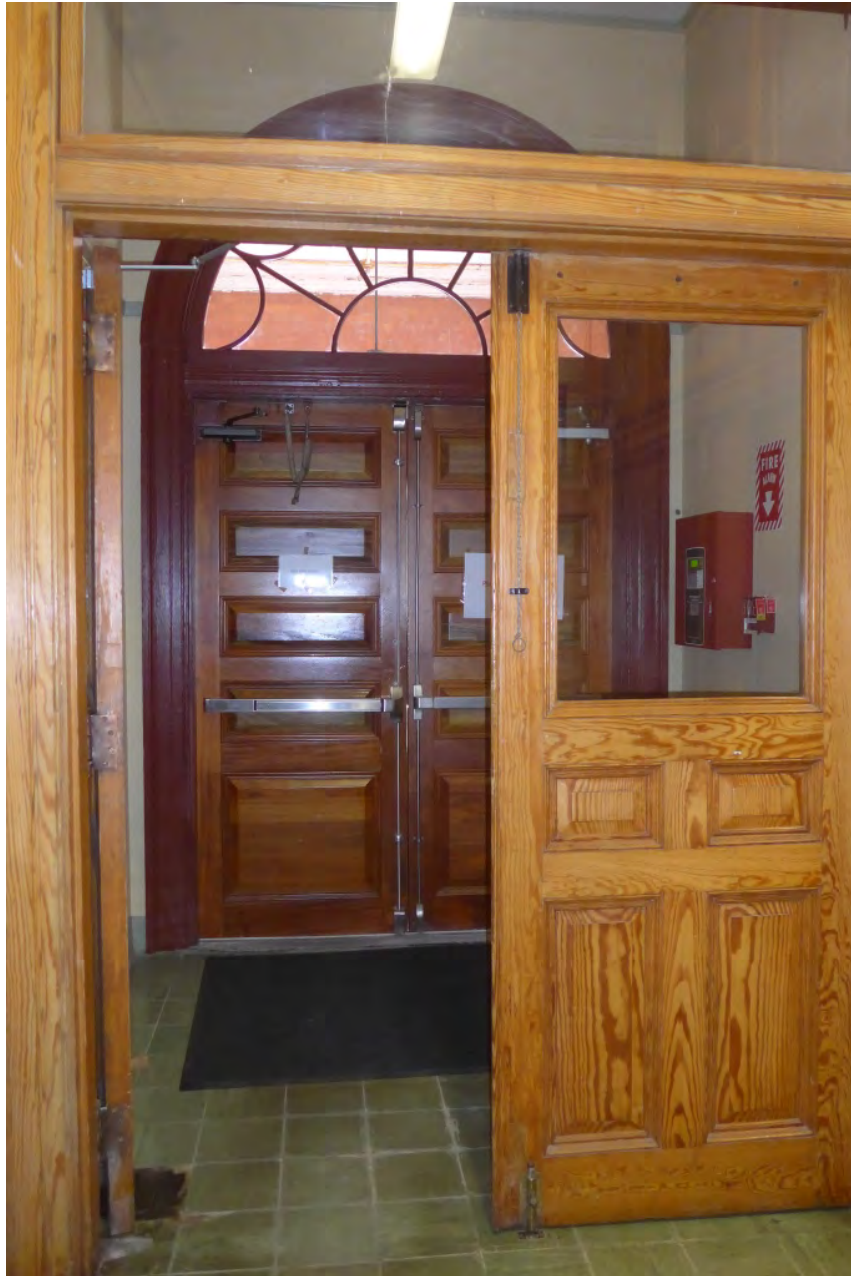
First Floor – Main, West Entrance

Cumberland Town Hall – Interior –Historic Finishes and Building Elements – Windows, Doors and Hardware

Overall in Condition Good; Inappropriate Finishes (Vinyl Floor tile) over Historic Material; Historically Inappropriate Ceiling Fixture

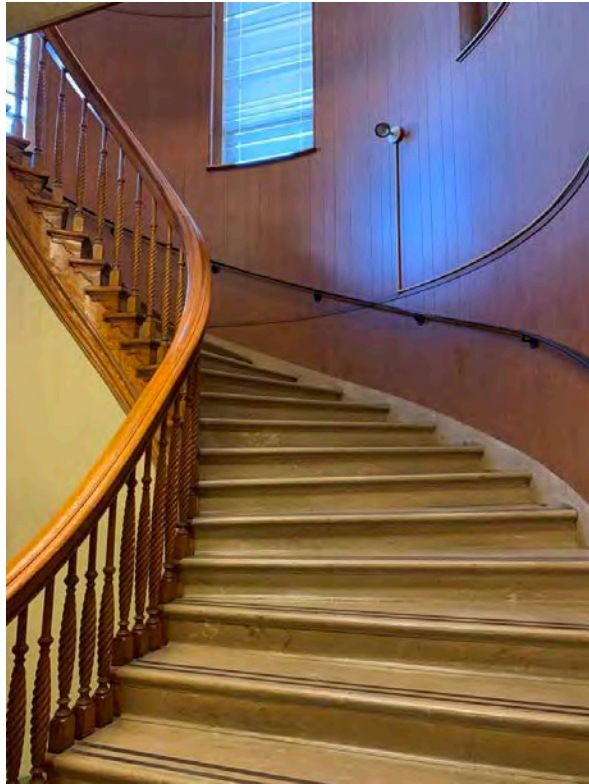
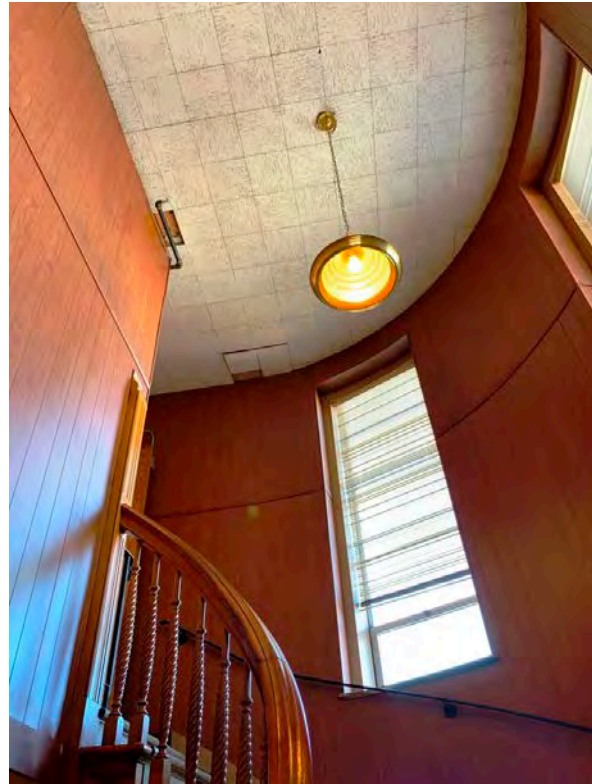
First Floor – Main Stair

Cumberland Town Hall – Interior – Historic Finishes and Building Elements

Overall Condition Good; Inappropriate Finishes (Veneer Paneling, Acoustical Ceiling Tiles) over Historic Material; Historically Inappropriate Ceiling Fixture

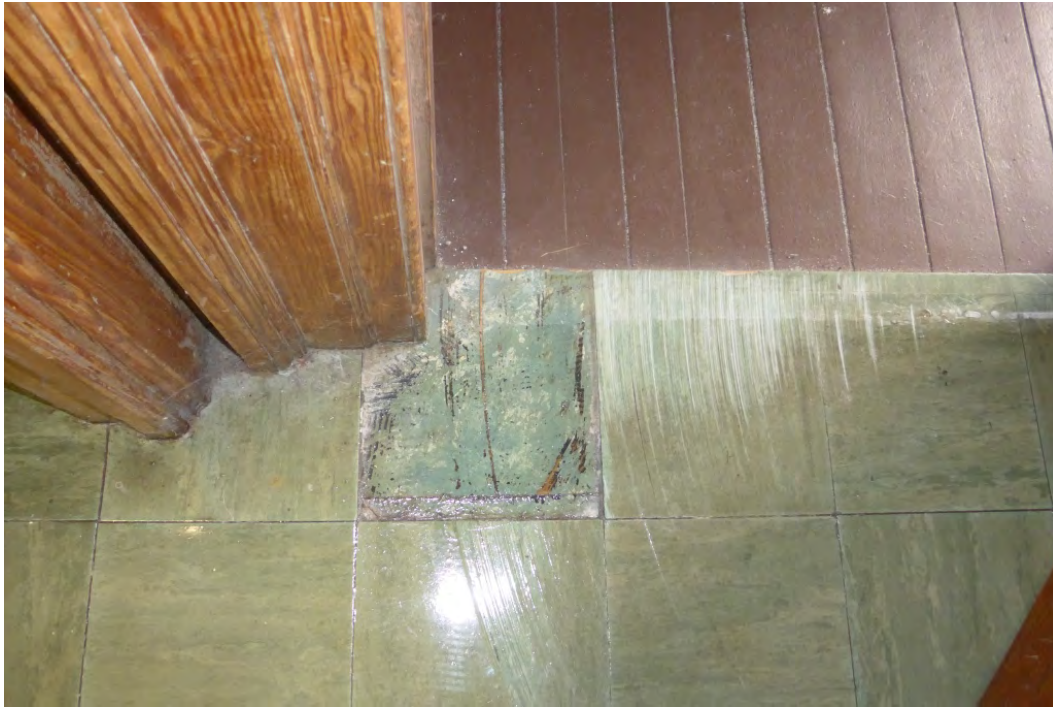
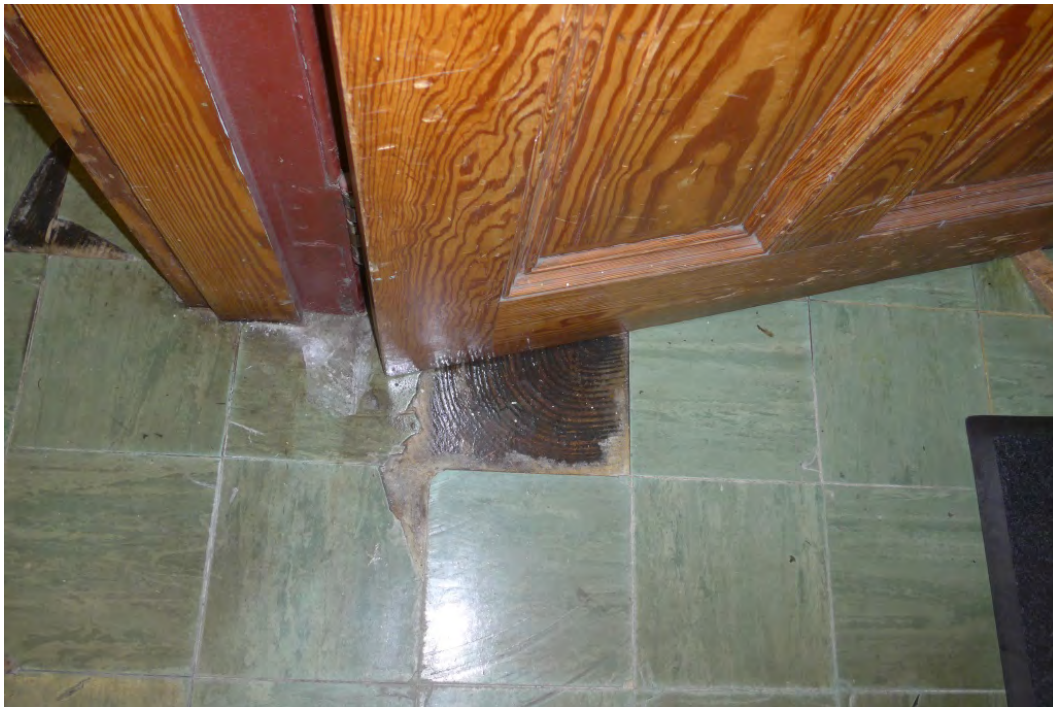
First Floor – Main Stair

Cumberland Town Hall – Interior – Historic Finishes and Building Elements - Floors

Overall Condition Good; Inappropriate Finishes (Vinyl Floor Tiles) over Historic Material; Damaged and Missing Vinyl Floor Tiles

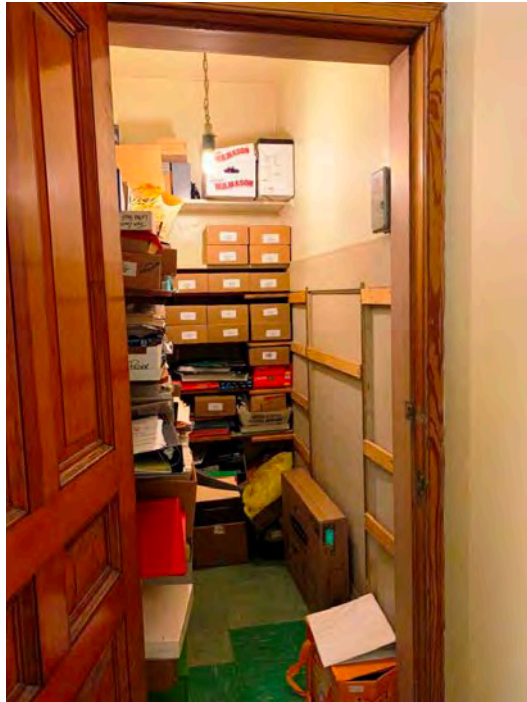
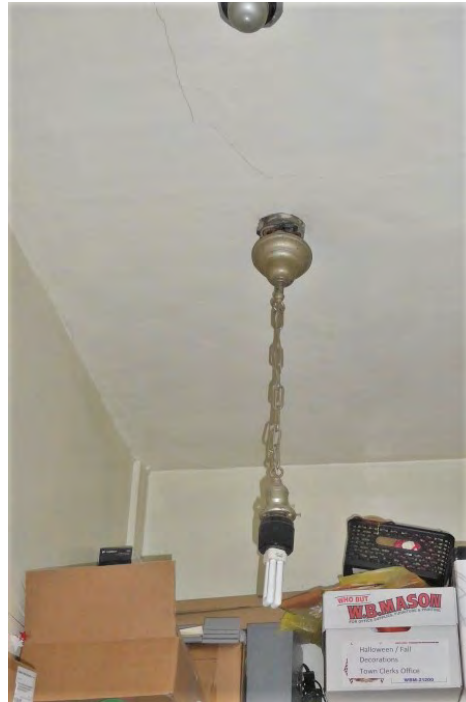
Cumberland Town Hall – Interior – Storage – Historic Finishes and Building Elements  
First Floor – Storage Closet  
Left: Typical Conditions in Storage Area; Right: Original Ceiling Fixture, Missing Globe

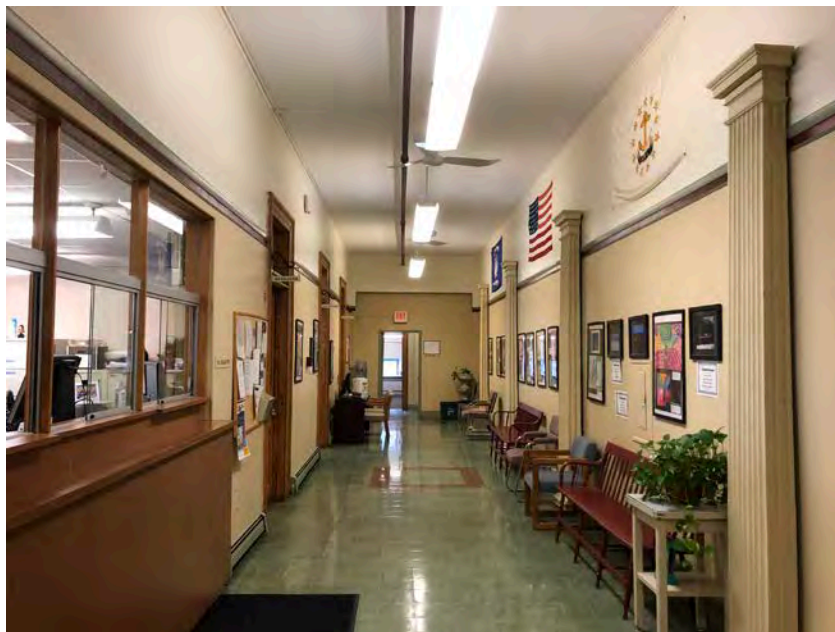
Cumberland Town Hall – Interior - Overalls – Historic Finishes and Building Elements  
First Floor – Central Hallway  
Overall Condition Good; Finishes Inappropriate to Original (Vinyl Floor Tiles, Veneer Paneling) over Historic Material; Some Alterations to Openings and Associated Trim; Historically Inappropriate Ceiling Fixtures; Salvaged Original Fluted Pilasters from Exterior of Clock Tower

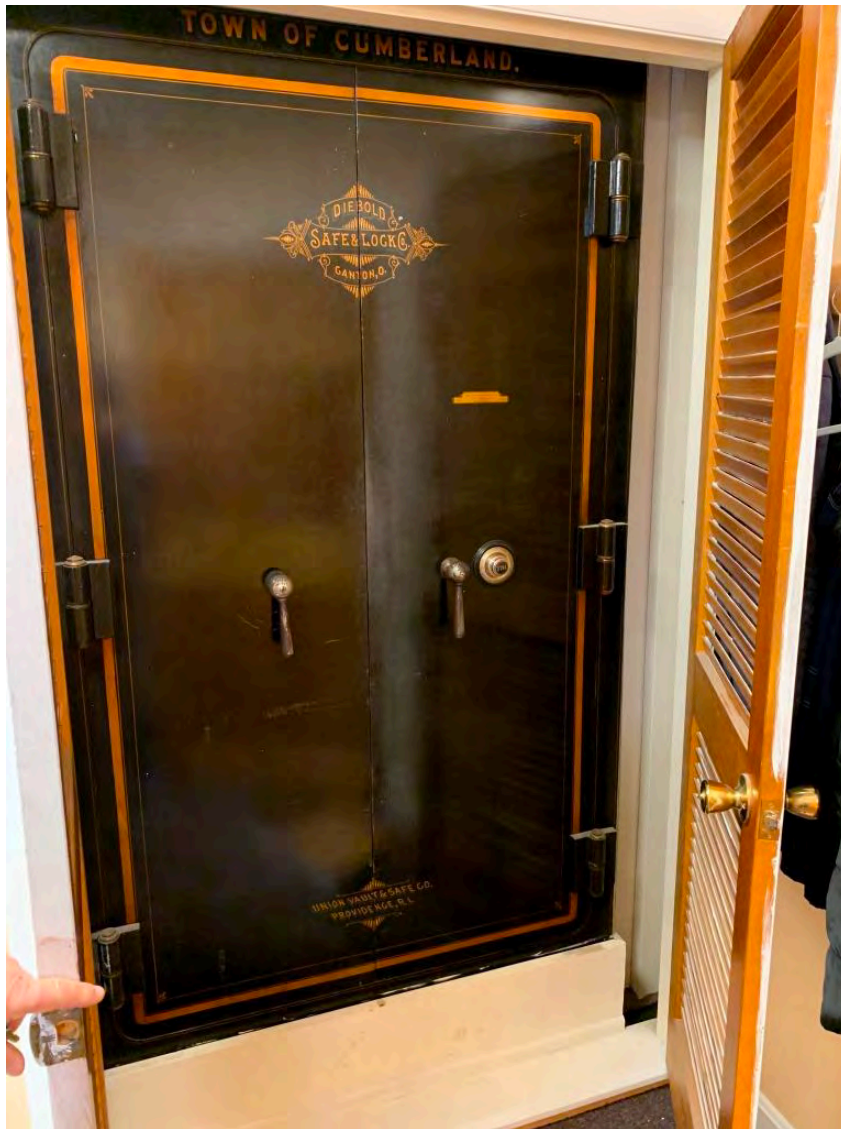
Cumberland Town Hall – Interior - Historic Finishes and Building Elements  
First Floor – Solicitor Office  
Original Safe

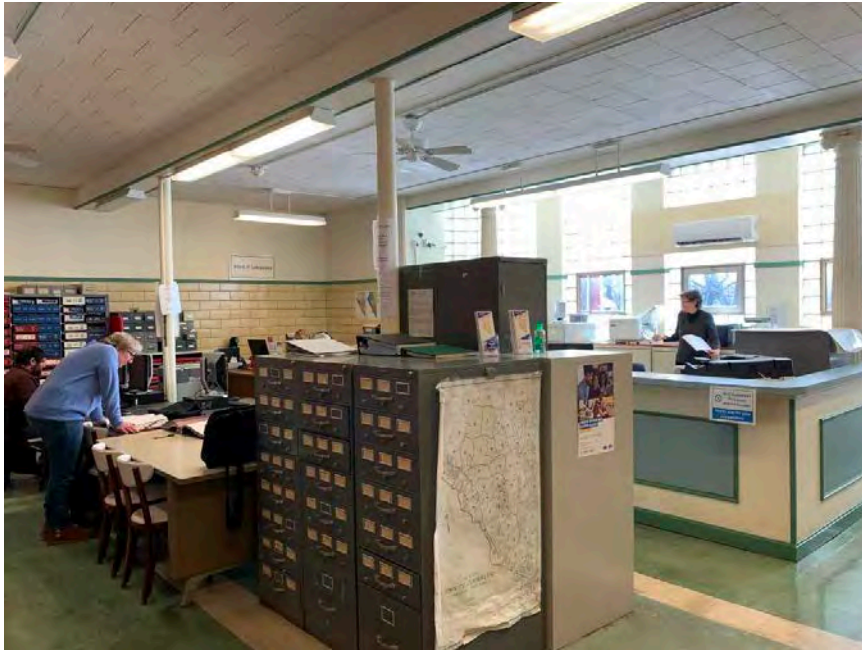
First Floor – Town Clerk Vault

Cumberland Town Hall – Interior - Historic Finishes and Building Elements – Code Compliance

Overall Condition Good; Finishes Inappropriate to Original (Vinyl Floor Tiles, Acoustical Ceiling Tiles) over Historic Material; Glass Block and Hopper Windows Inappropriate to Original Design and not Fireproof; Historically Inappropriate Ceiling Fixtures.

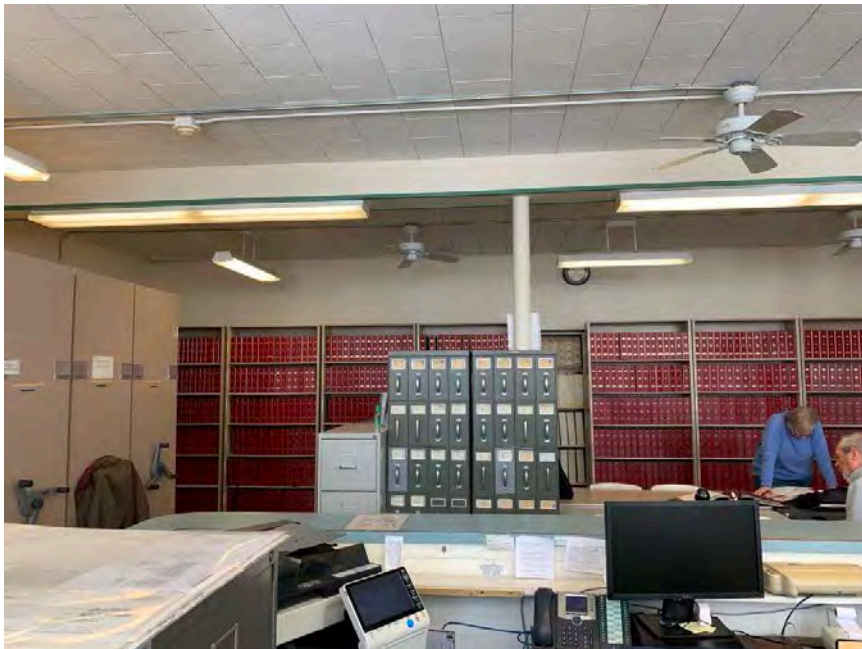
First Floor – Town Clerk Vault

Cumberland Town Hall – Interior - Overalls – Historic Finishes and Building Elements

Overall Condition Good; Finishes Inappropriate to Original (Vinyl Floor Tiles, Acoustical Ceiling Tiles) over Historic Material; Historically Inappropriate Ceiling Fixtures.

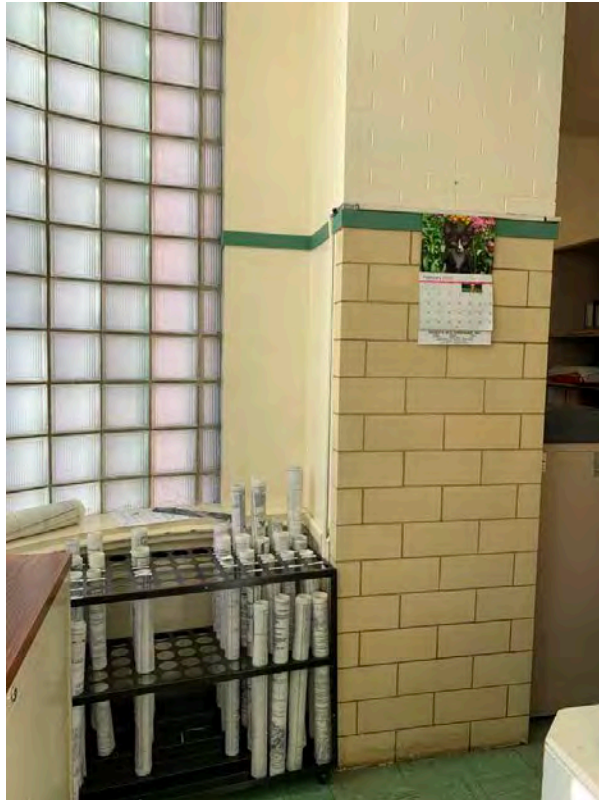
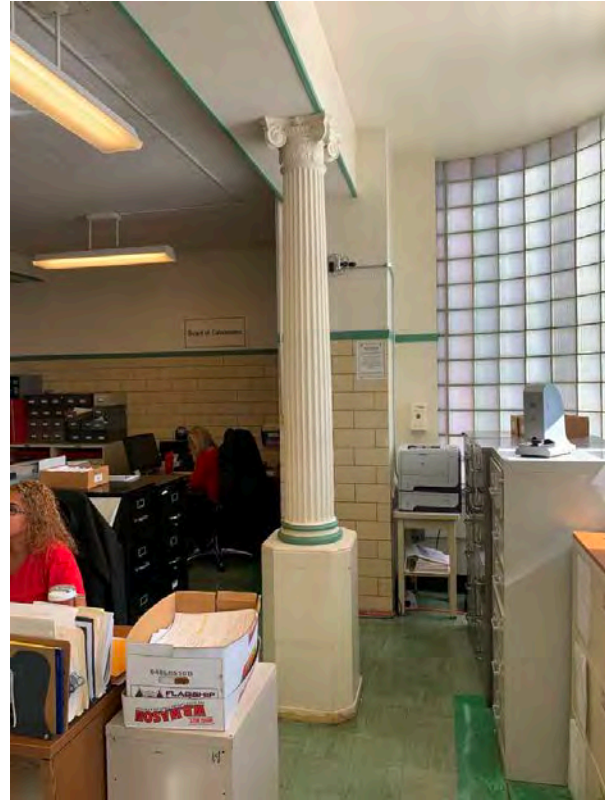
##### First Floor – Town Clerk Vault

#### Cumberland Town Hall – Interior - Overalls – Historic Finishes and Building Elements

Overall Condition Good; Finishes Inappropriate to Original (Vinyl Floor Tiles, Acoustical Ceiling Tiles, Glazed Tile Wainscot) over Historic Material; Glass Block and Hopper Windows Inappropriate to Original Design and not Fireproof; Historically Inappropriate Ceiling Fixtures; Original Column in Place. Later finishes (circa 1930s?) Could be Considered Historically Appropriate. Determination Should be Made Concerning Era to which Entire Building or Rooms within Building are to be Restored.
