# CUMBERLAND TOWN HALL CONDITIONS ASSESSMENT

**45 BROAD STREET  
CUMBERLAND, RI 02864**

**ISSUED:**

18 June 2020

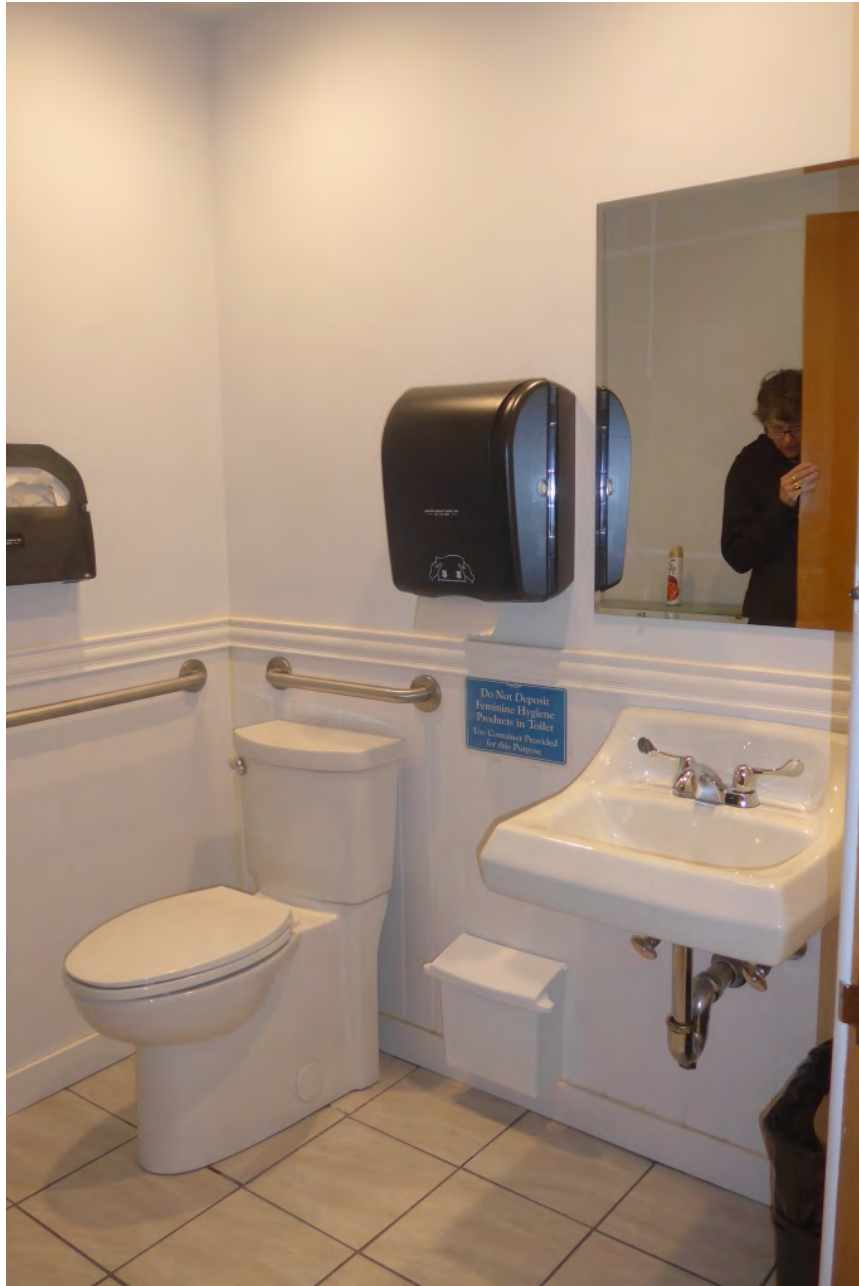
Cumberland Town Hall – Interior - Accessibility Conditions  
Unisex ADA Compliant Toilet Room

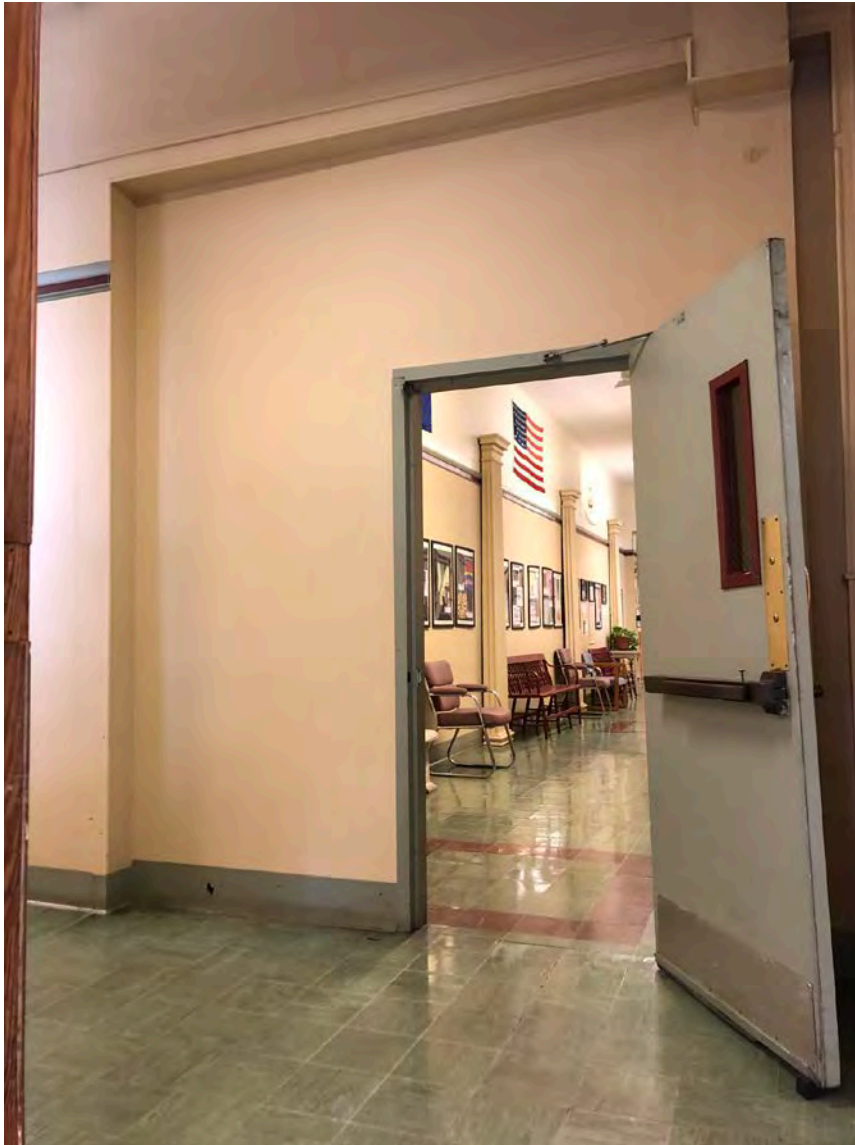
First Floor – East Stair/Entrance Hall

Cumberland Town Hall – Interior - Historic Finishes and Building Elements – Code Compliance

Fire Door and Partition Wall Code Compliant, but Not Historically Compatible; Door Propped Open Against Code.

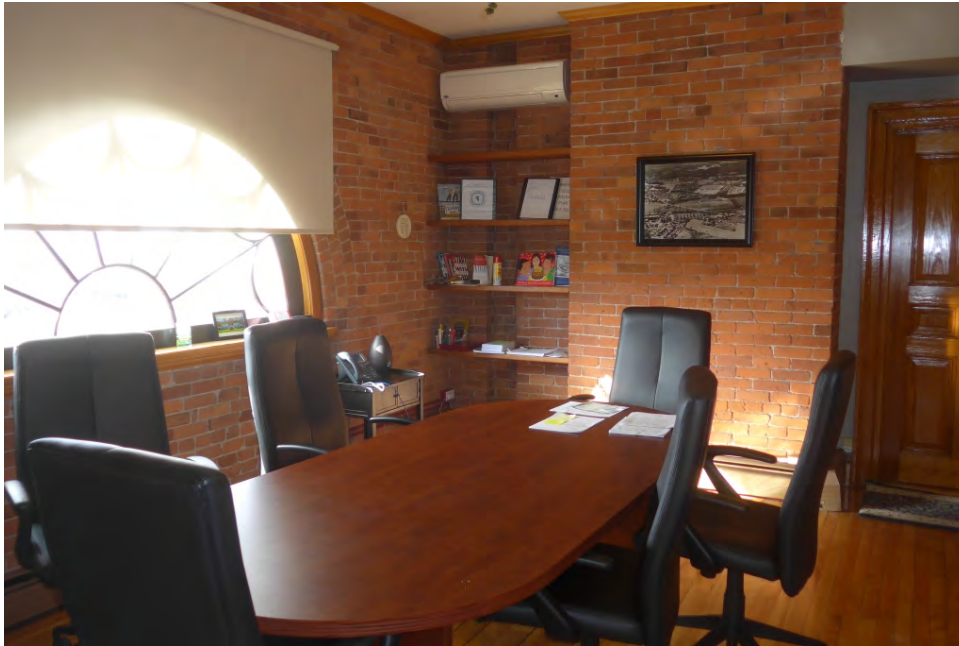
Cumberland Town Hall – Interior – Historic Finishes and Building Elements - Masonry  
Second Floor – Mayor's Office Suite  
Exposed Brick Walls

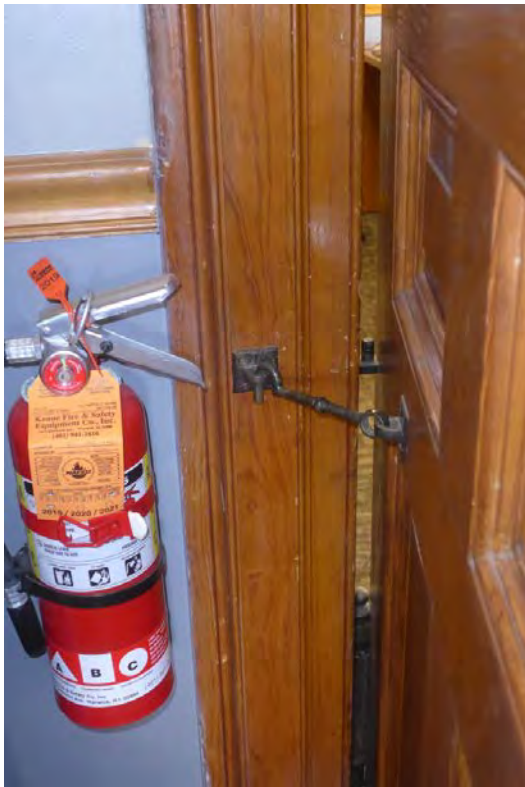
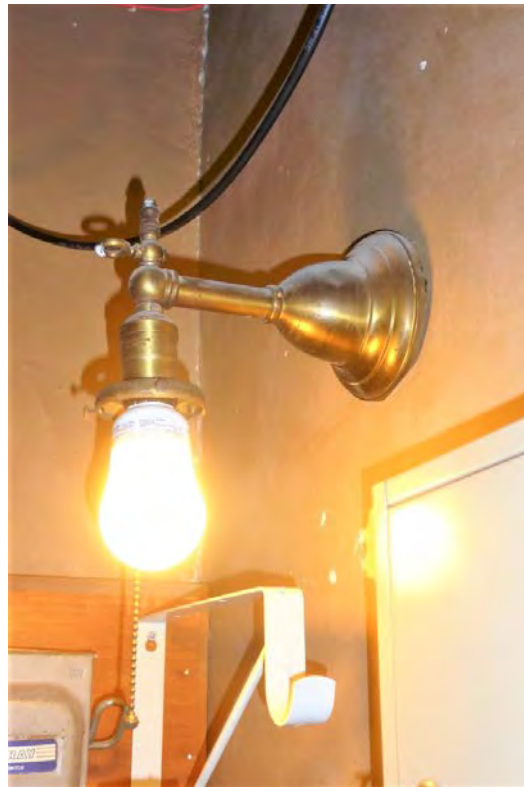
Cumberland Town Hall – Interior – Windows, Doors and Hardware and Historic Finishes and Details  
Second Floor – Mayor's Office Suite  
Left: Original Door Hardware; Right: Original Wall Sconce (In Closet under Stair)

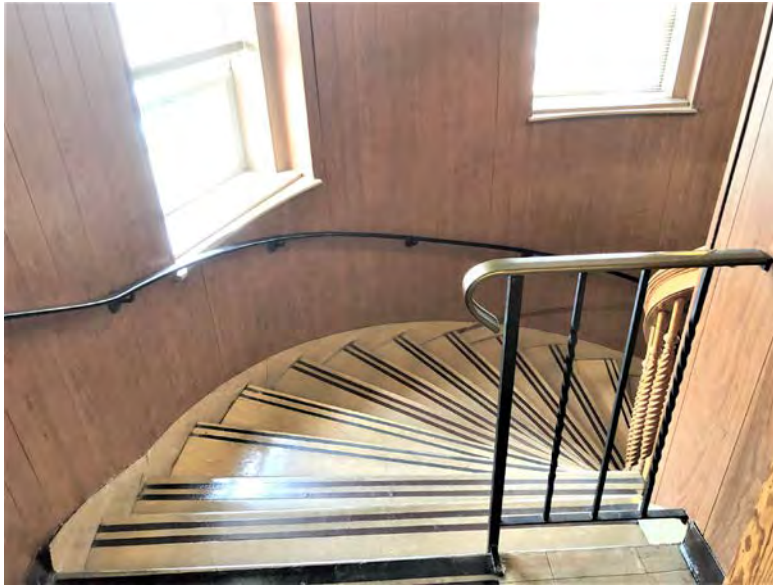
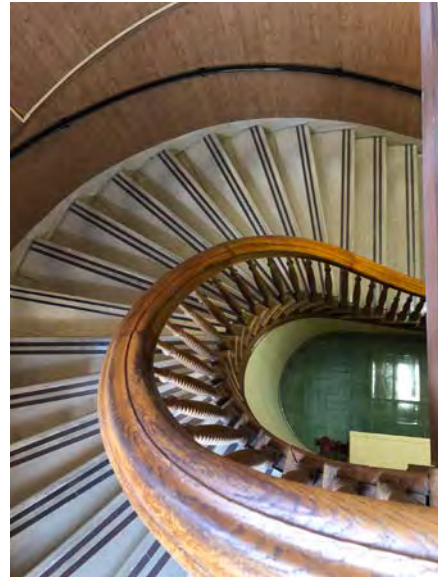
Cumberland Town Hall – Interior – Historic Finishes and Details  
Second Floor  
View of Main Stair  
Vinyl Applied to Treads, Veneer Paneling on Walls

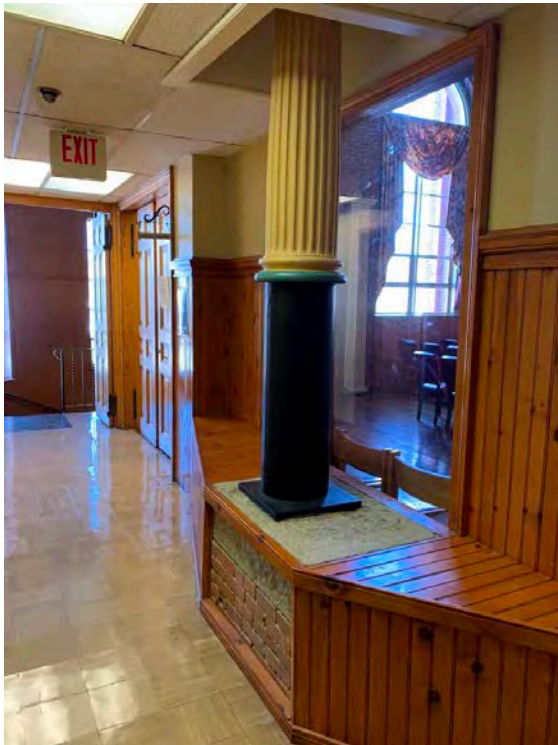
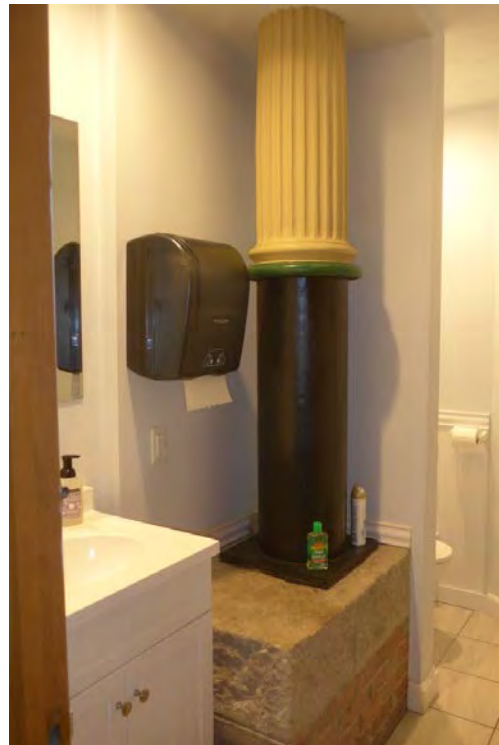
Cumberland Town Hall – Interior – Historic Finishes and Details  
Second Floor  
Left: Central Hallway at Council Chamber Entrance; Right: Unisex Room  
Overall Condition Good; Original Columns from Assembly Hall Exposed

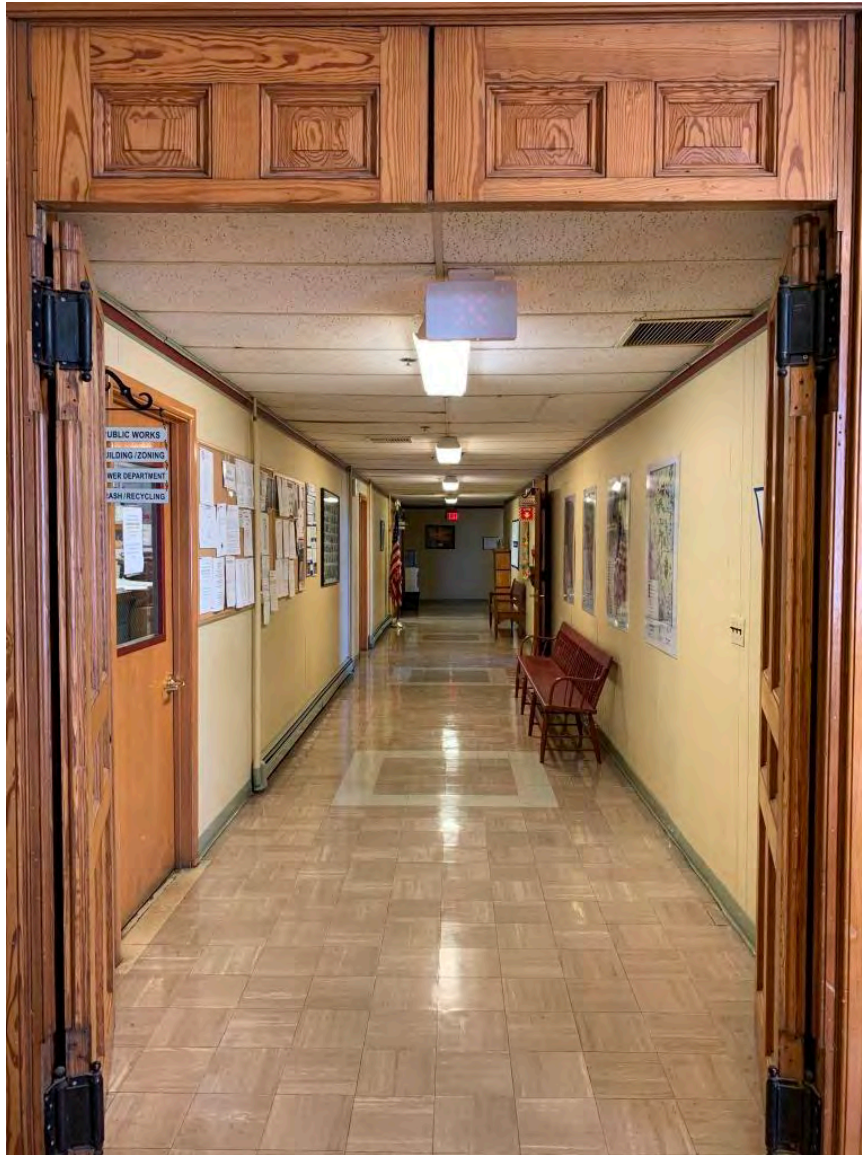
Second Floor – Central Hallway

Cumberland Town Hall – Interior – Historic Finishes and Details

Overall Condition Good; Original Doors at Rear of Assembly Hall Appropriately Finished; Finishes Inappropriate to Original (Vinyl Floor Tiles, Veneer Paneling, Dropped Ceiling) over Historic Material; Historically Inappropriate Ceiling Fixtures

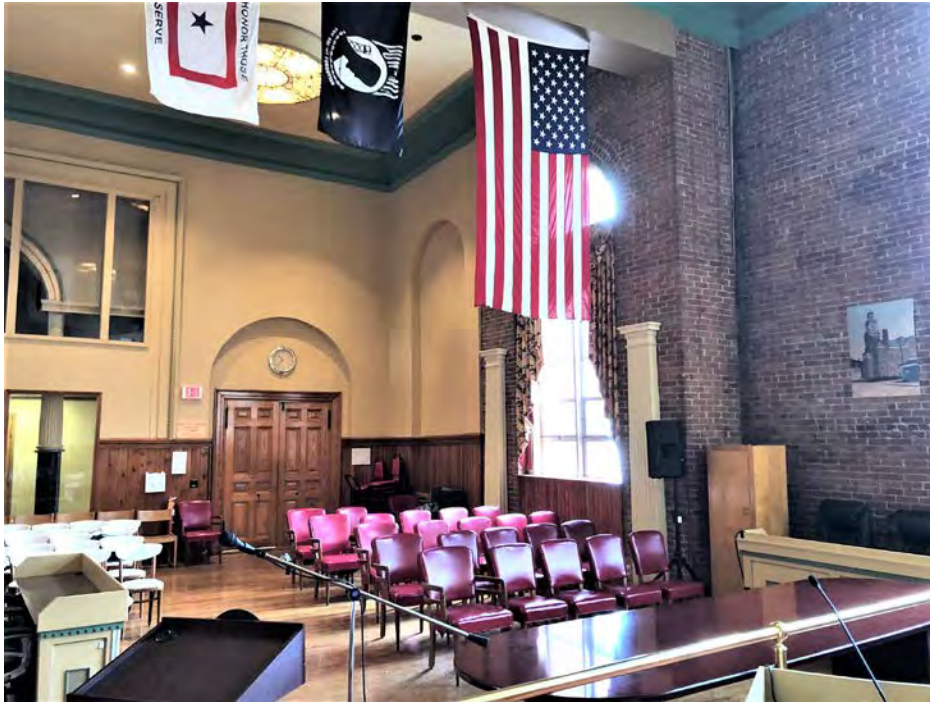
Cumberland Town Hall – Interior – Masonry – Historic Finishes and Building Elements  
Second Floor – Council Chamber Looking Northwest  
Overall Condition Good; Exposed Brick not Historically Appropriate

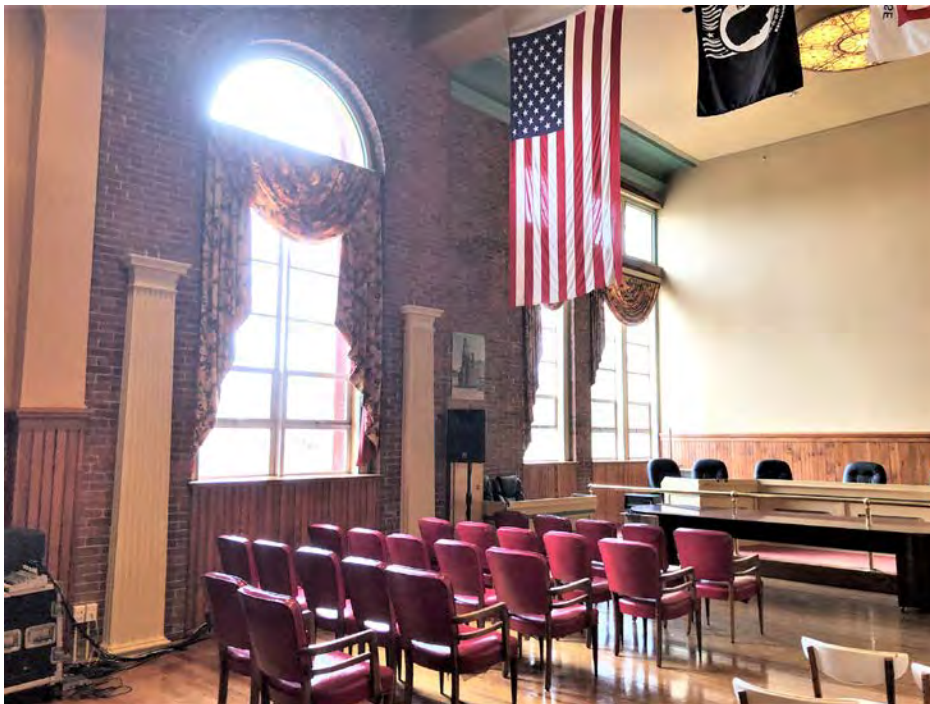
Cumberland Town Hall – Interior – Masonry - Historic Finishes and Building Elements  
Second Floor – Council Chamber Looking Northeast  
Overall Condition Good

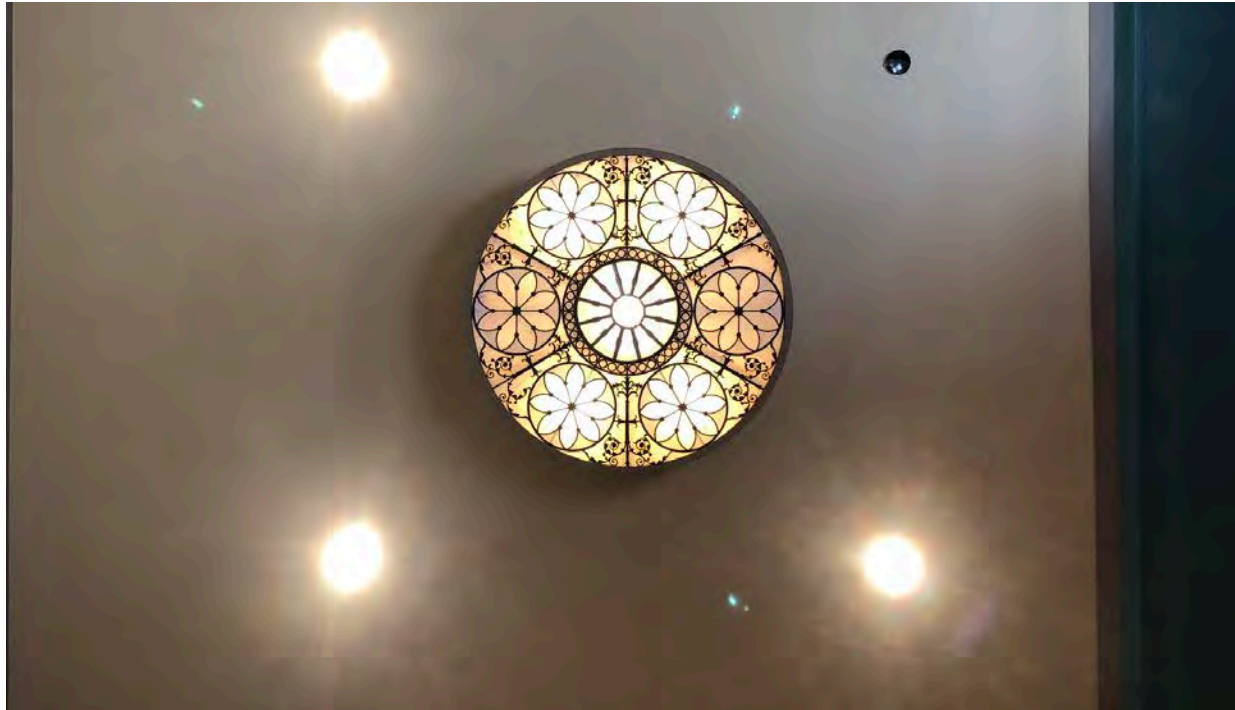
Second Floor – Council Chamber

Cumberland Town Hall – Interior – Historic Finishes and Building Details

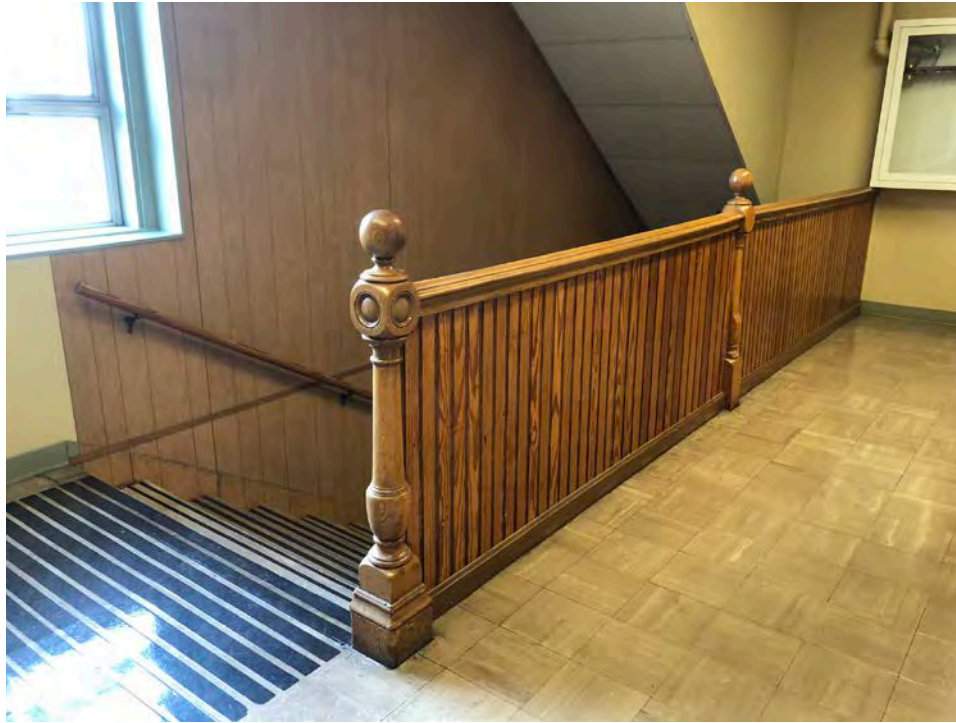
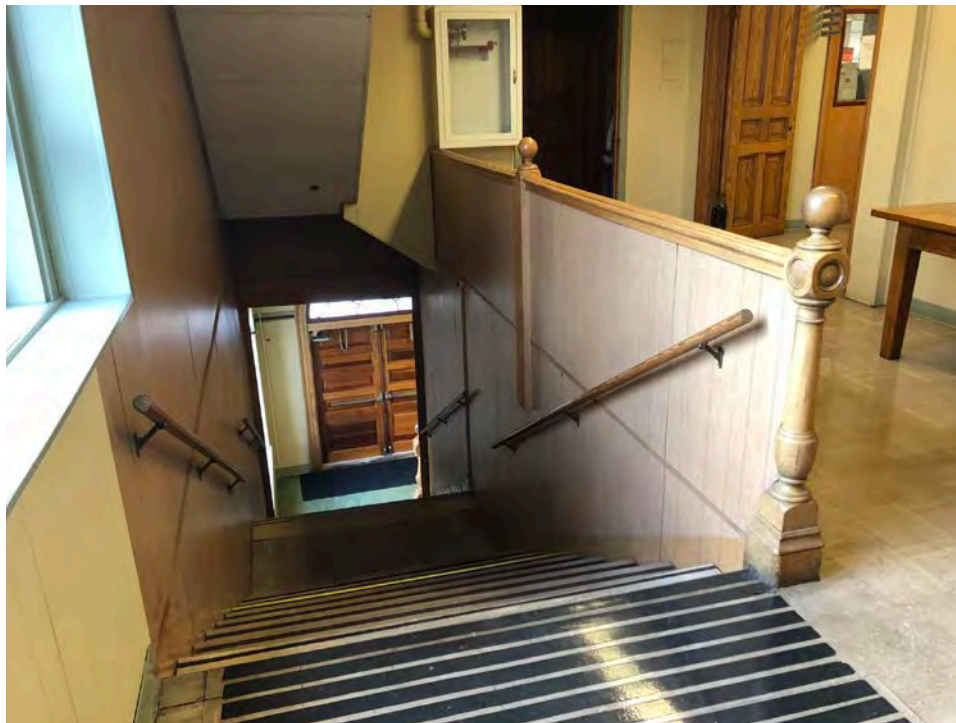
Second Floor – Rear Hallway and Stair

Overall Condition Good; Finishes Inappropriate to Original (Vinyl Floor Tiles, Dropped Ceiling) over Historic Material;  
Historically Inappropriate Ceiling Fixtures, Elevator in Background

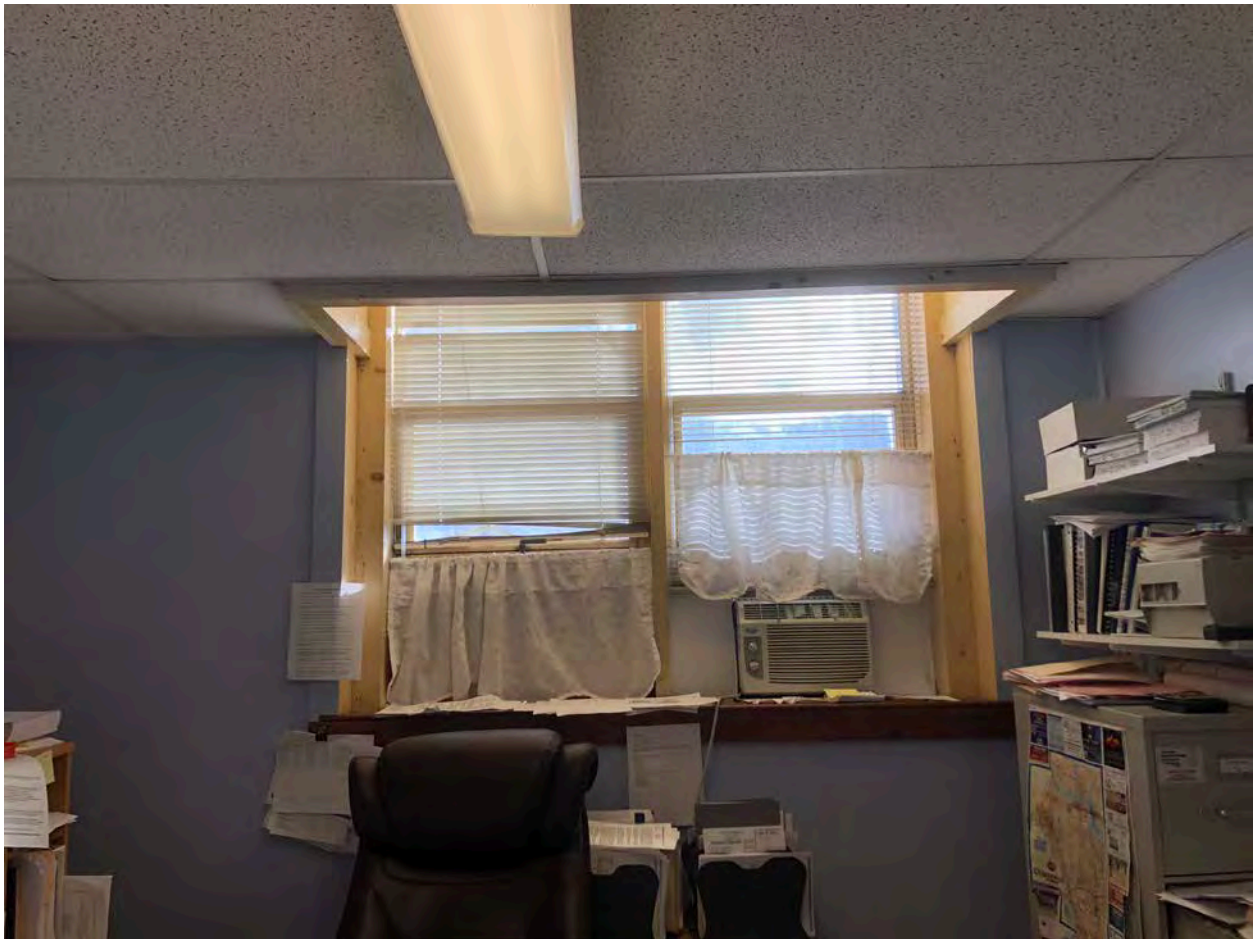
Cumberland Town Hall – Interior – Windows, Doors and Hardware  
Second Floor – Public Works Office  
Dropped Ceiling Bisects Original Windows; Inappropriate Replacement Windows; Transom Not Visible

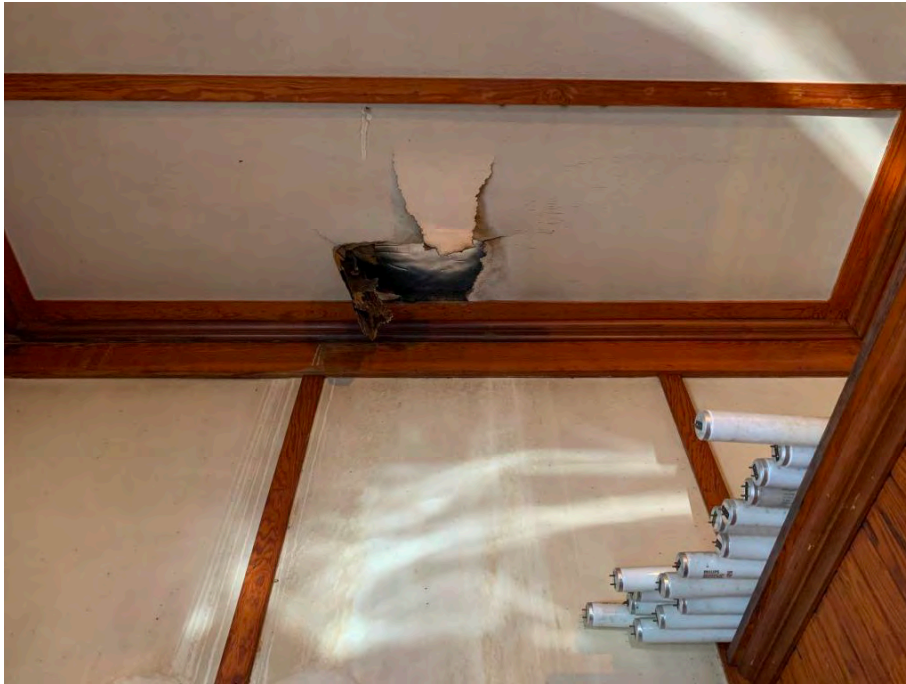
Cumberland Town Hall – Interior – Plaster Walls and Ceilings  
Third Floor – Base of Tower – Stair from Second to Third Floor  
Damaged Plaster and Wood Walls

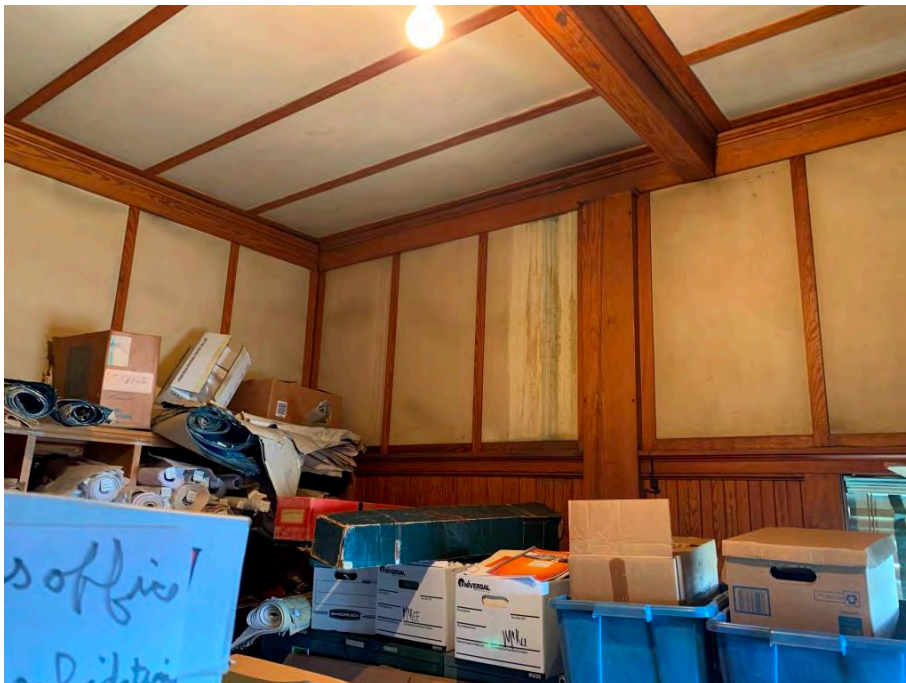
Cumberland Town Hall – Interior – Historic Finishes and Elements  
Third Floor – Southwest Corner Room  
1930s-era Paneled Walls and Ceiling Damaged from Previous Leak

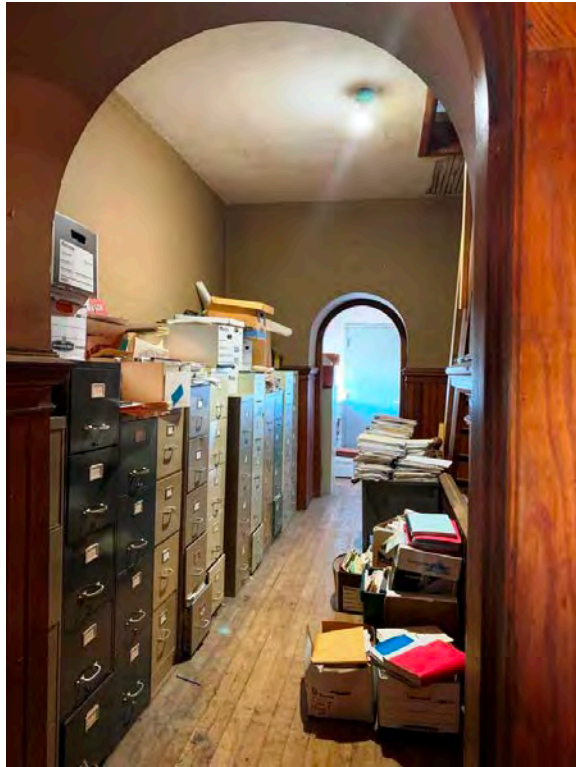
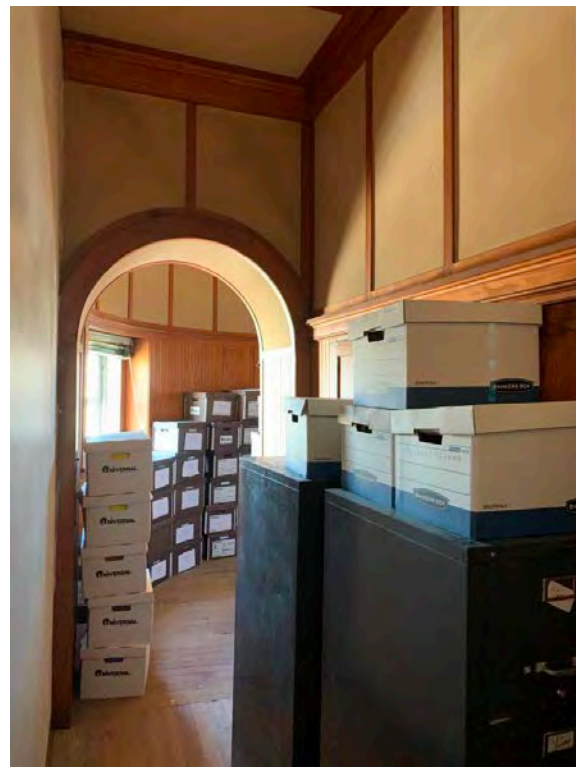
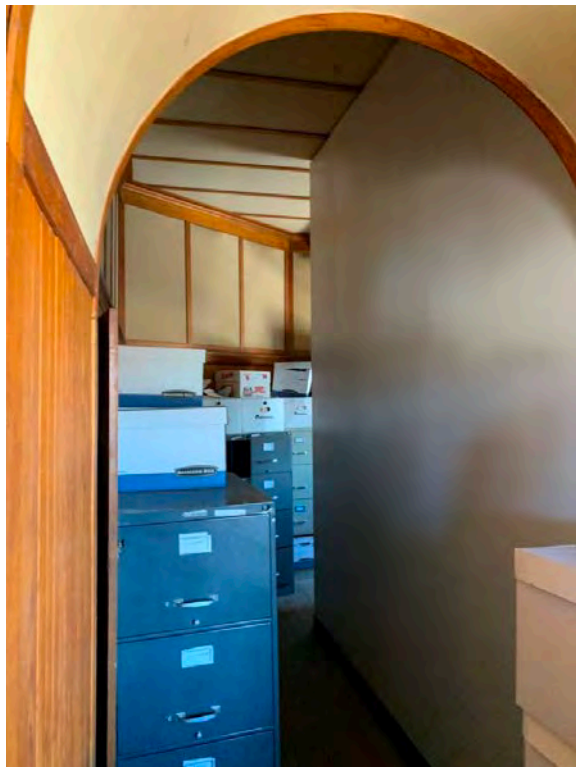
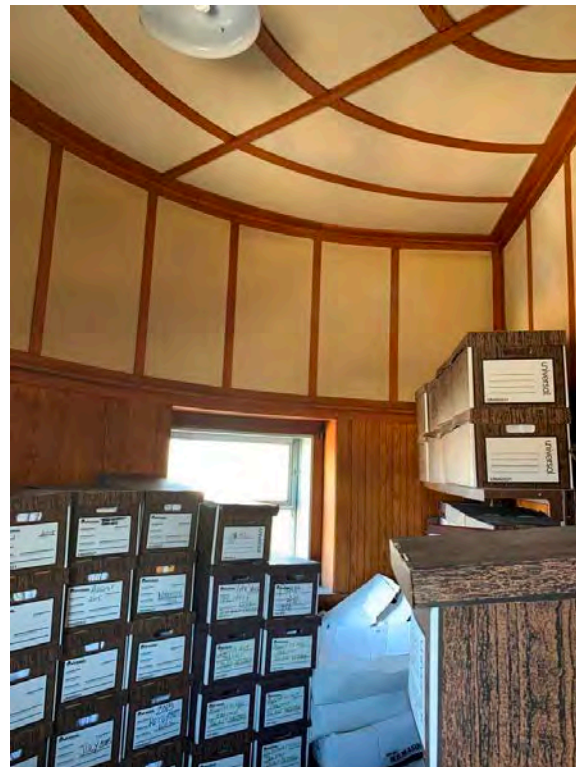
Cumberland Town Hall – Interior – Historic Finishes and Elements - Storage  
Third Floor – Southwest Corner Room  
1930s-era Inlaid Wood Floor Damaged from Storage-related Abuse  
Excessive Storage Creating Substantial Load

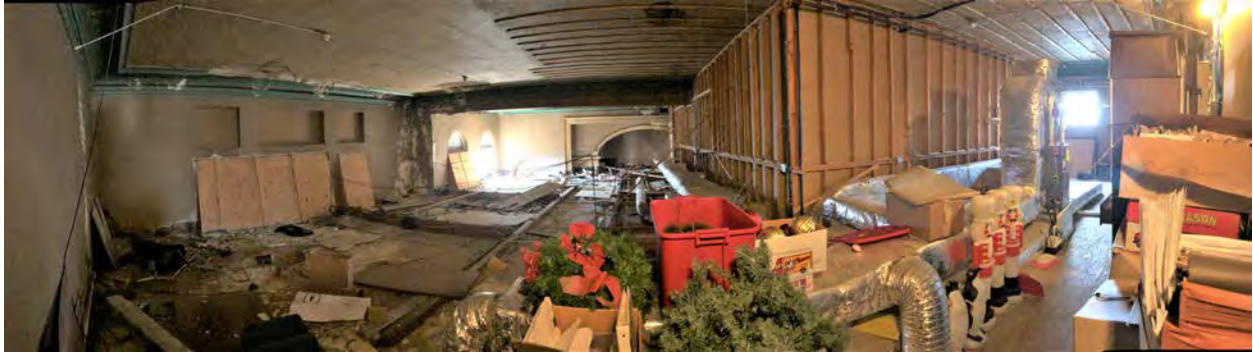
Third Floor – Original Upper Assembly Hall

Assembly Hall Partitioned for Council Chamber and Offices; Upper Portion Predominantly Unused; Remainder Used for Storage in HVAC Equipment Area.

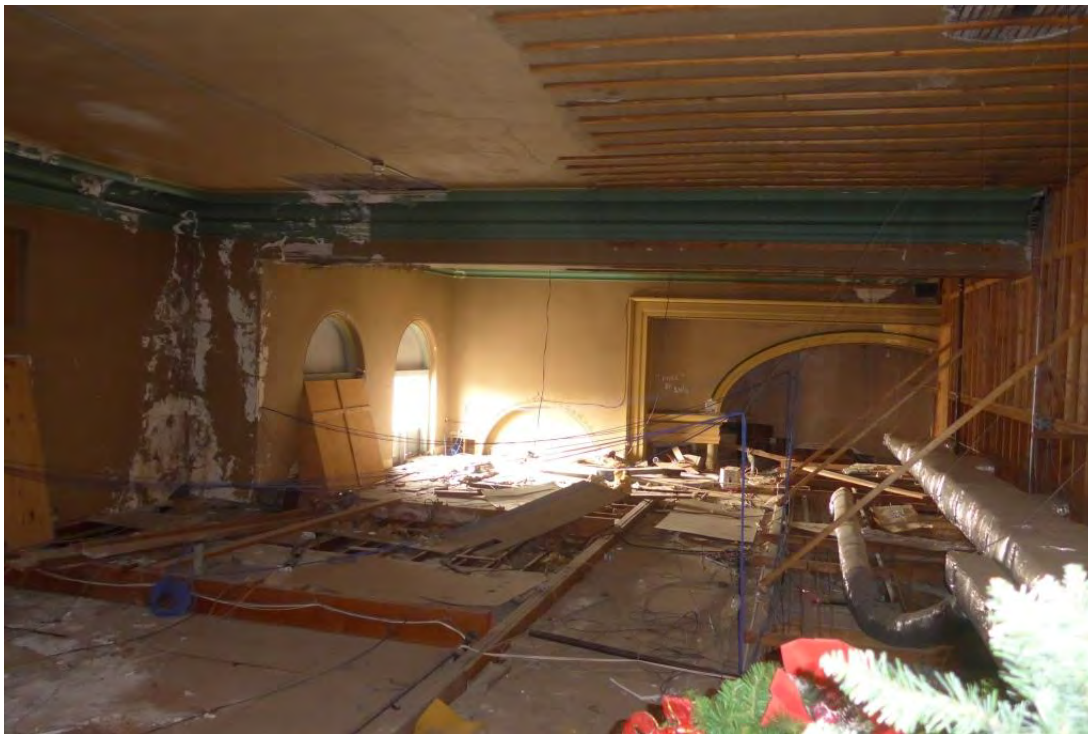
Third Floor – Original Upper Assembly Hall

Assembly Hall Partitioned for Council Chamber and Offices; Upper Portion Predominantly Unused; Remainder Used for Storage in HVAC Equipment Area; Unrepaired Damage to Plaster Walls, Ceiling, and Trim from Previous Leaks

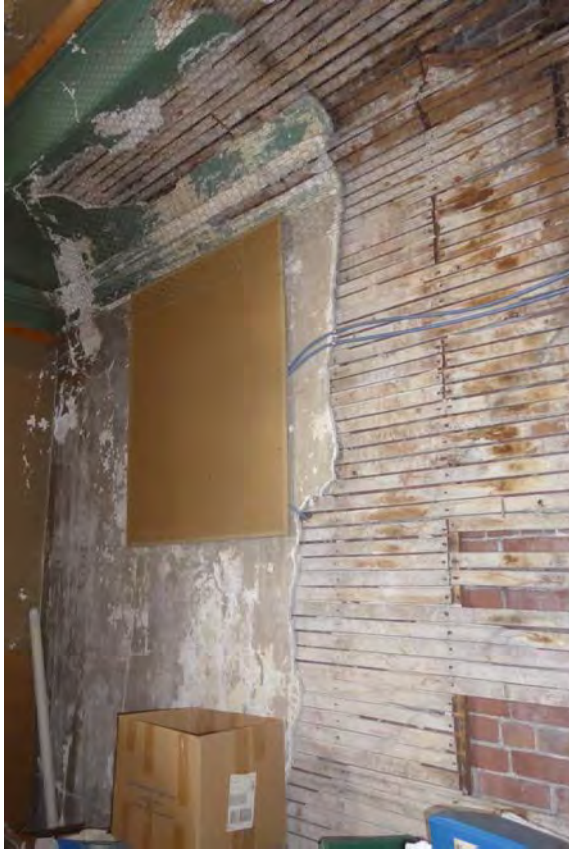
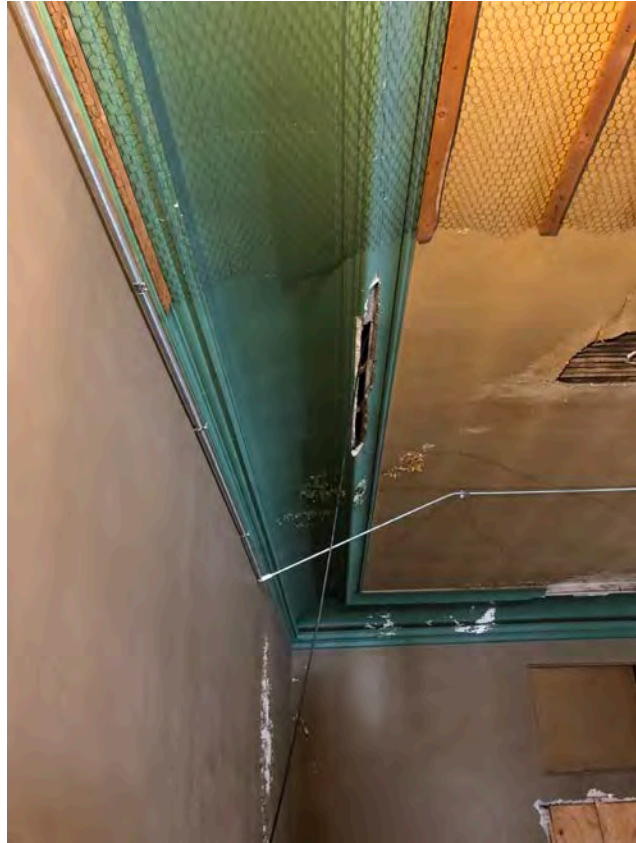
Cumberland Town Hall – Interior - Historic Finishes and Details – Plaster Walls and Ceilings  
Third Floor – Original Upper Assembly Hall  
Severe Unrepaired Damage to Plaster Walls, Ceiling, and Trim from Previous Leaks

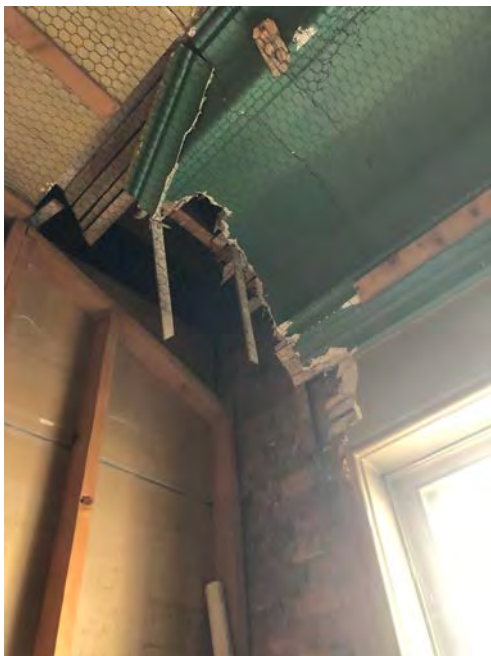
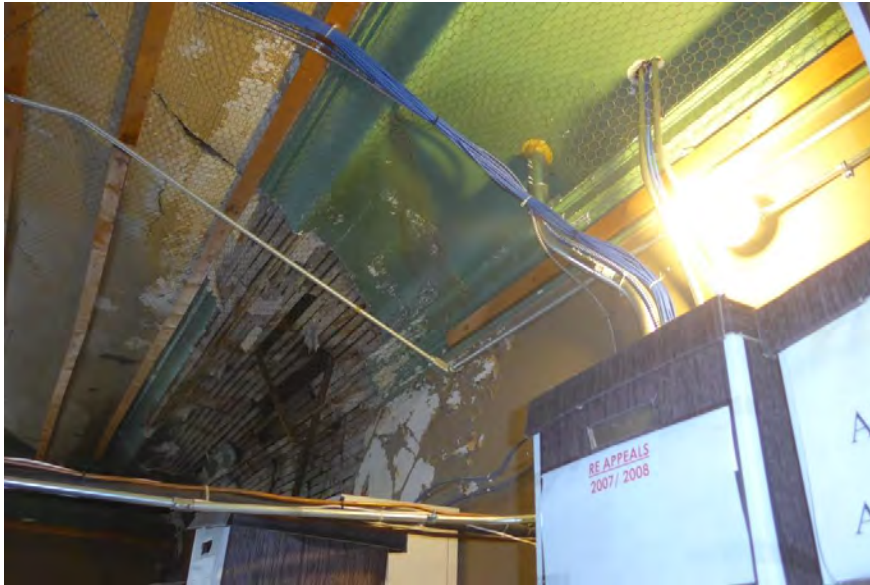
Cumberland Town Hall – Interior – Historic Finishes and Details – Plaster Walls and Ceilings  
Third Floor – Original Upper Assembly Hall  
Damaged Plaster Trim from Building Alterations; Unrepaired Damage to Plaster Walls, Ceiling, and Trim from Previous Leaks

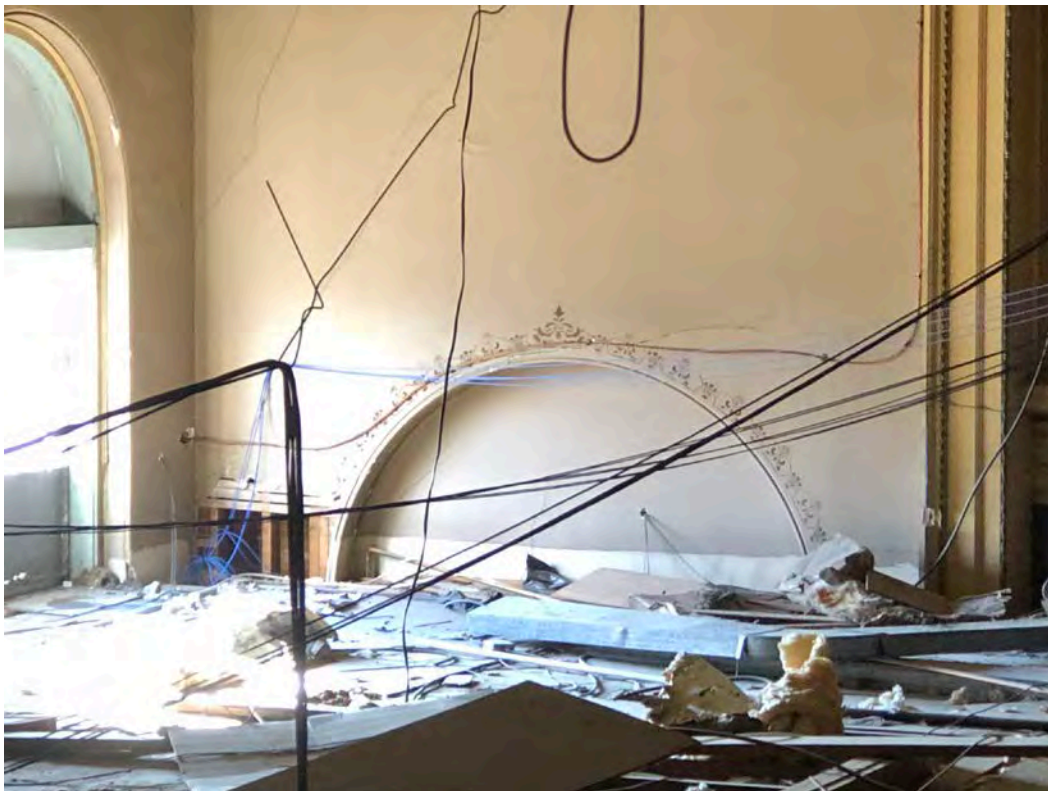
Cumberland Town Hall – Interior - Historic Finishes and Details – Plaster Walls and Ceilings  
Third Floor – Original Upper Assembly Hall  
Note: Original Stenciled Detail at Side Arch

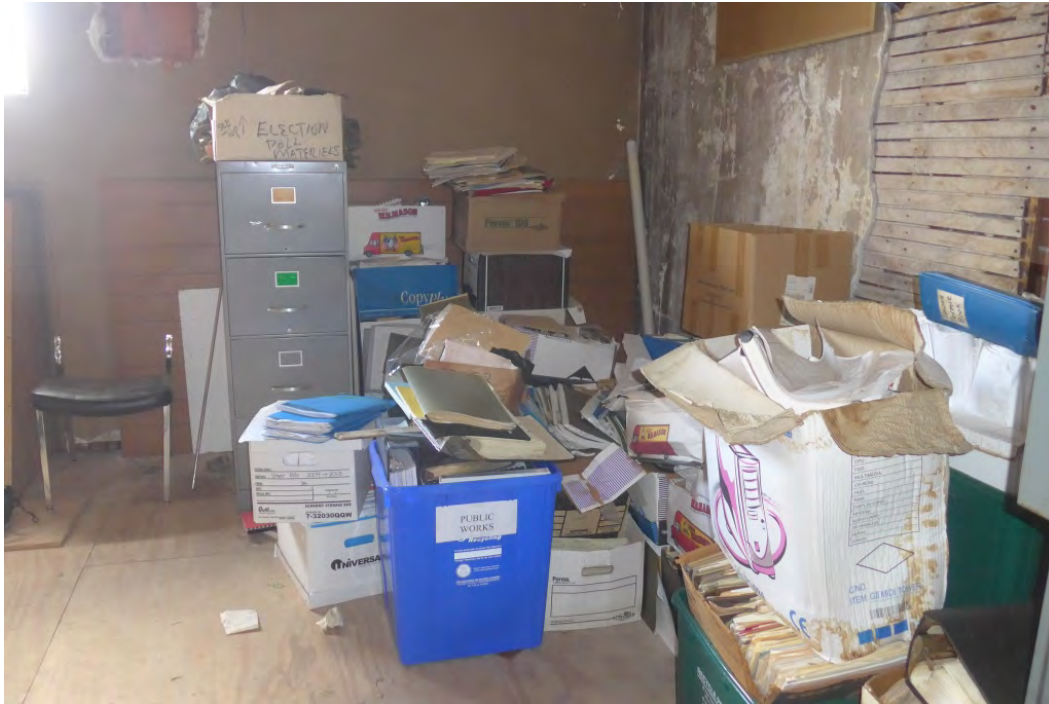
Cumberland Town Hall – Interior – Storage  
Third Floor – HVAC Area  
Excessive Storage Creating Substantial Load

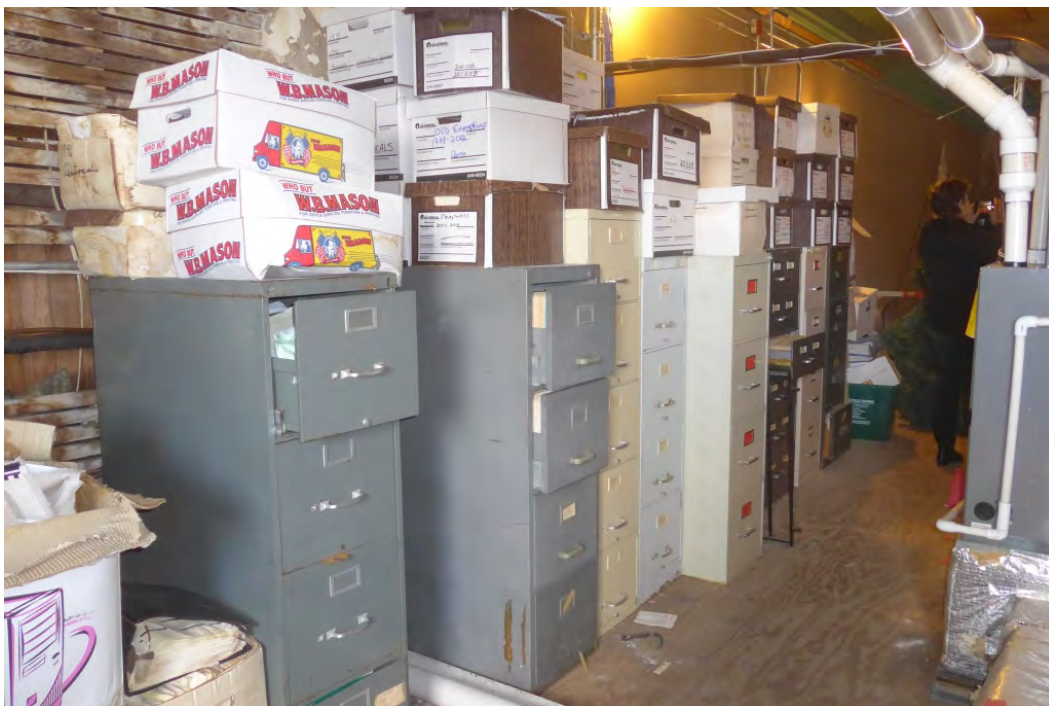
Cumberland Town Hall – Interior – Storage  
Third Floor – HVAC Area  
Excessive Storage Creating Substantial Load

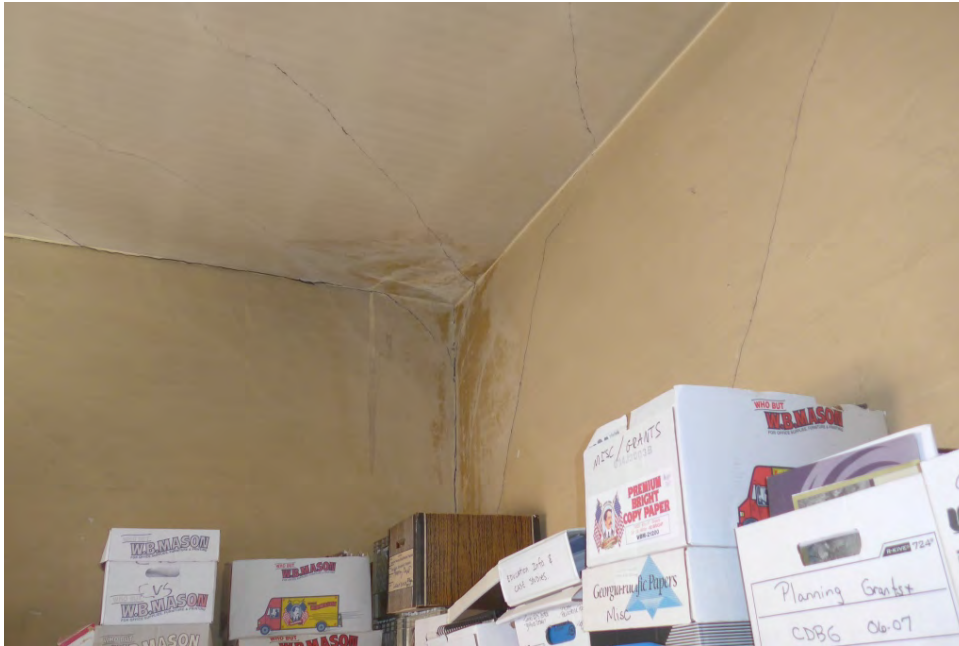
Cumberland Town Hall – Interior – Plaster Walls and Ceilings  
Third Floor – East Storage Area  
Damage from Previous Leak; Cracks in Plaster Walls and Ceiling

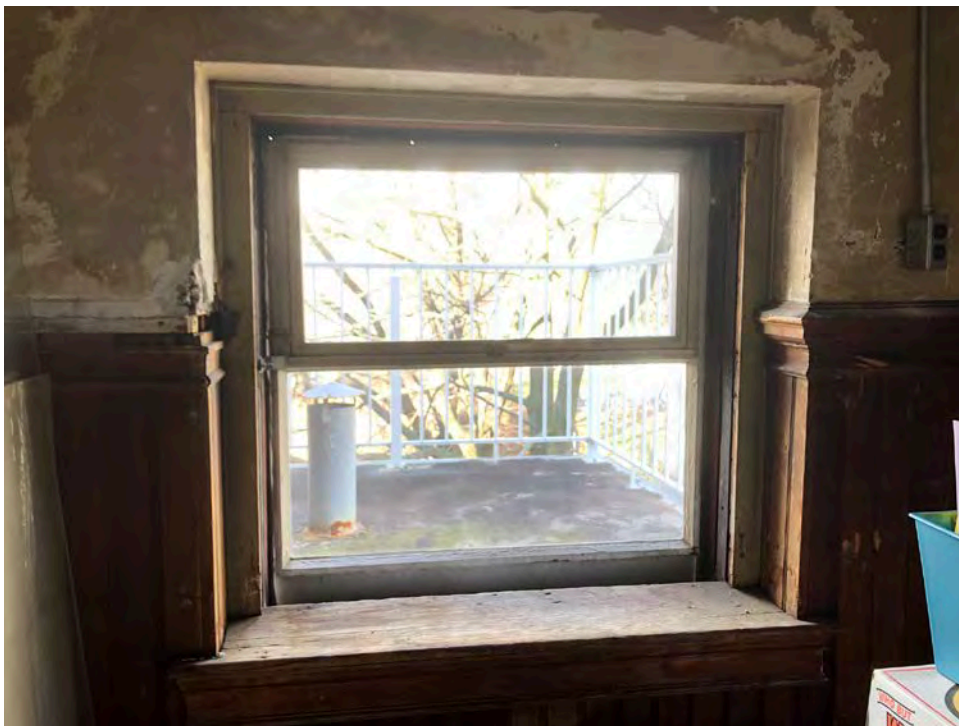
Cumberland Town Hall – Interior – Plaster Walls and Ceilings – Windows, Doors and Hardware  
Third Floor – East Storage Area  
Damage from Previous Leak

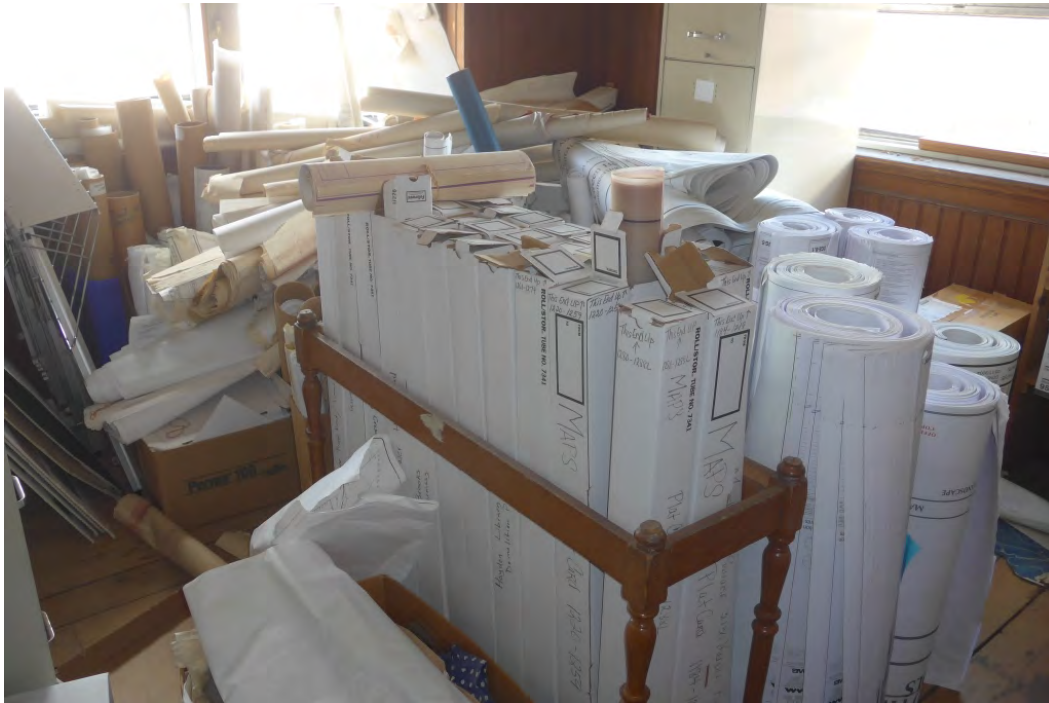
Cumberland Town Hall – Interior – Plaster Walls and Ceilings - Storage  
Third Floor – East Storage Area  
Excessive Storage Creating Substantial Load
