# CUMBERLAND TOWN HALL CONDITIONS ASSESSMENT

**45 BROAD STREET  
CUMBERLAND, RI 02864**

**ISSUED:**

18 June 2020

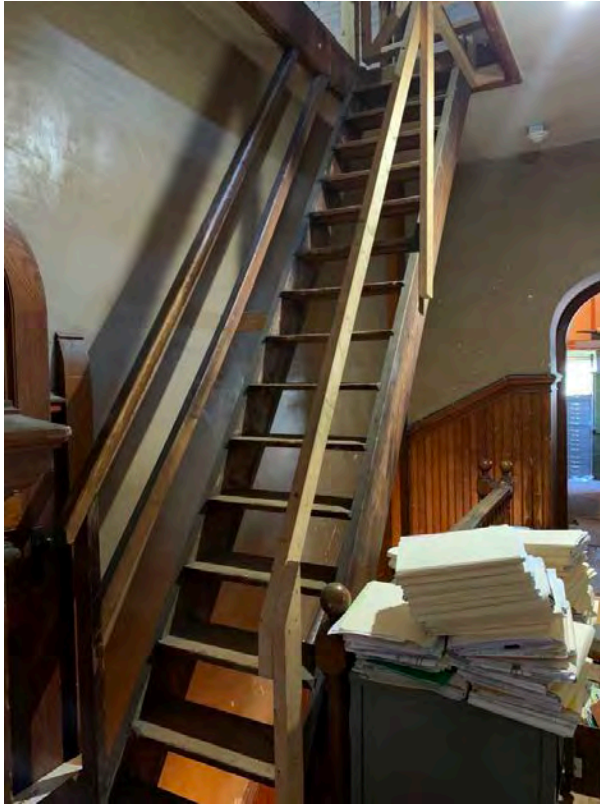
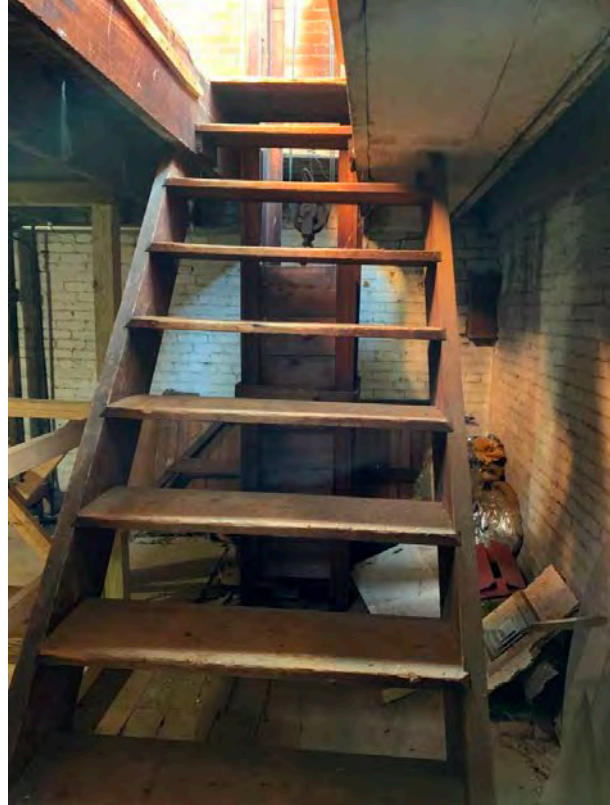
Cumberland Town Hall – Interior – Code Compliance  
Tower – Stairs Up to Tower  
Left: Steep Stairs; Right: No Handrail and Limited Access

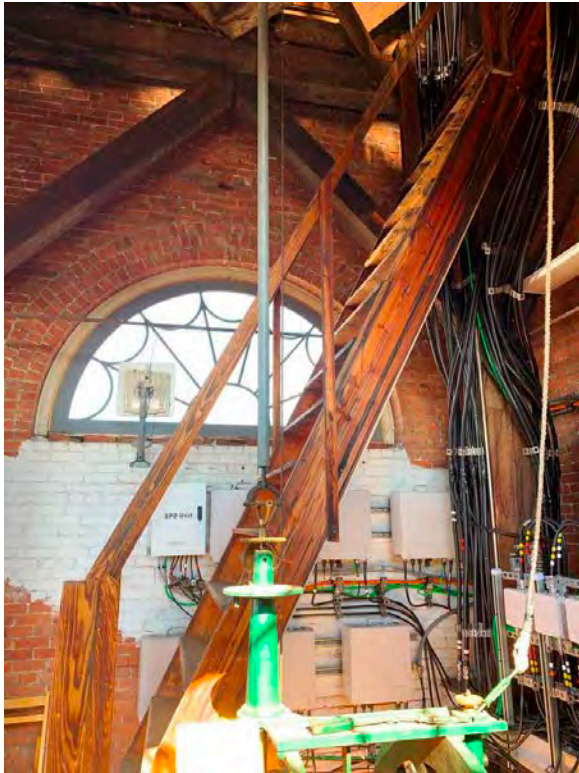
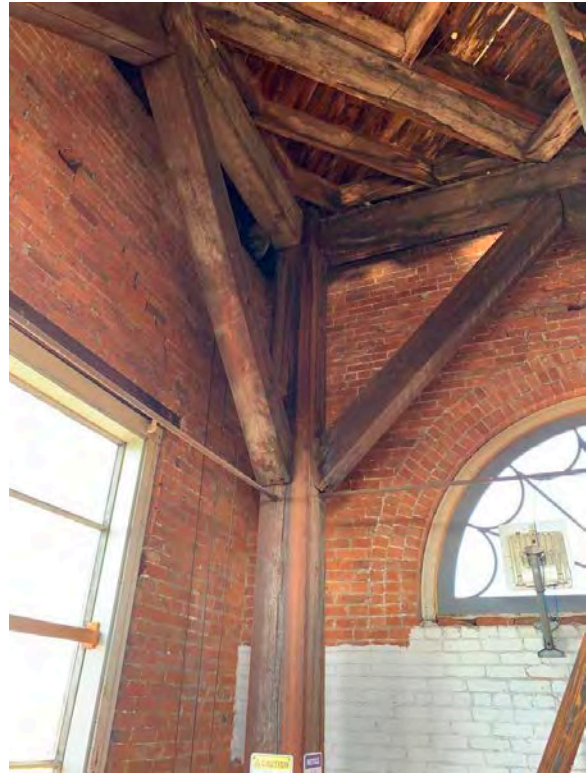
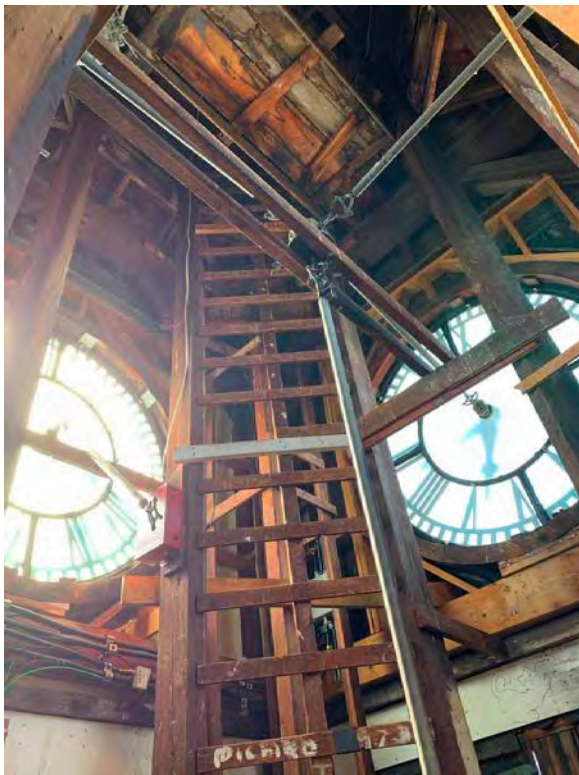
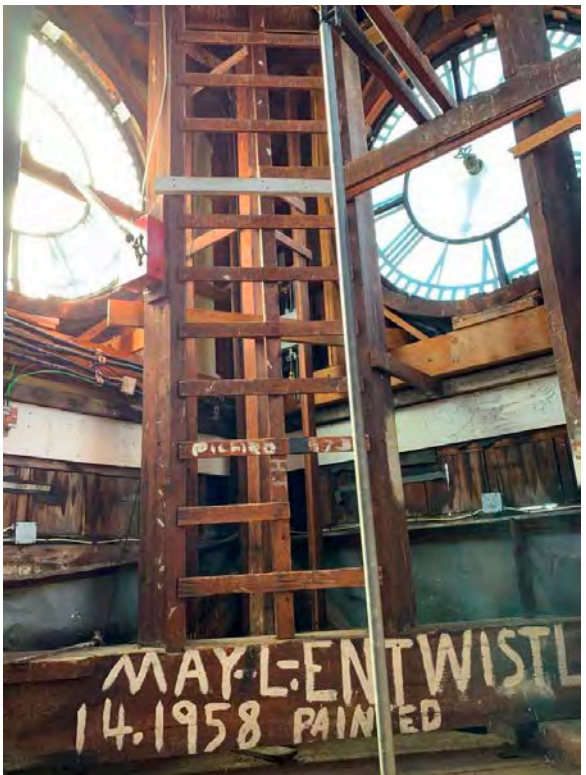
Cumberland Town Hall – Interior – Historic Finishes and Building Elements  
Tower – Overall Views – Top: Fifth Floor; Bottom: Sixth Floor at Clock Faces  
Overall in Good Condition

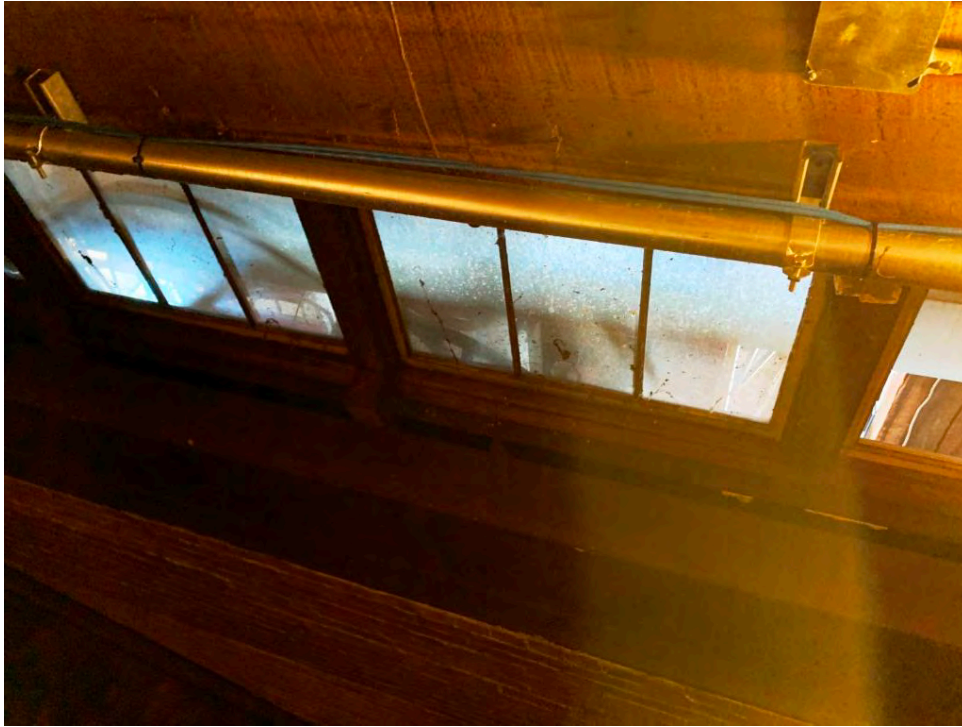
Cumberland Town Hall – Interior – Historic Finishes and Elements  
Tower – Windows Between Tower and Attic Over Assembly Hall

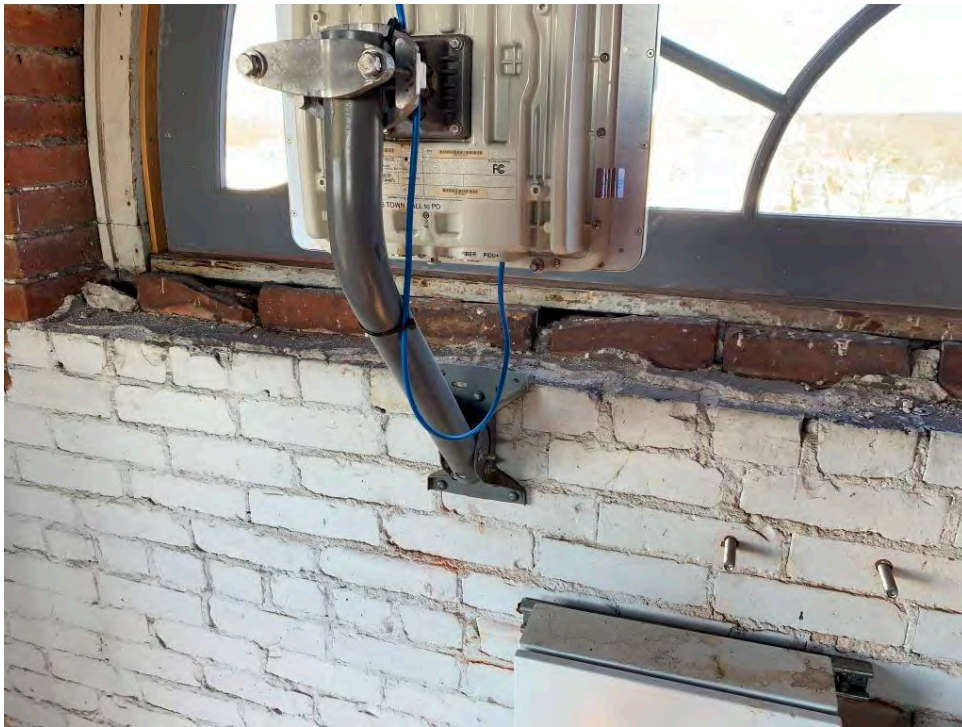
Cumberland Town Hall – Interior – Historic Finishes and Elements  
Tower  
Damaged Masonry

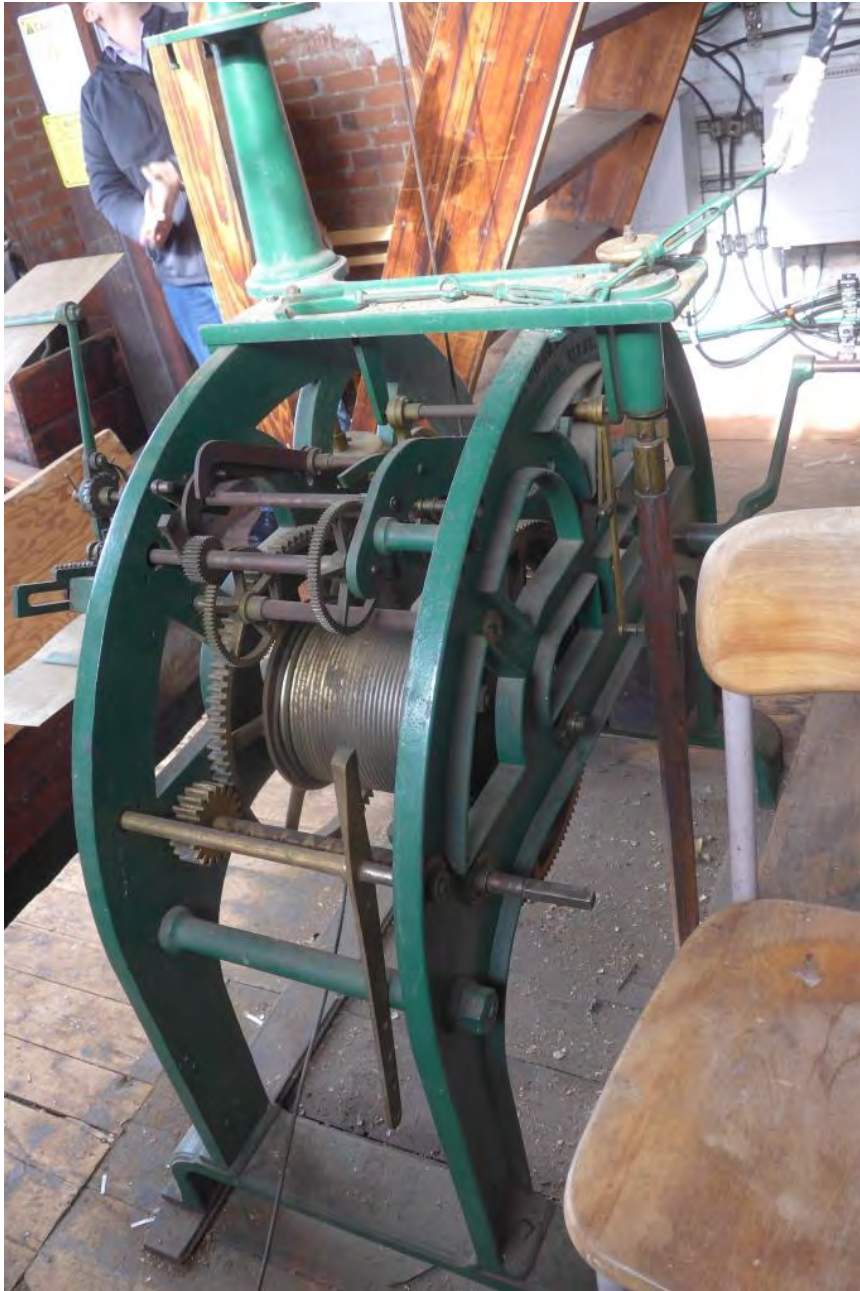
Cumberland Town Hall – Interior – Historic Finishes and Elements  
Tower – Fifth Floor  
Original Clock Mechanism

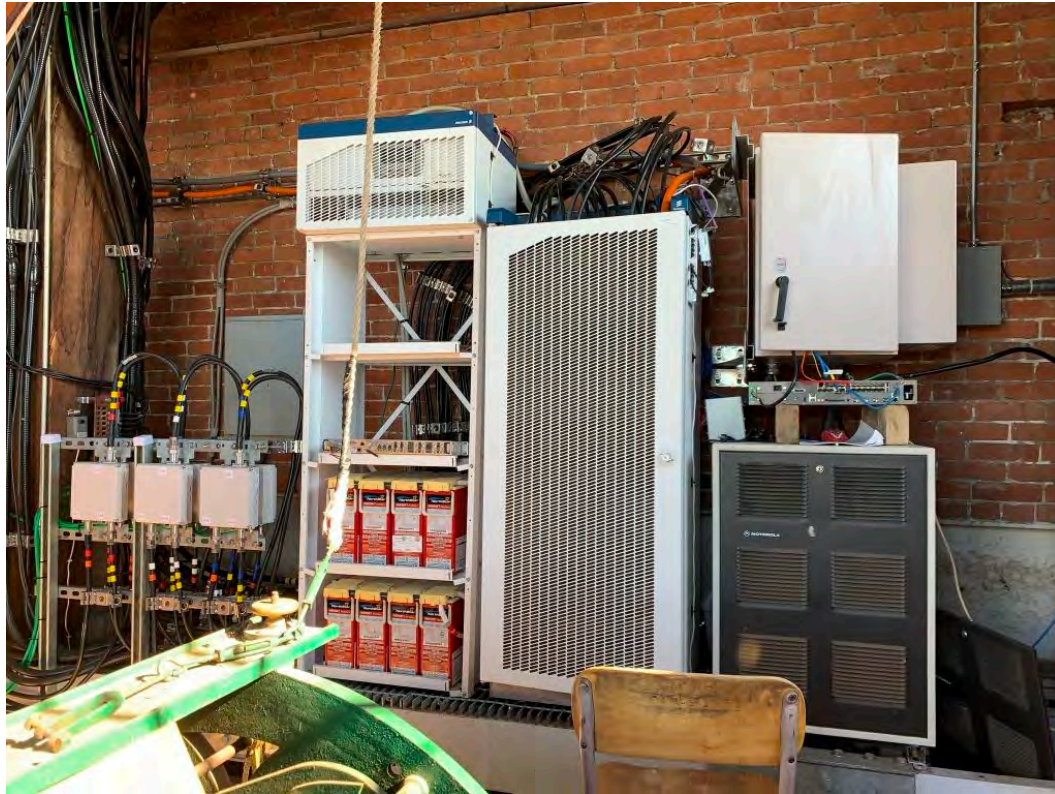
Cumberland Town Hall – Interior  
Tower – Fifth Floor  
Cell Service Equipment in Tower

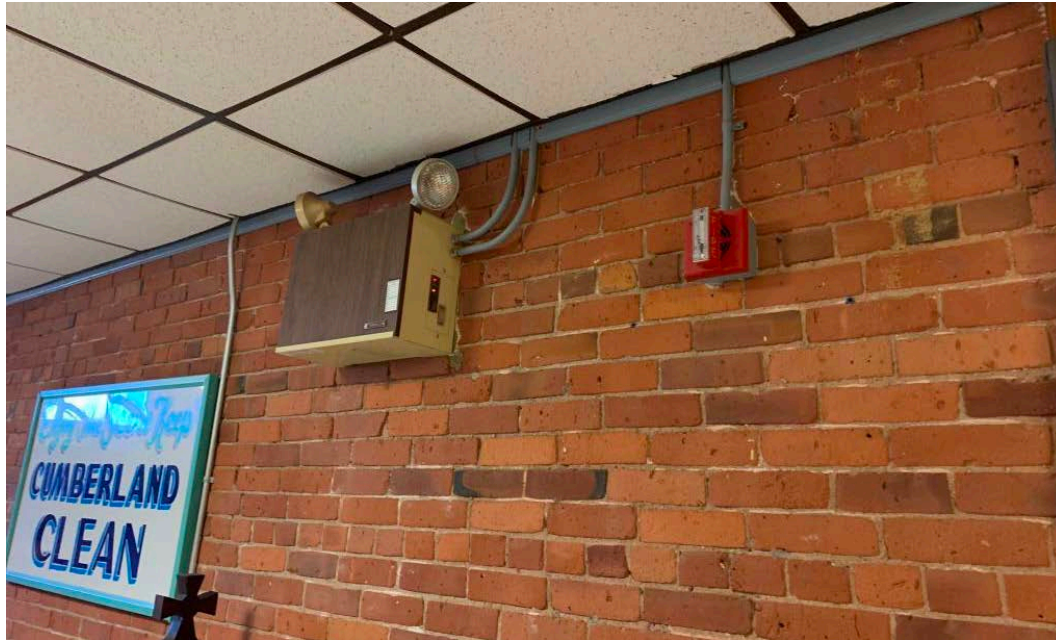
Cumberland Town Hall - Code Compliance Conditions  
Basement – Entrance at Handicapped Access  
Emergency Lighting and Fire Alarm

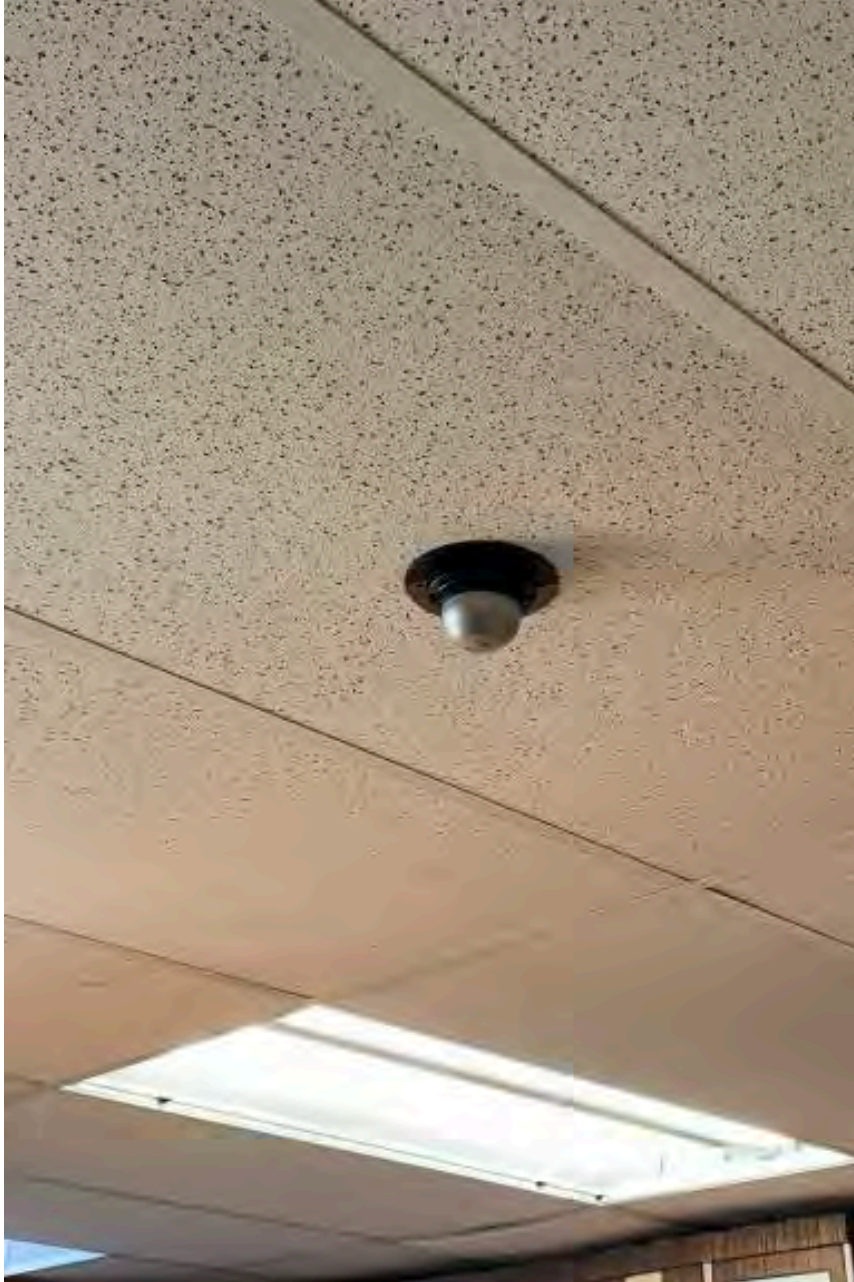
Cumberland Town Hall - Code Compliance Conditions  
Basement – Storage Room  
Existing Fire Sensor

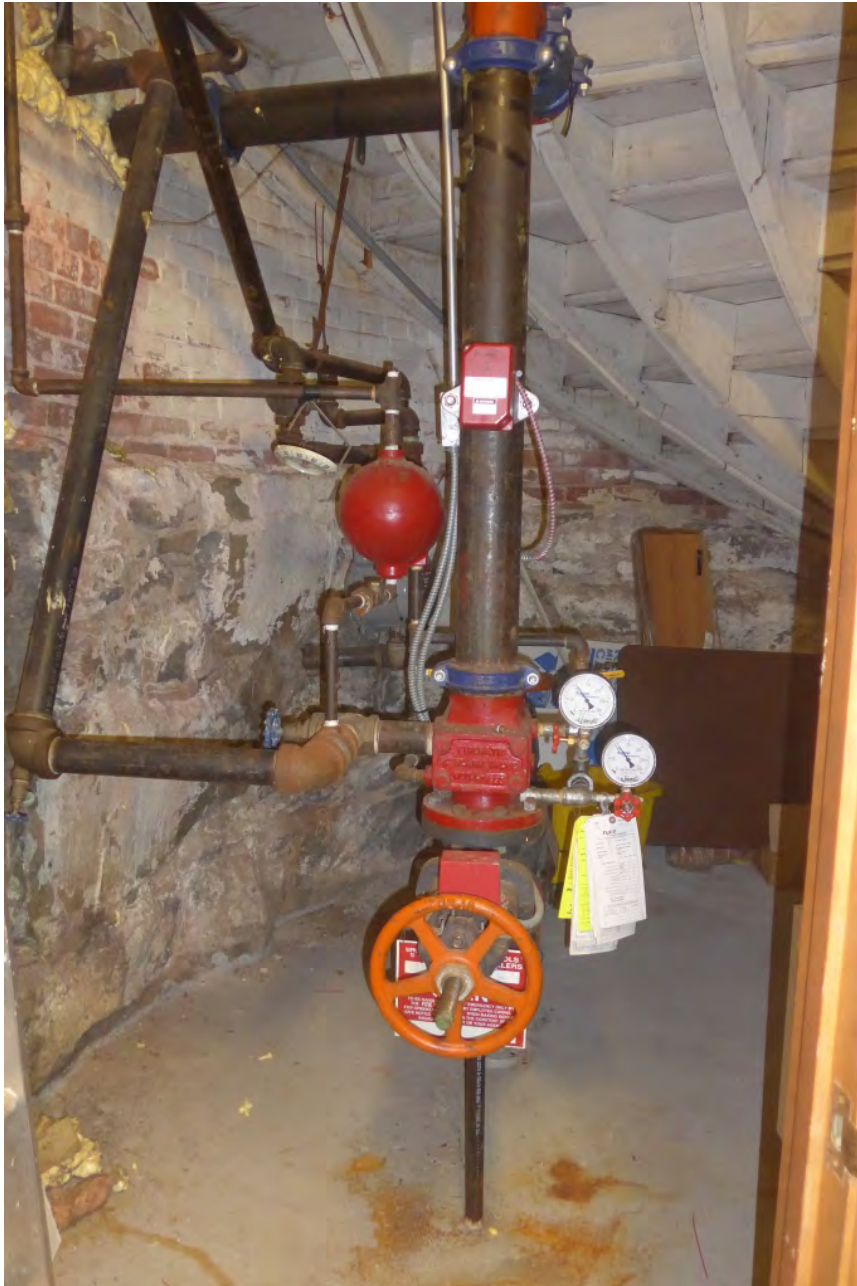
Cumberland Town Hall - Code Compliance Conditions - First Floor  
Basement – Under Main Stair  
Sprinkler System Pump

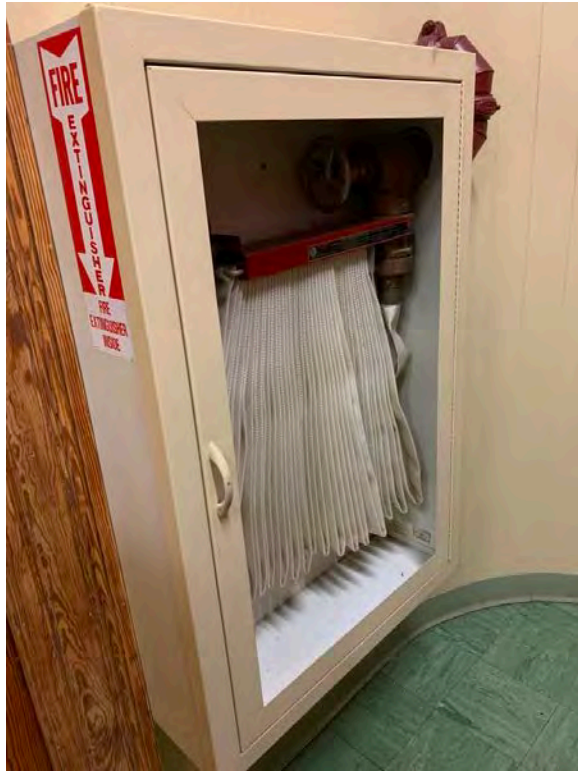
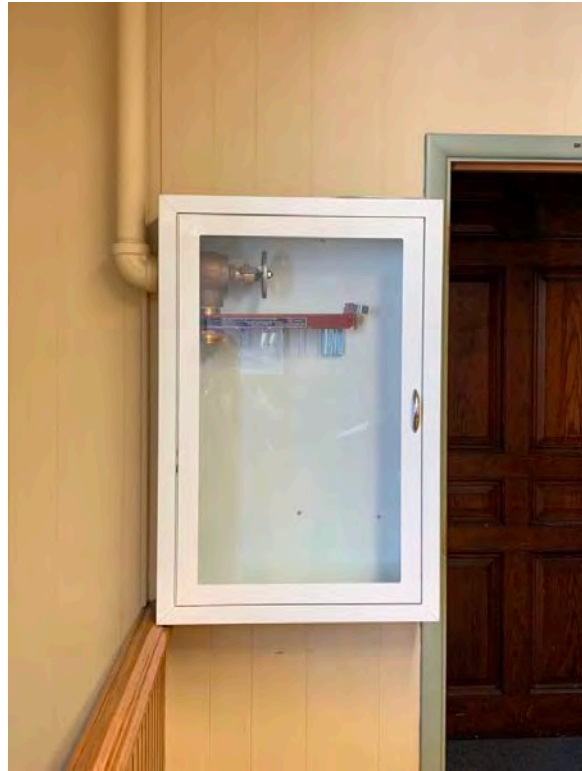
Left: First Floor at Main Stair; Right: Second Floor, East Stair Hall

Cumberland Town Hall - Code Compliance Conditions

Left: Code Compliant Fire Hose Cabinet - Compliant; Right: Hose Missing from Cabinet - Non-Compliant

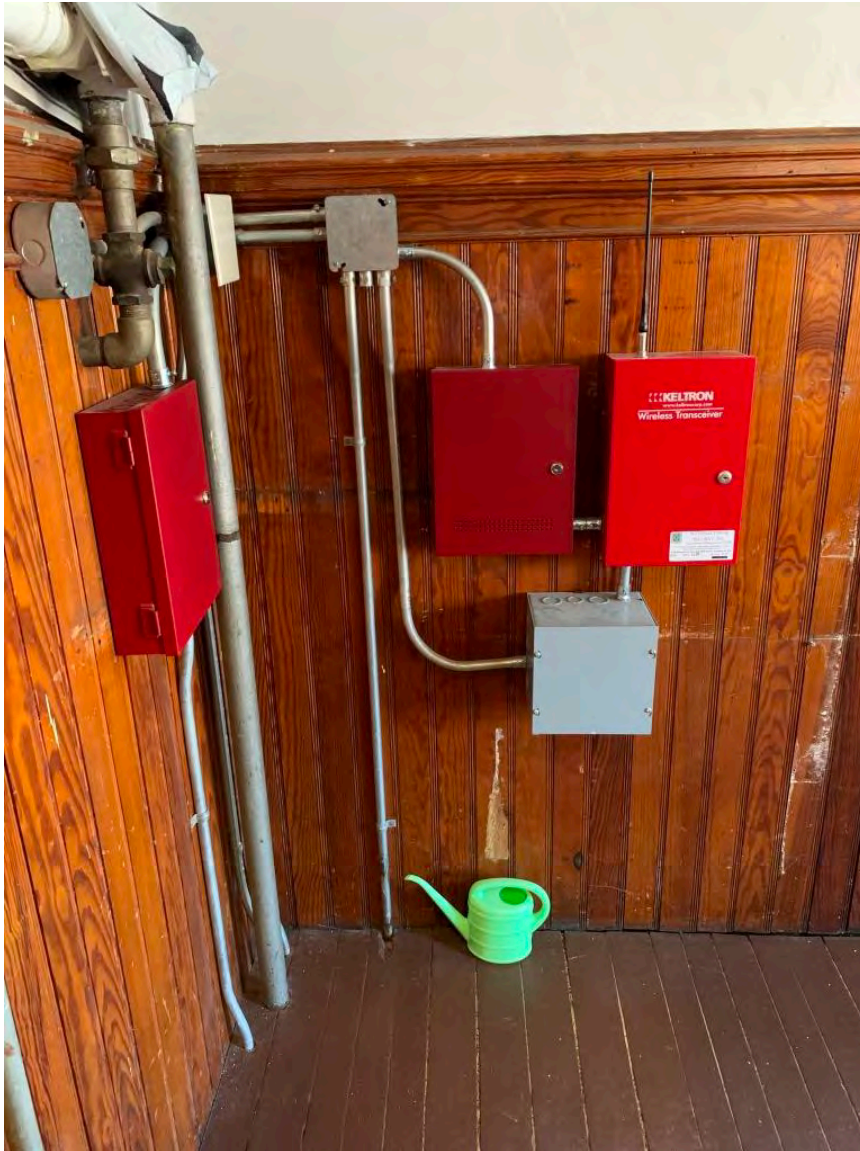
Cumberland Town Hall - Code Compliance Conditions  
First Floor – Landing at Top of Main Basement Stair  
Fire Alarm System

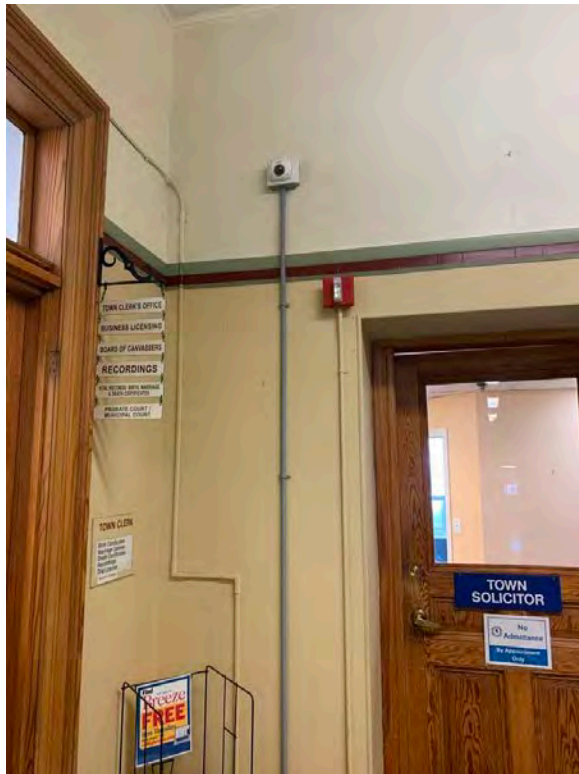
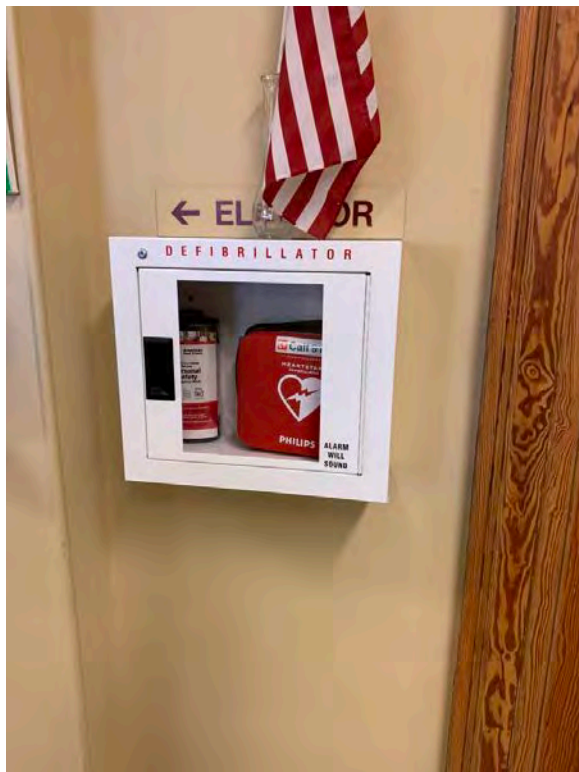
Cumberland Town Hall - Code Compliance Conditions  
First Floor - Main Hallway  
Left: Fire Alarm and Smoke Sensor; Right: Defibrillator

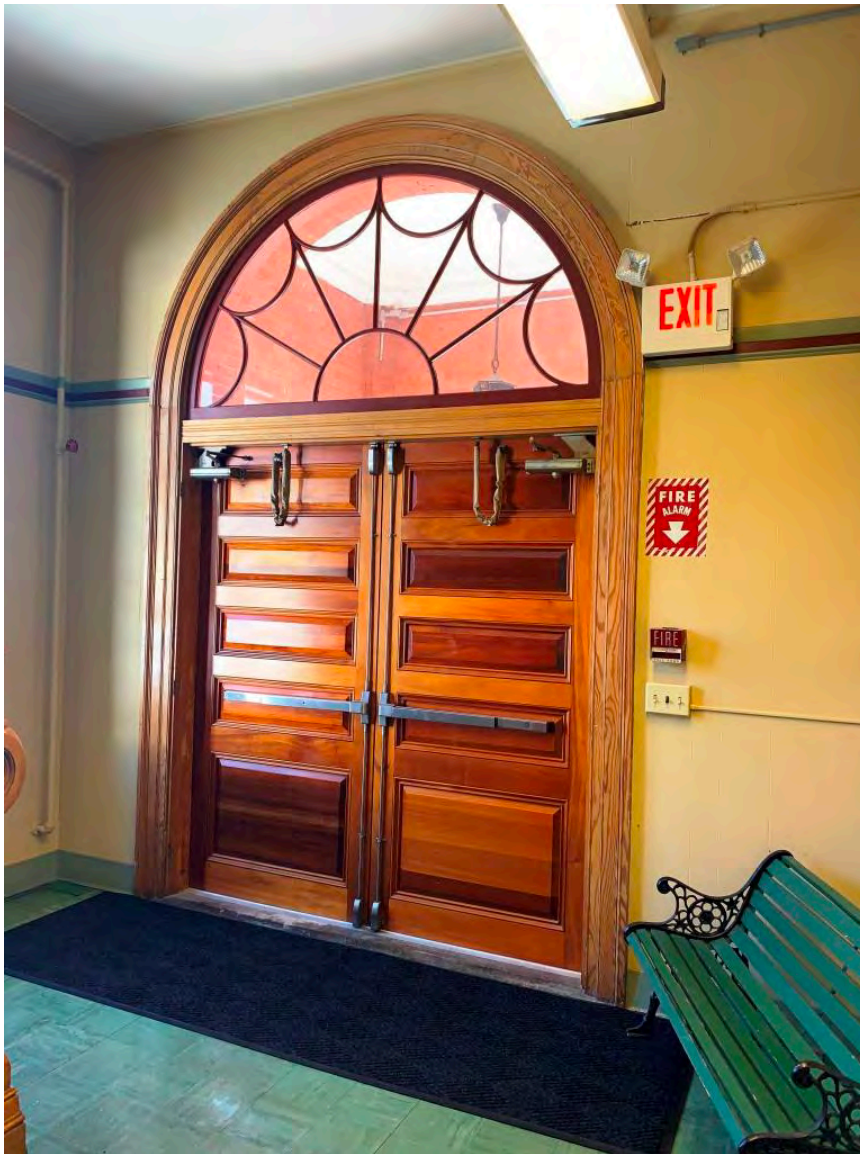
Cumberland Town Hall - Code Compliance Conditions  
First Floor – East Entrance/Stair Hall at Southeast Entrance  
Emergency Exit Panic Hardware, Signage, Emergency Lighting and Fire Pull Box

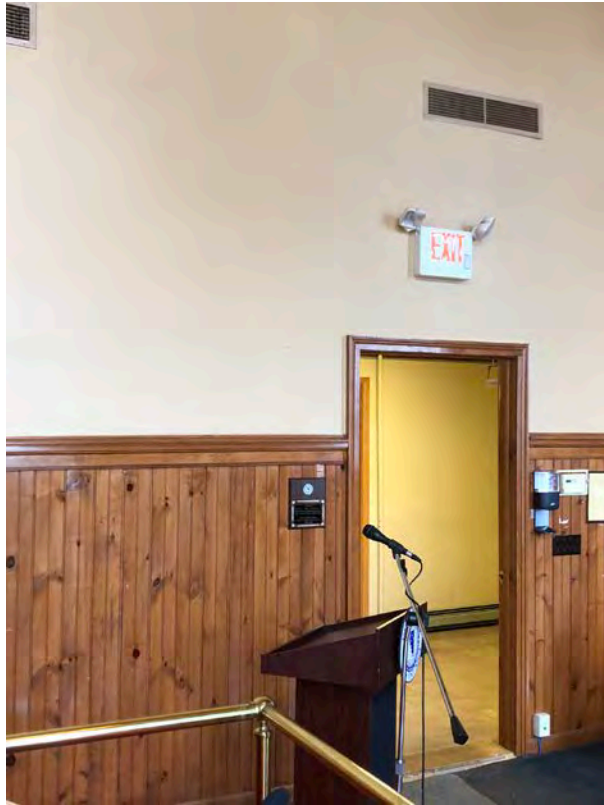
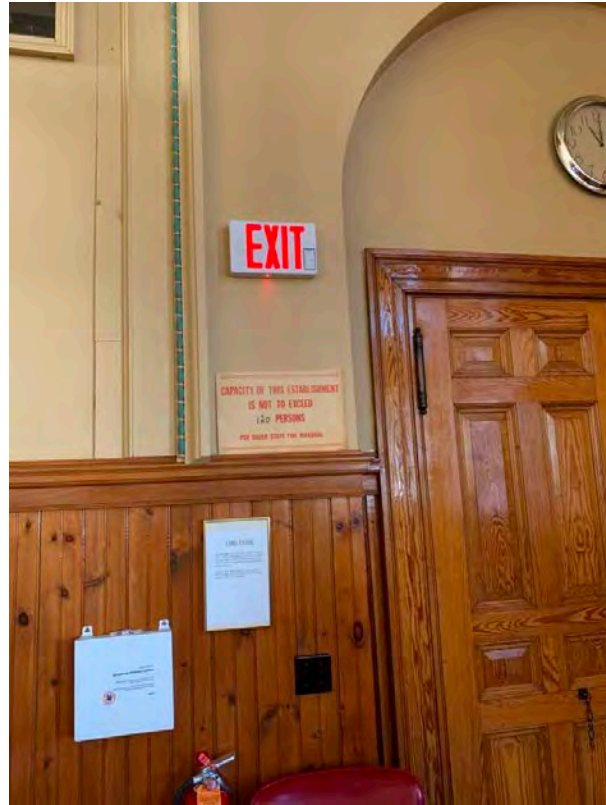
Cumberland Town Hall - Code Compliance Conditions  
Second Floor – Council Chamber  
Emergency Exit Signage and Emergency Lighting
