# **GATEWAY NATIONAL RECREATION AREA SANDY HOOK, NJ**

HISTORIC WATER PLANT BUILDING 341  
PMIS NO. 152823A

## **LIMITED STRUCTURAL INVESTIGATION & REPORT**

NATIONAL PARK SERVICE  
*January 14, 2014*

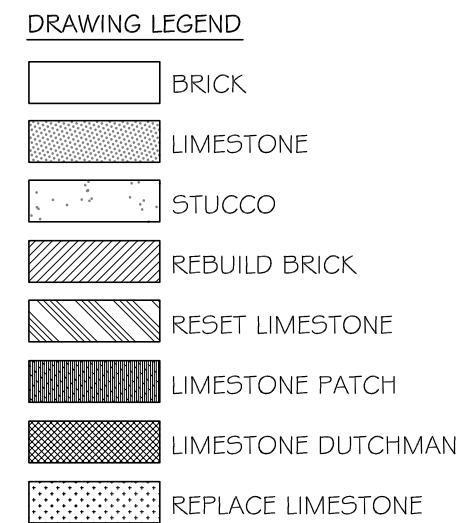
A-1

SCOPE OF WORK NOTES

In all areas where the masonry walls are deteriorating, each section will need to be disassembled and the bricks in good condition shall be salvaged. Approximately 20% of the bricks will need to be replaced, however existing bricks shall be reused where possible. The parapet will need to be rebuilt, replicating all details. For locations and quantities of brick to be rebuilt, refer to drawings on pages 23-25.

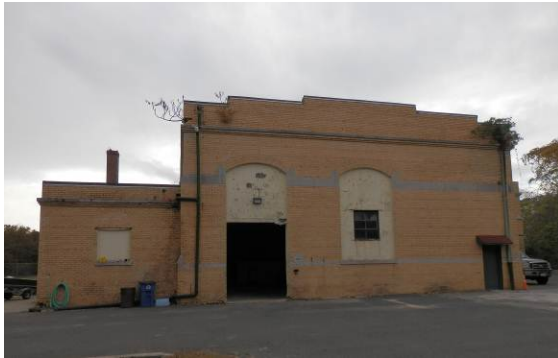
*Image 1– North elevation of the Water Plant.*

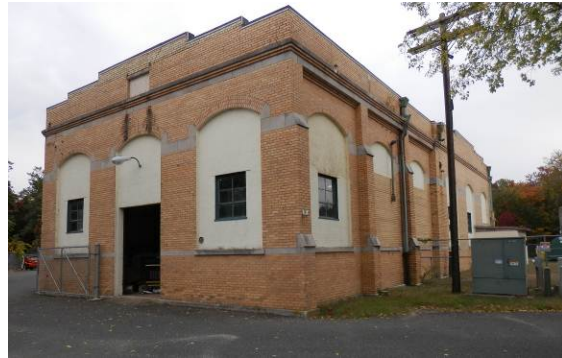
*Image 2– West and south elevations of the Water Plant.*

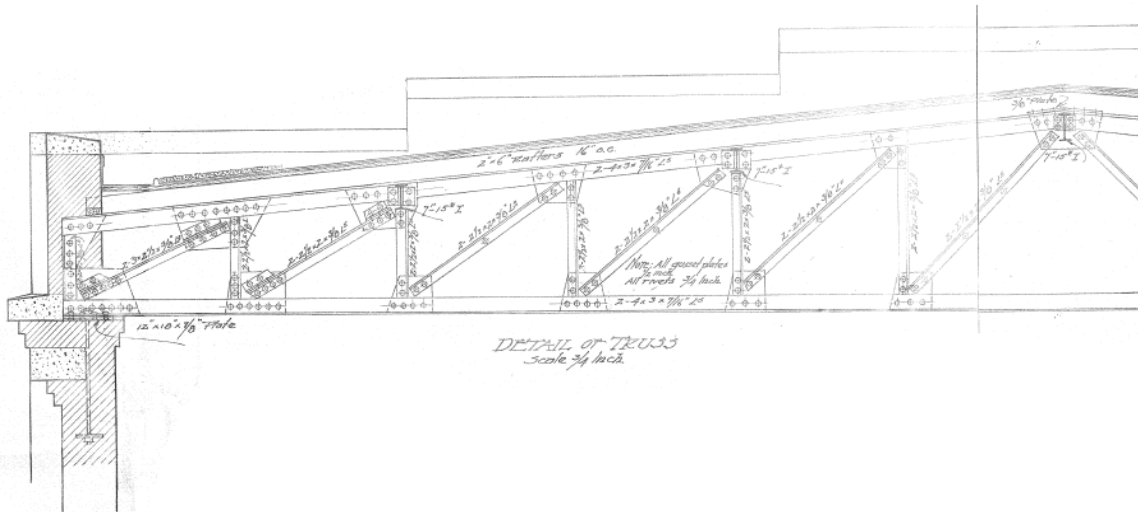
Trusses are built-up construction with steel plates and angles. In the original building and addition, trusses span the short direction, are pocketed into the masonry and bear on steel plates. The plates are anchored into the wall with 1" diameter anchors bolts (Image 3).

*Image 3– Truss detail from 1912 drawing.*

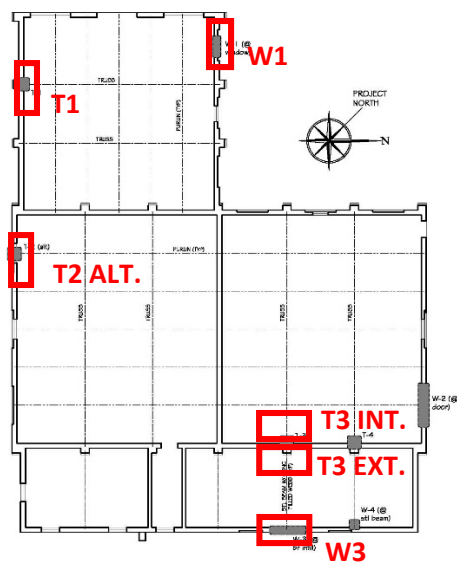
MORTAR SAMPLE LOCATIONS

Based on the mortar samples and common historic preservation practice, the bedding and pointing mortar recommended for future use is Type N (1 part cement/ 1 part hydrated lime/ 6 parts sand). This mortar is the best match for the age and hardness of the brick. Type N is a general-purpose, structural mortar, softer in nature, but more durable than the original lime mortar used on the Water Plant. Type N will provide a strength of 750 psi, and is recommended for severe weather exposure.
