# A Geotechnical Investigation of Pretty Rocks Landslide, Mile 45.4, Denali Park Road, Denali National Park, Alaska

Natural Resource Report NPS/DENA/NRR—2022/2365

March 2022

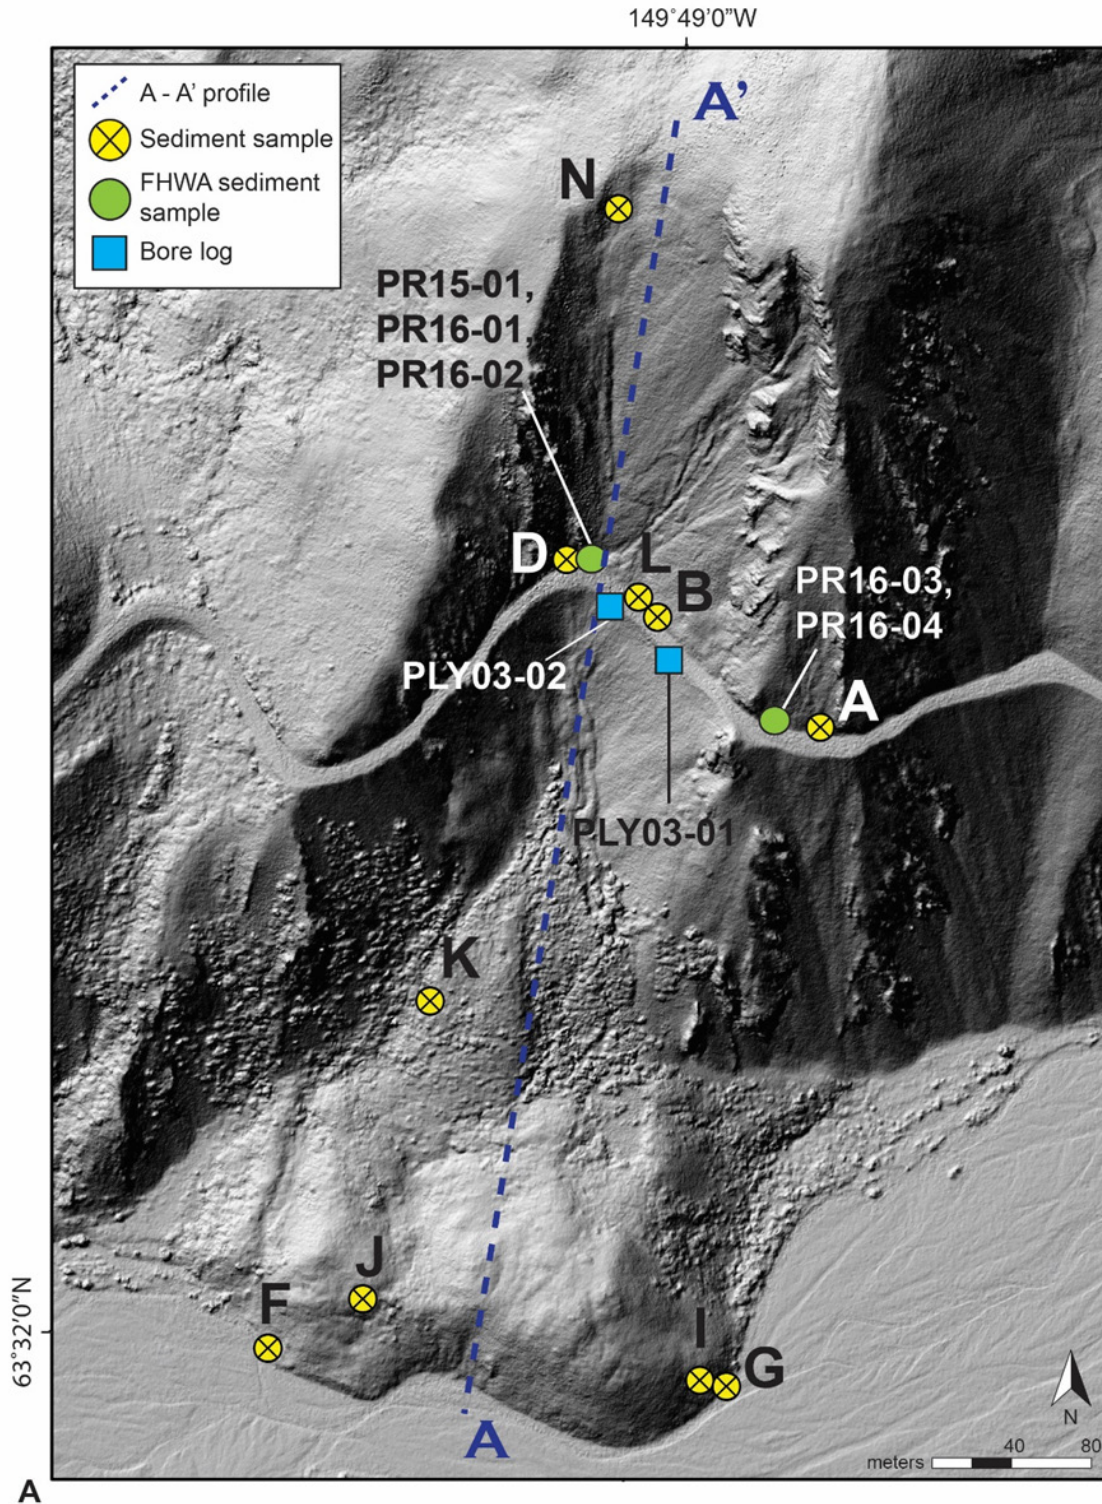
**Figure 6A.** (A) Location of slope profile, sediment sample locations, and drilling bore logs. Sediment samples PR15-01–PR16-04 collected by the FHWA. Samples A–N were collected during this study. Based on their location, distribution, and grain size, 10 of these samples were selected for laboratory analysis. See Engineering Test Results section for more details. Map background image 2015 SfM Digital Surface Model hillshade. (B, next page) A–A' profile.

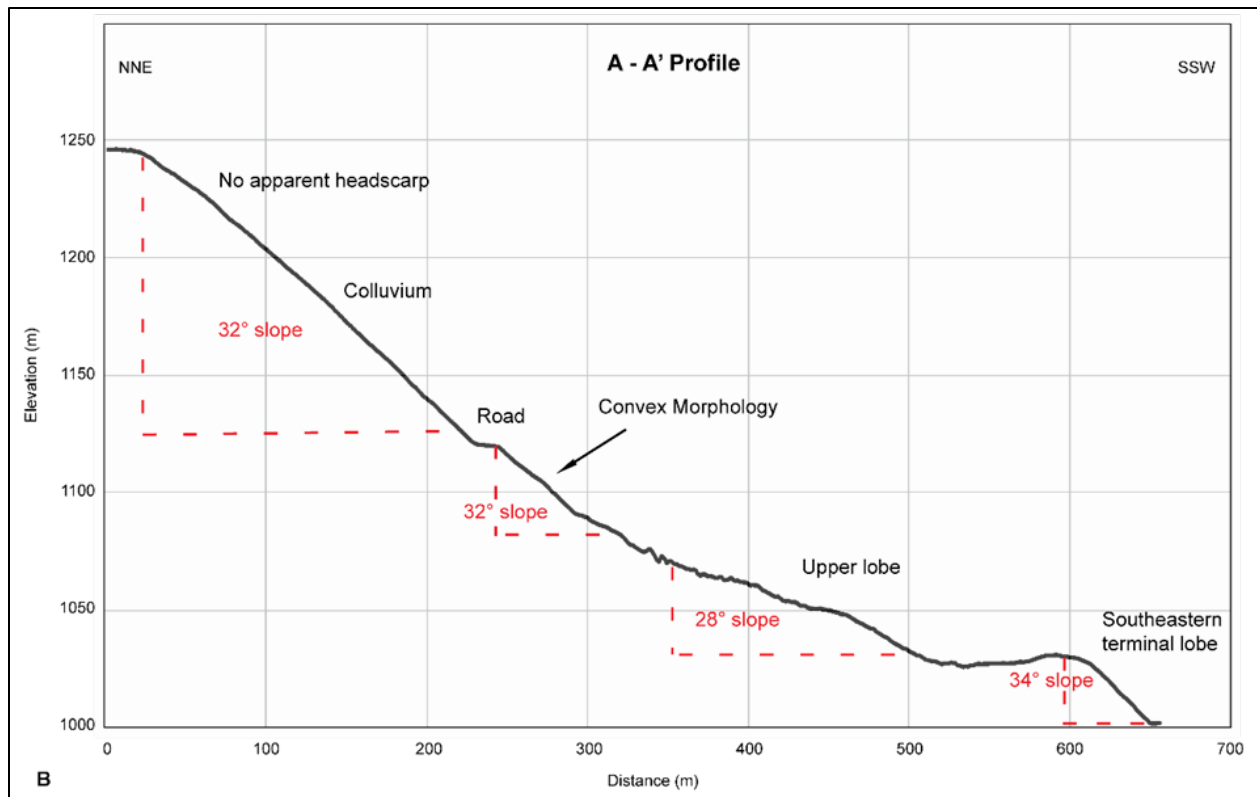
Pretty Rocks occurs in a rhyolite- dominated colluvium slope whose clasts resemble the rhyolitic bedrock east of the slope. Material from the perlite deposit is also being introduced to the Pretty Rocks slope by colluvial and alluvial processes, as seen from the ground (Figure 5) and in aerial photography. This material includes green clays, obsidian clasts, and perlite or devitrified glass. Overall, the slope is covered by a cobble and boulder veneer which is underlain by gravel-to-fine-grained sediment. Profiles produced from the 2015 digital aerial photogrammetry reveal a  $32^\circ$  slope angle above and below the road (Figure 6).

**Figure 6B.** A–A' profile of slope shown in Figure 6A.

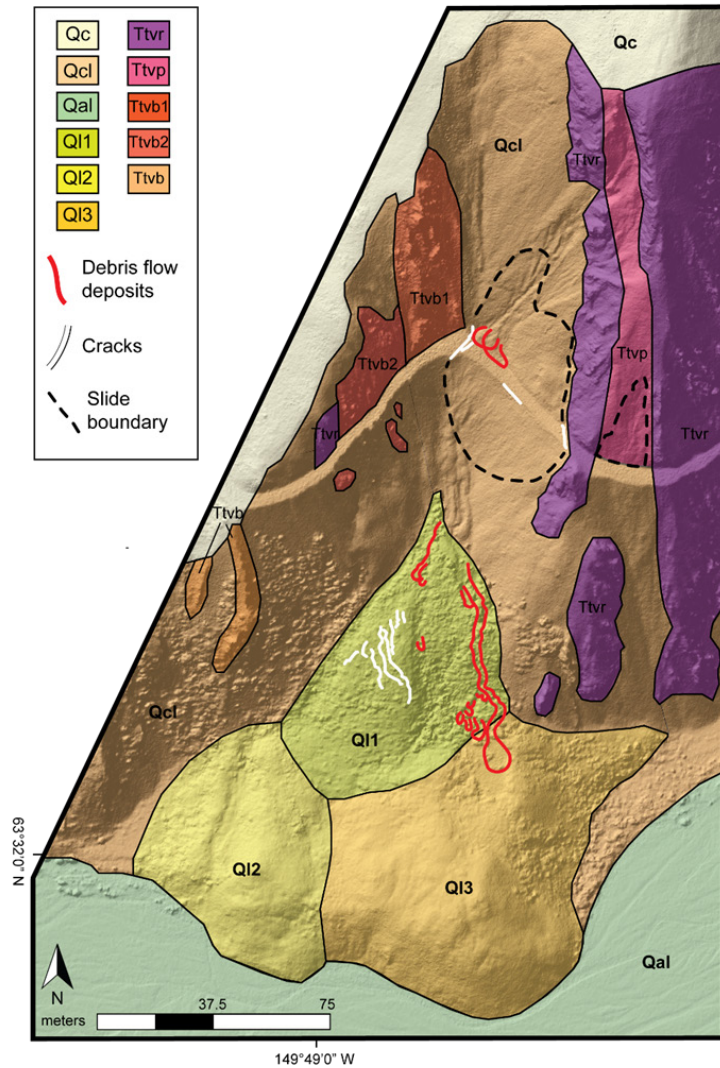
Ground truthing and field observations confirm these data. During field work, tension cracks in the road were observed at the northwestern and southeastern landslide boundaries (Figure 8, Figure 9, Figure 10). To the northwest, one dominant tension crack stretches from ~1.5–3 m upslope of the road to ~1 m downslope of the road. Occasionally, other en echelon tension cracks were observed depending on the road maintenance interval and on precipitation (Figure 9). To the southeast, tension cracks in the road surface were typically comprised of en echelon lineations with negligible horizontal and vertical offset (Figure 10). One tension crack extended ~1 m downslope of the road, turning easterly, paralleling the road's edge (Figure 10). Another tension crack extended over 30 m upslope of the road, following the boundary between the rhyolitic bedrock and the colluvium slope (Figure 10). Field-measured vertical offset was 30 cm and horizontal lineations were visible in the exposed landslide head scarp soils (Figure 11). Lastly, in July 2016, the ridge of increased elevations directly downslope of the road developed a tension crack on the downhill side, which paralleled the road.

**Figure 9.** Geologic map of project area, including geomorphic features. Qc: Quaternary cover, undifferentiated. Qcl: Quaternary colluvium, undifferentiated. Qal: Quaternary alluvium. Ql1: Quaternary landslide deposit 1. Basaltic. Ql2: Quaternary landslide deposit 2. Rhyolitic. Ql3: Quaternary landslide deposit 3. Rhyolitic. Ttvr: Tertiary Teklanika volcanic rhyolite. White to gray with brown and purple banding. Weathers to orangey tan. Aphanitic. 1% phenocrysts. 1% infilled amygdulose. 98% groundmass. Phenocrysts are fine to medium-grained euhedral-to-subhedral sanidine. Exhibits localized flow banding and soft-sediment deformation. Ttvp: Tertiary Teklanika volcanic perlite. Gray to black, weathers grayish-green. Holohyaline (i.e., vitric) with devitrification. Gradational contacts with Ttvr exhibiting sub-cm to cm-scale continuous parallel bedding. Ttvp1: Tertiary Teklanika volcanic basalt unit 1. Dark gray, weathers purple, orange, black and yellow. Aphanitic. 1% phenocrysts, 3% infilled alteration pockets, 96% groundmass. Phenocrysts are fine-grained subhedral plagioclase. Alteration pockets are cm-scale, elongate with parallel alignment, infilled with white to purple quartz or iron oxide precipitate. Highly weathered. Ttvp2: Tertiary Teklanika volcanic basalt unit 2. Gray, weathers red, orange, black and greenish gray. Aphanitic. 100% groundmass. Some weathering to greenish gray clay. Local spheroidal weathering. Highly weathered. Ttvp: Tertiary Teklanika volcanic basalt, undifferentiated. See Appendix for detailed rock descriptions including lateral variations and structural measurements. Nomenclature and descriptions restricted to project area. Map background image 2015 SfM DSM hillshade.

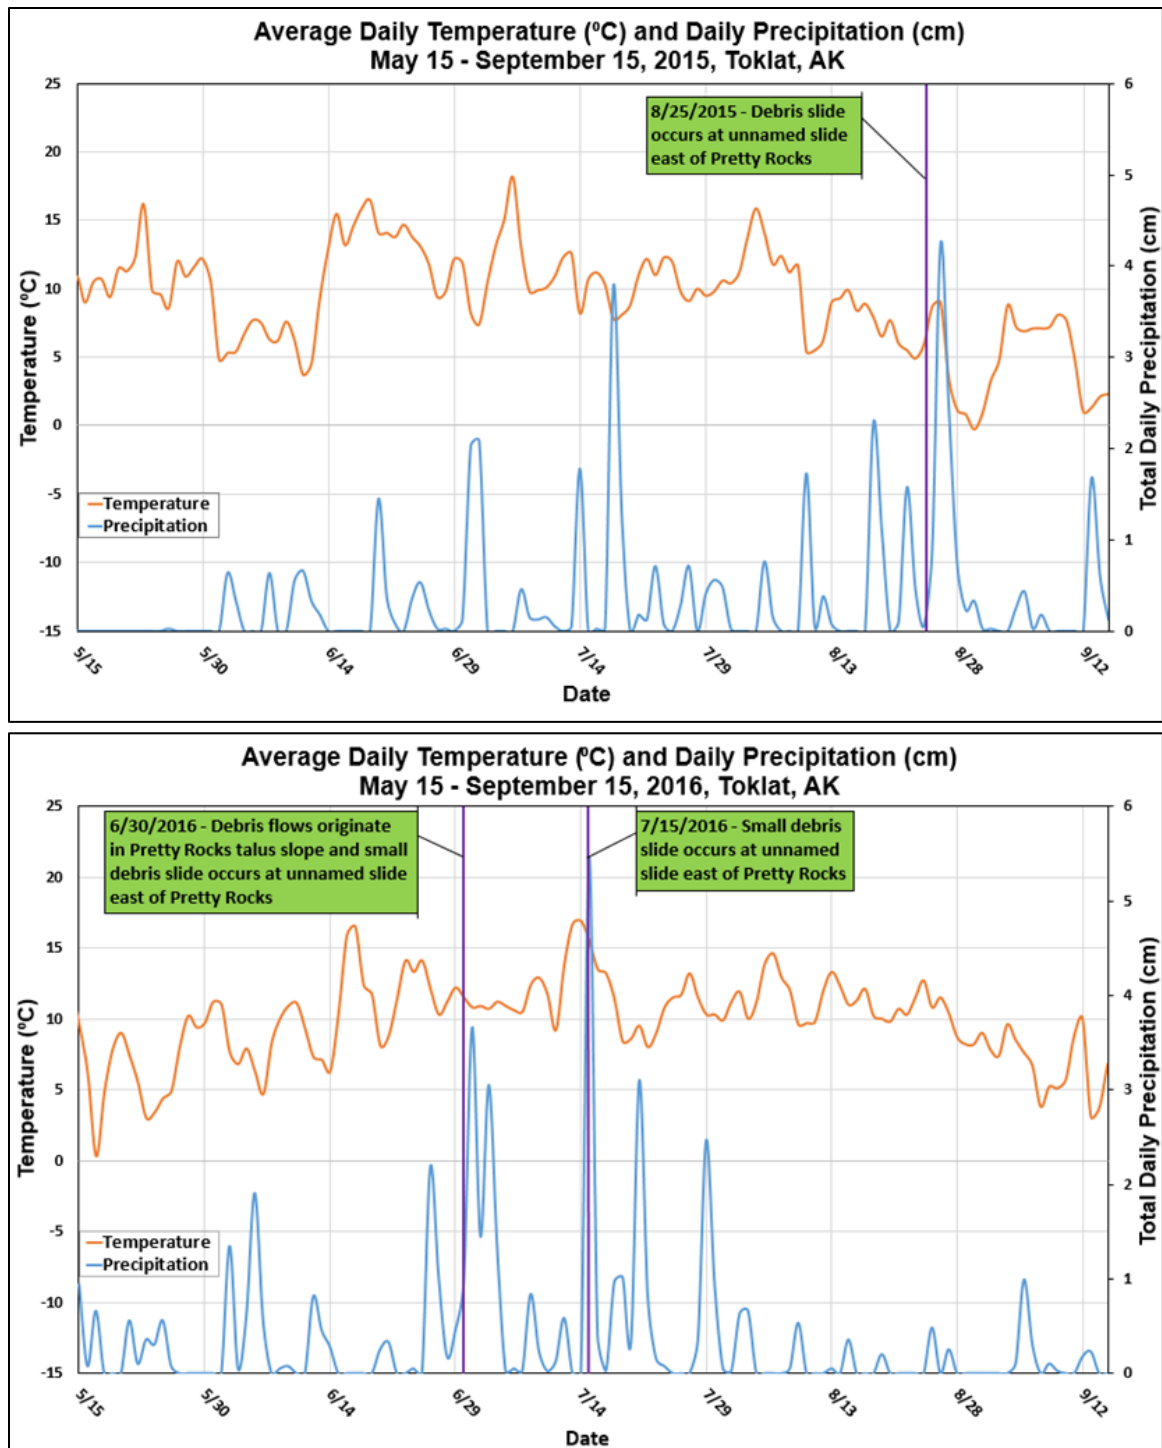
In addition to the large-scale downhill motion, the Pretty Rocks colluvium slope above the road experiences smaller debris flows and rockfall. Two debris flows occurred on June 30, 2016 just prior to a spike in precipitation on July 1, 2016 (Figure 12). Both originated in the colluvium slope above the road, in the area affected by the perlite material drainage (Figure 13). The larger of the two flows terminated in the ditch on the road's north (uphill) side, and the smaller flow ended just above it on the colluvium slope. Additionally, 1996 aerial photography reveals a large debris flow which crossed the road and deposited on the southeastern portion of the lower southeastern lobe (Figure 8). We mapped numerous older debris flow deposits on the tri-lobed landslide deposits at the slope's base. Older deposits are assumed to be masked by vegetation and covered by more recent debris flows.

**Figure 12.** Known landslide event dates compared to summer 2015 and summer 2016 temperature and precipitation data. Other failures may have occurred, but these are the only failures with reliable date constraints.

In 2015, the perlite deposit within the rhyolitic bedrock ridge to the east of Pretty Rocks began experiencing mass movement. On August 25, 2015, a landslide occurred that blocked half of the road. This failure preceded a spike in precipitation on August 26, 2015 (Figure 12). During field work in summer 2016, frequent changes in slope morphology within the perlite deposit were noted, and on July 15, 2016 the first author witnessed a small debris slide from the same location as the earlier, large debris slide failure. This landslide occurred during a spike in precipitation, and closely followed the warmest average daily temperature (16.9°C) recorded for the May 15–September 15, 2016 period at the Toklat RAWS. During the July 2016 field work, we also observed spring water flowing constantly at the geologic contact between the underlying perlite deposit and the overlying rhyolitic colluvium deposit where the landslide occurred. The water reached the road and continued eastward (Figure 14).

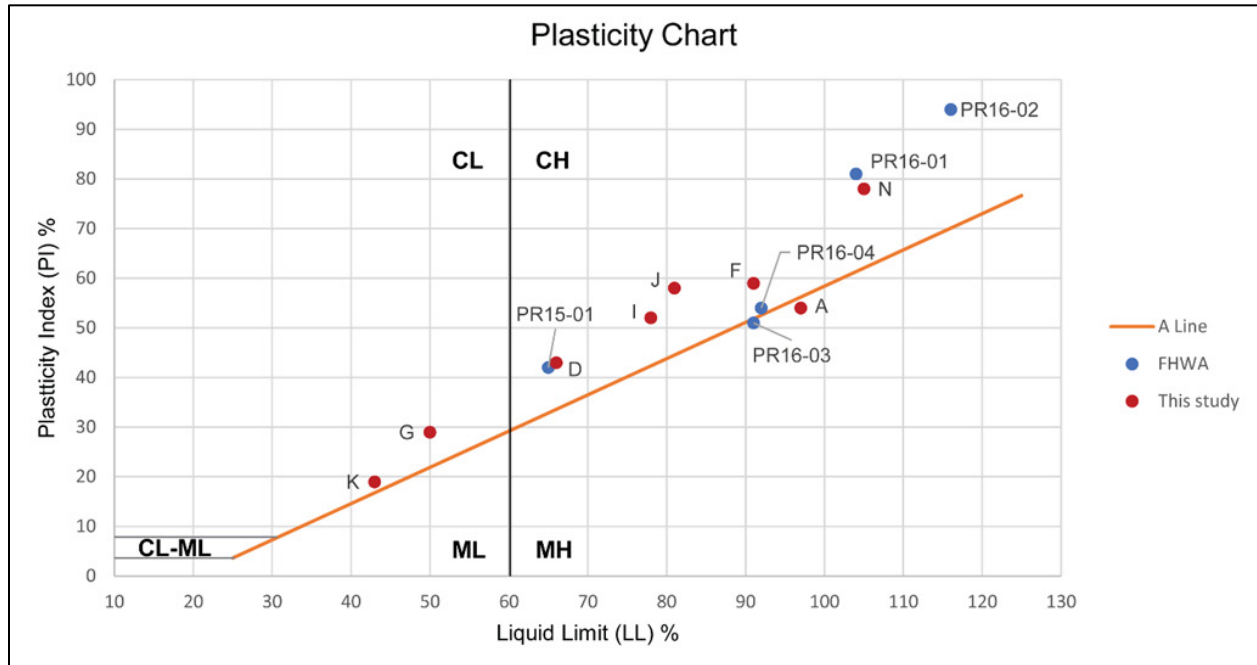
Two soil sampling efforts have been conducted at the project area. In May 2015 and 2016, the FHWA collected five samples (PR15-01–PR16-04). The samples laboratory testing included sieving (3/4 in–1  $\mu$ m), Atterberg Limit tests, and moisture content (Table 1, Figure 18).

Our study collected 14 samples (Samples A–N). We selected samples based on location within the project area, as well as color, plasticity and grain size. We targeted fine-grained sediments to test the hypothesis that the clays are very weak and contribute to the landsliding. Based on their location, distribution, and grain size, 10 of these samples were ultimately selected for laboratory analysis. Samples B, K, and L were composed predominantly of coarser grain sizes, and therefore underwent sieve analysis (3/4 in – #200). No further tests were performed on these three samples. Samples A, D, F, G, I, J, and N were visually determined to be comprised of silt and clay. These were tested for Atterberg Limits, moisture content, and organic content (Table 1, Figure 18). No sieve analyses were conducted on these samples.

**Figure 18.** Plasticity Chart from the USCS (U.S. Department of Agriculture Soil Conservation Service, 1990). Plasticity index is the difference between the Liquid Limit and the Plastic Limit, or the range in which a soil behaves plastically. The A-Line ( $PI=0.73(LL-20)$ ) separates silts from clays. CH = fat clays (high liquid limit). CL = lean clays (low liquid limit). MH = elastic silts (high liquid limit). ML = silt (low liquid limit).

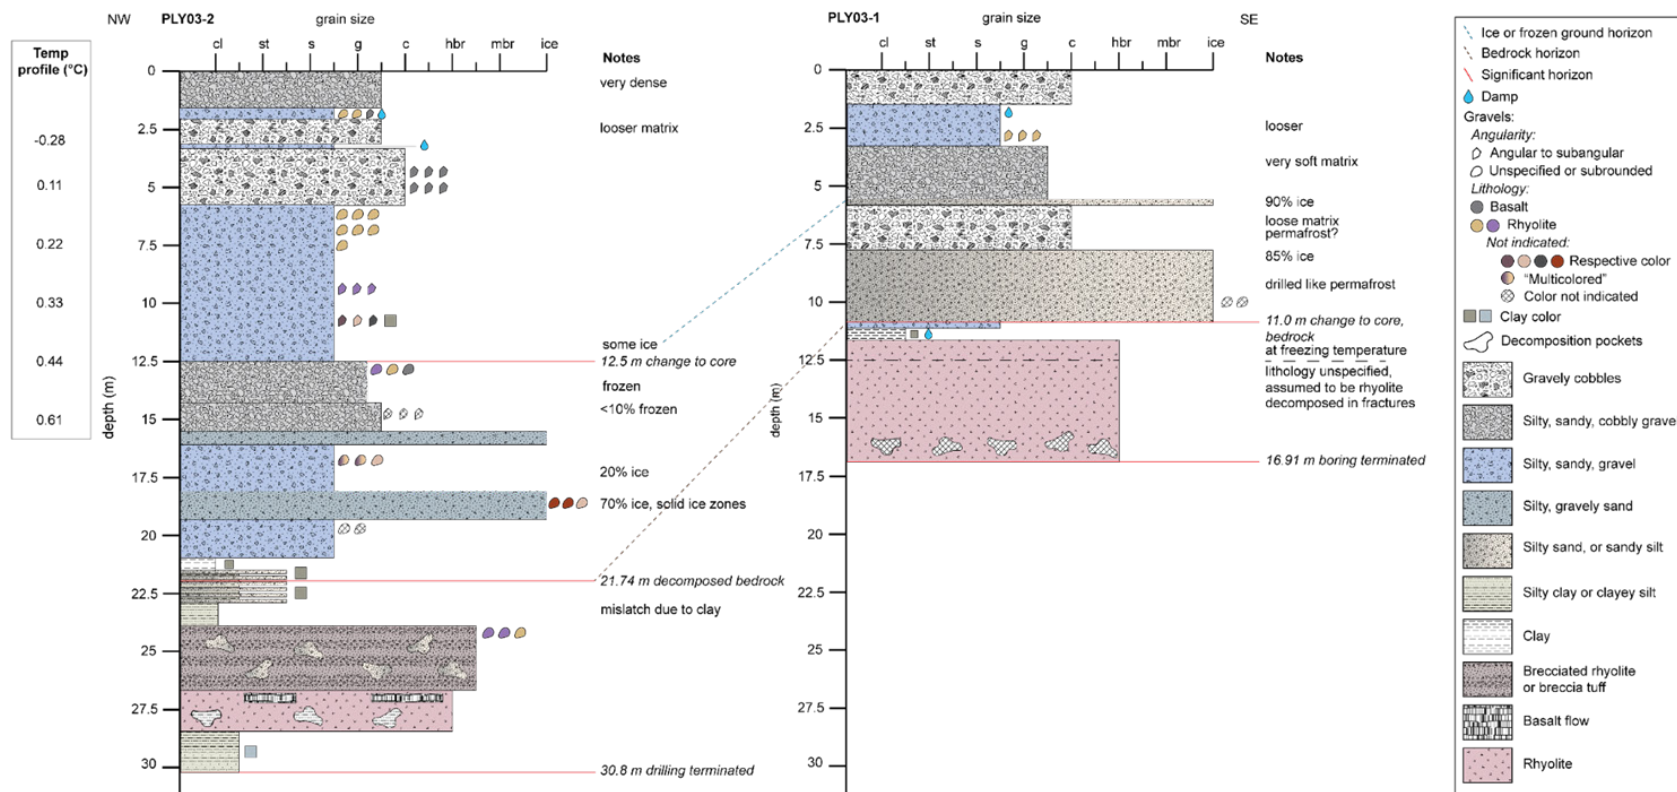
In June 2003, the FHWA drilled two borings—PLY03-1 and PLY03-2—through the road surface into the landslide (Figure 6, Figure 19). Soil and rock descriptions and uncorrected standard penetration test (SPT) rate blow counts were provided. PLY03-1 was drilled to a depth of 16.9 m and ground ice was first observed at 6.2 m. PLY03 2 was drilled to a depth of 30.9 m and ground ice was first recorded at ~12.3 m. In September 2003, thermistor string readings were collected from PLY03-2. Temperatures ranged from 0.3°C at 2.7 m to 3.7°C at 20.1 m at the base of the thermistor string.

**Figure 19.** Stratigraphic columns constructed from PLY03-1 and PLY03-2 boring logs. Grain sizes: cl = clay; st = silt; s = sand (undifferentiated); g = gravel; c = cobble; hbr = highly weathered bedrock; mbr = moderately weathered bedrock; ice =  $\geq 70\%$  ice. Drilling took place in June 2003. Temperature log was recorded in PLY03-2 in September 2003. Note the close proximity to the freezing temperature. The blue dashed lines correlate the first mentions of ground ice in each profile, while the red dashed line correlates the first mentions of bedrock.
