# Santa Rosa Life-Saving Station and Coast Guard Garage Restoration Feasibility Study

**Restoration Feasibility Report**

**JKOA**

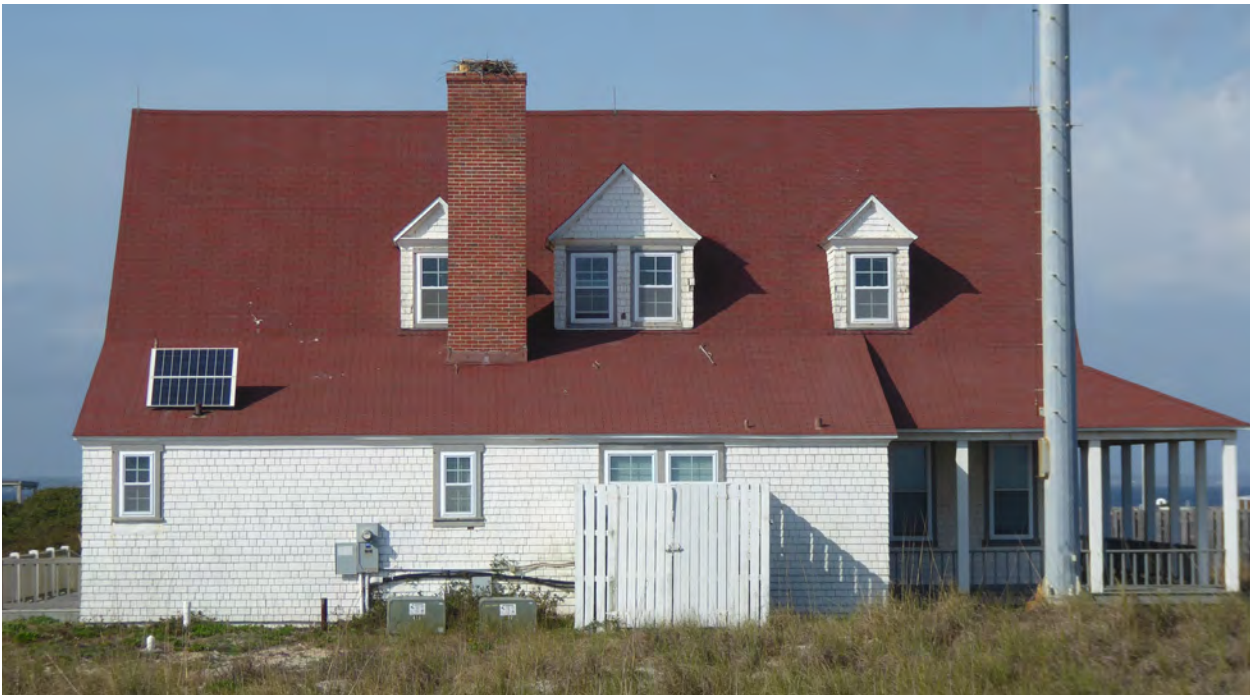
**Figure 2.9.** Present-day south elevation.

The south elevation was greatly impacted by the 1937 renovation. Most notable of the modifications were the removal of the lookout tower and the construction of a shed-roofed addition that spans about three-quarters of the elevation at the first-floor (Fig. 2.9). The addition has small punched window openings and an imposing brick chimney that obscures the dormers above. An additional window opening and exterior door are on the addition's east return, which abuts the truncated south wrap of the porch.

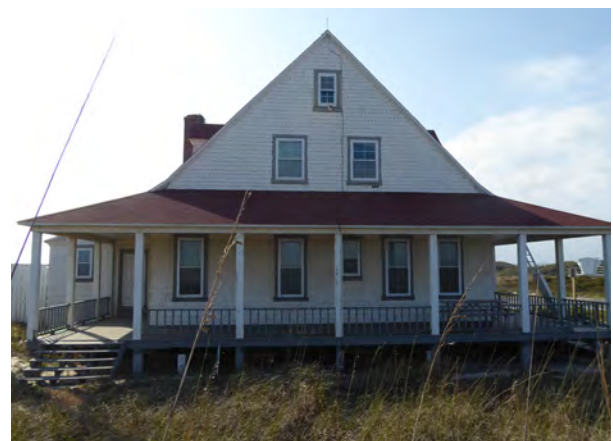
**Figure 2.11.** Present-day east elevation.

The east elevation saw relatively few changes as a result of the 1937 work (*Fig. 2.11*). The window openings at the first floor were shifted due to changing interior partitions and one was likely eliminated where a small window is now installed at a modern bathroom.

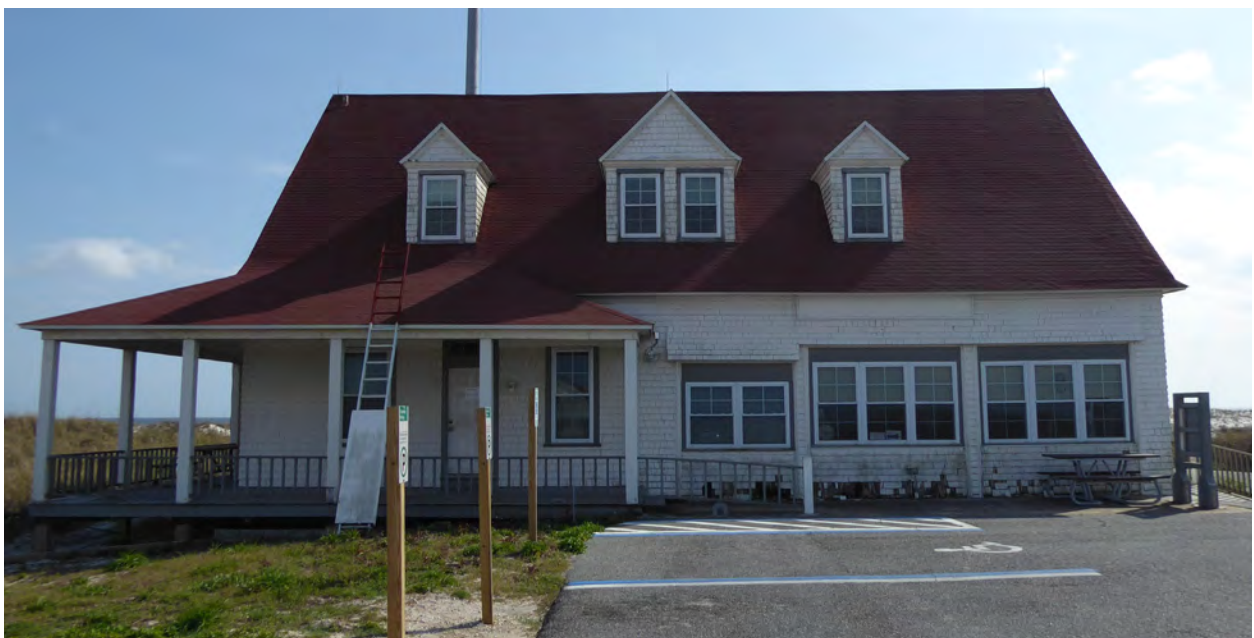
The removal of the tower and extension of the ridge of the roof to the west had equal impact to the north elevation as to the south (*Fig. 2.13*). Like the south elevation, the north also received a large dormer with two window openings. The single dormer that once occupied this location was likely disassembled and reinstalled shifted to the west. Six-over-six-light window sash appear to be installed at each dormer window, replacing the previous six-over-two-light sash. A railing is installed at the front porch with the exception of the westernmost and side bays.

Perhaps most notably, with the loss of the south-facing boat doors as a result of the addition, two of the doors and their frames were relocated to the north, flanking the original opening. The shingle flare above the doors was recreated or moved along with the doorways. The boat doorways were later infilled and currently hold modern vinyl windows (*Fig. 2.14*).

**Figure 2.14.** Present-day north elevation.

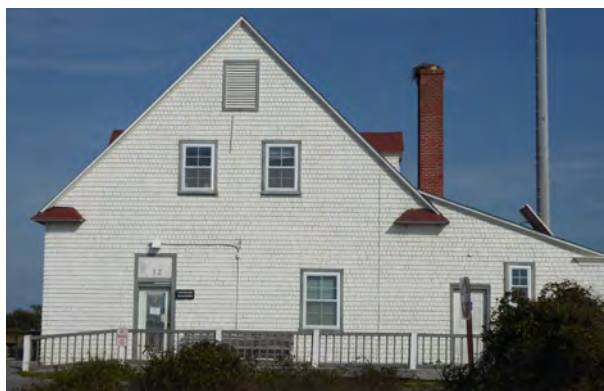
**Figure 2.16.** Present-day west elevation.

The removal of the lookout and extension of the roof ridge made the west elevation a single plane (Fig. 2.16). Remnants of the original eave line were left at the north and south ends of the gable to form shingled returns. Two small window openings were created at the second floor and a large opening was introduced at the attic level; however creation of the louver may have followed later.

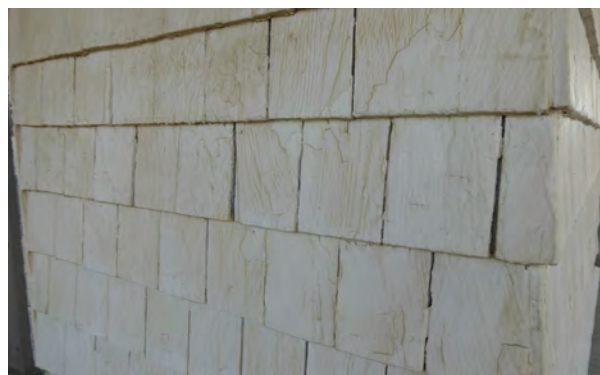
**Figure 2.17.** Example of early wood shingle siding beneath porch roof.

shingles measure about 18" long overall with an exposure ranging from 4½" to 5¼" tall. Some sections of shingle appear to be early or original, especially beneath the porch roof (*Fig. 2.17*).

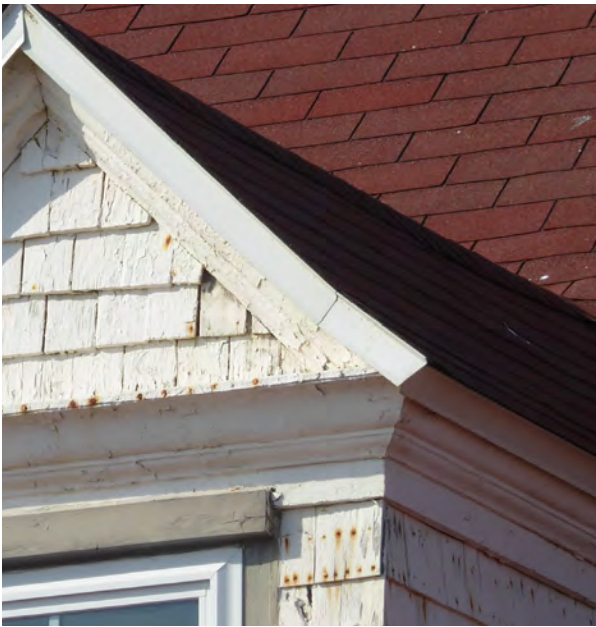
**Figure 2.18.** Detail of original cornice molding at dormer.

Cornice moldings are found at roof rakes, eaves, and at the pediments of each gable dormer (*Fig. 2.18*). The majority of these moldings appear to be early, based on the level of paint buildup and similarity to those in the prototype drawings. The cornice measures 5½" wide by 5¾" deep and is coupled with a frieze board at the dormer eaves measuring about 2½" tall.

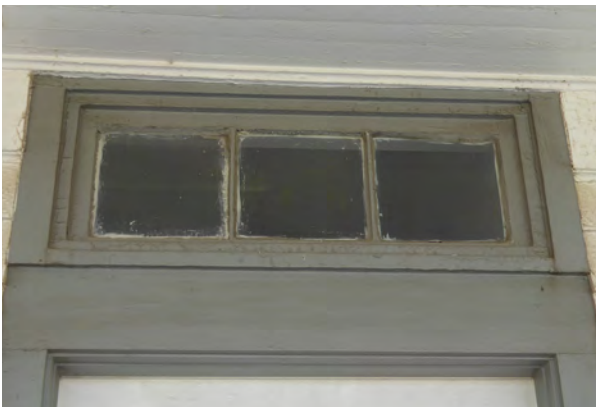
**Figure 2.19.** Original transom sash at north doorway.

The north doorway has an early or original three-light transom measuring 3'-0" wide by 1'-2" tall (*Fig. 2.19*). Sash stiles and rails measure 2¼" wide. The transom is the only remaining example of an early sash in the building, making it valuable for the purpose of recreating the proportions and muntins of the original window sash at other locations.

thick. Portions of early casing remain around the north transom, and measure about  $2\frac{3}{4}$ " wide (Fig. 2.19).

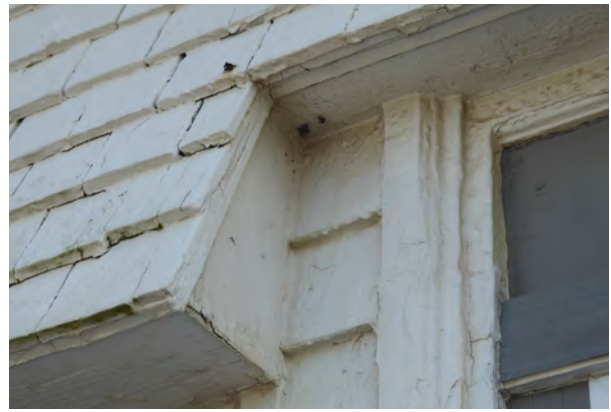
**Figure 2.20.** Flare in siding at north elevation boat doorways. This detail is expected to have been moved from the south elevation.

The infilled boat doorways on the north elevation retain what appear to be early door frames (Figs. 2.20-2.21). The center doorway remains in its original position, while the two flanking doorways are thought to have been removed from the south elevation and reinstalled at the north when the south addition was constructed. The original exterior casings measure  $2\frac{3}{4}$ " wide and have a molded inner edge (Fig. 2.21).

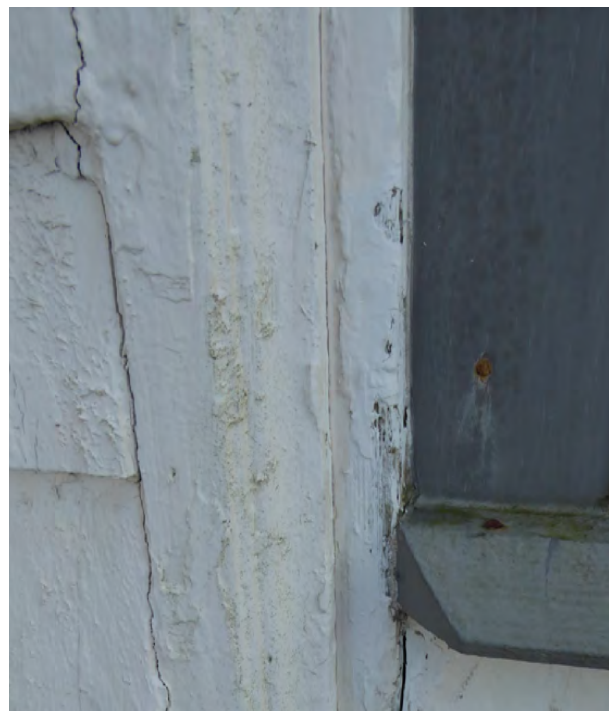
**Figure 2.21.** Detail of typical original exterior casing at boat doorways.

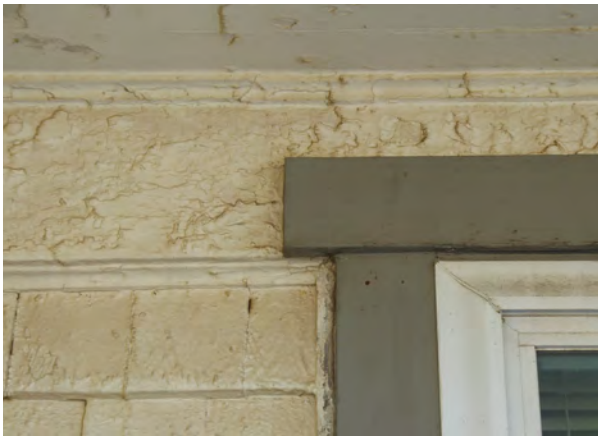
**Figure 2.22.** Original frieze board and trim below porch roof. Note added window lintel and casing.

Modern headers with extending ears lie in the same plane as the modern casings (*Fig. 2.22*).

A 1"-tall cove molding is consistent at the perimeter of the porch ceiling. The ceiling itself consists of 2½"-wide beaded boards running parallel to the building (*Fig. 2.26*). At the exterior wall of the building, the cove molding lines the top of a plank frieze board measuring 7" tall with a ¾" cove molding beneath (*Fig. 2.22*). Much of the ceiling and associated trim appears to be original.

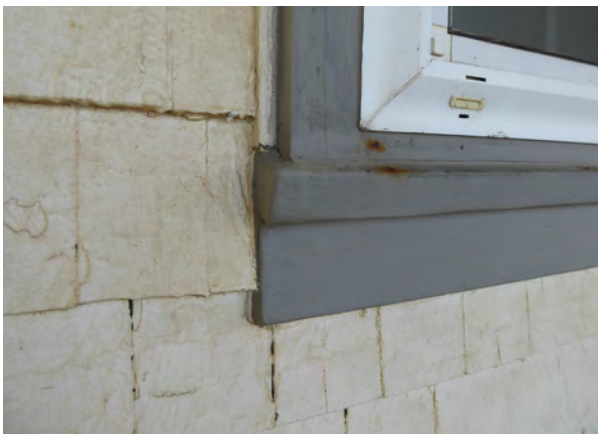
**Figure 2.23.** Detail of early or original exterior window sill below porch roof.

Early plank board exterior casings appear to remain at many window openings, are in the same plane as the exterior wood shingles (Figs. 2.23-2.24). A modern plank board casing has been applied on top of the early casings, likely to facilitate the installation of the vinyl windows.

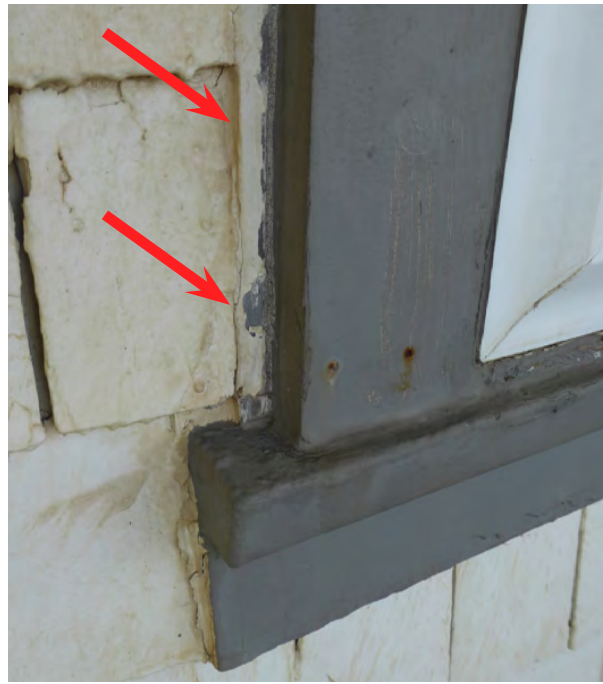
**Figure 2.24.** Detail of sill and overlay window casing. Note early casing flush with wood shingles at left.

The early casings exposed at the outer edges of the window openings measure 4½" wide by likely 1¼" thick. The modern overlay casings measure 4" wide by ¾" thick (*Fig. 2.24*).

Sloped exterior sills appear to be early, and measure 1½" thick. The sills extend about ½" beyond the modern casing and have early plank board aprons measuring 2¾" tall. The aprons sit just proud of the surrounding wood shingles (*Fig. 2.24*).

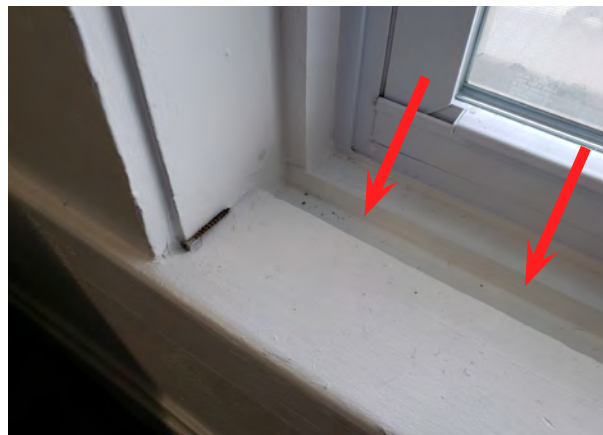
channels for the earlier wood sash visible on the interior (Fig. 2.25). Compared to the prototype plan, several window openings, particularly those on the first floor of the east elevation, have shifted locations. Early materials present at these openings could be original material that was reused, or could date from the time the windows were repositioned.

**Figure 2.25.** Interior view of typical window opening at sill. Note channel where wood sash would have been located. Stops have been added at the new vinyl window.

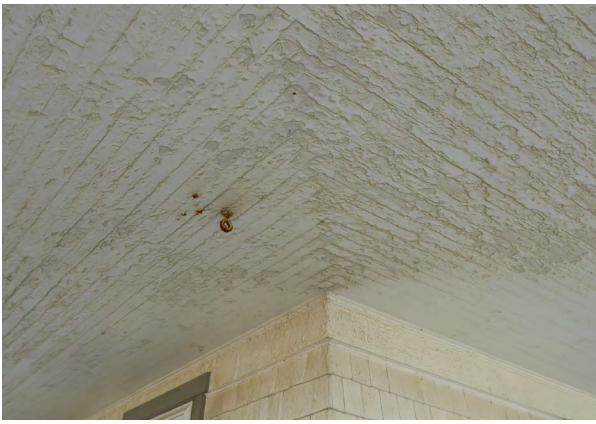
**Figure 2.26.** Original beaded-board porch ceiling.

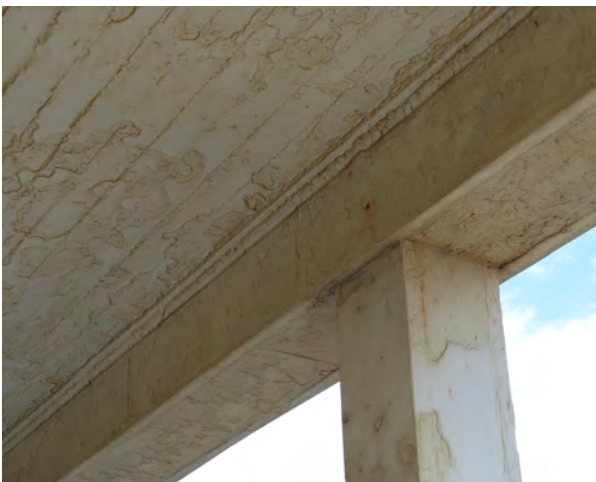
**Figure 2.27.** Original porch beam, trim, and post wrapping.

Poured-in-place concrete piers measuring 8" by 8" are centered beneath each wrapped wood post. Portions of the posts appear to be early based on the amount of paint buildup (*Fig. 2.27*).

An boxed carrying beam spanning between the posts measures 9¾" wide by 8 ¾" tall. A 1"-tall cove molding lines the top of both the inner and outer faces of the beam. The beam appears to be early or original (*Fig. 2.27*).

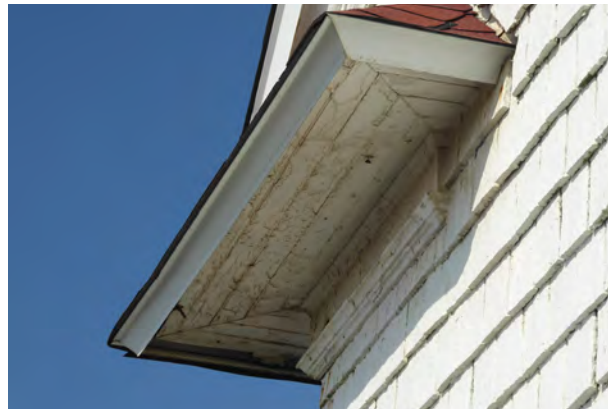
Two remaining sections of the original west eave line remain as returns on the west elevation (*Fig. 2.30*). Each has a beaded board soffit matching the original porch ceiling. A frieze board with applied molding at the base measures about 7" tall overall.

**Figure 2.30.** Remaining original portion of eave on west elevation.

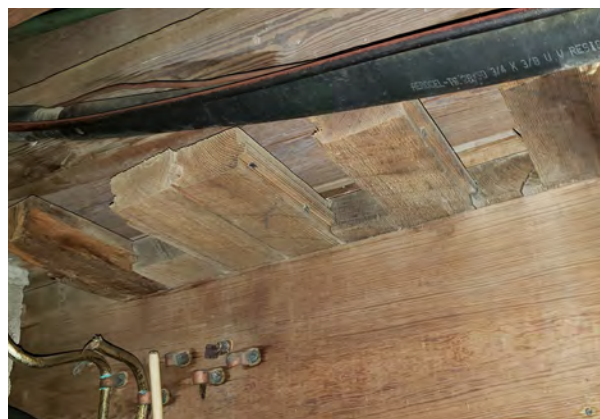
Likely original boat room flooring was observed in the crawlspace running east-west beneath Room 101C and measure  $3\frac{1}{2}$ " wide by  $1\frac{5}{8}$ " thick (Fig. 2.73). The extent of remaining early flooring throughout Room 101 is unknown; however, it is likely that this remaining flooring is representative of what was used throughout the room.

**Figure 2.73.** Ends of early floorboards beneath Room 101C as seen in the crawlspace.

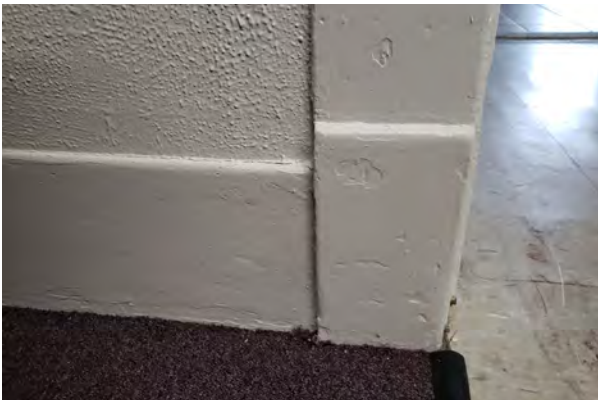
No original examples of baseboards were found. Plank baseboards measuring  $7\frac{1}{4}$ " tall by  $\frac{3}{4}$ " thick with rounded edges remain on select walls and in closets and were likely installed as part of the 1937 renovation (Fig. 2.74).

**Figure 2.74.** Example of typical 1937 plinth block and baseboard.

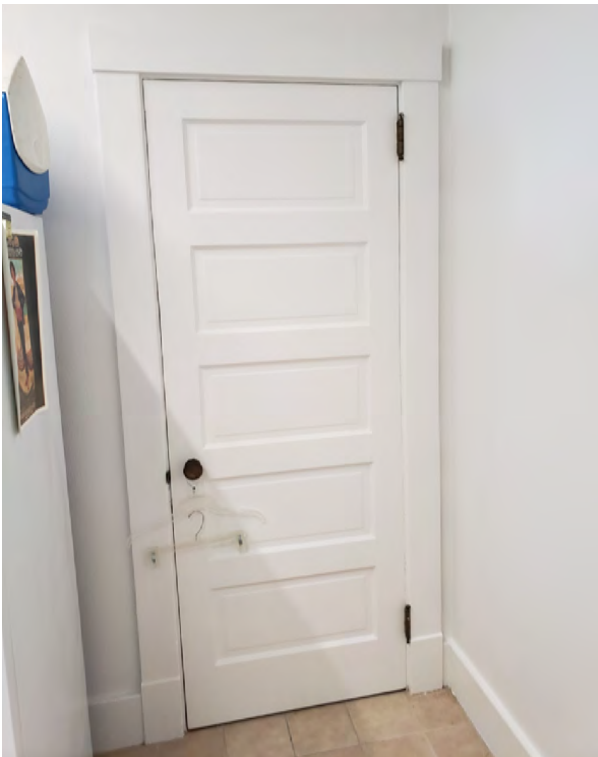
(Fig. 2.75). Similar modern variants of these doors are found in the later boat room partitions.

**Figure 2.75.** Example of typical 1937 five-horizontal-panel interior door in Room 105.

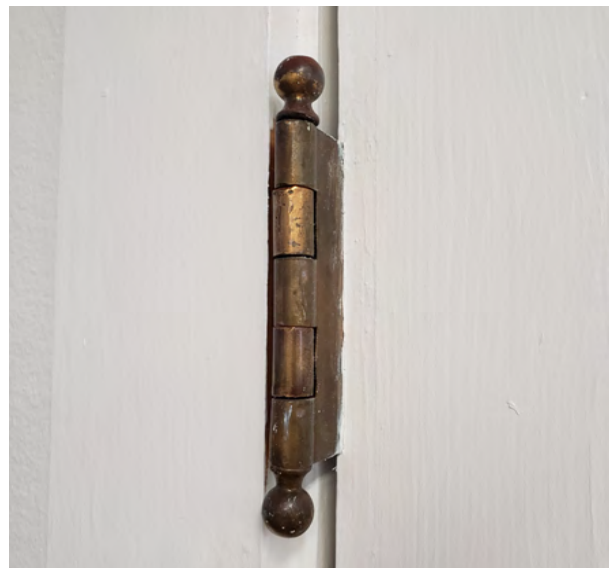
Several examples of 1937 five-horizontal-panel doors are coupled with 4"-tall ball-pin hinges and have mortised locksets with 2"-diameter rosettes and a 1½" by 1¼" rectangular keyhole escutcheon (Figs. 2.76-2.77). Based on the crispness of the molded sticking and apparent lack of paint layers on the doors, it is suspected that all of the early interior doors of this design have been chemically stripped.

**Figure 2.76.** Example of typical 1937 ball-pin hinge.

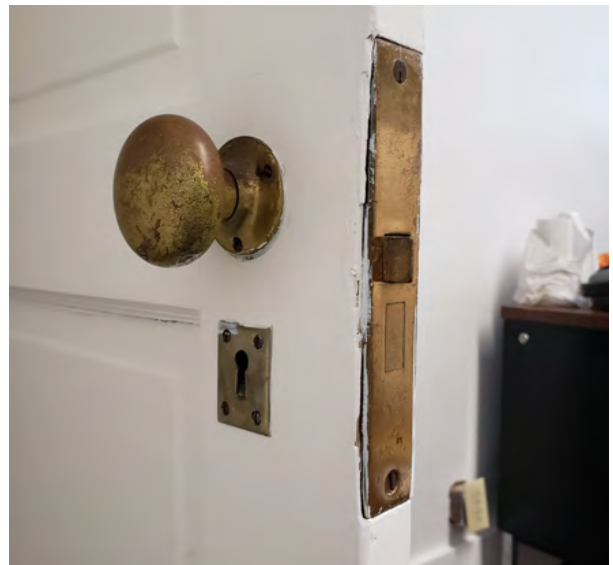
**Figure 2.77.** Example of typical 1937 mortised lockset, brass knob, and keyhole escutcheon.

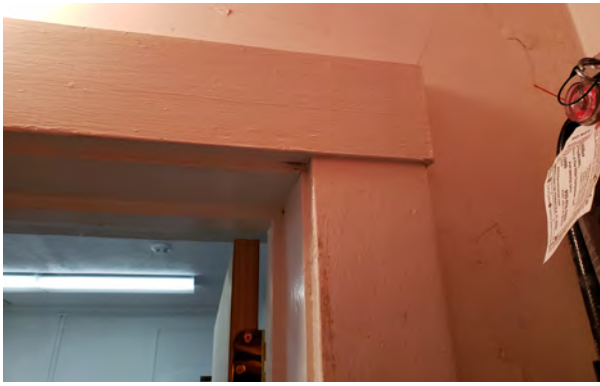
The most prevalent door casing type is consistent throughout most of both the original portion of the station building as well as the south addition. The casings have rounded corners and measure 4⅝" wide by ¾" thick at the sides and have plinth blocks at their base typically measuring the same width as the casing by 8¾" tall (Figs. 2.74-2.75, 2.78). The plinths extend about ¼" from the face of the casing and have a rounded top edge. The head casings measure 4⅝" tall by 1" thick, allowing them to project about ¼" beyond the face of the side casings. The head casings also extend ¼" beyond the side casings, creating ears. It is suspected that these casings were installed as part of the 1937

**Figure 2.78.** Example of typical 1937 lintel-cut casing with rounded edges and projecting header.

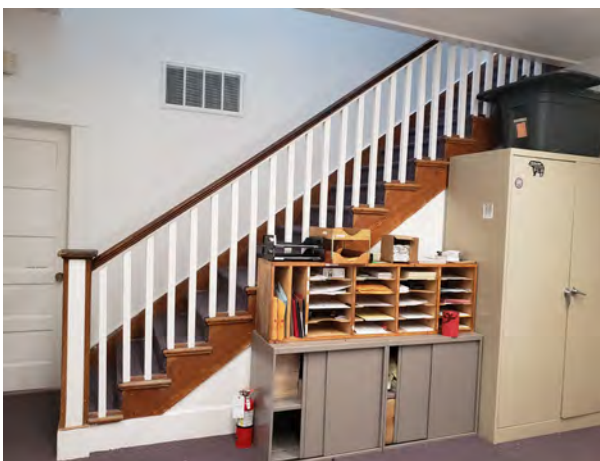
An open stair measuring 3'-0½" wide and dating to the 1937 renovation ascends along the west wall of Room 102 (*Figs. 2.79-2.81*). The stair consists of sixteen 11"-deep treads and sixteen 7½"-tall risers. The stair has 1"-deep rounded nosings that have mitered returns at the open side of the stair. A ½"-tall quarter-round molding lines the underside of the nosing.

**Figure 2.79.** Overview of 1937 stair in Room 102A.

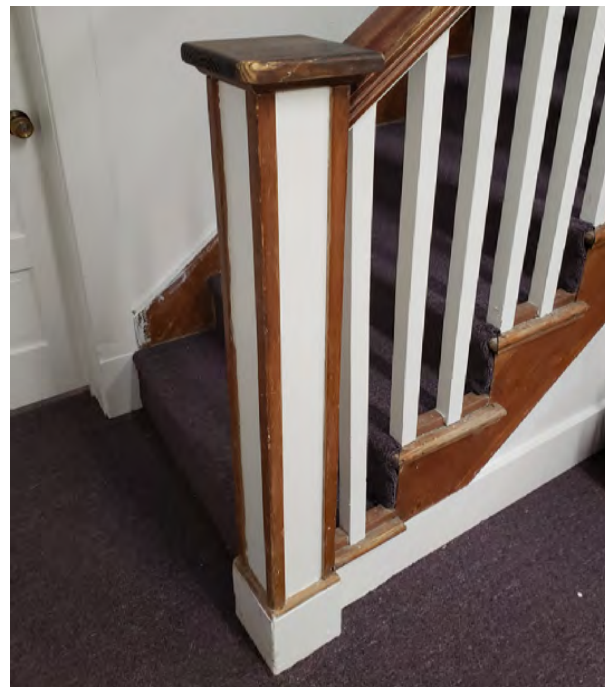
north south and has an 8" square cap. Later corner moldings with each leg measuring 1" wide have been added to the newel.

**Figure 2.80.** Newel post at base of stair. Newel at top of stair is similar.

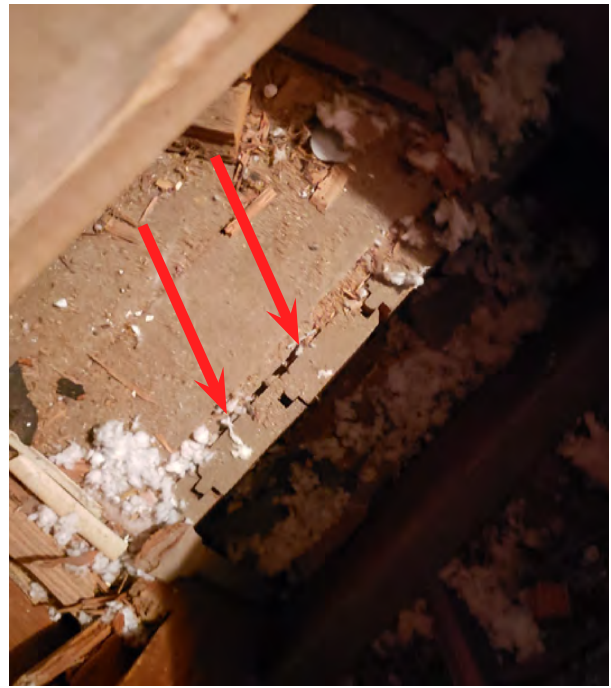
Potentially original vertical board interior paneling can be observed from the attic behind modern gypsum wallboard finishes on the south wall of Room 204 (*Fig. 2.100*). The vertical boards measure 2½" wide by ¾" thick. It is possible that portions of similar material may be concealed elsewhere on the second floor.

**Figure 2.100.** Early vertical wall cladding boards on south wall of Room 204 as viewed from attic.

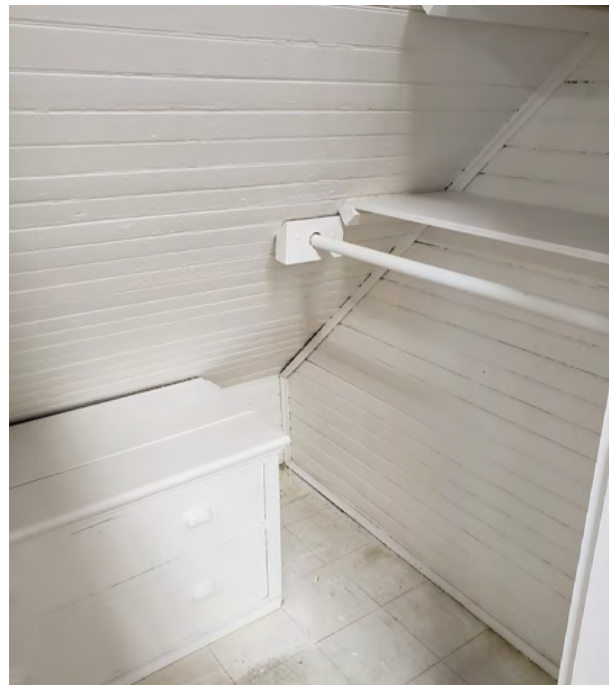
The north closet of Room 204 and all four crew closets in Room 105 have likely original horizontal beaded boards at the interior (*Fig. 2.101*). On the sloping roof structure and back walls, the boards are single-beaded and measure 2½" wide by likely ¾" thick. The side walls of the closets in Room 205 have single-beaded boards measuring 3½" wide by likely ¾" thick. The inside corners and base of the

**Figure 2.101.** Interior of typical crew closet in Room 205.

Each closet also has one early wood clothes pole measuring 1" in diameter. Plywood shelves measuring ½" thick are supported by beveled wood cleats (*Fig. 2.101*).

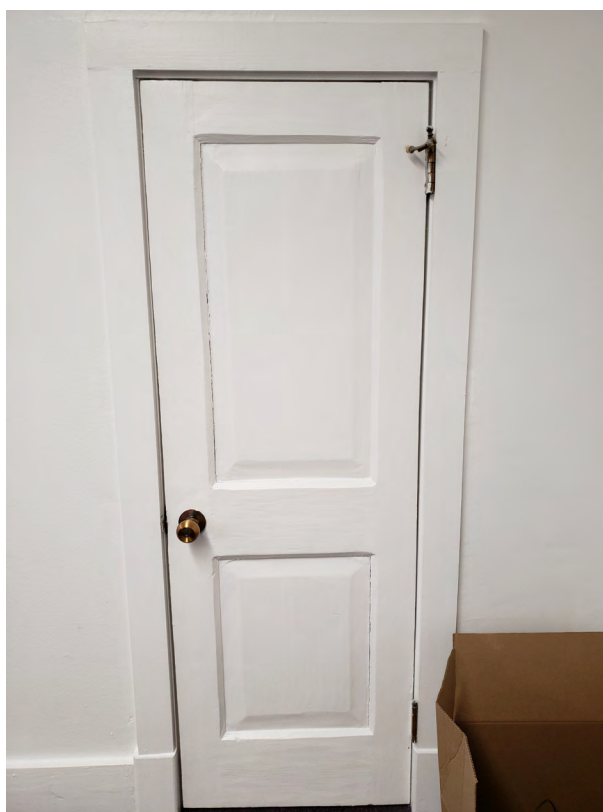
Original two-raised-panel doors are exclusively found at the four closets in Room 205 (*Fig. 2.102*). The doors typically measure 1'-11¾" wide by 5'-10¼" tall by 1¼" thick. The majority of the doors

**Figure 2.102.** Original two-panel doors in Room 205.

are hung with two 4'-tall early ball-pin hinges but have modern cylindrical locksets. The doors appear to have been chemically stripped and have lost definition of details of the molded sticking and raised panels.

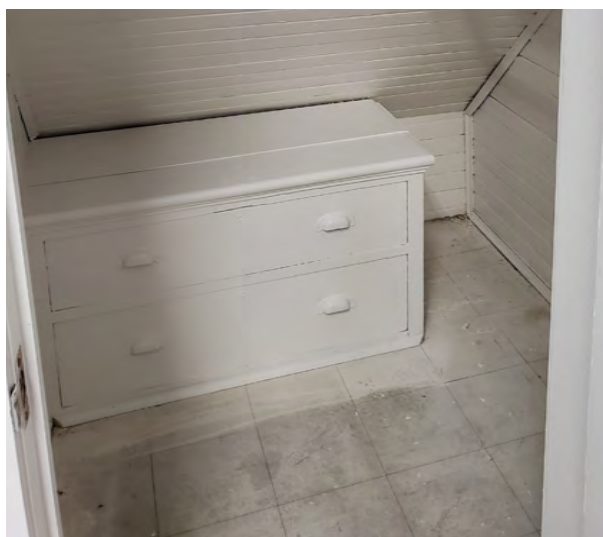
**Figure 2.103.** Typical original chest of drawers in closets of Room 205.

Original wood drawers are present in each of the four crew closets in Room 205 (*Fig. 2.103*). The drawer banks measure 3'-1½" wide by 1'-7" deep and have a bullnose top surface measuring 1" thick with a  $\frac{3}{4}$ "-tall cove molding running below. Each of the two drawers has two original bin pulls measuring 3½" wide.

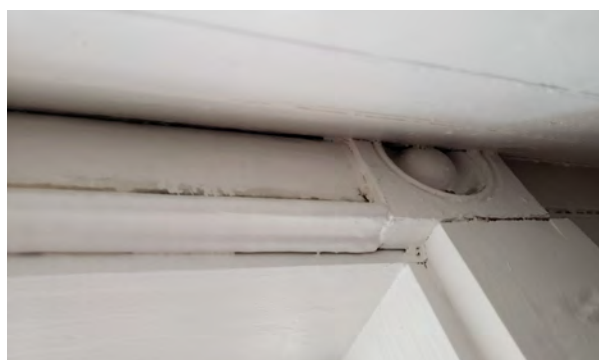
**Figure 2.104.** Partial original trim in southeast closet of Room 105.

interior trim (*Fig. 2.104*). The complex molded casing is a partial piece whose full section would have measured 4" wide by  $\frac{3}{4}$ " thick. The unique profile matches that found in the prototype details, proving that the Santa Rosa Station used the prototype's trim designs. Coupled with the head casings are two original corner blocks with rosettes measuring 4" square overall.

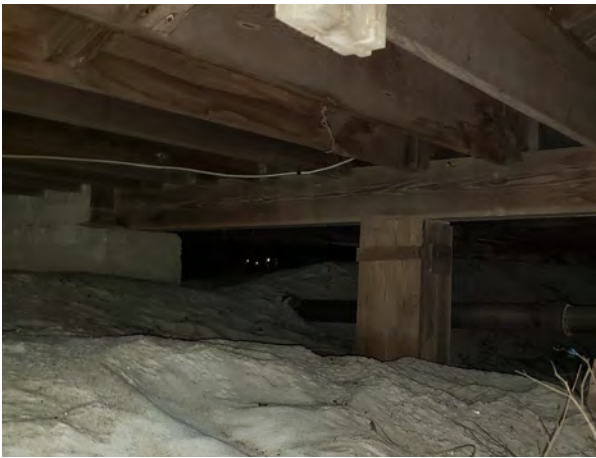
**Figure 2.105.** View of crawlspace beneath east portion of the building. Original chimney base visible at left. Major east-west beam lies in-line with chimney and rests on concrete piers. Note that wood forms remain on many piers in the crawlspace.

The building is supported by a grid of poured-in-place concrete piers, most measuring 10" by 10" square with spacing at the perimeter ranging from 4'-2" to 5'-3" apart. A center line of piers beneath the eastern portion of the building aligns with the remaining base of the demolished original chimney (*Fig. 2.105*). The chimney base measures 4'-10" east-west by 1'-8" north-south. The major east-west beam bears on the projecting shelf of the short ends of the chimney base.

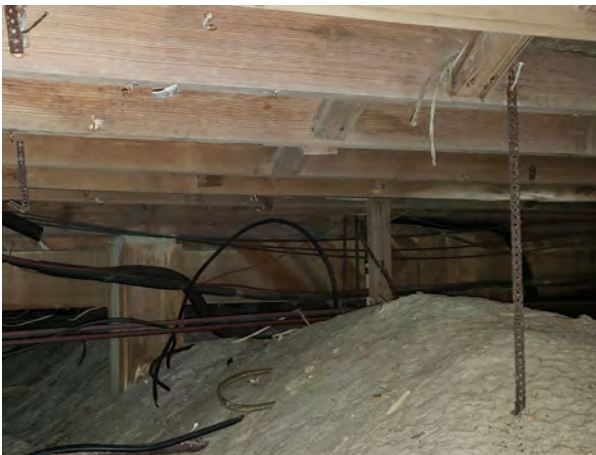
The western portion of the building, beneath the original boat room (Room 101) lies much closer to grade and while not easily accessible, appears to have two rows of concrete piers supported beams running east-west (*Fig. 2.106*).

**Figure 2.106.** View looking east in crawlspace. Note drop in framing height in background corresponding with transition to boat room level.

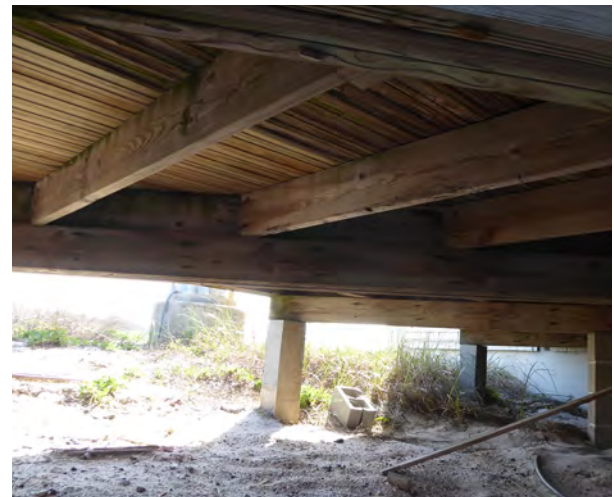
The major porch joists rest on original poured-in-place concrete piers that are positioned beneath each post and measure 8" by 8" square with spacing ranging from 7'-0" to 7'-10" apart (*Fig. 2.107*).

**Figure 2.107.** Typical porch floor framing.

The porch floor framing consists of joists running parallel to the building that measure 1¾" wide by 7¾" deep (*Fig. 2.107*). The joists are supported by major beams running perpendicular to the building between the exterior wall and the porch piers. The beams measure 5¾" wide by 7½" deep and radiate diagonally at the two outside corners of the porch.

The majority of the floor framing is thought to be original, with the exception of the porch floor framing, which matches the original configuration but is largely replacement material.

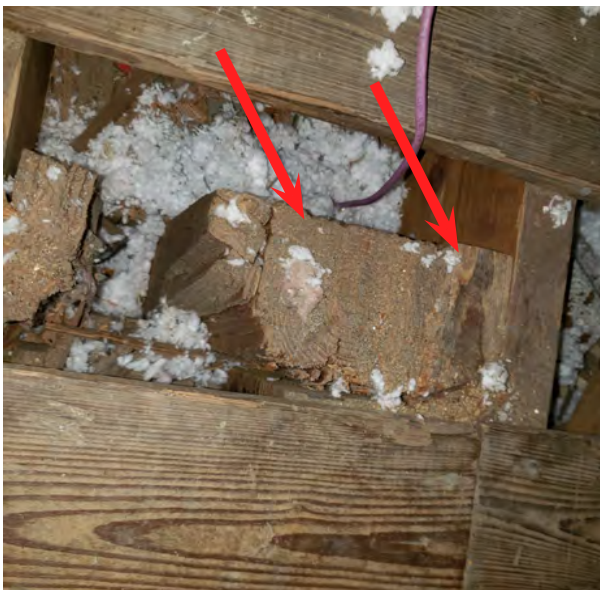
**Figure 2.109.** Original corner post of lookout as viewed in attic.

The northeastern corner support post for the original lookout tower is exposed in the joist space below the attic floor level (*Fig. 2.109*). The post measures 4" north-south by 5¾" east-west and is contained within the north wall of the second-floor hallway. Similar posts may remain within walls of the second floor. Further evidence of the tower's footprint is described in *Roof Framing* section.

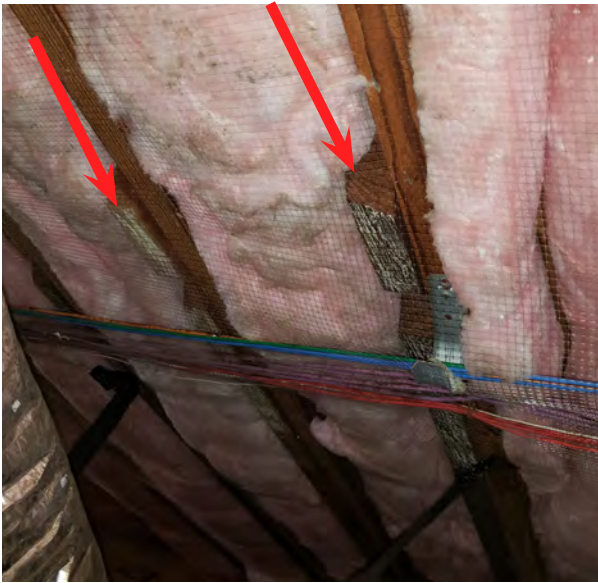
**Figure 2.112.** Typical partial rafters at location of original lookout tower. Note 1937 sister at right.

original gable end was extended west, eliminating the western hip (*Figs. 2.110-2.111*). Partial original joists extend to where the walls of the original tower would have intersected the roof structure on the north and south roof slopes (*Fig. 2.112*). These rafters have been sistered with full length rafters that extend to the later ridge pole.

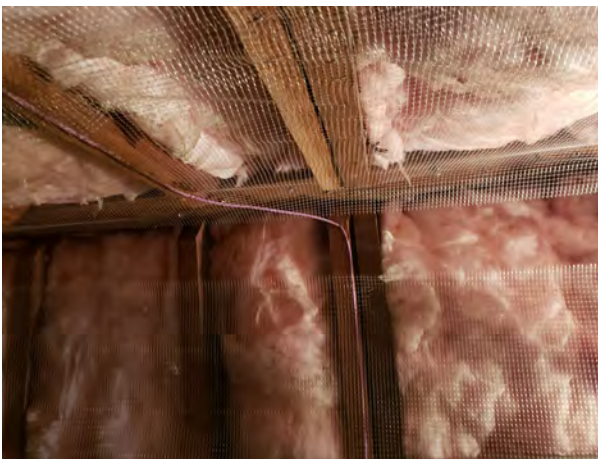
Upper roof framing is exposed at the attic level. A seam is present in the ridge beam where the

**Figure 2.113.** Transition point between 1908 and 1937 ridge pole and rafters.

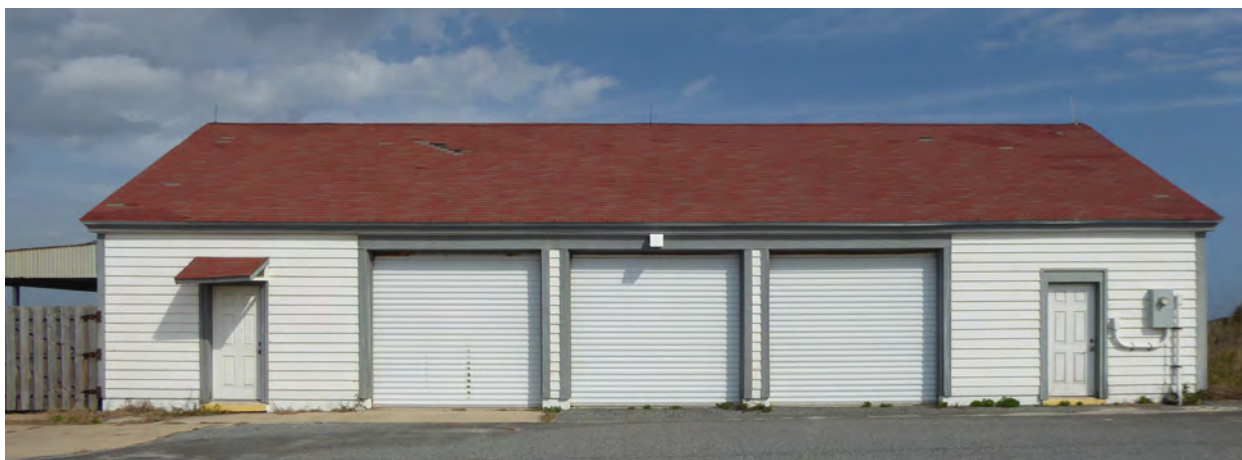
**Figure 2.117.** Garage - West elevation.

The west elevation is divided into five bays, each containing a doorway (*Fig. 2.117*). The center three bays access the central garage bay, while two symmetrical doors in the flanking bays provide personnel access to rooms adjacent to the garage space. Each of the garage doorways holds a modern roll-up metal overhead door. The two personnel doors are pre-hung modern six-panel steel doors. The northern doorway has wood-framed shed-roofed cover clad with asphalt shingles. All doorways have modern lintel-cut plank board casings. The head casing at each of the personnel doors is considerably taller than the current door, suggesting that the original doors were taller. The northern door has a shed-roofed covering. Modern plank corner boards are at each end of the elevation and a simple water table molding with skirt is at the base of the siding. A modern molded cornice is continuous at the eaves.

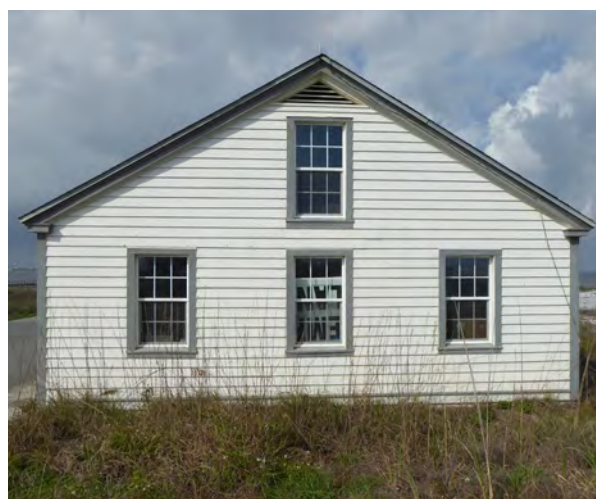
six-over-six-light vinyl window (*Fig. 2.118*). A single window opening at the gable end holds a similar window, but is slightly taller. The attic windows appear to have been enlarged (*Fig. 2.121*). Modern plank corner boards are at each end of the elevation and a simple water table molding with skirt is at the base of the siding. openings at the first floor. A triangular wood louver as at the peak of the gable. The fascia and cornice molding of the east and west elevation eaves turn to form simple returns at the base of the gable end. The rake projects slightly and has a modern molded cornice.

**Figure 2.118.** Garage - South elevation.

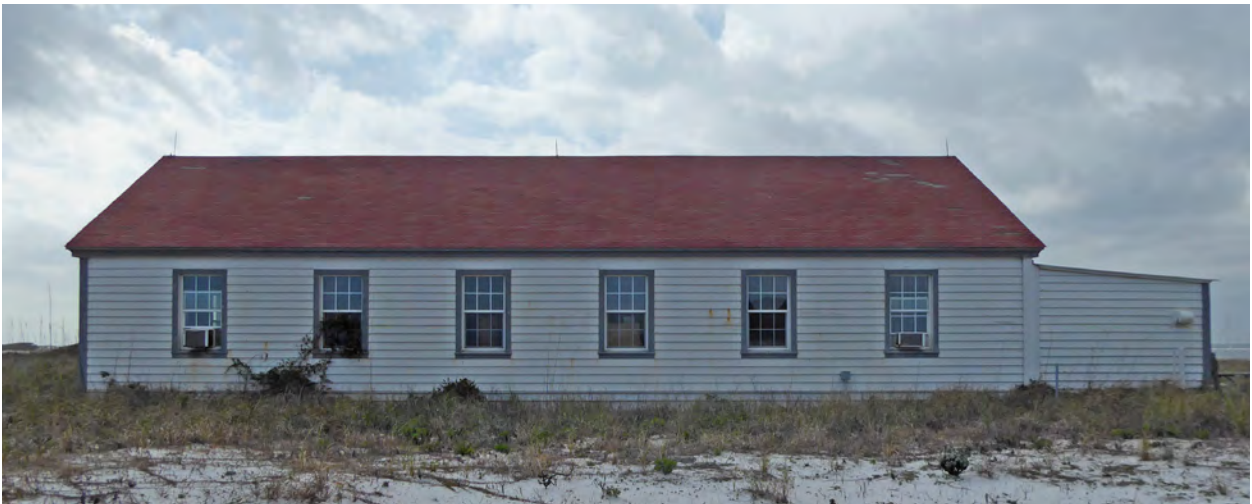
The east elevation has six equally sized and spaced window openings matching those found on the south elevation (*Fig. 2.119*). Typical modern exterior casings, corner boards, and water table are consistent across the elevation. An early cornice molding lines the top of the fascia board at the roof eave. The east elevation of the northern

**Figure 2.119.** Garage - East elevation.

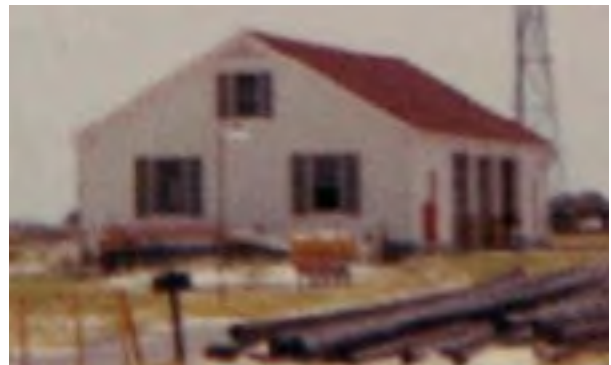
The north elevation is similar to the south elevation, but lacks the central opening at the first floor. The elevation shares the same trim elements as the south elevation, but has early cornice molding at the roof rake and eave returns matching the molding found on the east elevation. A historic photo of the north elevation, likely from the 1970s, shows the condition before the addition was constructed (*Fig. 2.121*). Note that the attic window was considerably smaller and each window opening had shutters installed.

**Figure 2.121.** Garage - North elevation prior to addition. Low photo quality due to structure not being the focus of the original photo. (NPS ID not given, provided March 2020 by previous contracting officer's representative (COR)).

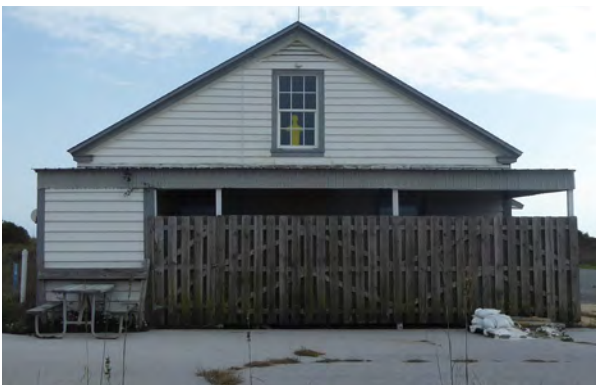
A shed-roofed addition runs the length of the north elevation and has an enclosed space at the east end (*Fig. 2.120*). The north elevation of the enclosed space has no openings, while the west return has a modern six-panel doorway at the south end that accesses a restroom. The remainder

of the shed-roofed structure is an open covering with a corrugated metal roof and matching corrugated fascia. The structure is constructed of modern nominal framing and is supported by three 4x4 posts. A modern shadowbox fence secures the covered area and has a pair of gates at the south end and a small gate at the east end of the north elevation.

**Figure 2.120.** Garage - North Elevation.

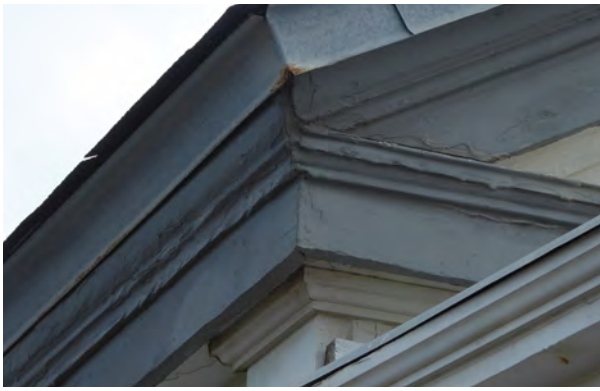
**Figure 2.123.** Early cornice molding and fascia as seen at northwest corner.

The early cornice molding at the eaves and rake on the north and east elevations measures 3" deep by 3½" tall (*Fig. 2.123*). An early molding spans the top edge of the two north eave returns and measures 1¼" deep by 1⅝" tall.

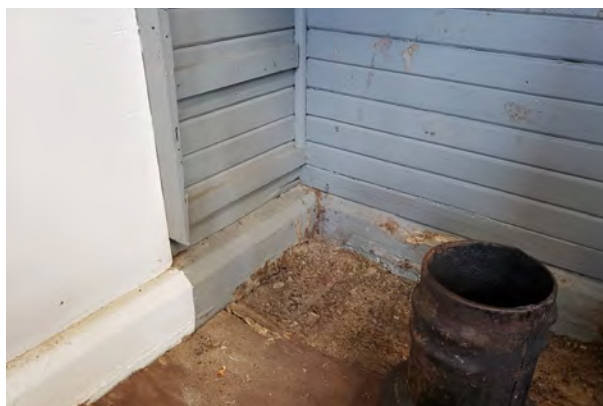
An original concrete curb measuring about 6" tall is consistent at the base of the exterior and original interior walls (*Fig. 2.133*). The height of the curb varies as the floor slab slopes slightly to the west to drain toward the garage doors. The curb has a beveled edge measuring  $\frac{3}{4}$ " tall and is painted grey. A gap in the curb in at the east ends of the interior walls in Room 102 have been infilled with beveled wood and indicate the location and widths of

**Figure 2.133.** Original concrete curb and wall cladding in Room 103.

The north wall of Room 103 has original horizontal double V-groove boards measuring  $5\frac{1}{4}$ " wide by  $\frac{3}{4}$ " thick (*Figs. 2.133, 2.135*). The diagonals of each "V" measures  $\frac{1}{4}$ " wide. The early V-groove cladding is only exposed at the rear and western end of an original piece of casework on the north wall, while the rest of the room is clad with plywood. A  $\frac{3}{4}$ "-wide piece of quarter-round trim is at the intersection of the north and west walls, and is likely representative of the typical original inside corner treatment (*Fig. 2.133*).

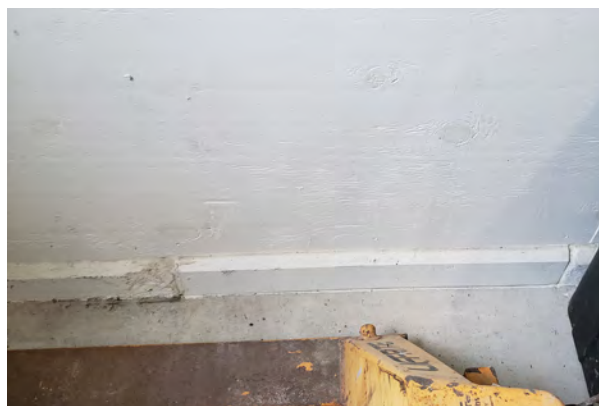
original interior doorways (*Fig. 2.134*). The current interior door between Rooms 101A and Room 102 is spanned by the concrete curb at the threshold, indicating this is likely a new opening.

**Figure 2.134.** Example of wood patch in concrete curb at original interior doorway location in Room 102.

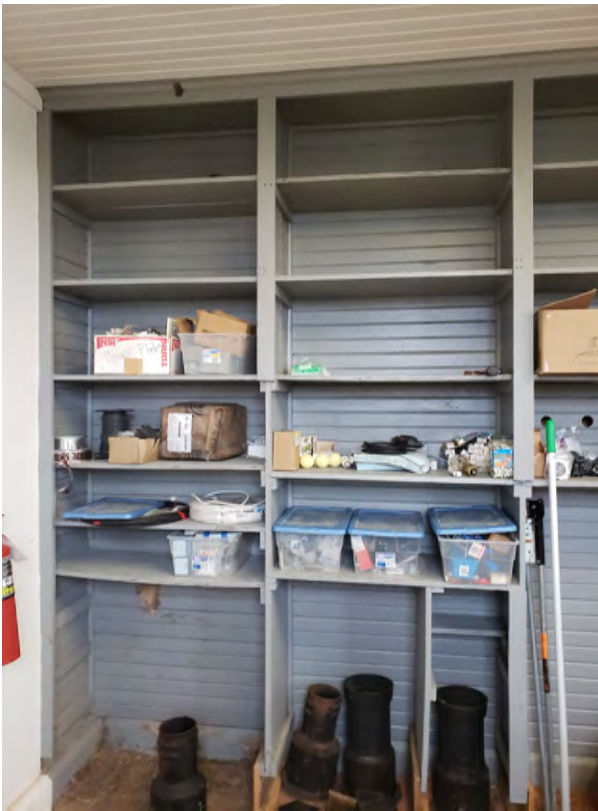
**Figure 2.135.** Original horizontal V-groove boards at rear of casework in Room 103.

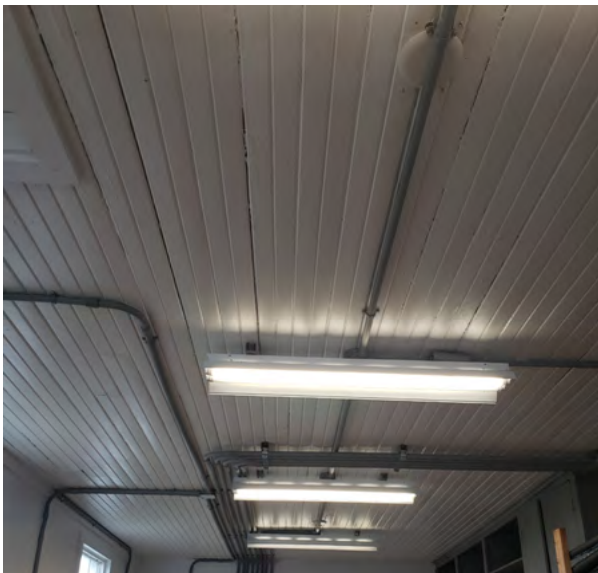
The ceilings in Rooms 101A, 101B, and 103 retain original double V-groove boards matching those on the west wall of Room 103 (*Figs. 2.136-2.137*). The ceiling of Room 102 is finished with modern

**Figure 2.136.** Original v-groove ceiling in Room 103.

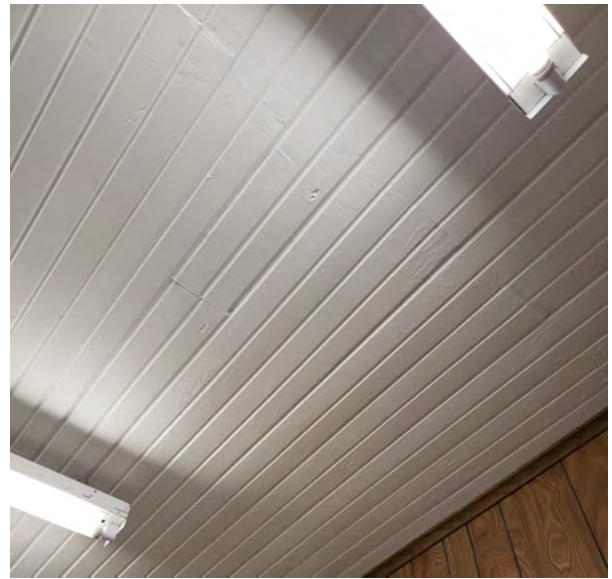
**Figure 2.137.** Original v-groove ceiling in Room 101A. The same ceiling is in Room 101B.

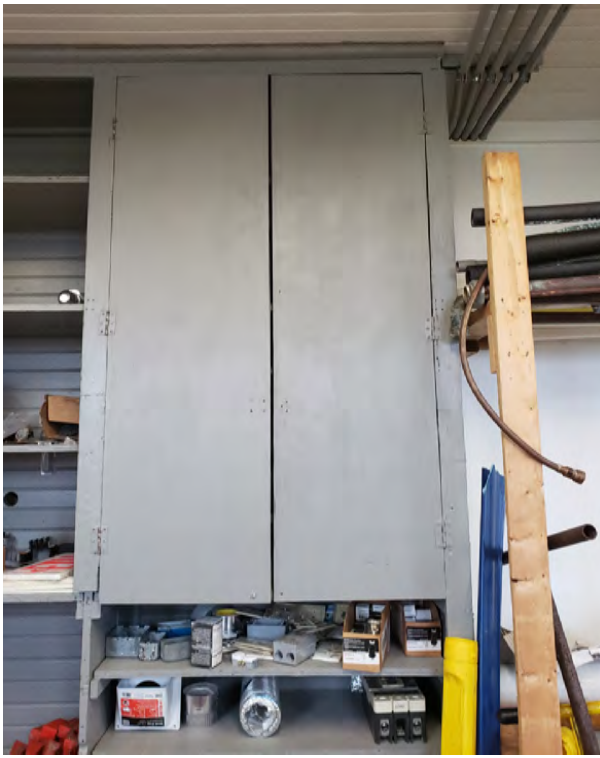
Likely original floor-to-ceiling casework remains on the north wall of Room 103 and consists of four equal sections, the western three of which are open shelving (*Figs. 2.135, 2.138*). The remaining section has a pair of solid wood doors each hung with two surface-mounted 3"-tall cabinet hinges. Holes and ghost marks for hinges indicate that the open bays once had doors of the same design. An original 1½"-tall cove molding lines the top of the casework

**Figure 2.138.** Section of casework with remaining doors in Room 103.
