# Santa Rosa Life-Saving Station and Coast Guard Garage Restoration Feasibility Study

**Restoration Feasibility Report**

**JKOA**

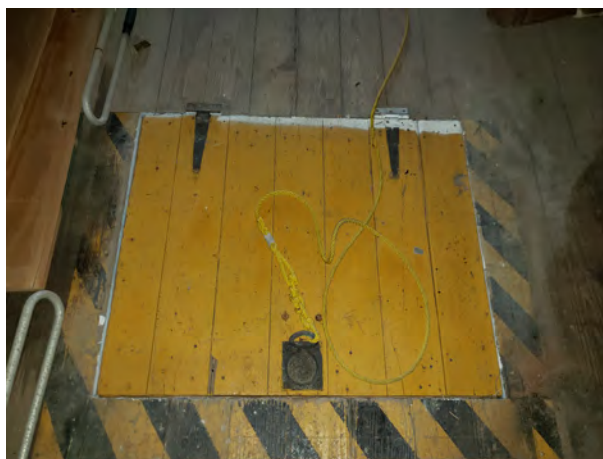
Three floor hatches open to the first floor. Two are located in the center portion of the attic and one is near the south gable end. One of the openings is original and the others are modern. The early hatch at the center portion of the attic measures 3'-0" by 3'-0" and holds a board door consisting of two layers of boards measuring 5¼" wide by ¾" thick. The door is hung with two barn hinges and

has a recessed loop pull. The hinges and hardware appear original (Fig. 2.146).

**Figure 2.146.** Early hatch door in floor of center portion of the attic.

yellow-and-black striped border surrounds the original hatch opening and the hatch itself is painted yellow. These painted details remain from the building's use by the Coast Guard and should be retained.

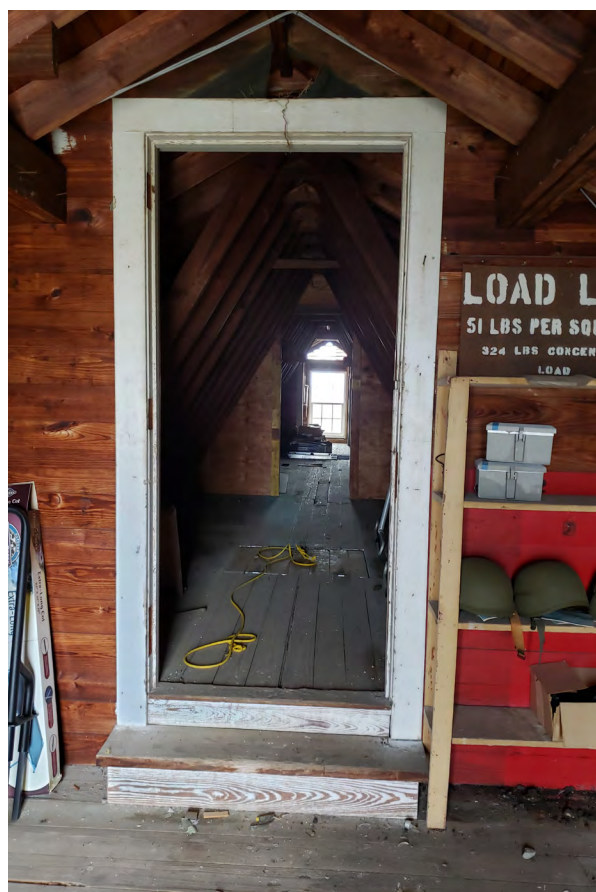
of the north doorway, and an incised mark for a similar keeper remains on the south doorway. Each doorway has lintel-cut plank board casings measuring 4½" wide by ¾" thick with rounded edges (Fig. 2.147). Given the utilitarian character of the garage, it is plausible that similar casings were originally in place at doorways and potentially window openings at the first floor.

**Figure 2.147.** Typical doorway and casing in attic.

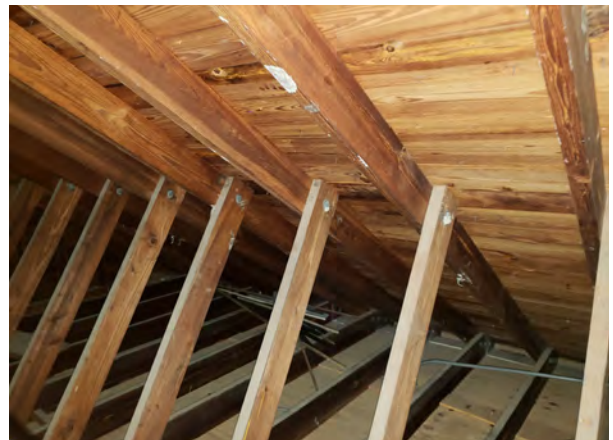
The joists at the attic level measure 1½" wide by 7½" deep and are spaced at 16" on center (Fig. 2.150). At the north and south ends of the building, the joists span north-south, while joists at the center portion span east-west. The joists are through-bolted at each roof rafter within the center section.

Rafters are consistent throughout the attic and measure 1½" thick by 5¼" deep spaced at 16" on center (Figs. 2.149-2.151). The diagonal members of the center section have the same dimensions as the rafters and form an A-frame at the center. Collar ties at each truss measure 1½" thick by 7½" deep. The rafters are bolted to the diagonal members at the ridge and there is no ridge pole (Fig. 2.151). Additional diagonal member support the rafters at their midspan and measure 1½" thick by 7½" deep. The diagonals are bolted to the rafters and to the ceiling joists (Fig. 2.150).

**Figure 2.150.** Diagonals at the midspan of the rafters of the center portion. Note exposed floor joists and topside of plywood ceiling of Room 102.

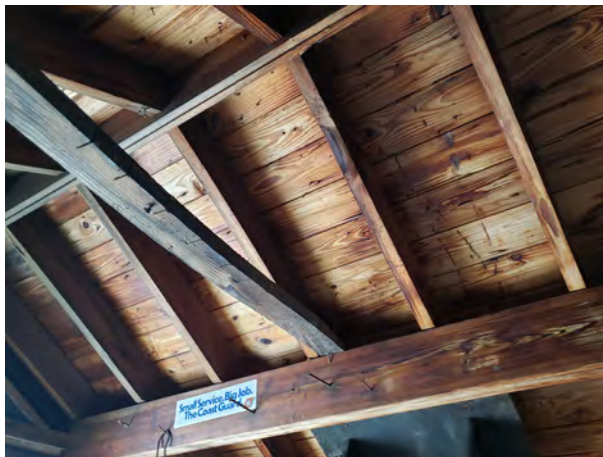
members (*Figs. 2.152-2.153*). The beam bears on the gable end framing and on the east-west partition walls. Tongue-and-groove decking boards measure 5¼" wide by ¾" thick. Unlike the center section, there is a ridge pole that is made up of two ¾"-thick by 7½"-deep members (*Fig. 2.152*).

**Figure 2.152.** Ridge pole at north and south ends of the attic.

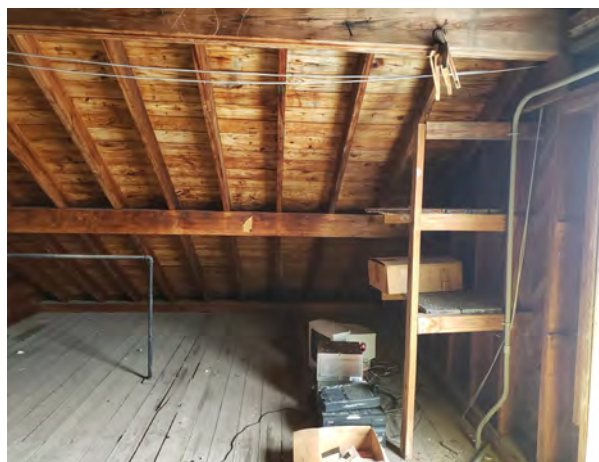
At the north and south ends, the rafters are supported at the one-third points by two beams each made up of three 1¾" thick by 7½" deep

**Figure 2.153.** Roof framing at ends of attic. Note pair of beams supporting the rafters.
